ASBESTOS MANAGEMENT PLAN

Downtown Carpark

Prepared for Auckland Transport | 07-Feb-2020

Asbestos Management Survey

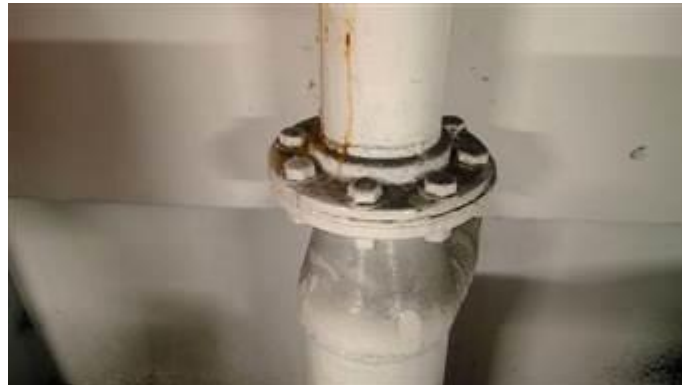
Photo No: S-002

Asbestos Type: No Asbestos
Detected

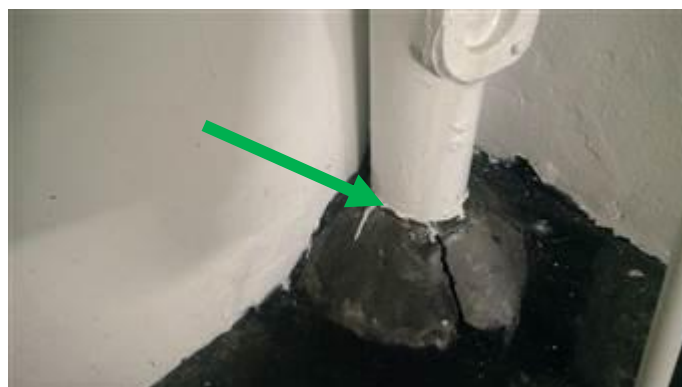
Photo No: S-003

Asbestos Type: No Asbestos
Detected

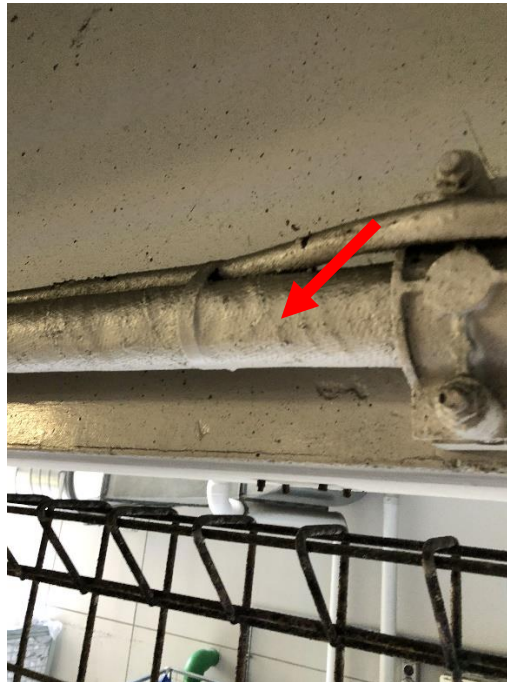
Photo No: S-004

Asbestos Type: Chrysotile
