Project Number #18043.000.001

**Preliminary Environmental Site
Investigation**

118 Montgomerie Road, Manukau, Auckland

Goodman Nominee (NZ) Limited

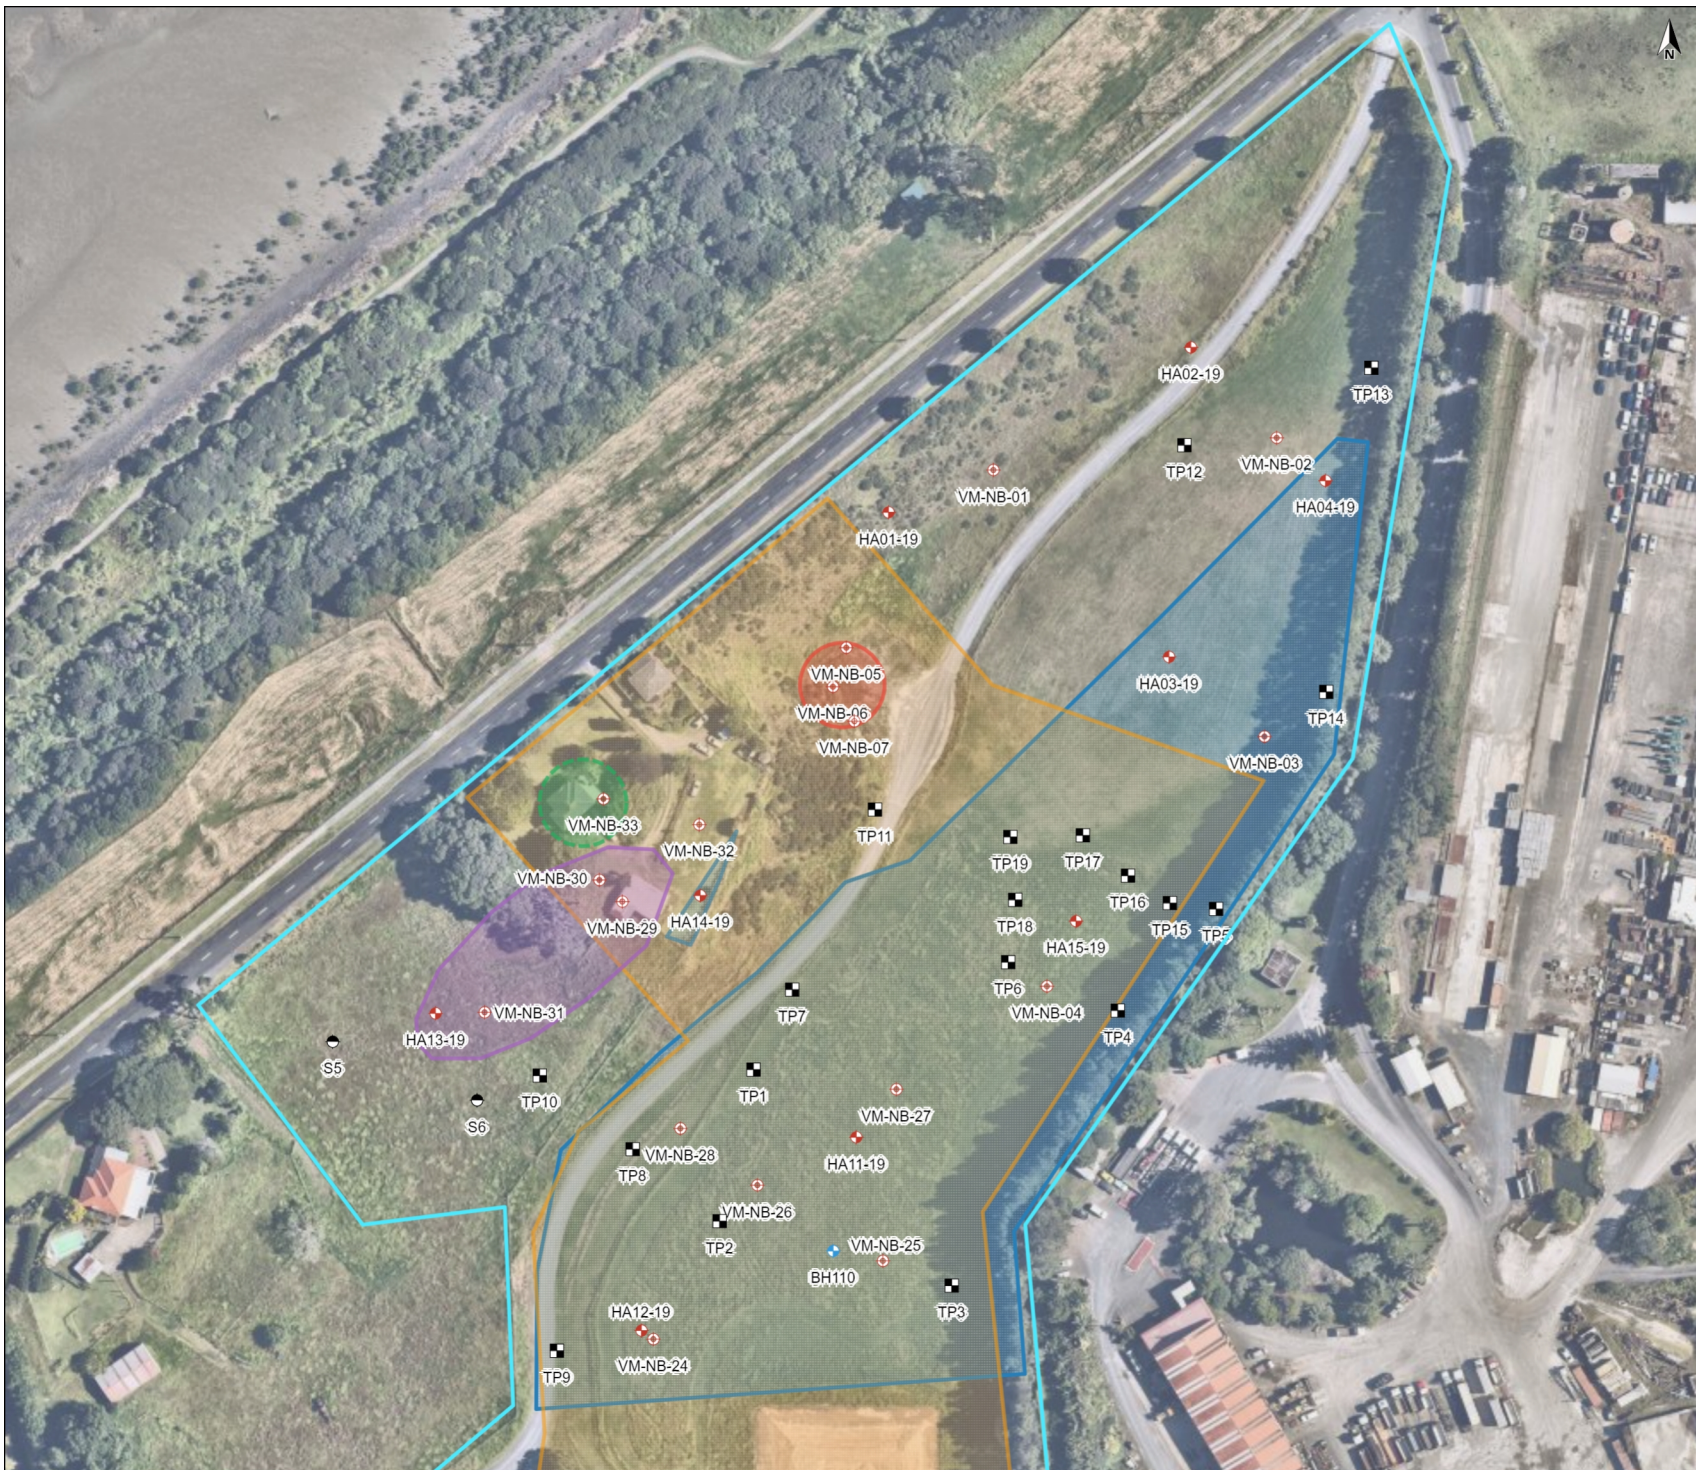
Title: Previous Investigation Location Plan - North		
Client: Goodman Nominee (NZ) Limited	Size: A4	
Project: Oruarangi Road, Mangere	Drawn: VP	Figure: 2a
Date: 07-03-2024	Checked: EM	
Proj No: 18043.000.001 Plan Change	Scale: 1:2100	Version: 2.0

This investigation report was included as an appendix to the 4Sight consulting report discussed below. It involved the excavation of 19 test pits across the northern portion of the site, shown on Figure 2a. Fill was encountered in several holes to a maximum depth of 2.1 metres near the southern half of the 350 Oruarangi Road property. Fill was described as containing various proportions of mixed topsoils, decomposed wood and vegetation, broken bricks, concrete, gravels, and in one location glass and steel. Based on this and the additional fill identified in the 4Sight Consulting (2019a) and CMW (2020) investigations below, an estimated fill extent polygon is shown on appended Figure 2a.

A sample of soil was collected below the stockpile of treated timber fence posts in the north-western side of 350 Oruarangi Road (shown in a red circle on appended Figure 2a). Arsenic in this sample was detected at 71 mg/kg, just above the commercial / industrial guideline value of 70 mg/kg (MfE, 2011b). This minor soil impact is considered to be local to the area immediately beneath the stored timber and not representative of the wider site soils. The laboratory results summary table is included in Appendix 3 for reference.

Fill was identified in four locations within the northern area of site (Figure 2a):

- HA03-19 – silty sand fill to 0.3 metres depth (in the north of the investigation area);
- HA04-19 – silty sand fill to 0.5 metres depth (in the north of the investigation area);
- HA11-19 – clayey silt fill to 1.0 metres depth (suspected fill; in the centre of the investigation area); and
- HA14-19 – clayey silt fill to 0.4 metres depth (east of the dwelling shown in Figure 2a).

- Two shallow soil samples were collected from the paddock at 400 Oruarangi Road (labelled S5 and S6 in Figure 2a) to provide site coverage and assess potential impacts from buildings / building use in this area.

Investigation location labelled BH110 on Figure 2a (in the north of the site) identified fill to 2.5 metres below ground level which comprised of clayey silts with minor gravel of basalt. No anthropogenic material was logged and the location suggests that it is reworked native soil used to fill in the former swamp in this location.

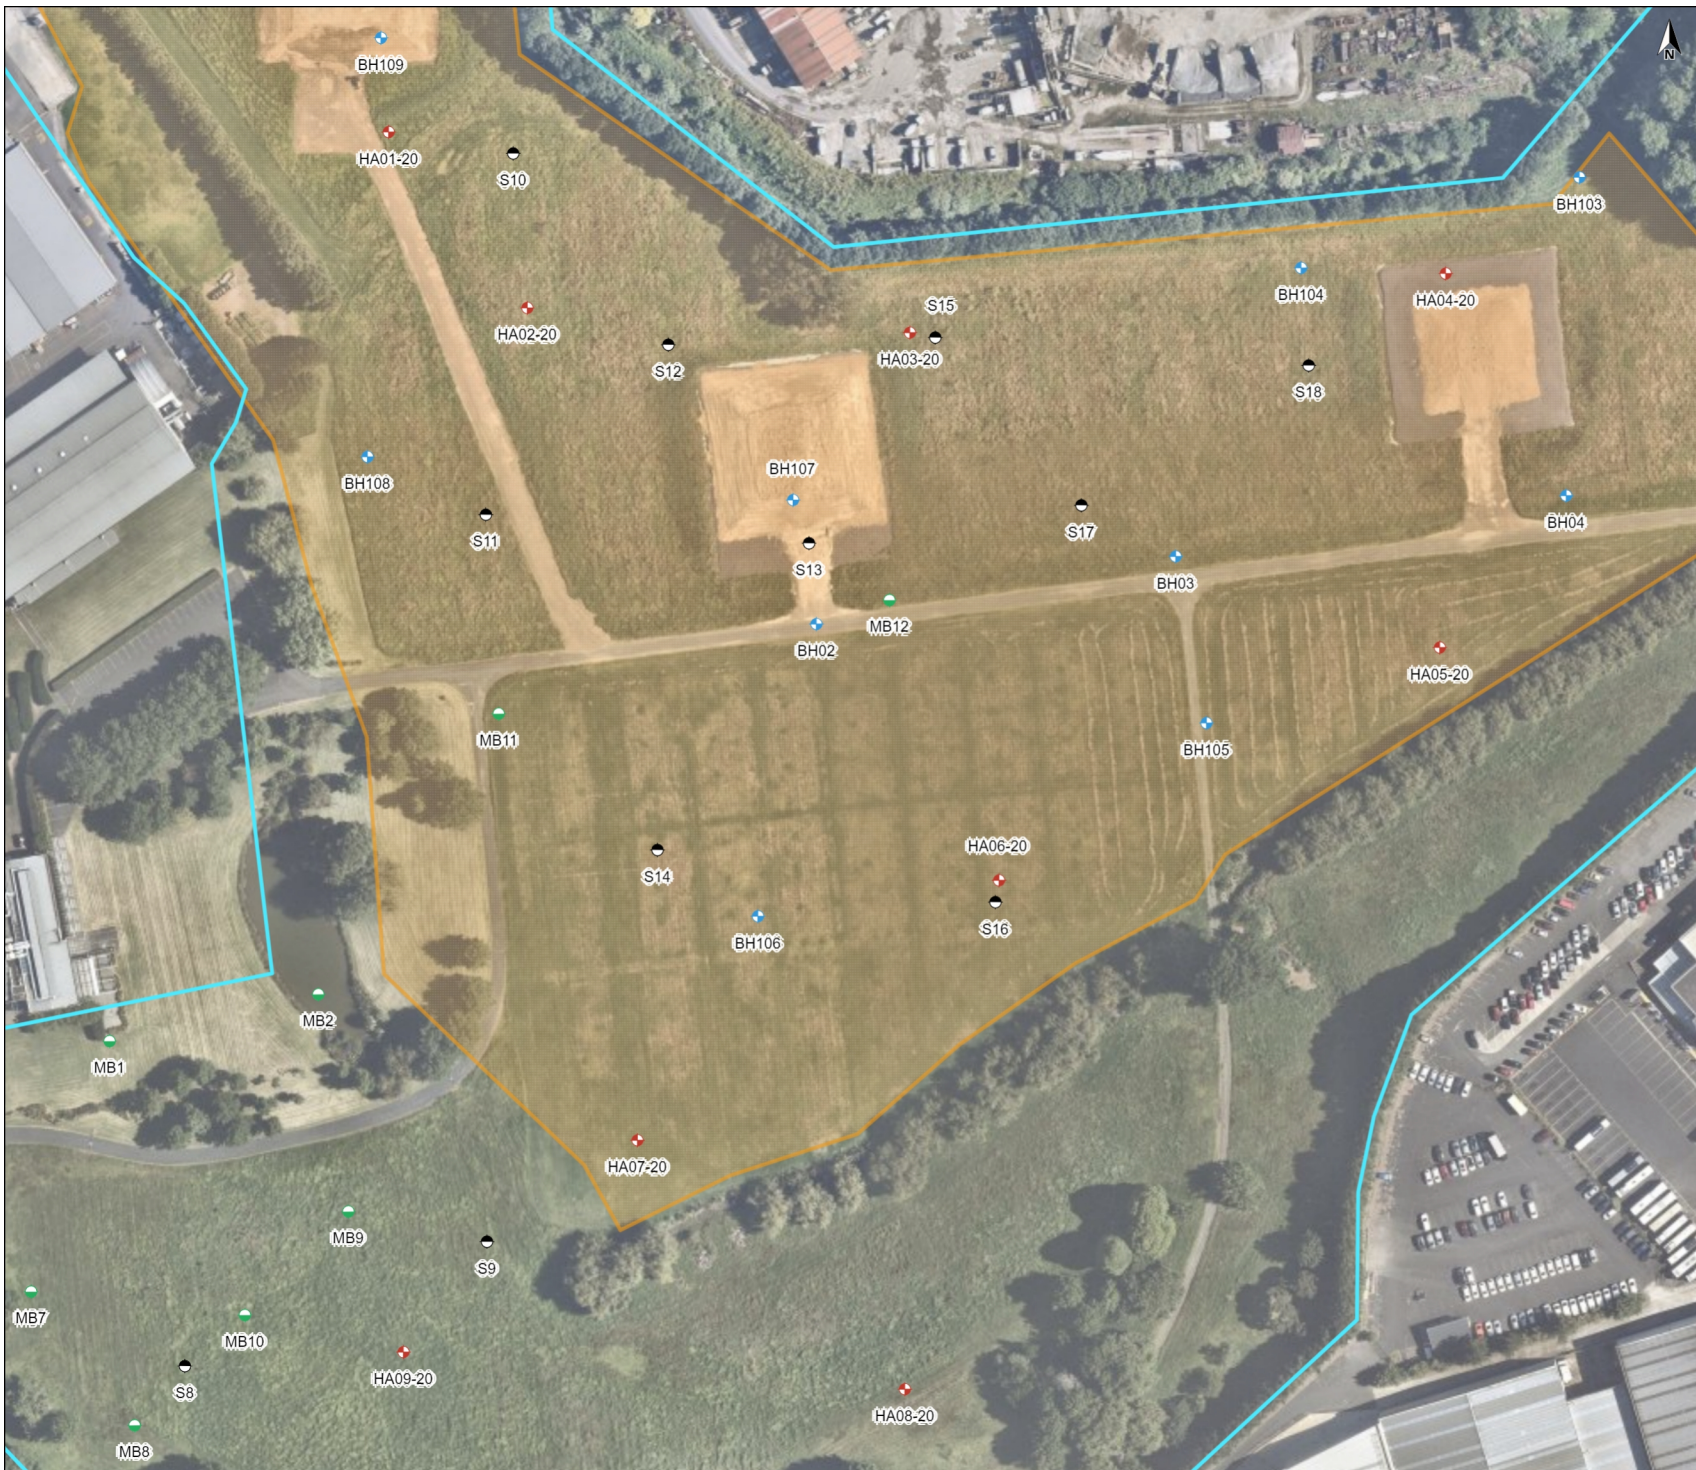
Title: Previous Investigation Location Plan - Central		
Client: Goodman Nominee (NZ) Limited	Size: A4	
Project: Oruarangi Road, Mangere	Drawn: VP	Figure: 2b
Date: 07-03-2024	Checked: EM	
Proj No: 18043.000.001 Plan Change	Scale: 1:2143	Version: 2.0

- Two shallow soil samples were collected from the landscaped area south of the present Villa Maria buildings, on the crater floor (samples labelled S7 and S8 in Figure 2b). This area was subject to horticultural land use from the mid-1980s till early 2000s. Both samples were analysed for heavy metals / metalloids (including mercury) which were identified to be below naturally occurring background concentrations for volcanic soils (AC, 2016).

Four samples from two locations (S14 and S17 on Figure 2b) contained concentrations of contaminants above naturally occurring background levels.

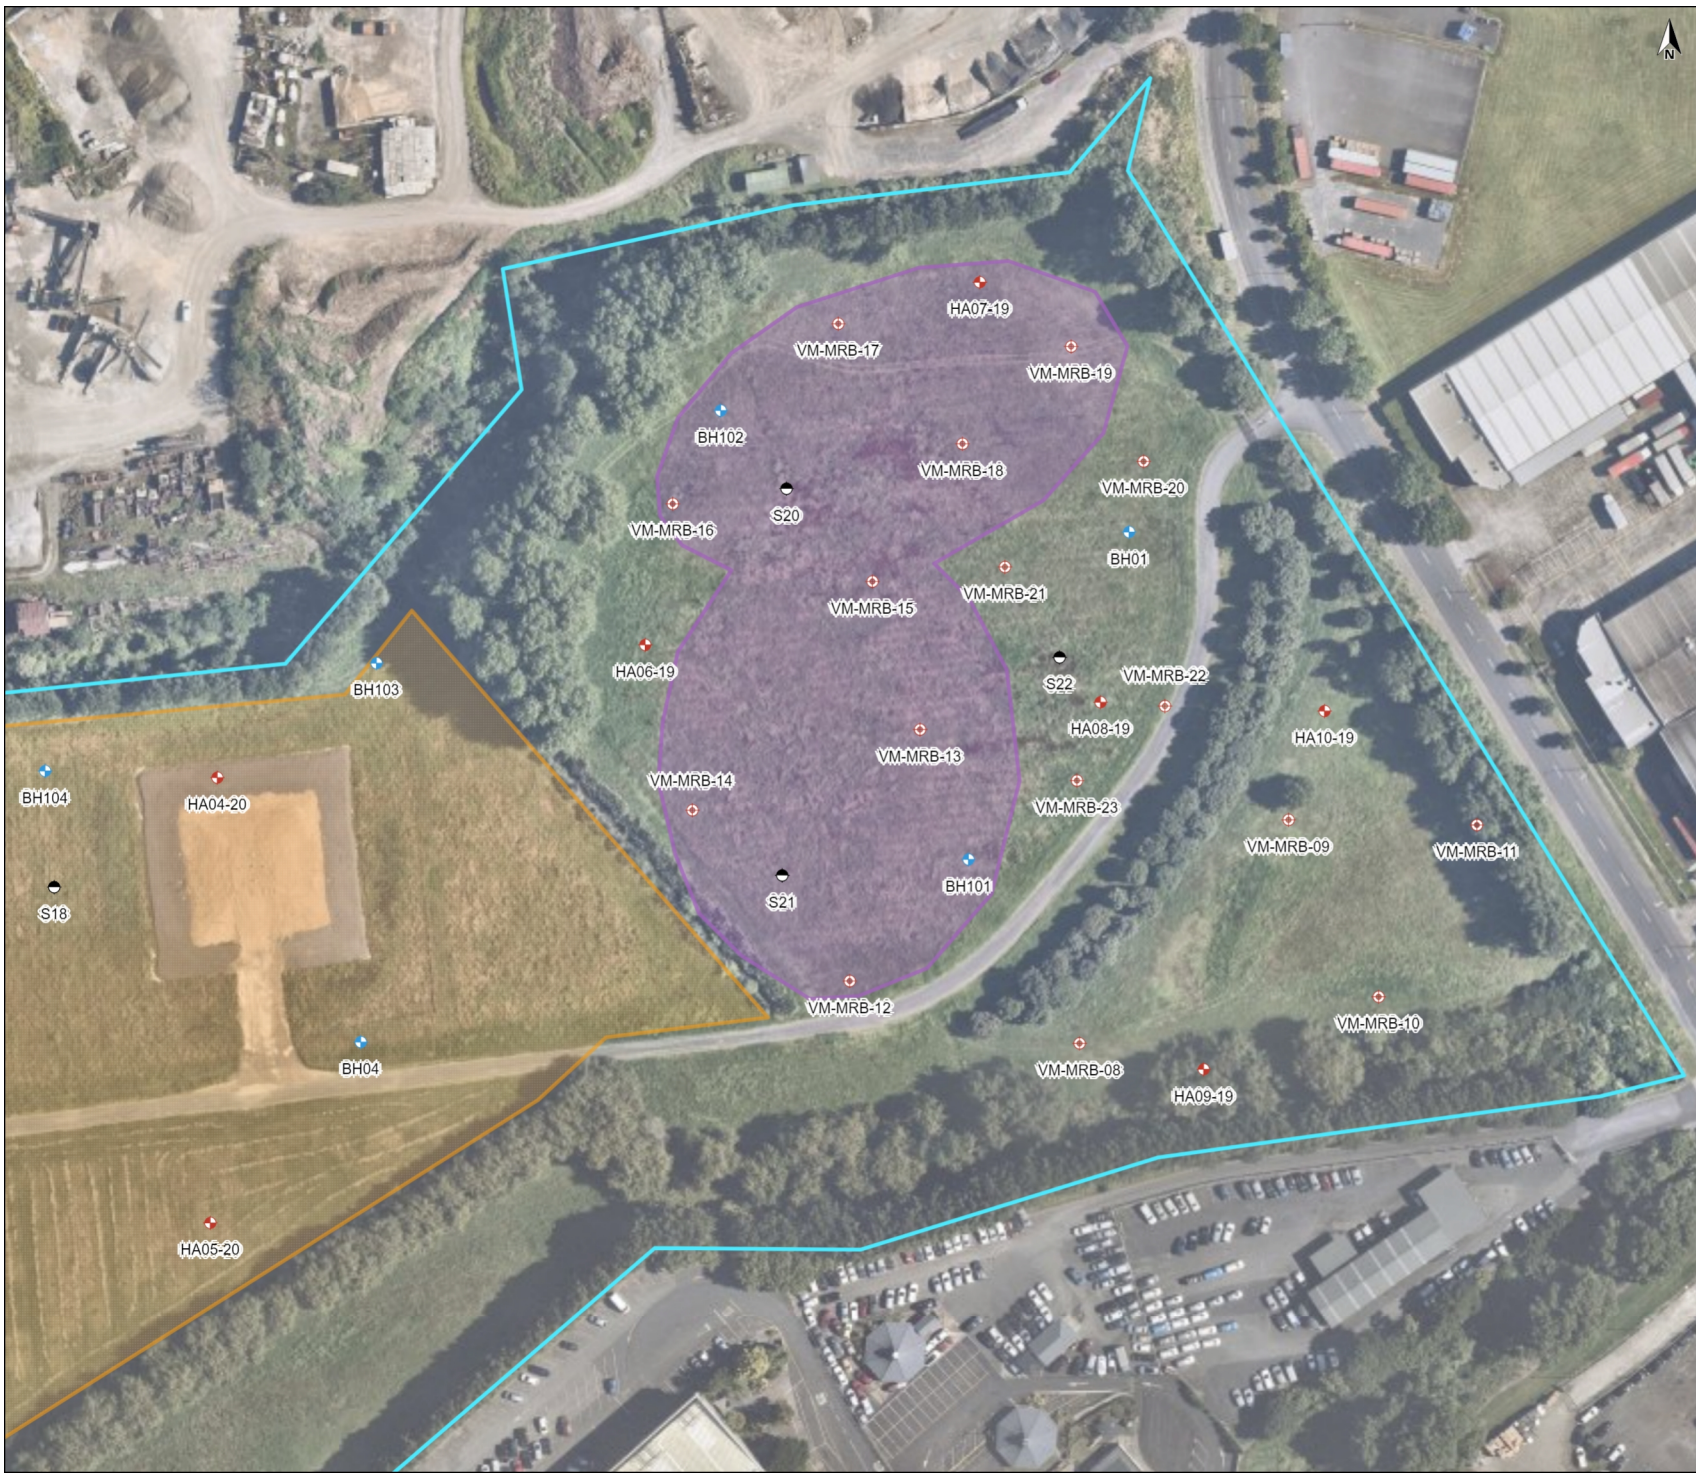
Title: Previous Investigation Location Plan - East		
Client: Goodman Nominee (NZ) Limited	Size: A4	
Project: Oruarangi Road, Mangere	Drawn: VP	Figure: 2c
Date: 07-03-2024	Checked: EM	
Proj No: 18043.000.001 Plan Change	Scale: 1:1800	Version: 2.0

The investigation focused on the eastern end of the site (shown on appended Figure 2c)

Surface topsoil samples were collected from sixteen sample locations and composited into four samples. Samples were analysed for lead, arsenic, copper and OCPs. No OCPs were detected above the laboratory limit of reporting. The report assessed soils against both the non-volcanic and volcanic background levels for metals. The non-volcanic background levels for copper were exceeded, whereas the volcanic background levels were not. Recent geotechnical investigations (Initia, 2022) have identified Auckland Volcanic Field soils at the surface in this location (boreholes BH101 and BH102), indicating that the volcanic soil criterion for copper would be more appropriate for comparison against. A copy of the investigation location plan is included as Figure 2c.

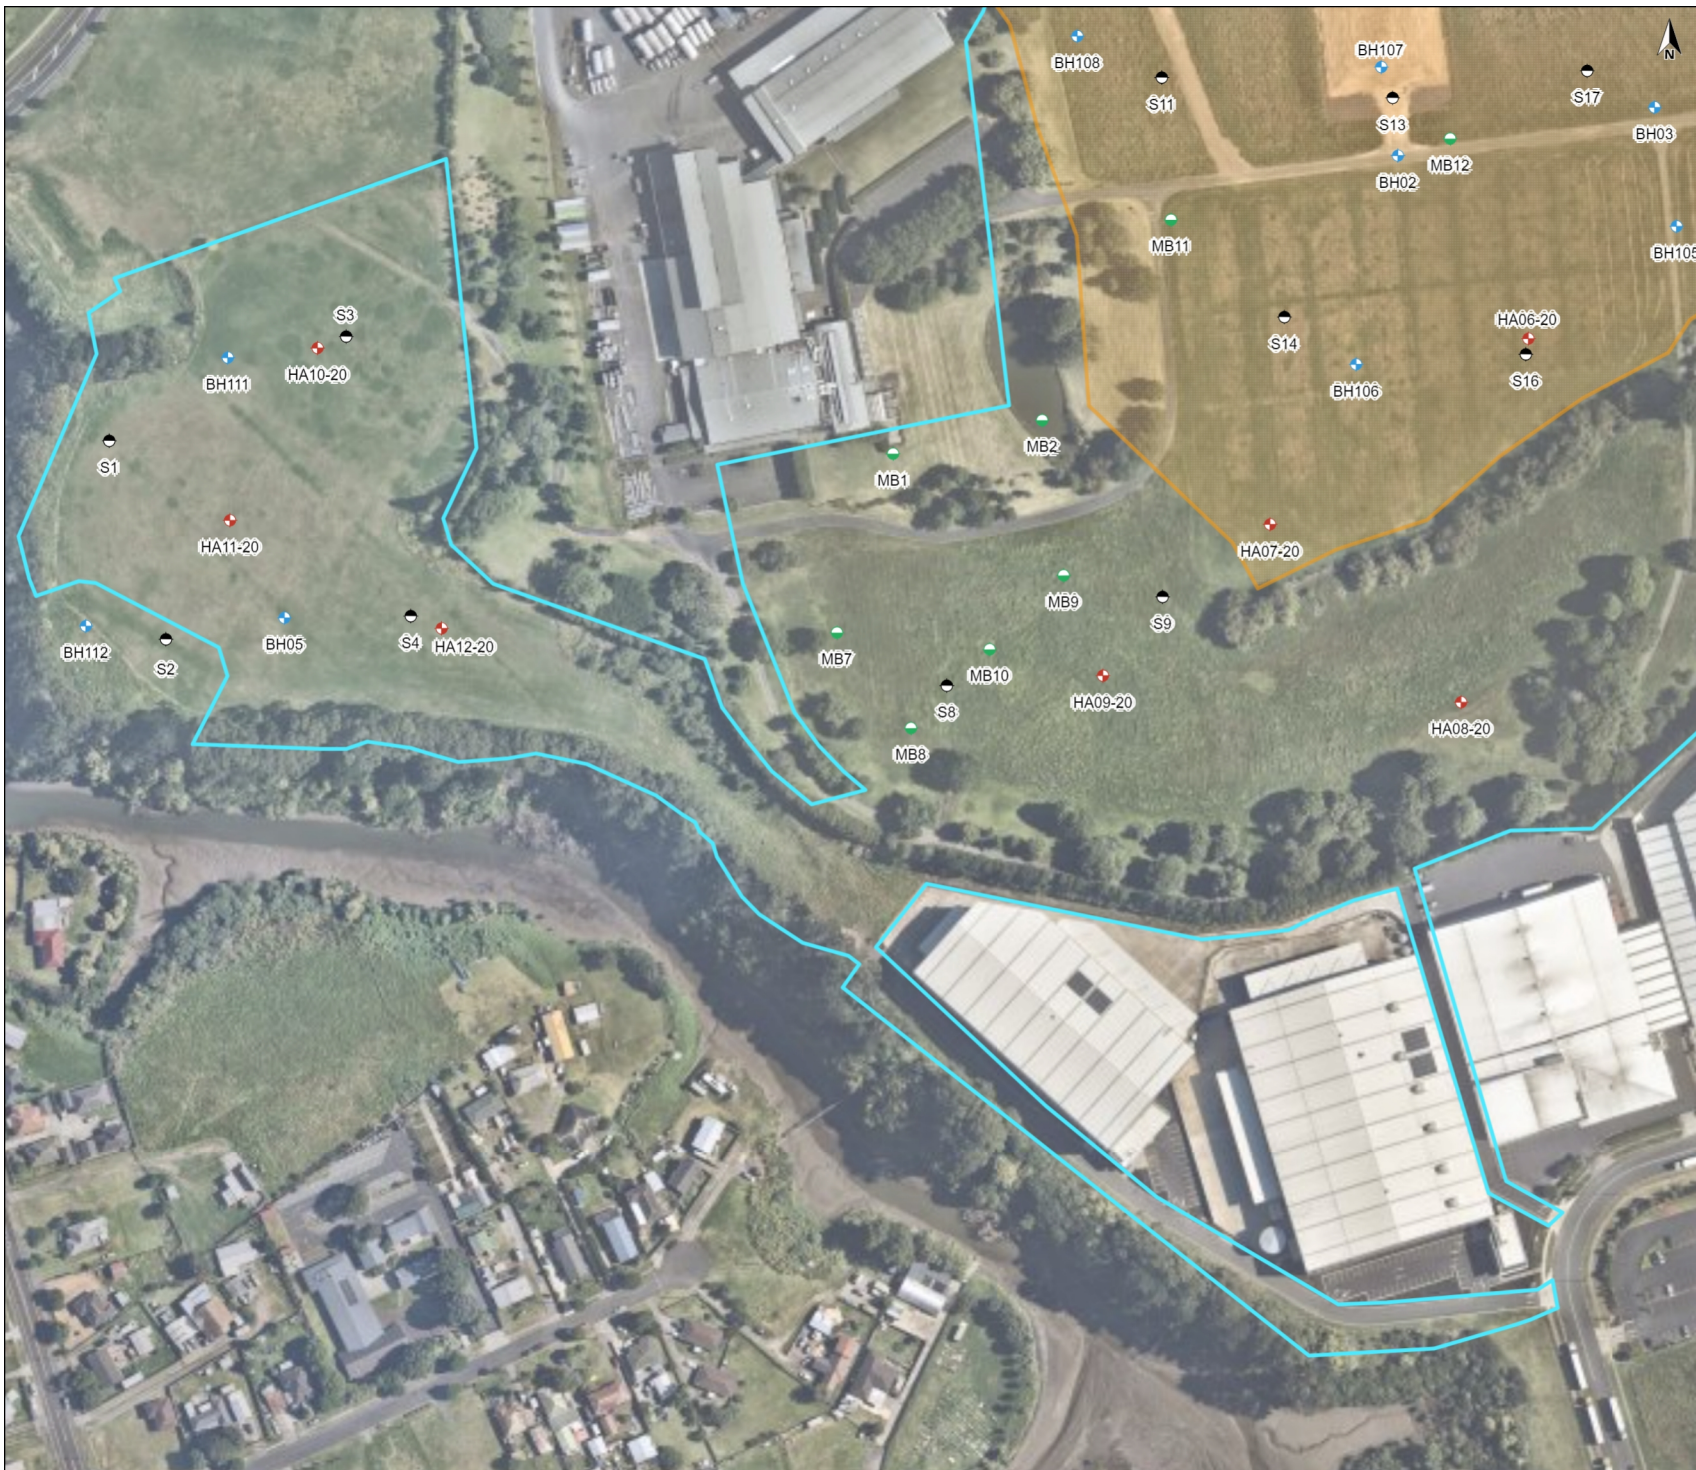
Title: Previous Investigation Location Plan - South		
Client: Goodman Nominee (NZ) Limited		Size: A4
Project: Oruarangi Road, Mangere	Drawn: VP	Figure: 2d
Date: 07-03-2024	Checked: EM	
Proj No: 18043.000.001 Plan Change	Scale: 1:3000	Version: 2.0

- Four shallow soil samples were collected from the relatively flat land at the top of the tuff ring in the southeast of the site (labelled S1 – S3 on Figure 2d). Based on historical aerial imagery, this area was subject to horticultural / orcharding land use between 1987 and 2001. Three samples of shallow topsoil were selected for analysis of heavy metals / metalloids and OCPs. Concentrations of heavy metals / metalloids were within naturally occurring background ranges for volcanic soils (AC, 2016) and OCPs were not detected above the lower laboratory limit of reporting.

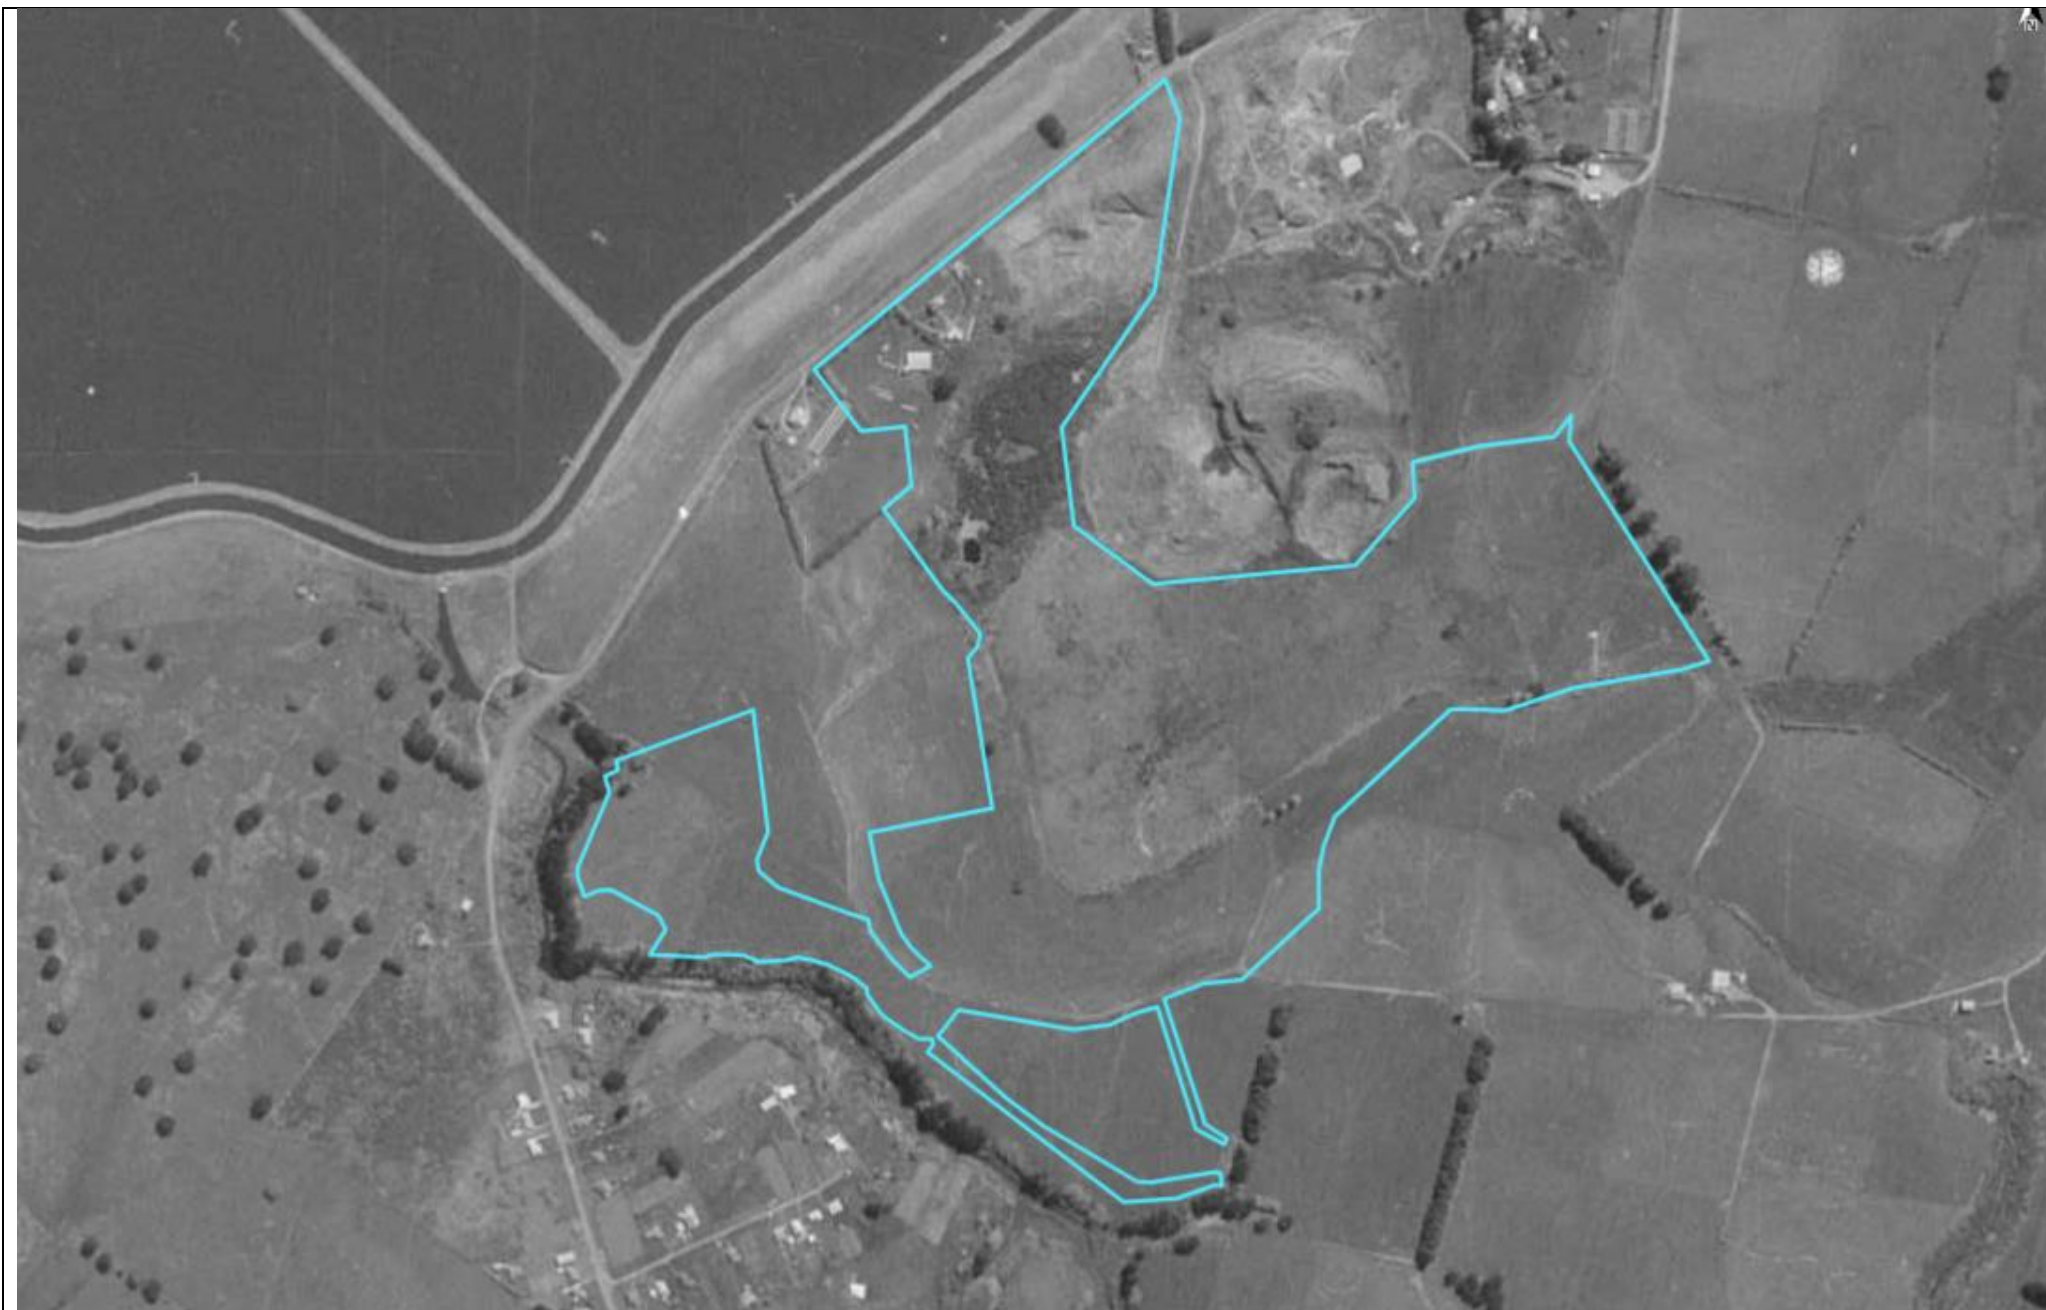
Historical Imagery – 1968
Source: Retrolens

By 1968 a large farm shed has been constructed in the northwest of the site, to the south of the dwelling at the 400 Oruarangi Road address (northern corner of the site). Standing water can be observed in the south of the remaining swamp area in the central north of the site.

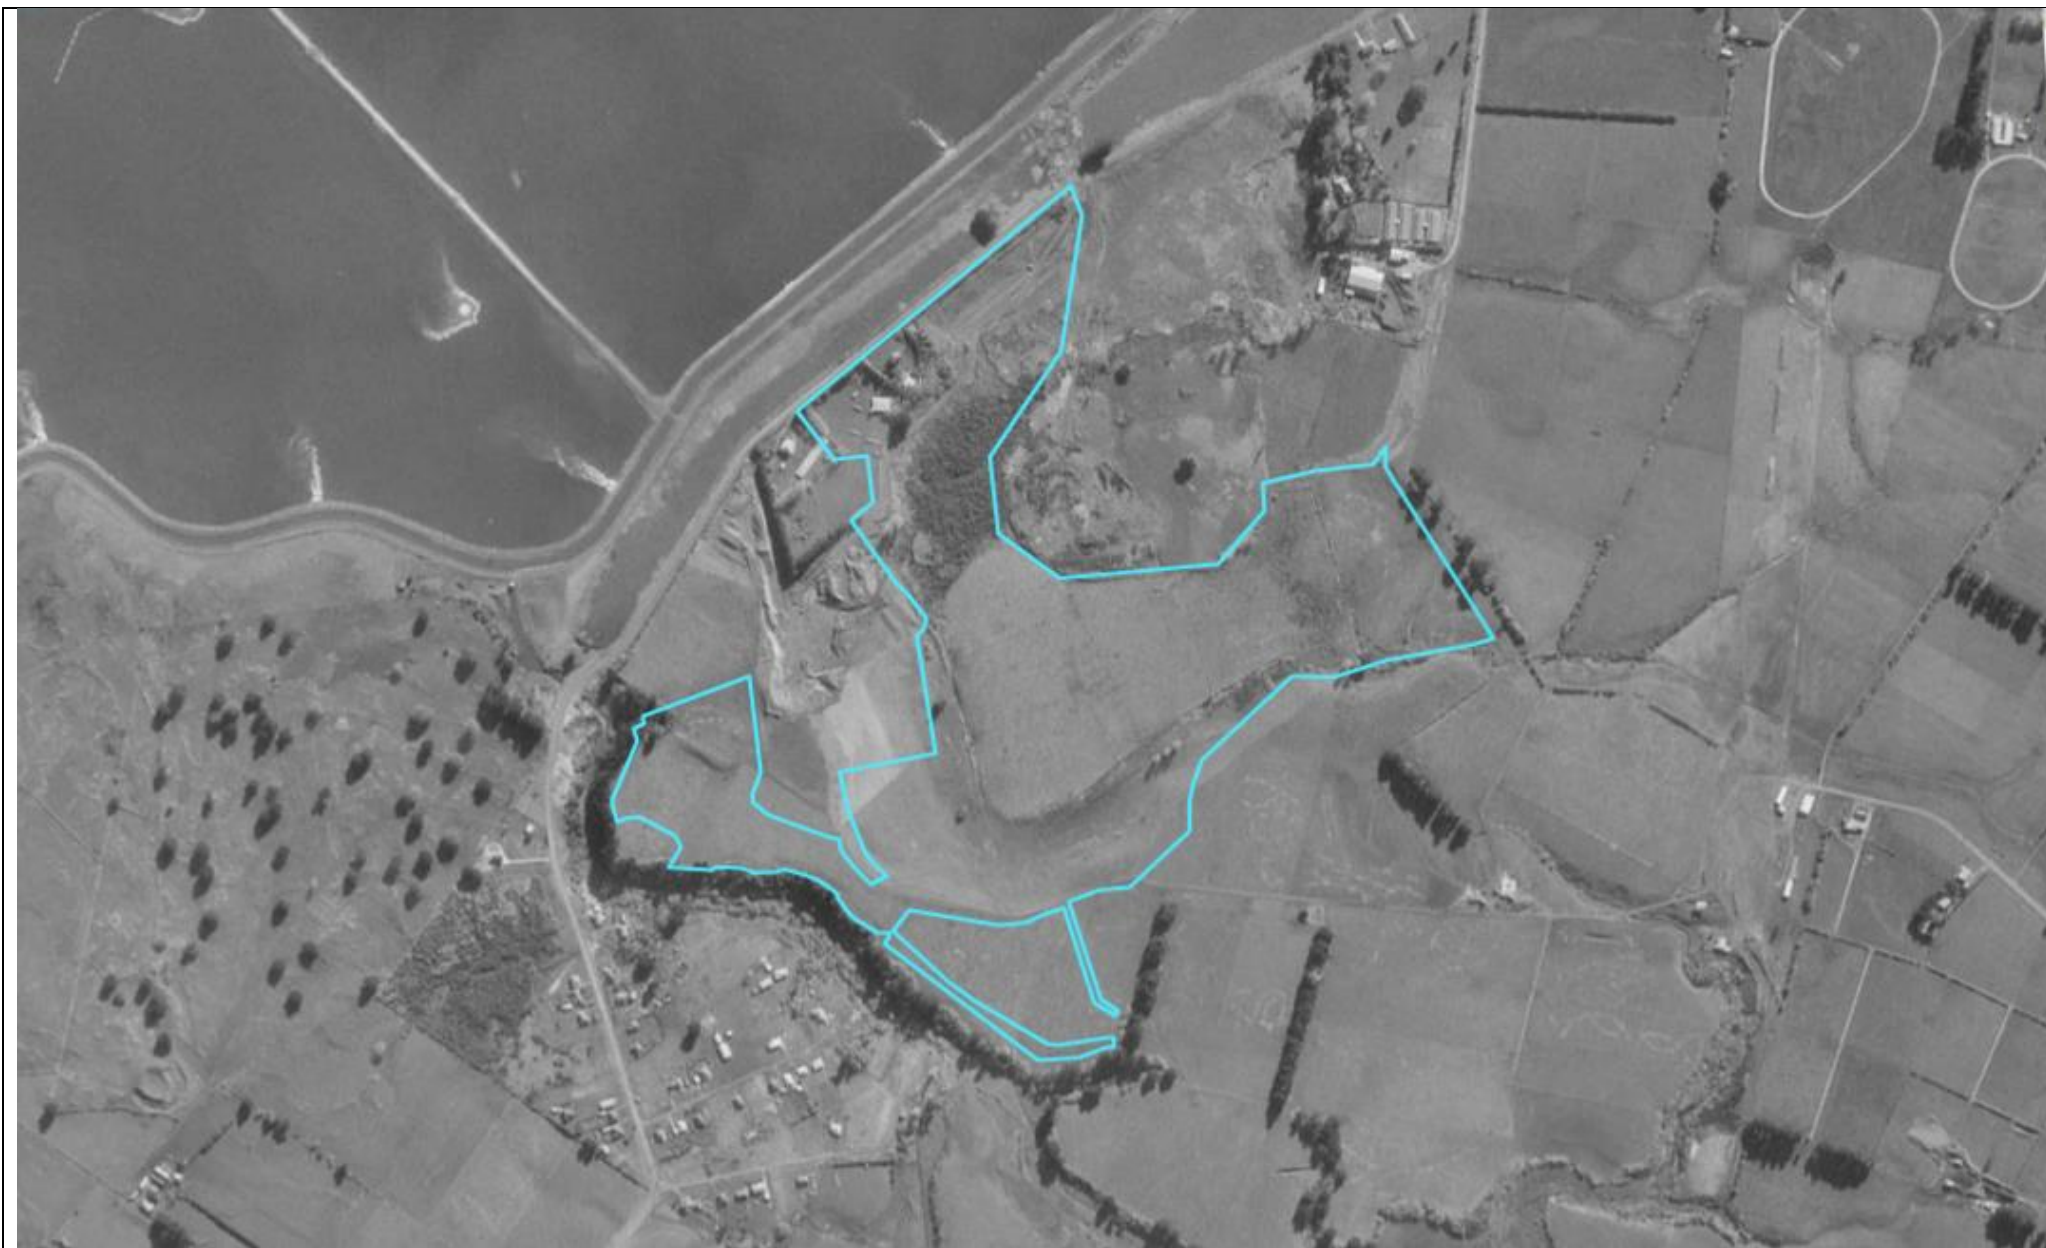
Historical Imagery – 1975
Source: Retrolens

By 1975, the volcanic cones have largely been removed, and the land which is now 350 Oruarangi Road appears to be being surface stripped / quarried (northern end of the site).

The 1975 image shows significant earthworks (cut) on the 470 Oruarangi Road property (not currently assessed), and there appears to be reinstatement of the former quarried areas at the eastern end of the property at 350 Oruarangi Road (north of the site)
