Date: 17 April 2024

COPY TO: Matt Ashworth, Trevor Canty (Neil Group Ltd) Document No: 10139-003-2

WHENUAPAI BUSINESS PARK – STREAM CONDITION ASSESSMENT

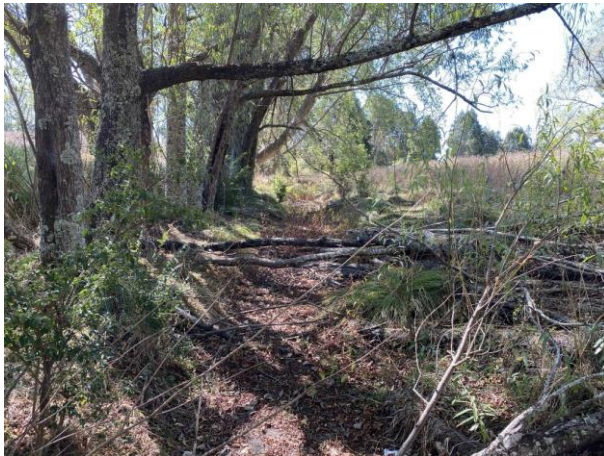
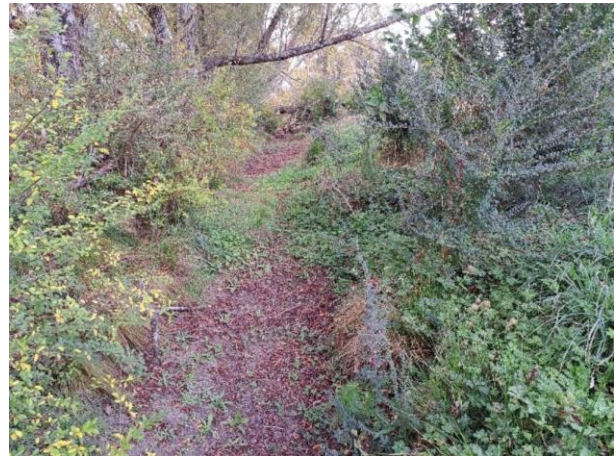
Photo point C was located near the upstream extent of the watercourse. The channel was represented by a formed, but shallow depression. Leaf litter and debris was present on the base suggesting no recent flushing flows. No significant changes in the reach of stream were observed with the exception of continued growth of vegetation. Exotic weeds such as woolly nightshade and privet were abundant and appeared to be more prolific than during the 2020 survey. Channel form was largely unchanged despite the significant flood event in 2023.

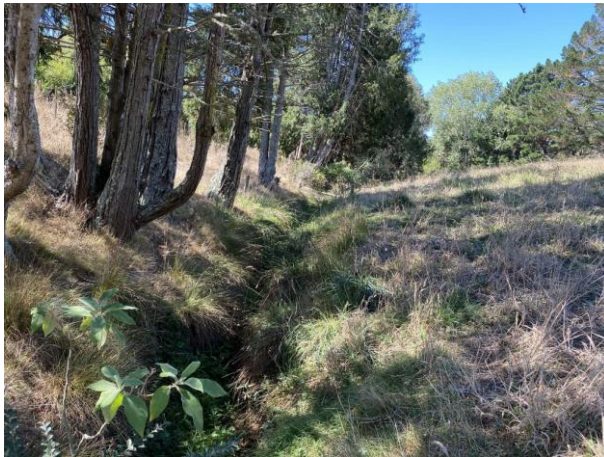
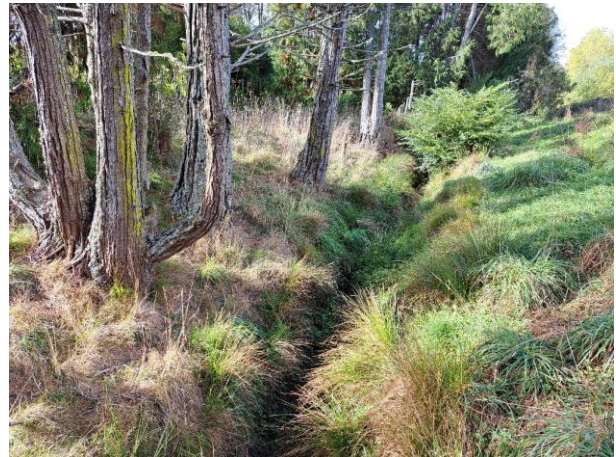
Photo point E1 was located directly south of the Spark NZ facility on Brigham Creek Road. The channel was moderately incised during both the 2020 and 2024 surveys. There were no significant changes in channel condition, despite the significant 2023 flood event. Vegetation growth along the channel banks had increased, likely due to the removal of grazing stock.

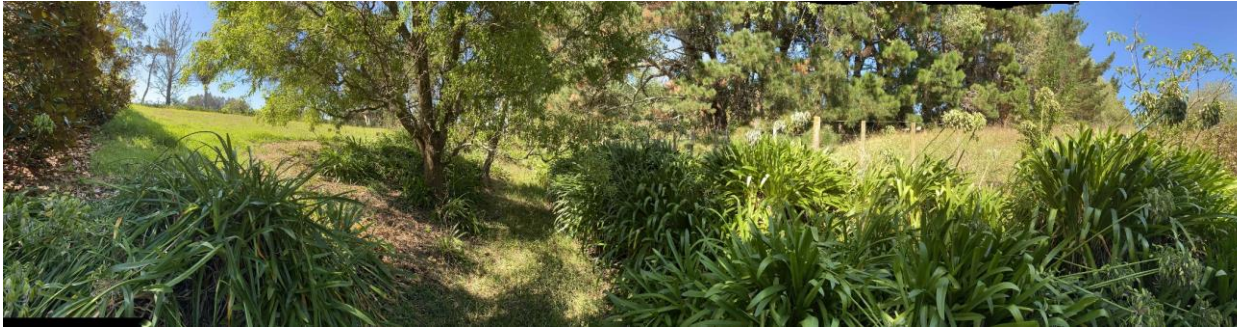
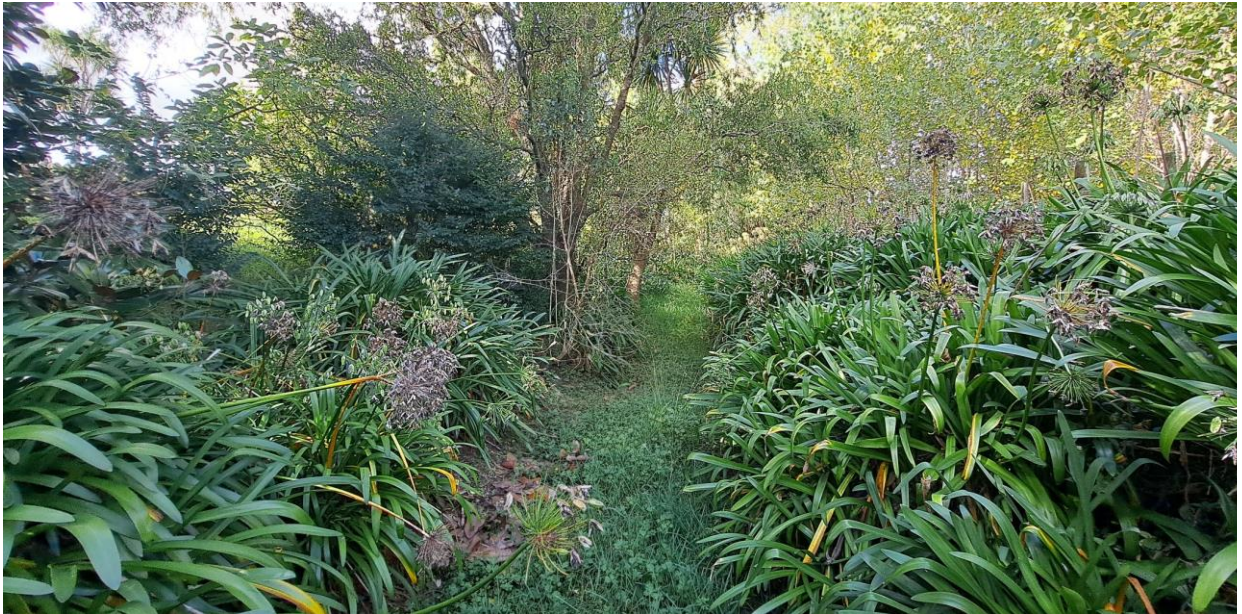
Photo point H2 was located in what would have been the front garden of the main house at 151 Brigham Creek Road, which has been demolished. There were no significant changes in the channel or banks, despite the 2023 flood event. The channel was defined and not incised. During both surveys, the channel contained terrestrial vegetation, indicating it is not regularly inundated. The banks were characterised by abundant agapanthus, along with other garden and ornamental plants and trees.

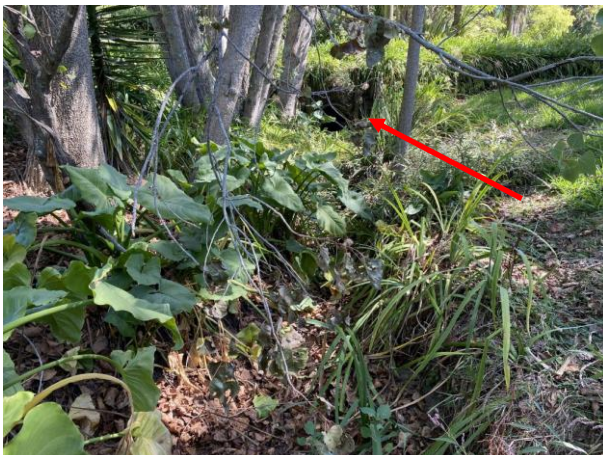
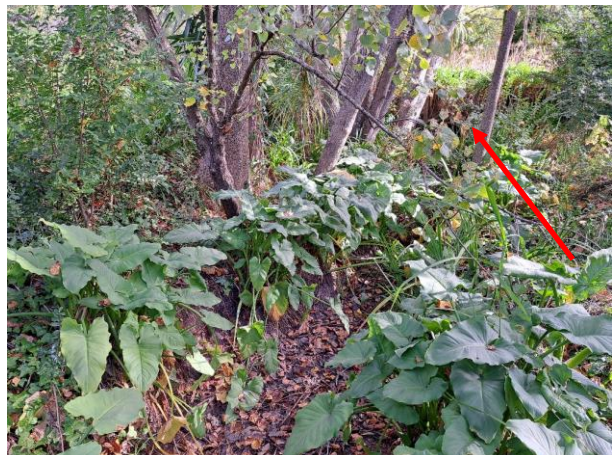
Photo point K was located looking upstream, towards the culvert (indicated by the red arrows) that would have provided access to the main house at 151 Brigham Creek Road (now demolished). The channel was ill defined, and occupied a shallow vegetated depression. During both surveys the channel was entirely filled with leaf litter, suggesting no flushing flows. There was no evidence of scour or erosion, including around the culvert. Pest plants such as agapanthus and arum lily were abundant during both surveys.

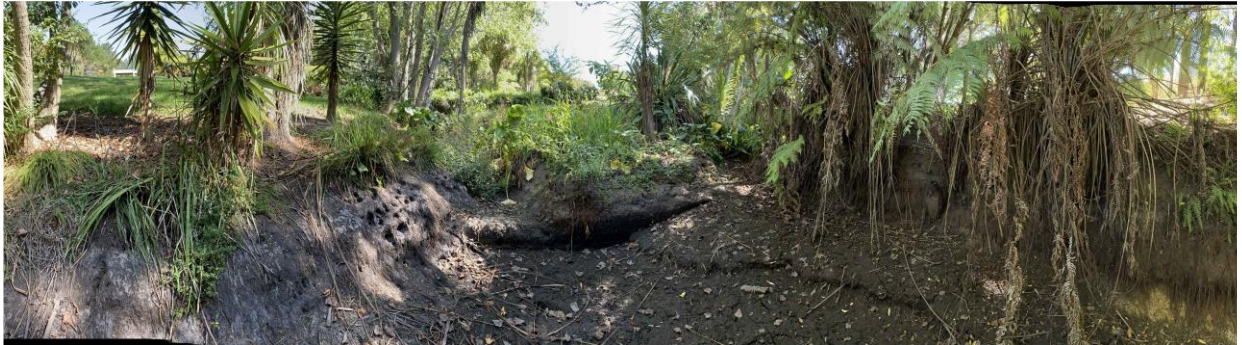
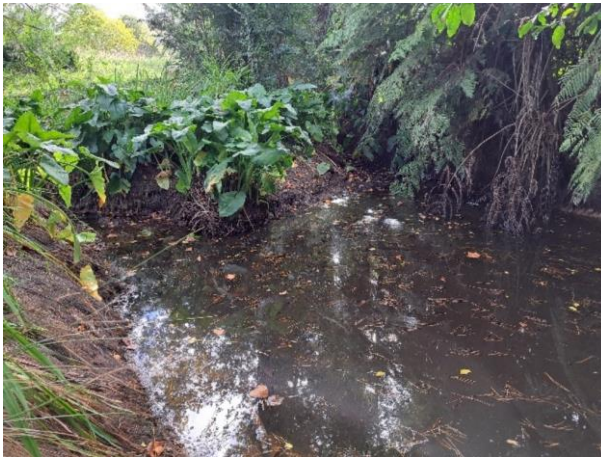
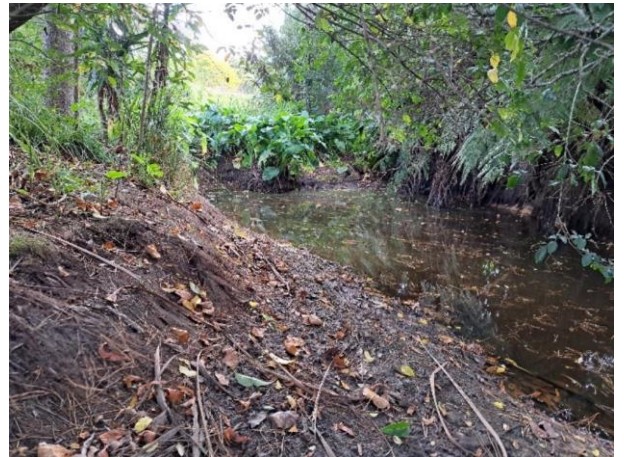
Photo point L could not be perfectly replicated due to the presence of water. It was located looking upstream, towards the upstream end of the artificial pond located at the confluence of the two main intermittent channels. The banks were well defined, as expected of a constructed pond. There was no undercutting, scour or areas of obvious erosion, despite water being present during 2024, but not during 2020. The perimeter of the pond was stable, likely the result of the significant vegetation in the immediate surrounds.

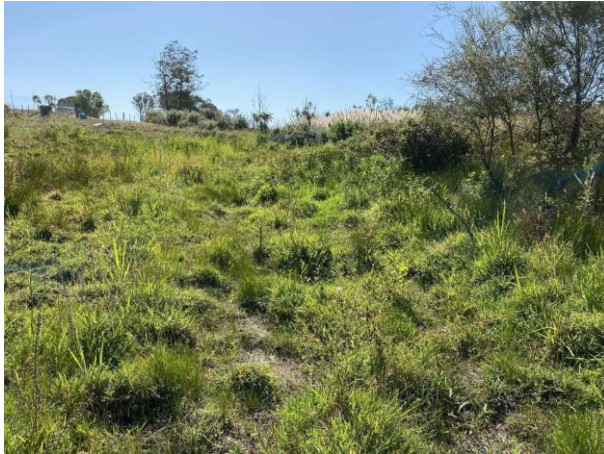
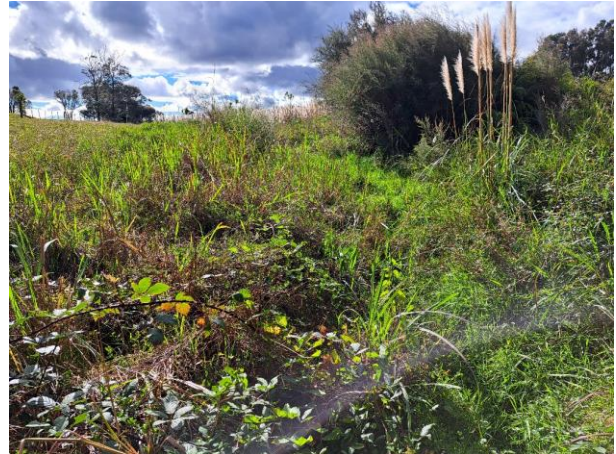
Photo point L3 was located on the intermittent tributary that flows from the stormwater pond within the airbase on the opposite side of Brigham Creek Road. The watercourse was ill defined. The main difference between the two surveys was the proliferation of vegetation, including mixed pasture grasses, blackberry and pampas, attributable to the removal of stock from the paddock. The 2020 survey yielded significant pugging on this reach, however no pugging was observed during 2024, due to the lack of stock. The watercourse was considered to be more stable in 2024, despite the significant floods experienced in 2023, likely due to the removal of stock from the paddocks.

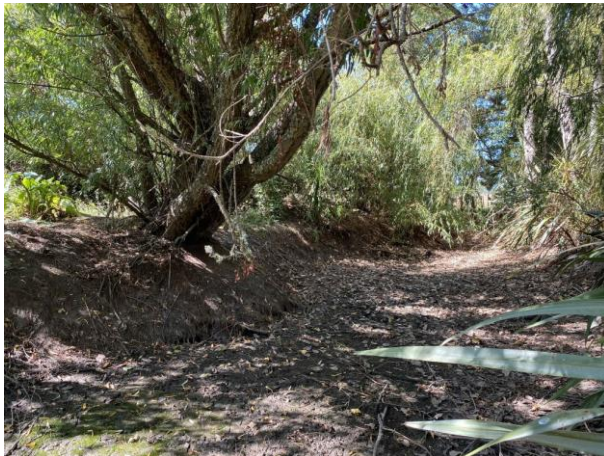
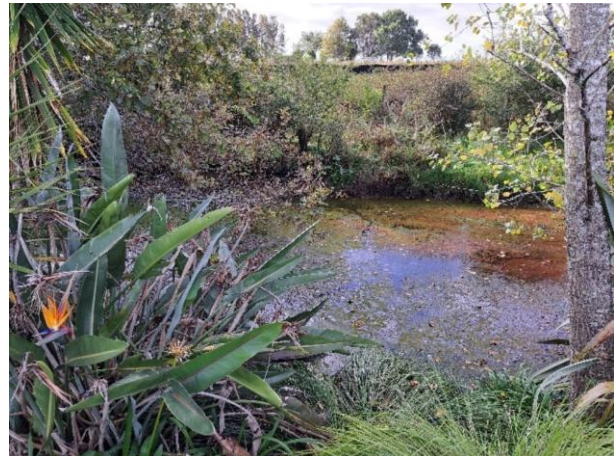
Photo point M was located at the downstream end of the artificial pond. The photo point could not be replicated due to the presence of water within the pond. The 2020 image was taken from within the pond when it was dry. Despite not being able to replicate the photo, the banks of the pond were observed. No evidence of scour, erosion or bank undercutting were observed, suggesting the outlet of the pond was stable, despite the significant floods that occurred in 2023. The vegetation growth around the pond has likely contributed to bank stability.

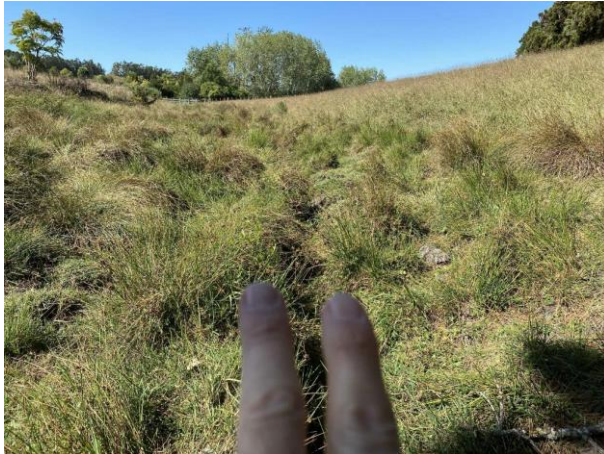
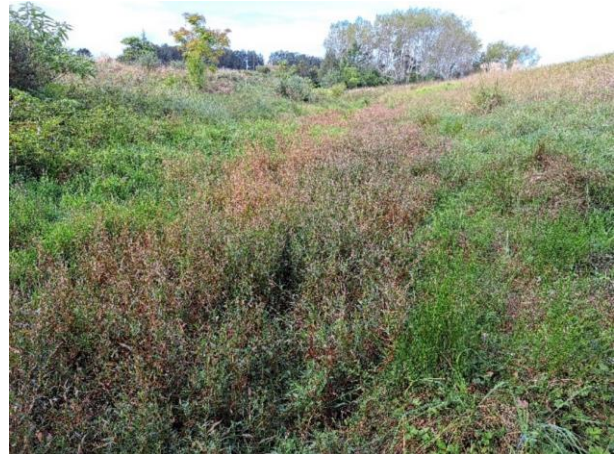
Photo point O was located downstream of the constructed pond, looking downstream. The channel during both surveys was ill defined, and contained no obvious flow or non-vegetated channel. Cattle were present during 2020, which have likely caused the shallowness of the channel through pugging and trampling. During 2024 there was some water present, though the channel can be more accurately described as damp ground rather than a flowing channel, however the channel was no more defined than 2020, despite the high flows experience during 2023, and the removal of cattle from the paddocks.

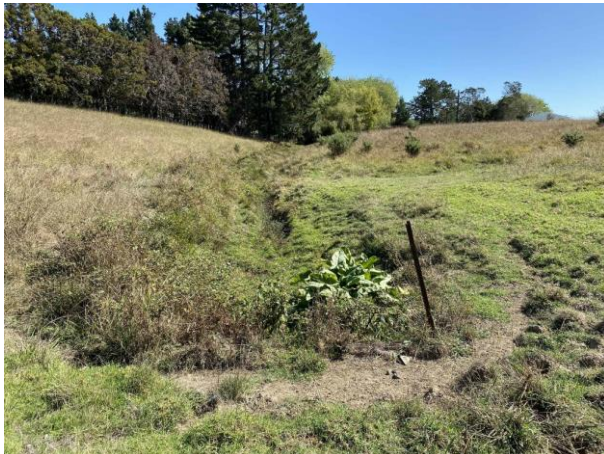
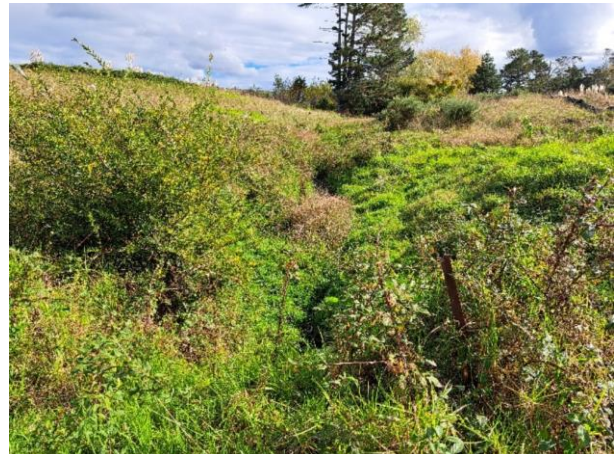
Photo point Q was located on a culvert crossing, looking upstream towards the constructed pond (which is located in the vegetated area in the distance). The watercourse was contained within a defined, but shallow channel, which widened towards the upstream end of this photo where it became less defined. The channel was well vegetated during both surveys, with blackberry encroaching along the entire length during the 2024. There was no evidence of any scour or erosion, including around the culvert. Some water was present during 2024, however it can be more accurately described as a damp channel, rather than flowing or standing water.

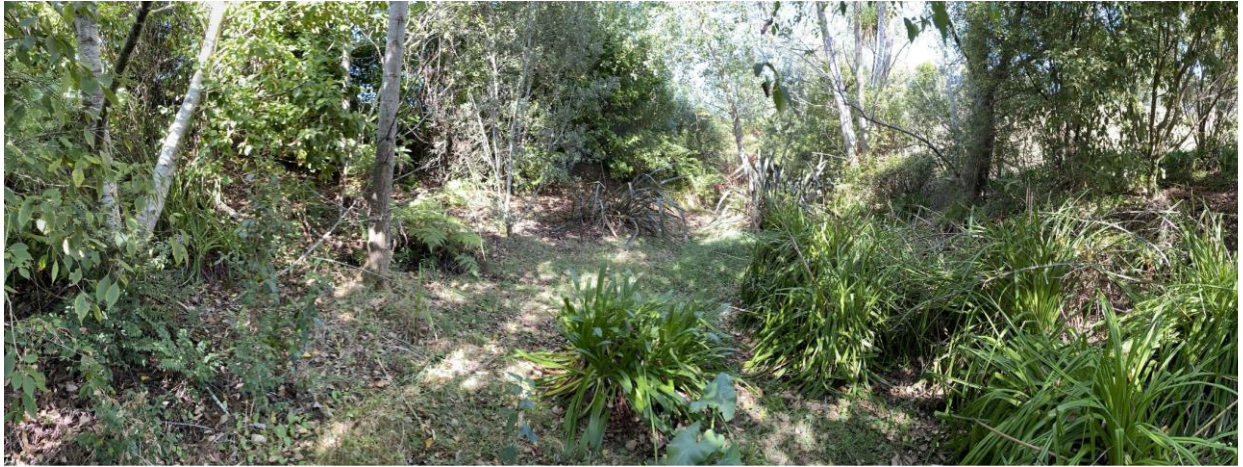
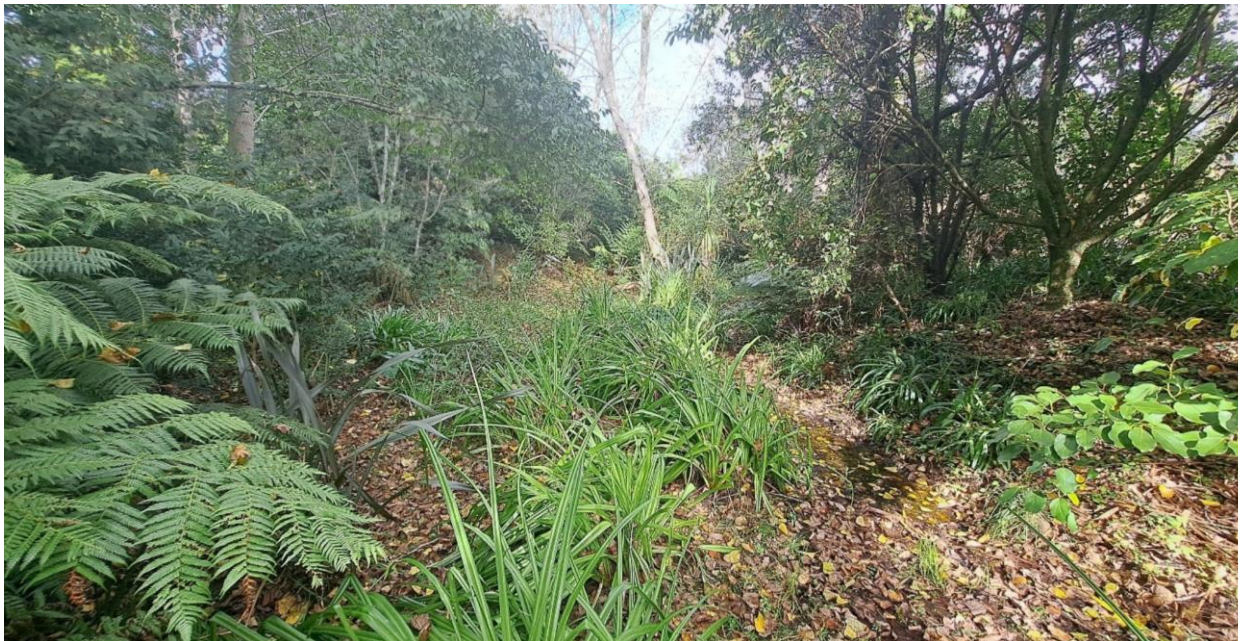
Photo point R was located downstream of the culvert crossing within an area of native dominated vegetation. The wetted channel was present, but not easily defined. It was present in a generally low area. There were no obvious changes between the two surveys. During 2024 water was present, however it was not flowing and it formed a series of isolated, stagnant pools. Abundant leaf litter was present within the channel suggesting no recent flushing flows. No evidence of scour, erosion or channel damage was identified.

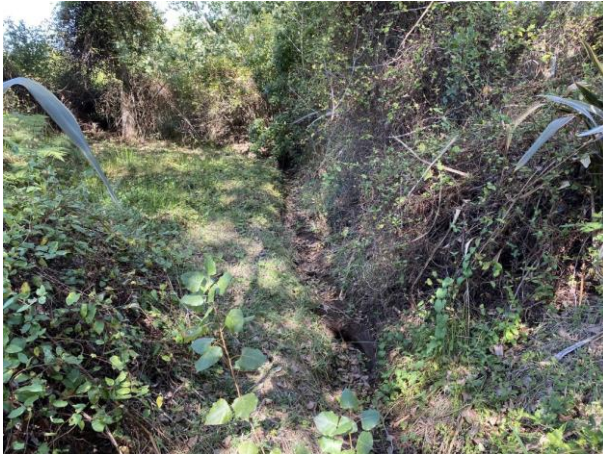
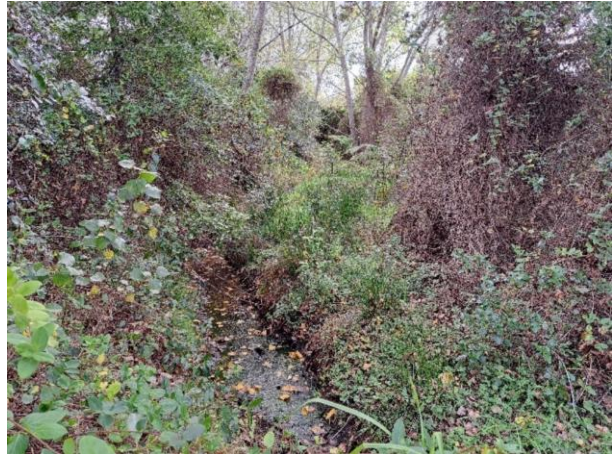
Photo point U was located close to Brigham Creek Road. The channel was shallow, and moderately incised, and located within an area of mixed vegetation, with a high incidence of weeds. Water was present during the 2024 survey, but did not appear to be present during 2020. Water was not flowing during 2024, rather it was present as a shallow, stagnant pool. Extensive leaf litter was present during both surveys suggesting no recent flushing flows. No evidence of scour or erosion were observed.

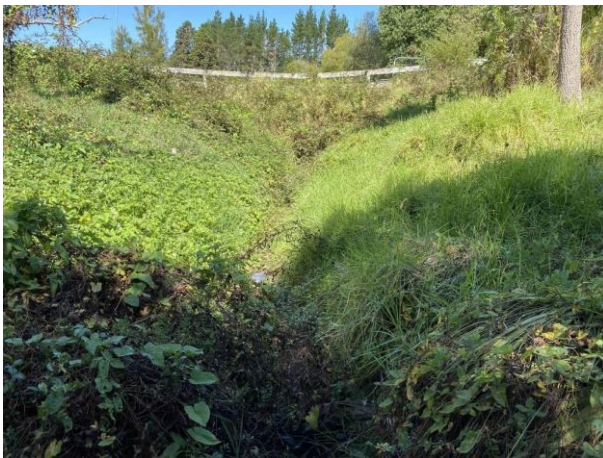
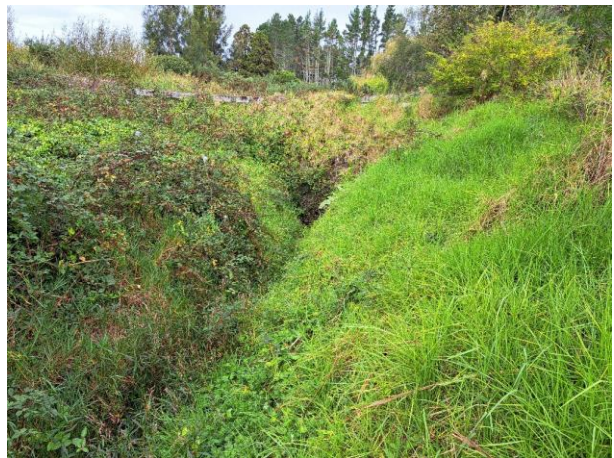
Photo point V was taken looking downstream towards a culvert crossing. The channel was well defined, and contained within relatively steep, but not incised banks. During both surveys vegetation was abundant on the channel banks and around the culvert. There were no obvious differences between the two surveys, and no evidence of scour, erosion or bank damage.

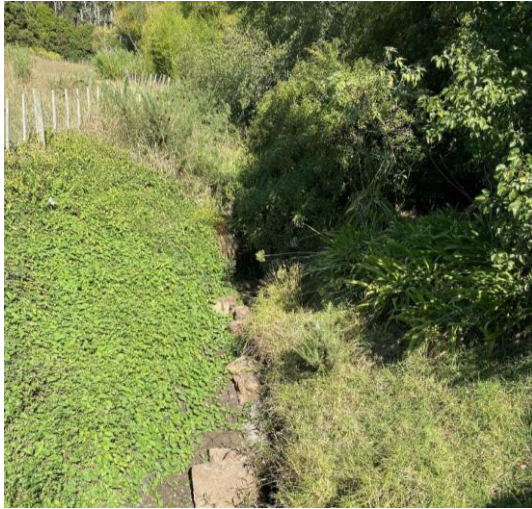
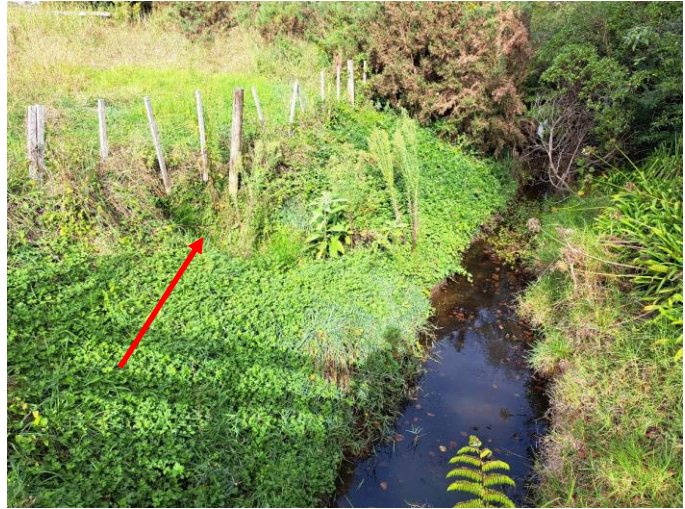
Photo point W was the only location where there was evidence of erosion observed. The photo point was located downstream of a culvert crossing, looking downstream. The channel was well defined, with the wetted area slightly incised. Water was present, during 2024 though flow was not obvious. The channel was dry during 2020. On the true left bank an area of slumping was present during 2024 (indicated by the red arrow). As a result, a gap of approximately 0.5 m was present between the ground level and the fence. Where the slumping has occurred, the bank is steep. The slumping does not appear to have been caused by the flow of the stream. Rather, it is likely overland sheet flow, potentially from Brigham Creek Road, has made its way towards the stream via an ephemeral flow path, resulting in the bank slumping. The slumping itself is above the normal level of the stream, on the upper bank. It is expected this area will continue to erode during periods of high flow, though it is noted that high flows appear to be uncommon.

Generally, the condition of the intermittent and permanent waterways within the site was good. There was largely no evidence of erosion or scour, or other bank damage such as undercutting, slumping, cracking or undermining of vegetation. The only exception was an area of bank slumping around photo point W. The removal of stock from the site has resulted in vegetation growth increasing, though there were no obvious improvements in channel condition, such as narrowing of the channel and resumption of a more natural cross section. It is likely the lack of regular flows has prevented normal stream processes, such as a normal level of erosion, occurring. The extensive vegetation along large portions of the riparian margin are also likely playing a stabilising role for the watercourses. Removal of vegetation may increase the risk of the erosion, however this can be easily mitigated through planting of the riparian yard, appropriately engineering culverts and crossings, and addition of rock rip rap in any erosion prone areas such as bends in the channel.

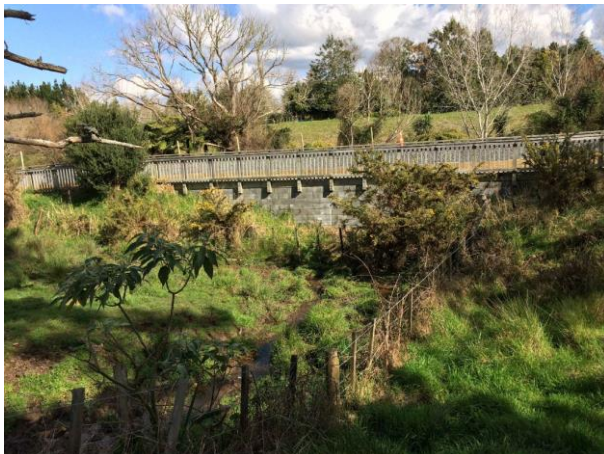
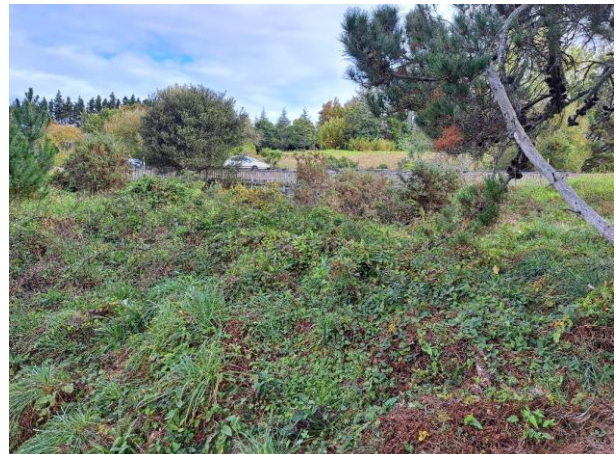
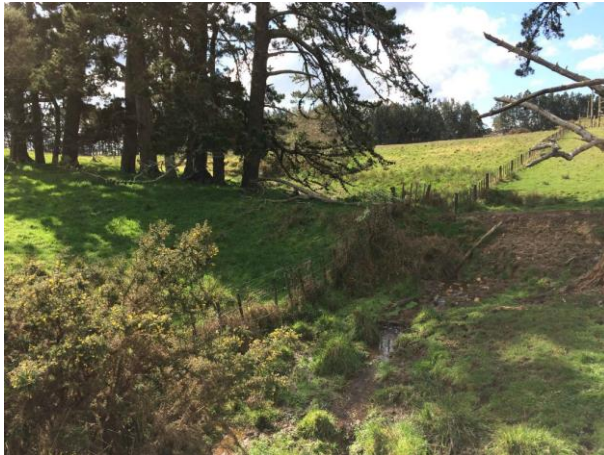
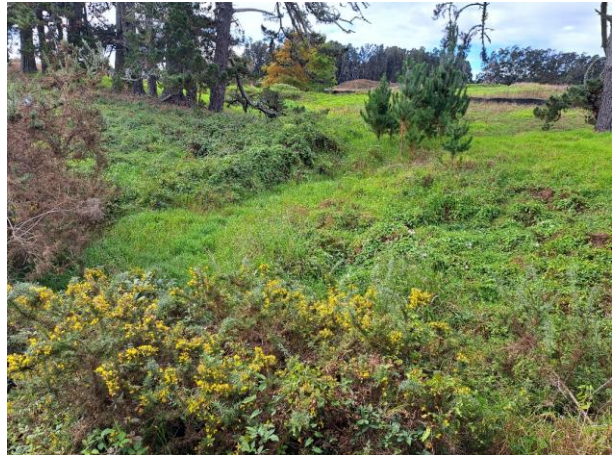
Photo points V1 and V2 were located on the opposite side of Brigham Creek Road on a channel that drains a constructed pond, and flows through a culvert under Brigham Creek Road and into the watercourse within the site. The channel was ill defined, and was represented by a shallow depression rather than a formed channel. The area was entirely vegetated. Vegetation was significantly more dense during 2024 than 2020. No evidence of scour, erosion of channel damage was observed.

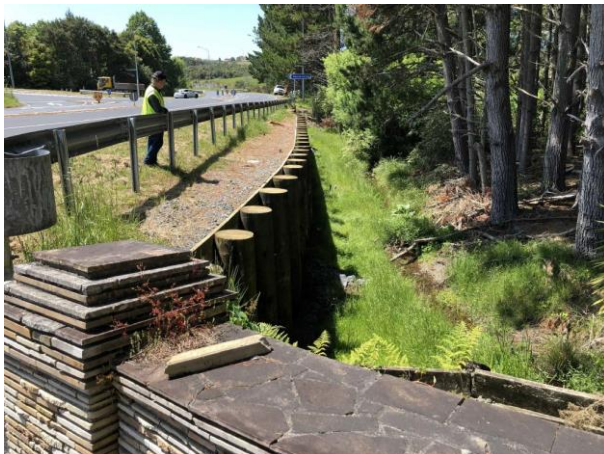
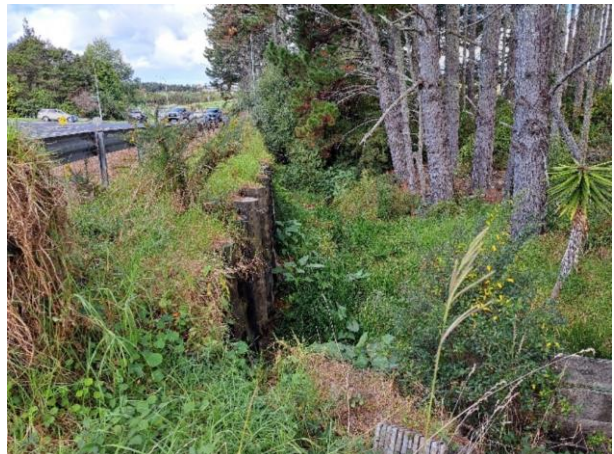
Photo point Z was located along the Brigham Road embankment, near its intersection with Kauri Road. The channel not easily observable during 2024 due to vegetation growth, while it was readily visible during 2020. The extensive vegetation growth suggests the channel and banks are stable enough to allow vegetation to proliferate. No evidence of scour or erosion were observed, including around the culverted entry between 159 and 163 Brigham Creek Road, which was where the photo was taken from.

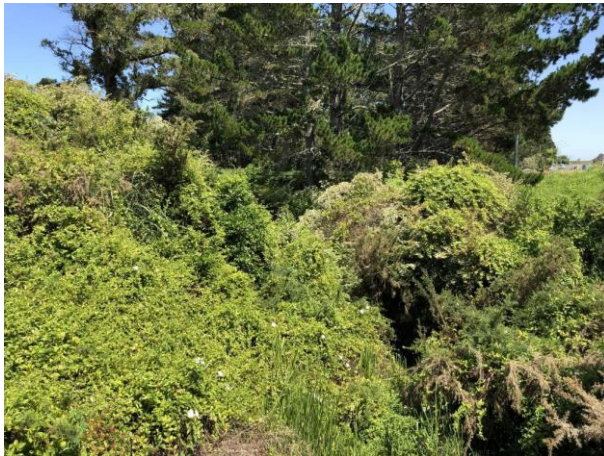
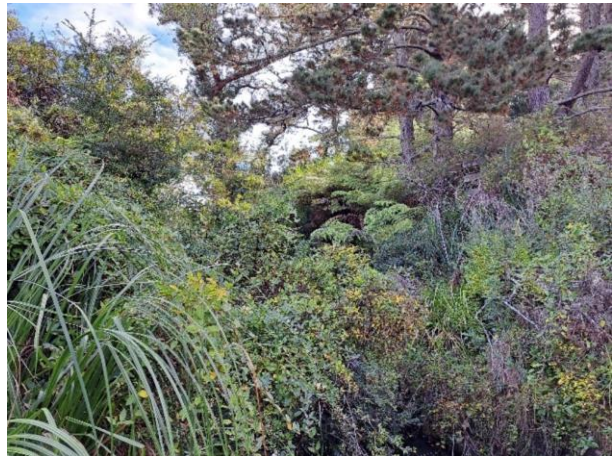
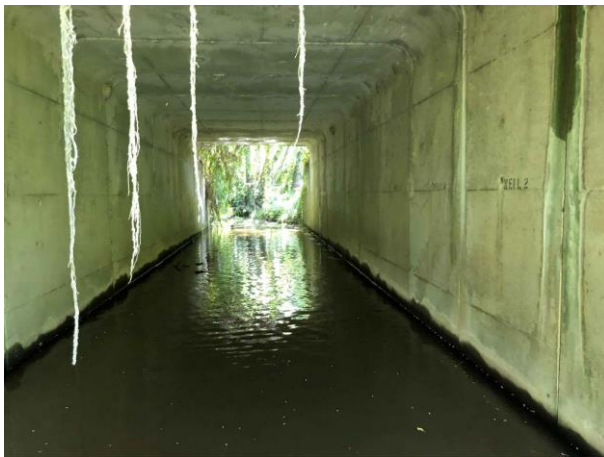
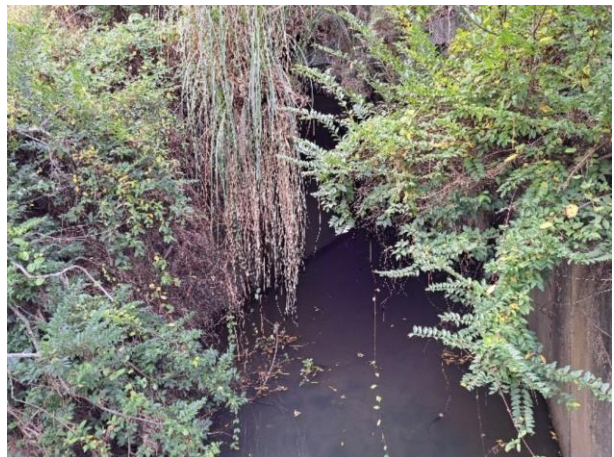
Photo points Z2 and Z3 were located at the downstream end of the watercourse, where it flows under Brigham Creek Road. Neither photo point could be fully replicated due to the depth of the water within the stream. However, extensive vegetation was present during both surveys and there was no evidence of any scour, erosion or channel damage observed, despite the high flows experienced during 2023.
