**INITIAL SEISMIC ASSESSMENT  
TAPORA COMMUNITY HALL  
5 OKAHUKURA ROAD, TAPORA  
AUCKLAND  
FOR  
AUCKLAND COUNCIL**

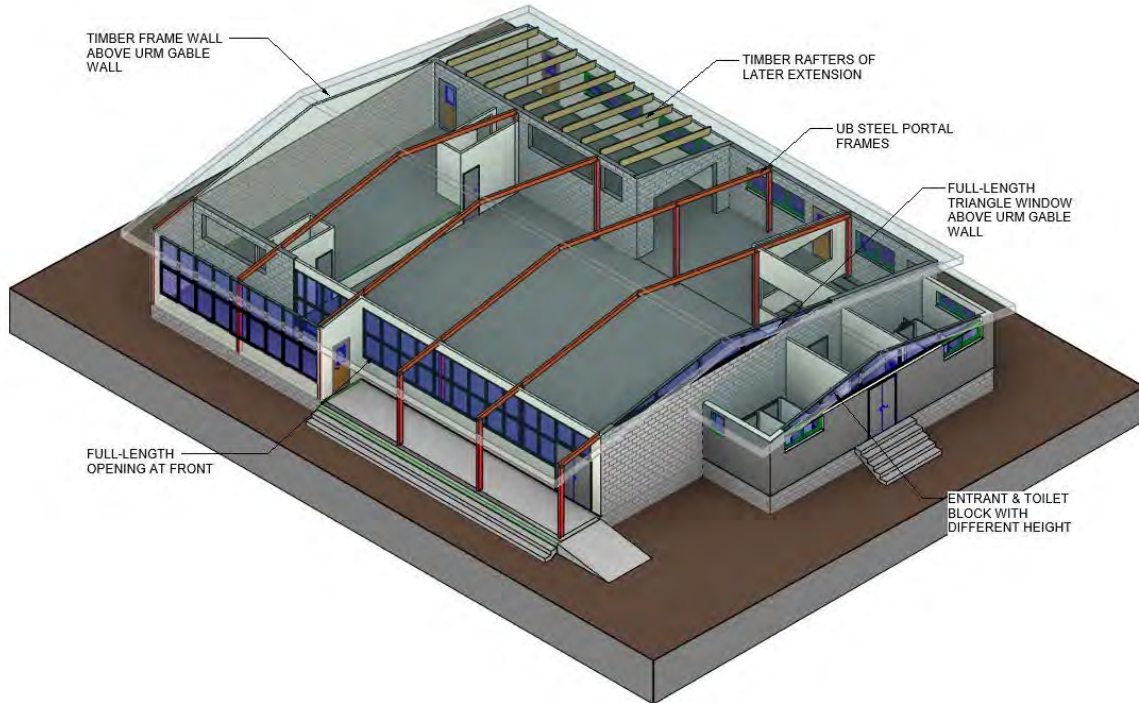
Figure 1. Isometric Drawing of The Building

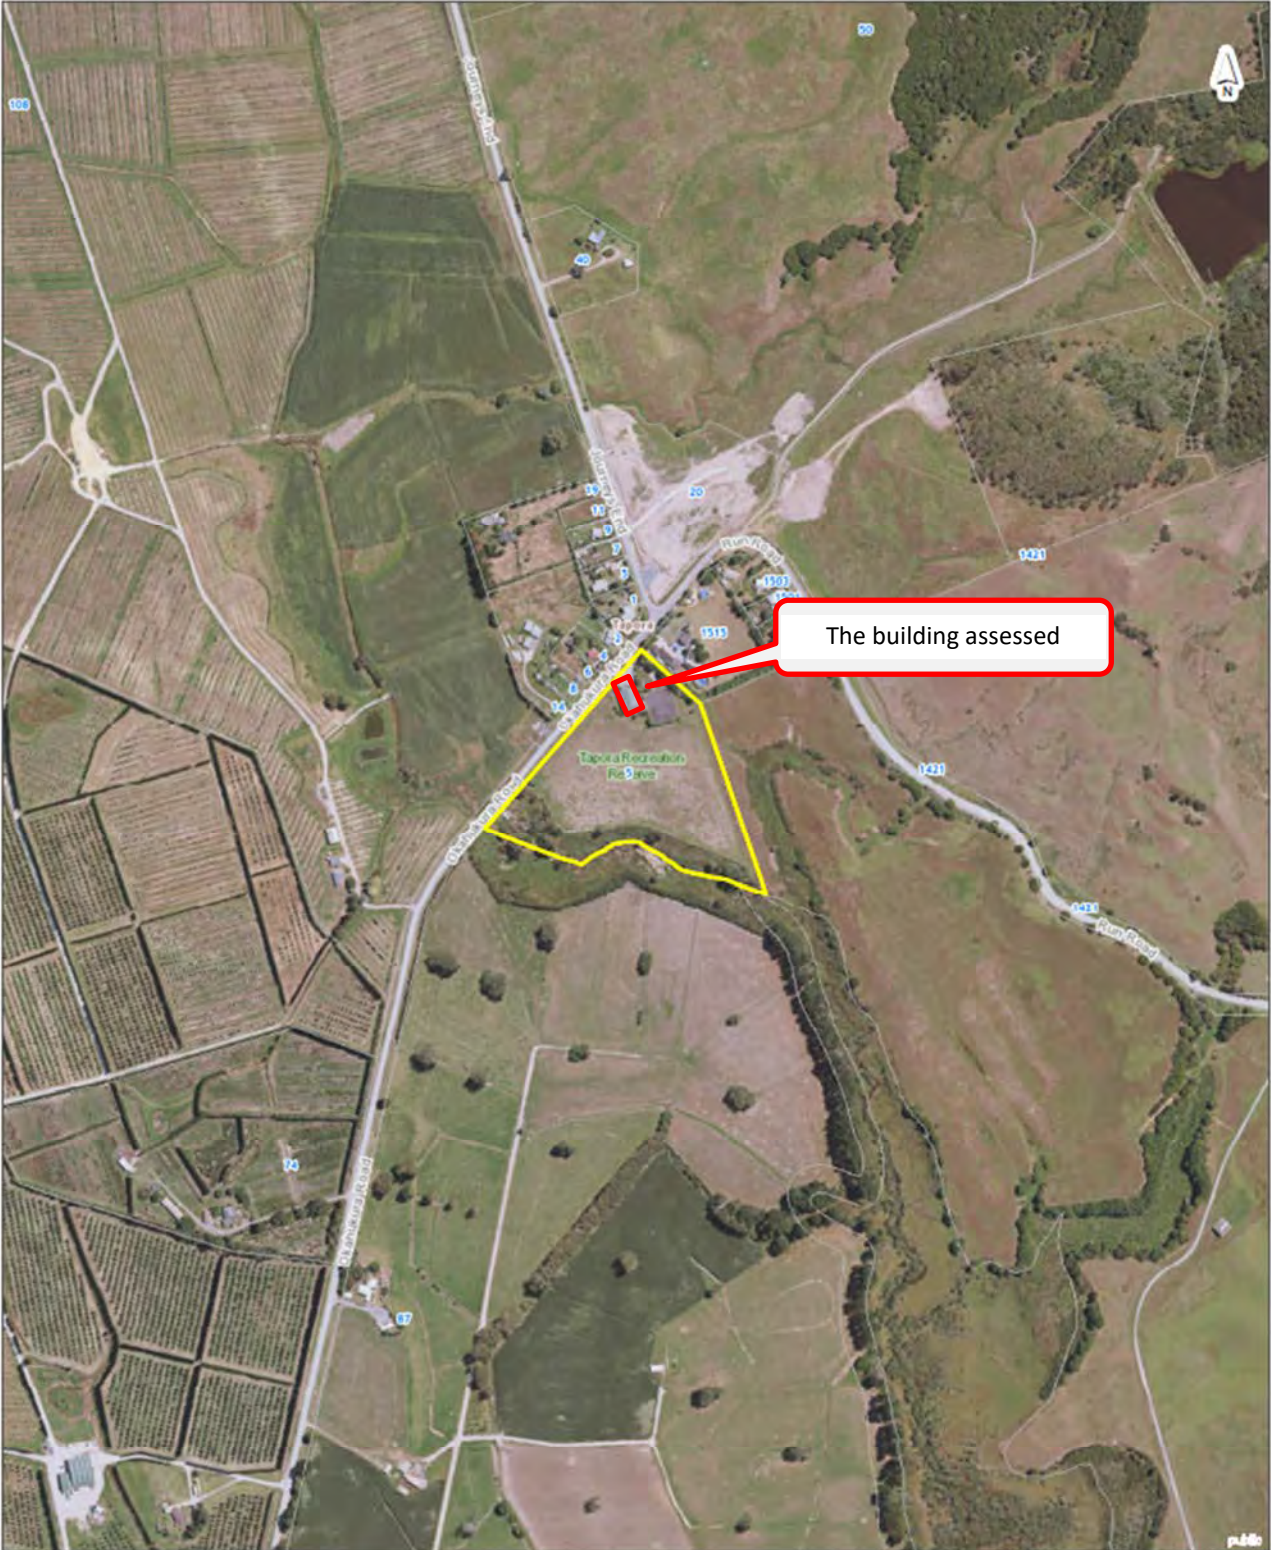
**DISCLAIMER:**  
This map/guide is illustrative only and no responsibility should be taken for any errors or omissions. It is not intended to be used as a substitute for professional advice. Auckland Council is not liable for any loss or damage arising from the use of this map/guide. Auckland Council gives no warranty as to the accuracy and completeness of any information contained herein, and accepts no liability for any errors or omissions in view of the information brought to them by Auckland Council.

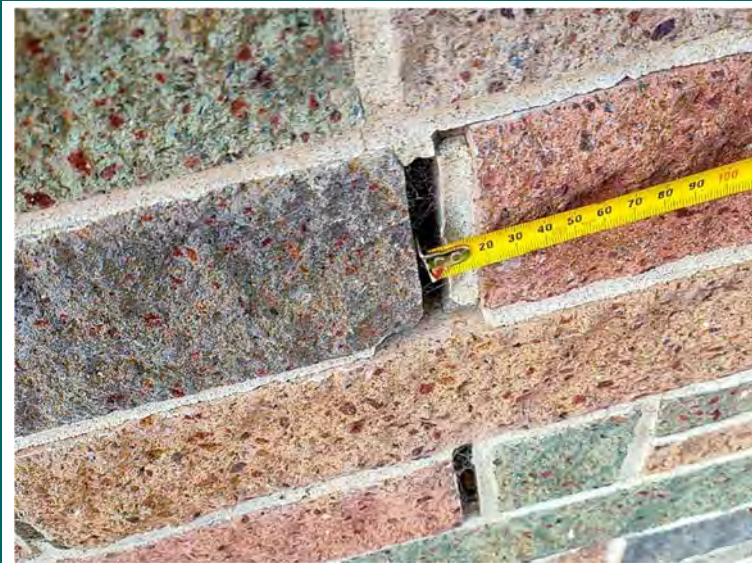
3. Crack on the brick veneer (The foyer & toilet block)

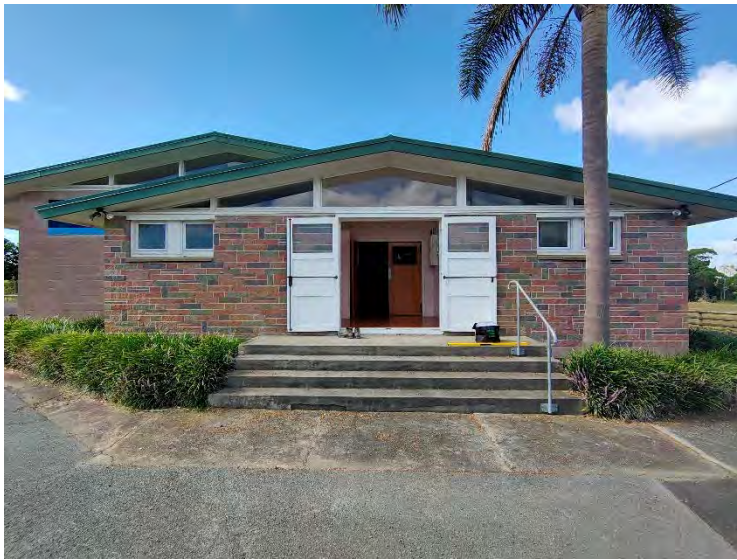
4. Entrant foyer & toilet block (North)

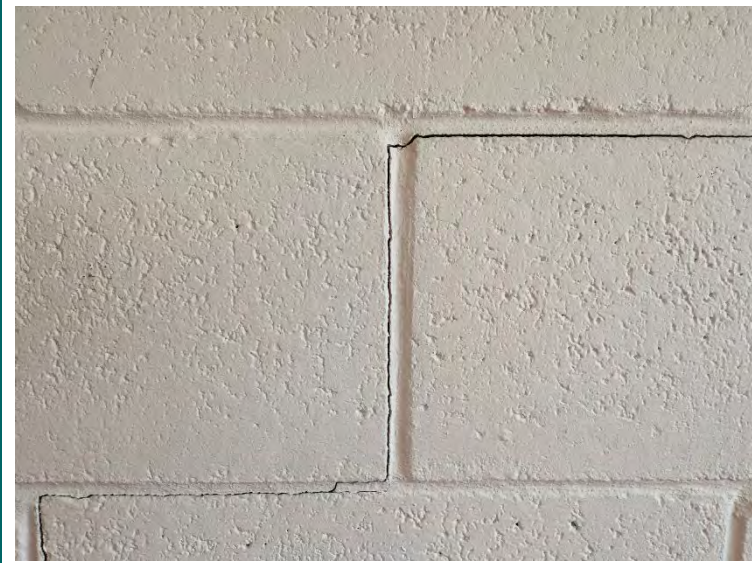
12. Crack on the URM gable wall

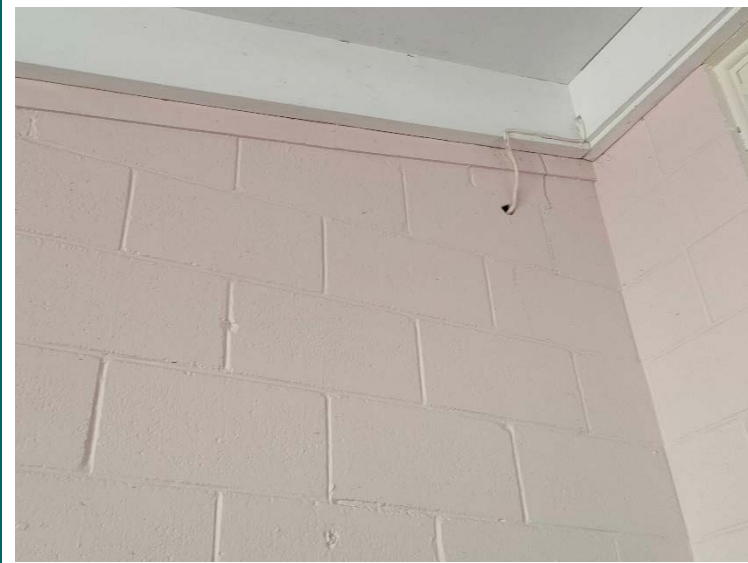
13. Crack at top of the internal concrete block wall (URM) of the play group room

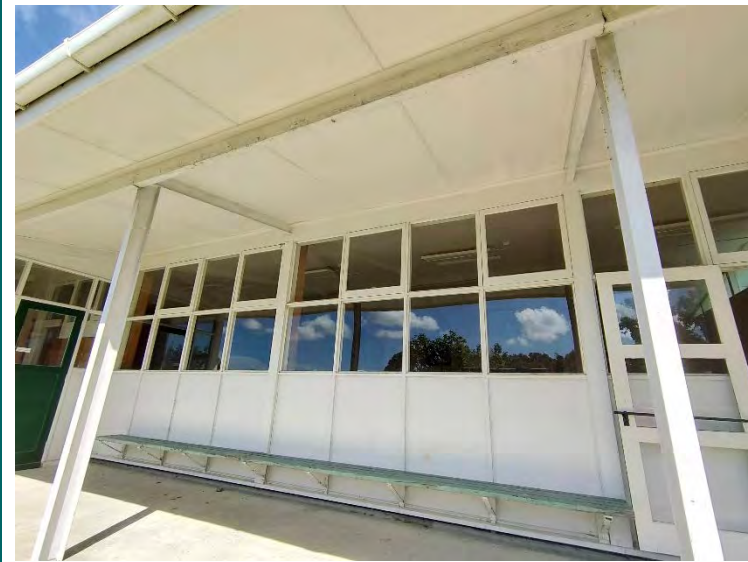
14. Exposed steel portal frame (side span) of the east corridor

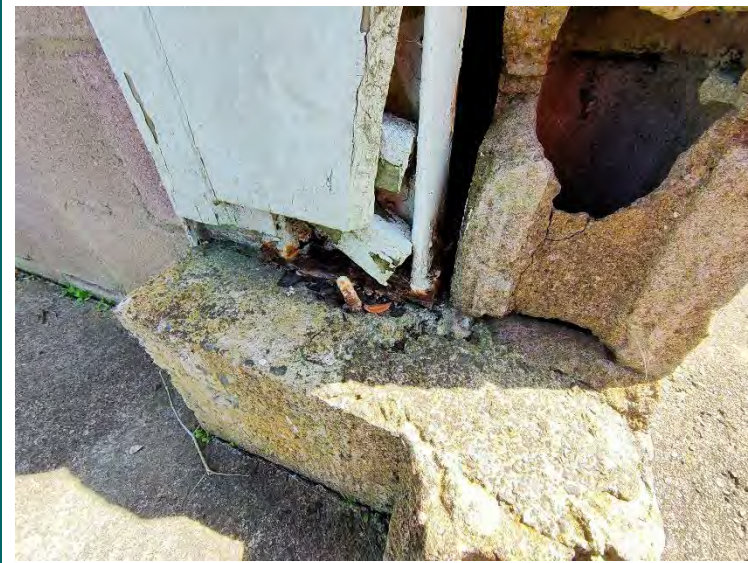
14. the broken concrete block and the UB steel column is corroded at the east-south corner (exterior)

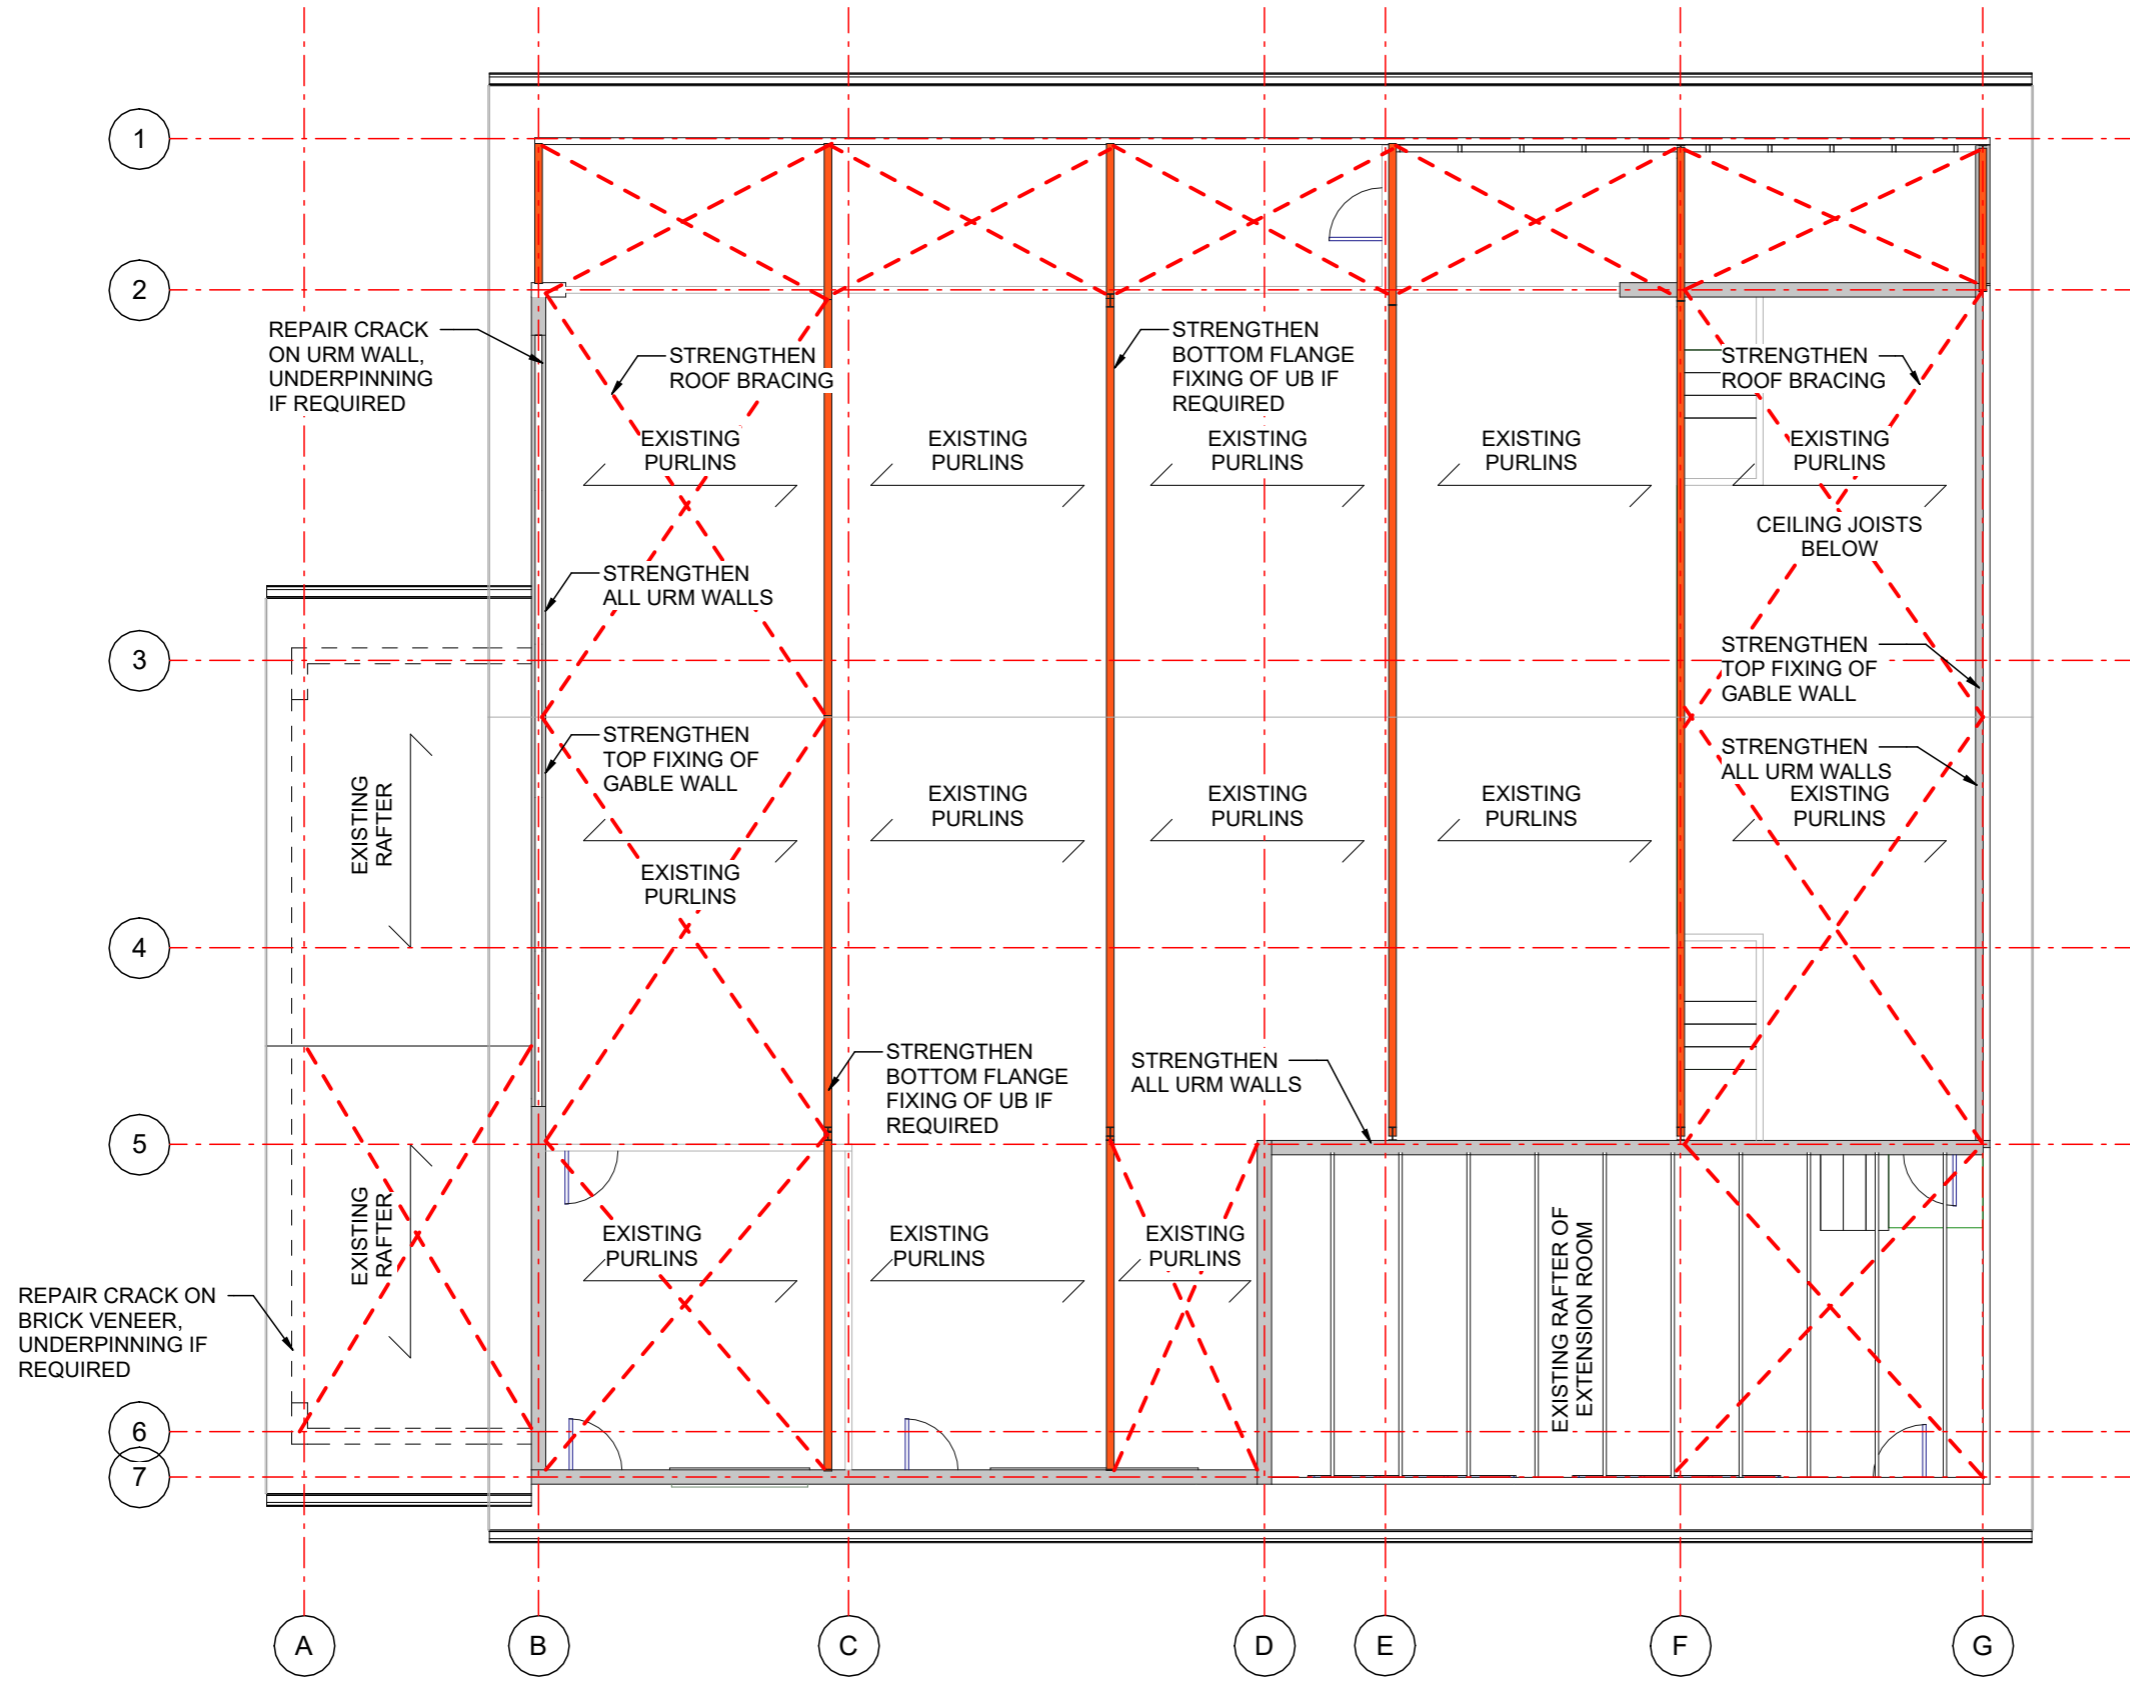
Refer to Table 5 of this report for the recommendations of strengthening of the structure to achieve 67% NBS. Some drawings and details are attached below as reference. These typical details are only based on general engineering judgment and practice. None of specific calculation was completed. A DSA and detailing design are required for the remedial drawings.

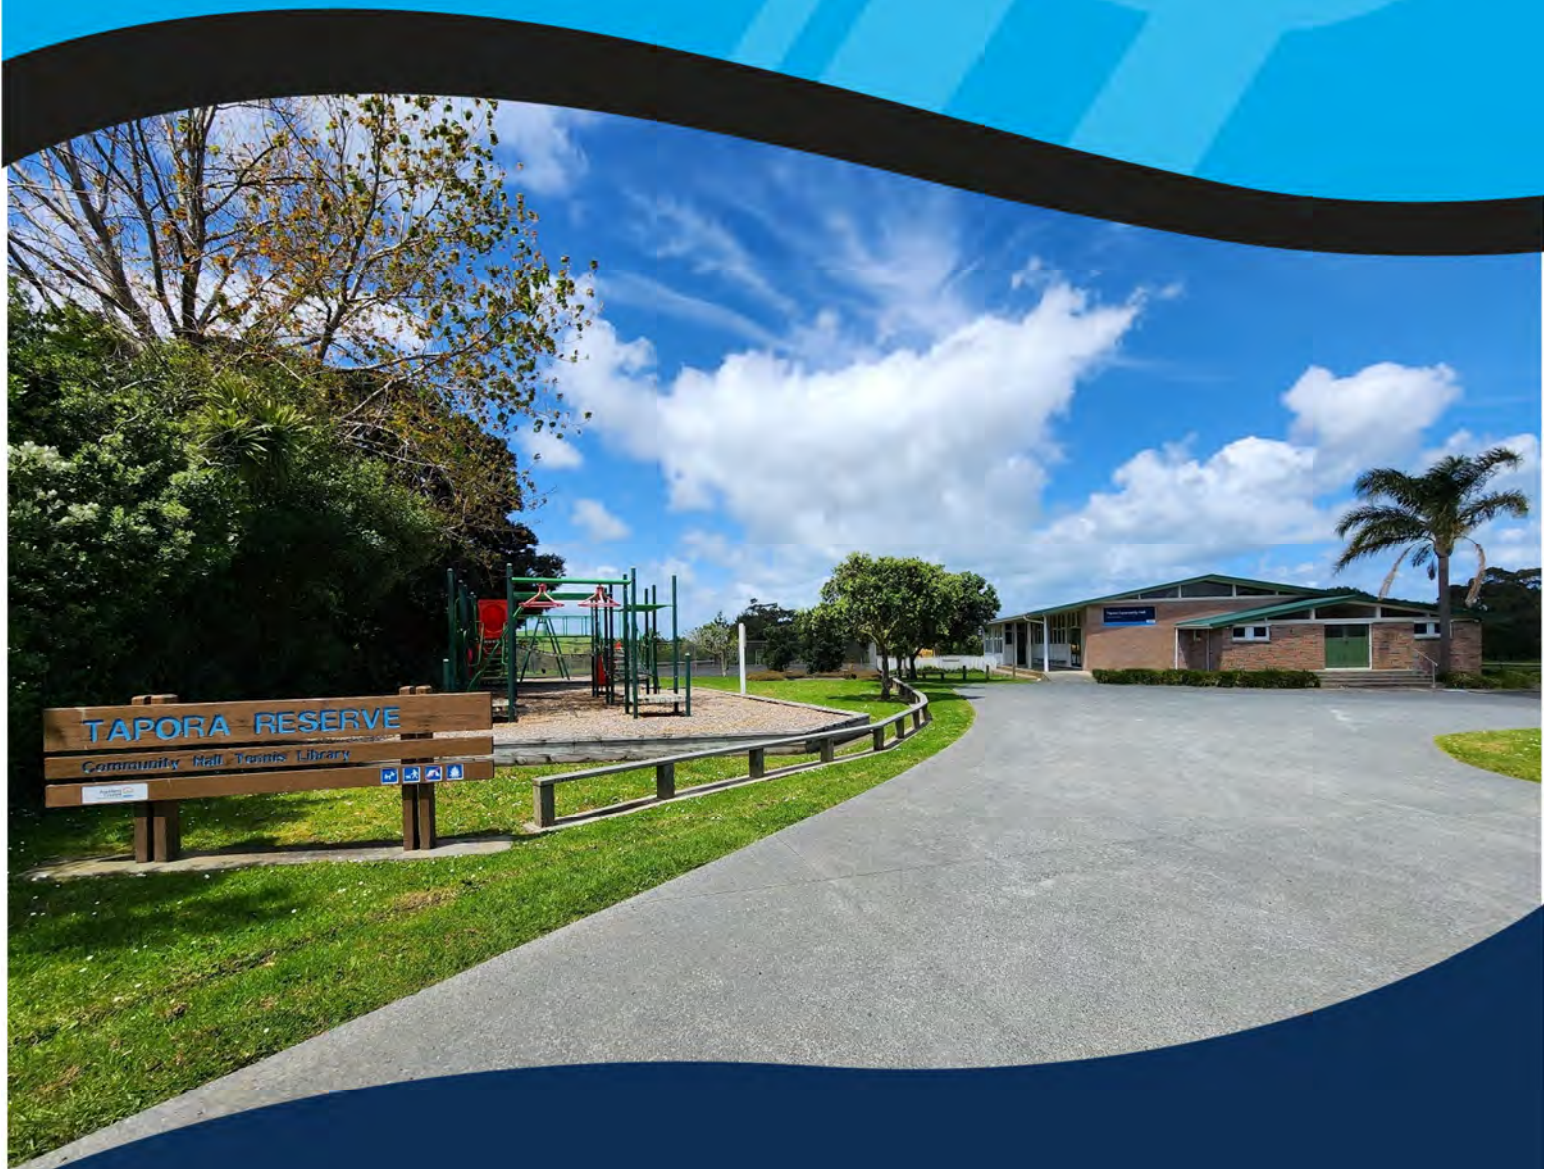
**Tapora Community Hall**  
**5 Okahukura Road,**  
**Tapora**

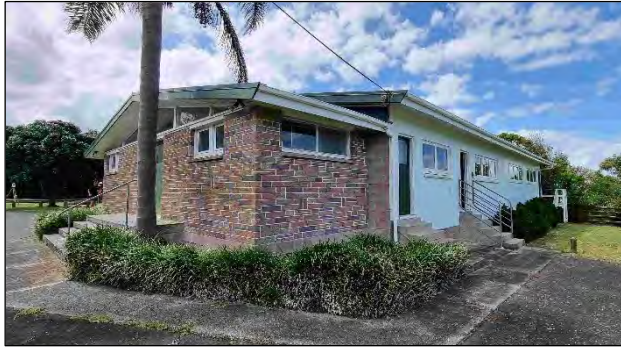
Photo 1: North western building elevation

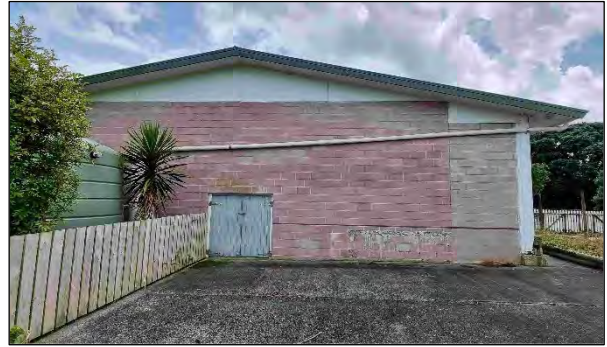
Photo 2: Southern building elevation

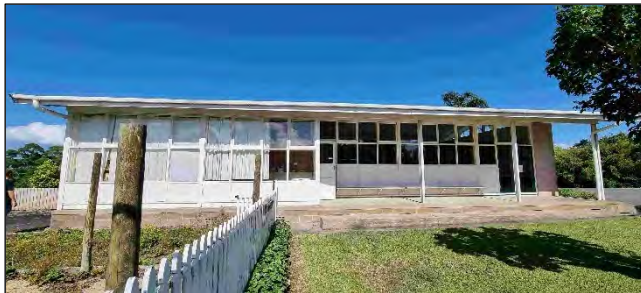
Photo 3: Eastern building elevation

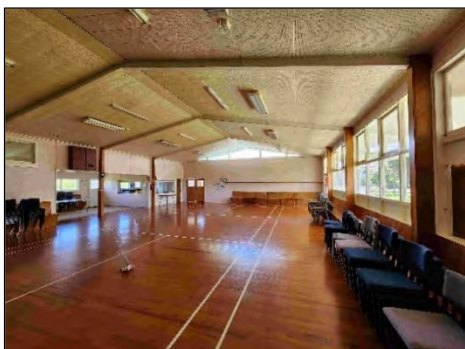
Photo 5: Hall Interior

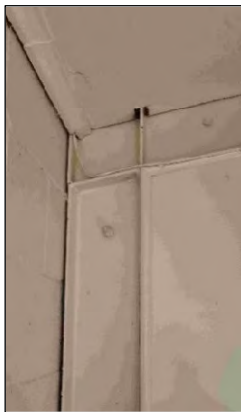
Photo 7: Portal Frame Knee

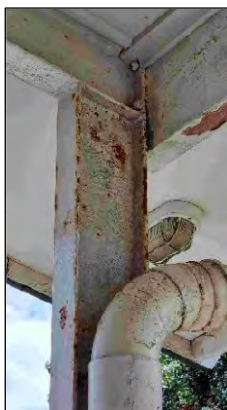
Photo 10: Frame Knee

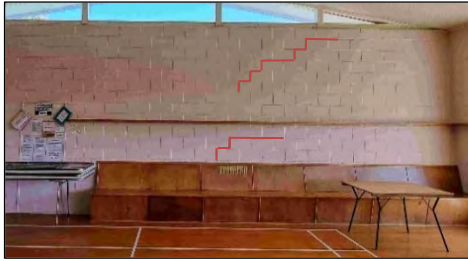
Photo 13: Northern gable end wall cracks

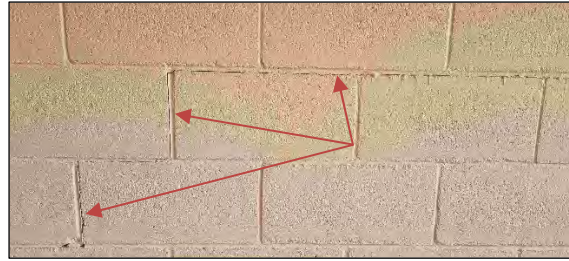
Photo 14: Northern gable end wall cracks

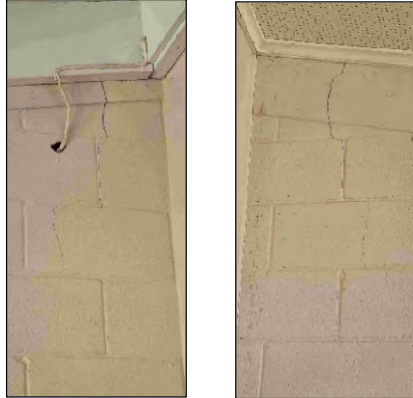
Photo 15: Playgroup return wall cracks

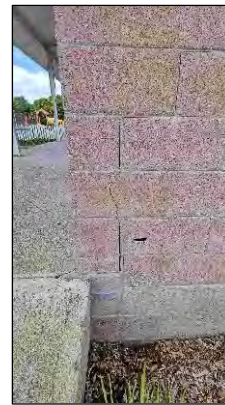
Photo 16: Northern gable end wall cracks

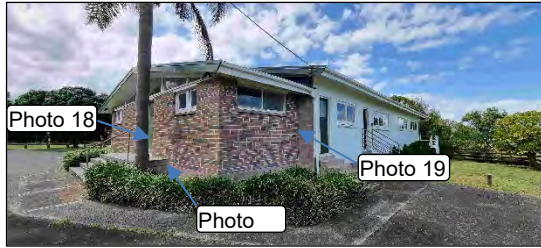
Photo 17: Brick veneer NW elevation

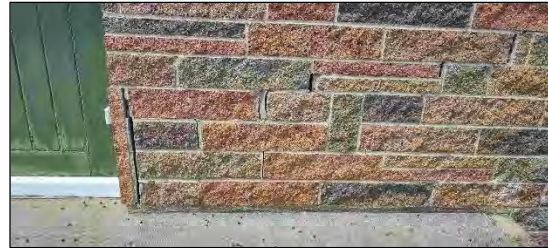
Photo 18: Brick veneer stepped cracks

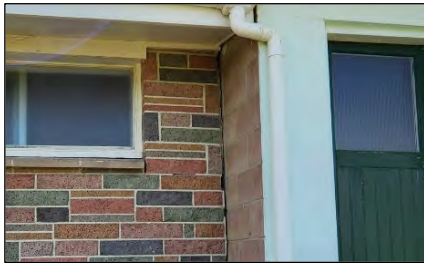
Photo 19: Gap at western return wall

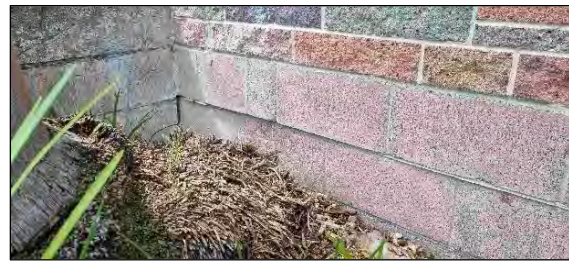
Photo 20: Foundation wall moved by Palm tree

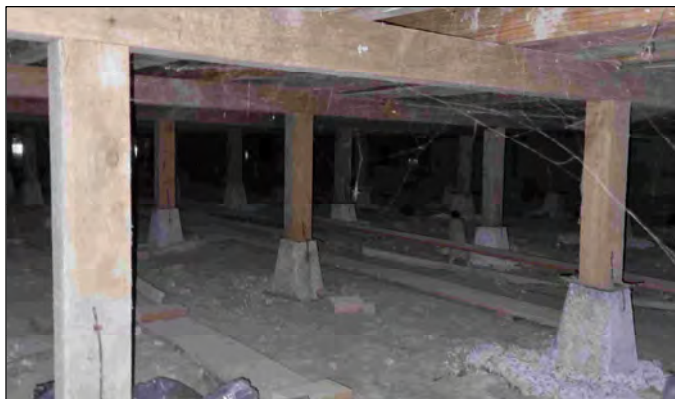
Photo 21: Typical view on subfloor

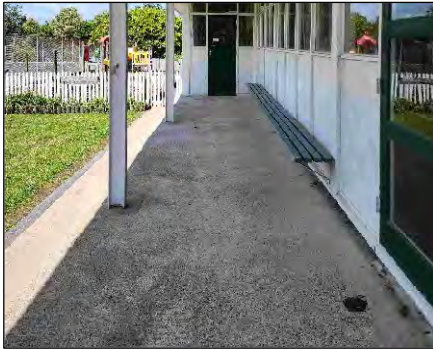
Photo 23: Verandah Slab

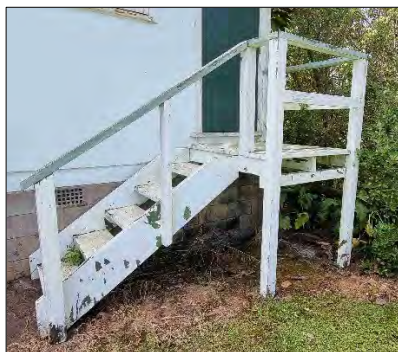
Photo 25: Timber Staircase

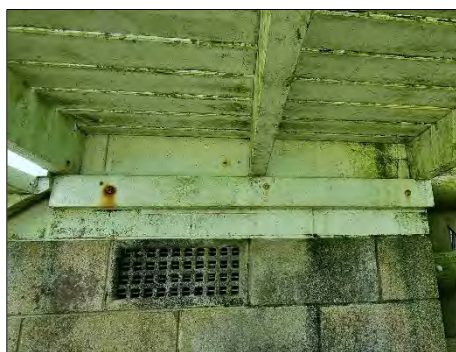
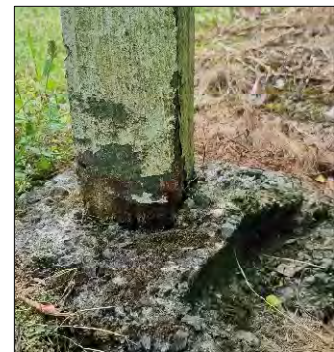
Photos 26 and 27: Corroded stringer fixings and rotting timber post

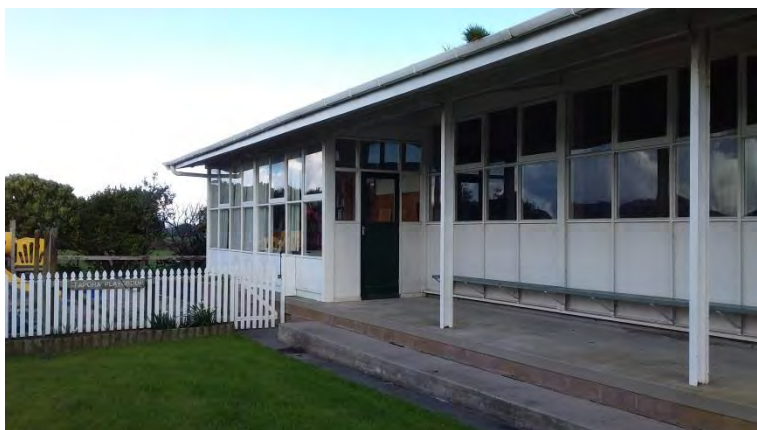
### 4.0 INTRODUCTION

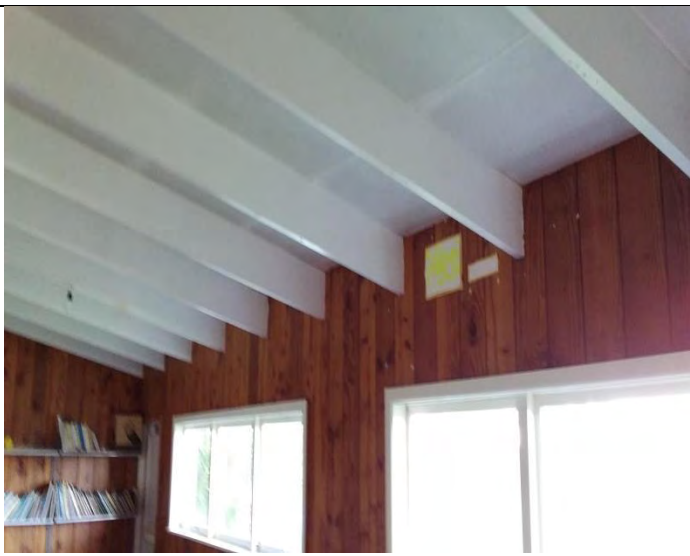
| <p>Ceiling<br/>Finishes</p> | <p>3</p> | <p>Average</p> | <p>The ceilings are made of plasterboard with paint finish and suspended false ceiling tiles. The ceilings are in fair condition.</p> | |

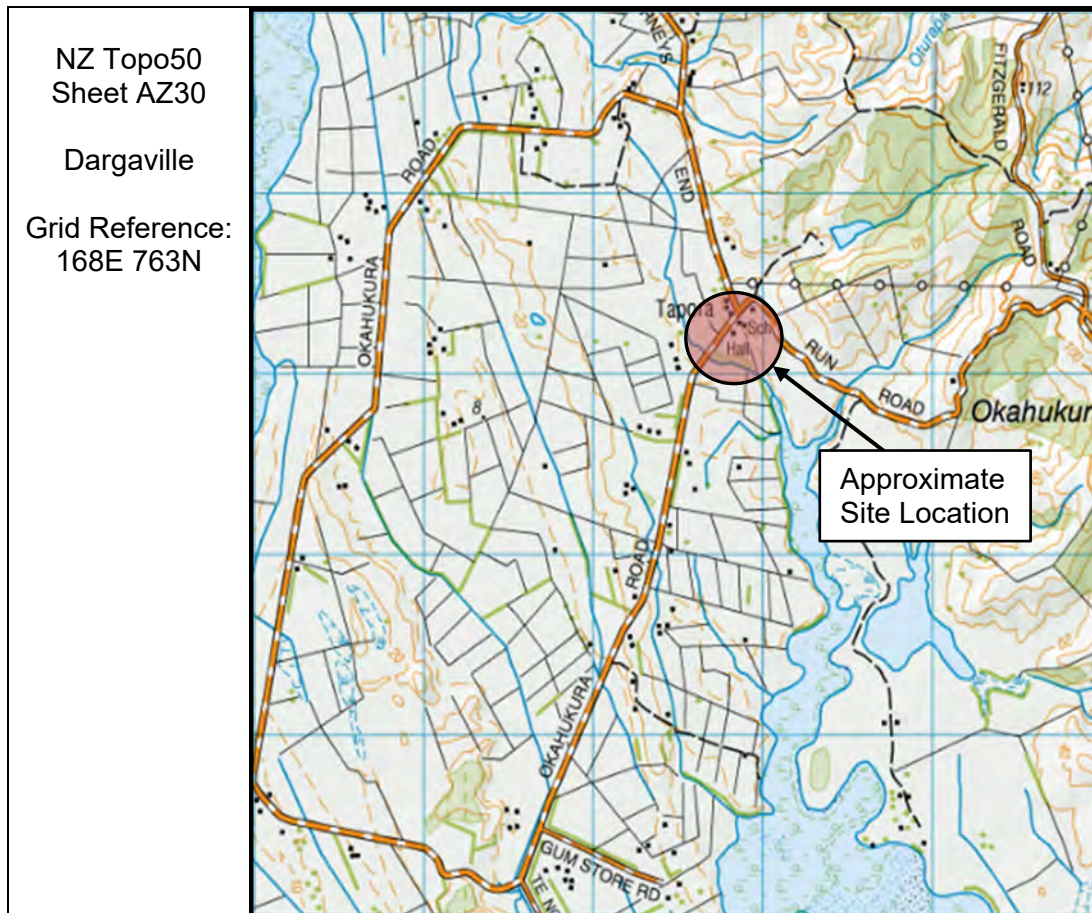
Figure 1 NZ Topo50 Map

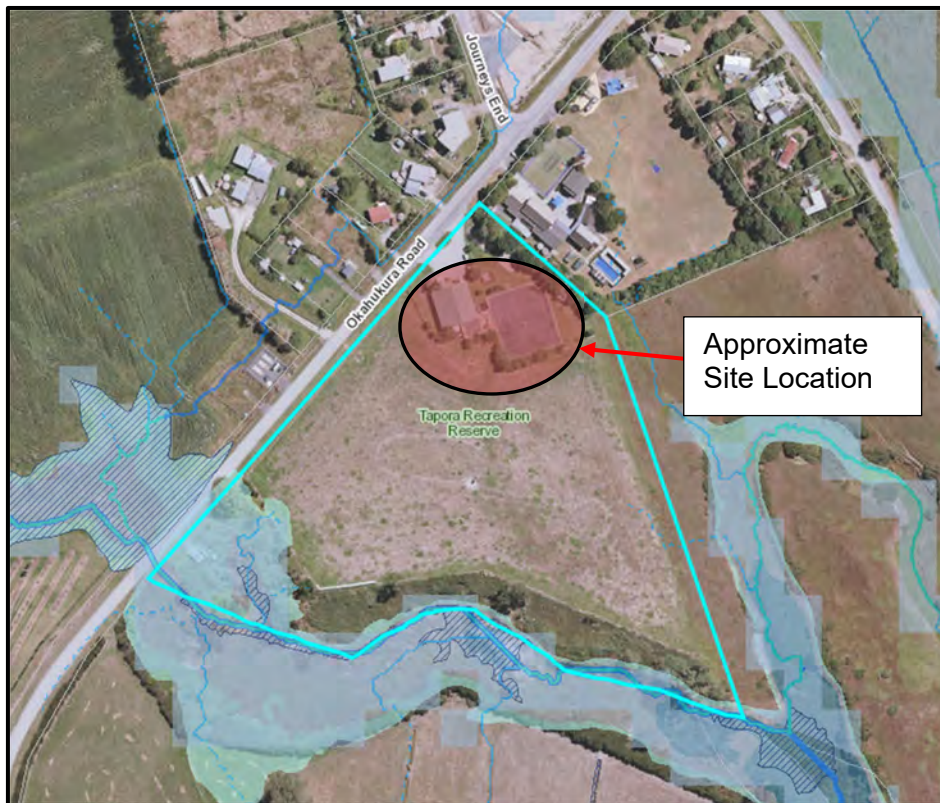
Figure 5 Auckland Council Geomaps– Catchments and Hydrology and Emergency Management overlays

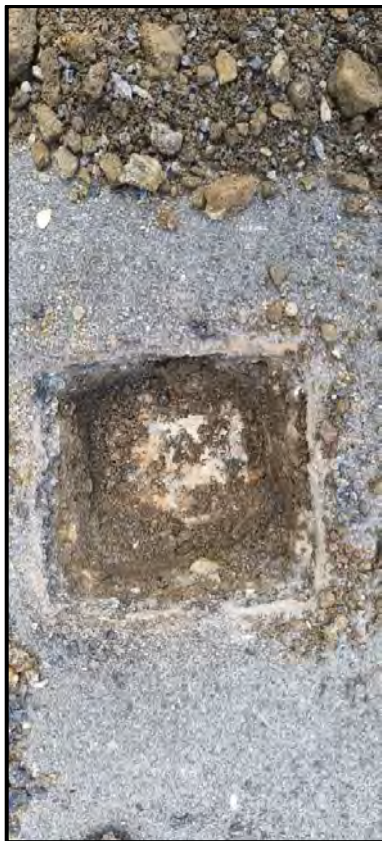
**Photo 3 – Test pit 1**

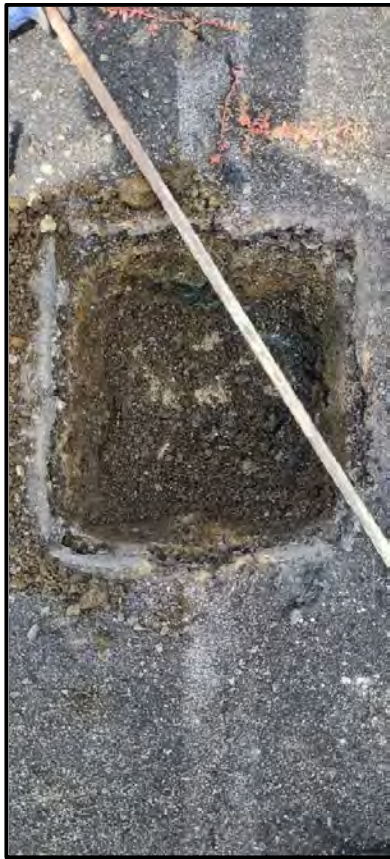
*Photo 5 – Test pit 2*

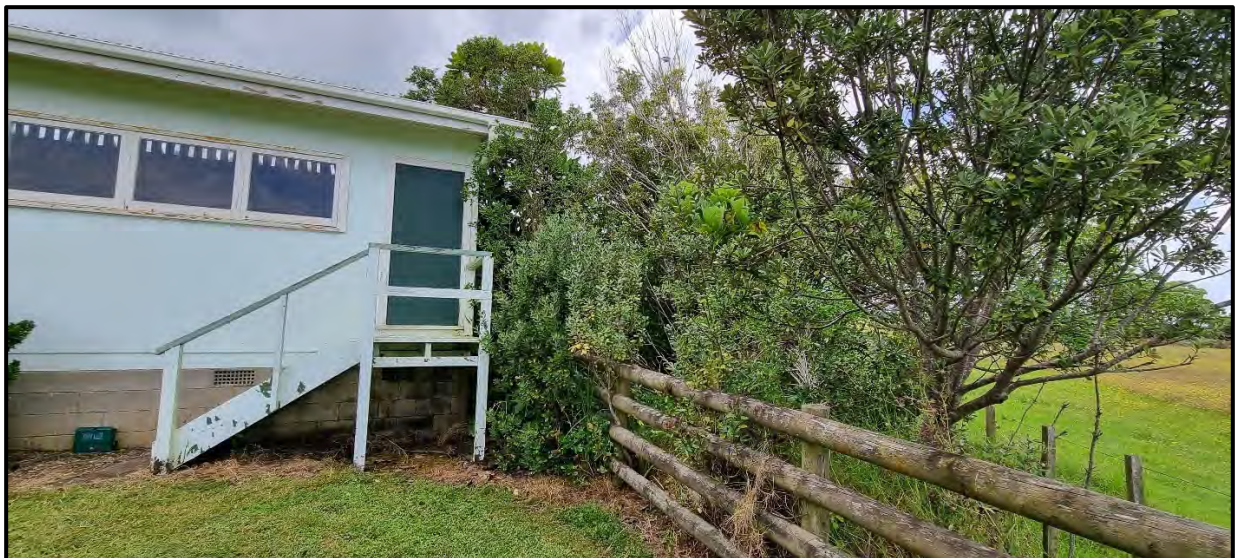
*Photo 7 Existing trees within close proximity to hall building*

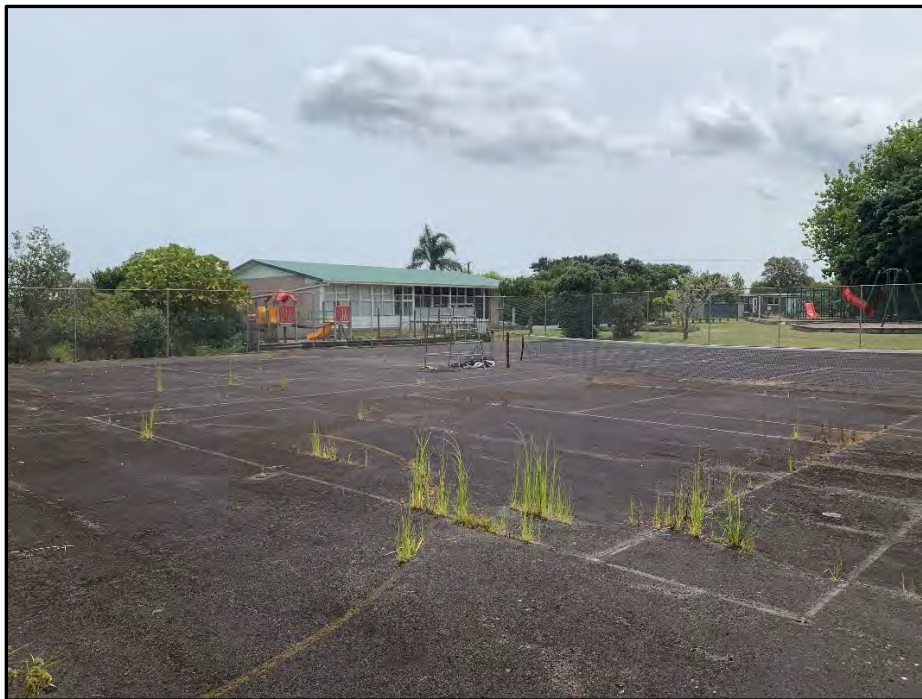
**Photo 8 Existing tennis court**

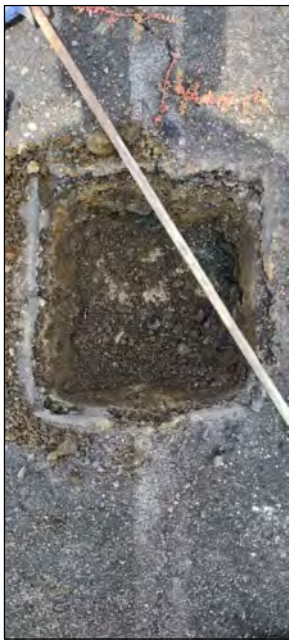
| SCALA PENETROMETER | | |

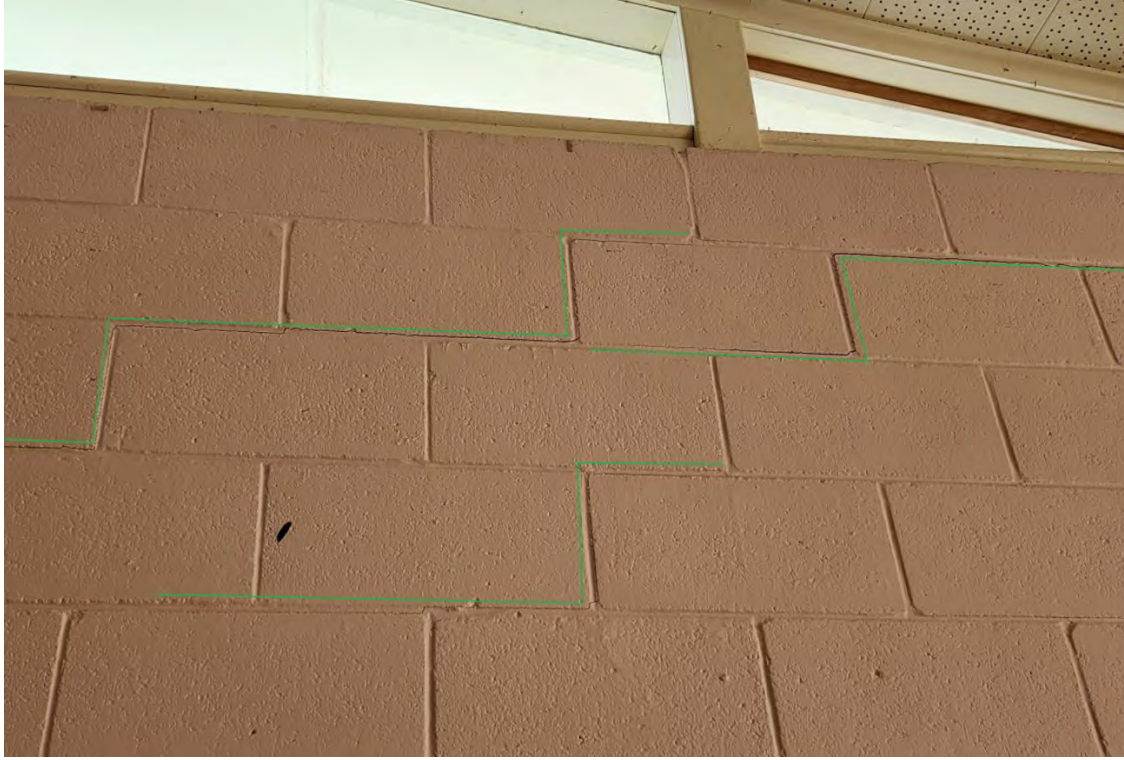
There is significant cracking present throughout the URM end walls and transverse walls that requires attention. The cracking can be observed in nearly every section of masonry throughout the building.

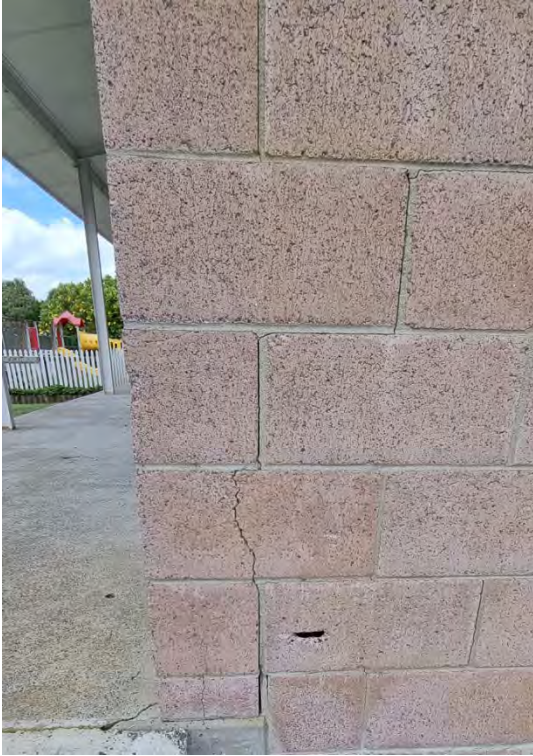
The existing masonry in the sub-floor presents an example of the condition of the URM that is expected to extend throughout the building.

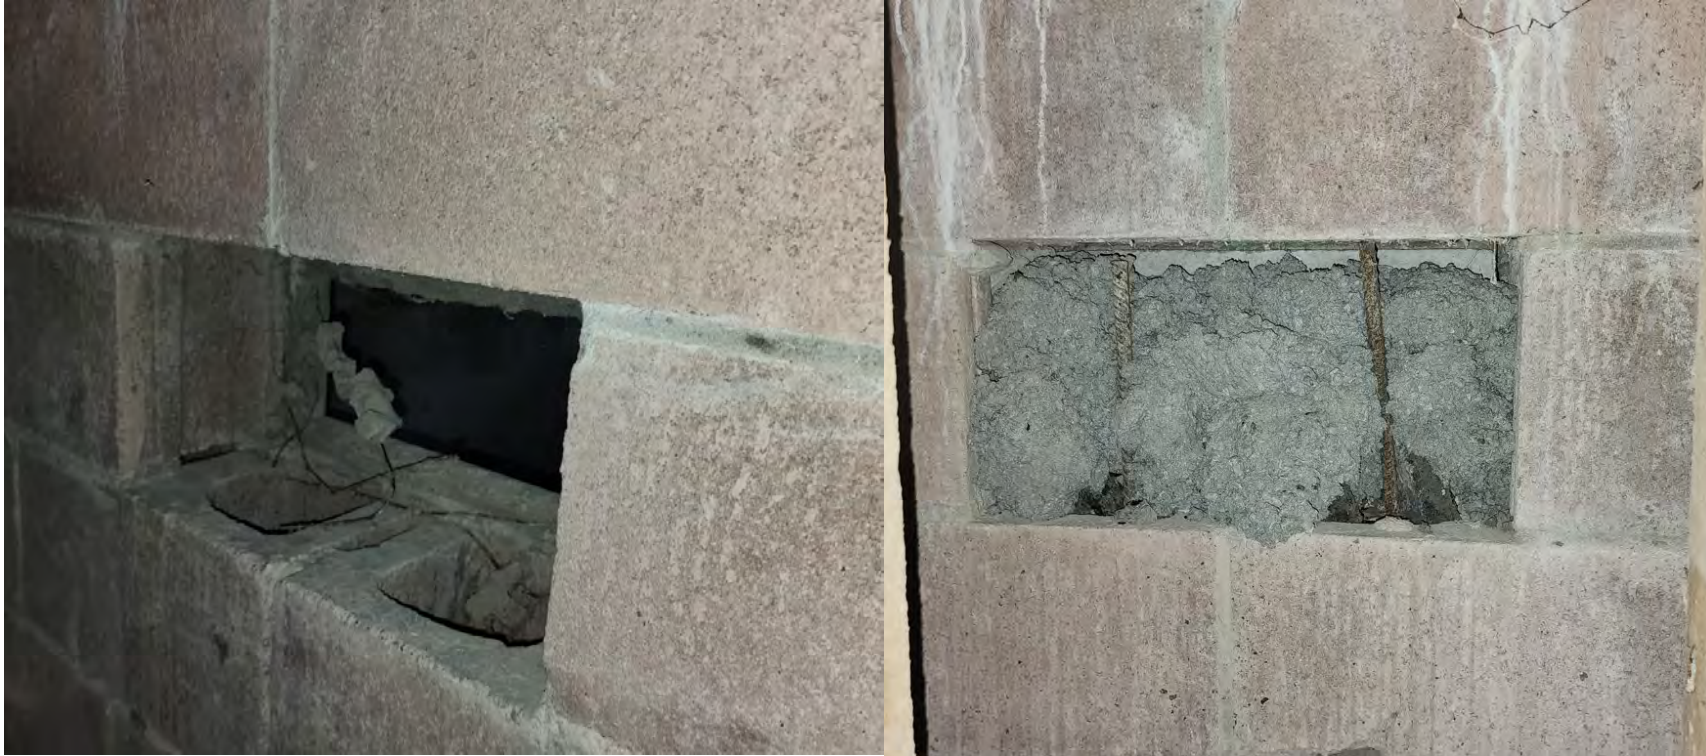
The structural steel portal frames cannot be observed in their entirety within the building, however the external portals visible at the lean to areas on the eastern side of the building display advanced corrosion at their connection. Whilst the corrosion is not guaranteed to extend to the internal portal frame structure, you would need to strip all claddings to observe the remainder of the structural steel in order to provide any future certainty of their condition, which is a significant undertaking.

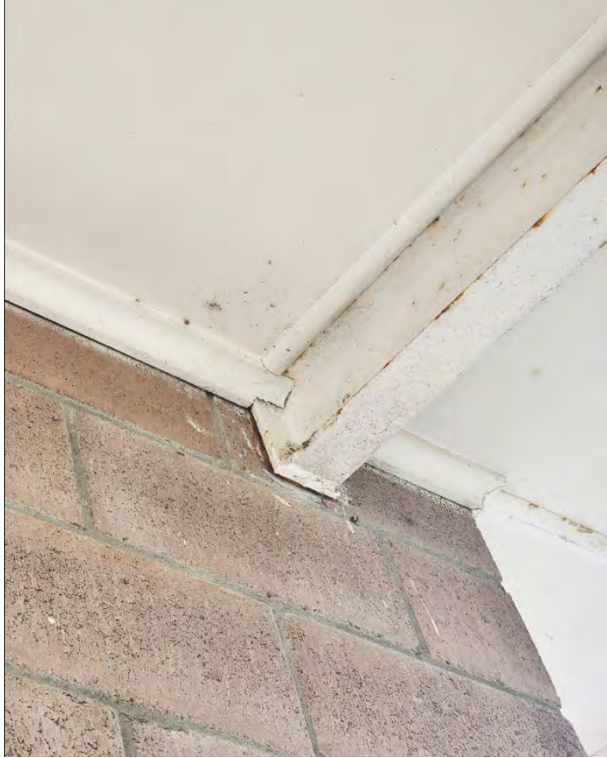
The foundations of the hall sub-floor are not braced, as mentioned above, and are also of the 1960s era of 100 x 70 mm timber pile supported on a 200 x 200 mm concrete footing, only superficially embedded below the ground surface.
