**INITIAL SEISMIC ASSESSMENT  
TAPORA COMMUNITY HALL  
5 OKAHUKURA ROAD, TAPORA  
AUCKLAND  
FOR  
AUCKLAND COUNCIL**

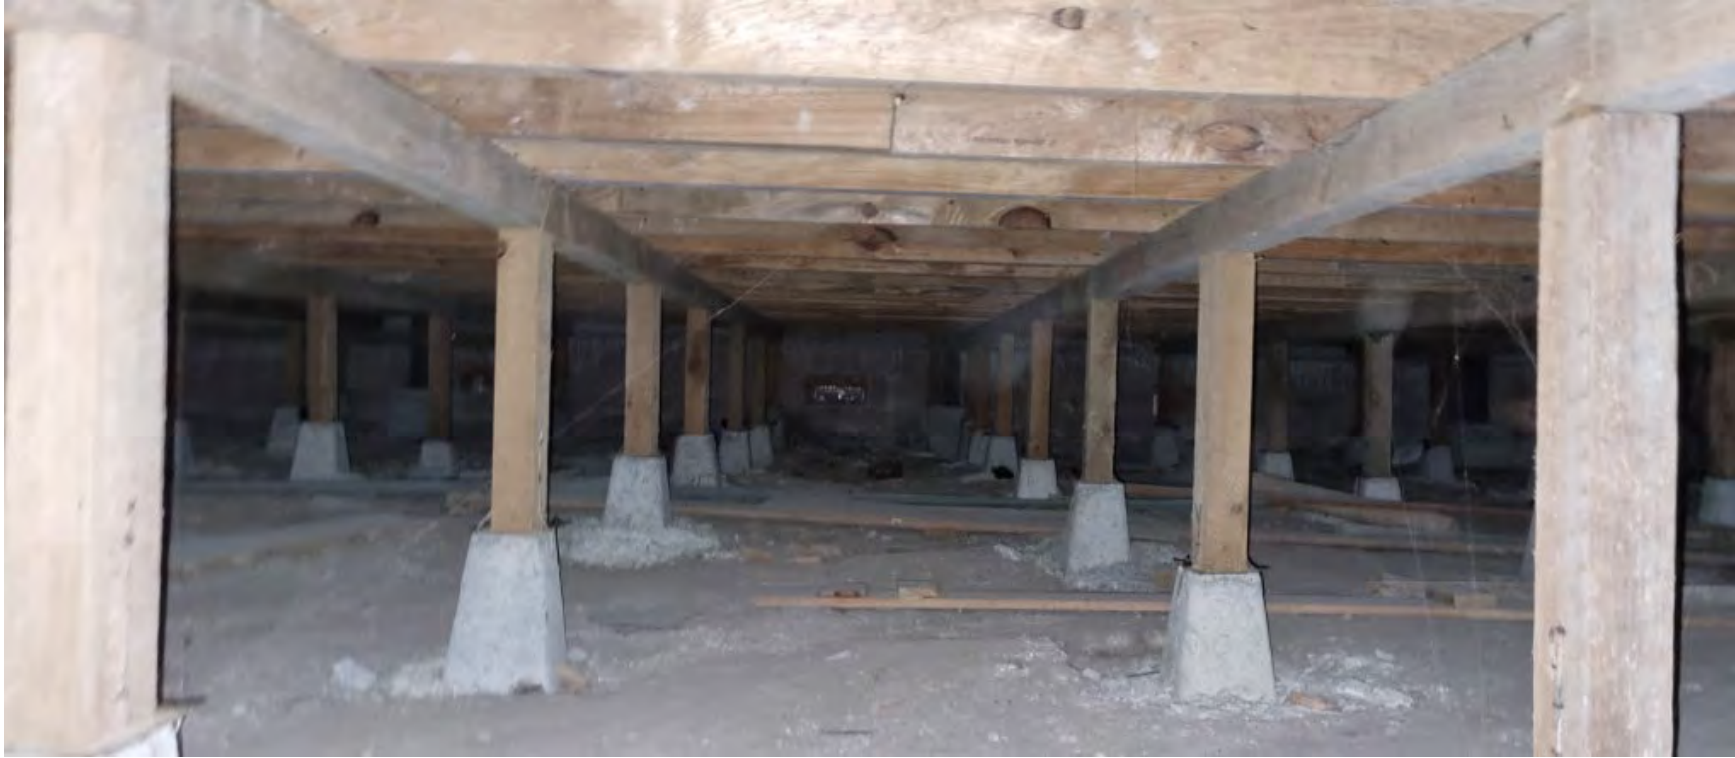
The foundations of the URM walls comprise concrete perimeter strip footings that are also inadequately founded to mitigate the effects of soil shrinkage.

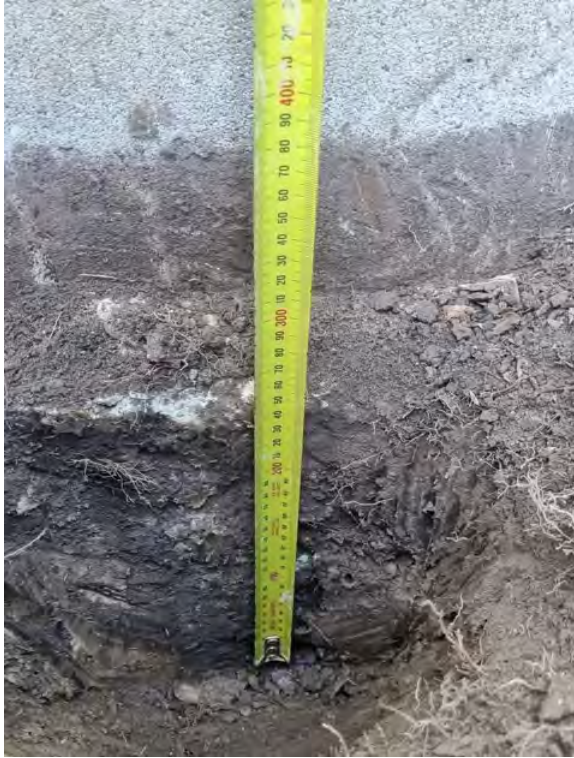
The more recently constructed toilet block add-on to the northern end of the building displays significant cracking in the veneer cladding system and the foundations. The building is clearly inadequately founded in relation to both ground conditions and the presence of surrounding vegetation, and has settled differentially. The toilet block would not be worth salvaging during any seismic retrofit of the northern end walls of the hall building and would require full replacement.

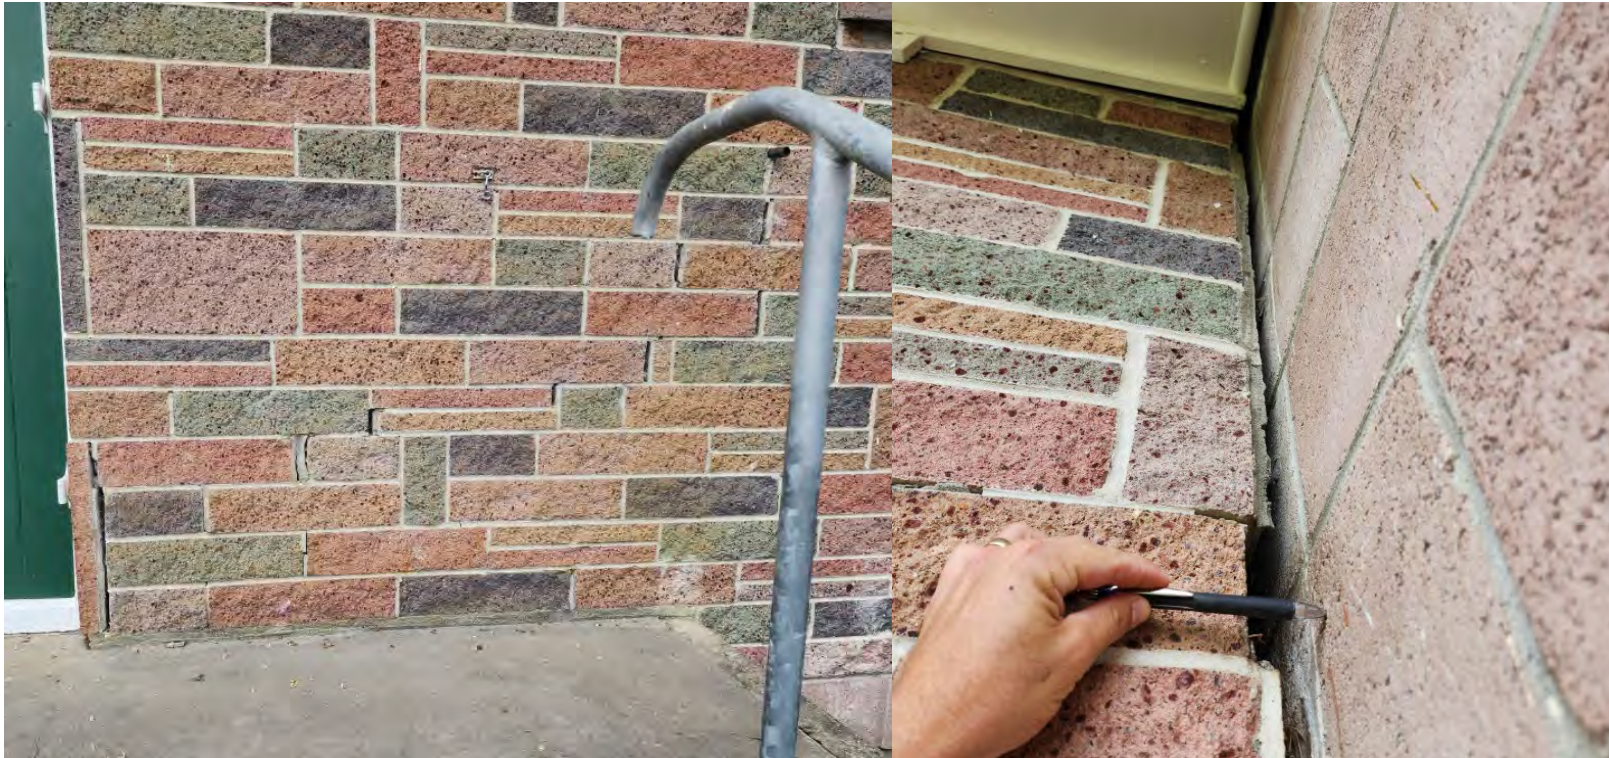
The timber Playcentre extension on the southwestern corner of the building is in poor condition, appears to have been subject to little maintenance over time and poses future durability issues. As you are aware there are also Asbestos Containing Materials around the Playcentre and various other areas of the building that require attention.
