Waitakere Coastal Communities Landslide Risk Assessment

Appendix C – Muriwai Slope Stability Assessment Report

Auckland Council

30 April 2024

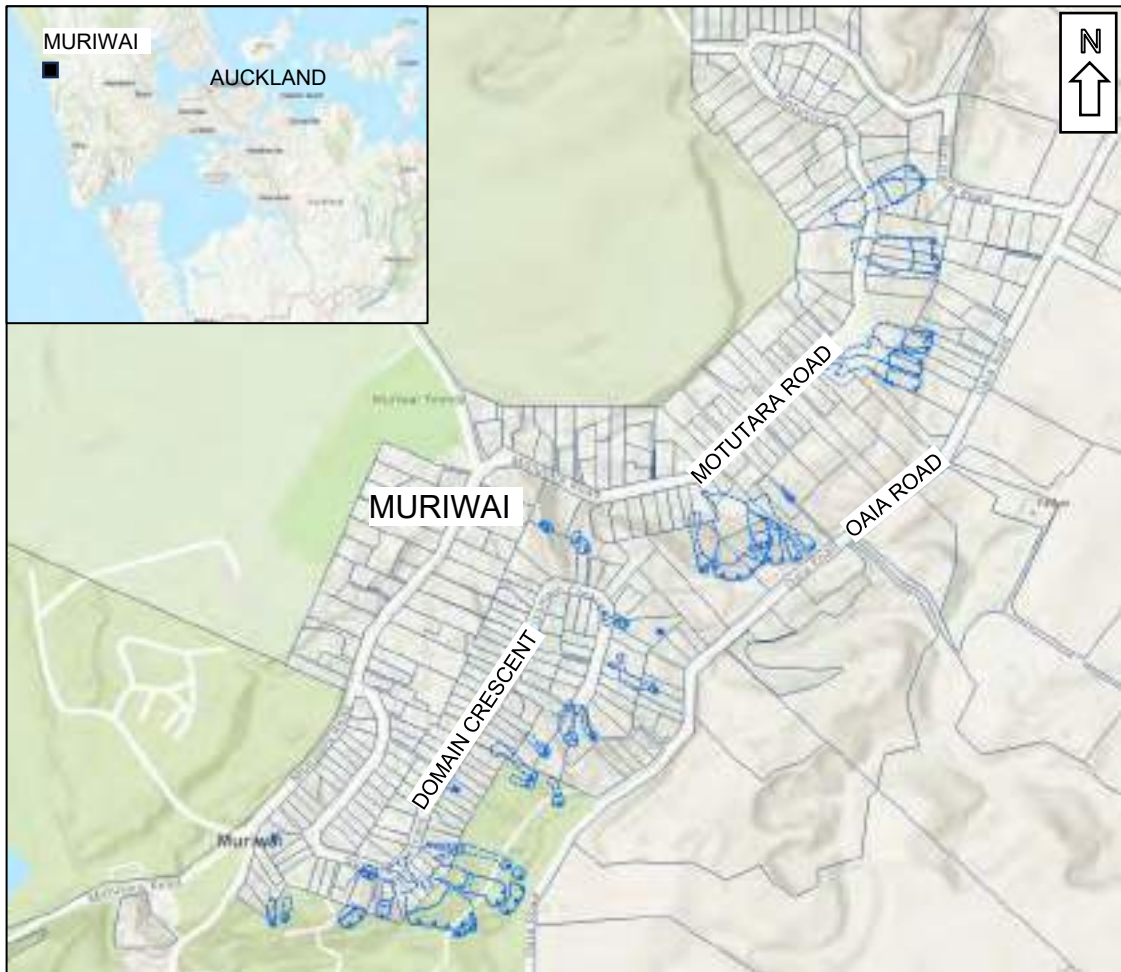
Figure C-1 Muriwai location showing the February 2023 landslides mapped by GHD (blue lines)

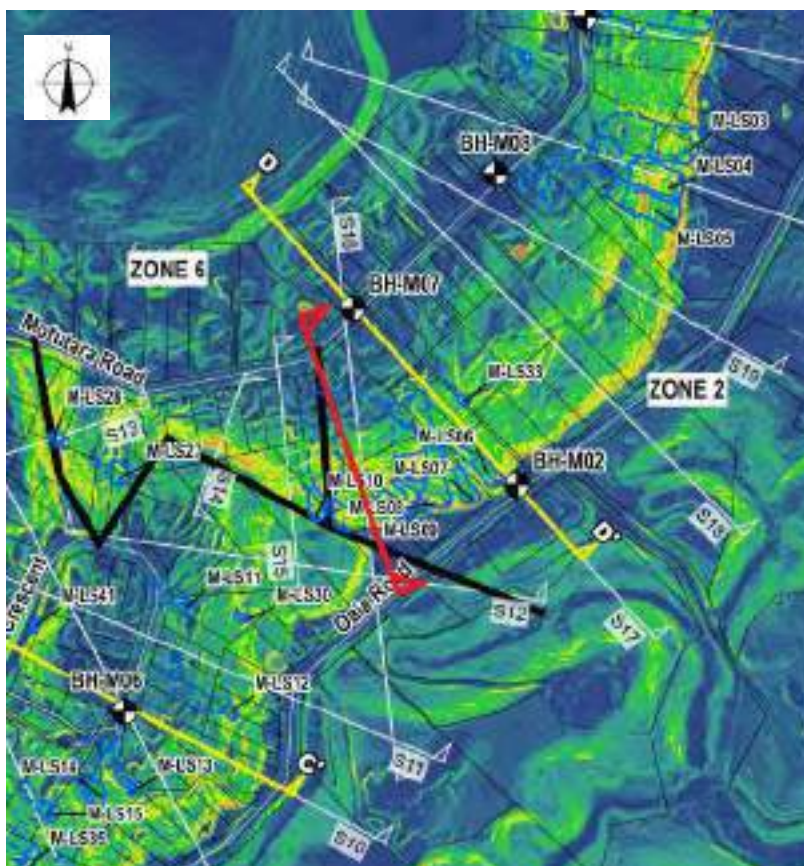
The cross section shown in Figure C-2 was selected for assessment purposes as being a conservative (i.e. steep) example of the range of failure geometries. The cross-section extends for approximately 260 m horizontally and approximately 100 m vertically. A comparison of landslide cross section profiles is presented in Figure C-3.

Figure C-2 Assessment area plan indicating the major February 2023 slip areas and the analysed cross-section A-A (retrieved from Google Earth Pro and GHD Atlas). A close-up view of Figure A125 (see Appendix A) showing the analysed cross section 'A' relative to other slope profiles, cross sections and boreholes.

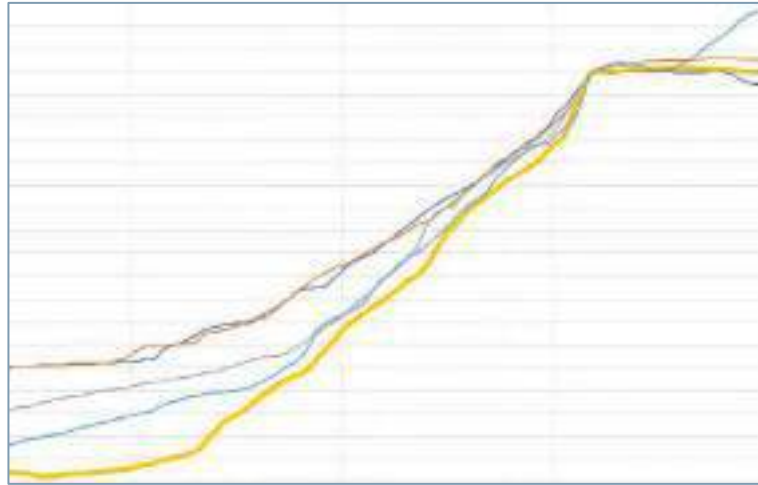
Figure C-3 *Indicative comparison of cross section slope profiles at February 2023 landslide sites. The slope profiles at the upper slope have a similar geometry. The thick orange line is the analysed profile.*

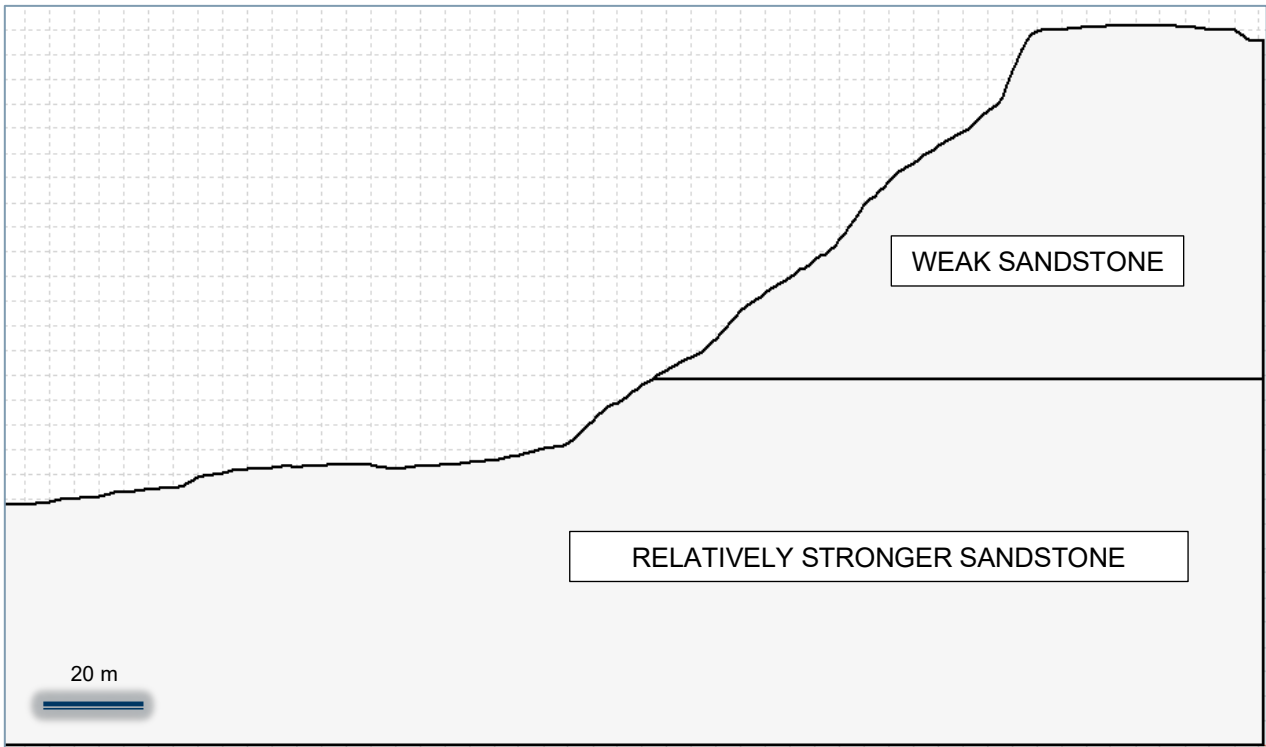
For the purposes of our analysis, we have made a nominal subdivision with weaker sandstone overlying a higher strength sandstone.

We employed R_u values to model varying degrees of saturation as an alternative to groundwater level, which was unknown at the time of landsliding in February 2023.

Figure C-4 Simplified ground model used for the analyses

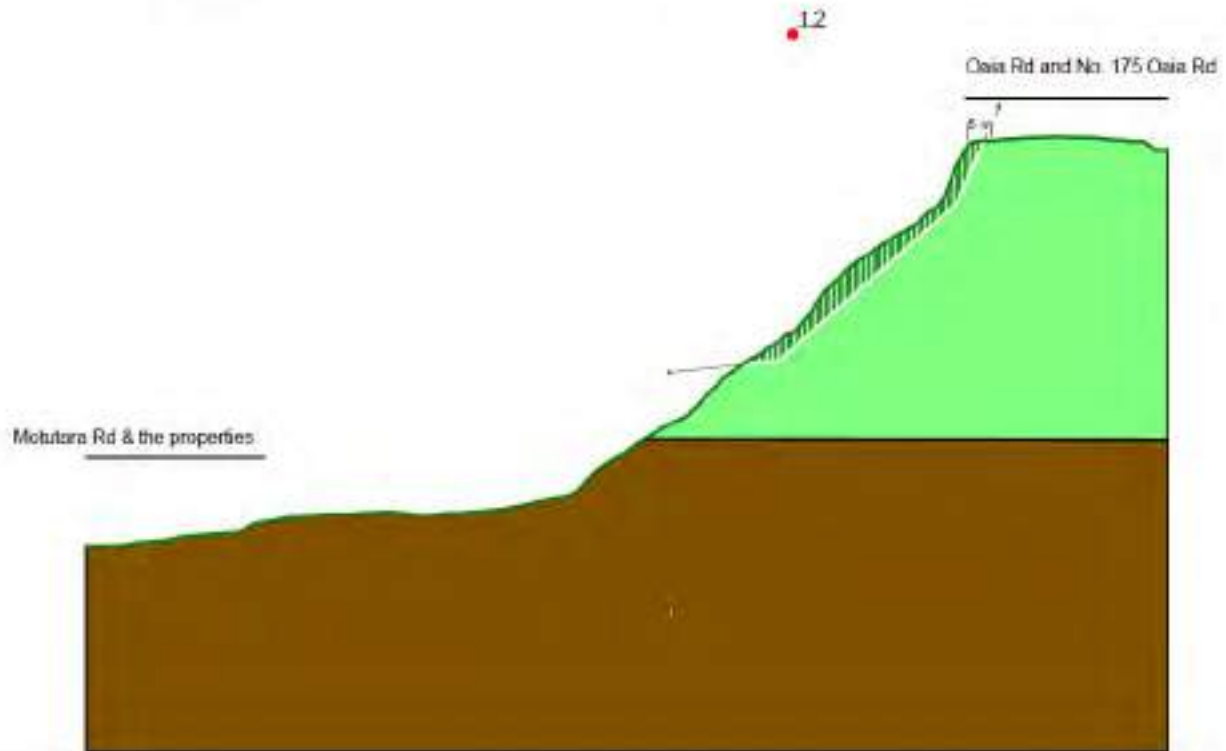
Figure C(A)-1. Back Analysis - Normal Groundwater

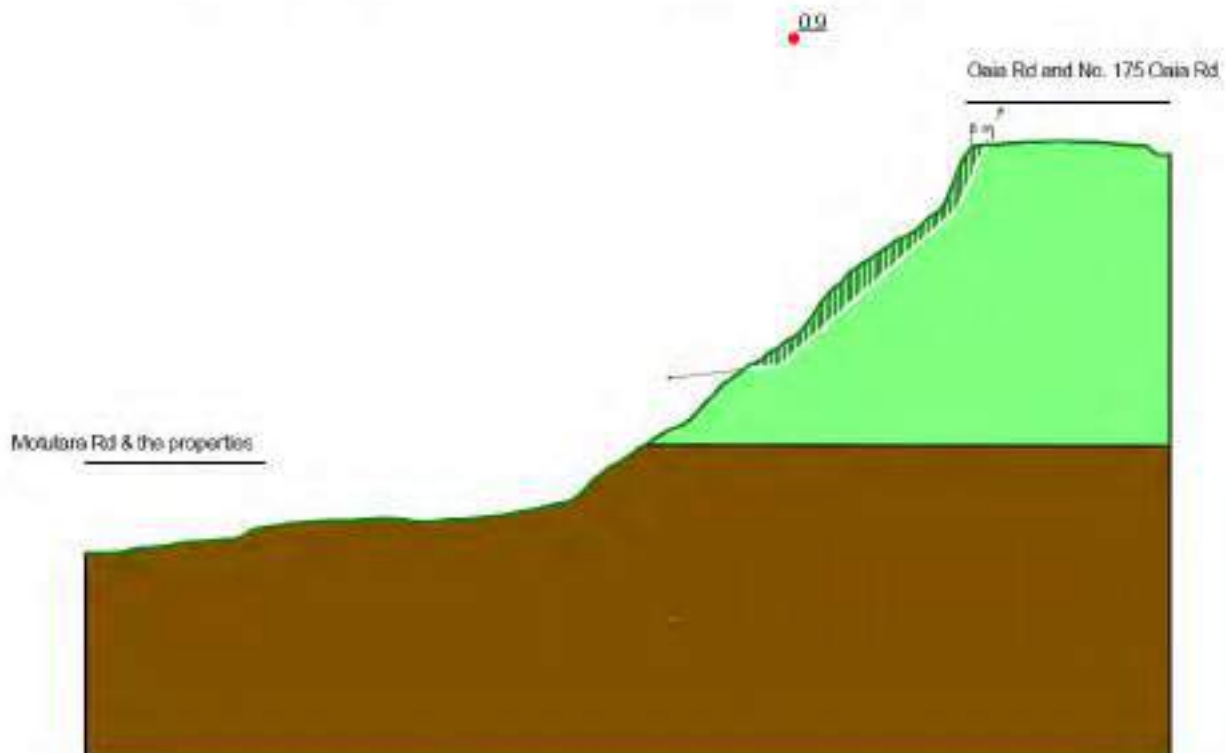
Table C-2 shows the results of the sensitivity analysis as Ru was increased. It will be seen that at an Ru value of 0.3, failure of the slope effectively occurs. This is an indication that the parameters utilised are providing reasonable agreement with observed behaviour.

Figure C(A)-2. Back Analysis - Extreme Groundwater
