# Waitakere Coastal Communities Landslide Risk Assessment

**Overall Report - Muriwai**

Auckland Council
15 May 2024

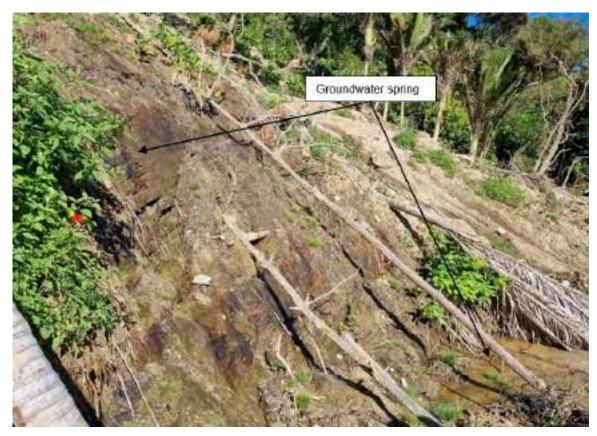
Figure B20 Groundwater seepage above highly oxidised (limonite) layer within Awhitu Formation 'less cemented' sand

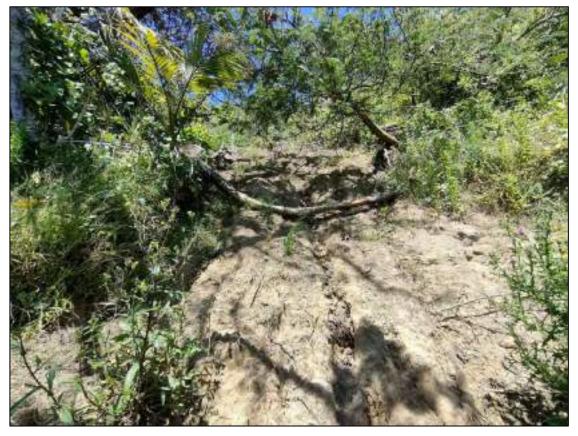
Figure 2.9 Failure surface (evacuated zone) exhibiting evidence of post failure erosion. Looking upslope.

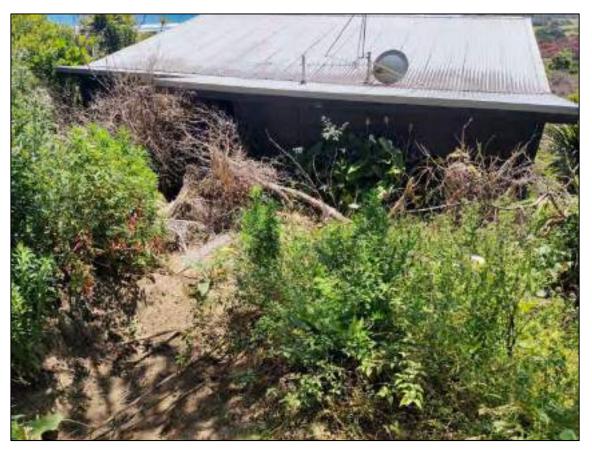
Figure 2.10 Debris piled up at the rear of dwelling (estimated up to 1.5 m thick)

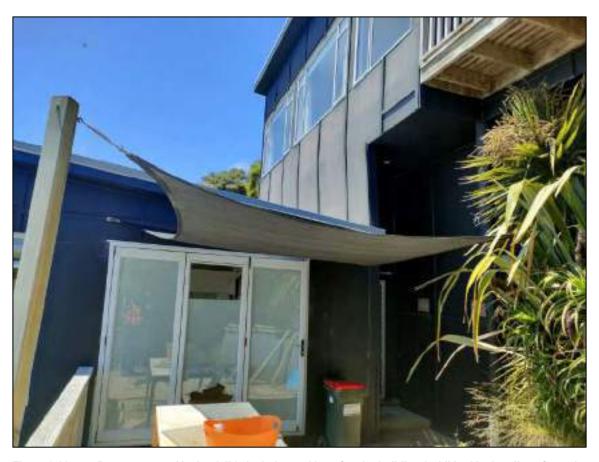
Figure 2.11 Damage caused by landslide includes racking of entire building (exhibited by bending of exterior wall)

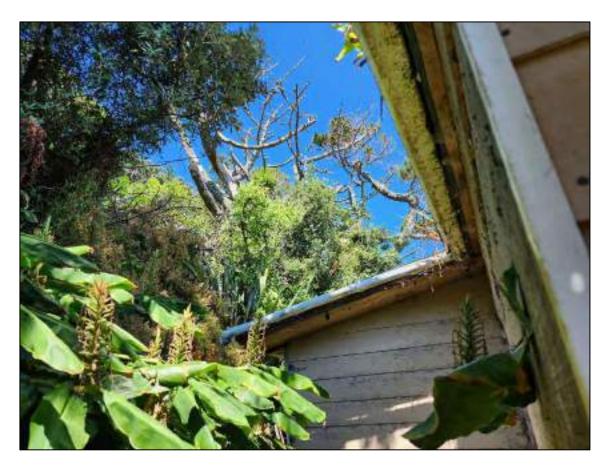
Figure 2.1 Steep vegetated slope at the rear of the dwelling

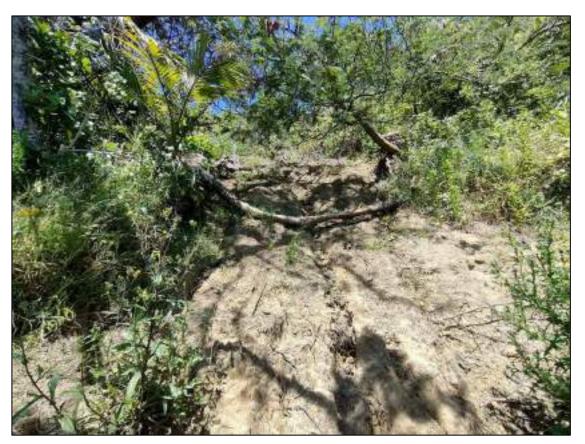
Figure 2.9 Failure surface (evacuated zone) exhibiting evidence of post failure erosion. Looking upslope.

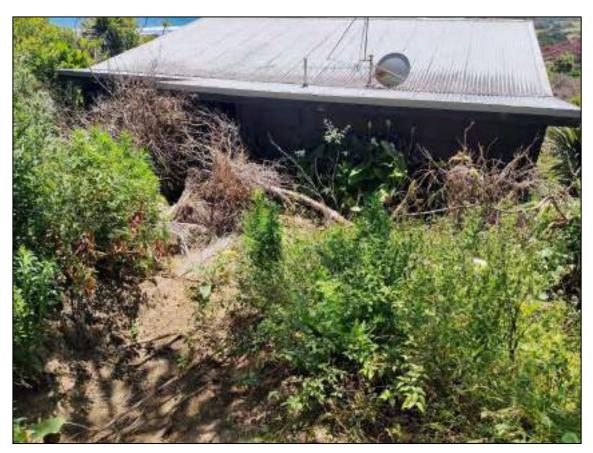
Figure 2.10 Debris piled up at the rear of the dwelling at No. 85 Domain Crescent (estimated up to 1.5 m thick)
