Subject:	Stream Erosion Risk Assessment	Date:	18/10/2024
		Memo No:	44712-ME-C-EG04-D
Site Address:	Whenuapai Business Park, Whenuapai, Auckland	Status:	For Notification
Author:	Paul Kleynhans (CPEng, BE)	No of Pages:	35

Memo

WHENUAPAI BUSINESS PARK – STREAM CONDITION ASSESSMENT

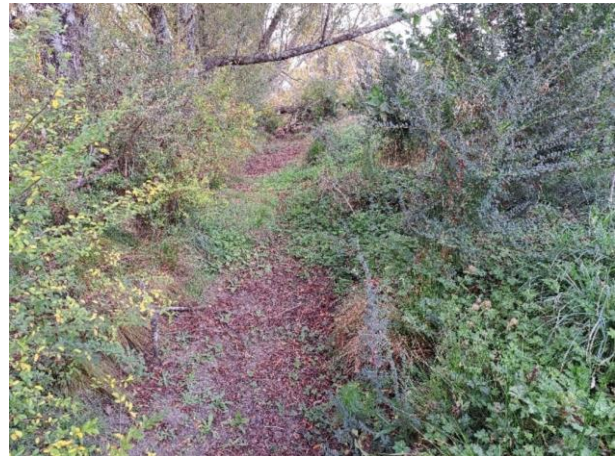
Photo point C was located near the upstream extent of the watercourse. The channel was represented by a formed, but shallow depression. Leaf litter and debris was present on the base suggesting no recent flushing flows. No significant changes in the reach of stream were observed with the exception of continued growth of vegetation. Exotic weeds such as woolly nightshade and privet were abundant and appeared to be more prolific than during the 2020 survey. Channel form was largely unchanged despite the significant flood event in 2023.

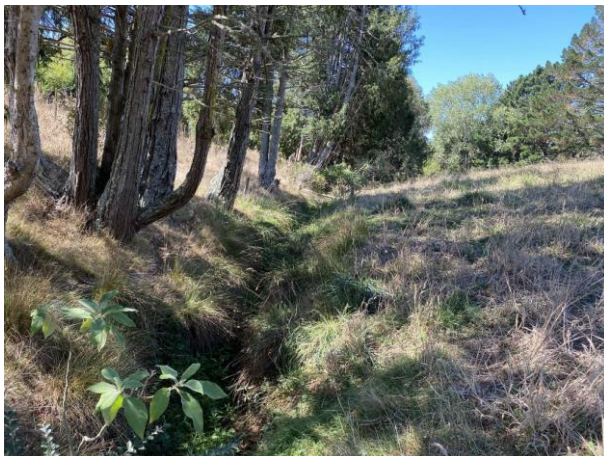
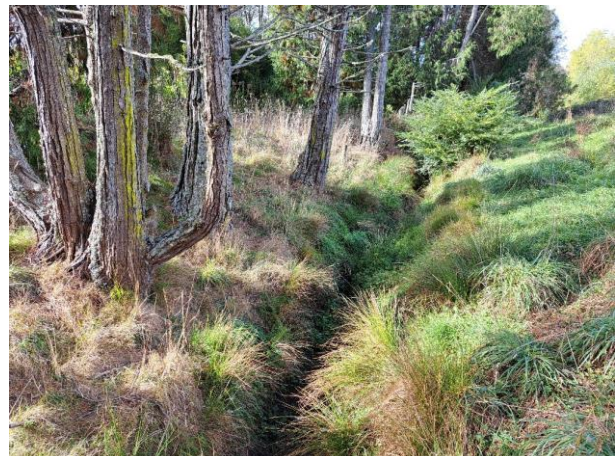
Photo point E1 was located directly south of the Spark NZ facility on Brigham Creek Road. The channel was moderately incised during both the 2020 and 2024 surveys. There were no significant changes in channel condition, despite the significant 2023 flood event. Vegetation growth along the channel banks had increased, likely due to the removal of grazing stock.

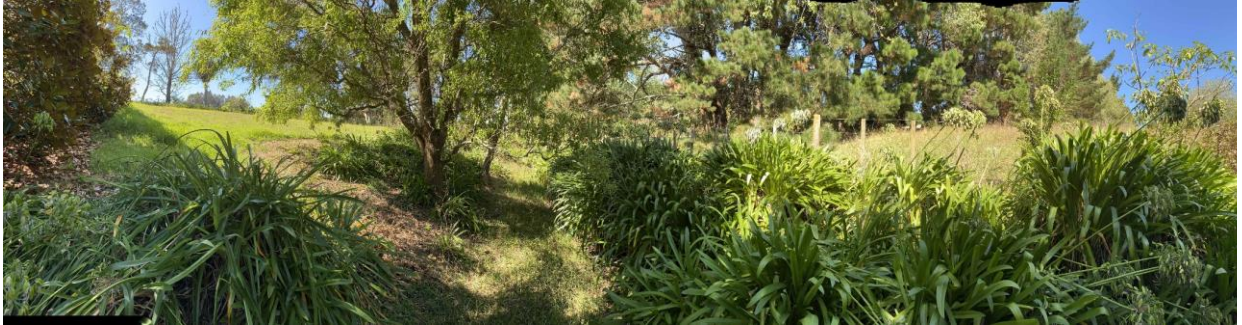
Photo point H2 was located in what would have been the front garden of the main house at 151 Brigham Creek Road, which has been demolished. There were no significant changes in the channel or banks, despite the 2023 flood event. The channel was defined and not incised. During both surveys, the channel contained terrestrial vegetation, indicating it is not regularly inundated. The banks were characterised by abundant agapanthus, along with other garden and ornamental plants and trees.

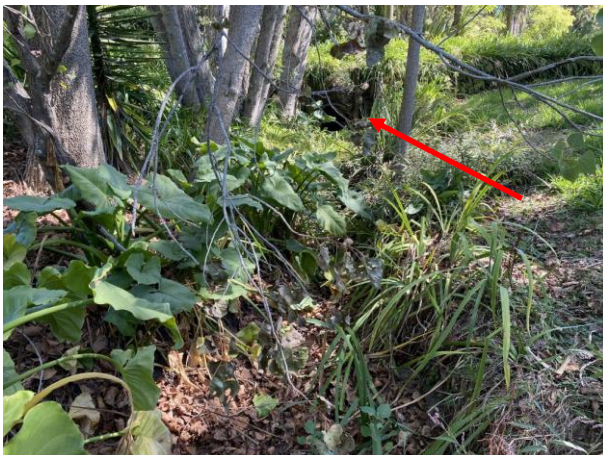
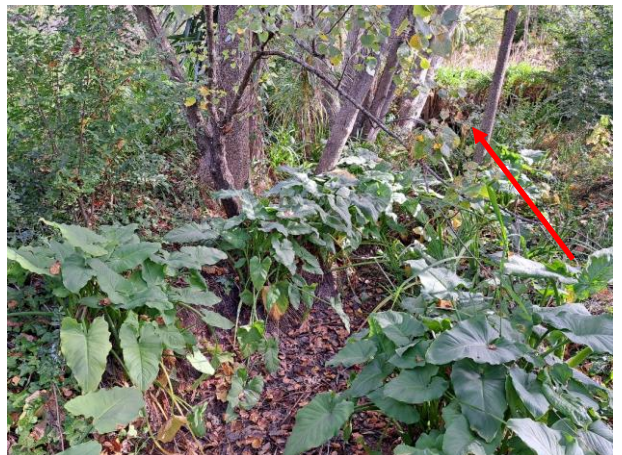
Photo point K was located looking upstream, towards the culvert (indicated by the red arrows) that would have provided access to the main house at 151 Brigham Creek Road (now demolished). The channel was ill defined, and occupied a shallow vegetated depression. During both surveys the channel was entirely filled with leaf litter, suggesting no flushing flows. There was no evidence of scour or erosion, including around the culvert. Pest plants such as agapanthus and arum lily were abundant during both surveys.

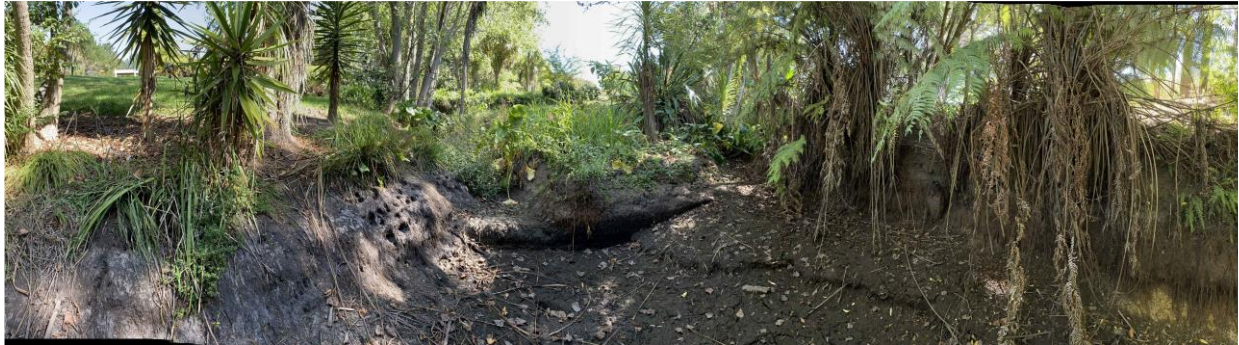
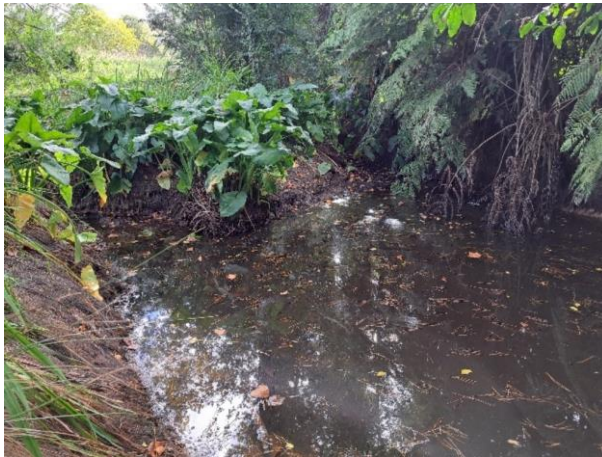
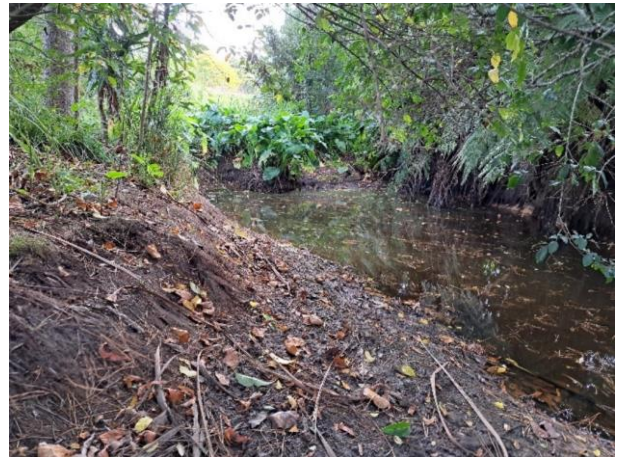
Photo point L could not be perfectly replicated due to the presence of water. It was located looking upstream, towards the upstream end of the artificial pond located at the confluence of the two main intermittent channels. The banks were well defined, as expected of a constructed pond. There was no undercutting, scour or areas of obvious erosion, despite water being present during 2024, but not during 2020. The perimeter of the pond was stable, likely the result of the significant vegetation in the immediate surrounds.

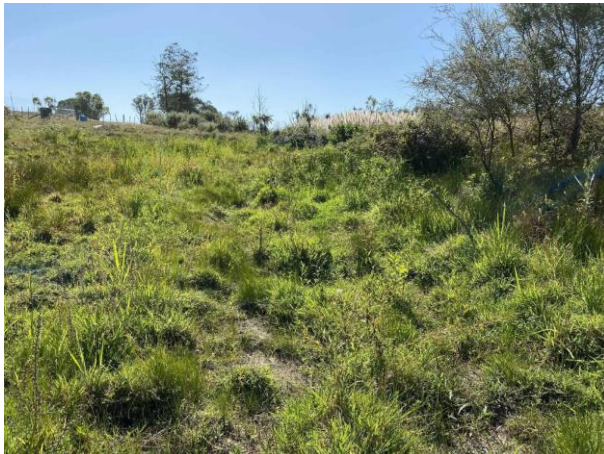
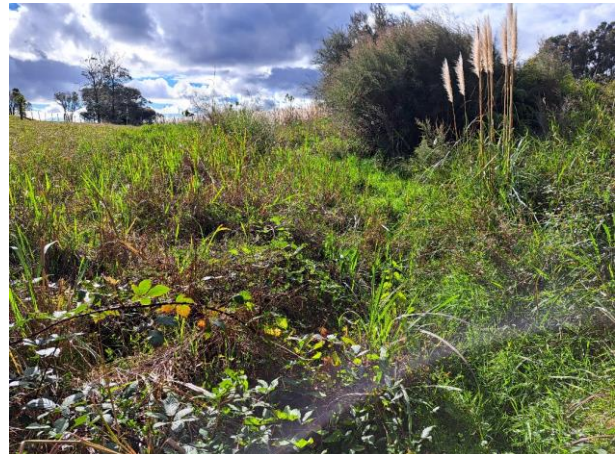
Photo point L3 was located on the intermittent tributary that flows from the stormwater pond within the airbase on the opposite side of Brigham Creek Road. The watercourse was ill defined. The main difference between the two surveys was the proliferation of vegetation, including mixed pasture grasses, blackberry and pampas, attributable to the removal of stock from the paddock. The 2020 survey yielded significant pugging on this reach, however no pugging was observed during 2024, due to the lack of stock. The watercourse was considered to be more stable in 2024, despite the significant floods experienced in 2023, likely due to the removal of stock from the paddocks.

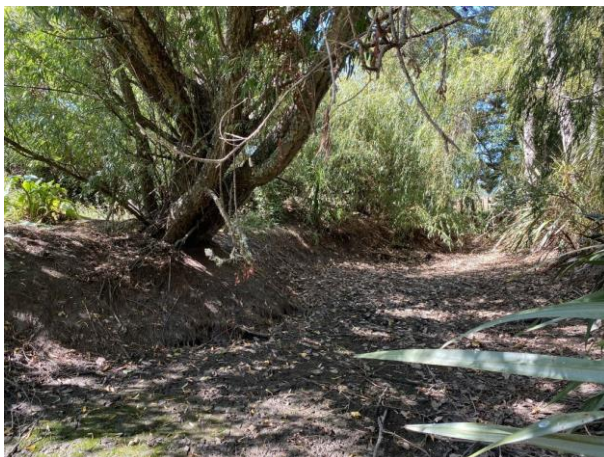
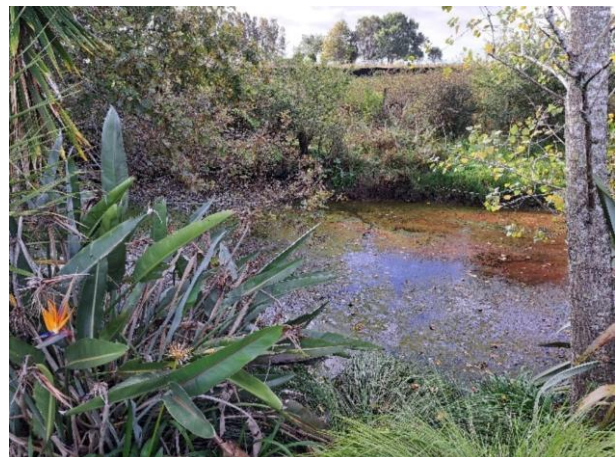
Photo point M was located at the downstream end of the artificial pond. The photo point could not be replicated due to the presence of water within the pond. The 2020 image was taken from within the pond when it was dry. Despite not being able to replicate the photo, the banks of the pond were observed. No evidence of scour, erosion or bank undercutting were observed, suggesting the outlet of the pond was stable, despite the significant floods that occurred in 2023. The vegetation growth around the pond has likely contributed to bank stability.

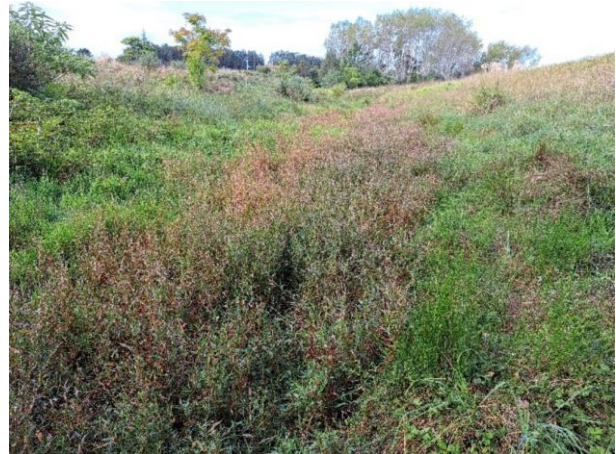
Photo point O was located downstream of the constructed pond, looking downstream. The channel during both surveys was ill defined, and contained no obvious flow or non-vegetated channel. Cattle were present during 2020, which have likely caused the shallowness of the channel through pugging and trampling. During 2024 there was some water present, though the channel can be more accurately described as damp ground rather than a flowing channel, however the channel was no more defined than 2020, despite the high flows experience during 2023, and the removal of cattle from the paddocks.

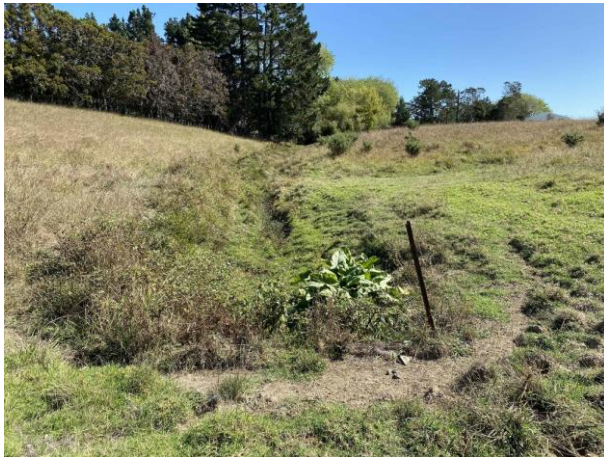
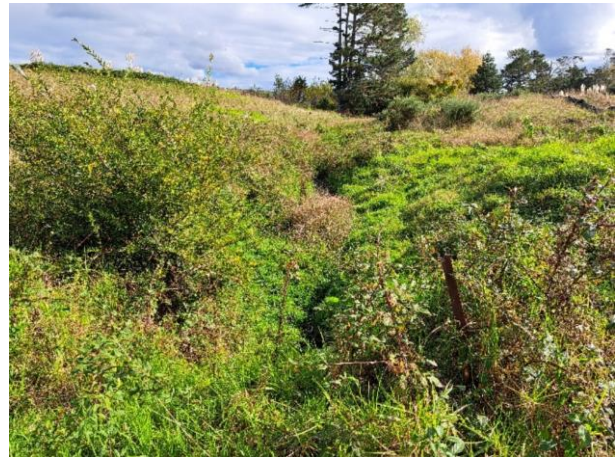
Photo point Q was located on a culvert crossing, looking upstream towards the constructed pond (which is located in the vegetated area in the distance). The watercourse was contained within a defined, but shallow channel, which widened towards the upstream end of this photo where it became less defined. The channel was well vegetated during both surveys, with blackberry encroaching along the entire length during the 2024. There was no evidence of any scour or erosion, including around the culvert. Some water was present during 2024, however it can be more accurately described as a damp channel, rather than flowing or standing water.

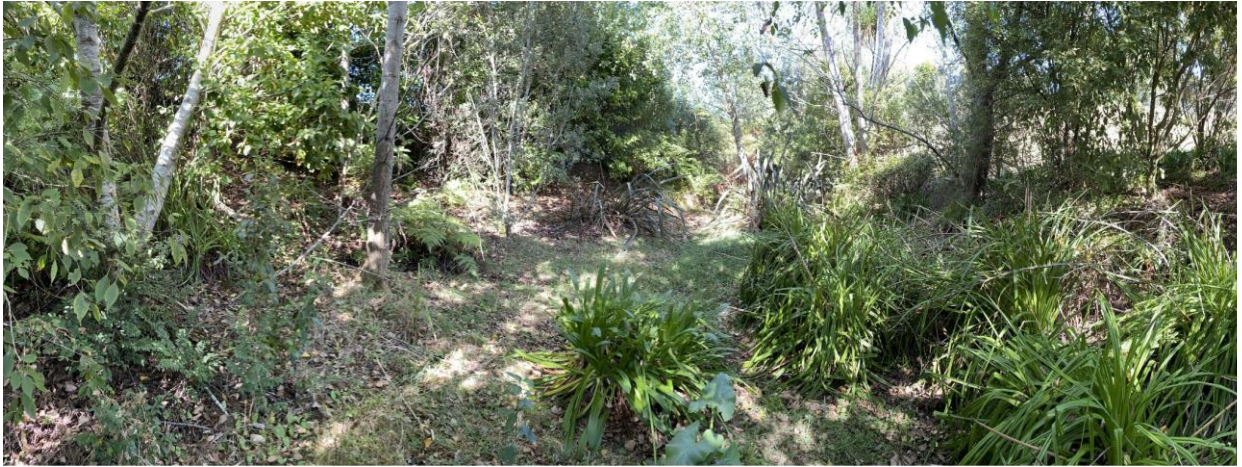
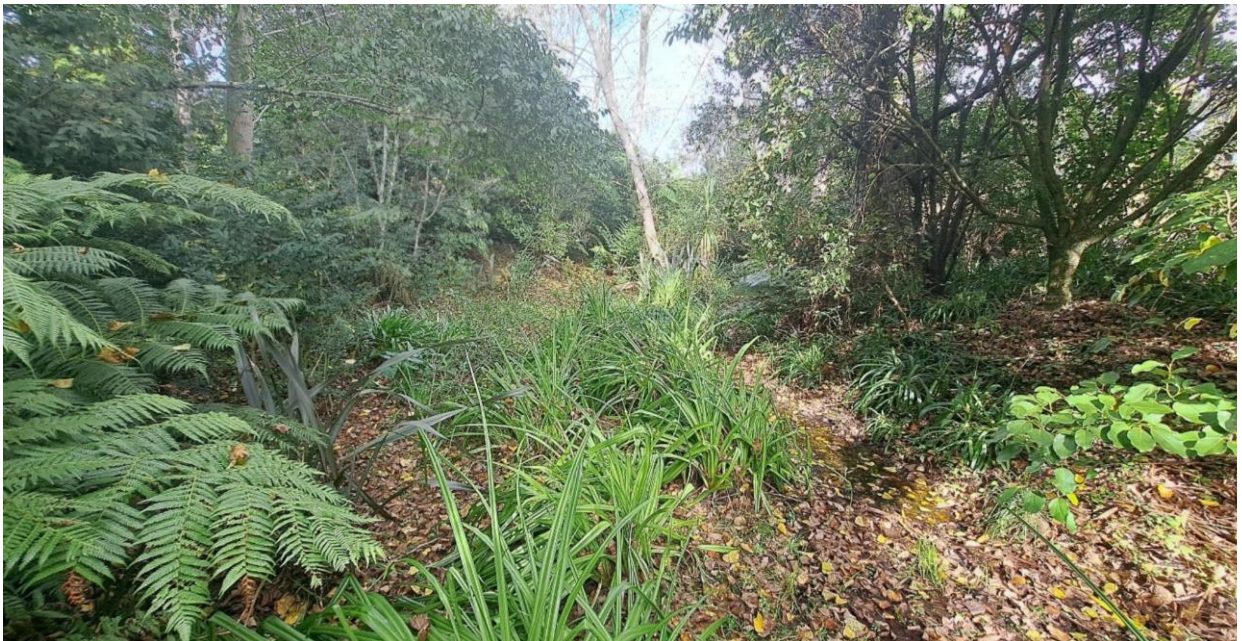
Photo point R was located downstream of the culvert crossing within an area of native dominated vegetation. The wetted channel was present, but not easily defined. It was present in a generally low area. There were no obvious changes between the two surveys. During 2024 water was present, however it was not flowing and it formed a series of isolated, stagnant pools. Abundant leaf litter was present within the channel suggesting no recent flushing flows. No evidence of scour, erosion or channel damage was identified.

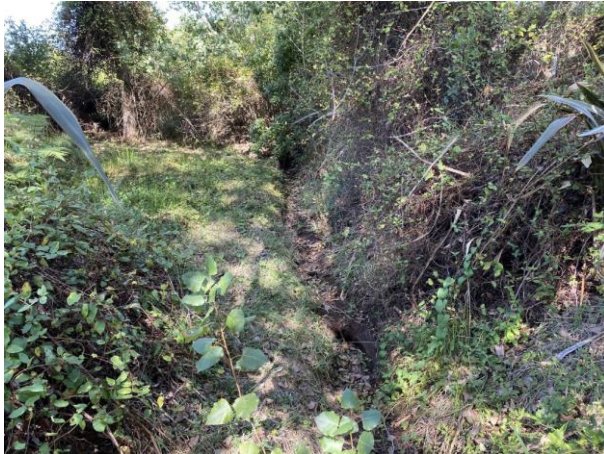
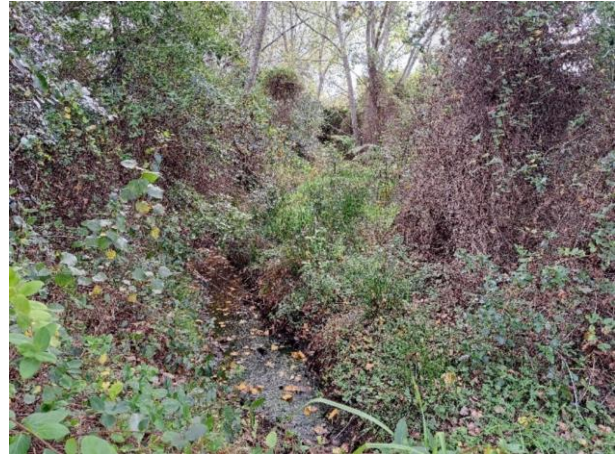
Photo point U was located close to Brigham Creek Road. The channel was shallow, and moderately incised, and located within an area of mixed vegetation, with a high incidence of weeds. Water was present during the 2024 survey, but did not appear to be present during 2020. Water was not flowing during 2024, rather it was present as a shallow, stagnant pool. Extensive leaf litter was present during both surveys suggesting no recent flushing flows. No evidence of scour or erosion were observed.

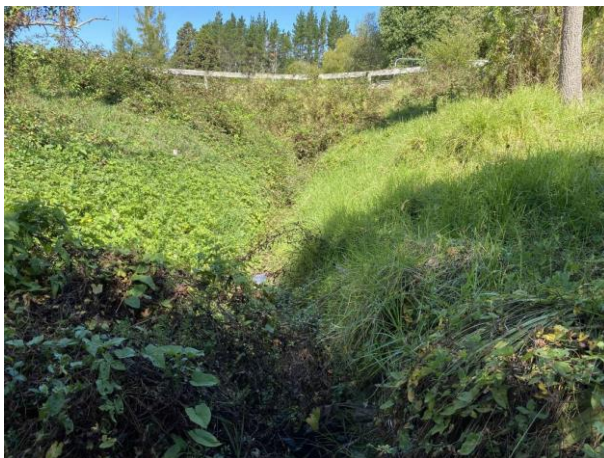
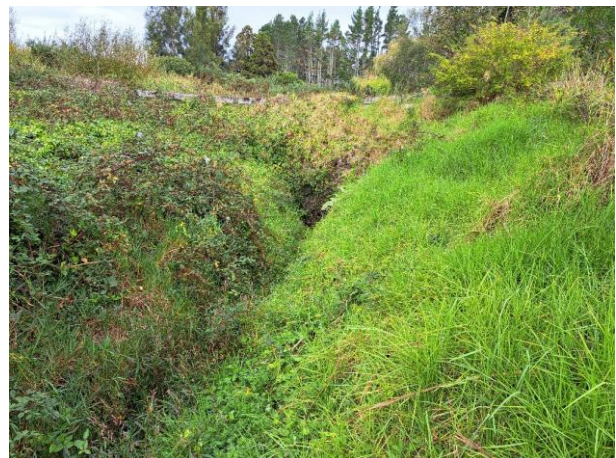
Photo point V was taken looking downstream towards a culvert crossing. The channel was well defined, and contained within relatively steep, but not incised banks. During both surveys vegetation was abundant on the channel banks and around the culvert. There were no obvious differences between the two surveys, and no evidence of scour, erosion or bank damage.

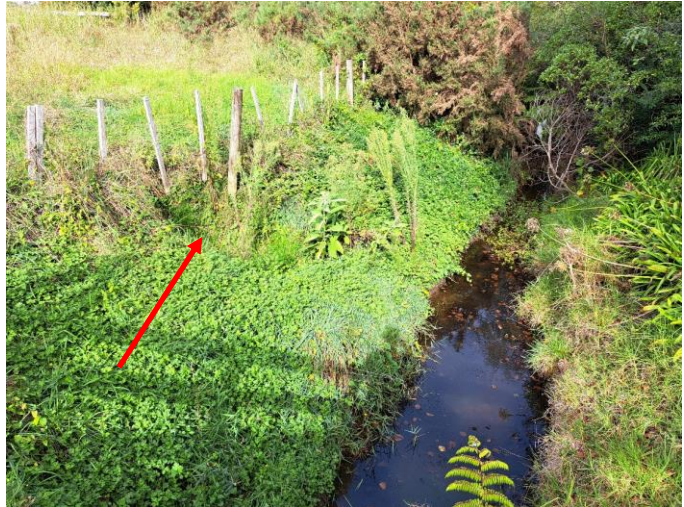
Photo point W was the only location where there was evidence of erosion observed. The photo point was located downstream of a culvert crossing, looking downstream. The channel was well defined, with the wetted area slightly incised. Water was present, during 2024 though flow was not obvious. The channel was dry during 2020. On the true left bank an area of slumping was present during 2024 (indicated by the red arrow). As a result, a gap of approximately 0.5 m was present between the ground level and the fence. Where the slumping has occurred, the bank is steep. The slumping does not appear to have been caused by the flow of the stream. Rather, it is likely overland sheet flow, potentially from Brigham Creek Road, has made its way towards the stream via an ephemeral flow path, resulting in the bank slumping. The slumping itself is above the normal level of the stream, on the upper bank. It is expected this area will continue to erode during periods of high flow, though it is noted that high flows appear to be uncommon.

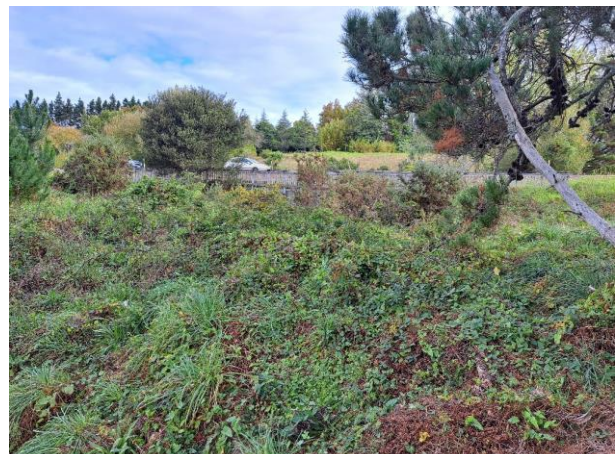
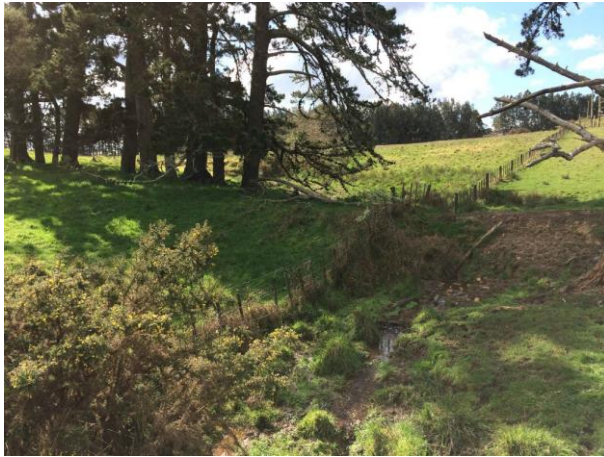
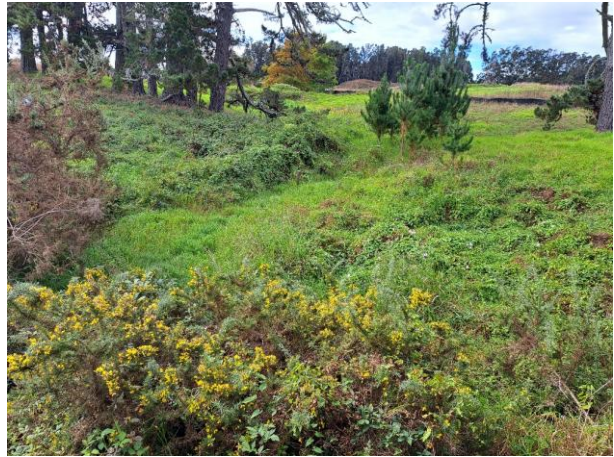
Photo points V1 and V2 were located on the opposite side of Brigham Creek Road on a channel that drains a constructed pond, and flows through a culvert under Brigham Creek Road and into the watercourse within the site. The channel was ill defined, and was represented by a shallow depression rather than a formed channel. The area was entirely vegetated. Vegetation was significantly more dense during 2024 than 2020. No evidence of scour, erosion of channel damage was observed.

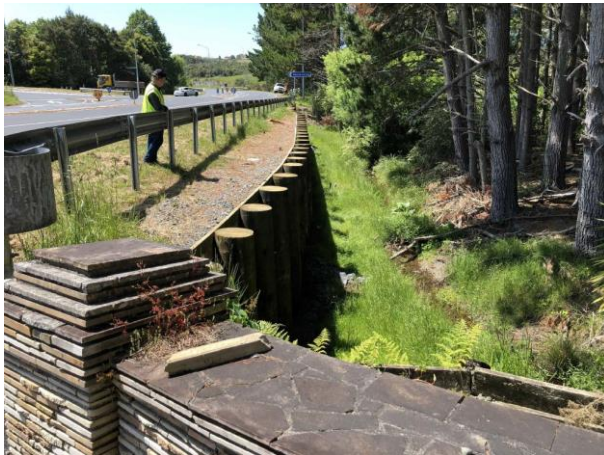
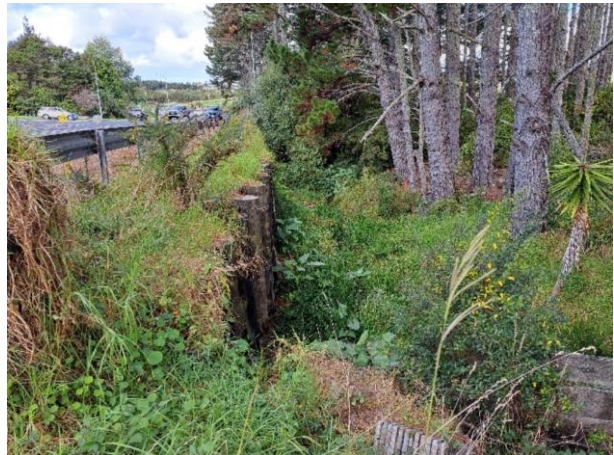
Photo point Z was located along the Brigham Road embankment, near its intersection with Kauri Road. The channel not easily observable during 2024 due to vegetation growth, while it was readily visible during 2020. The extensive vegetation growth suggests the channel and banks are stable enough to allow vegetation to proliferate. No evidence of scour or erosion were observed, including around the culverted entry between 159 and 163 Brigham Creek Road, which was where the photo was taken from.

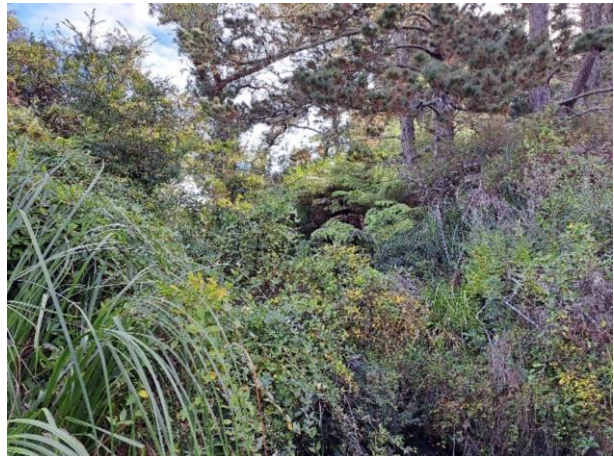
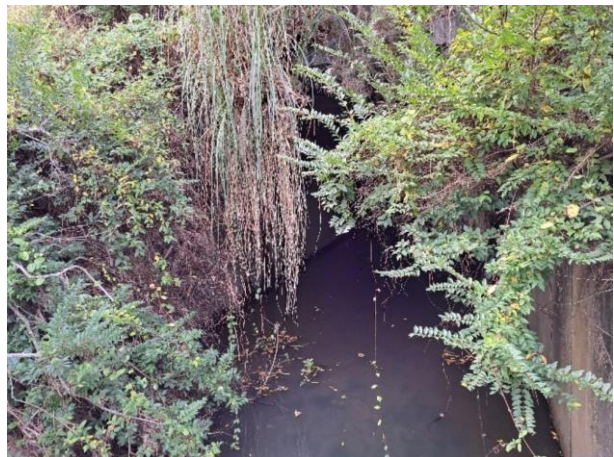
Photo points Z2 and Z3 were located at the downstream end of the watercourse, where it flows under Brigham Creek Road. Neither photo point could be fully replicated due to the depth of the water within the stream. However, extensive vegetation was present during both surveys and there was no evidence of any scour, erosion or channel damage observed, despite the high flows experienced during 2023.
