**GEOTECHNICAL COMPLETION REPORT**

**10-LOT**

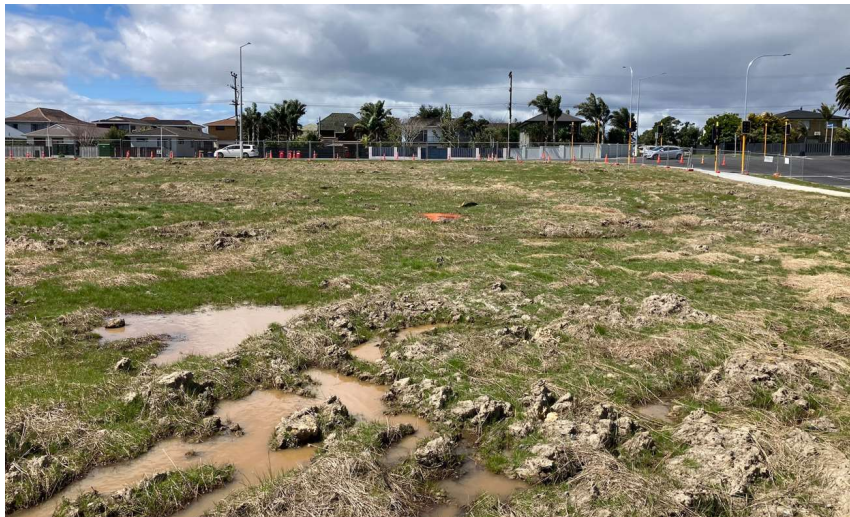
*Figure 2. Photo taken of Lot 5 looking towards Hobsonville Road in the background. Note the ponded water and deep rutting evident*

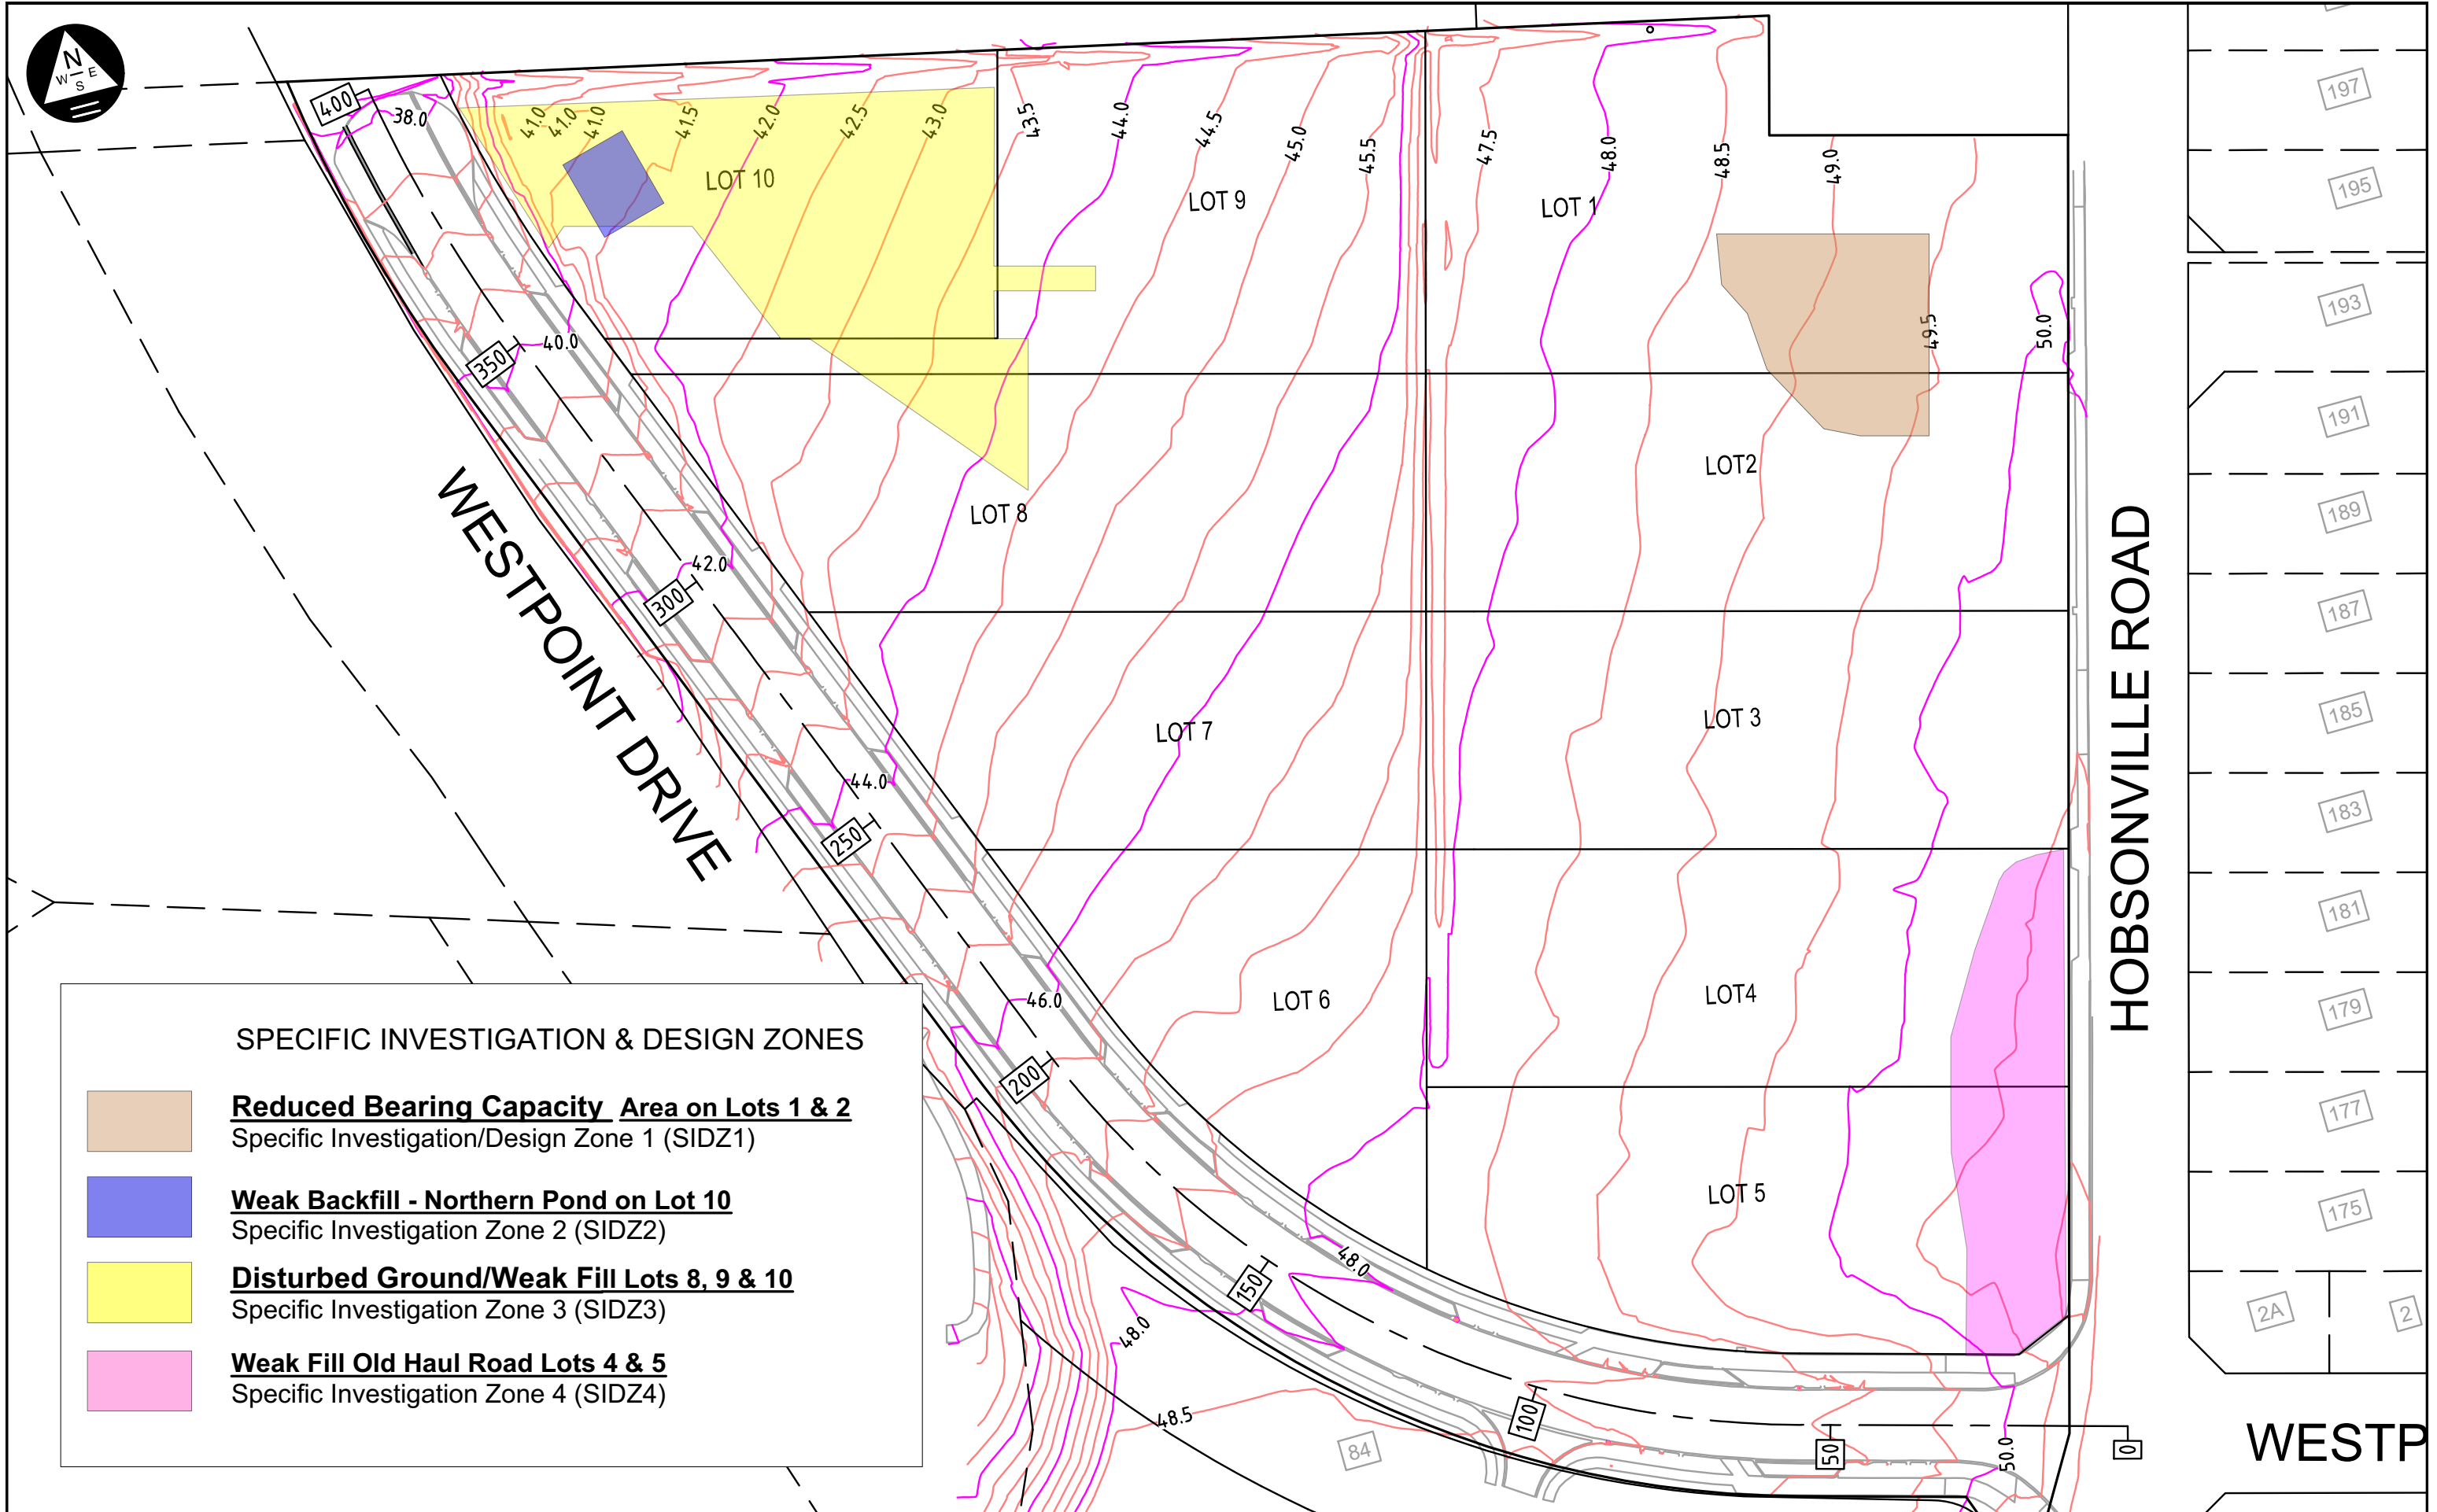
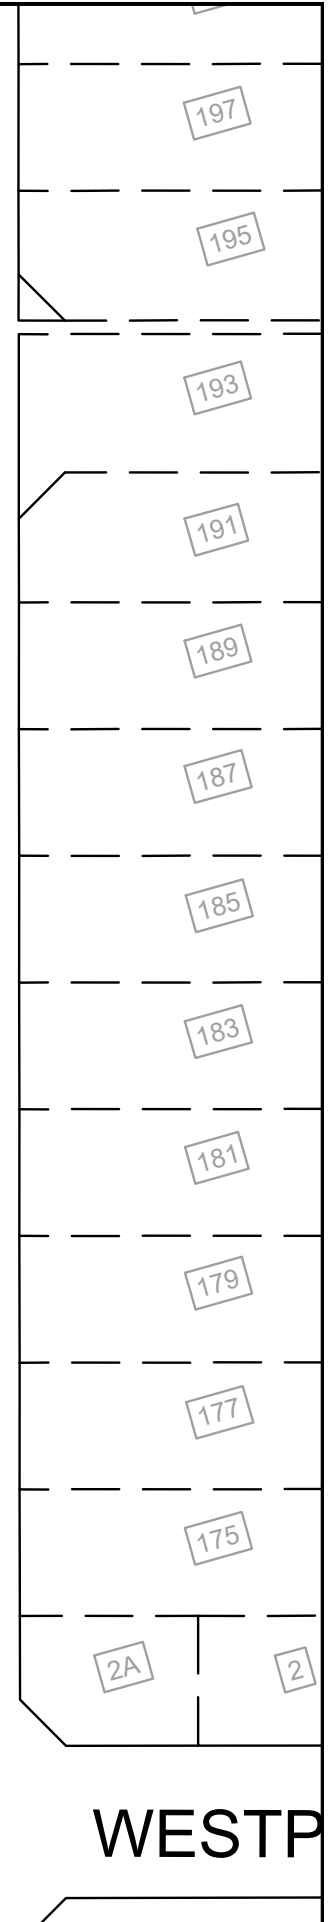
**SPECIFIC INVESTIGATION & DESIGN ZONES**

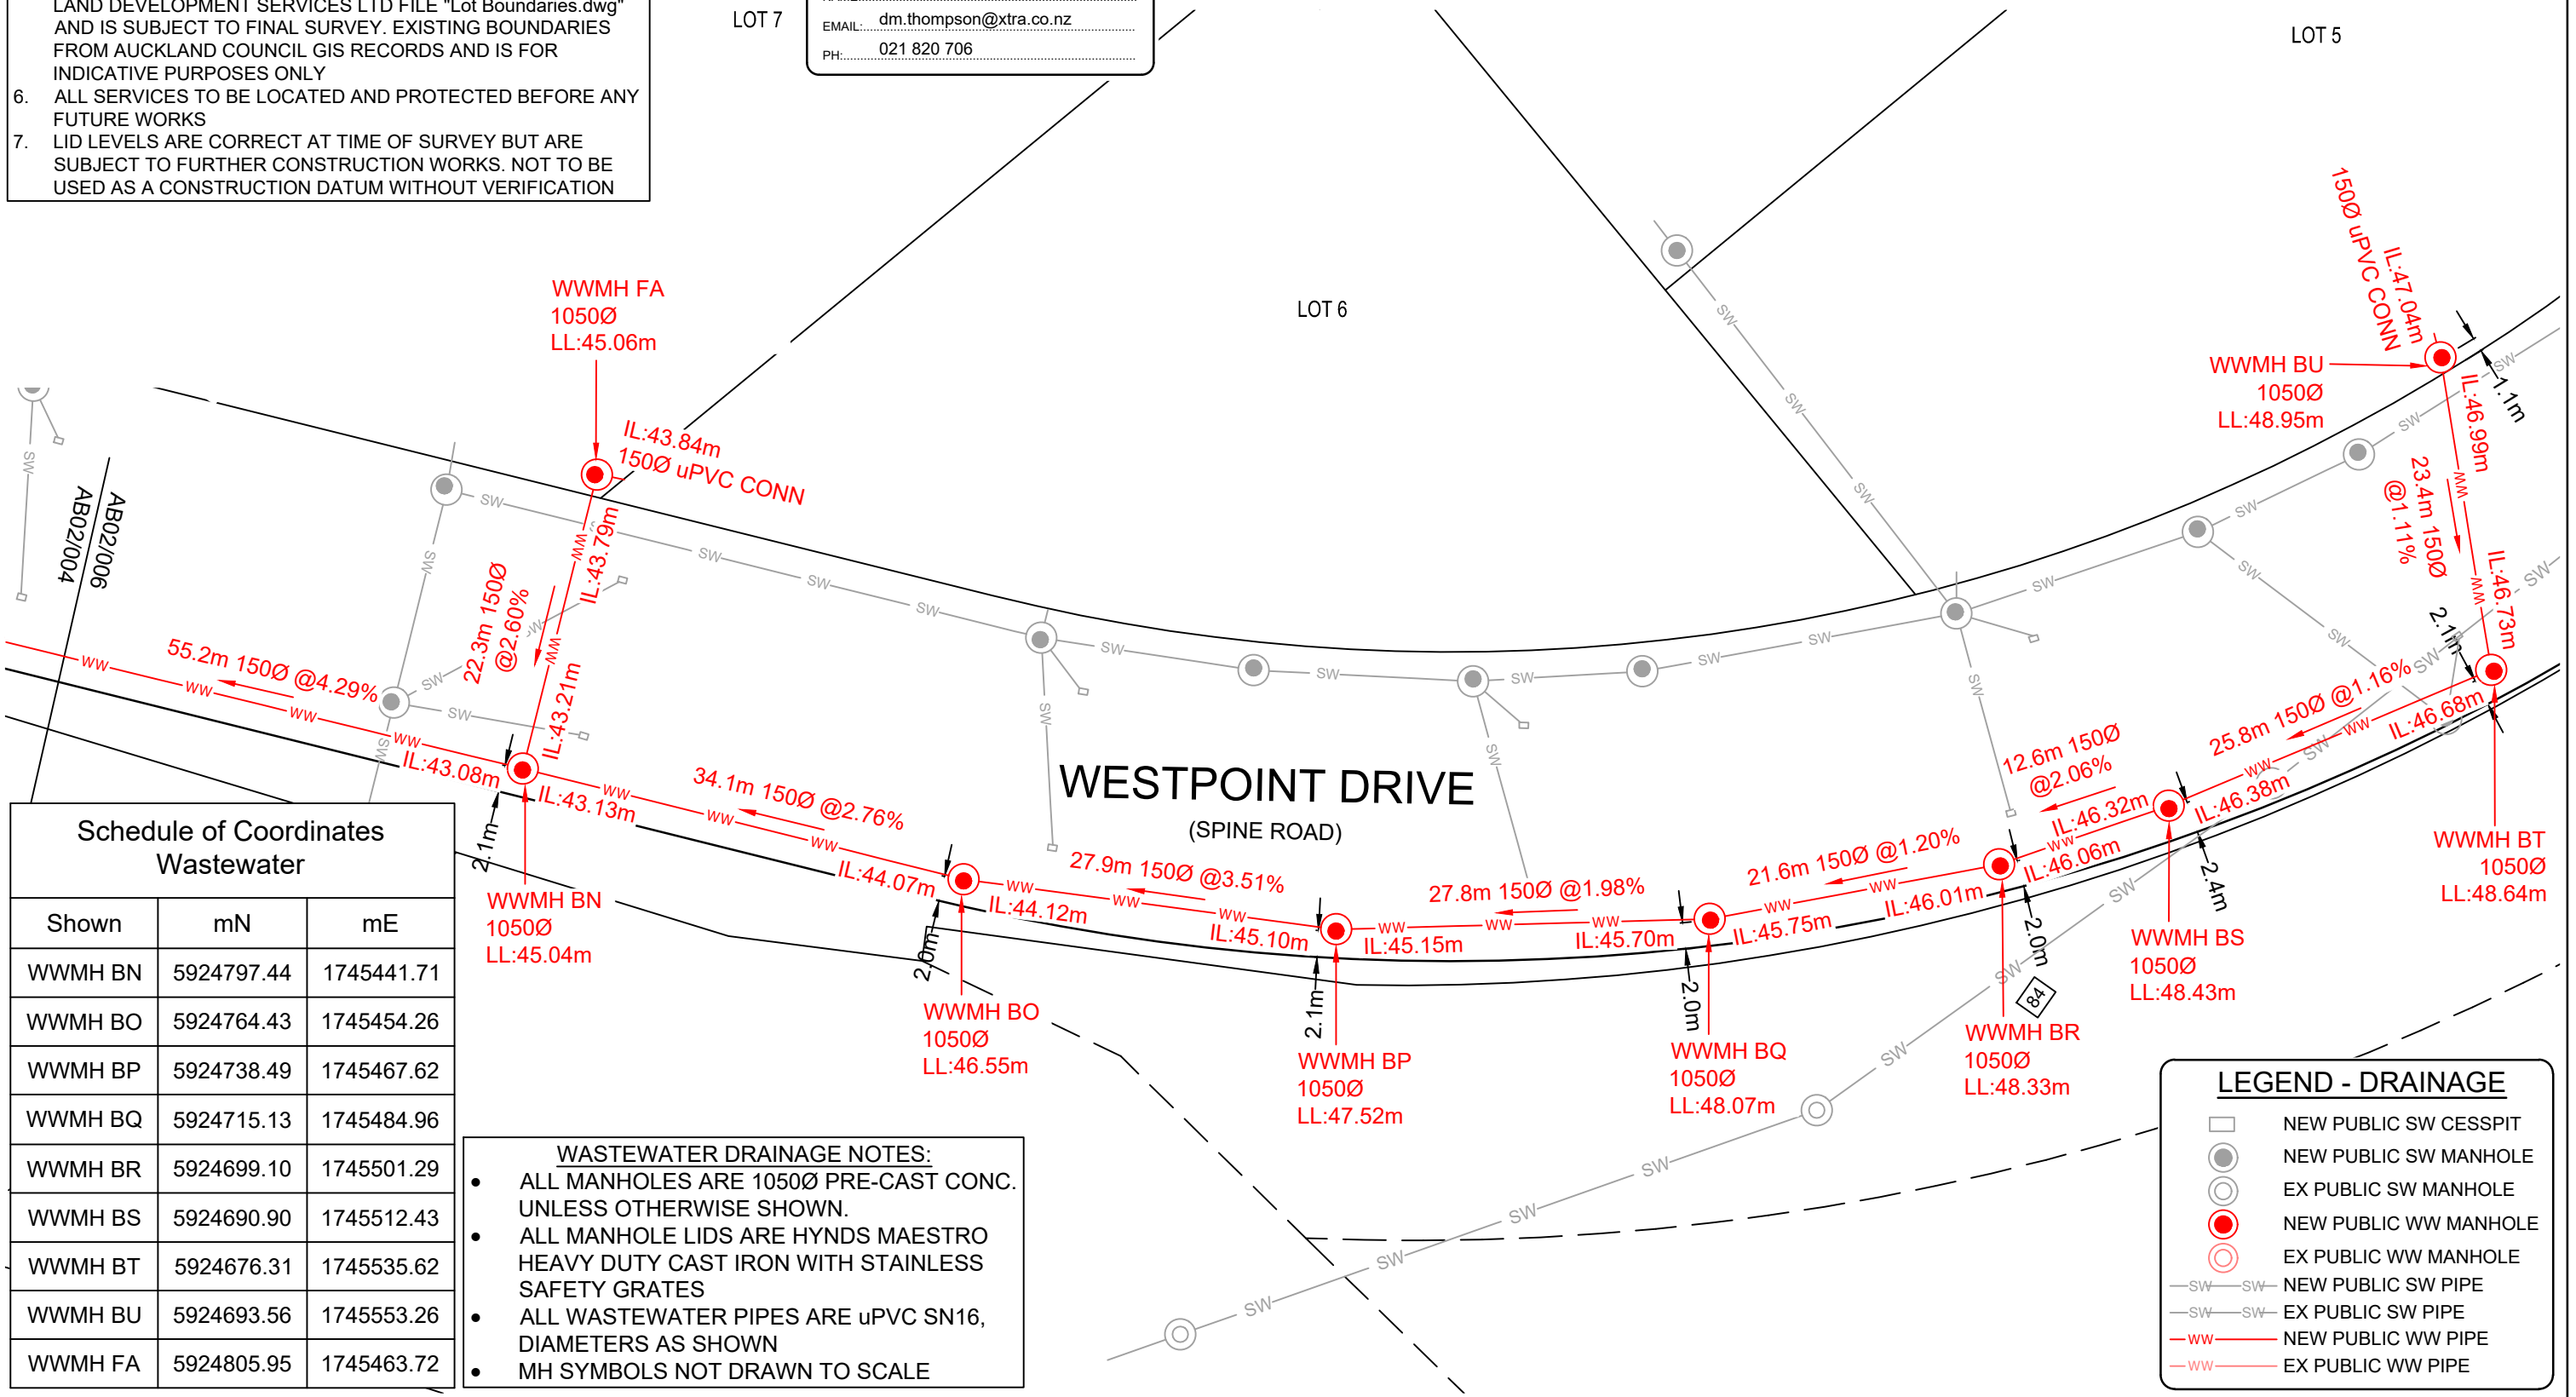
Schedule of Coordinates Wastewater		
Shown	mN	mE
WWMH BN	5924797.44	1745441.71
WWMH BO	5924764.43	1745454.26
WWMH BP	5924738.49	1745467.62
WWMH BQ	5924715.13	1745484.96
WWMH BR	5924699.10	1745501.29
WWMH BS	5924690.90	1745512.43
WWMH BT	5924676.31	1745535.62
WWMH BU	5924693.56	1745553.26
WWMH FA	5924805.95	1745463.72

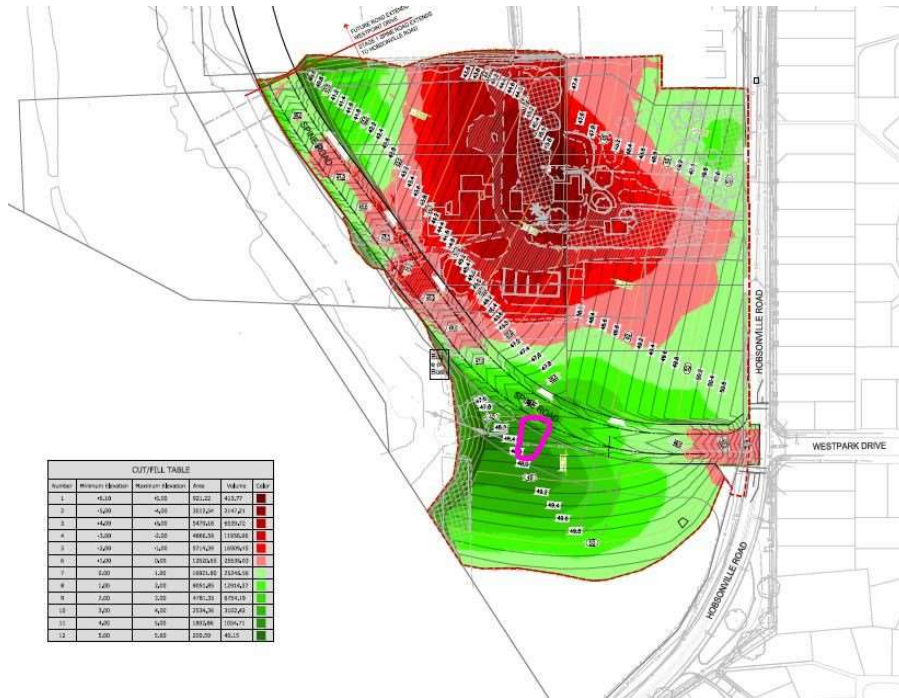
Number	Minimum Elevation	Maximum Elevation	Area	Vol./m	CU
1	46.00	45.00	502.220	442.277	1
2	45.00	44.00	393.547	344.241	2
3	44.00	43.00	347.648	303.672	3
4	43.00	42.00	308.626	270.648	4
5	42.00	41.00	277.720	244.649	5
6	41.00	40.00	253.049	224.649	6
7	40.00	39.00	232.648	209.649	7
8	39.00	38.00	214.648	194.649	8
9	38.00	37.00	198.648	179.649	9
10	37.00	36.00	184.648	164.649	10
11	36.00	35.00	172.648	152.649	11
12	35.00	34.00	162.648	142.649	12

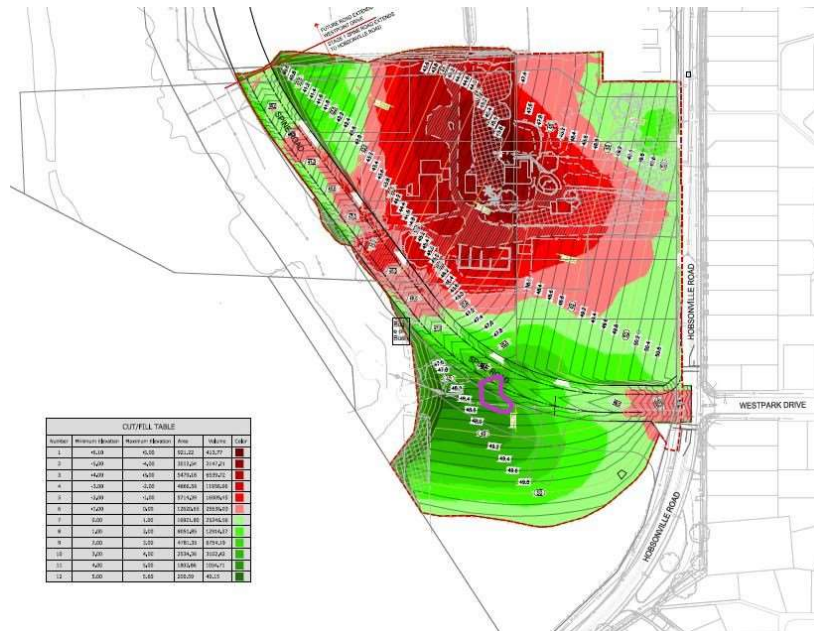
Plan showing approximate location of fill placed marked in purple.

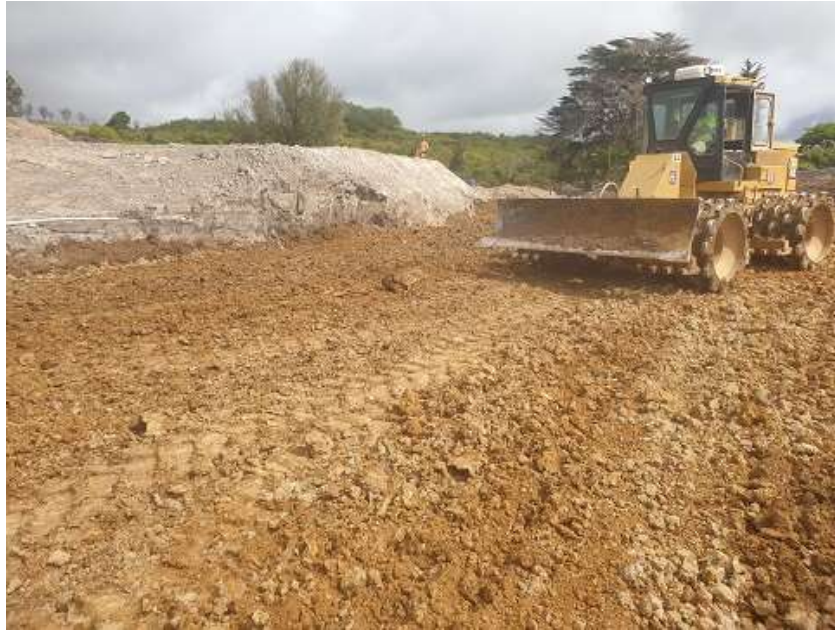
Photo of site showing site conditions at time of inspection.

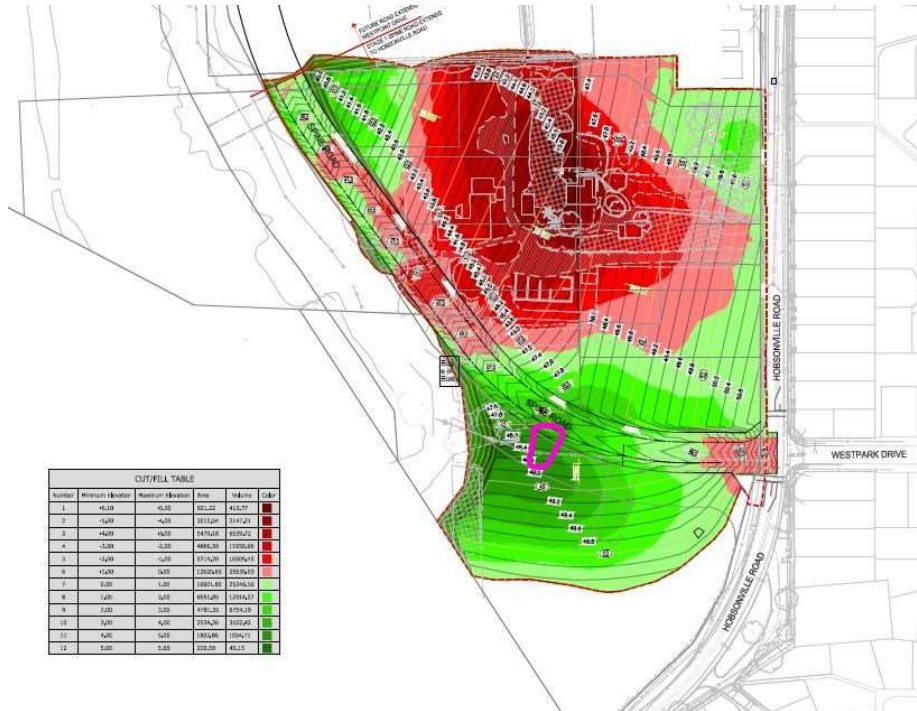
Plan showing approximate location of fill placed marked in purple.

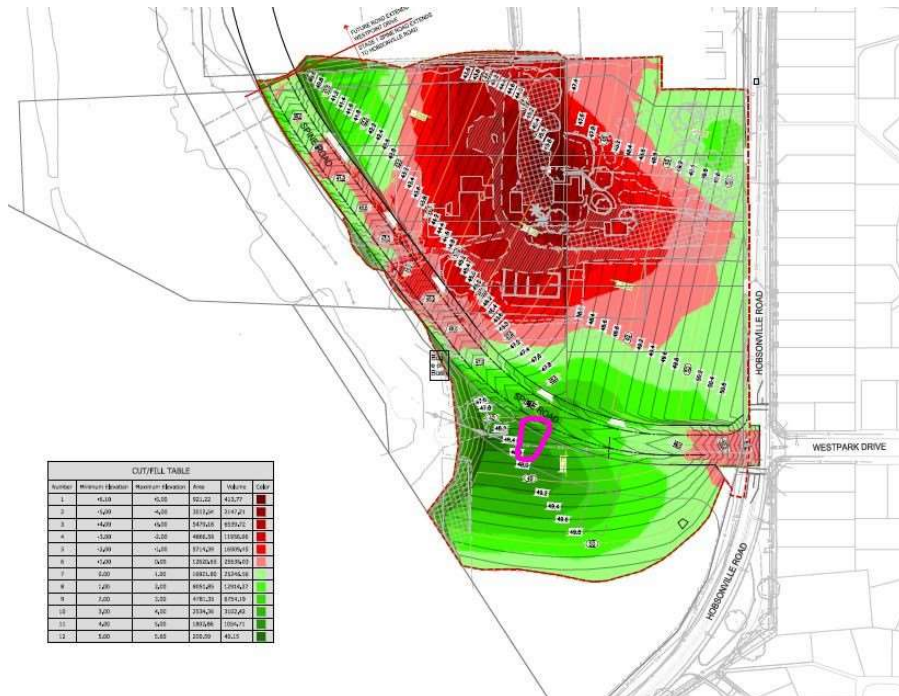
Plan showing approximate location of fill placed in purple.

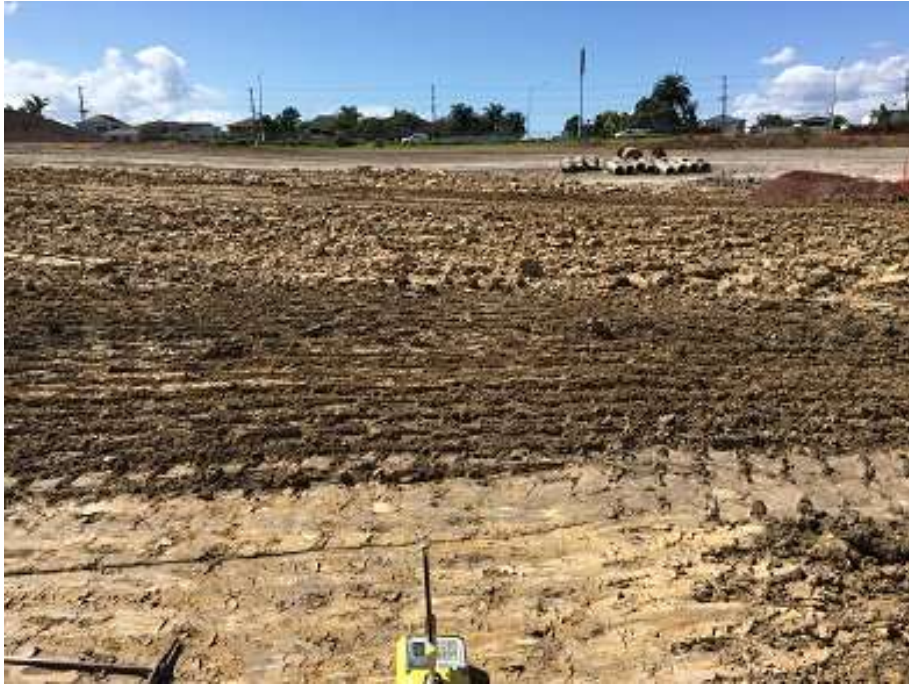
Photo of site showing site conditions at time of inspection.

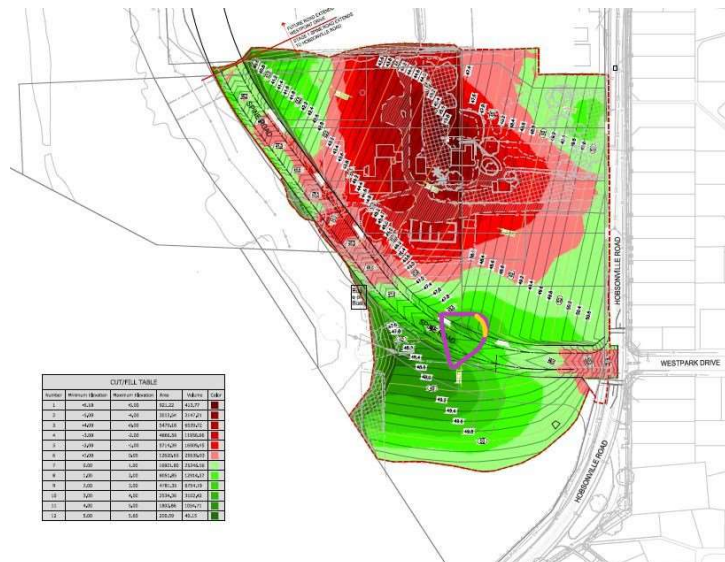
Plan showing approximate location of fill placed marked in purple, and stripped area in yellow.

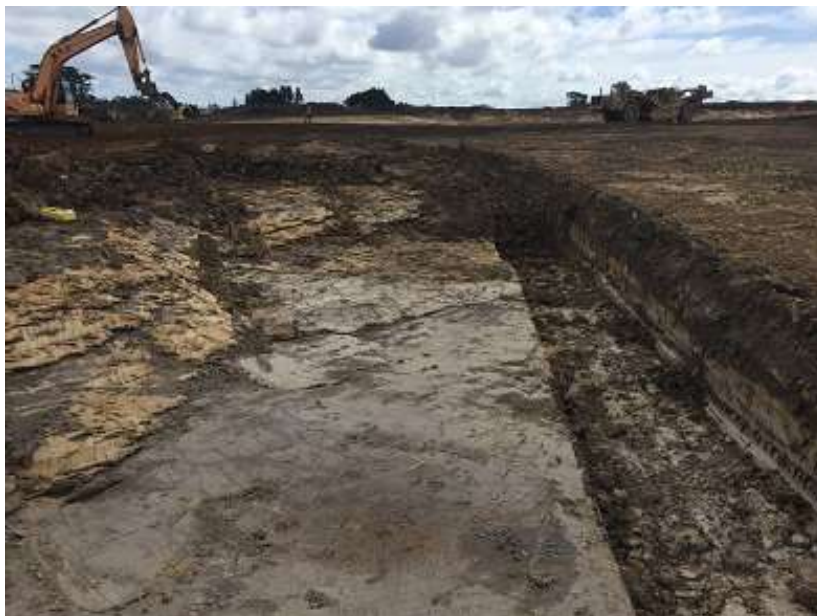
Photo of site showing area where topsoil previously identified under fill has been stripped out (centre). A small wedge left to remove in the side of cut of swale at right.

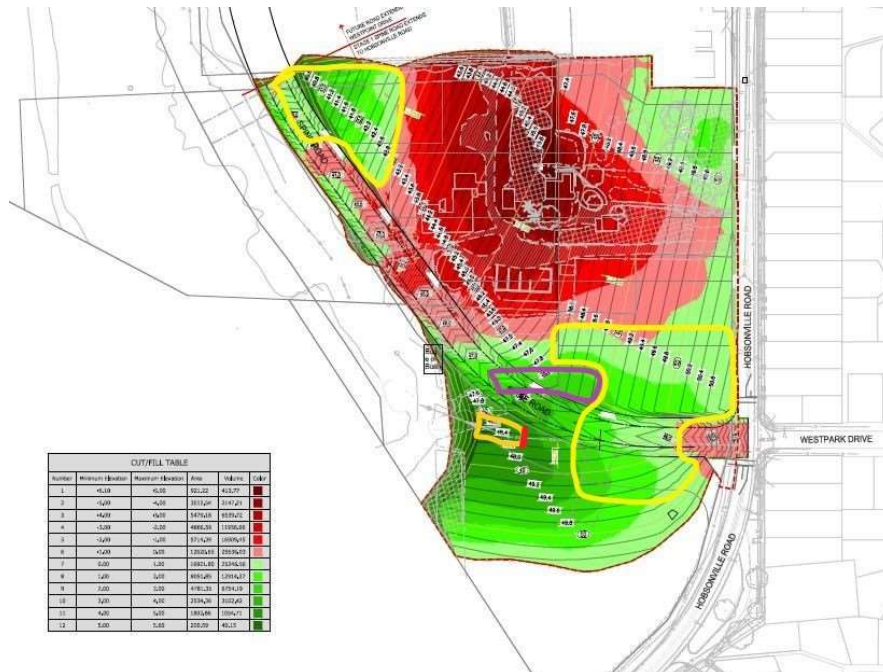
Plan showing approximate location of fill placed marked in purple, and stripped area in yellow. Red line east of south-western gully stripped area is concrete and pipework in side of fill batter.

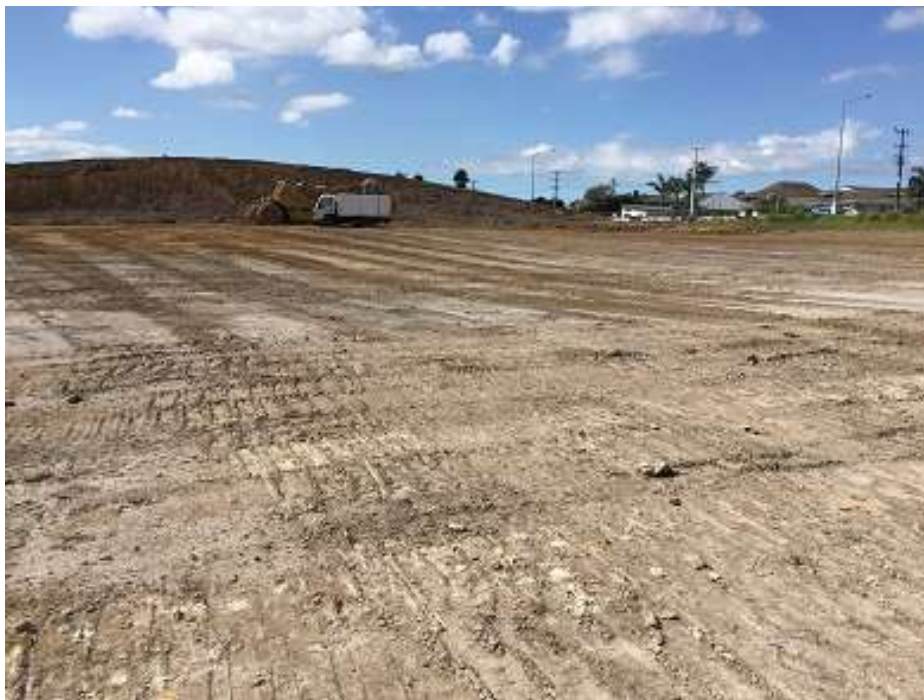
Photo of site showing the dry south-eastern stripped area.

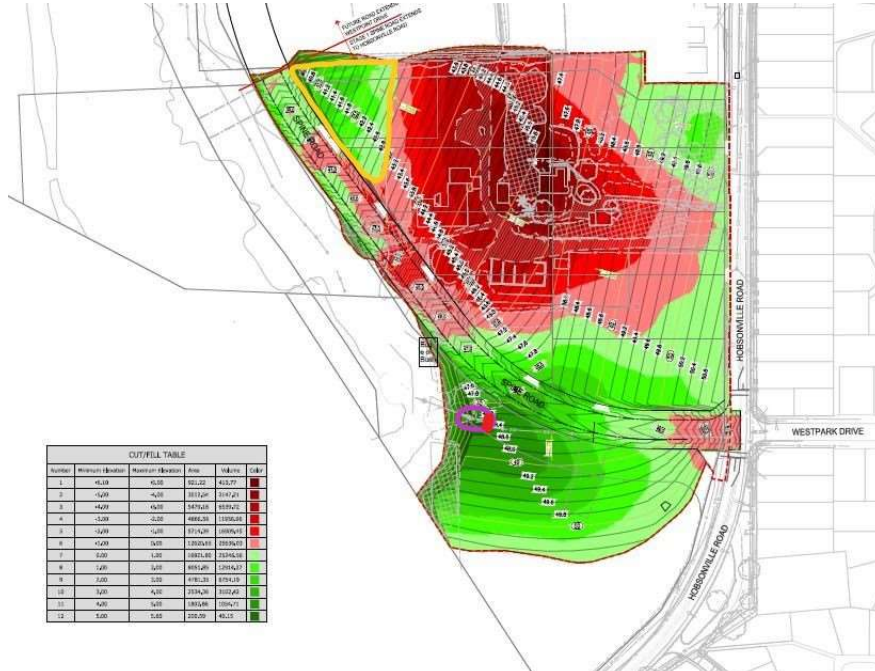
Plan showing approximate location of fill placed marked in purple, and stripped area in yellow.

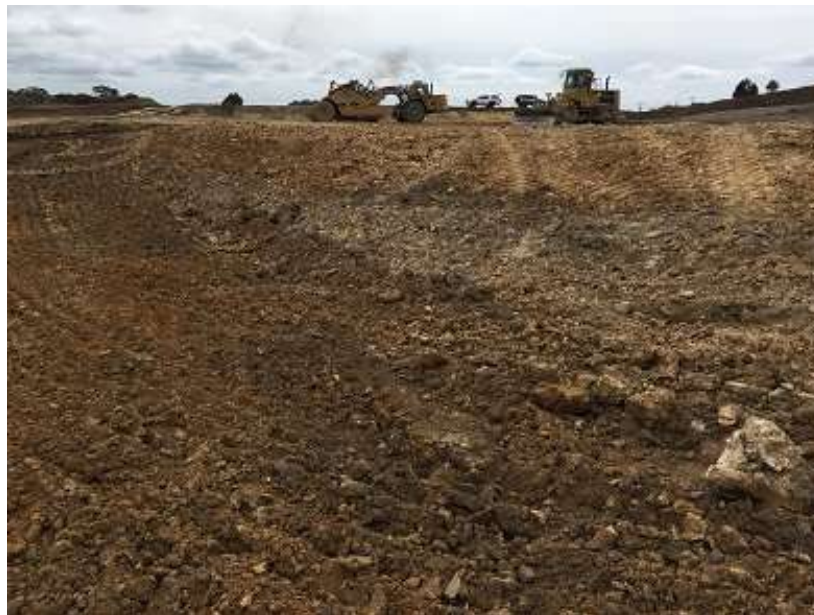
Photo of site showing south-eastern fill area.

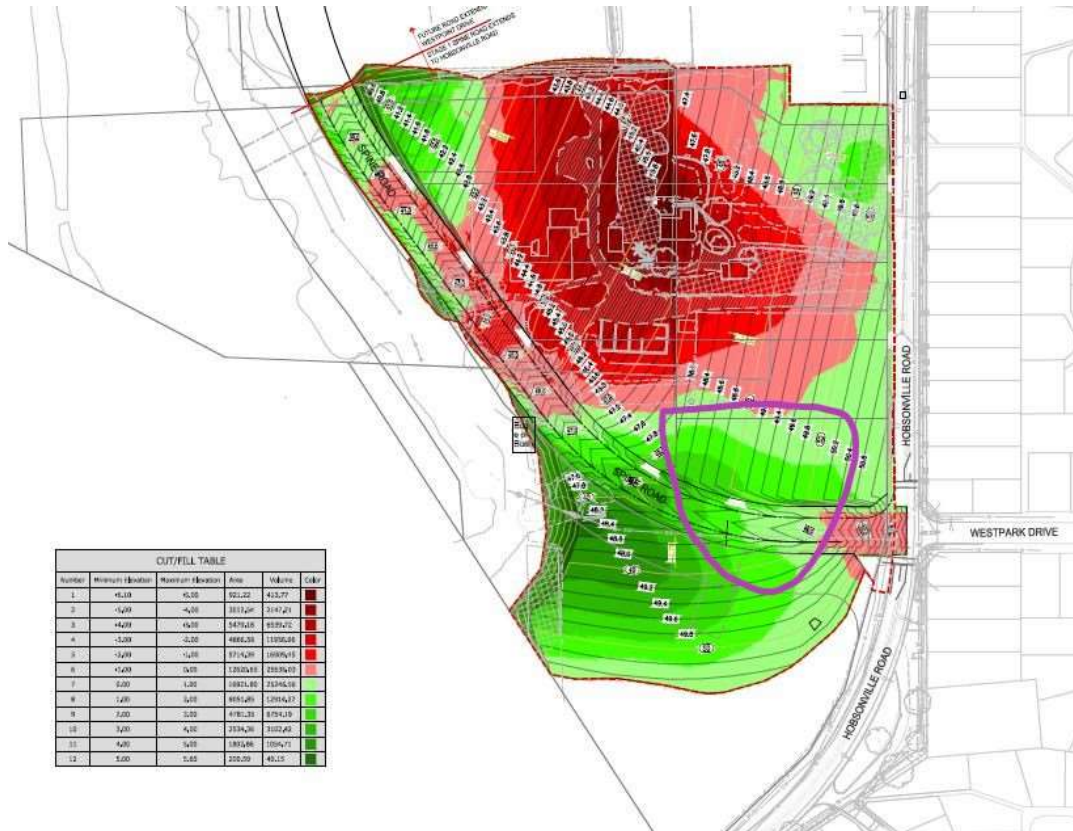
Plan showing approximate location of fill placed marked in purple.

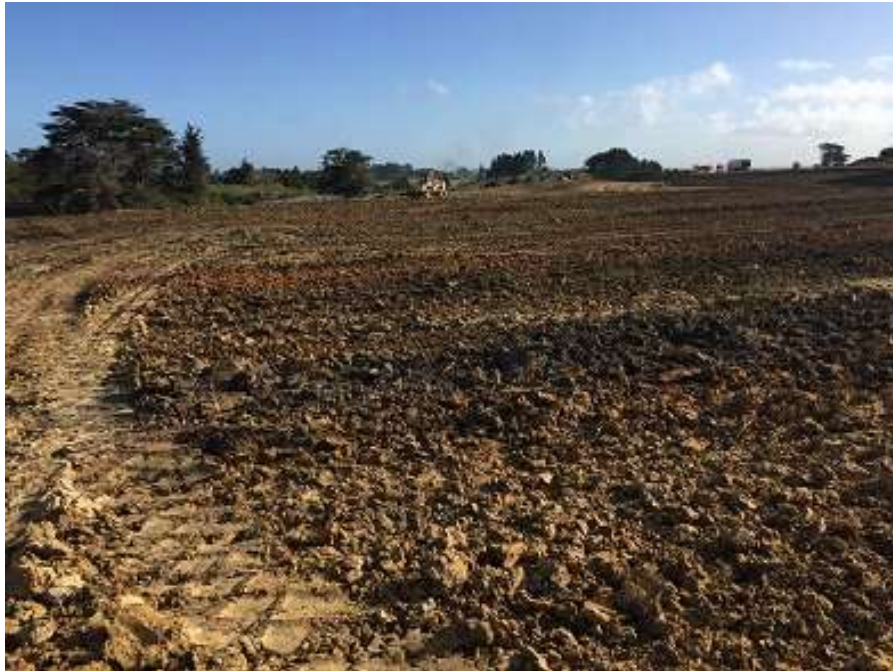
Photo of site showing south-eastern fill area.

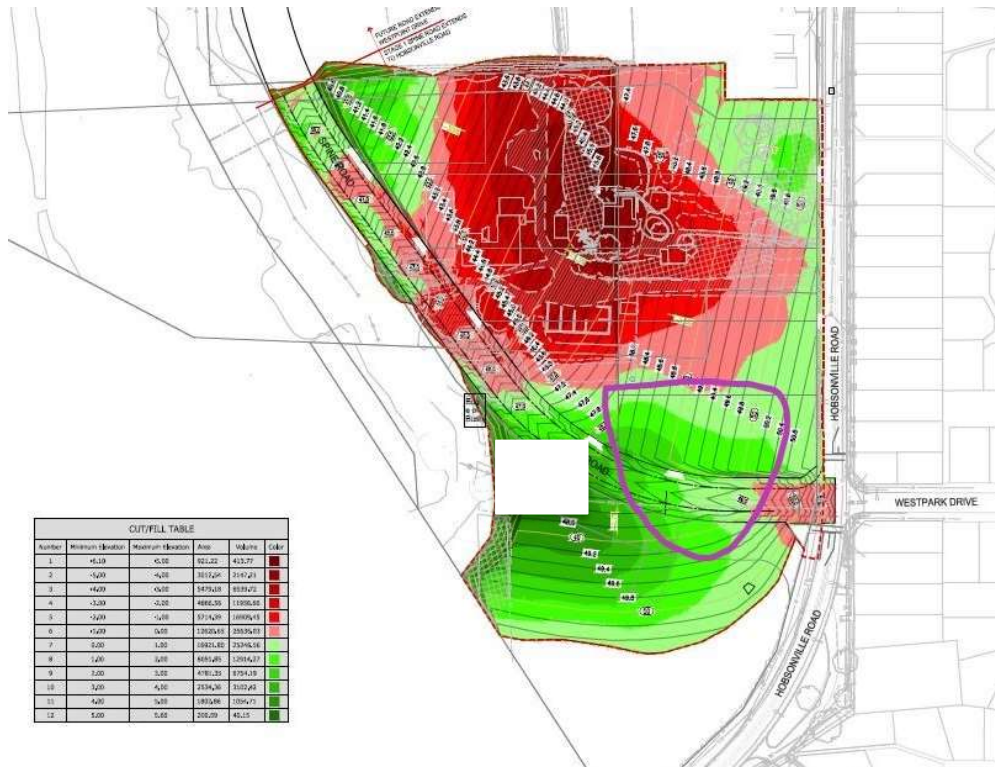
Plan showing approximate location of fill placed marked in purple.

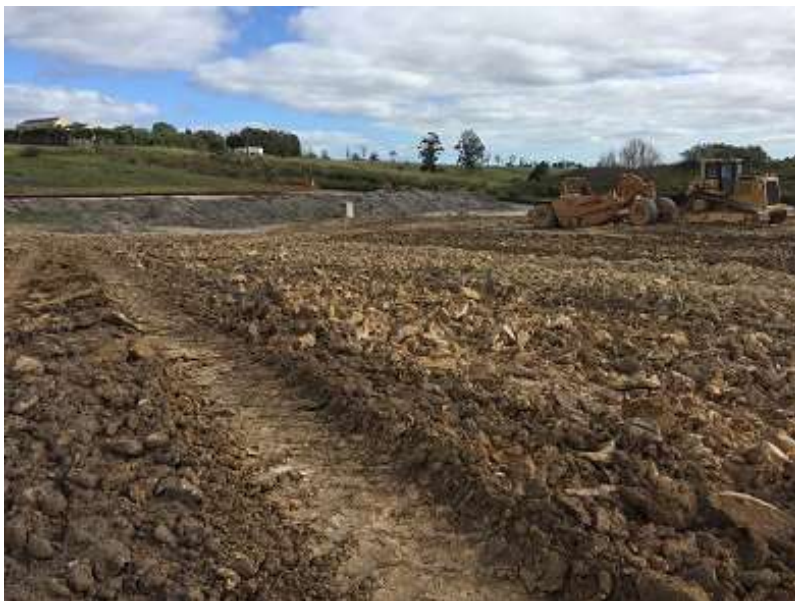
Photo of site showing site conditions at time of inspection.

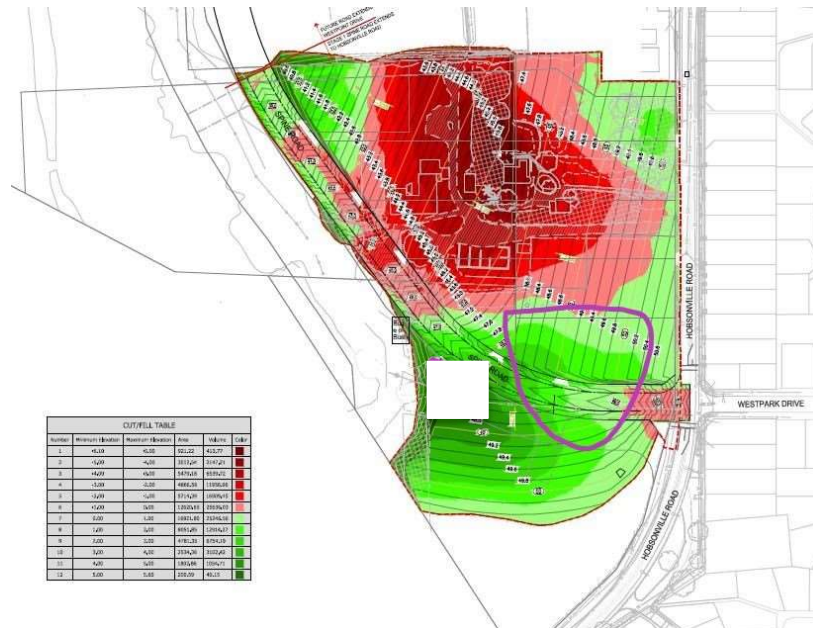
Plan showing approximate location of fill placed marked in purple.

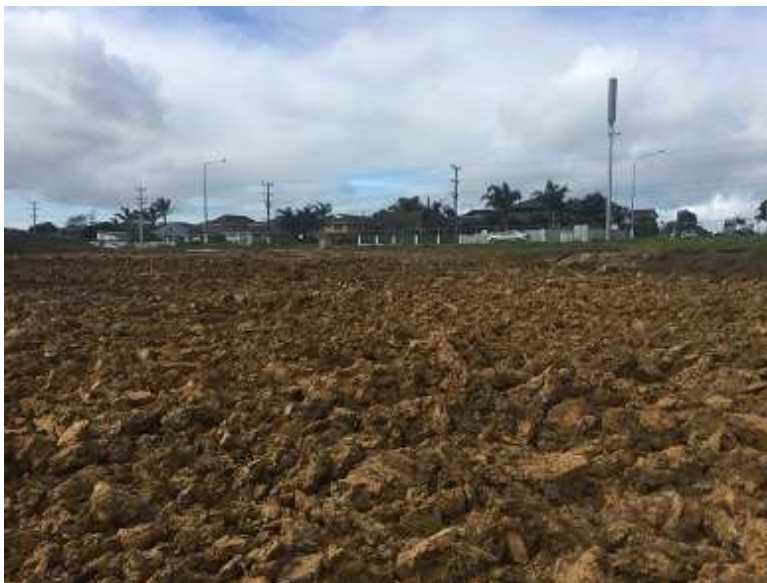
Photo of site showing south-eastern fill area.

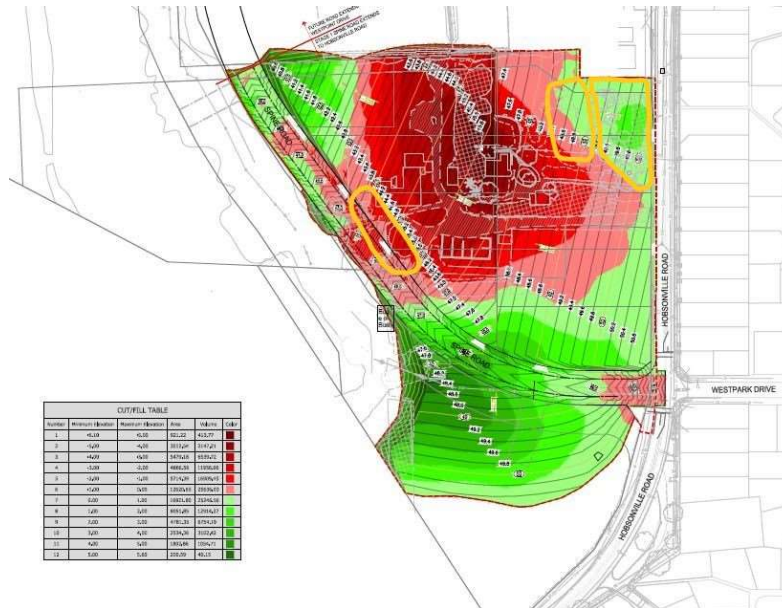
- Central western area has been cut down to approx finished level, all of the old rubbish seen yesterday has been removed with the cut. All into competent natural subgrade.
- Stripping mostly completed near north-eastern corner of site, with a small area in the process of being stripped back while on site. Excavated several test pits through the topsoil in the area that had not yet been fully stripped. Where exposed, all into competent natural ground, OK to proceed, later received photos of this area fully stripped from the contractors.

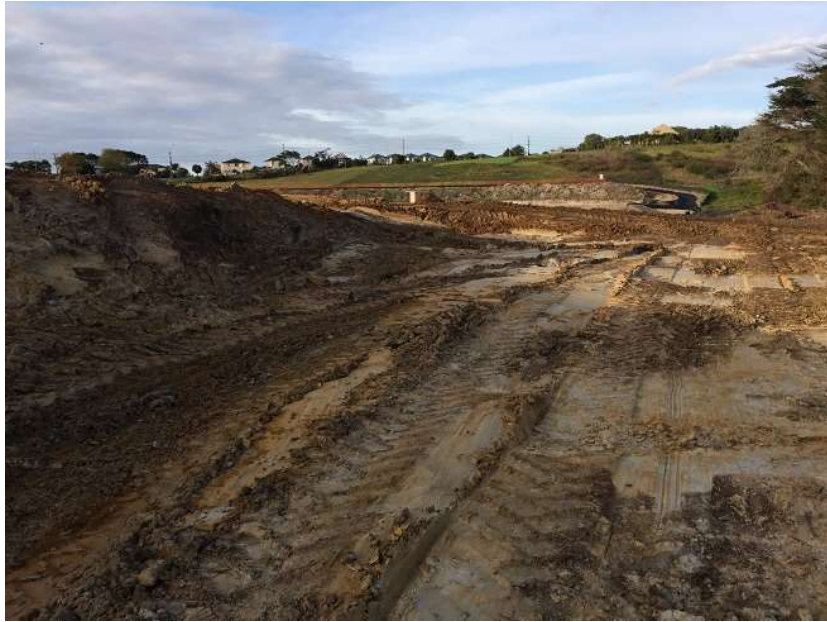
Photo of site showing cut area after additional stripping since yesterday.

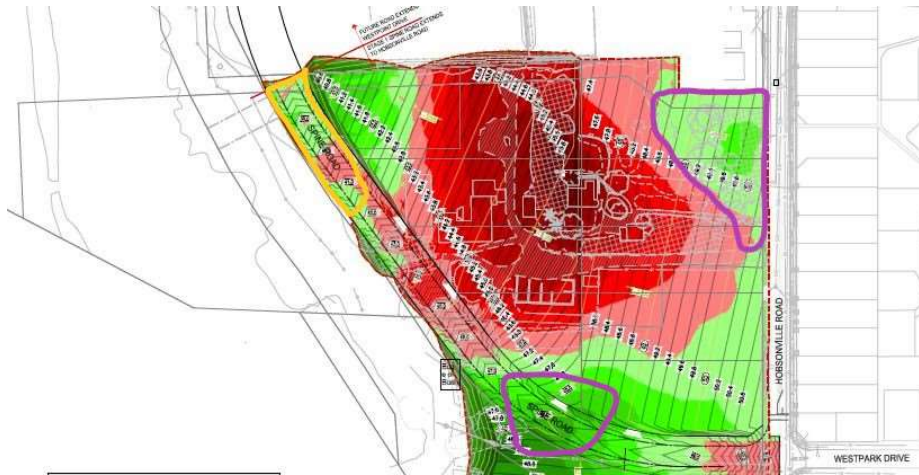
Plan showing approximate location of fill placed marked in purple, stripped area in yellow.

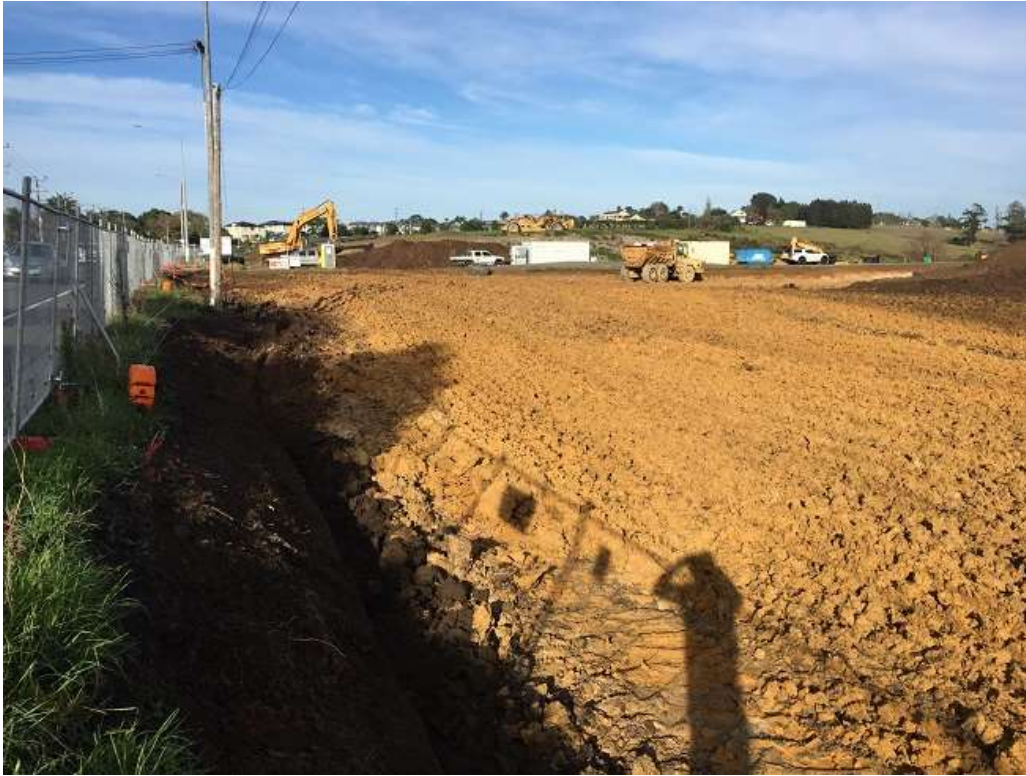
Photo of site showing start of fill being placed in north-eastern corner.

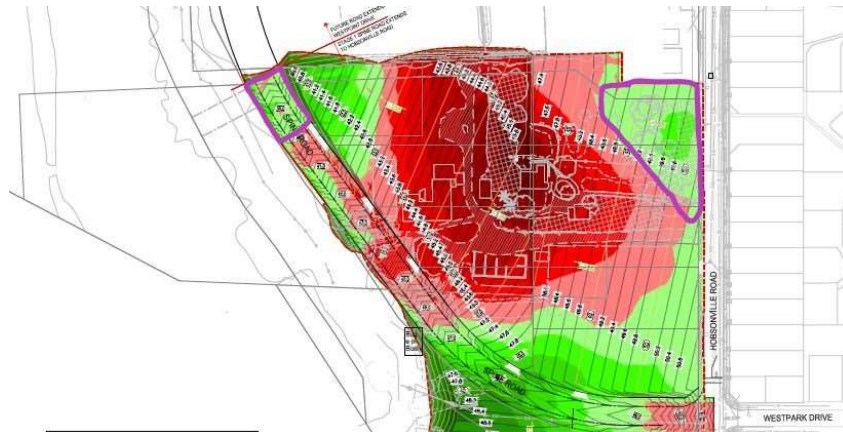
Plan showing approximate location of fill placed marked in purple.

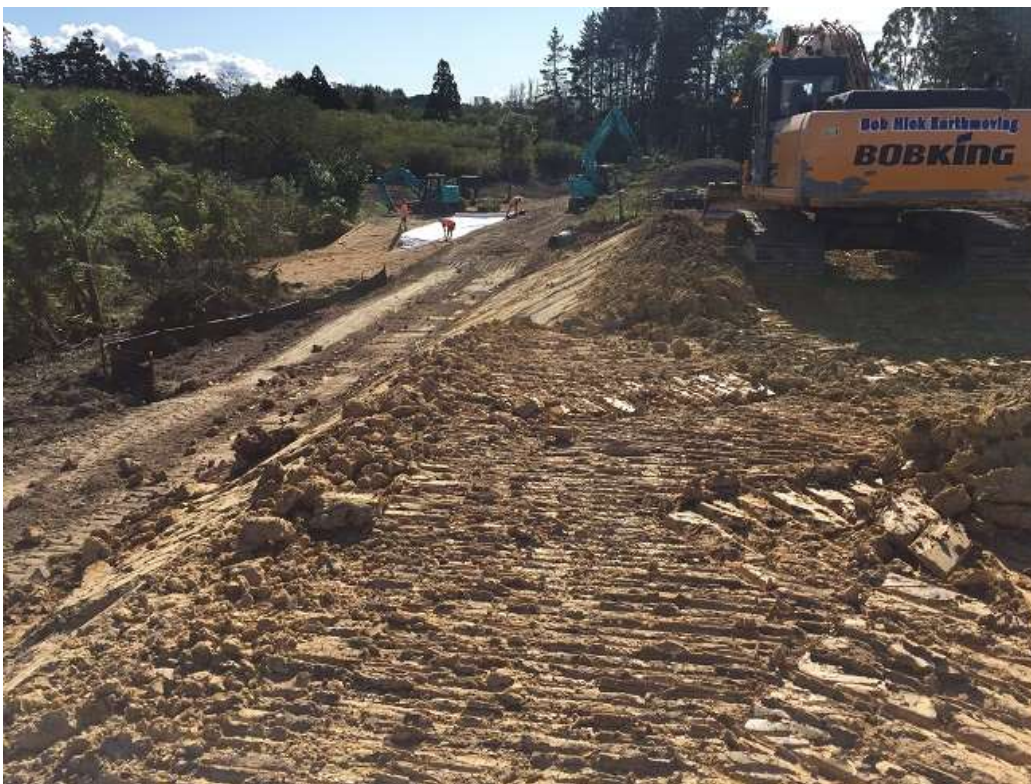
Fill batter being formed in north-western part of site under future Spine Road.
