**GEOTECHNICAL COMPLETION REPORT**

**10-LOT**

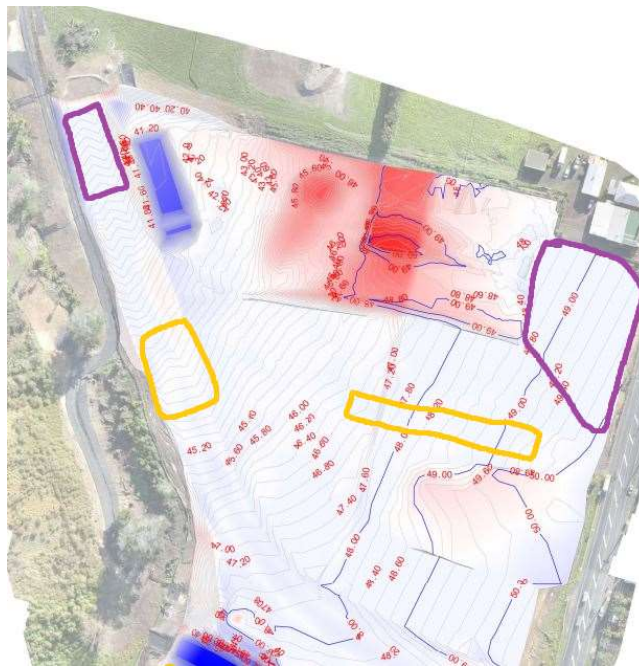
Plan showing approximate location of fill placed marked in purple and stripped area in yellow.

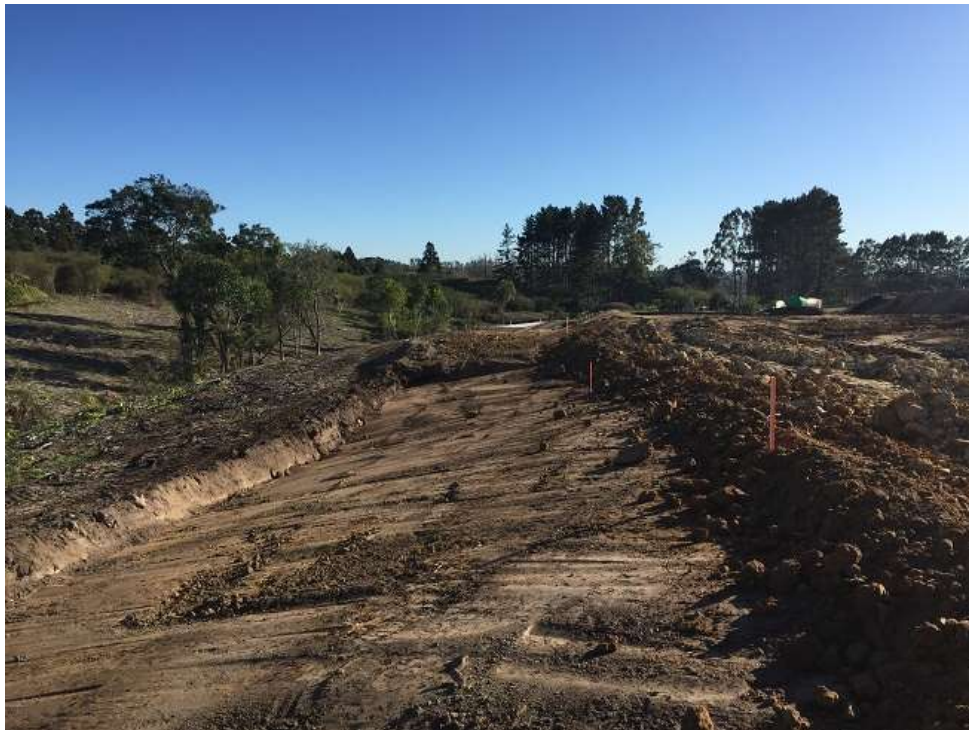
Stripping along western boundary under approx. edge of Spine Rd carriageway.

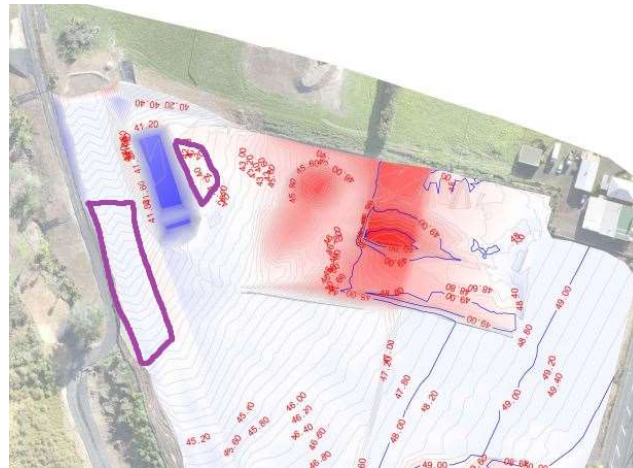
Plan showing approximate location of fill placed marked in purple.

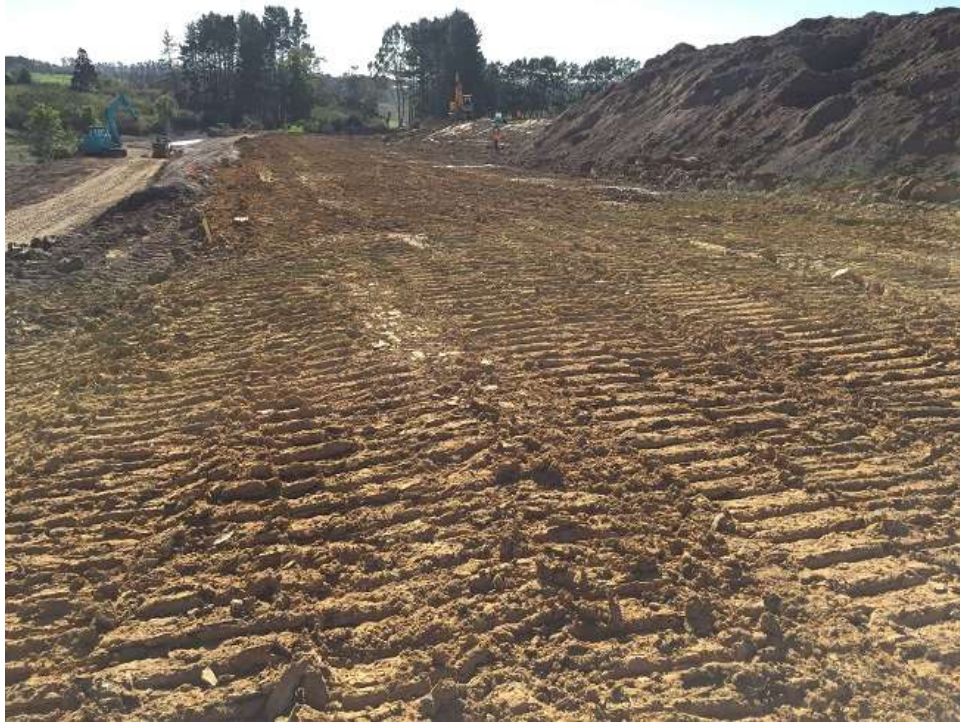
Filling along western boundary under approx. future Spine Rd carriageway.

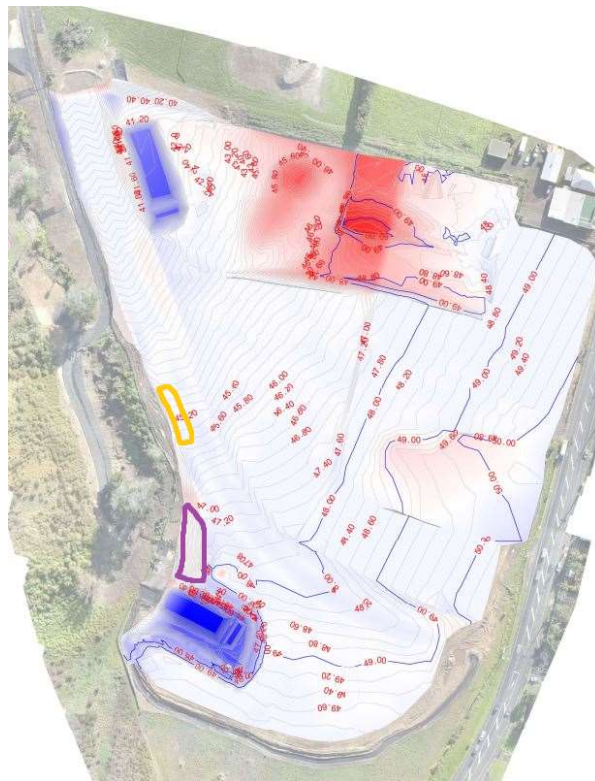
Plan showing approximate location of fill placed marked in purple and stripped area in yellow.

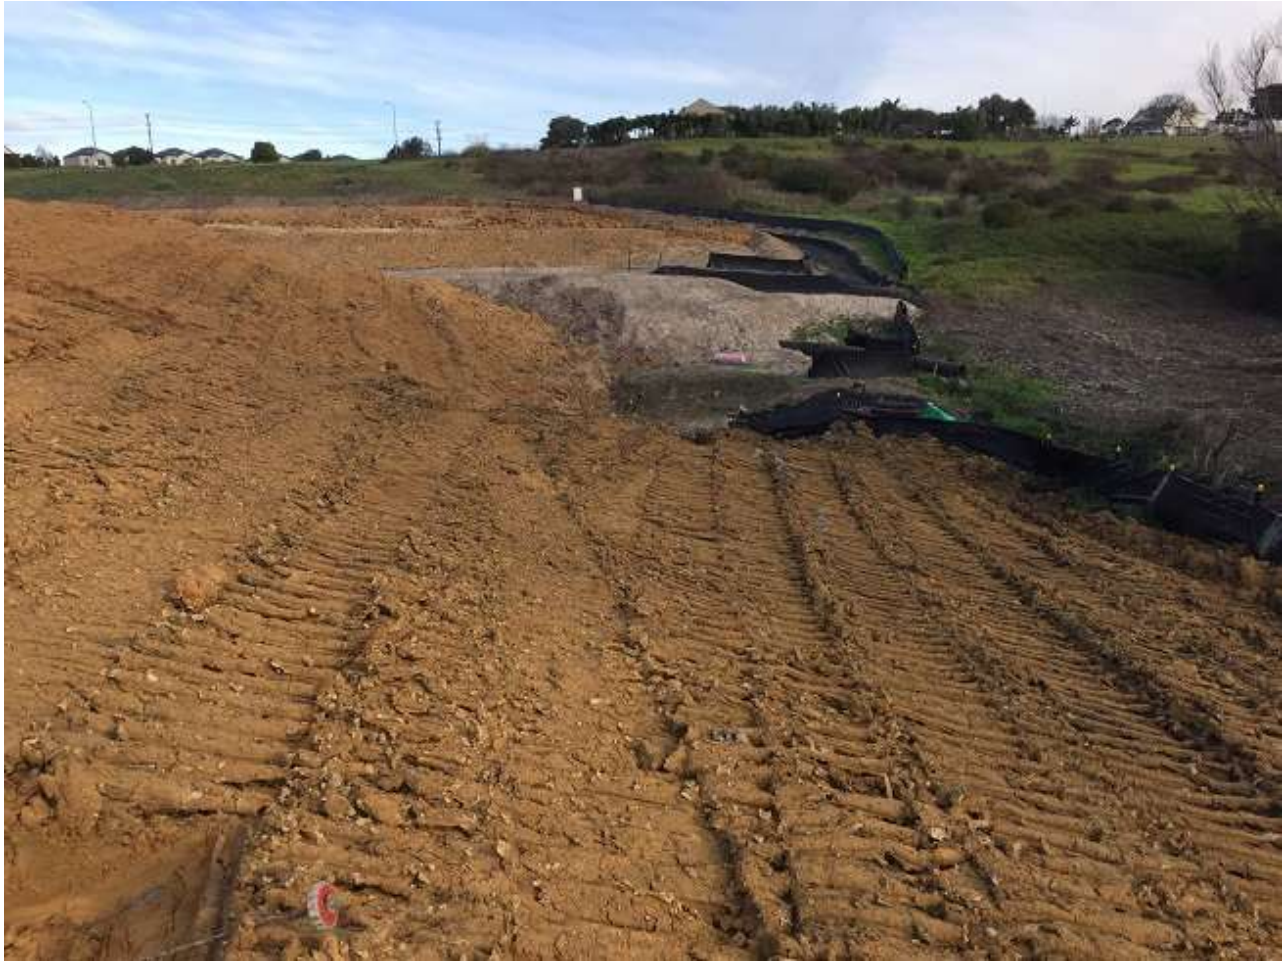
Fill progress near the western boundary, north of the southern pond.

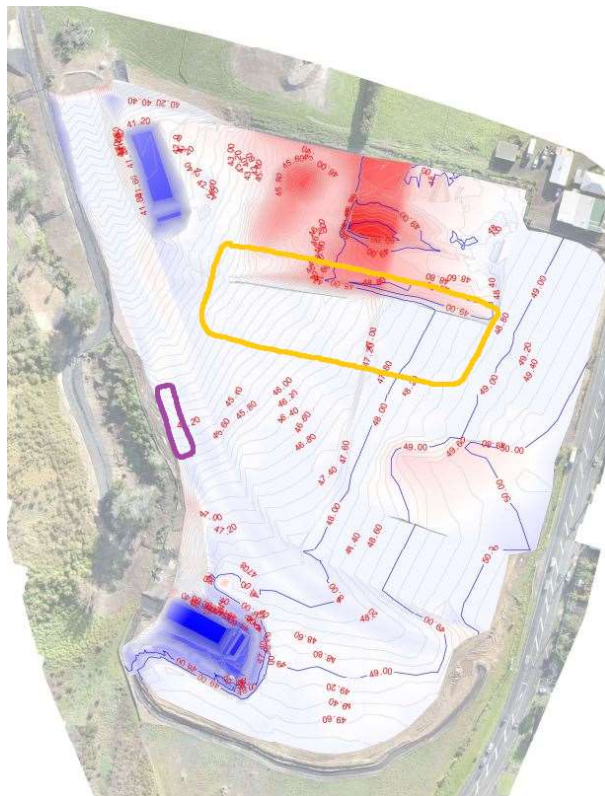
Plan showing approximate location of fill placed marked in purple and major cut area in yellow.

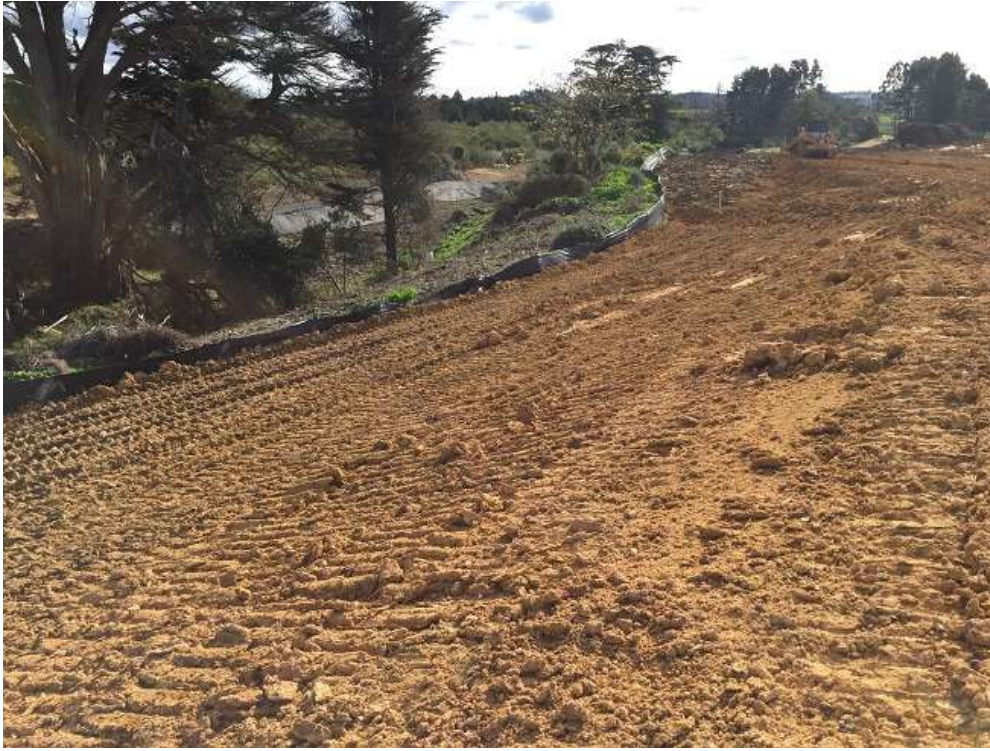
Extent of fill placed near western boundary.

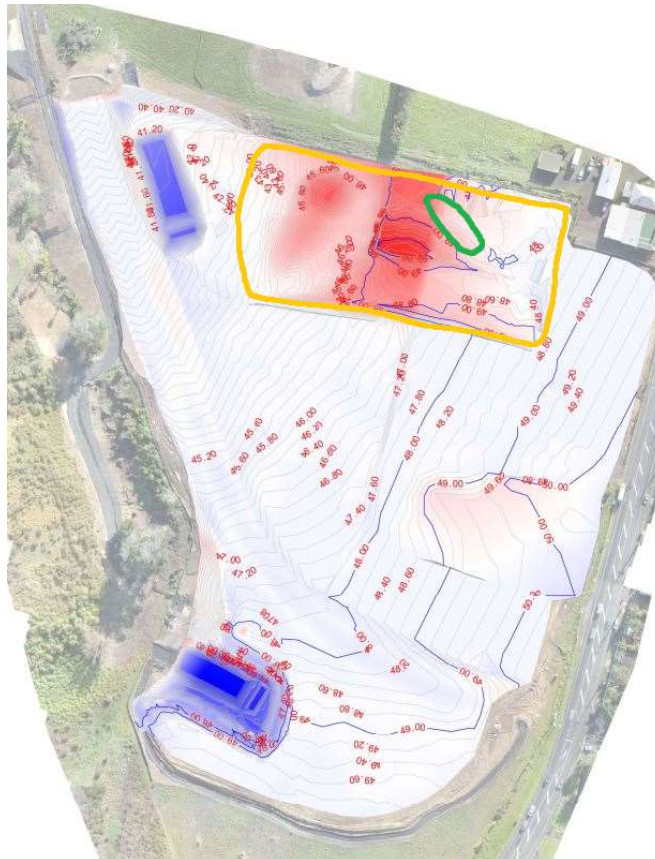
Plan showing approximate location of the bulk cut taking place, with the approx. extent of the alluvial material in green.

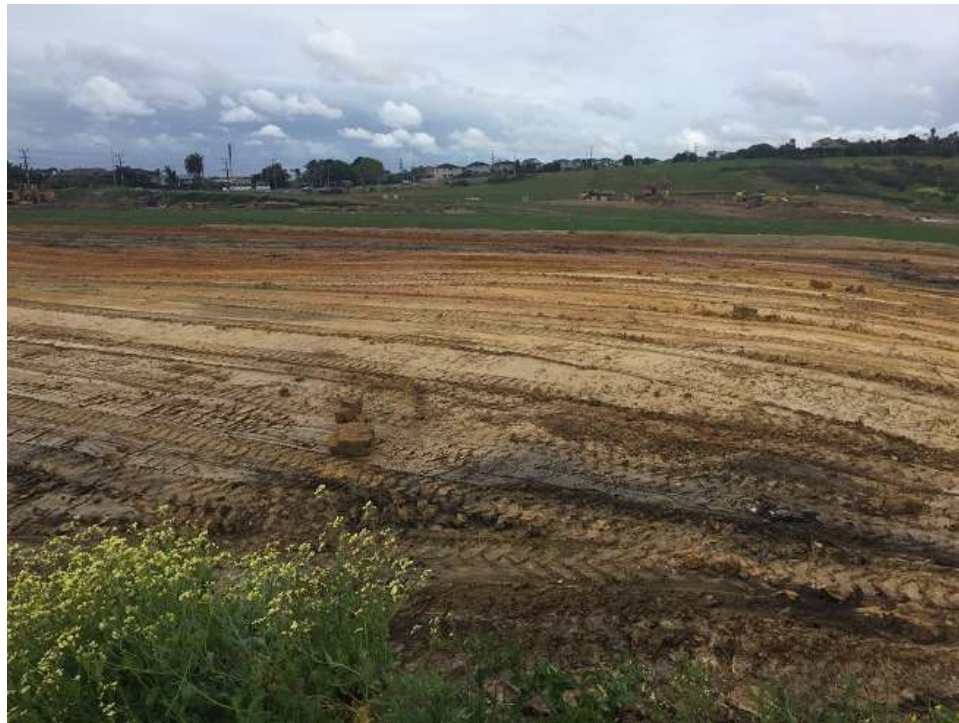
Another part of the bulk cut area with the more typical orange clay exposed

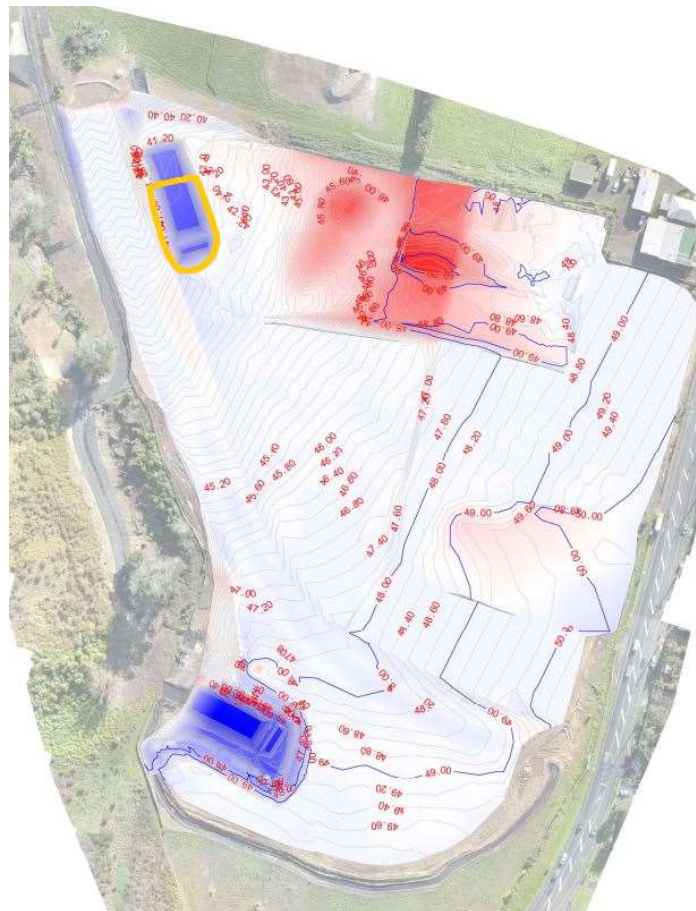
Plan showing approximate location of stripped area in yellow.

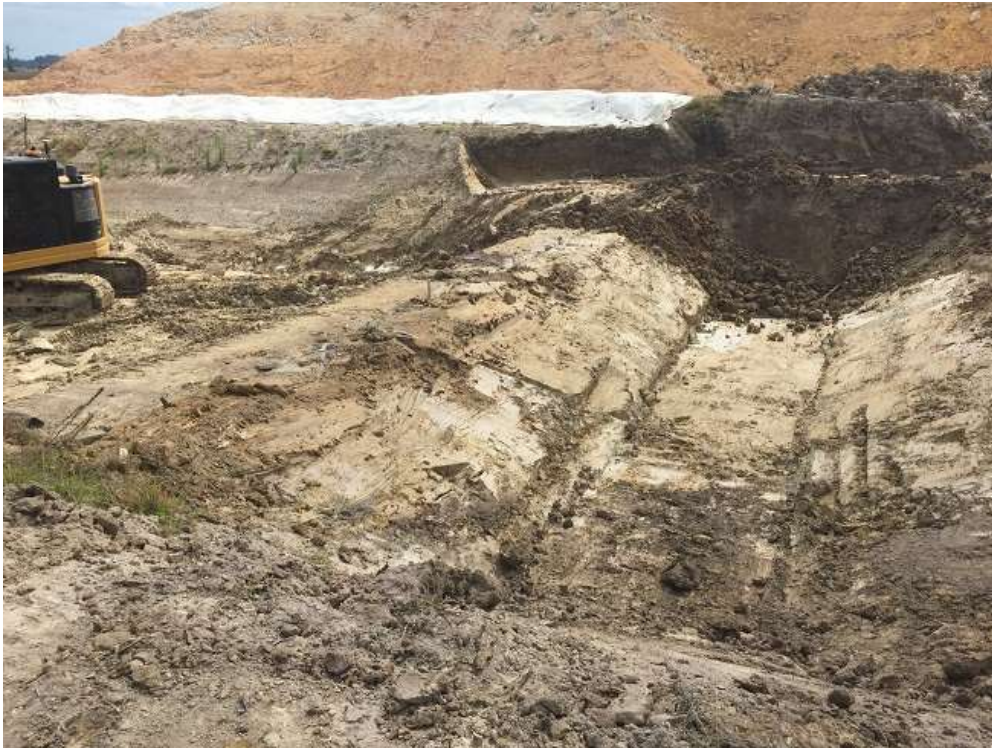
Forebay area stripped - the loose bits tracked in by roller visible at rear were cleaned up while on site.

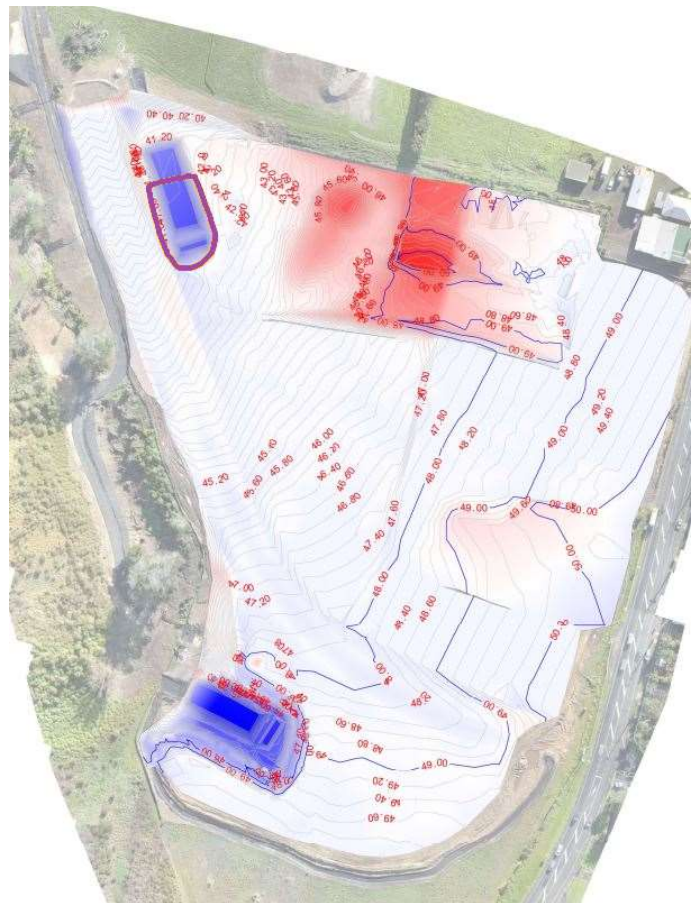
Plan showing approximate location of fill area in purple.

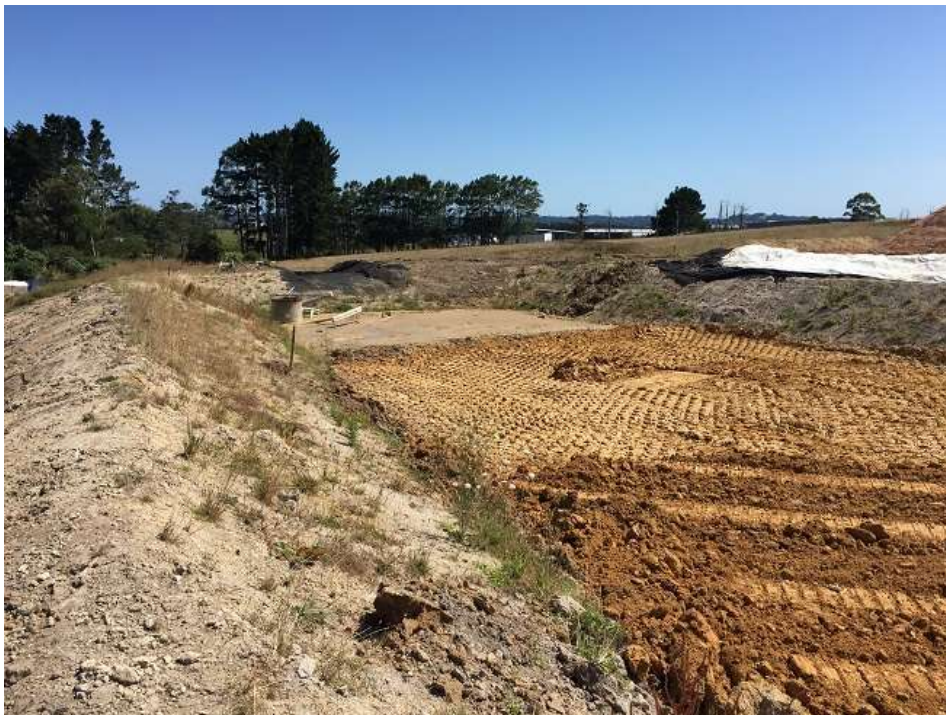
First lift of fill in the southern end of the pond.

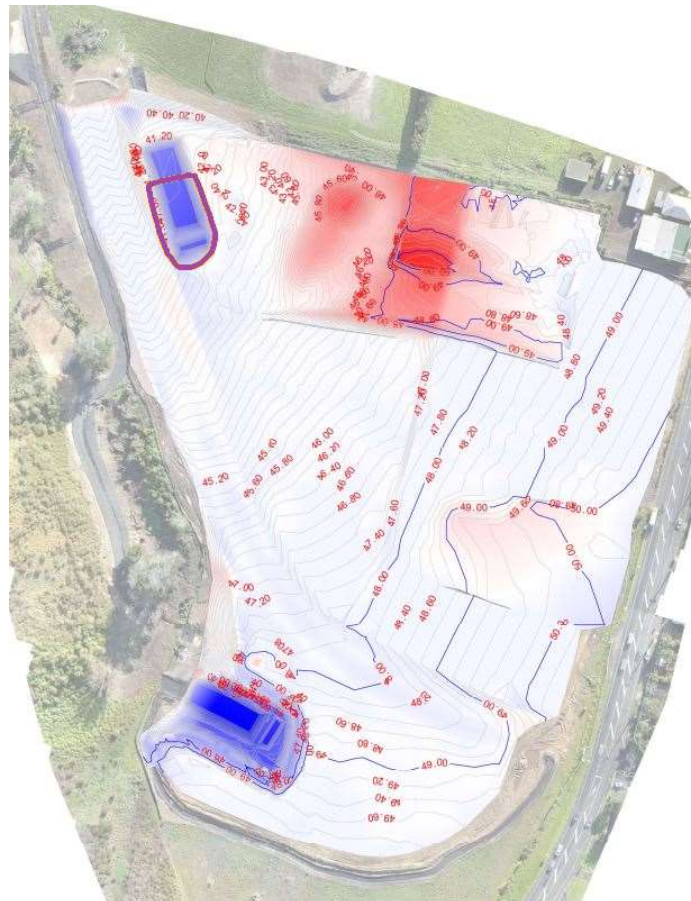
Plan showing approximate location of fill area in purple.

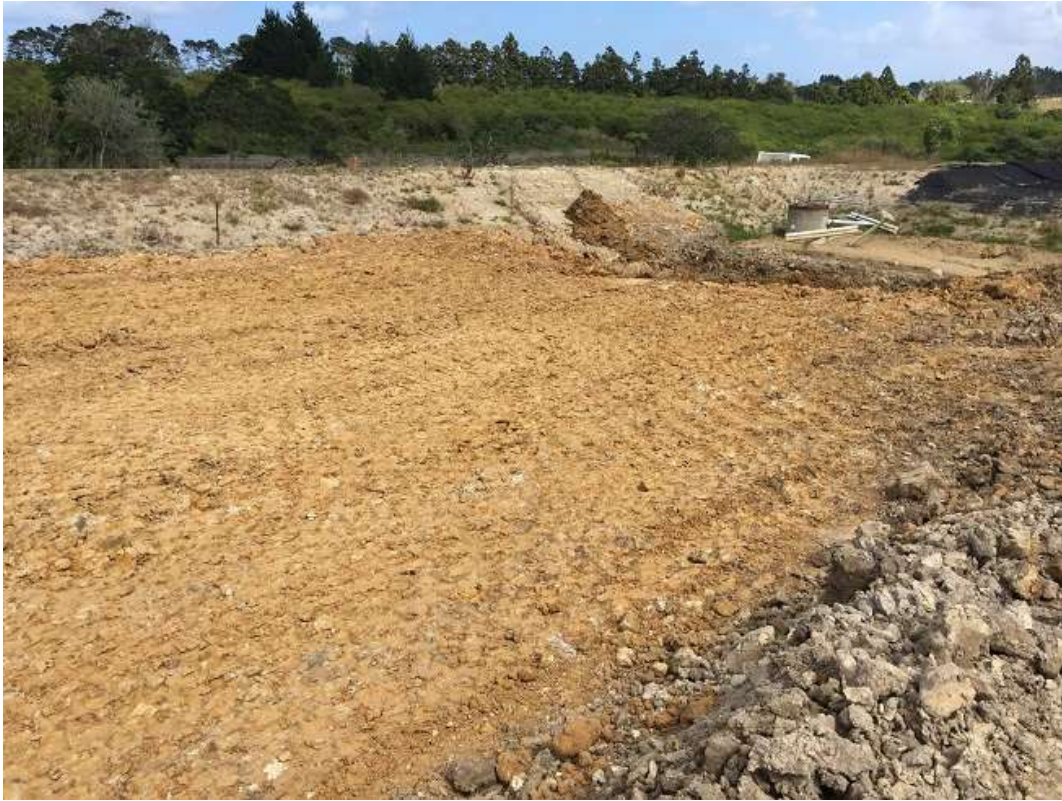
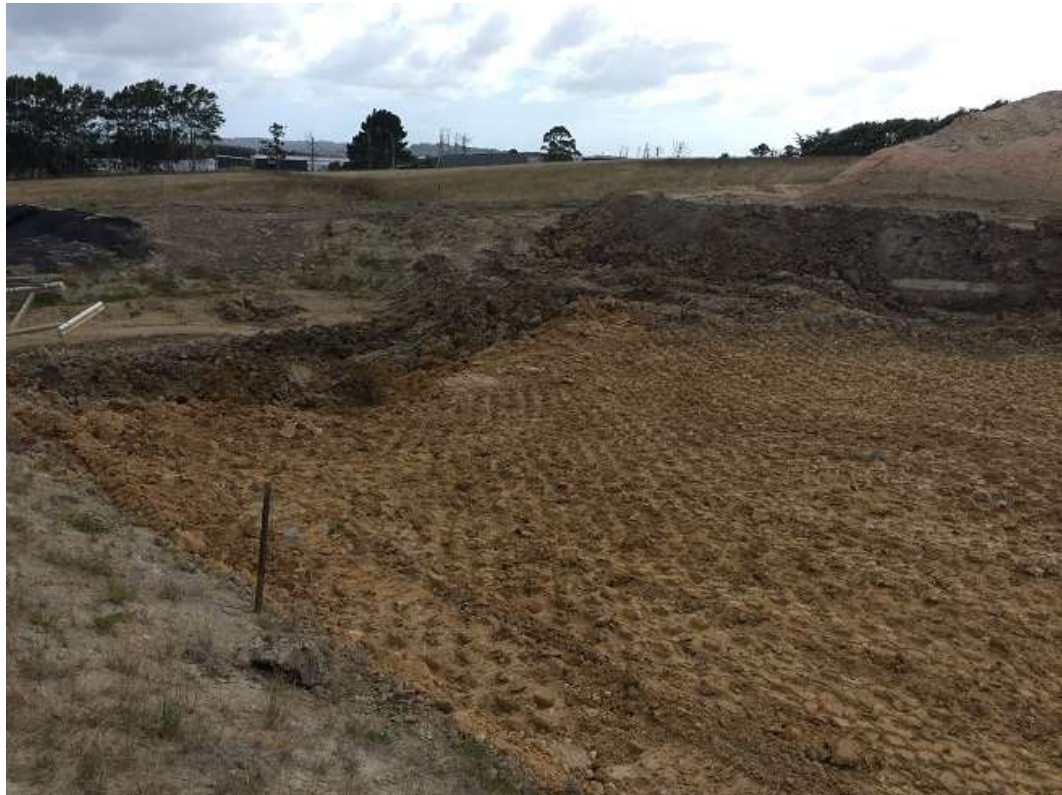
Fill placed in the southern end of the pond.

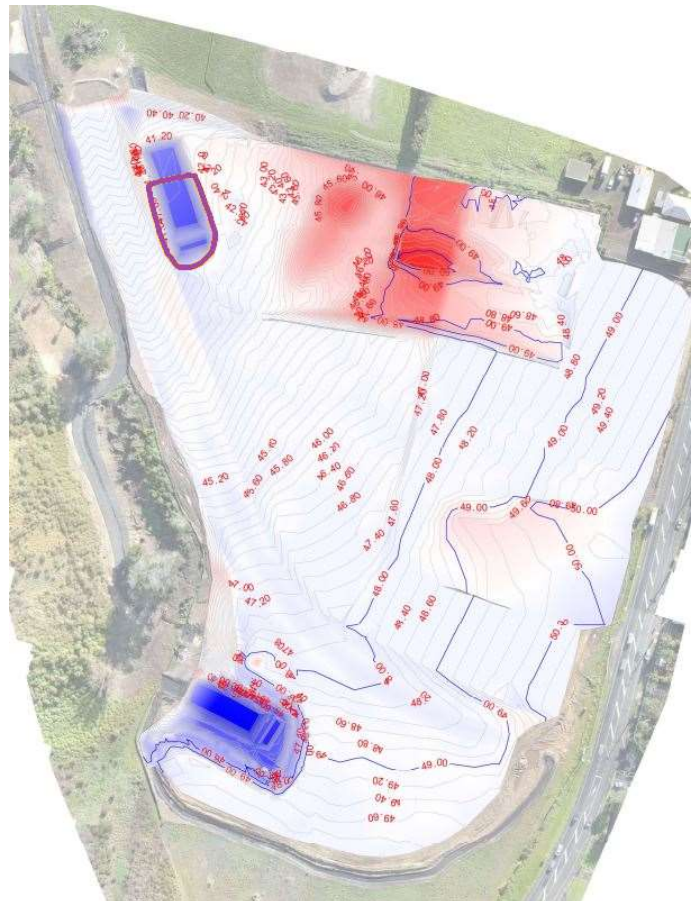
Plan showing approximate location of fill area in purple.

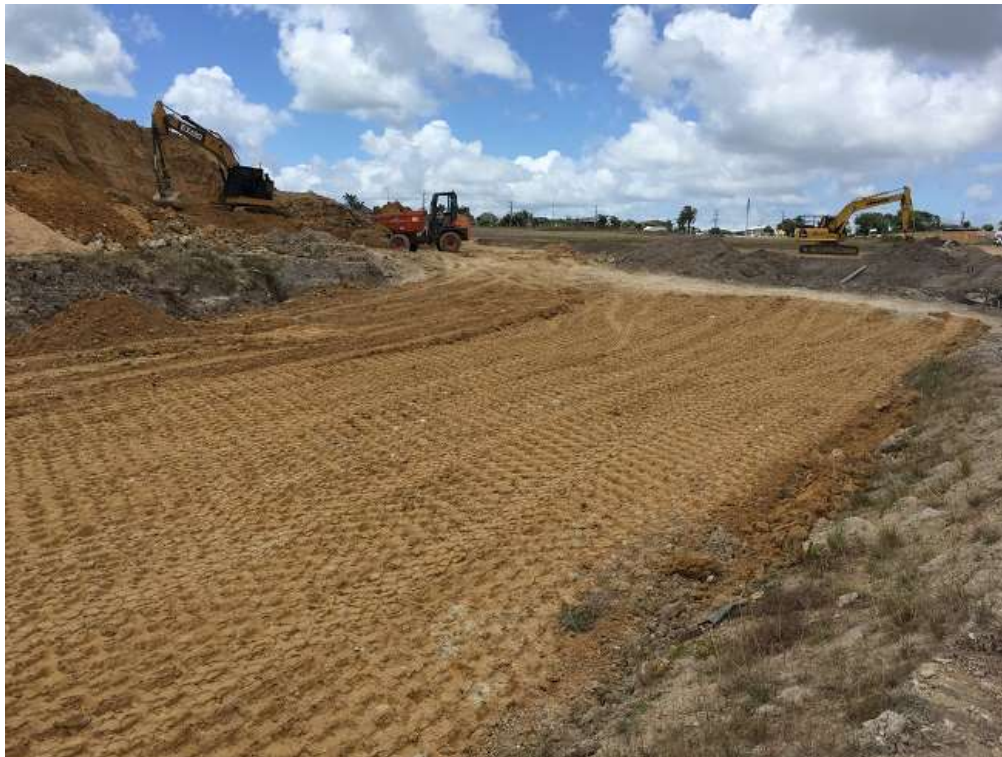
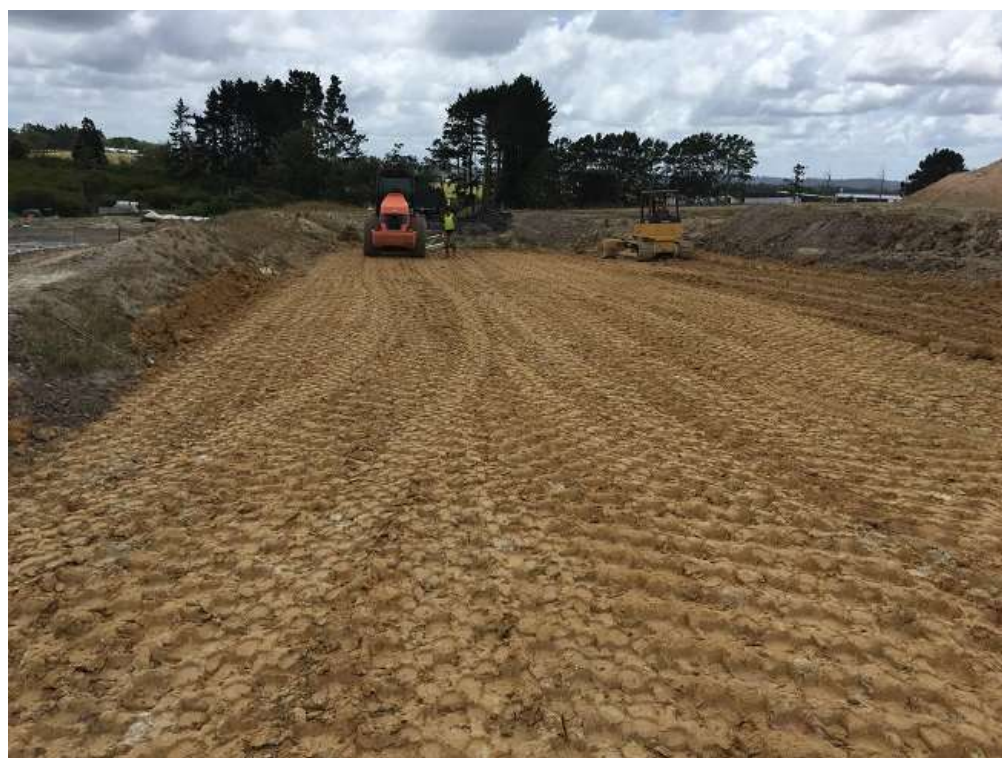
Fill placed in the southern end of the pond.

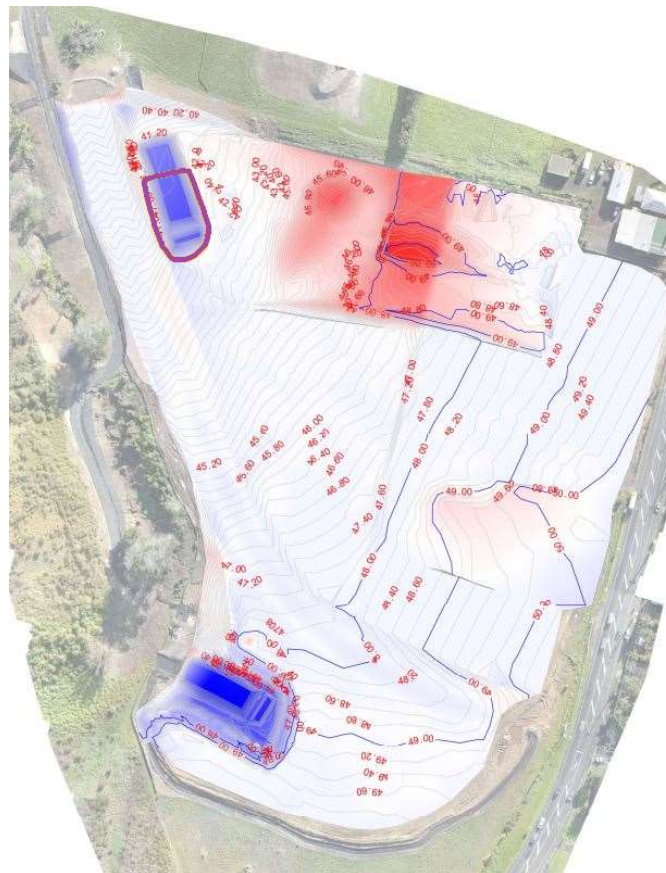
Plan showing approximate location of fill area in purple.

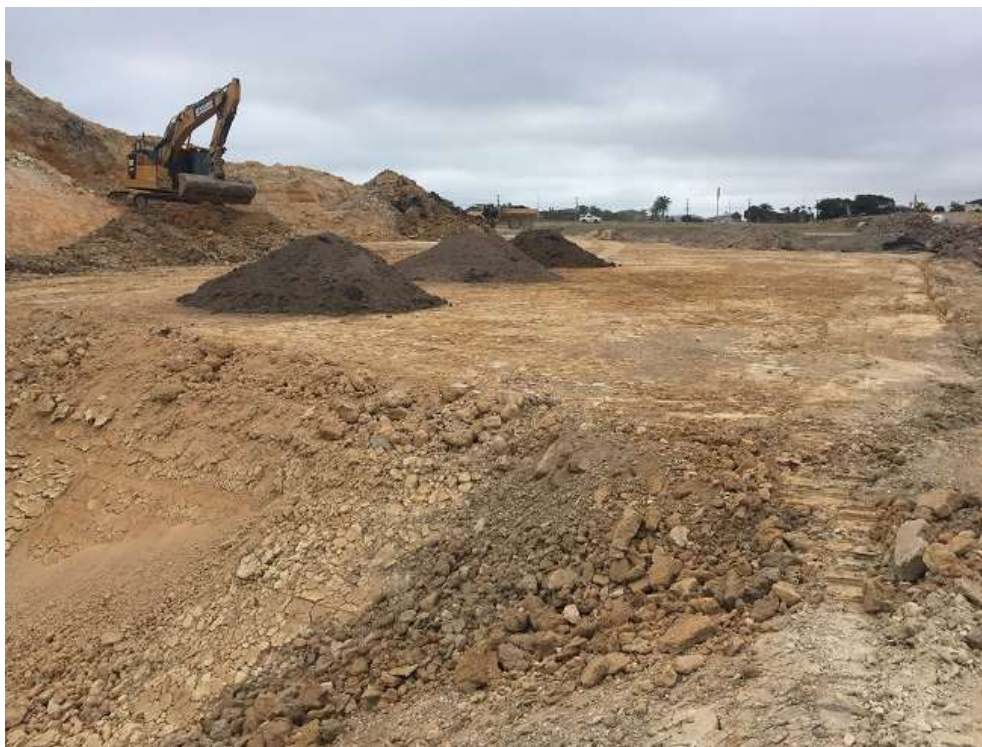
Trimmed fill surface on 27/01/21.

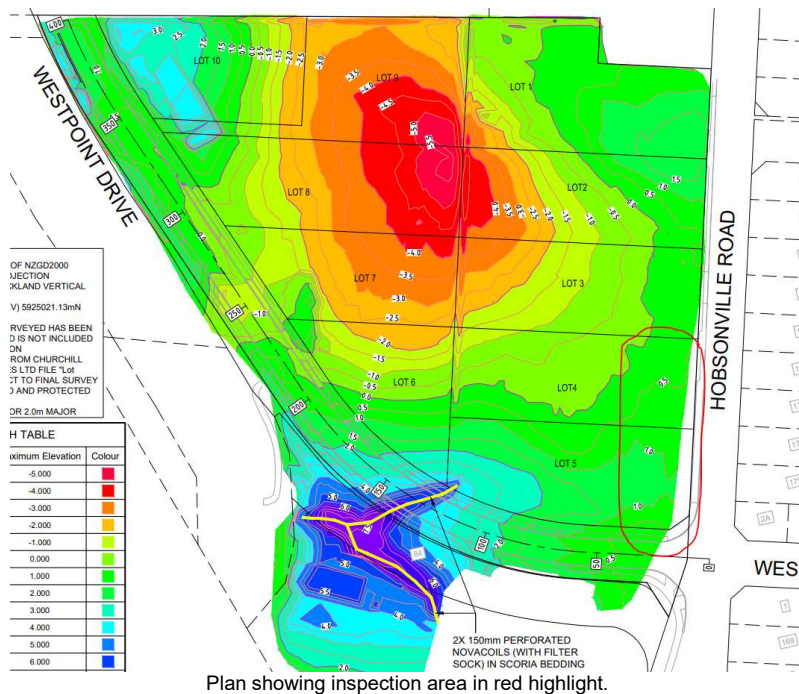
This inspection report is to advise that we have carried out an inspection as required by our client (or client's agent) on this project. It is NOT intended to serve as any form of certificate or producer statement, as that must be signed by a Chartered Professional Engineer once the project is completed.

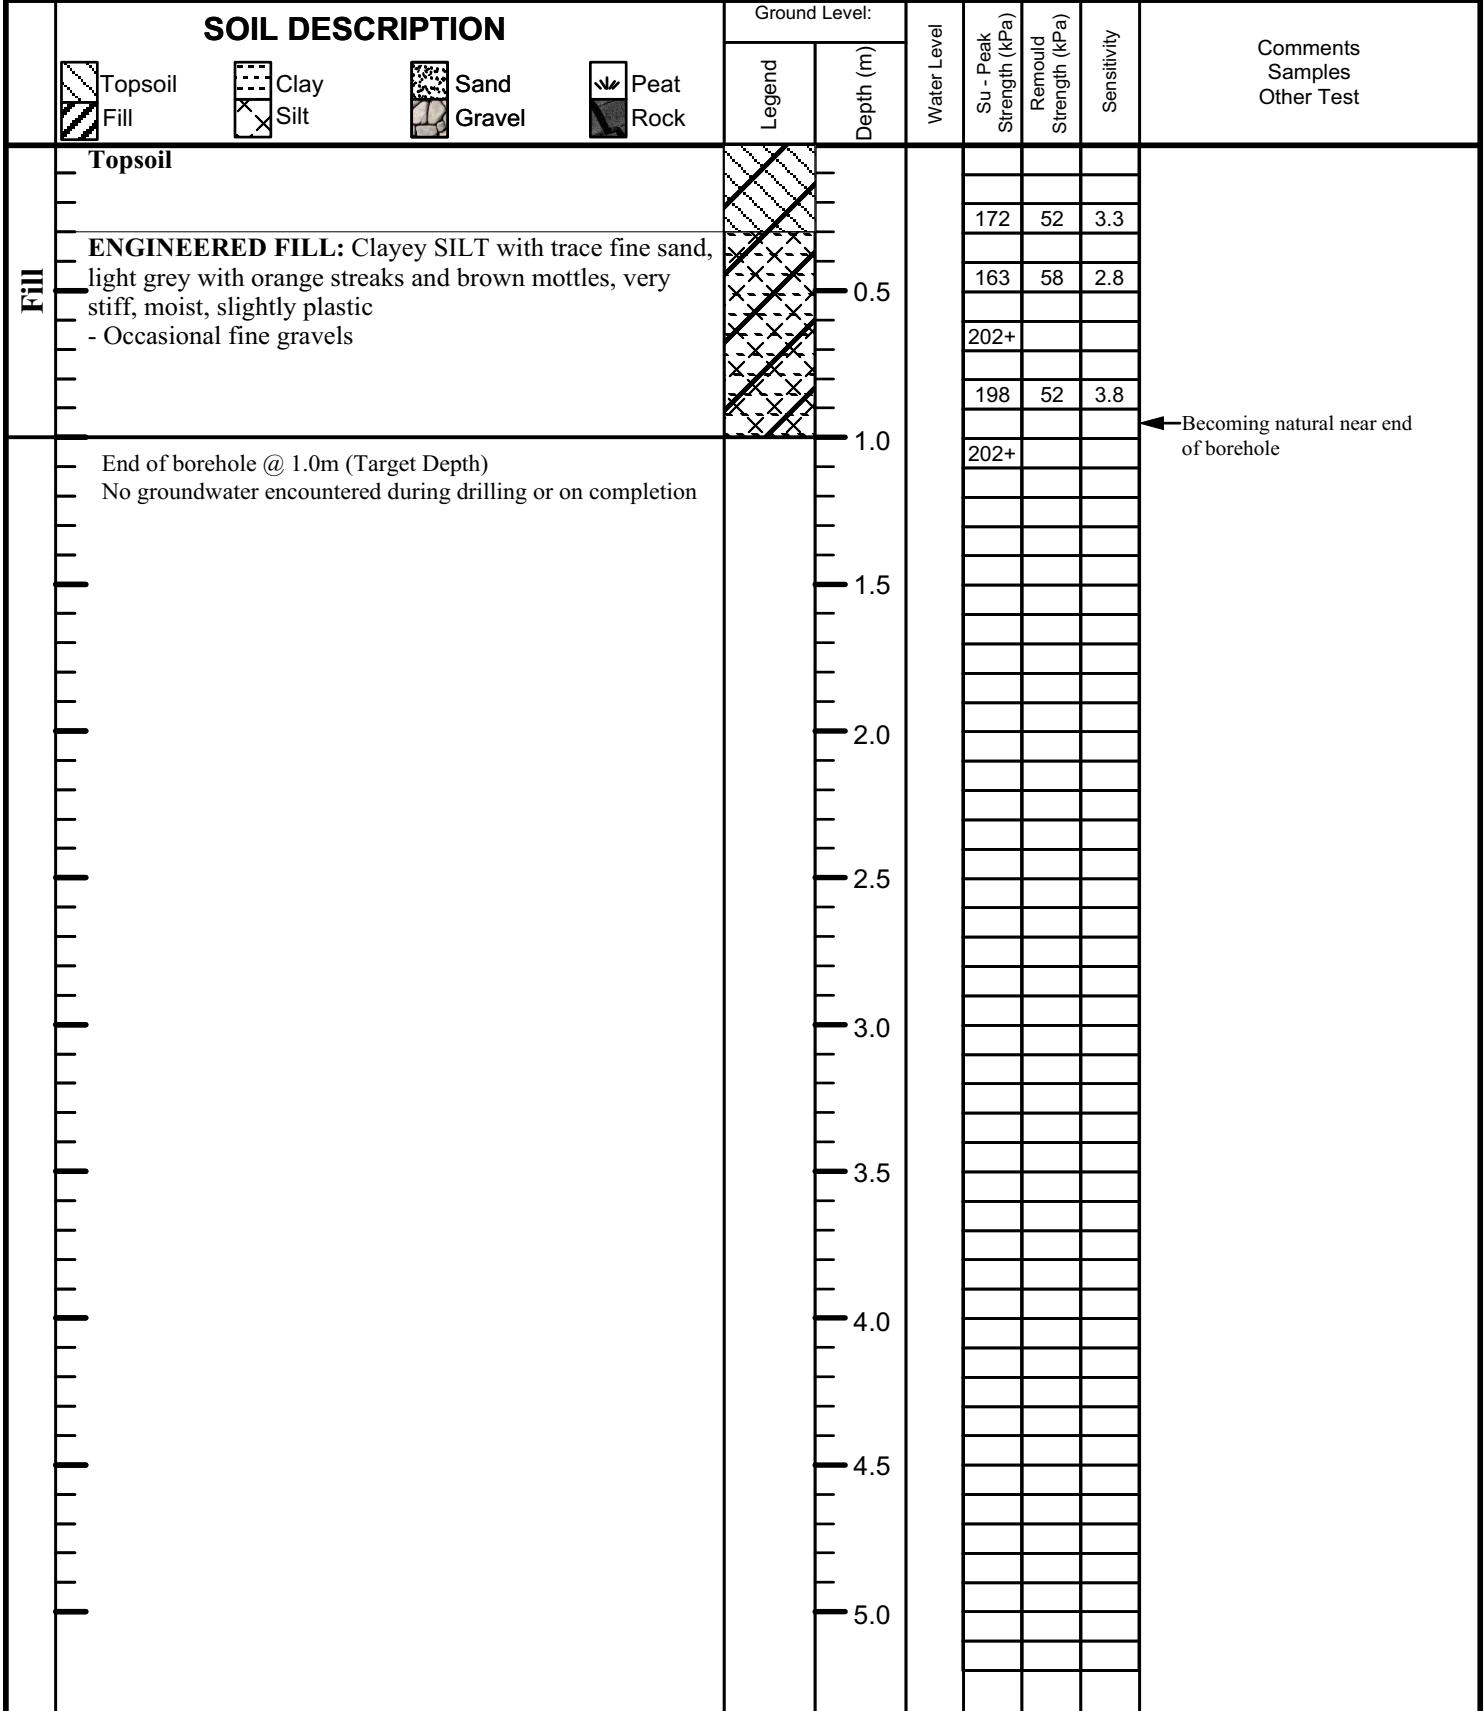
<b>CLIENT:</b> Austino Hobsonville 2	LOGGED: JM	SHEET: 7 of 72	JOB REF: 94185
<b>LOCATION :</b> 86 Hobsonville Road Hobsonville	CHECKED: MF		
	DIAMETER: 50mm	DATE: 28/07/2021	HAND AUGER No: C3
	SV DIAL: 20828

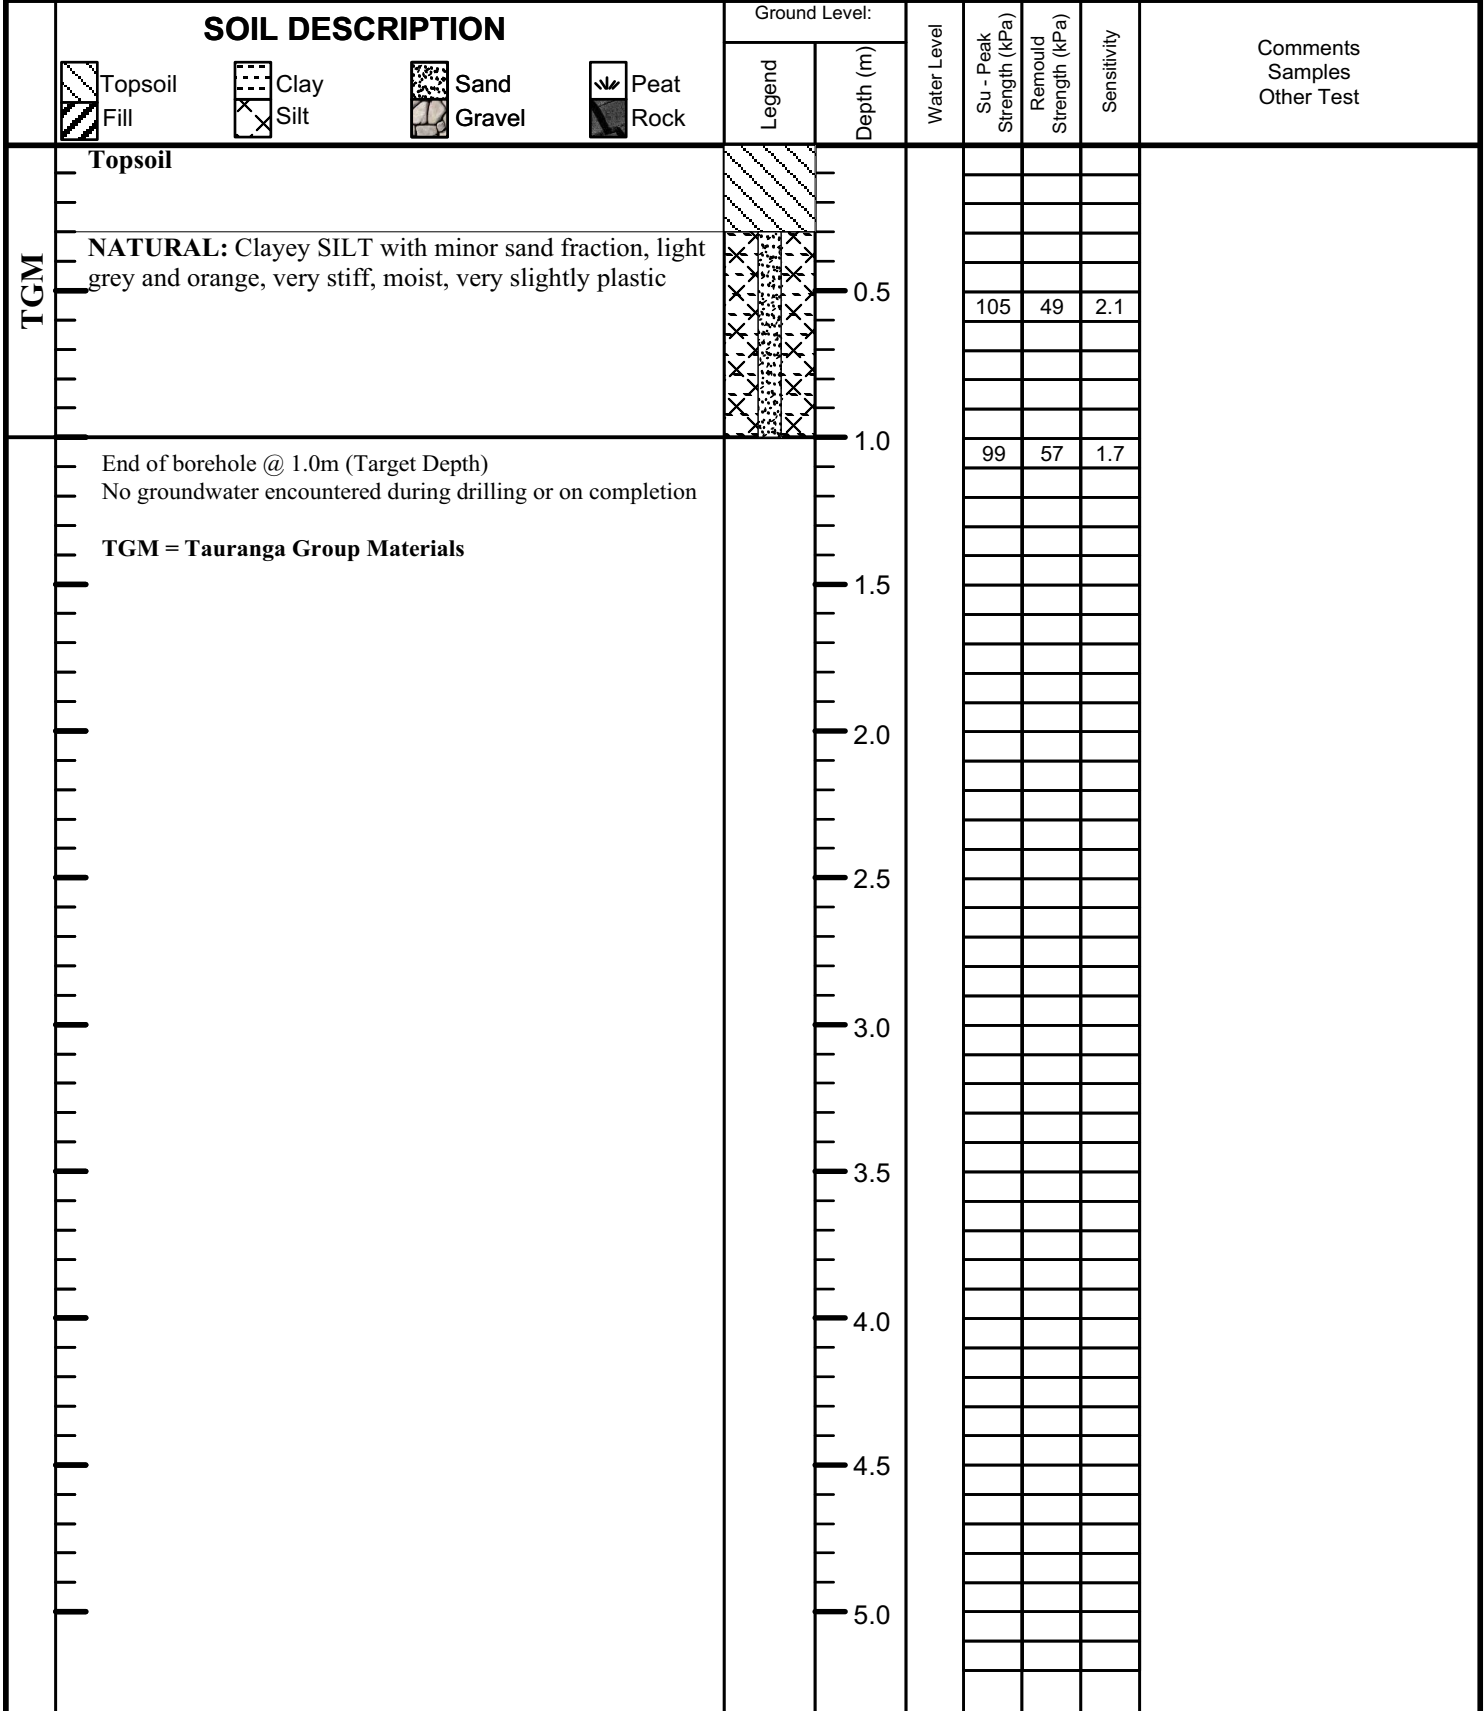
<b>CLIENT:</b> Austino Hobsonville 2	LOGGED: STL	SHEET: 16 of 72	JOB REF: 94185
<b>LOCATION :</b> 86 Hobsonville Road Hobsonville	CHECKED: MF	DATE: 28/06/2021	HAND AUGER No: E2
	DIAMETER: 50mm SV DIAL: 2862
