**GEOTECHNICAL COMPLETION REPORT**

**10-LOT**

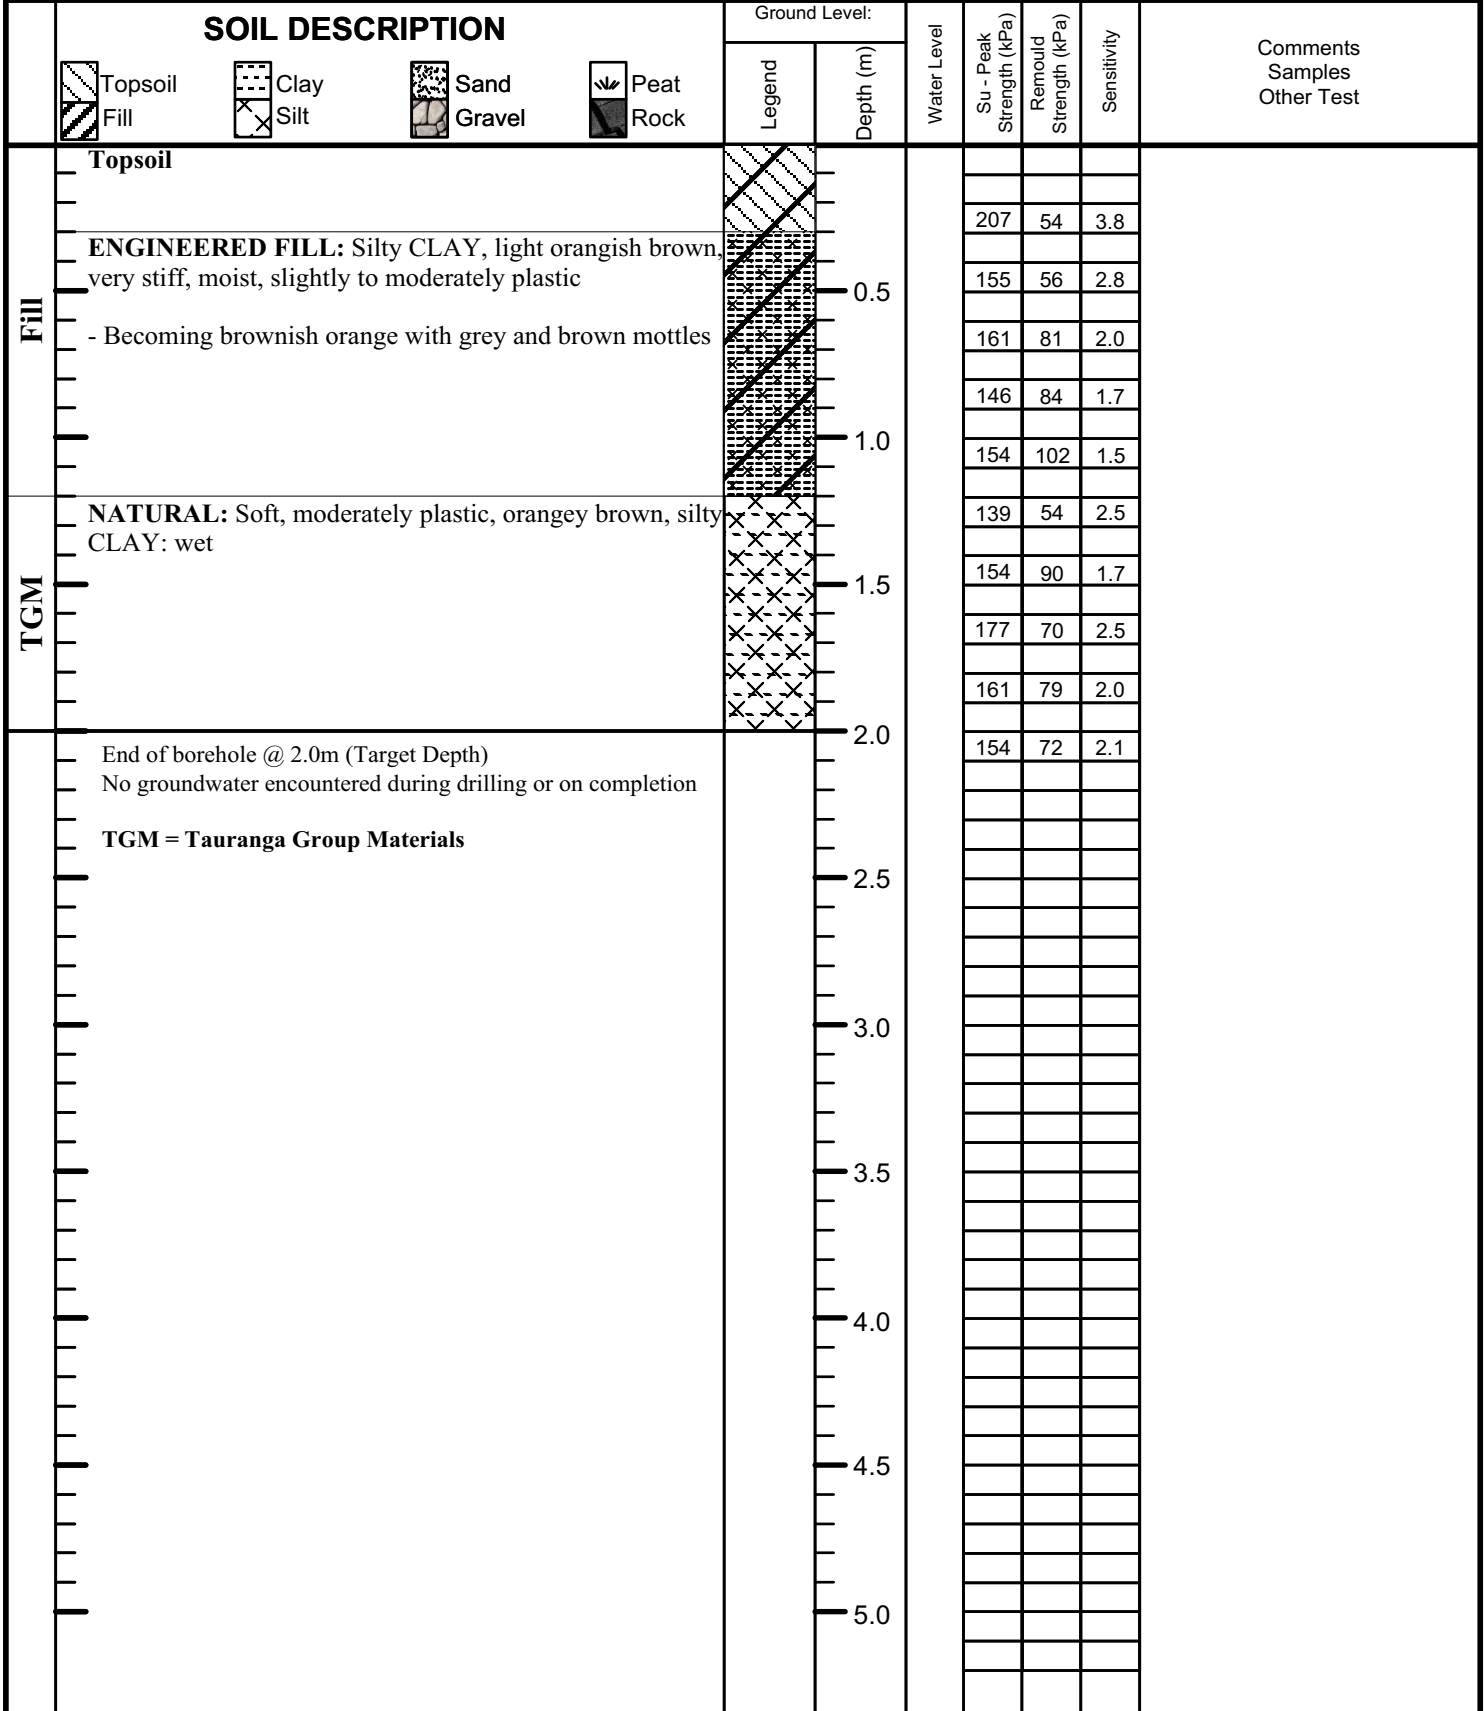
<b>CLIENT:</b> Austino Hobsonville 2	LOGGED: AH	SHEET: 64 of 72	JOB REF: 94185
<b>LOCATION :</b> 86 Hobsonville Road Hobsonville	CHECKED: MF	DATE: 23/09/2021	HAND AUGER No: J8
	DIAMETER: 50mm		
	SV DIAL: 1335

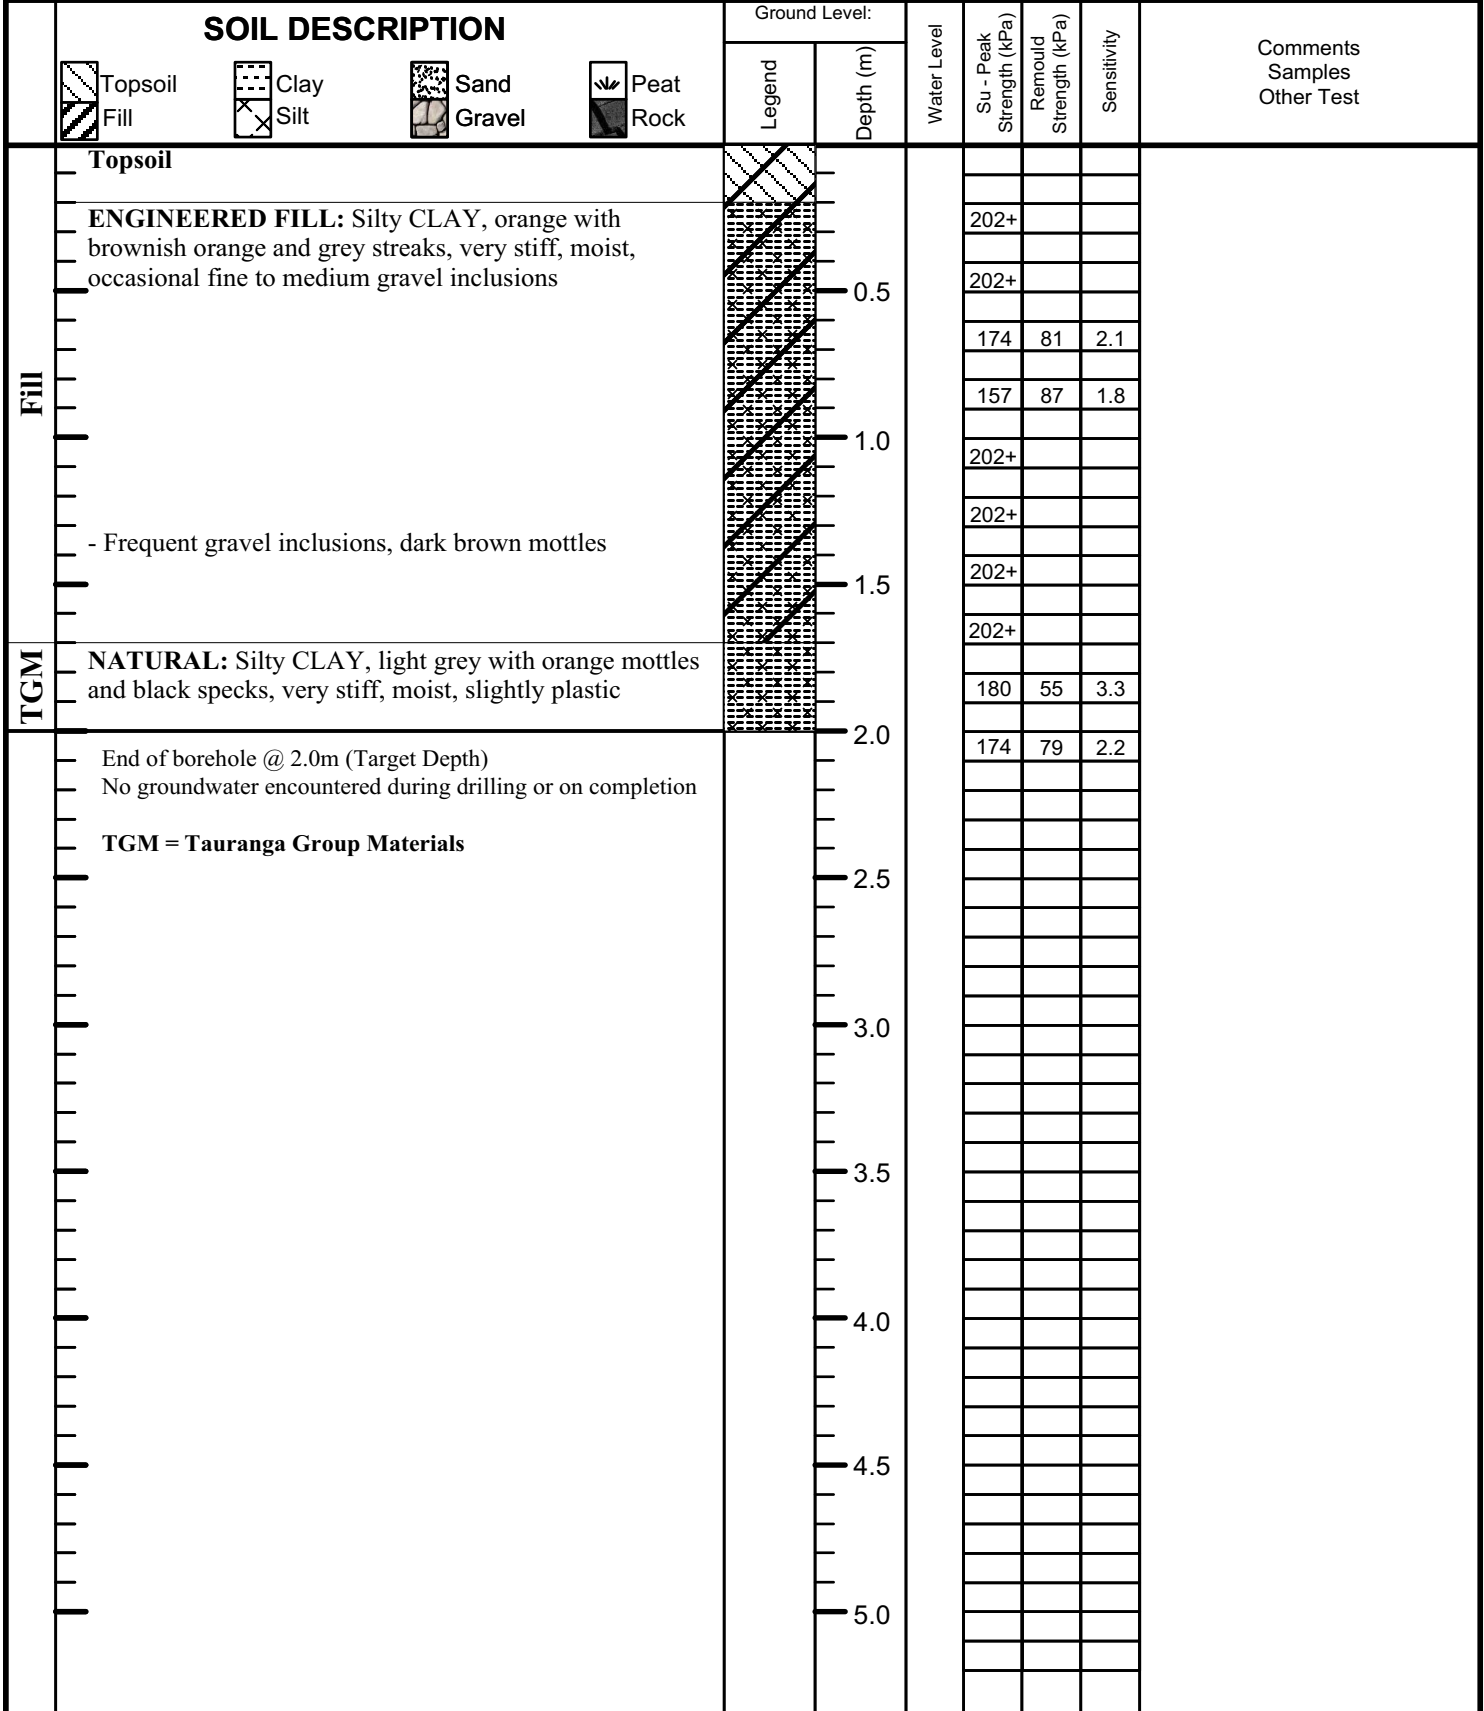
<b>CLIENT:</b> Austino Hobsonville 2	LOGGED: JM	SHEET: 66 of 72	JOB REF: 94185
<b>LOCATION :</b> 86 Hobsonville Road Hobsonville	CHECKED: MF		
	DIAMETER: 50mm	DATE: 27/07/2021	HAND AUGER No: K2
	SV DIAL: 2433

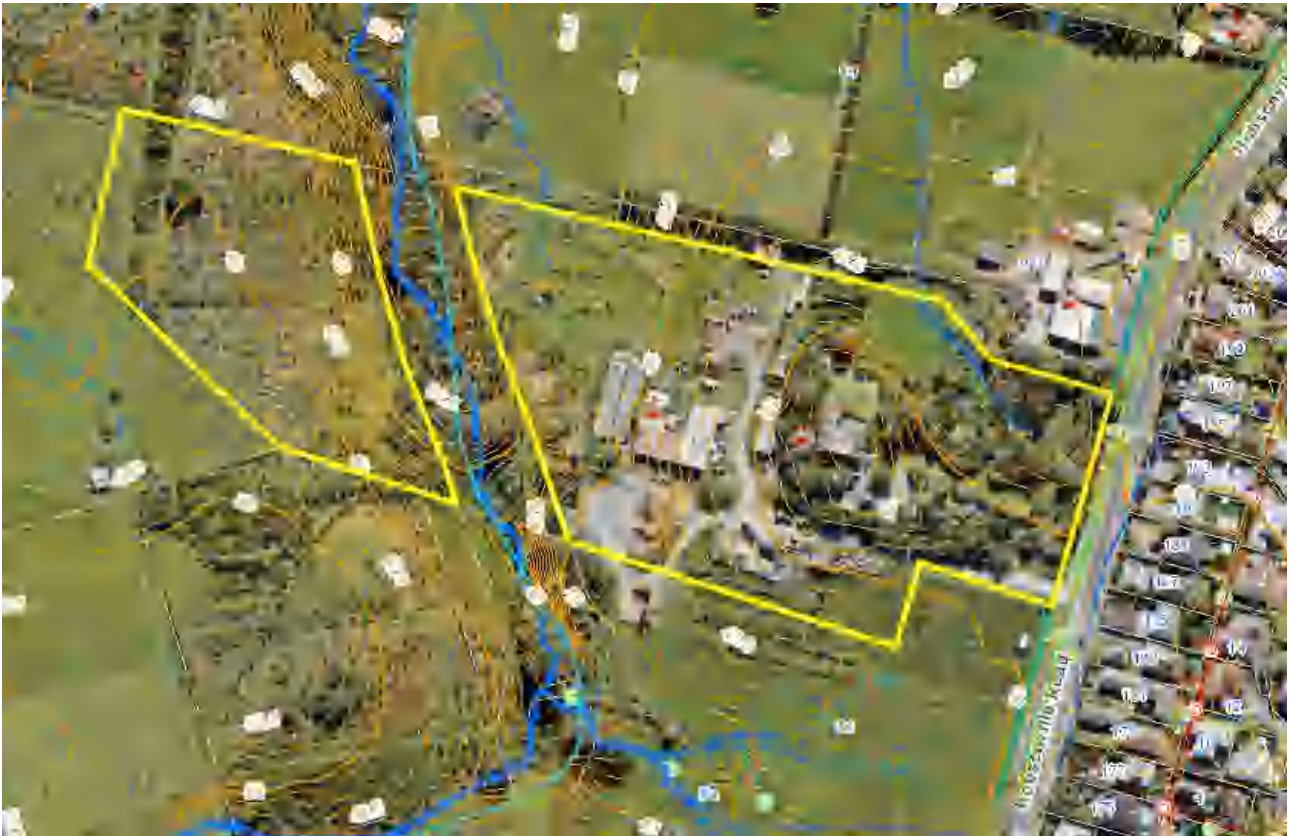
*Figure 1: Aerial photograph showing Number 88 Hobsonville Road which is separated into two land parcels by a central gully. Please note, the eastern land parcel of number 88 is subject to this report whilst the western land parcel will be subject to a future geotechnical report. Existing site contours in orange at 0.5m intervals and existing aerial photograph ca. 2017, from the Auckland Council GIS database (ALGGI).*
