**PRIVATE PLAN CHANGE 92 WELLSFORD**

**WELLSFORD WELDING CLUB LIMITED**

## **APPENDIX 9 ECOLOGICAL IMPACT ASSESSMENT**

## **APPENDIX 10 ENGINEERING ASSESSMENT REPORT**

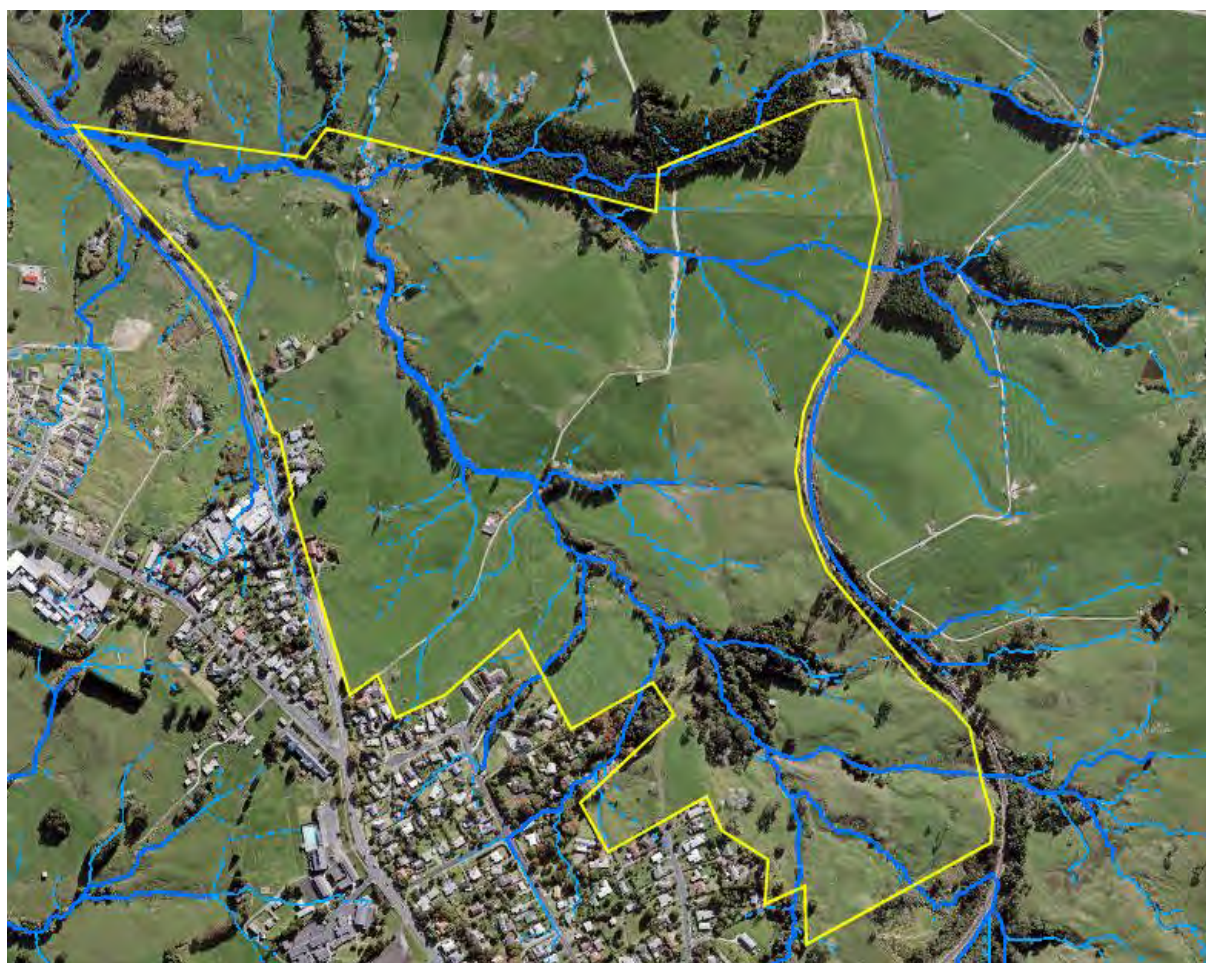
**Figure 1. The Structure Plan area at Rodney Street and Monowai Street, Wellsford. Approximate extent is shown in yellow, with predicted overland flow paths shown in blue, as per the Auckland Council Geomaps.**

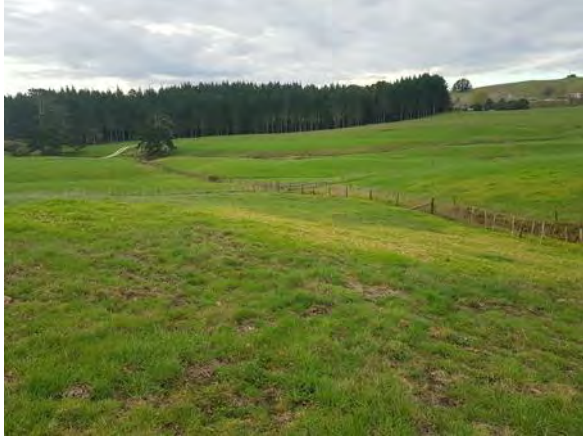
A relatively small pine plantation is located along the northern border of the site. The canopy is a monoculture of maturing pine (*Pinus radiata*). The understorey consists predominately of exotic species with a few common native species establishing. Exotic species present included high infestations of pest plant species such as arum lily (*Zantedeschia aethiopica*), tree privet (*Ligustrum lucidum*), Chinese privet (*Ligustrum sinense*), blackberry (*Rubus fruticosus* agg.), woolly nightshade (*Solanum mauritianum*) and wild ginger (*Hedychium gardnerianum*). Native species included māhoe (*Melicetyus ramiflorus*), kawakawa (*Piper excelsum*) and tī kōuka (*Cordyline australis*).

**Figure 4. Pine plantation along the northern boundary**

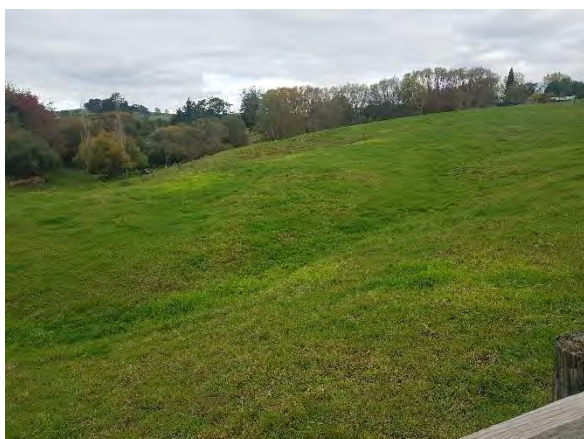
The understorey of these areas typically included either pasture or pest plant species such as gorse (*Ulex europaeus*), tradescantia (*Tradescantia fluminensis*), pampas (*Cortaderia selloana*), privet, arum lily and wild ginger. Also, within the mixed exotic vegetation, a few common native species were present which predominately included tōtara (*Podocarpus totara*), harakeke (*Phormium tenax*), tī kōuka and māhoe.

**Figure 6. Mixed exotic vegetation along the central stream**

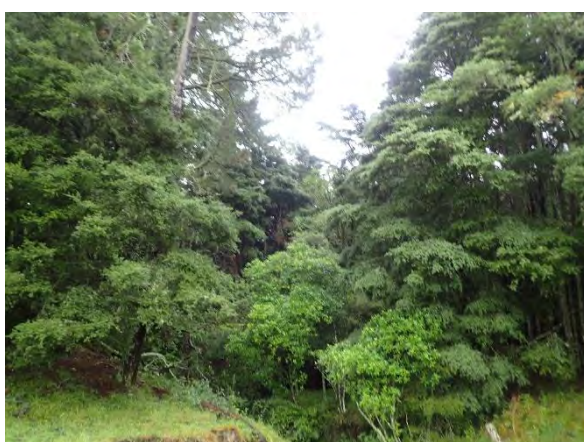
Within the southern portion of the site an approximate 1.8 ha patch of regenerating native podocarp forest is present. The vegetation within this area forms the riparian margin of two streams and consists of a canopy of predominately tōtara. Although native species were dominant, there was a high abundance of exotic vegetation within the canopy, including pines, brush wattle and Chinese privet. The understorey appears damaged from grazing/browsing by stock and pests (evidence of goats and cattle access was observed) and was made up of māpou (*Myrsine australis*), Carex species, hangehange (*Geniostoma ligustrifolium*) and multiple ground fern species including hard shield fern (*Polystichum* sp.), crown fern (*Lomaria discolor*), kiokio (*Parablechnum procerum*) and hounds' tongue (*Microsorium pustulatum*). Exotic species were also abundant, including pest plant species such as, arum lily, tradescantia, woolly nightshade and blackberry.

**Figure 8. Native vegetation within the site**

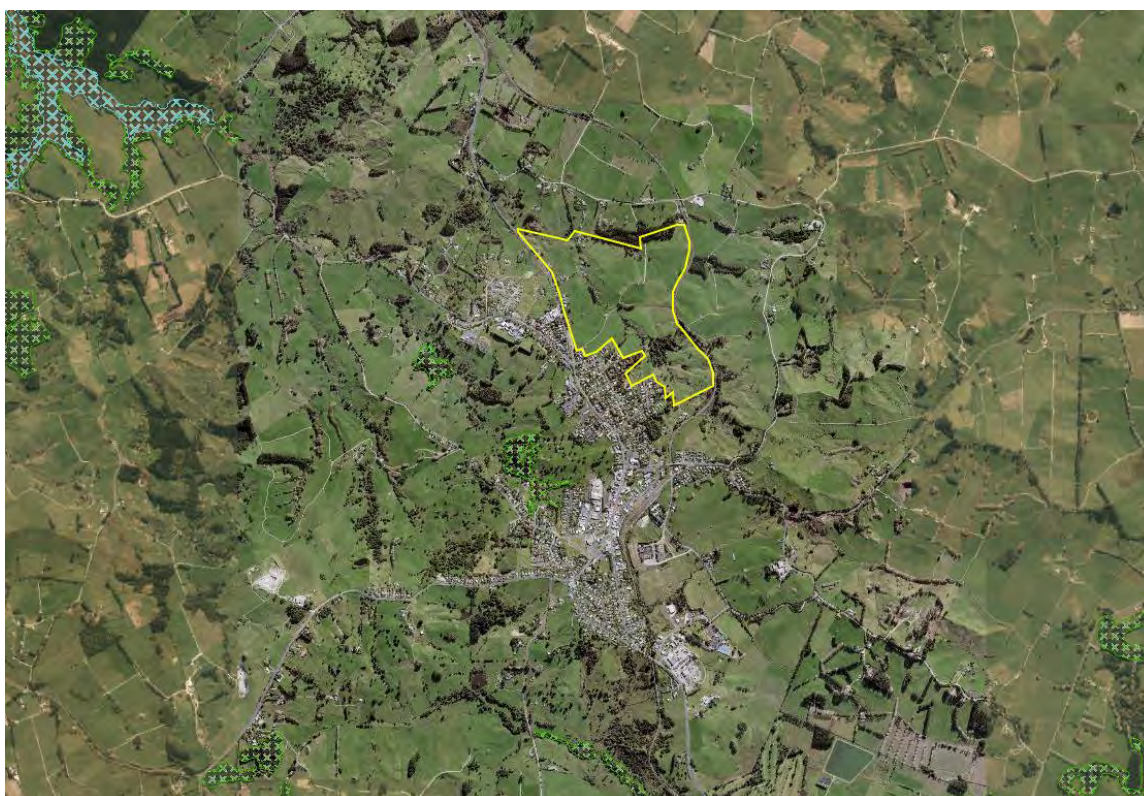
**Figure 10. A terrestrial SEA (green crosses) was located approximately 900m west of the native vegetation within the site (yellow polygon). Larger SEAs or areas of native vegetation were not in close proximity to the site.**

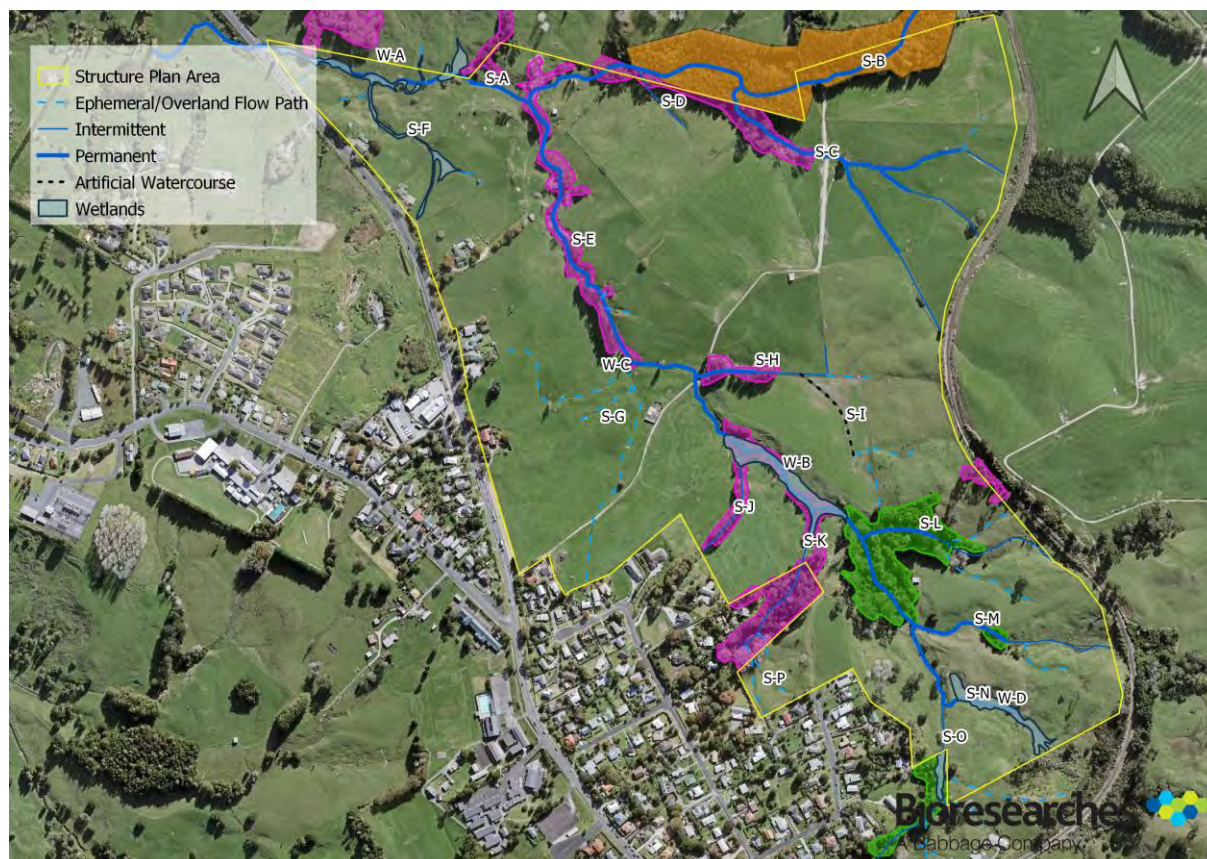
Aerial images obtained for the site indicated the presence of multiple watercourses on the property. These were ground-truthed and classified during the site visits as permanent or intermittent streams, ephemeral flow paths, natural wetlands, or constructed features (Figure 11).

Figure 11. Freshwater features identified on site, including the permanent, intermittent or ephemeral status of streams, and wetland areas.

Numerous streams (S-A to S-P, Figure 11) were identified within the site. One main permanent stream (S-A & S-D) flows from the south of the site to the north and generally bisects the site in half. All other streams identified with the site were tributaries of this main stream. The catchments within the site feed the Whakapirau Creek, which eventually drains to the Kaipara Harbour via the Oruawharo River.

A number of ephemeral streams or overland flow paths were identified within the site, namely the reaches within areas S-G and S-P of **Figure 11** (Figure 23 & Figure 33). These overland flow paths had ill-defined channels, no flowing water 48 hrs after a rain event, no natural pools, rooted terrestrial vegetation (pasture grasses) across their widths and no evidence of substrate sorting. As such, these overland flow paths were classified as ephemeral reaches and due to the complete lack of freshwater habitat these reaches were considered of negligible ecological value.

One artificial watercourse was identified within the site (S-I, Figure 11). The watercourse is uniform and has clearly been constructed and maintained to improve the drainage of the surrounding land (Figure 25). Early aerials from 1961 show no evidence of this watercourse (Figure 2), as such it was considered that this watercourse contained no natural portions from its confluence with the connecting stream to its headwaters.

Four wetlands were identified within the site (W-A to W-D, Figure 11). Wetlands were identified and classified using the latest MfE wetland protocols and guidance.

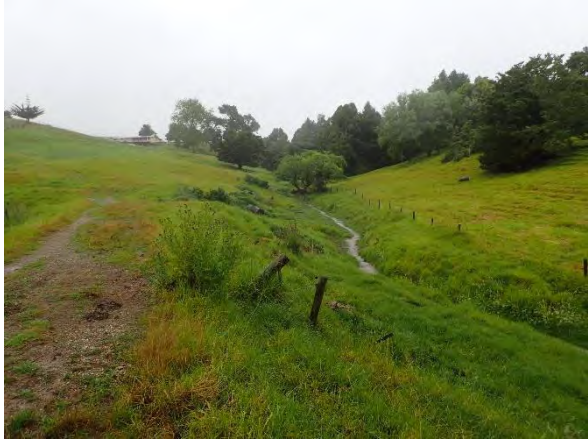
**Figure 21. Upper SEV reach of Stream S-E.**

A Stream Ecological Valuation (SEV) was undertaken (May 2019) on a reach within stream S-E directly upstream of the native vegetation (Figure 21). While not a complete true reflection of all the differing streams ecological values within the site, the SEV reach was considered a fair general representation of the degraded stream environments throughout the site.

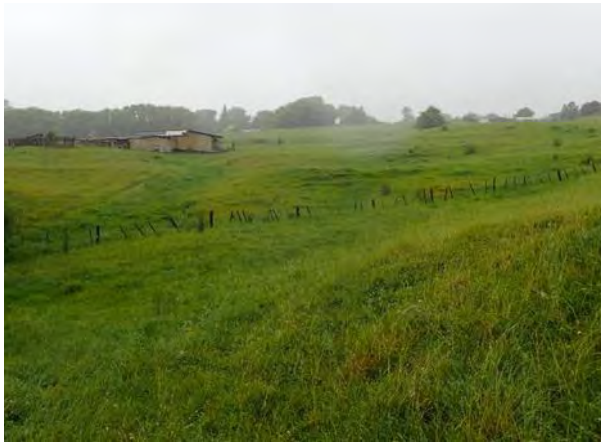
**Figure 23. Ephemeral reaches within area S-G.**

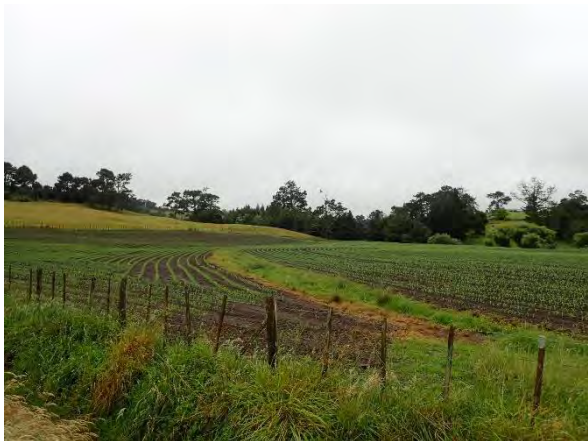
**Figure 25. Artificial watercourse S-I.**

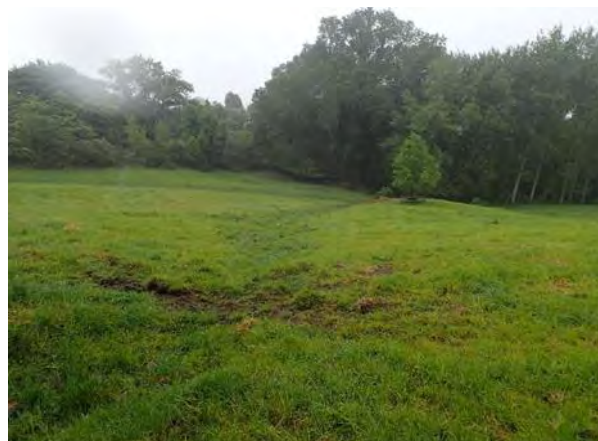
**Figure 33. Ephemeral reaches within area S-P.**

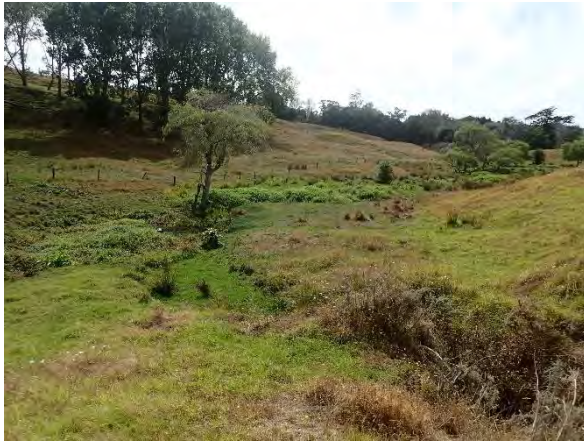
Stock have direct access to the wetland. Wetland vegetation identified included parrot's feather, soft rush, mercer grass, carex spp. and water pepper. The wetland was considered of low ecological value due to its degraded and artificial nature, the low diversity and structural complexity of plant species and lack of native species. This wetland represents a constructed pond with degraded pasture rather than a natural wetland.

**Figure 35. Wetland sequence within W-A.**

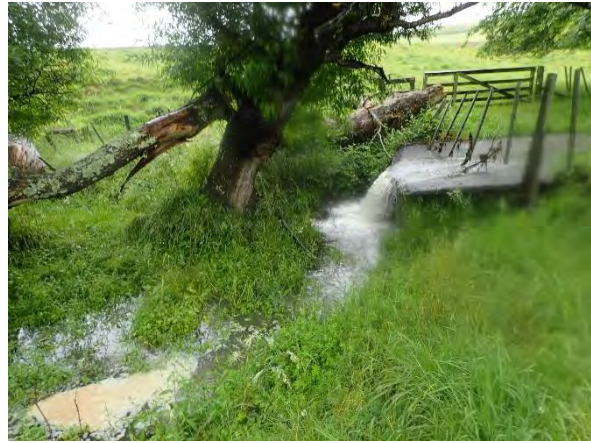
**Figure 36. Weir within wetland W-B.**

A number of culverts and farm crossings are located throughout the site. Some of these culverts are perched, such as the culvert within stream S-E upstream of the native vegetation, and form a significant fish passage barrier. A weir is also present within stream S-E, just downstream of the confluence with S-I, and forms another significant fish passage barrier.

Wetland W-B is a relatively large wetland (≈0.5 ha) located approximately midway along stream S-E. An instream weir is present (Figure 36) which has at least partially induced the wetland. Permanent wetland hydrology was evident consisting of standing water, flowing water and boggy ground.

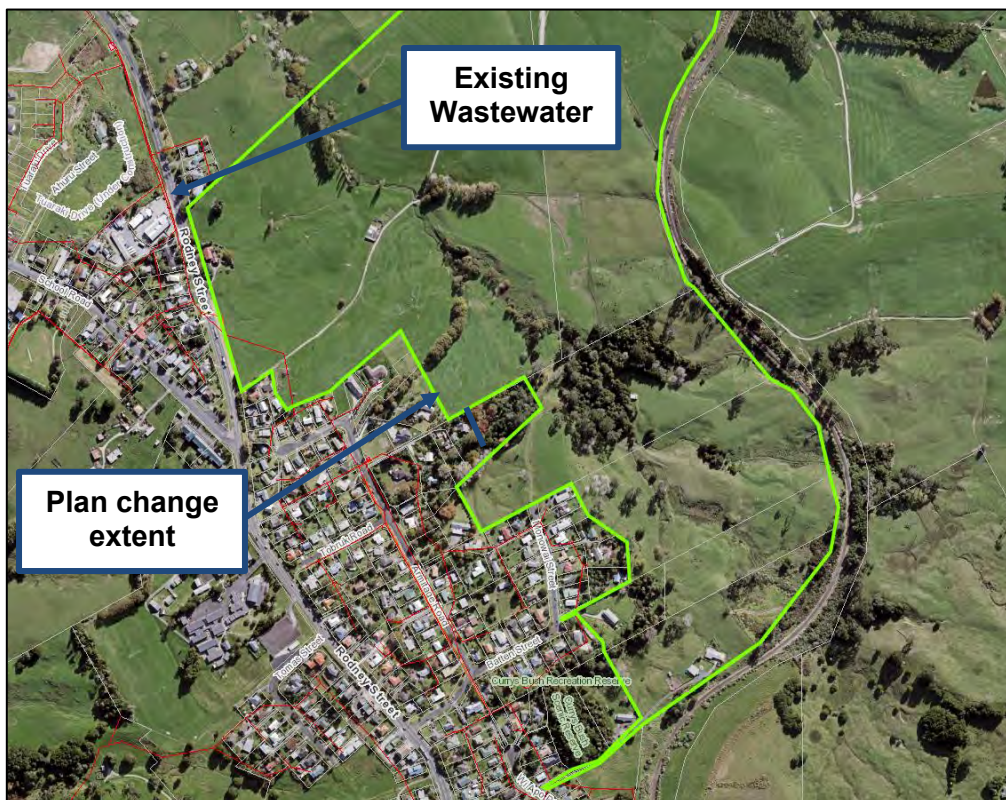
The Auckland Council GeoMap System indicates an existing public wastewater network bisecting through the south western corner of 338 Rodney Street, refer to Figure 4 for locality details.

Figure 4: Auckland Council GeoMap Depicting Existing Wastewater Network

The ideal connection point for any future residential subdivision into the public wastewater network would be at 338 Rodney Street as it is readily available. As part of future subdivision civil works, the existing wastewater pipe that bisects through the south western corner of 338 Rodney Street should be redirected, so it does not traverse through a future residential site.

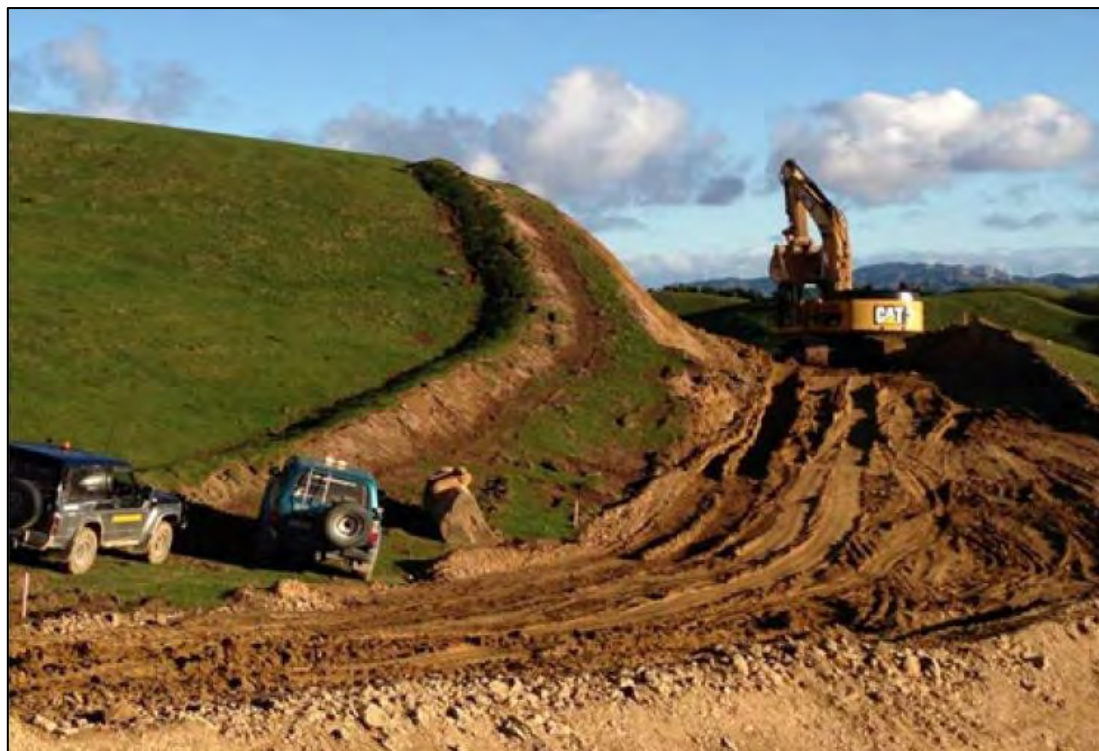
Clean water diversion bunds will be installed along the upper end of the sub staged catchments to divert clean water flows away from the earthworks areas to avoid sediment contamination within the downstream environment.

*Figure 8: Photograph of Clean Water Diversion Bund*

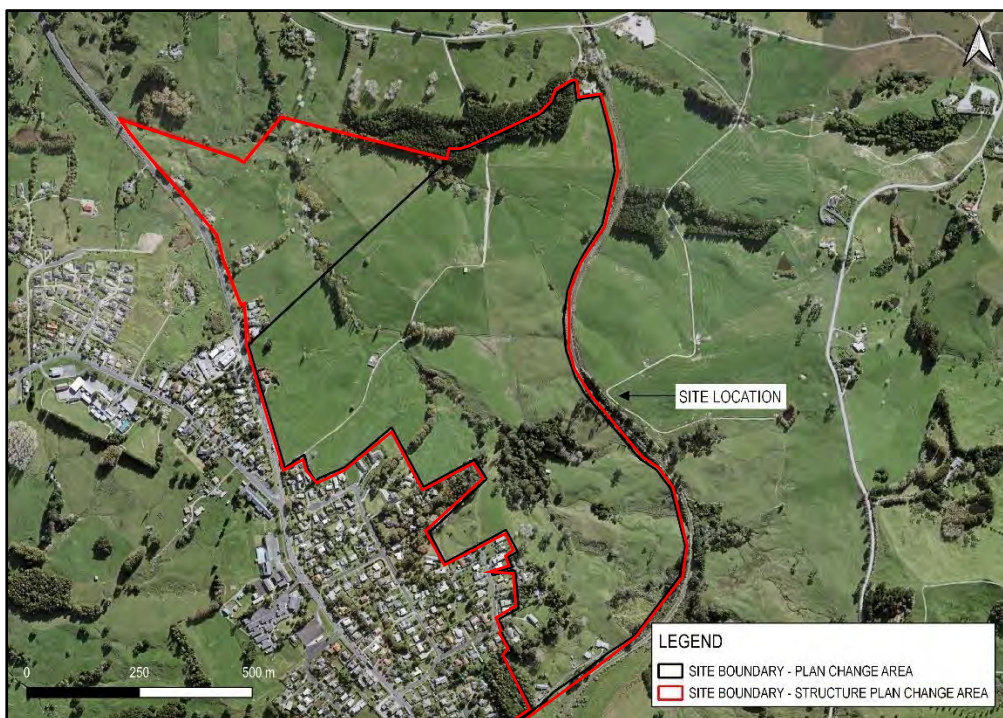
Figure 1-2: Location plan (scale 1 in 7,500)

Figure 1-2 indicates the extent of the PPC and PSP areas. The PPC covers the central and eastern area of the site as indicated by the black outline (approximately 52.3 ha). The PSP includes the area in the PPC and several additional properties to the north-west as indicated by the red outline (approximately 77.5 ha).

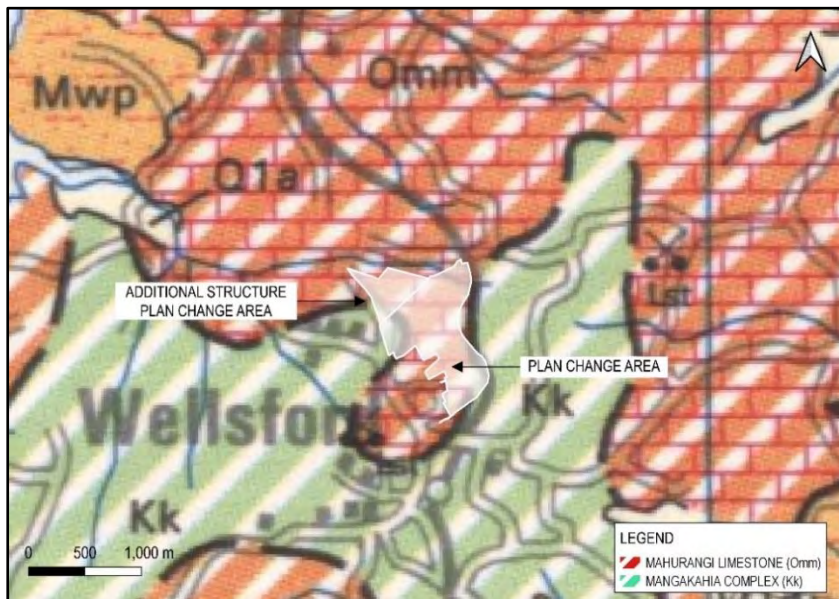
Figure 2-1: Extract of the 1:250,000 geological map of the Auckland area

The GNS Science 1:250,000 geological map of the Auckland area<sup>4</sup> shows part of the site underlain by Mahurangi Limestone (Omm) of the Northland Allochthon. This material is described as a series of pale grey to white, laminated muddy limestones, commonly interbedded with graded sandstone beds. Mangakahia Complex (kk) of the Northland Allochthon is mapped to the east and west of the site. This material is described as closely fractured to sheared, light or dark coloured, siliceous, and

Annotated extracts of the geological maps showing the site location are presented in Figure 2-1 and Figure 2-2.

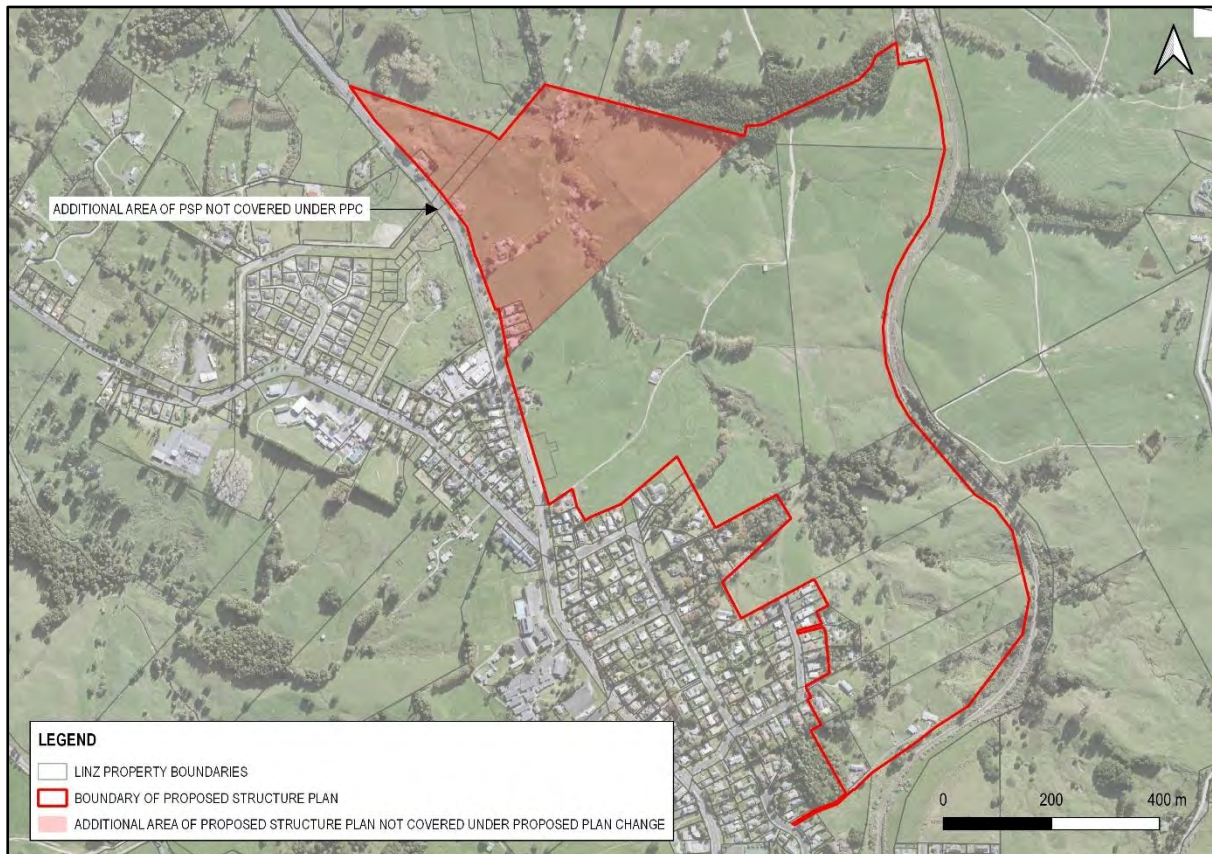
Figure 3-1: Proposed Structure Plan area (outlined in red). The shaded area is not covered by the Proposed Plan Change

This section of the report includes a preliminary assessment of the northern part of the PSP area which is not covered by the PPC, shaded red in Figure 3-1 below. This assessment is based on a geotechnical desktop study and visual observations made from public land and adjoining properties in April 2022. This information has been used to review the likely suitability of the ground and groundwater conditions for the proposed new land use, and comments on the possible geotechnical implications which may affect the development.

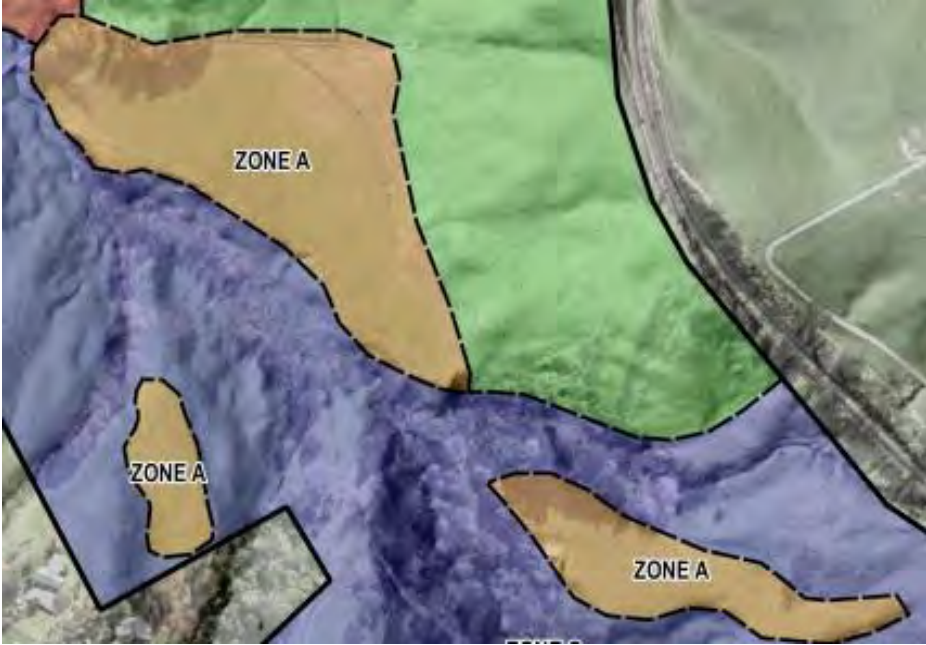
<p><b>Terrain:</b> Zone A typically comprises terrace features which slope at between about 2 and 3 degrees to the northwest.</p> <p><b>Data confidence:</b> Published maps of the area indicate that these areas are underlain by Mahurangi Limestone of the Northland Allochthon. Our site observations indicate that these terraces comprising alluvial soils overlie the Allochthon (as described below). No other historical supporting information is readily available for this zone.</p> <p><b>Inferred ground conditions:</b> Our preliminary investigations indicate that the ground conditions within the areas denoted Zone A are likely to comprise alluvial deposits. Alluvial deposits can be highly variable and may comprise soft compressible, or liquefiable granular materials. We infer that these terrace deposits were deposited during a period of elevated sea level, indicating that they are in the order of 100,000 to 150,000 years old.</p>	<p><b>Geotechnical Implications:</b> The inferred ground conditions within these zones are anticipated to be favourable for light weight residential development on shallow or raft type foundations. Where adverse ground conditions are encountered, local ground improvement measures could be incorporated into the earthworks development of these sites. Development will need to be set back from steeper slopes to satisfy Auckland Councils minimum factor of safety for slope stability.</p> <p><b>Confirmation of Geotechnical Assessment:</b> Development within this Zone is achievable but requires confirmation of ground conditions and may require assessment of liquefaction vulnerability and slope stability where development near steep slopes is proposed.</p>

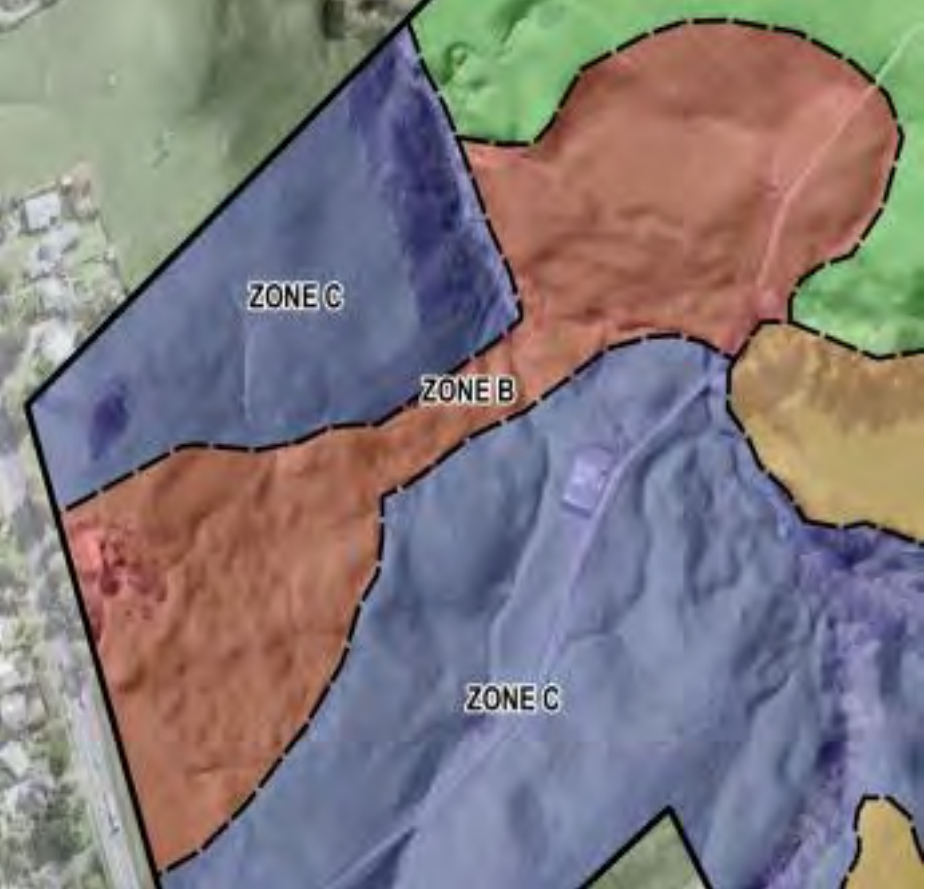
<p><b>Terrain:</b> Zone B typically comprises gently to moderately sloping hummocky and undulating topography leading from SH1 down toward the central drainage gully. Above the gully immediately east is a small pocket of land that falls west, back toward the central drainage gully. The hummocky terrain located centrally within this zone displays obvious signs of active earth movement within the upper soils and broken zone of upper rock. It appears that a series of manholes and relief wells are located on the site below SH1 that may be associated with stabilisation of the road. Moderately sloping ground either side of this is potentially subject to shallow surface creep.</p> <p><b>Data confidence:</b> Published maps of the area indicate that these areas are underlain by Mahurangi Limestone and Mangakahia Complex of the Northland Allochthon. Our site observations also indicate the presence of Mangakahia Complex. No other historic supporting information is readily available for this zone.</p> <p><b>Inferred ground conditions:</b> Our preliminary investigations indicate that near surface soils within this Zone are underlain by fissile mudstone. Clay shale may also be present, and it is likely that this material is present within the zone of active movement. These materials generally correspond to the mapped geology of and Mangakahia Complex mudstone of the Northland Allochthon.</p>	<p><b>Geotechnical Implications:</b> The investigations undertaken for this report generally indicate that the underlying moderately weathered rock is located within about 5 m of the surface over most of Zone B. The relatively shallow rock and active instability lends the site toward a conventional but relatively complex bulk earthworks mass stabilisation comprising a series of stabilised terraces or slopes. Stability improvement can be achieved through deep earthworks shear keys and drainage measures that extend through the broken zone into the top of the intact rock. This type of earthworks and retention solution is typical of the large scale recent development surrounding the Silverdale area. Development will need to maintain or improve the stability of adjacent properties and infrastructure such as State Highway 1 to the west.</p> <p><b>Confirmation of Geotechnical Assessment:</b> Development within this Zone is possible but requires confirmation of ground conditions, slope stability assessment and large scale earthworks design.</p>

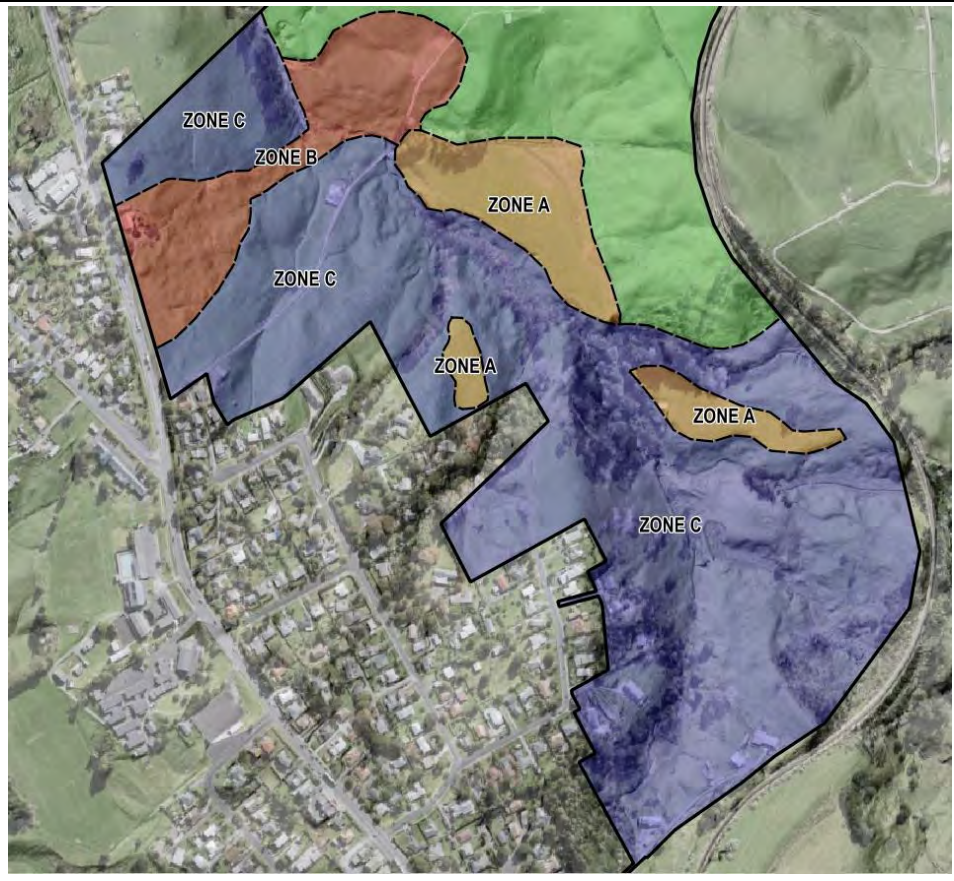
<p><b>Terrain:</b> Zone C typically comprises a series of ridge crests and drainage gullies with gently to moderately inclined side slopes up to about 20 degrees (locally steeper), falling toward watercourses at the base of the slopes. This zone is considered susceptible to primarily shallow surface creep and local instability within the upper 3 m to 4 m on slopes steeper than about 14 degrees. Deeper seated instability or instability on slopes as gentle as 7 degrees is less likely, but cannot be ruled out at this stage.</p> <p><b>Data confidence:</b> Published maps of the area indicate that these areas are underlain by Mahurangi Limestone and Mangakahia Complex of the Northland Allochthon. This is supported by our site observations and investigations. No other historic supporting information is readily available for this zone.</p> <p><b>Inferred ground conditions:</b> Our preliminary investigations indicate that near surface soils within this Zone are underlain by variable brittle sandstones, siltstones and limestone. These materials generally correspond to the mapped geology of Mahurangi Limestone of the Northland Allochthon. Due to the high variability of Northland Allochthon materials, fissile mudstone / clay shale (Mangakahia Complex) may also be present locally within this zone.</p>	<p><b>Geotechnical Implications:</b> The investigations undertaken for this report generally indicate that the underlying moderately to highly weathered rock is located within about 3 m to 4 m of the surface over most of Zone C. Some areas within Zone C may be suitable for development with relatively simple stability improvement measures such as deep drainage to lower ground water pressures. The feasibility of mass earthworks stabilisation should be considered against the achievable lot density in Zone C. Some areas within this zone may lend themselves to specific mass earthworks stability enhancement where greater lot densities can be achieved, if economically feasible. This may be the case in the western corner of the site.</p> <p>Where stabilisation of large land areas to enable density is not economically feasible, then stabilisation of selected building platforms within larger lot sizes may be more suitable to this Zone. Building platforms in some areas may not be economically feasible to develop in this zone and may be better suited to green spaces within larger lots.</p> <p>Typically, building or site-specific engineering design in Zone C may comprise solutions such as piled foundations designed to resist soil creep, local earthworks stabilisation, drainage, and in-ground reinforced concrete palisade walls. Shallow foundations may be suitable in some situations or areas that have been enhanced through earthworks and/or deep drainage measures.</p> <p><b>Confirmation of Geotechnical Assessment:</b> Development within this Zone is possible but requires confirmation of ground conditions. Depending on the chosen development density, suitable building platforms will need to be identified. This is likely to entail site specific geotechnical investigation and design.</p>

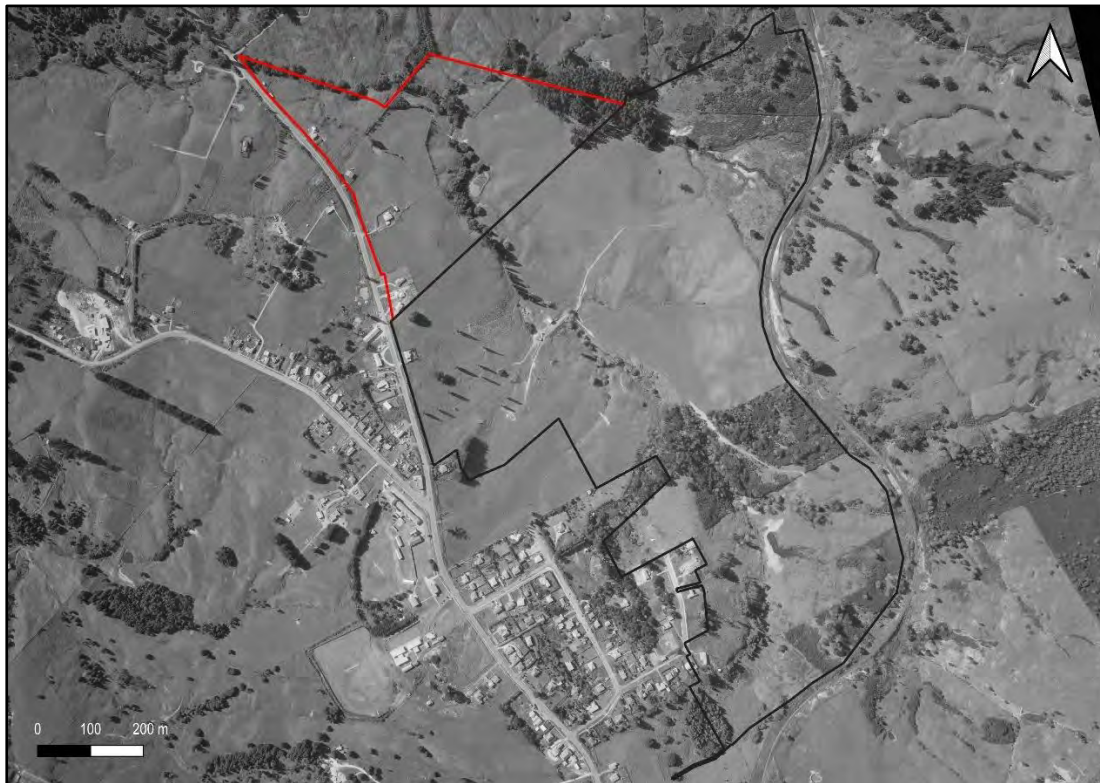
Figure B-5-1: 1961 Aerial photograph (Retrolens)

- 1 Based on the aerial photography from 1961 (sourced from Retrolens), the site appears to be primarily used as farmland. The building at the corner of Batten Street and Monowai Street, and several existing dwellings along the western boundary of the site are constructed. Part of the existing farm tracks is visible near the centre of the site. Numerous slope deformation features can be observed across the site including hummocky ground and small landslides including what we infer to be a recent landslide feature near south-eastern corner of the site.

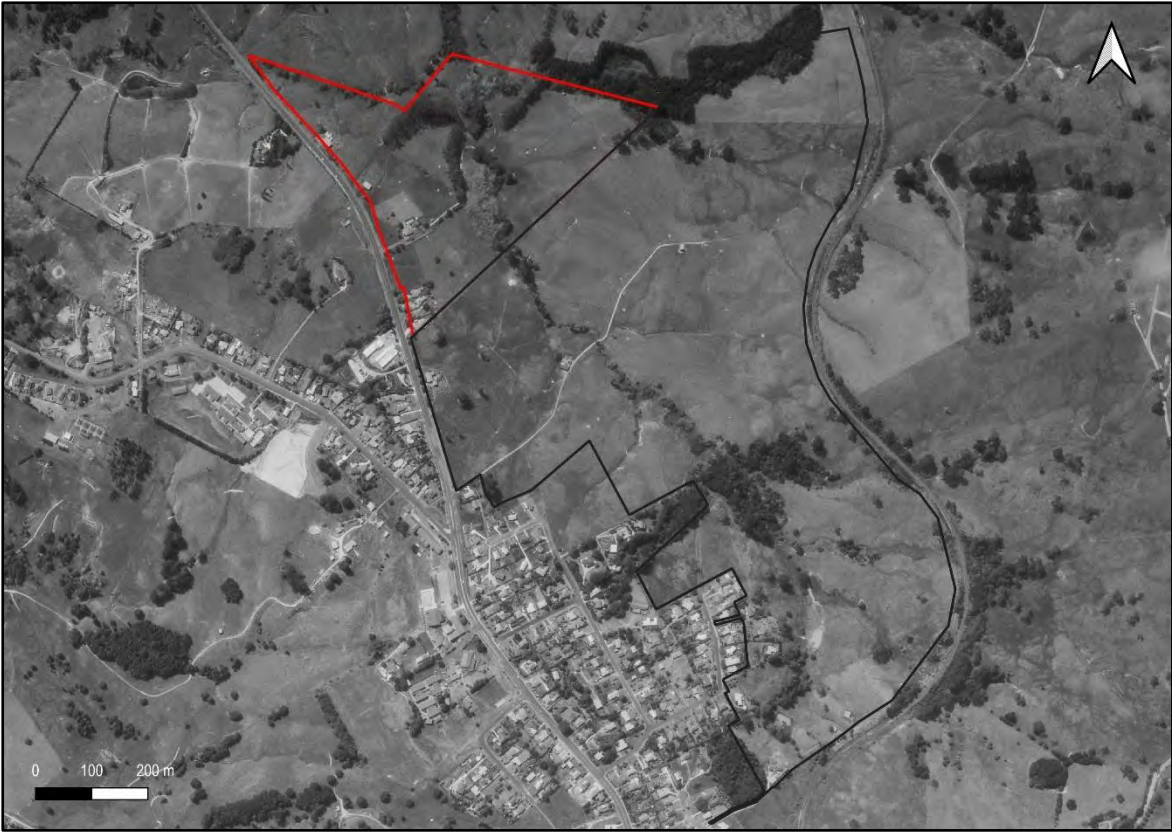
Figure B-5-5: 1992 Aerial photograph (Retrolens)

- 3 No notable changes are observed between 1982 and 1992 aerial photography. Construction had begun on the development at Kelgary Place near the south-western corner of the site, and a barn was constructed near the centre of the site.

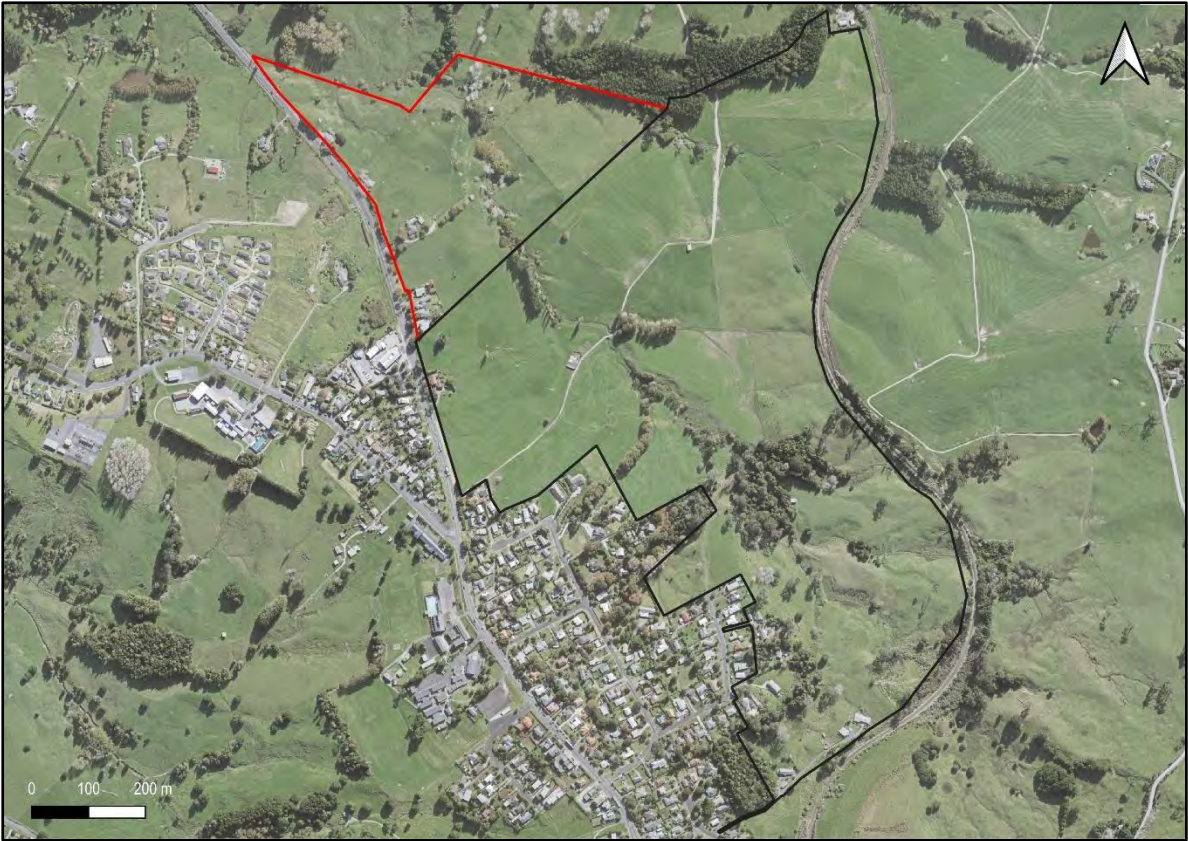
Figure B-5-9: 2017 Aerial Photograph (LINZ)

- 4 From 1992 to 2017, the site appears visually to be largely the same. A new access track was constructed near the northern end of the site from Bosher Road. Changes to SH1 near the western boundary of the site are also observed which we infer to have occurred prior to 2006, based on Google Earth imagery. These changes appear to be associated with earthworks stabilisation of SH1 and may also comprise installation of subsoil drainage and relief wells.

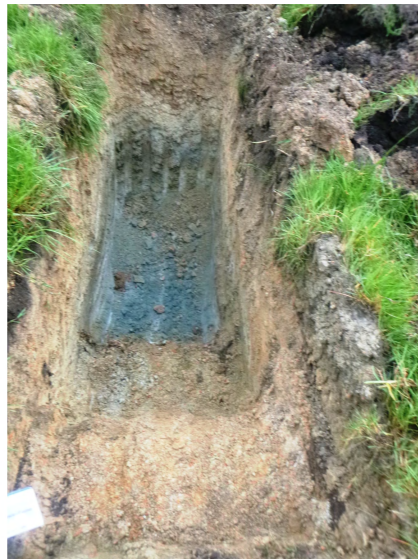
COMMENTS: Slumped slopes. Rushes and surface water. Large macrocarpa stumps.

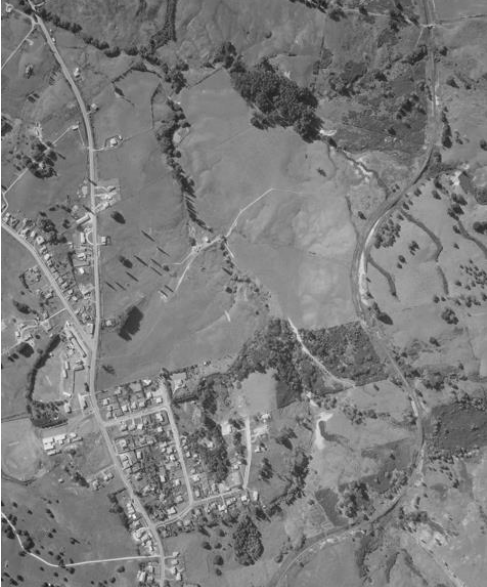
<p>Land appears predominantly pastoral. Several buildings evident along Monowai Street. Three dwellings evident on western boundary of Structure Plan Area.</p>	Retrolens
1966

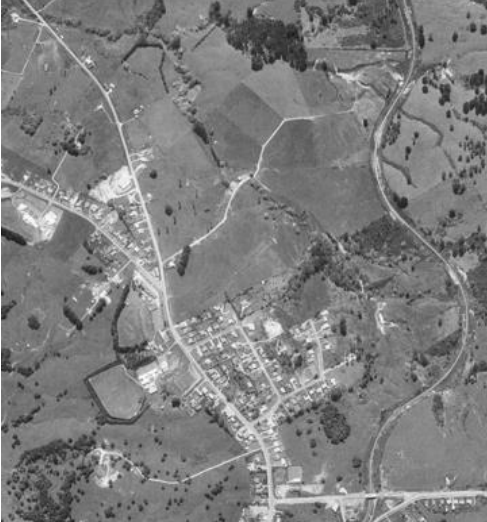
<p>Land remains predominantly pastoral. Farm track more prominent running centrally west to east across site. Several additional dwellings noted on Monowai Street. Matheson Road now traverses southern portion of area. Railway evident to east of development area.</p>	Retrolens

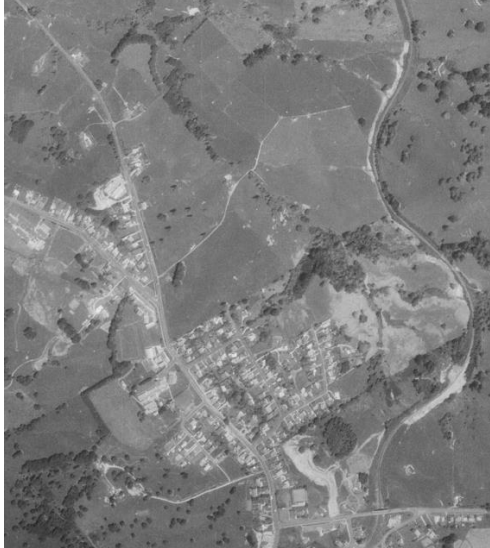
<p>Land remains predominantly pastoral. Image unclear, although potential soil disturbance on south-eastern and southern portion of site. Monowai Street now fully residential. Railway evident to east of site.</p>	Retrolens
1982

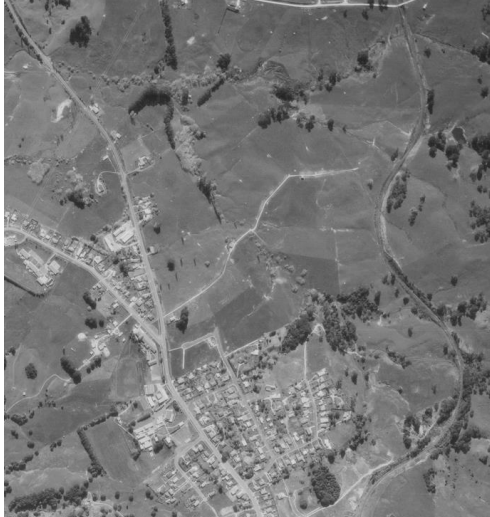
<p>Site remains relatively unchanged from the 1976 image. White patches that may indicate soil disturbance, no longer evident. Some residential development in Wi Apo place evident.</p>	Retrolens
1992

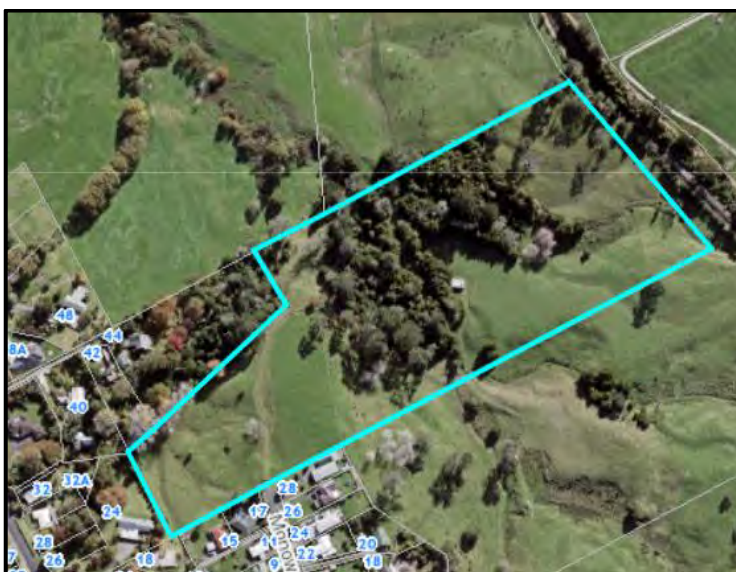
Figure 6: Aerial image of Pt Allot 4 DP 9919, Monowai Street, Wellsford

The site is partly covered in bush with a very small farm accessory building, located in the centre of the site. This is visible from 2006 in historical aerial photography, although Auckland Council holds no record of this building. It is considered given the age and scale of the structure, that it is very unlikely to pose any risk to human health. The eastern border of the site is adjacent to KiwiRail's existing North Auckland Line and as such uncertified fill and potential migration of contaminants from railway activities into soil on the eastern boundary may be a consideration. Fencing separates the paddocks. Nil of concern noted in site walkover. Cadmium screening recommended as site will become residential large lot zone.

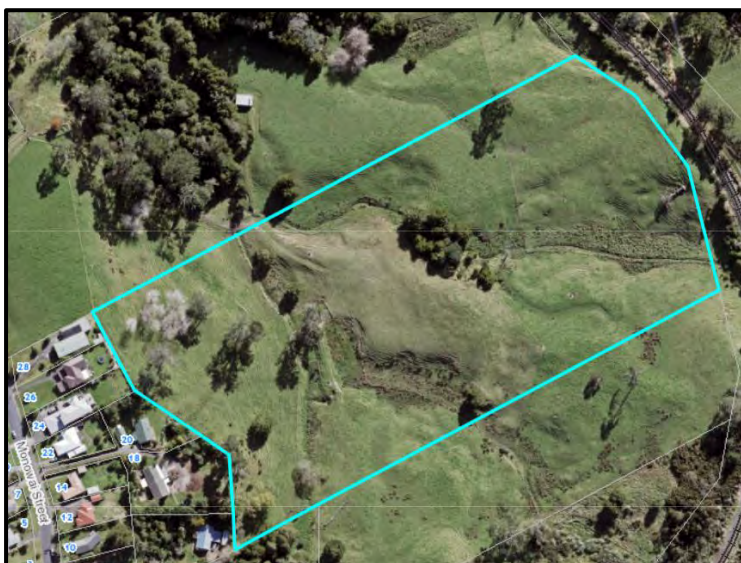
**Figure 7: Aerial Image of Pt Allot 2 DP 26722, Monowai Street, Wellsford**

The site is vacant pastoral land, with the North Auckland Railway Line adjoining the eastern boundary. The eastern border of the site is adjacent to KiwiRail’s existing North Auckland Line and as such uncertified fill and potential migration of contaminants from railway activities into soil on the eastern boundary may be a consideration. The site is fenced into paddocks with water troughs for stock. Nil of concern was noted during site walkover. Cadmium screening recommended as site will become residential large lot zone.

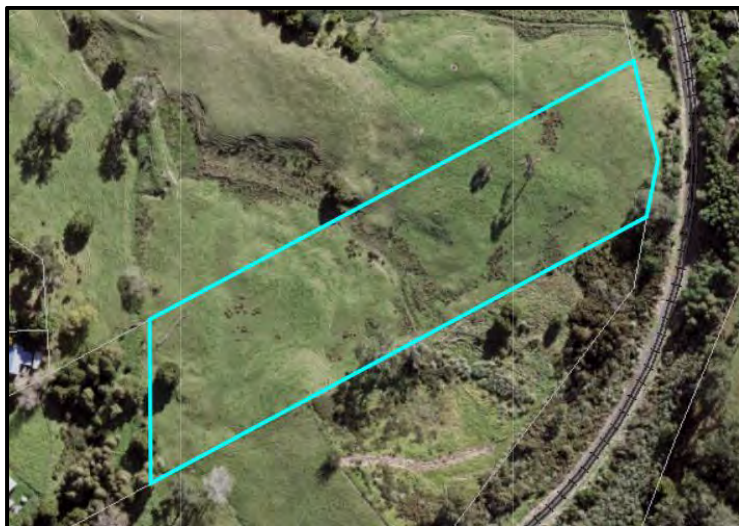
**Figure 8: Aerial image of Pt Sec 25 DP 9682, Monowai Street**

The site is vacant pastoral land, and the eastern boundary of the site adjoins the North Auckland Railway Line. The eastern border of the site is adjacent to KiwiRail’s existing North Auckland Line and as such uncertified fill and potential migration of contaminants from railway activities into soil on the eastern boundary may be a consideration. Nil of concern was noted during site walkover. Cadmium screening recommended as site will become residential large lot zone.
