**PRIVATE PLAN CHANGE 92 WELLSFORD**

**WELLSFORD WELDING CLUB LIMITED**

## **APPENDIX 9 ECOLOGICAL IMPACT ASSESSMENT**

## **APPENDIX 10 ENGINEERING ASSESSMENT REPORT**

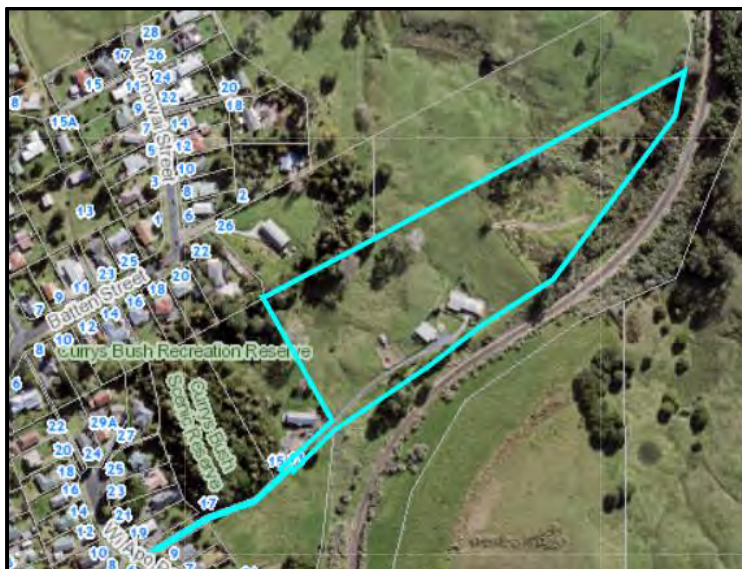
**Figure 9: Aerial image of 11 Wi Apo Place, Wellsford**  
*Image courtesy of Auckland Council GIS Maps*

Two dwellings are situated in the south-eastern corner of the property with vehicle access gained from Wi Apo Place. The western dwelling is of fibrolite construction and in good condition. The second dwelling is of hardiplank construction with an attached carport garage. Also in good condition. Along with 11 Wi Apo Place, this site forms the southern edge of the proposed Wellsford North Structure Plan area. The eastern border of the site is adjacent to KiwiRail’s existing North Auckland Line and as such uncertified fill and potential migration of contaminants from railway activities into soil on the eastern boundary may be a consideration. Inspection was undertaken from driveway only. Cadmium screening recommended as site will become residential large lot zone.

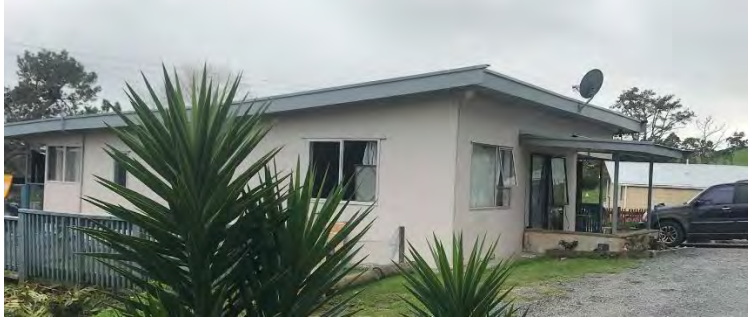
**Image 1: Western most dwelling of fibrolite construction 11 Wi Apo Place**

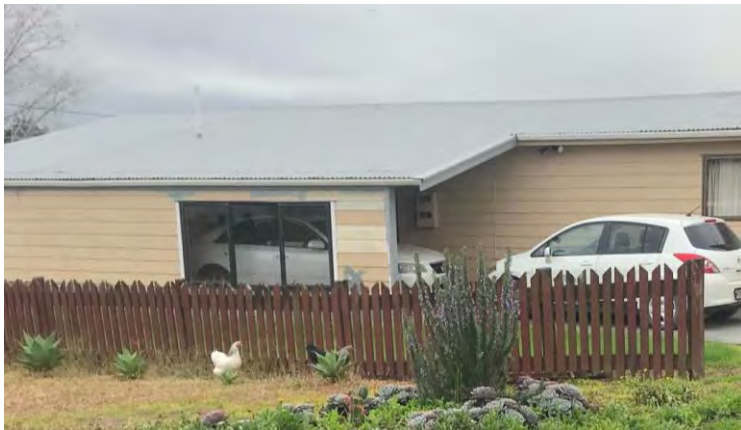
**Image 2: Second dwelling 11 Wi Apo Place visible to east of fibrolite dwelling, of hardiplank construction with iron roof.**

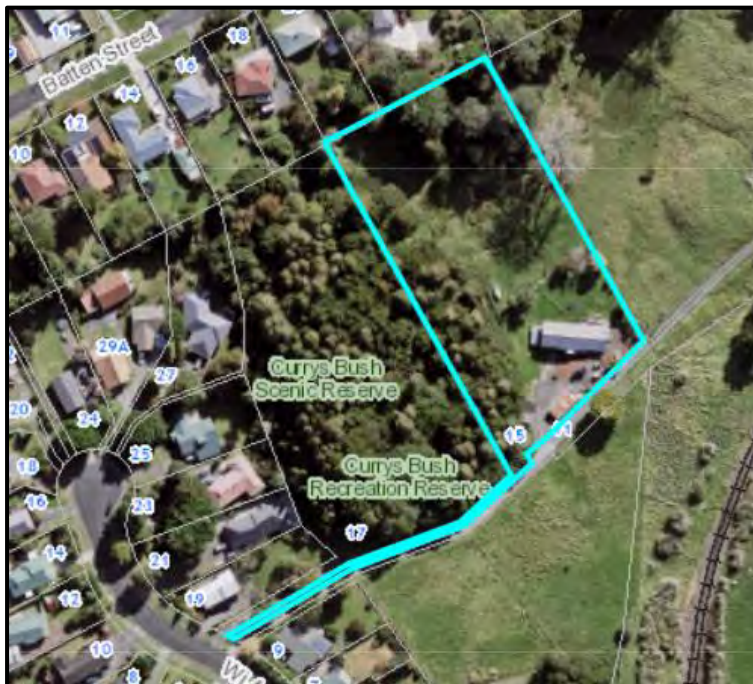
**Figure 10: Aerial image of 15 Wi Apo Place, Wellsford**

A hardiplank home with aluminium joinery which was constructed in 1984 is located centrally near the southern boundary of the site, with the remainder of the site being vacant and pastoral with mature vegetation. A small timber clad garden shed is situated on the southern boundary. Protected native bush is located on the western boundary. Nil of concern noted at time of site visit. Visual inspection was undertaken from the driveway only. Cadmium screening recommended as site will become residential large lot zone.

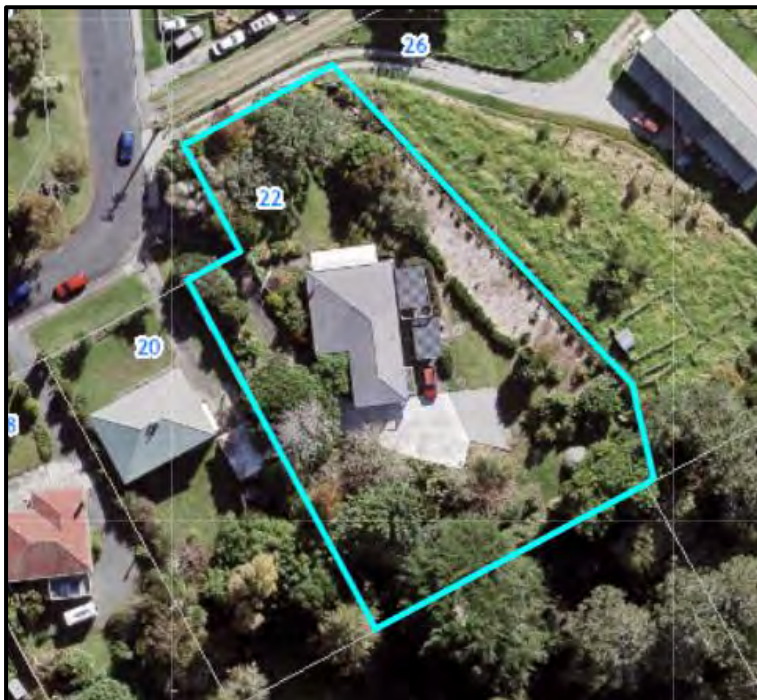
**Figure 11: Aerial image of 22 Batten Street, Wellsford**  
*Image courtesy of Auckland Council GIS Maps*

A dwelling is located centrally on the site and is surrounded by established trees and vegetation. The house is constructed of orange brick, with concrete surrounds. Nil of concern noted. Site sits within a residential neighbourhood with vehicle access gained from Batten Street, with the southern boundary of the site adjoining 15 Wi Apo Place.

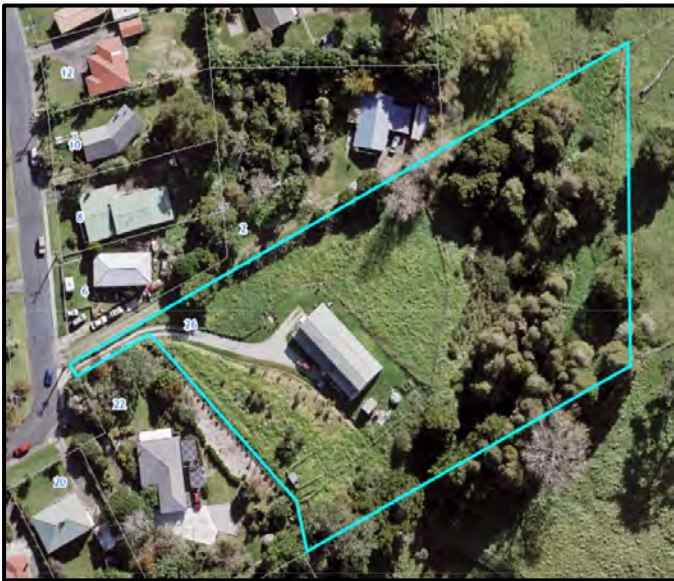
Figure 12: Aerial image of 26 Batten Street, Wellsford

A large site situated on the edge of the residential area with rural land on the eastern boundary. Coloursteel constructed barn constructed in 2005 and converted to a dwelling is located on the western portion of the site with the remainder of the site being grass and established trees and vegetation. Nil of concern noted. Visual inspection conducted from drive only.

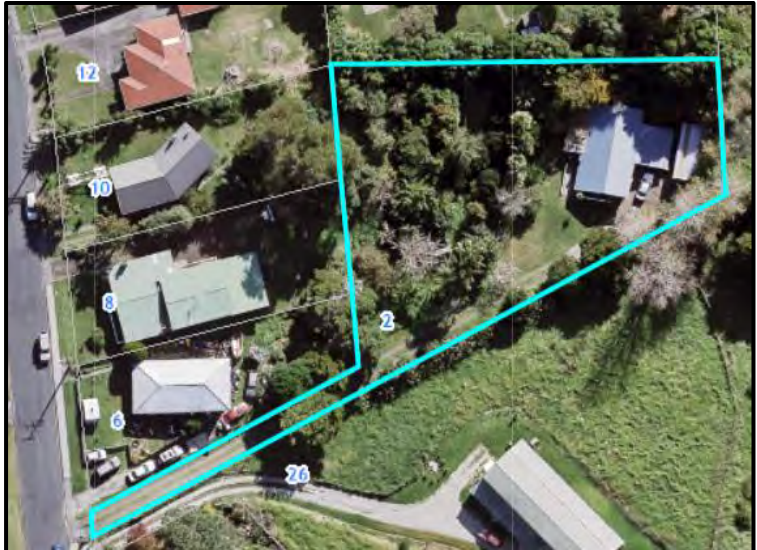
**Figure 13: Aerial image of 2 Monowai Street, Wellsford**  
*Image courtesy of Auckland Council GIS Maps*

A dwelling (constructed pre-1971) is located on the eastern portion of the site with the western portion containing established trees and vegetation. A garage was constructed in 2002. The site is situated down a right of way and is located on the edge of a residential area with rural land on the eastern boundary. Dwelling appears to be hardiplank construction with iron roof, no records are held on Council files for the dwelling, despite additional enquiry. A scheme plan held on file however, showing a proposed subdivision of the surrounding land, shows the house in-situ in 1971. Refer Appendix 5. Visual inspection was undertaken from road only.

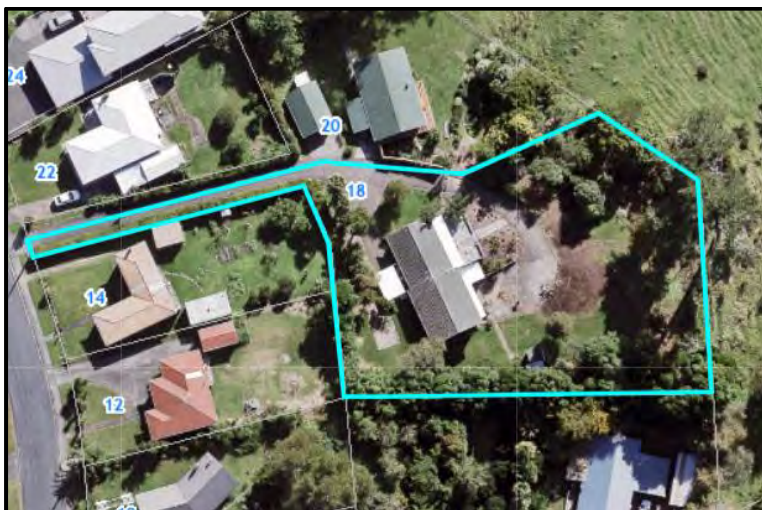
**Figure 14: Aerial image of 18 Monowai Street, Wellsford**  
Image courtesy of Auckland Council GIS Maps

The site contains a dwelling (constructed in 1972) located in the western portion of the site which is surrounded by established trees and vegetation. A garage was constructed in 2002. Access to the site is via a right of way gaining access from Monowai Street. All adjoining sites contain established residential development with the exception of the site adjoining the eastern boundary, which is rural. Home is hardiplank construction with a concrete basement. Visual inspection of site undertaken from driveway only.

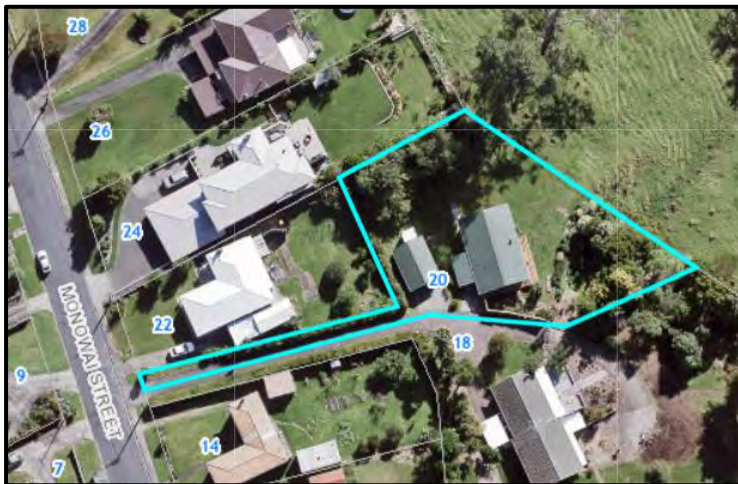
**Figure 15: Aerial image of 20 Monowai Street, Wellsford**  
*Image courtesy of Auckland Council GIS Maps*

The site contains a dwelling and a stand-alone garage constructed in 1993. Home is orange brick with concrete surrounds. Nil of concern noted. The site is situated down a right of way which gains access from Monowai Street. The land adjoining the eastern boundary is rural, with all other adjoining land containing established residential development.

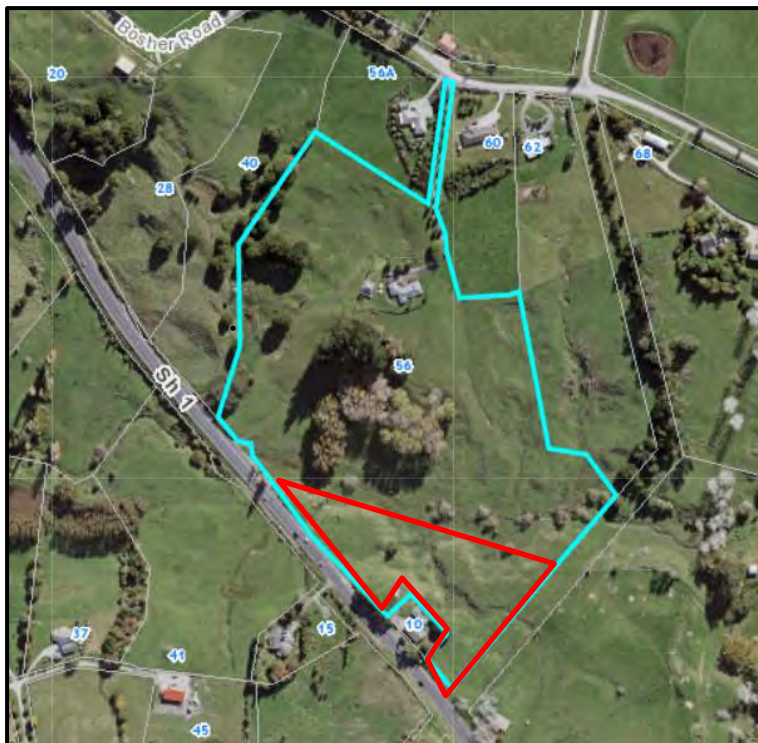
Figure 16: Aerial image of 56 Boshier Road, Wellsford

Only a small portion of this site is included in this report as indicated in red below. The portion of land is currently vacant pastoral land.

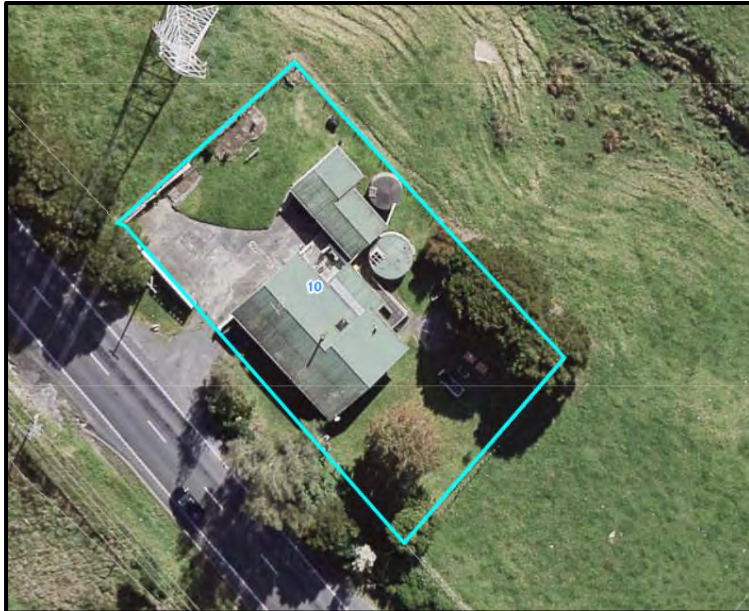
**Figure 17: Aerial image of 10 State Highway 1, Wellsford**  
*Image courtesy of Auckland Council GIS Maps*

Dwelling located on the main State Highway with a separate garage. The property is on tank water with 2 large tanks visible. The home is brick with fibrolite soffits and wooden joinery. Auckland Council do not hold any permits for the dwelling despite additional enquiry, however, the home is visible in 1976 imagery. No HAIL activities have been identified on this site as the home is brick, however, asbestos should be a consideration, should the buildings ever be removed.

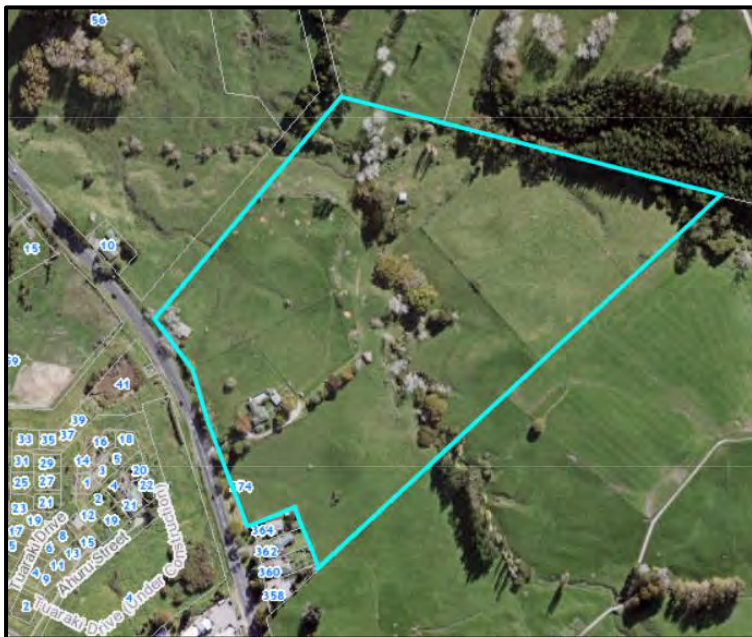
**Figure 18: Aerial image of 374 Rodney Street, Wellsford**  
*Image courtesy of Auckland Council GIS Maps*

There are two dwellings recorded on the property, constructed in 1957 and 1967. There is also a permit for additions to a dwelling in 1972 where brick veneer and concrete block walls were added. The description of works specifies that fibrolite asbestos shall be used on soffits in this building. A workshop for farm vehicle maintenance is located on the property. The remainder of the site is predominately pastoral and separated into paddocks with established trees. Access to view buildings could not be gained at the time of site visit but nil of concern noted on pastoral land. HAIL activities to be addressed at the time of further investigation.

Asbestos survey required if buildings are to be demolished or removed from the site. Leaded paint survey required if buildings are to be demolished or removed and site development is to occur. Site to be classified as Unverified HAIL I in relation to potential leaching of lead from leaded paint given the age of the buildings on site, and Unverified HAIL F4 applicable to this property in relation to the workshop, noting that this had a concrete pad.

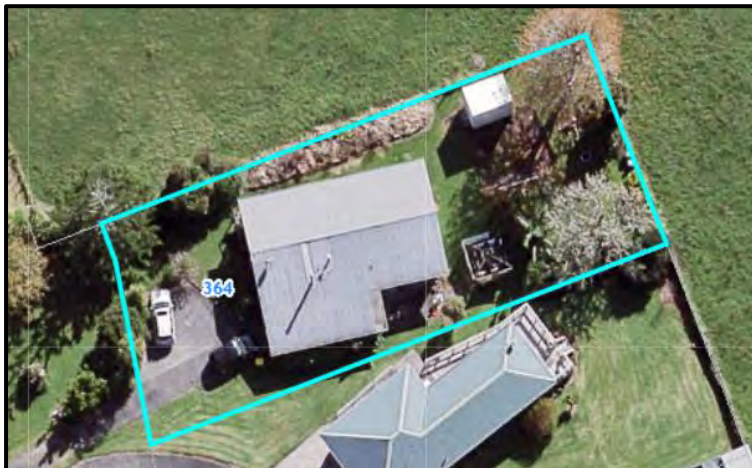
**Figure 19: Aerial image of 364 Rodney Street, Wellsford**  
*Image courtesy of Auckland Council GIS Maps*

Dwelling built in 1964, primary surrounded by pastoral land. Dwelling is white weatherboard in good condition. The home has a block and hardiplank carport attached and wooden joinery. Site is flat with established trees.

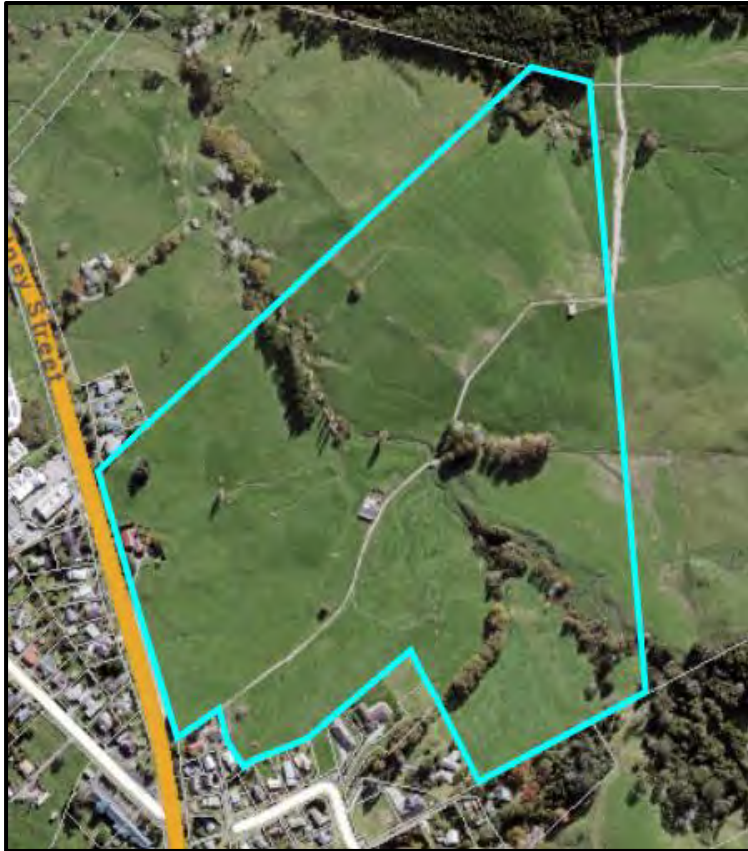
**Figure 23: Aerial image of 338 Rodney Street, Wellsford**  
*Image courtesy of Auckland Council GIS Maps*

The site is predominately pastoral with a dwelling located on the western boundary. A farm race runs through the entire site from west to east with a farm building (small milking shed) or timber, iron and concrete construction with concrete floor, located in the centre of the site and a second smaller accessory building on the eastern boundary, half round corrugated hay barn. The site is surrounded by farmland to the north and east and residential housing to the west and south.

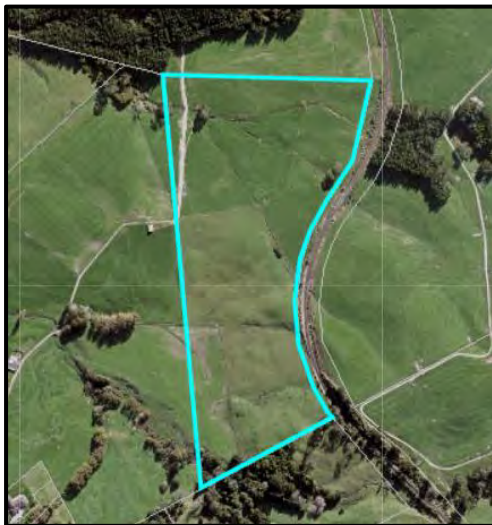
**Figure 24: Aerial image of Pt Allot 117 SO 22925 State Highway 1, Wellsford**  
*Image courtesy of Auckland Council GIS Maps*

Vacant pastoral land. The site has a railway line on the eastern boundary.

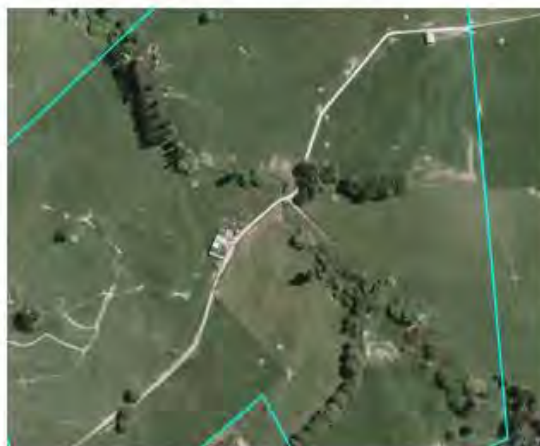
There is no contamination information within Council records for 338 Rodney Street however aerial images indicate soil disturbance onsite (see below aerial image)

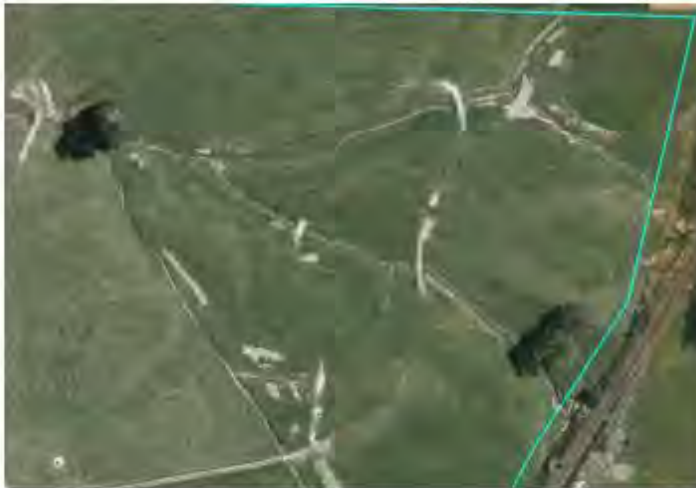
There is no contamination information within Council records for Pt Allot 117 SO 22925, State Highway 1 however aerial images indicate soil disturbance onsite (see below aerial image) Due to the adjacent railway, there is potential for uncertified/non-engineered fill to be present on site.

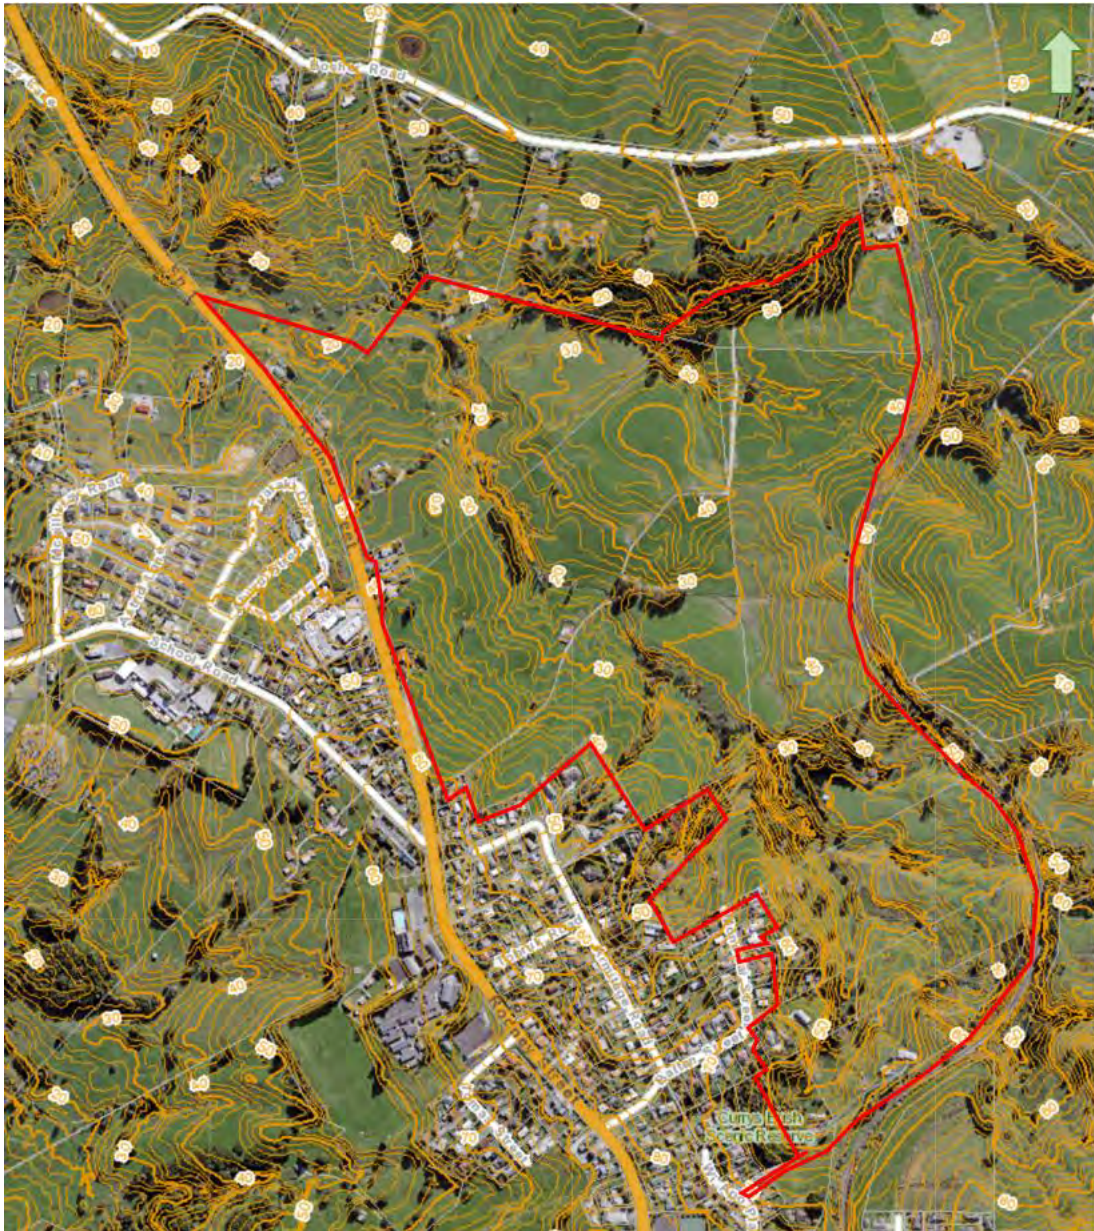
**Figure 19. Aerial photograph with contours showing the Plan Change Area outlined in red (source: Auckland Council Geomaps)**

The Plan Change Area is characterised by an undulating landscape with rolling hills sloping down to a stream gully that runs through the central section with several branches in the south. The land is mostly grass covered with trees visible along the stream and its branches. These features can be seen in the aerial photographs shown in Figure 19 and Figure 20.

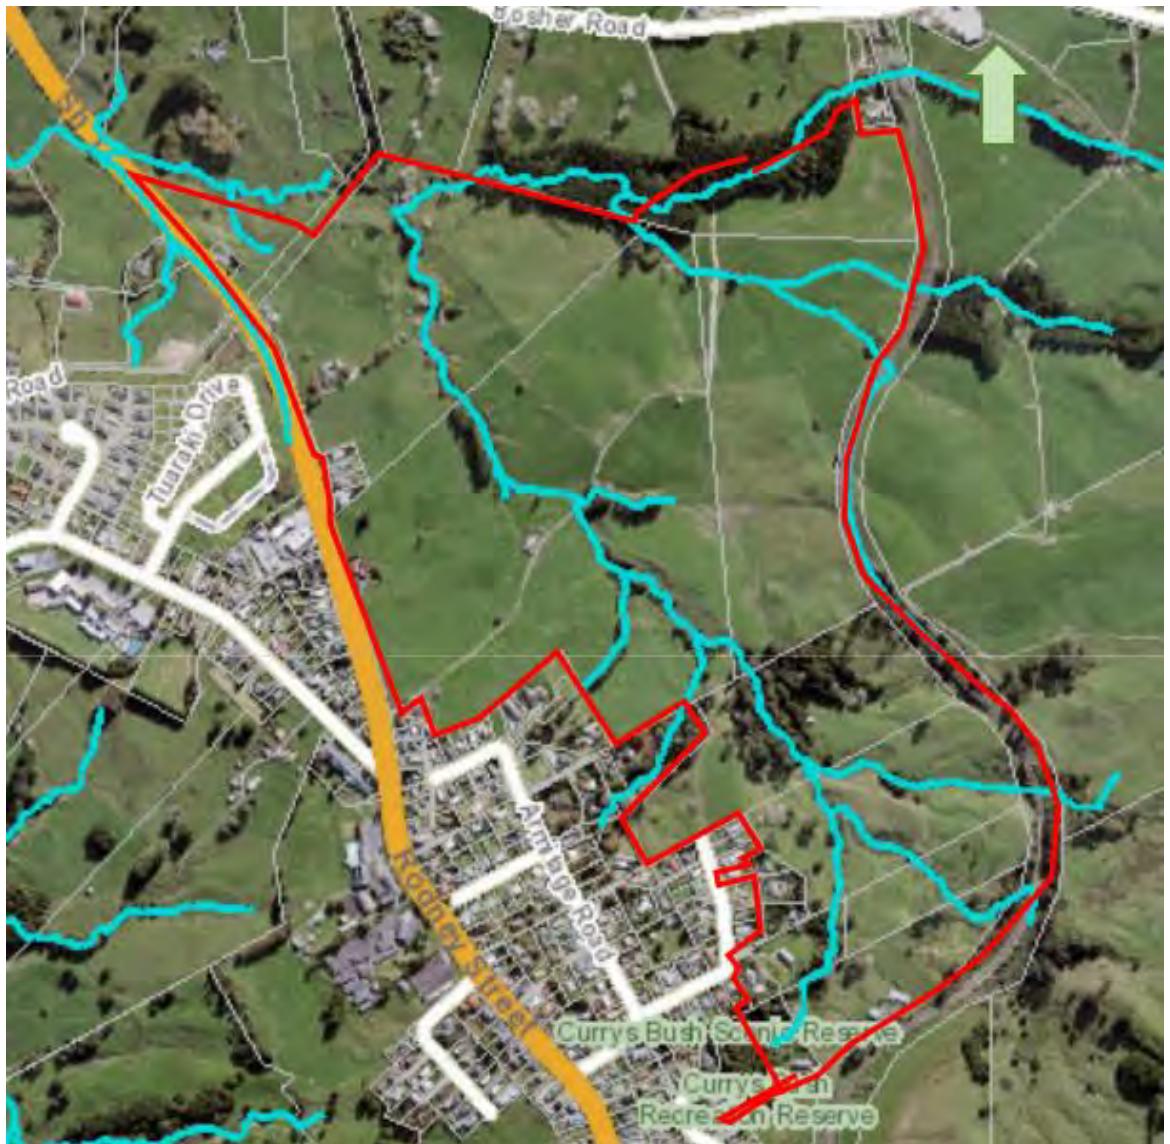
Figure 20. Aerial plan showing the streams running through the Plan Change Area, which is outlined in red (source: Auckland Council Geomaps)

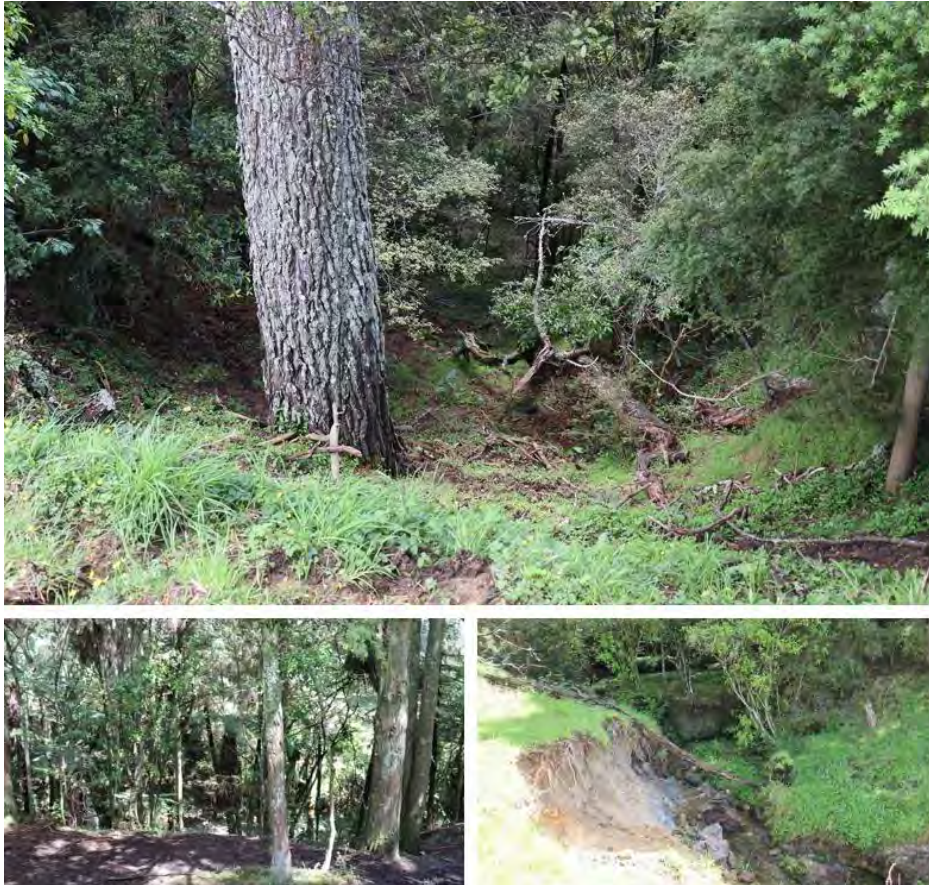
**Figure 29. Top: standing on west side of central stream on central-south side of property, facing down slope towards stream. Bottom left: standing on east side of central stream on central-south side of property, facing down slope towards stream. Bottom right: significant erosion and large rocks in central stream on central-south side of property, facing north**

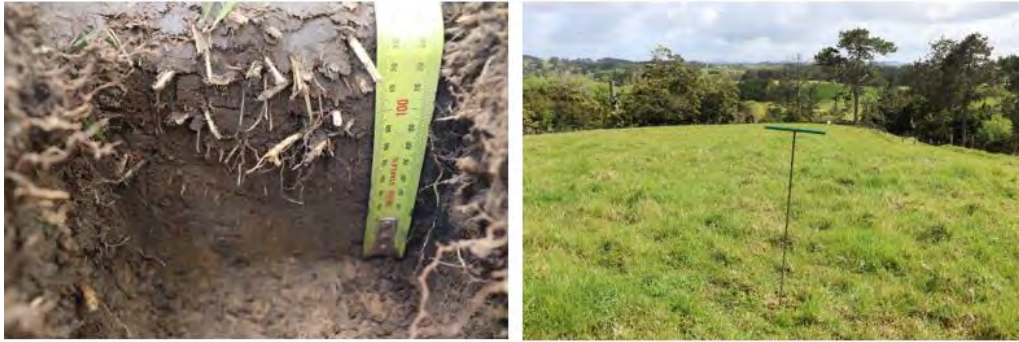
Figure 32. Left: stratigraphy of Profile 1. Right: location of Profile 1 facing north

Profile 1 (Figure 32) was obtained from a test pit placed on the south/southwest side of the property at the top of a hill above the central stream. This pit was 15cm deep and the stratigraphy was as follows:

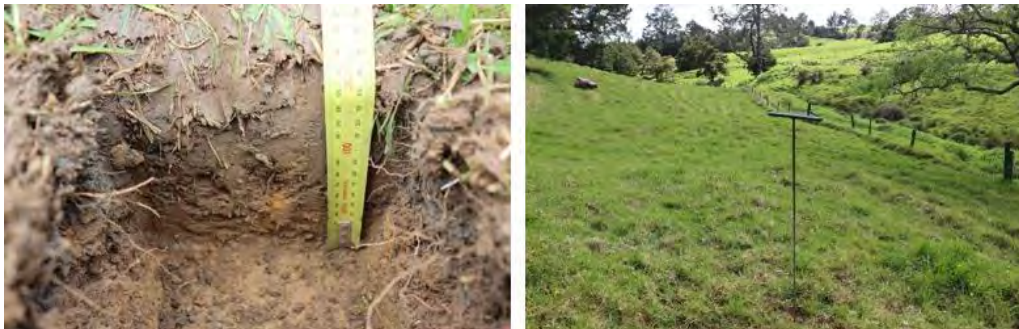
Figure 33. Left: stratigraphy of Profile 2. Right: location of Profile 2, facing north

Profile 2 (Figure 33) was obtained from a test pit on placed on the south side of the property adjacent to a stream-branch of the central stream. This pit was 17cm deep and the stratigraphy was as follows:

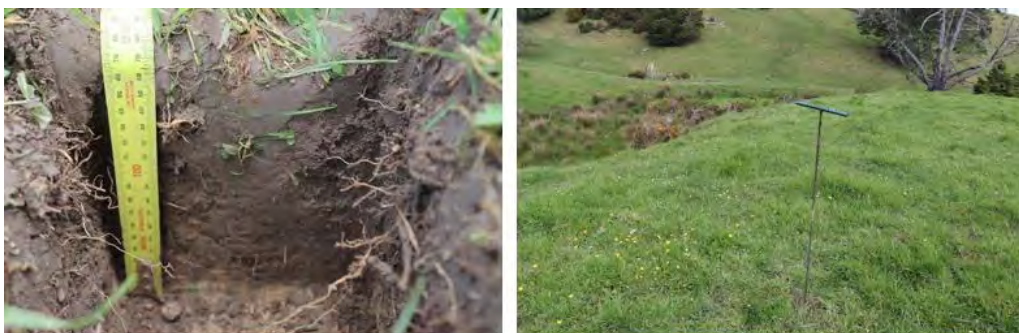
Figure 35. Left: stratigraphy of Profile 4. Right: location of Profile 4 facing southwest

Profile 4 (Figure 35) was obtained from a test pit placed on the south side of the property on top of a hill adjacent to a branch of the central stream. This pit was 20cm deep and the stratigraphy was as follows:

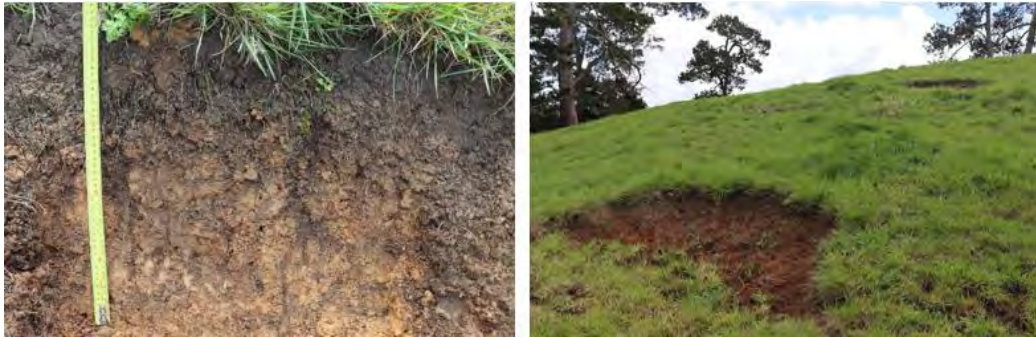
**Figure 36. Left: stratigraphy of Profile 5. Right: Profile 5, facing north. Note another patch of erosion further up the hill**

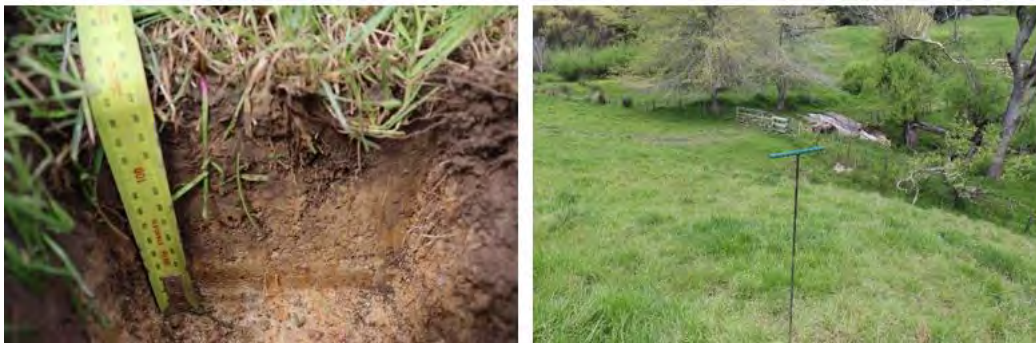
**Figure 37. Left: stratigraphy of Profile 6. Right: location of Profile 6, facing south**

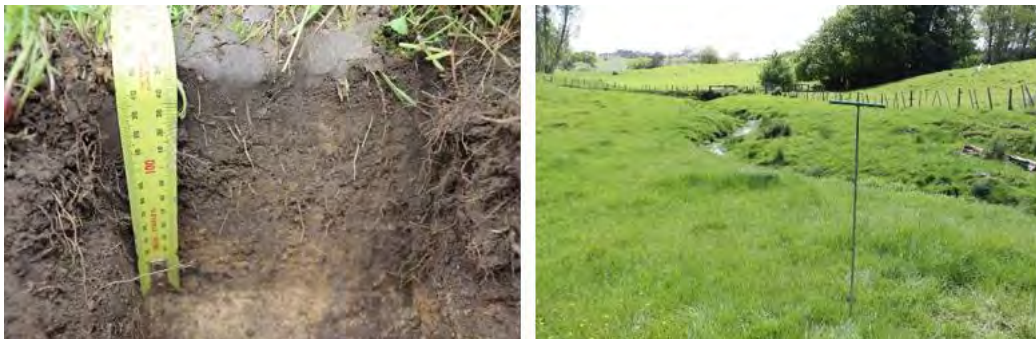
**Figure 38. Left: stratigraphy of Profile 7. Right: location of Profile 7, facing north**

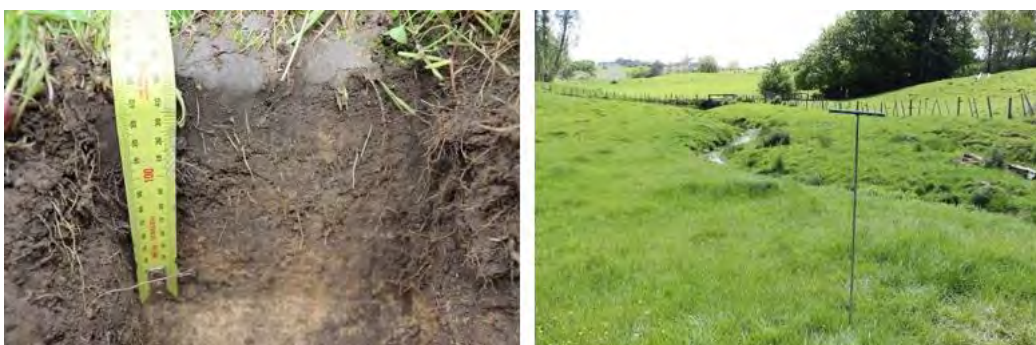
**Figure 39. Left: stratigraphy of Profile 8. Right: location of Profile 8, facing northwest**

Both the ground surface and subsurface of the majority of the property appears to be relatively undisturbed. However, the stratigraphy from almost every profile showed evidence of significant stock trampling where clay had mixed with topsoil. Only two areas where a profile was obtained did not appear to display this stock trampling disturbance. These were Profile 4 from the south side of the property on top of a hill adjacent to one of the branches of the central stream, and Profile 8 from the northeast side of the property adjacent to the northeast stream.

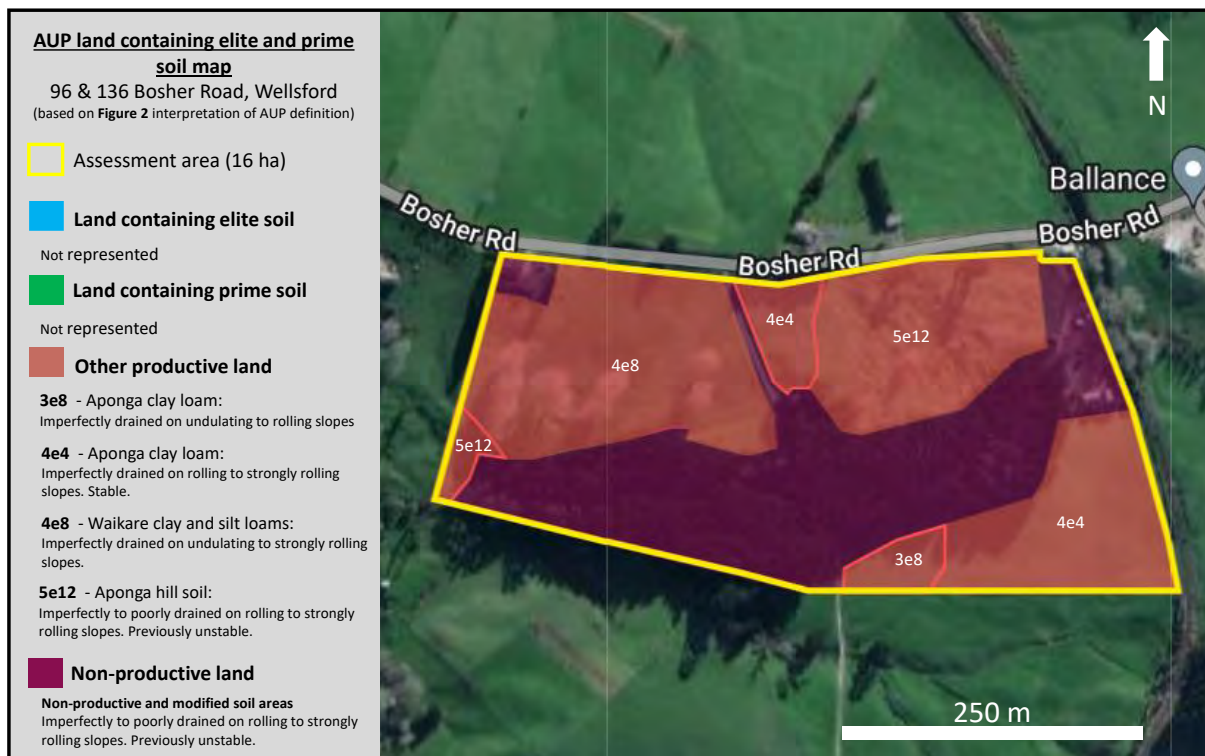
**Figure 4.** Distribution of soils and LUC units for the assessment area, 96 & 136 Boshier Road. (based on Figure 2 interpretation of AUP definition).

**Figure 4** and **Figure 5** show the distribution of soils, LUC units, and land containing elite and prime soil for the site.

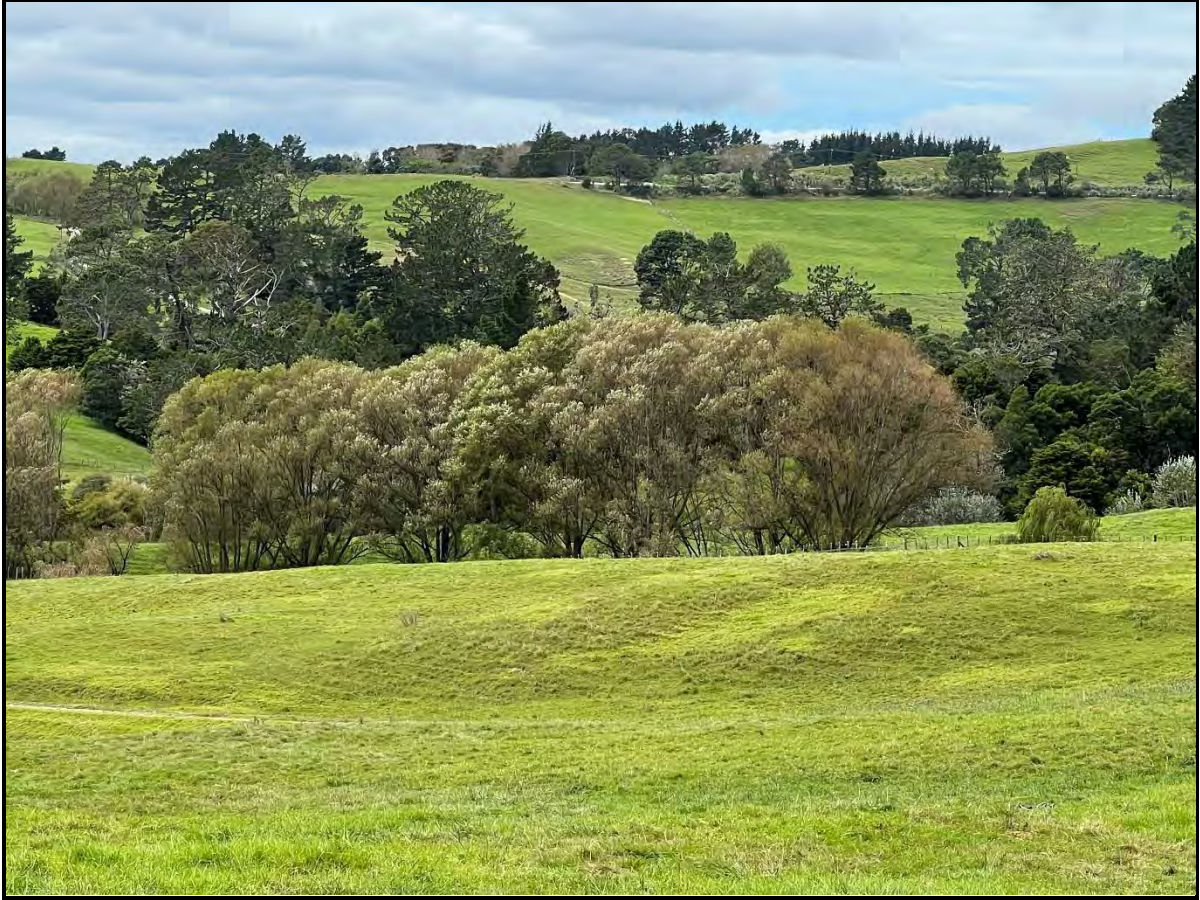
*Figure 7: Looking east, through the valley south of the maize fields.*
