••	то	Tanvir Bhamji	FROM	Oliver Hunt, Mark Bellingham and Alan Pattle				
		Watercare Services Ltd	DATE	17 May 2024				
	RE	Assessment of Potential Effects on Overland Flow System (Memorand	ent of Potential Effects on Soils and Ecology from Beachlands WWTP d Flow System (Memorandum 4)

WATERCARE BEACHLANDS MARAETAI WWTP

:	ТО	Tanvir Bhamji	FROM	Khun Chueaphoodee
		Watercare Services Ltd	DATE	17 May 2024
	RE	Beachlands Maraetai WWTP Option Report	ns Assessmen	t: Soil Sampling LA site – Factual

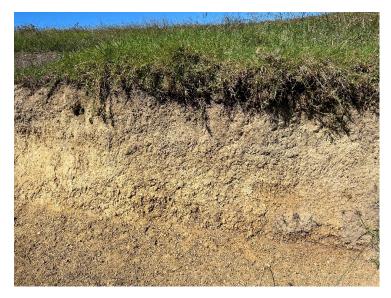
Figure 1: Soil Profile observed within the proposed overland flow expansion area

The soils at the site are described in PDP (2024) as consisting of 200 – 300mm deep silty topsoil overlying a silty clay subsoil. This report is attached to this memorandum for convenience. The soils are predominantly mottled or gley indicating poor drainage characteristics as evidenced by the slow field infiltration test results in the region of 2.4mm/hr for the topsoil and 0.6mm/hr for the subsoil. The typical soil profile is shown in Figure 1. Further profile photos are included in the attachments to the soils reports including adjacent to the existing area and at the proposed expansion area.

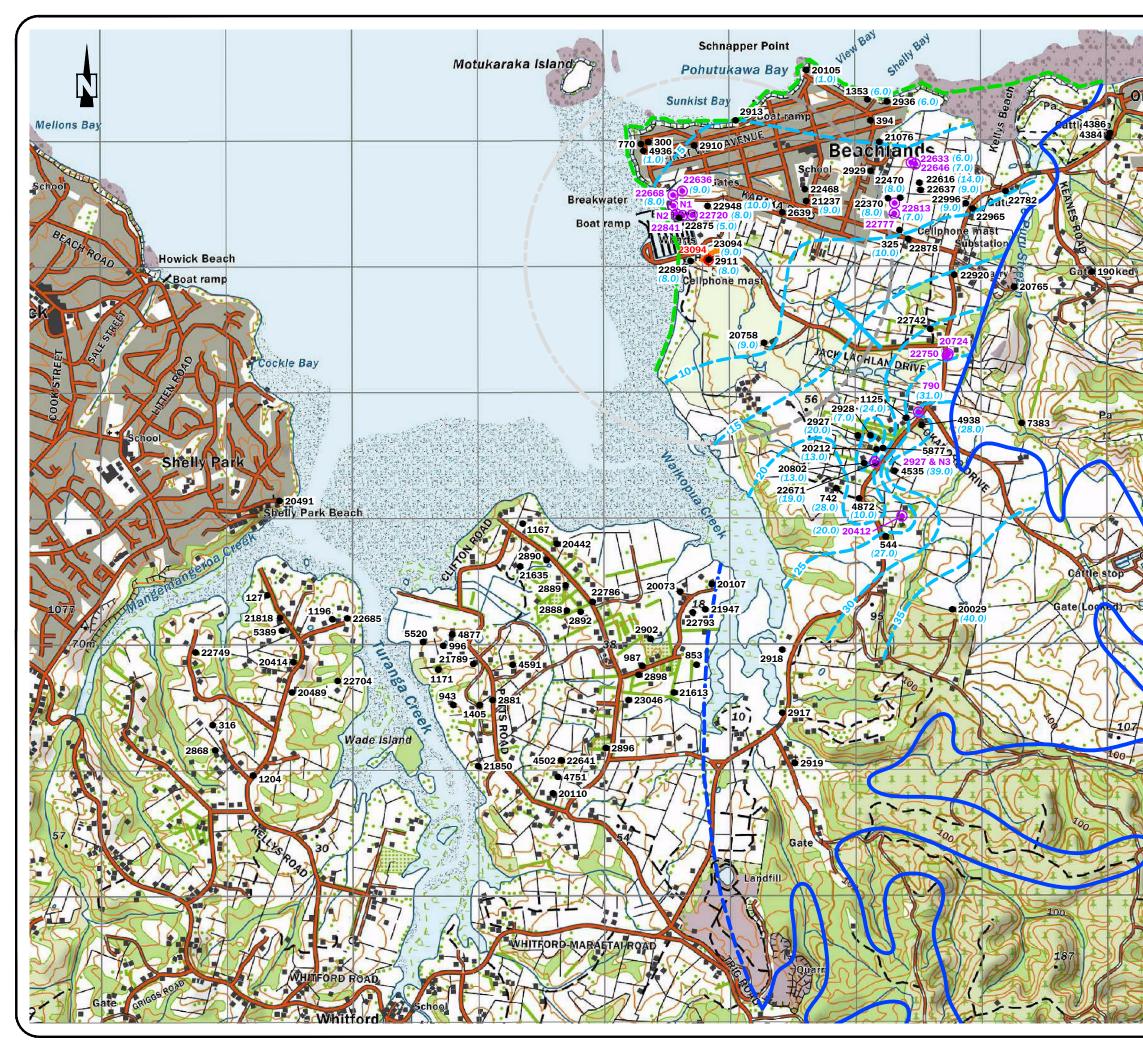
00	KEY:					
EA	<b>23094</b>		oduction			
35 /		Potential Extent of Confined Aquifer within the Beachlands Waitemata Block				
		Base of Waitemata Contours (m RL)				
the second second	٠	ata Datap	oints			
	for Contours					
Mha						
oviid.	Source: 1. Base plan derived f	rom IGNS	Map 3 (A	uckland) 1:	250,000,	
Point	<ol> <li>2001.</li> <li>Base of Waitemata received from ARC</li> </ol>					
		011 18 @ 2	21/11/200	9 (see App	enaix E).	
	B Issued for Con			Jan 10		
2	A Issued for Rev No. Revision	iew		Sep 09 Date	App.	
C A	No. Nevision		By	Checked	Date	
	Designed		P.N.		Mar 09	
	Drawn		D.R.		Mar 09	
	Approved for issue: Approved for constr	uction:				
	This drawing is not for					
	This drawing is not for COPYRIGHT ON					
N						
Q1a	COPYRIGHT ON	I THIS D	RAWING	IS RESER'		
Q1a	COPYRIGHT ON	I THIS D	RAWING	IS RESER'		
Q1a	Client : Pine Har	I THIS D	RAWING	IS RESER'		
Q1a	Client : Pine Har Project :	bou	r Ma	rina I	Ltd

The groundwater level in the ECBF is inferred to be at RL40m about 1.3km to the west of the overland flow site (Figure 2). However, the reliability of this measurement is low as it is based on an assumed wellhead level for the bore and is likely to underestimate the depth to groundwater. Based on the general groundwater level trend shown in the Figure 2, the groundwater level beneath the site is expected to be no higher than 10 m to 15 m below ground under the high plateau area of the overland flow site and at stream level along the tributaries. Groundwater beneath the site is expected to move along flow paths that discharge to the tributary of Te Puru Stream within the immediate downstream reaches.

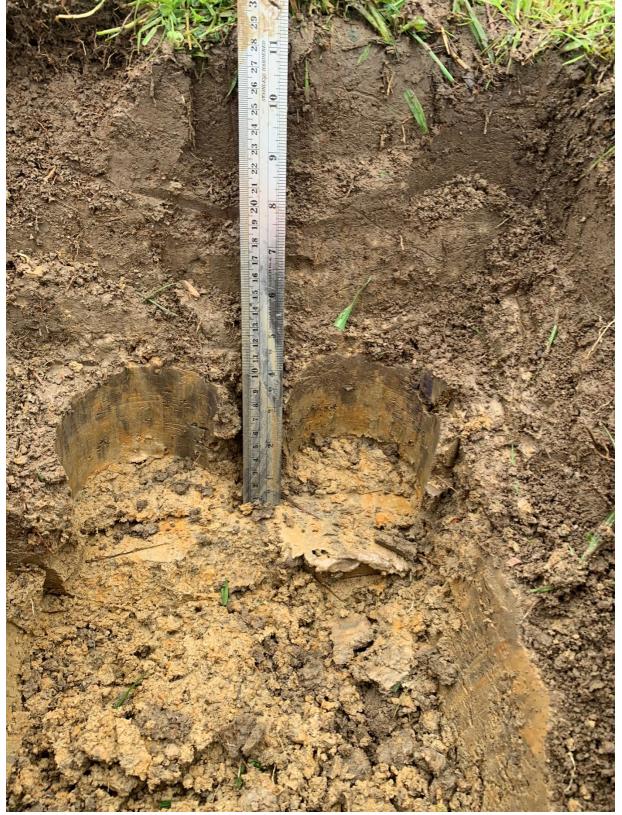
## Soil Profile at Sampling Point GP1

A soil profile photograph was taken of the excavated pit formed by the soil infiltration core removal process at each location. The soil profile photographs are shown in Appendix B. Generally, the soil profiles across all sampling locations can be described as having compact silty topsoil and clayey sub soil. Soil profile at sampling point GP1 was observed to be relatively more compact and wet with texture similar to that of gley compared to other sampling locations.

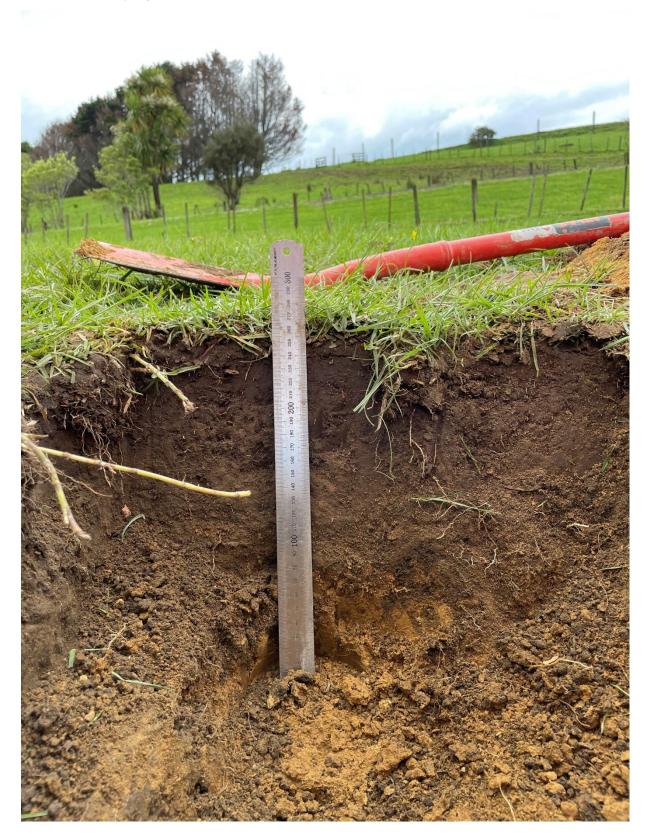
## Soil Profile at Sampling Point GP2

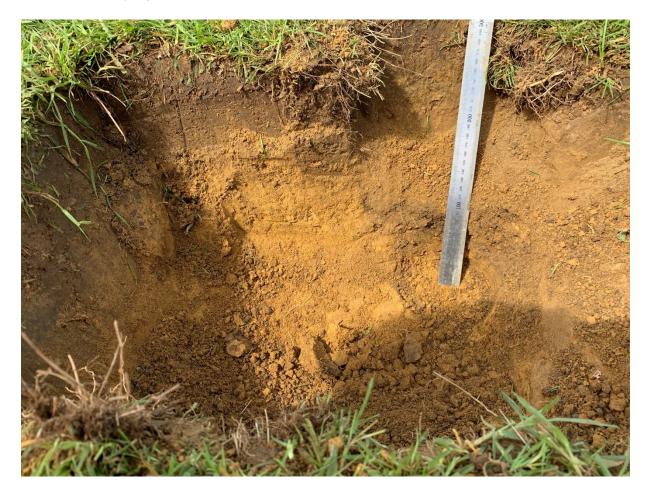
## Soil Profile at Sampling Point GP3

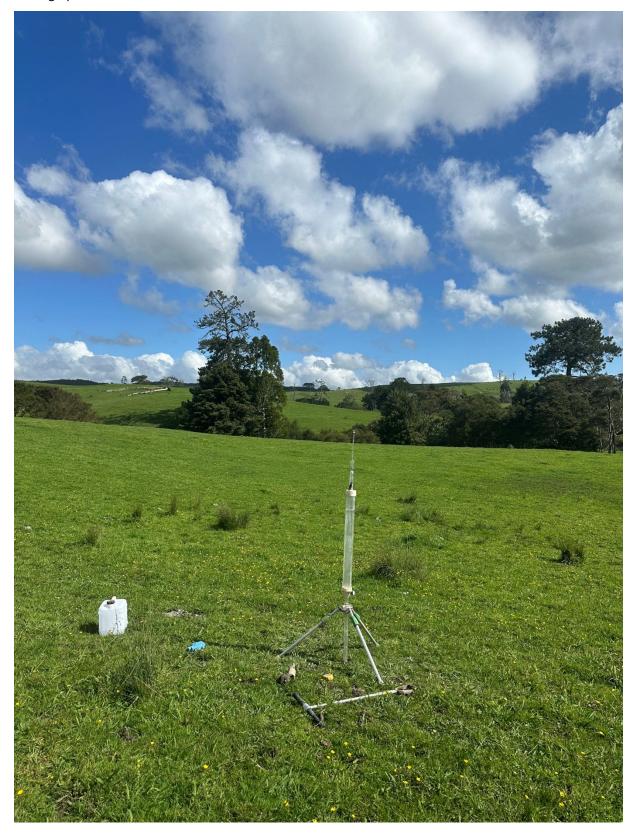
#### Close-up Photograph of the Pasture on Site

Pasture was approximately 5 – 10 cm, comprised of typical dense pasture across the investigated site at all sampling locations. No ponding or signs of water were observed at the site. However, it was noted that the soil was relatively wet due to rainfall on preceding days. Topsoils at all sampling points were typical brown, allophanic soil with little variation both visually and in texture. Topsoil was generally denser and wet with a layer of dryer and crumblier subsoil. Large rocks and stones were observed throughout the site.
