26 March 2024

BEACHLANDS MARAETAI WWTP RESOURCE CONSENT RENEWAL: STREAM HYDRAULIC ASSESSMENT

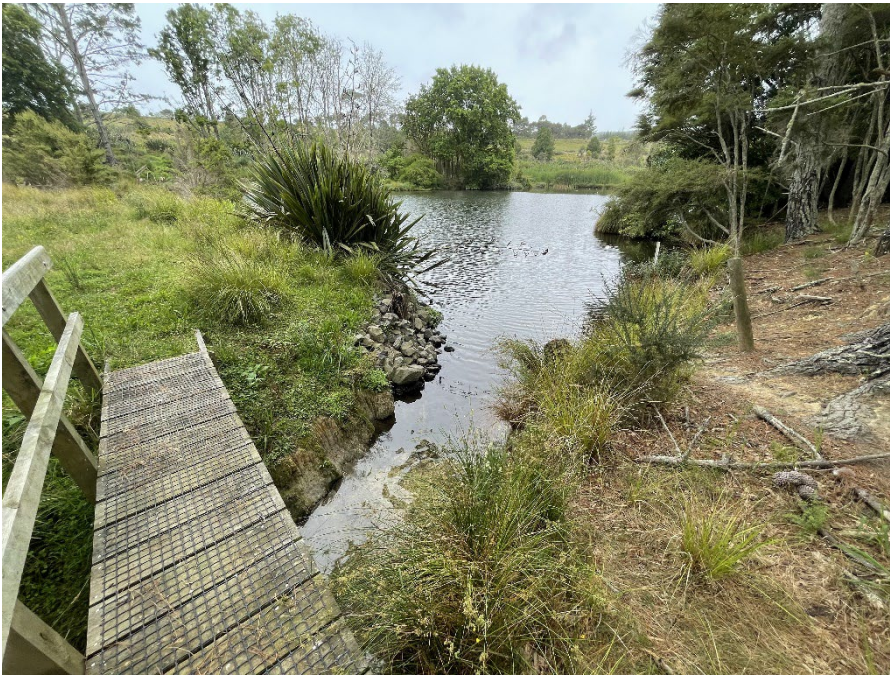
Treated effluent discharge occurs into the current overland flow system that comprises a vegetated strip around the northern extent of the pond and the on-line pond itself (Figure 1). The edge of this pond and a section of the stream reach shown in Figure 2 have been surveyed as included in Appendix B.

Figure 2: WWTP Discharge Pond Outlet Channel (18/01/2024)

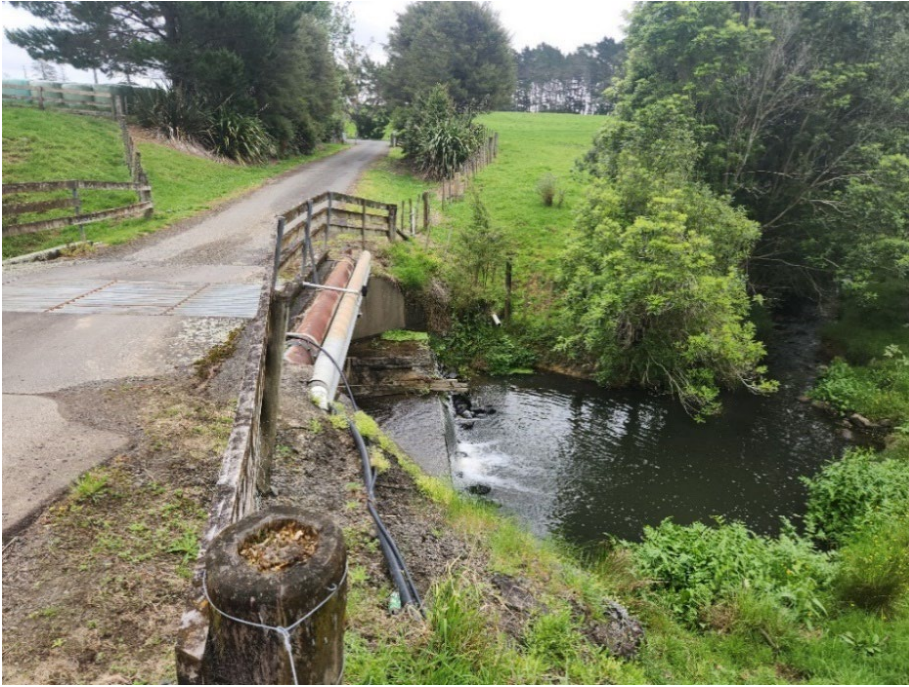
A water level sensor was installed on the downstream side of the bridge culvert, as shown in Figure 3, and on the site plan in Appendix A. This sensor has recorded the level of the stream for the last 3 months (the level sensor was installed on 27th October 2023 and remains in place). The levels have been used to estimate flows within the stream to support its characterisation (i.e., the production of flow duration curves).

Figure 3: Downstream Extent of Bridge (18/01/2024)

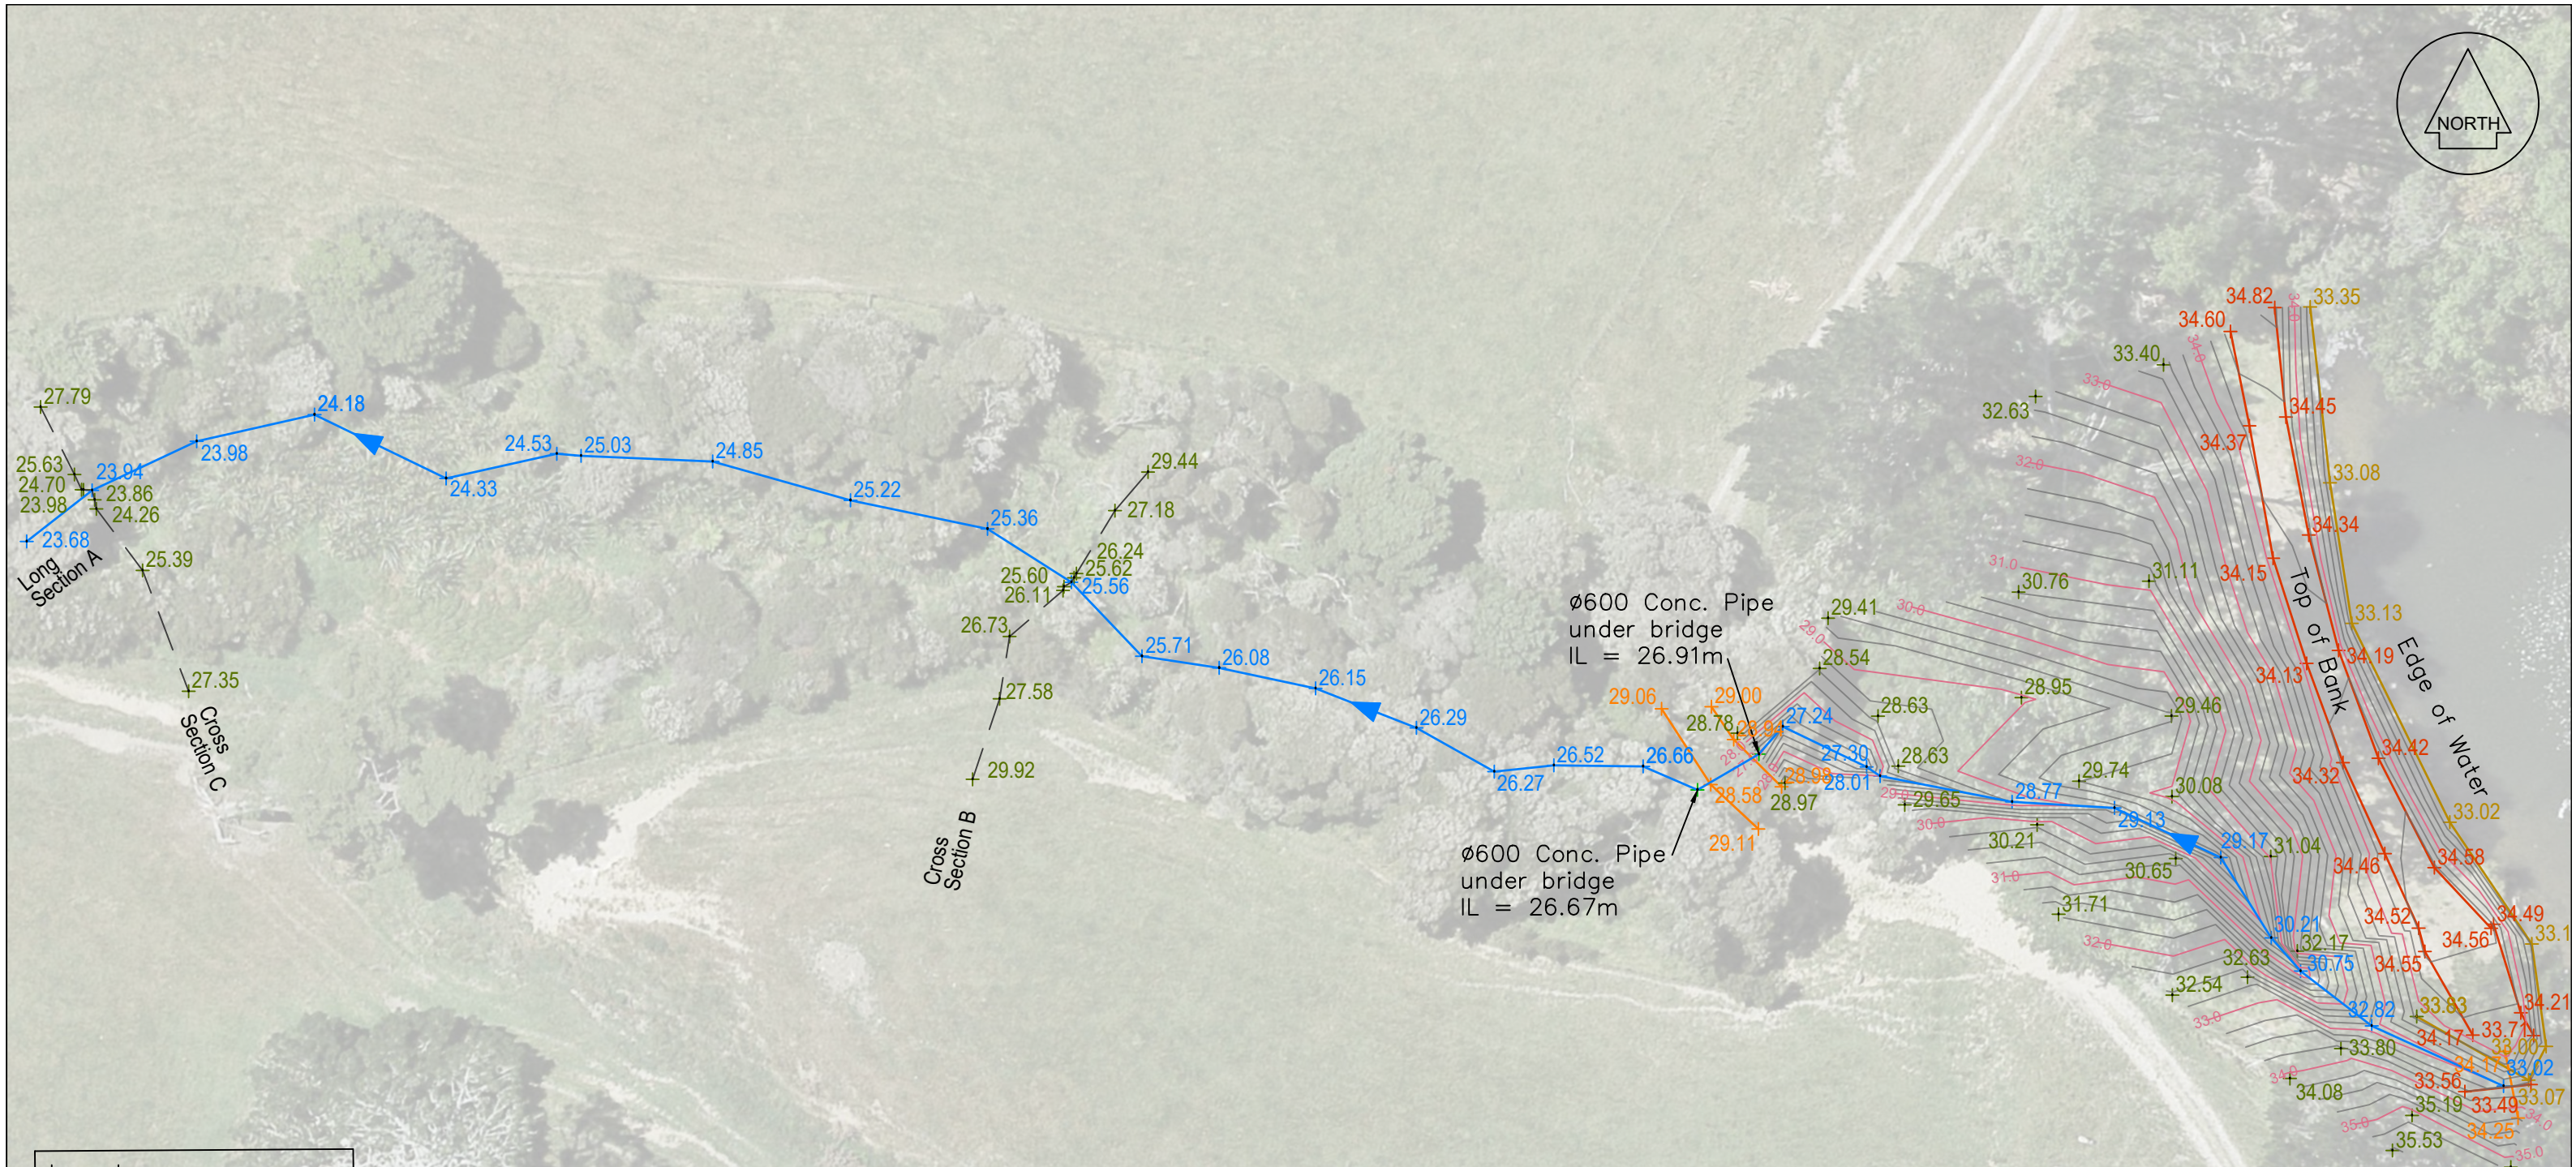
An existing DN 600 culvert is positioned downstream of the pond as shown on in Appendix B and Figures F and G. Based on the flows estimated from HEC-HMS modelling, this culvert appears to be insufficiently sized for the current and future 10-year average recurrence interval (ARI) stream flows. During a site visit on the 23rd October 2023 this pipe was observed to be over half full at the inlet and outlet at typical stream flows. This indicates that the culvert would be a constriction during storm events, however no evidence of overtopping was observed. The culvert also does not have an adequate upstream headwall or downstream wingwall to protect against erosion. WSL may need to investigate the capacity of this culvert further to prevent localised erosion from the additional wastewater flows.

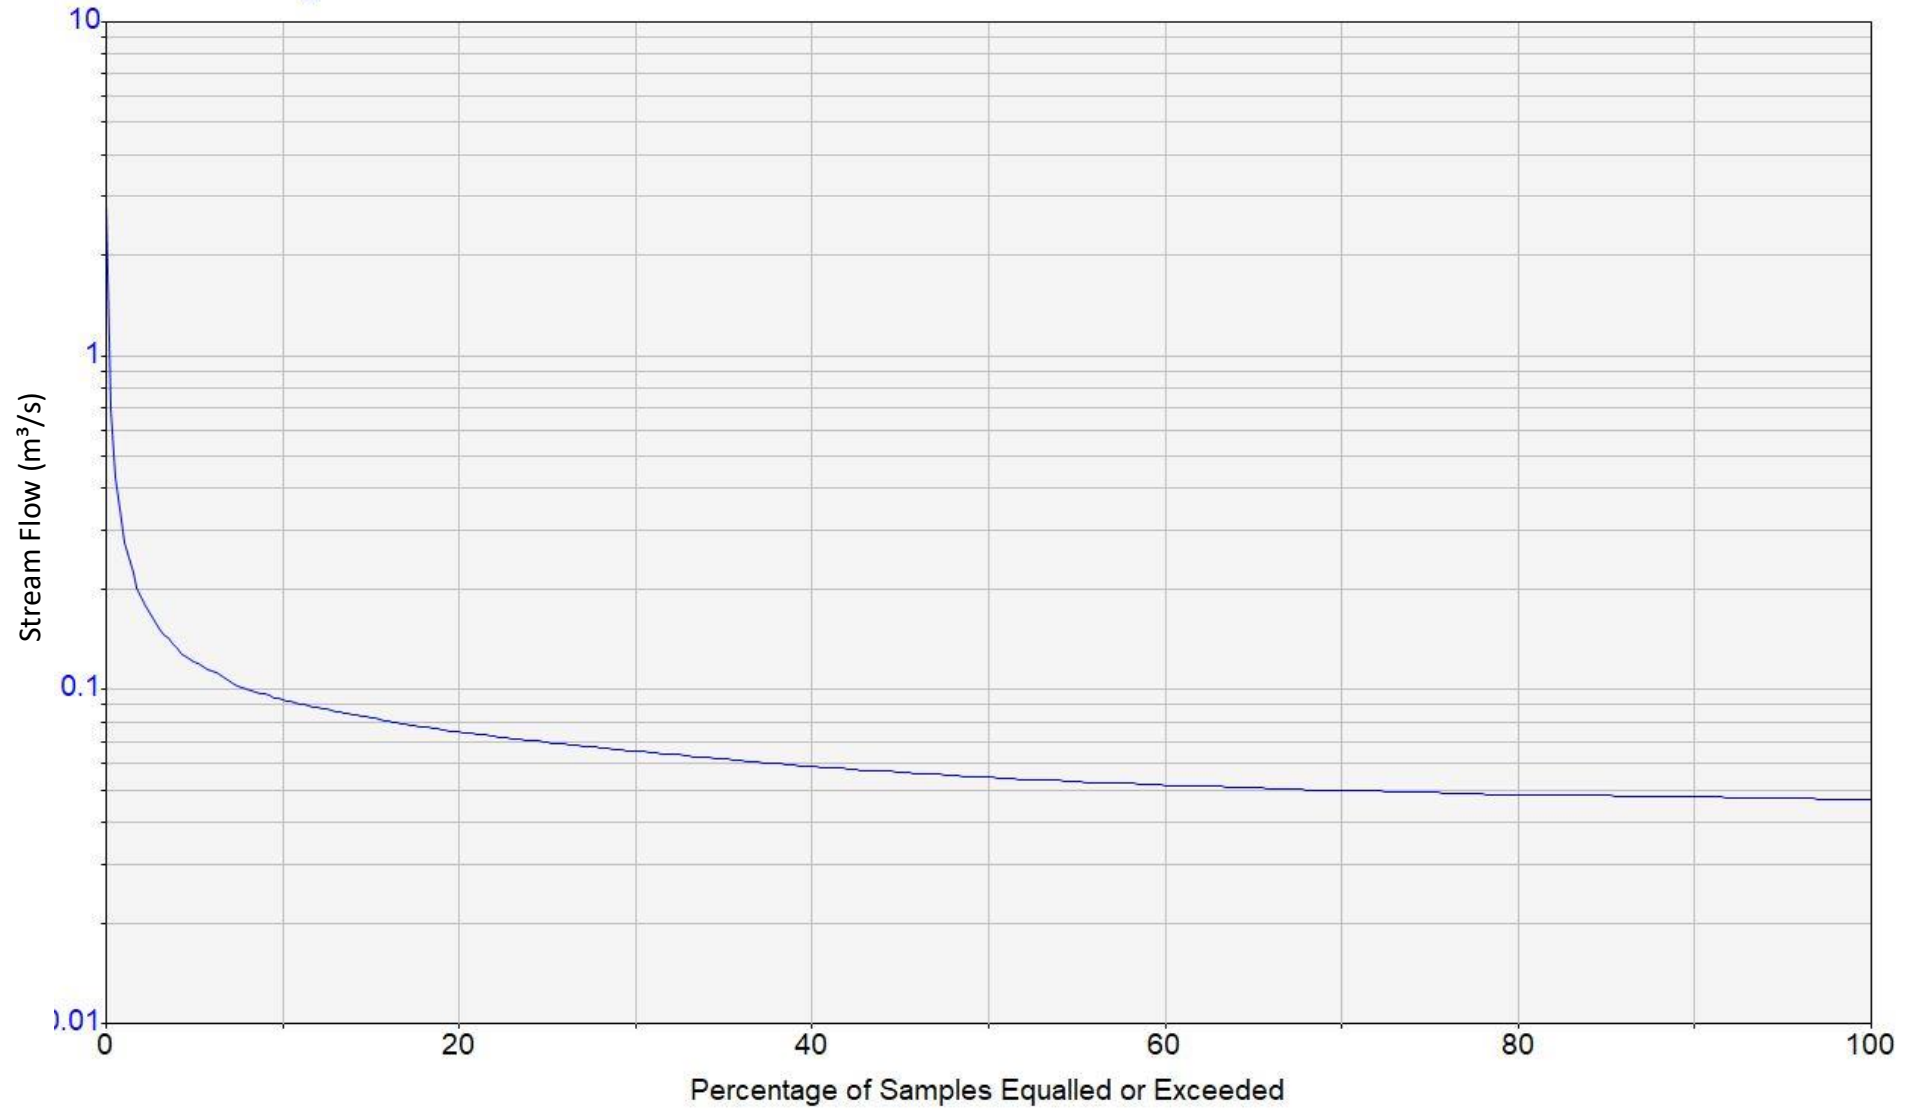
FIGURE 5: QUARRY SITE FLOW DISTRIBUTION CURVE – WITHOUT NATURALISATION

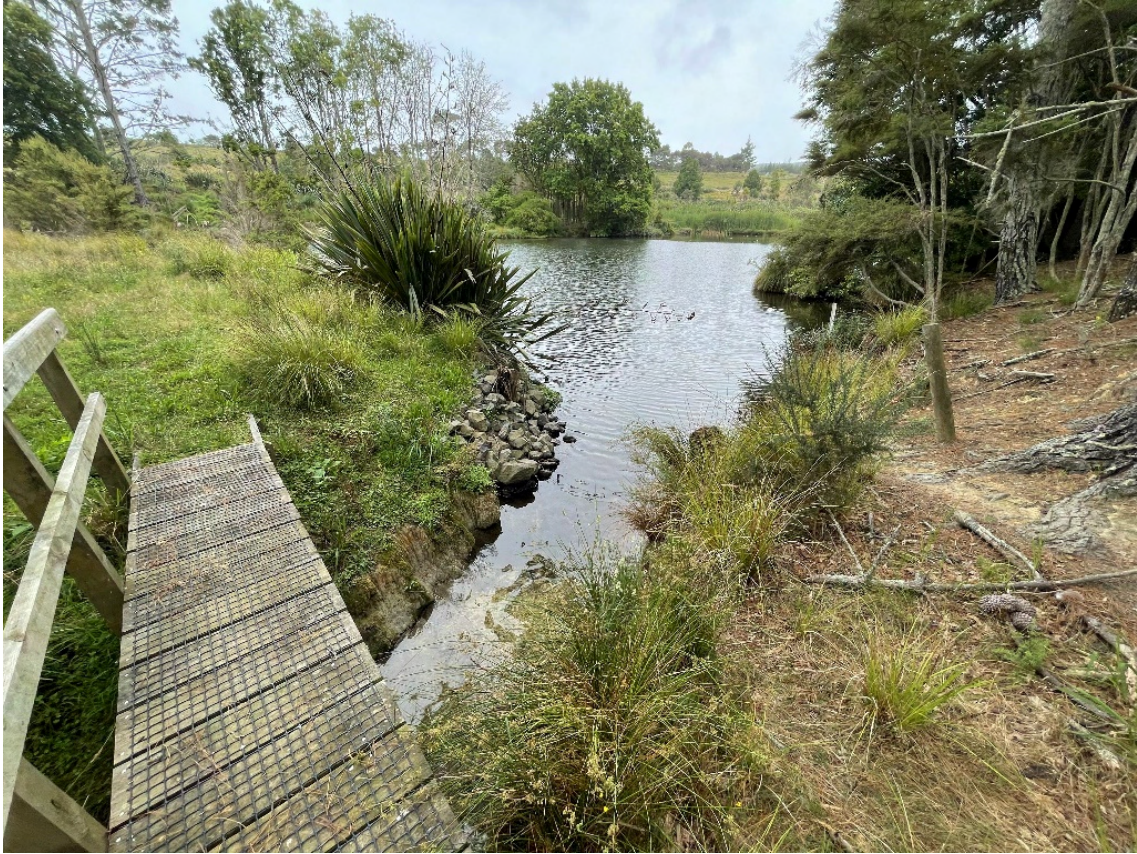
Downstream of the pond outlet, riprap was observed on the stream banks as shown in Figure D. Minimal bank erosion was observed here, however it is presumed that this riprap was placed for preventative erosion protection and/or diversion of the stream. Further riprap can be seen at the pond outlet as shown in Figure A, and immediately downstream of the bridge as shown in Figure I.

Figure A: WWTP Discharge Pond Outlet Channel (18/01/2024)

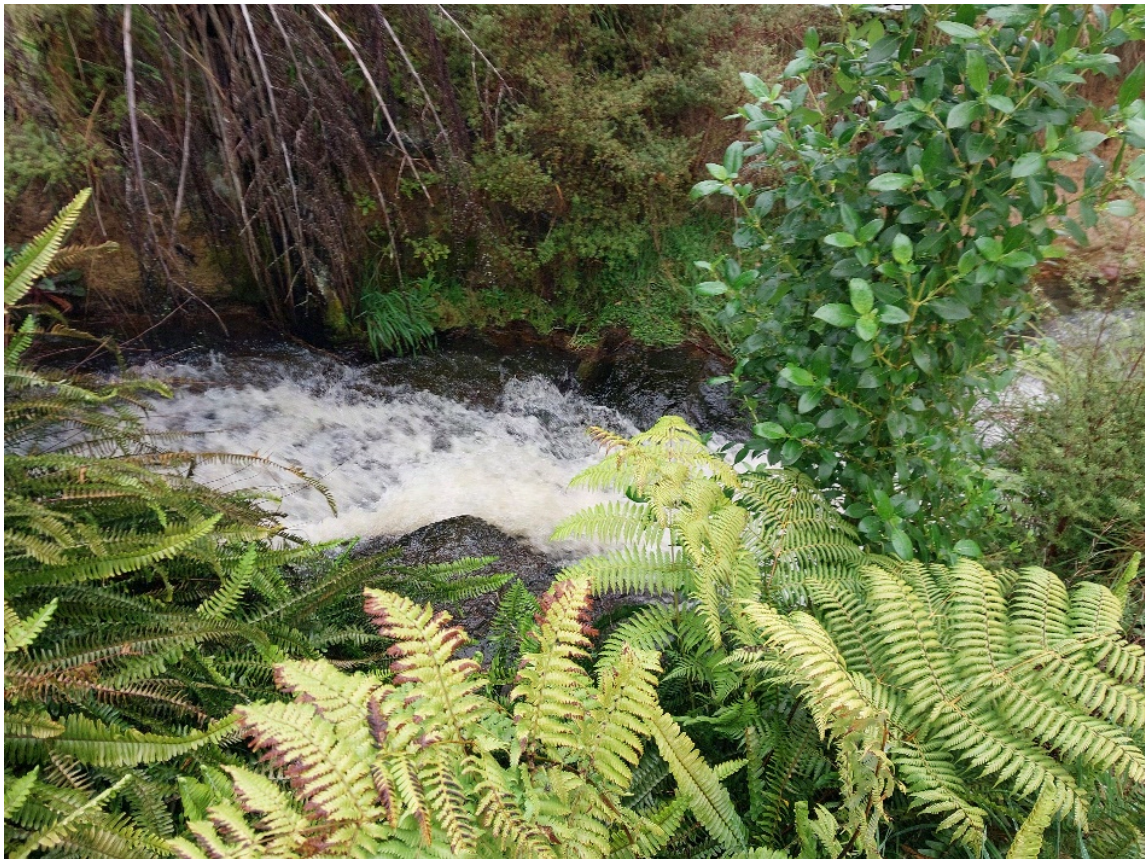
- ∴ Figure B shows velocities in the steep section of the stream a short distance downstream of the pond, upstream of Figure C where the left stream bank has been undercut to bedrock;
- ∴ Figure E shows the stream banks being undercut adjacent to the farm track where the stream changes direction upstream of the DN 600 culvert; and
- ∴ Figure J shows the toe of stream banks being eroded away, with tree roots observed.

Figure B: Normal Flow within Stream (18/01/2024)

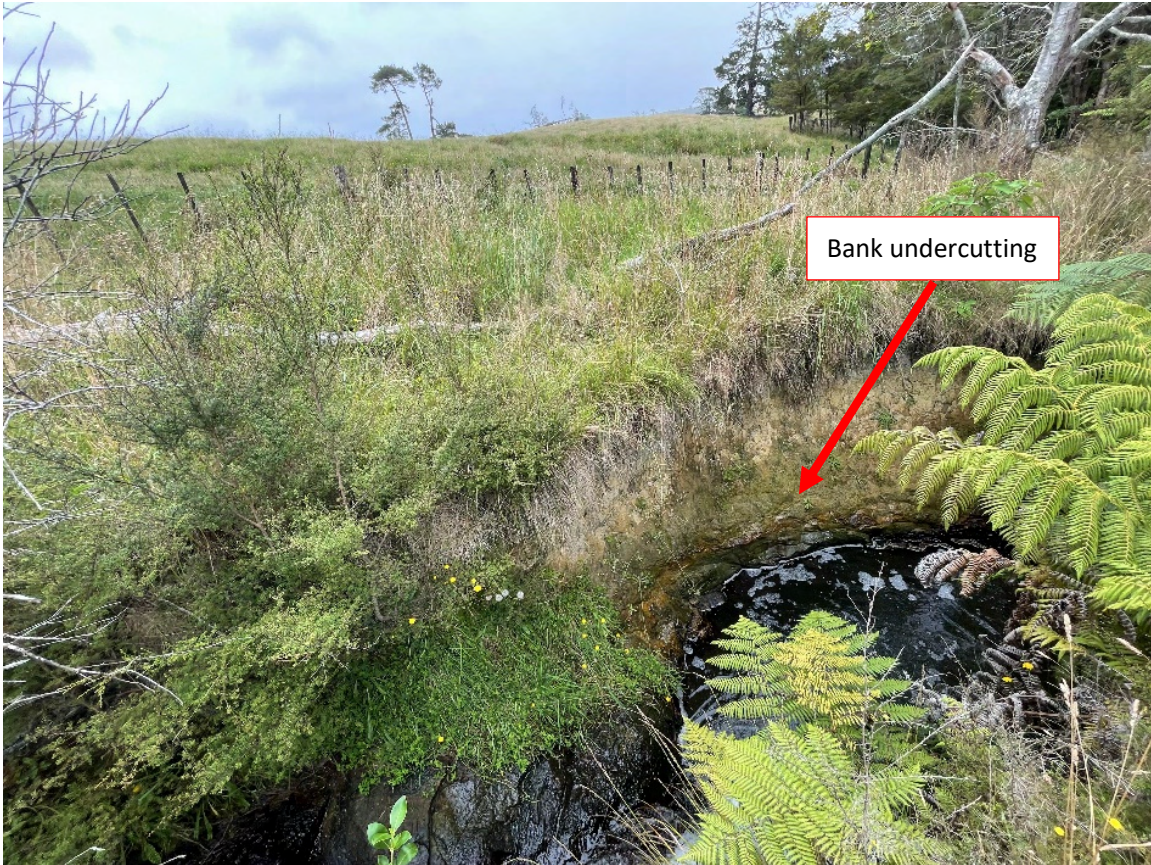
Stream banks are being undercut to bedrock on the outside of meandering points. The majority of this erosion is expected to have occurred during storm events, based on the flows and velocities in Table 2 and 3. While undercutting was observed, the stream banks appear to be stable for the majority of the reach with established vegetation present and no large bank failure was observed. Through this reach, an increase in flow from future wastewater discharges is expected to marginally increase erosive potential where the stream meanders but not elsewhere in the reach. This may weaken banks in storm events / bank full flows but will only be in the localised areas. Vegetation is supporting bank stability in places. The undersized culvert at the farm track will attenuate flows and reduce downstream erosive velocities beyond the culvert outlet (a scour pool was not observed).

Figure C: Undercutting of Stream Bank (18/01/2024 – Facing Downstream)

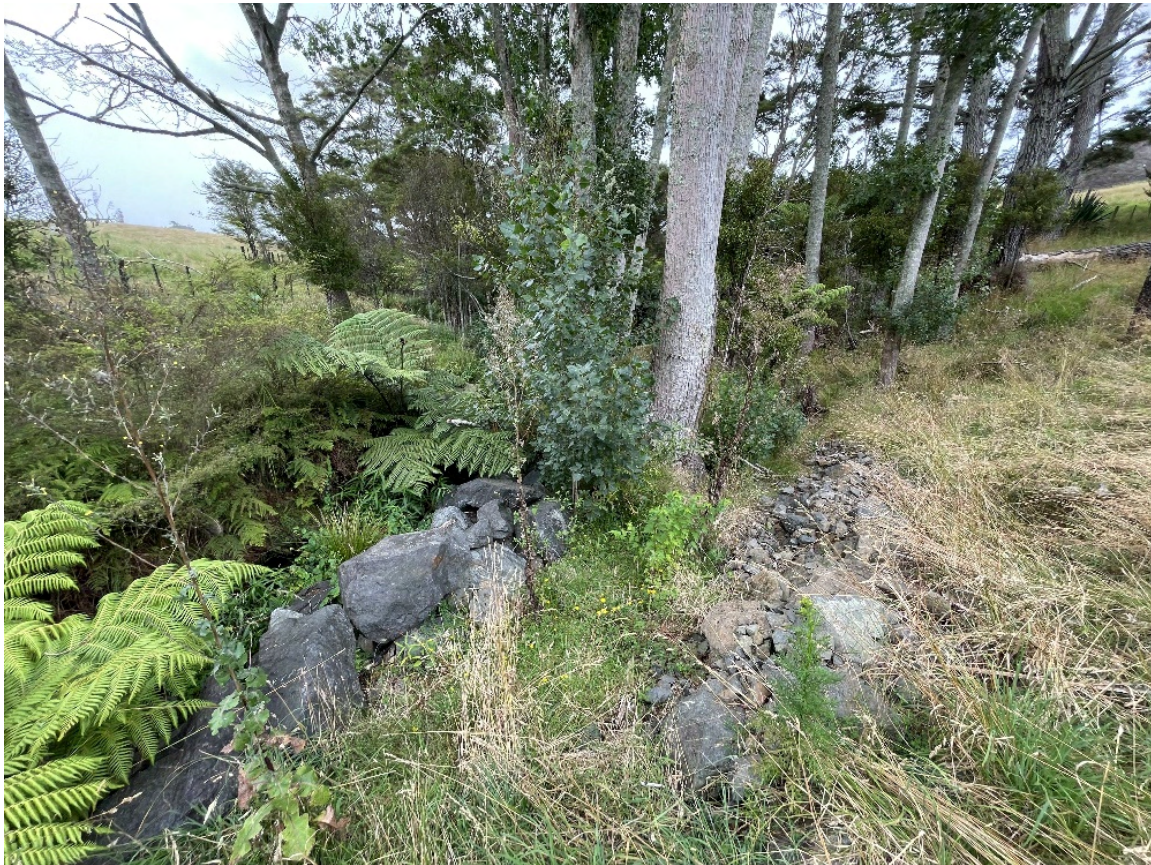
Figure D: Riprap along Stream (18/01/2024 – Facing Downstream)

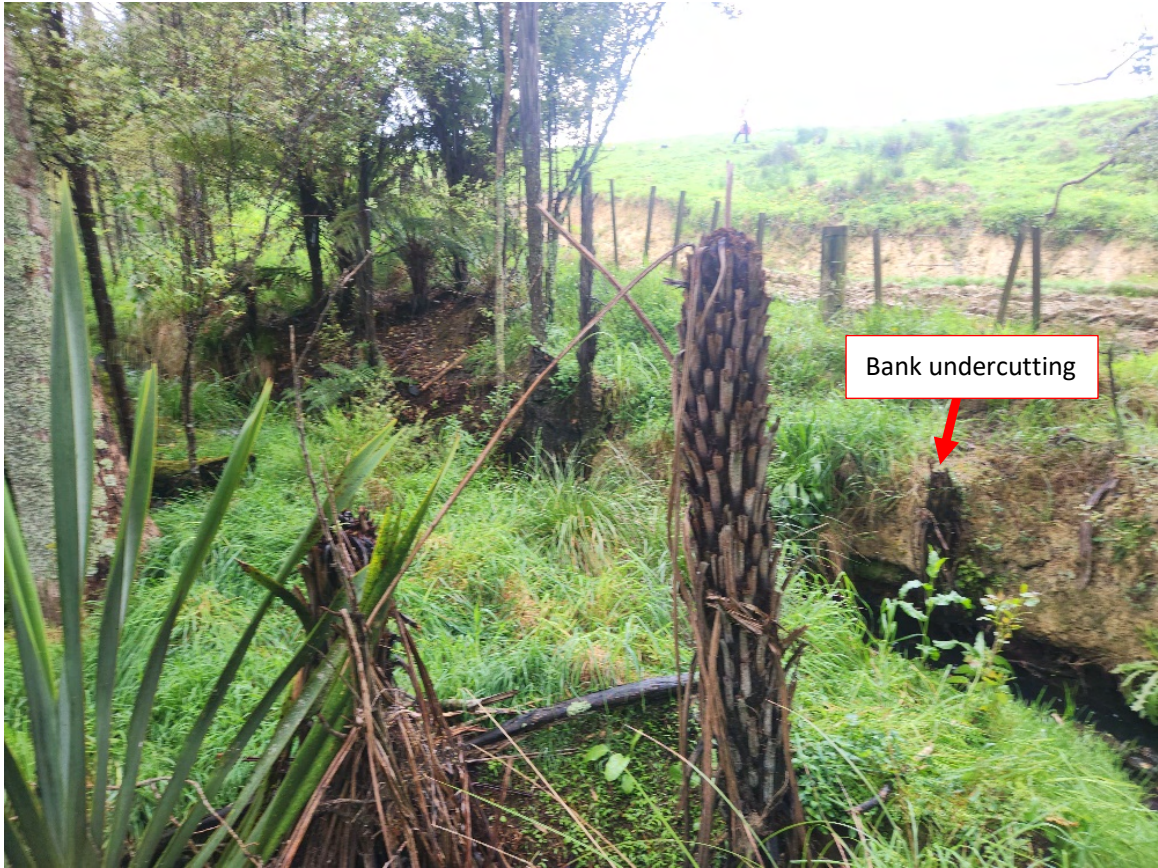
Figure E: Undercutting of Stream Bank Example 2 (06/09/2023 – Facing Upstream)

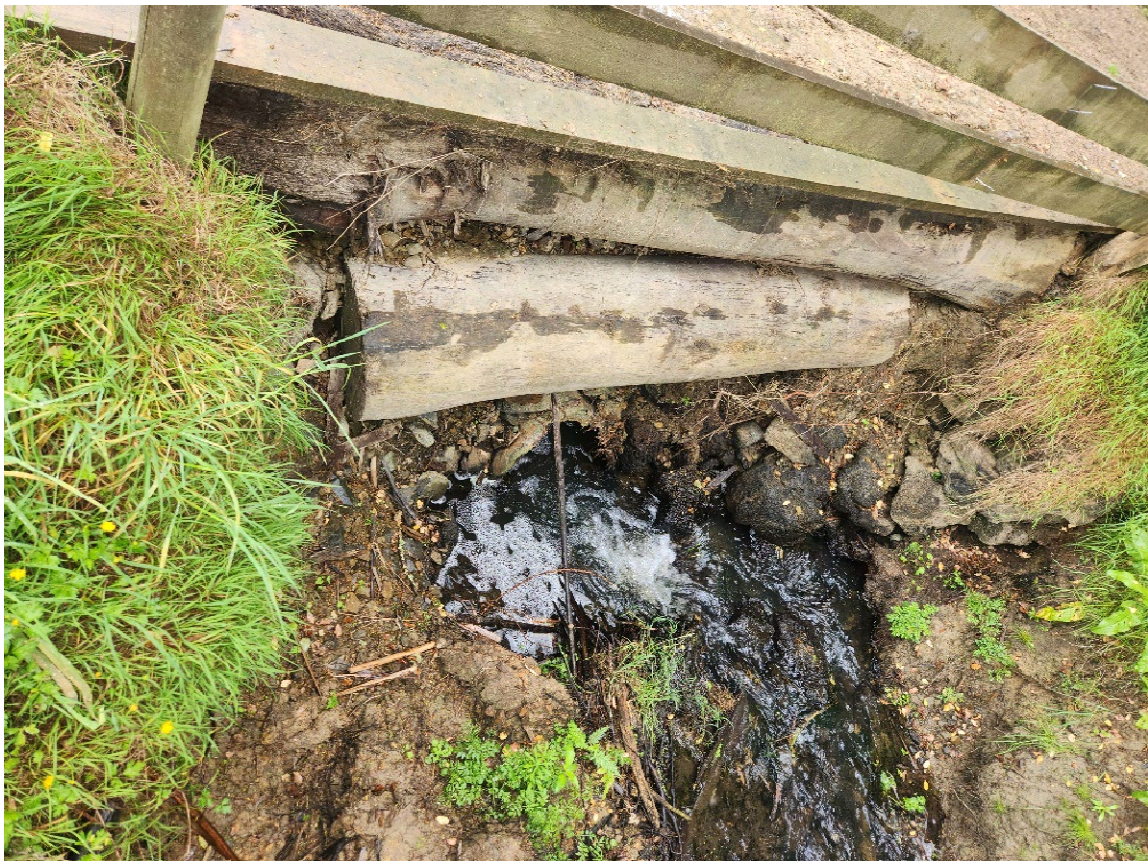
Figure F: DN 600 Culvert Inlet (06/09/2023)

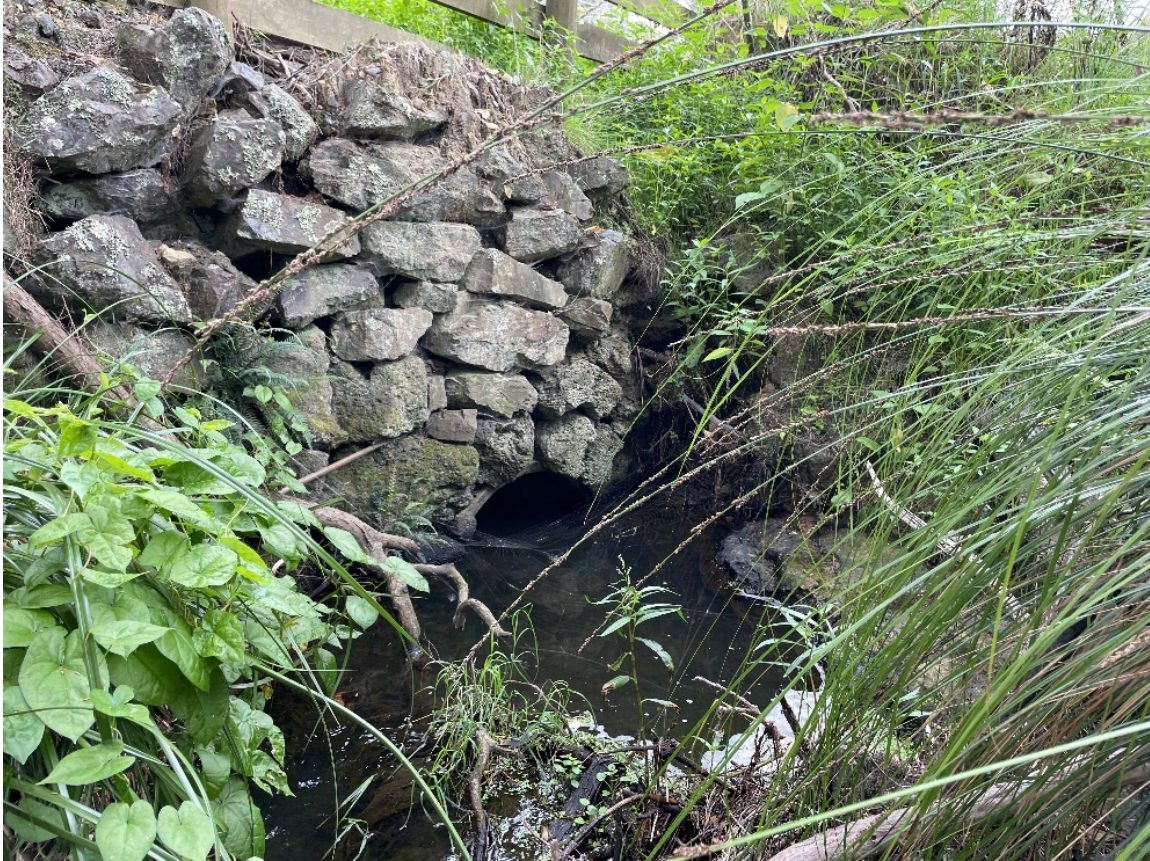
Figure G: DN 600 Culvert Outlet (18/01/2024)

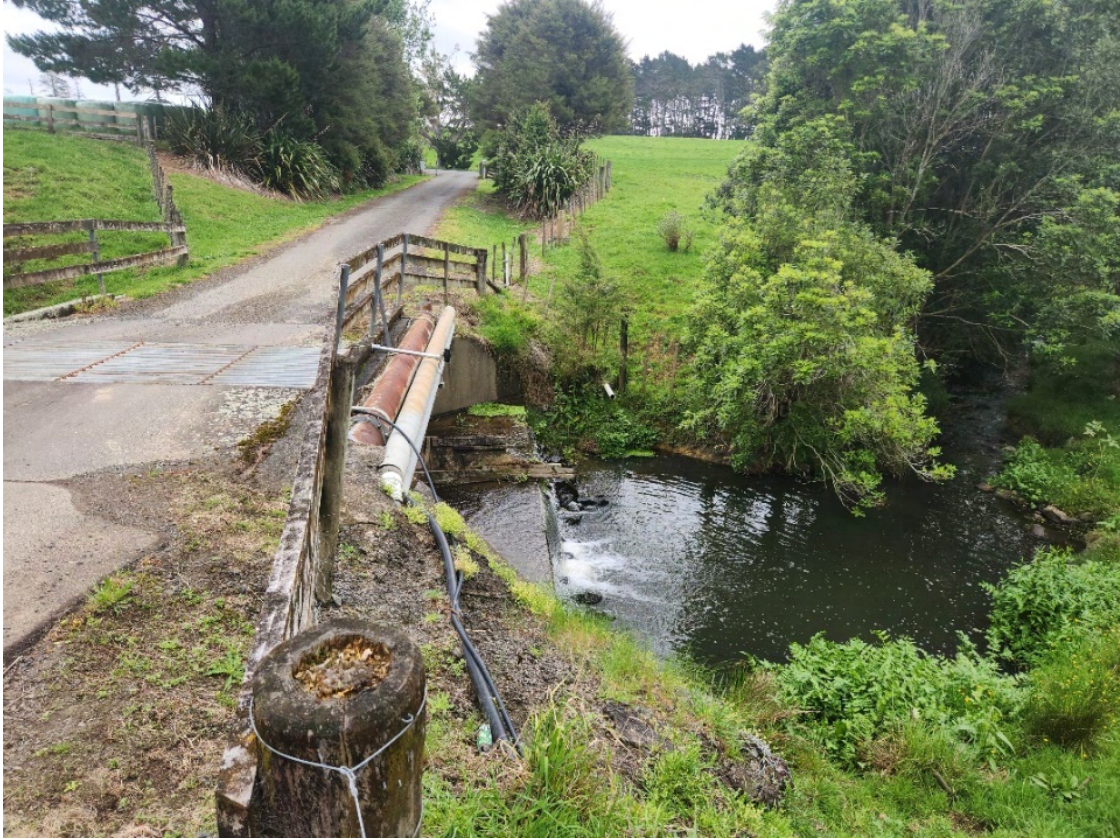
Figure I: Downstream Extent of Bridge (18/01/2024)

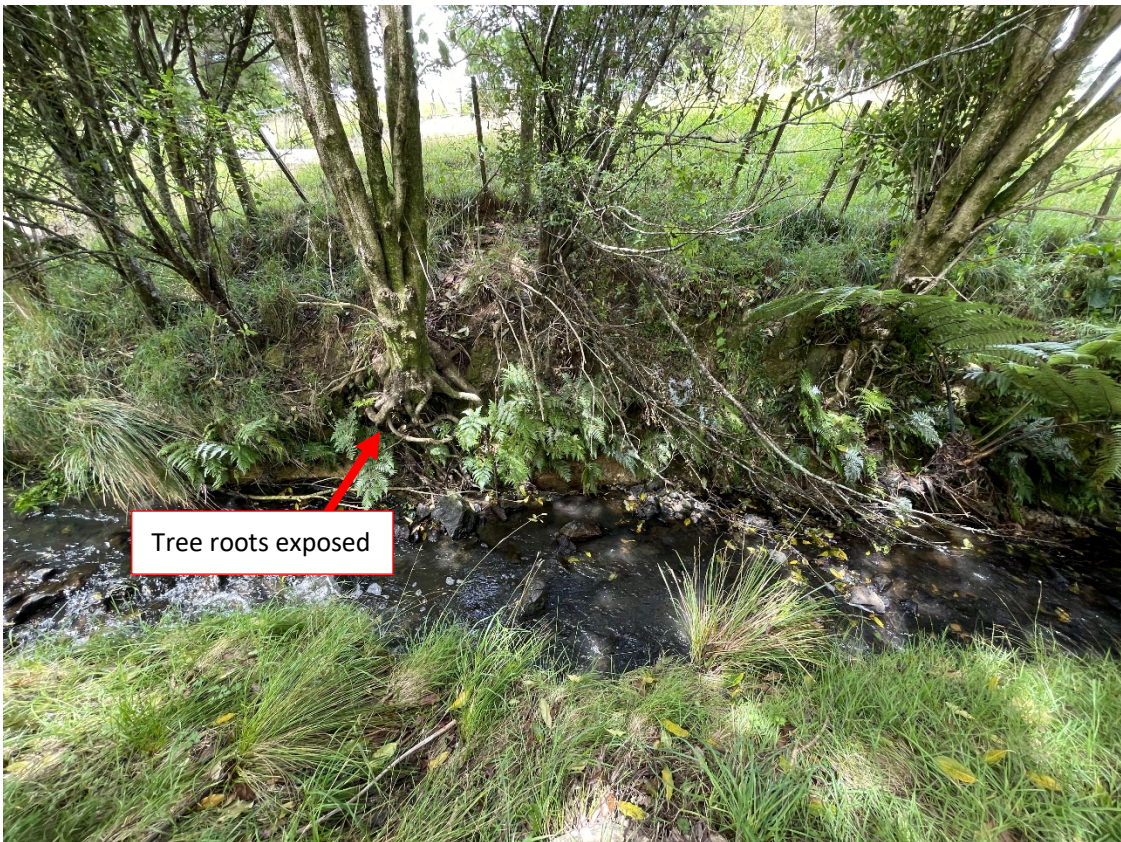
Figure J: Bank undercutting downstream of Bridge (18/01/2024)

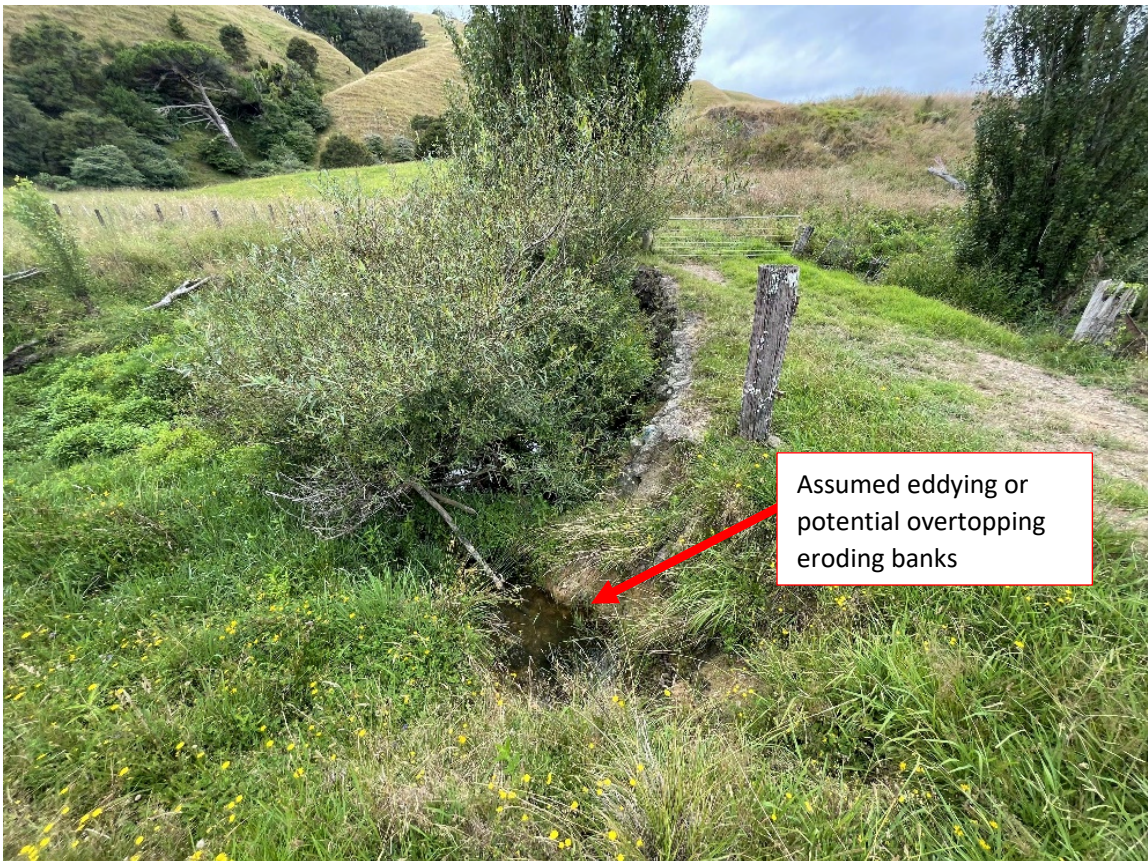
- ∴ Figure L shows bank erosion downstream of a farm culvert. This farm culvert, observed to be a DN 1200 concrete culvert, is located upstream of Point C as shown in Appendix A (is outside of WSL land). The culvert was observed to be over half full during typical stream flows (i.e., baseflows and average WWTP discharge), indicating that the culvert would be a restriction in storm events. The erosion observed is assumed to be associated with the farm track overtopping; and

Figure L: Erosion Downstream of DN 1200 Farm Culvert (18/01/2024)

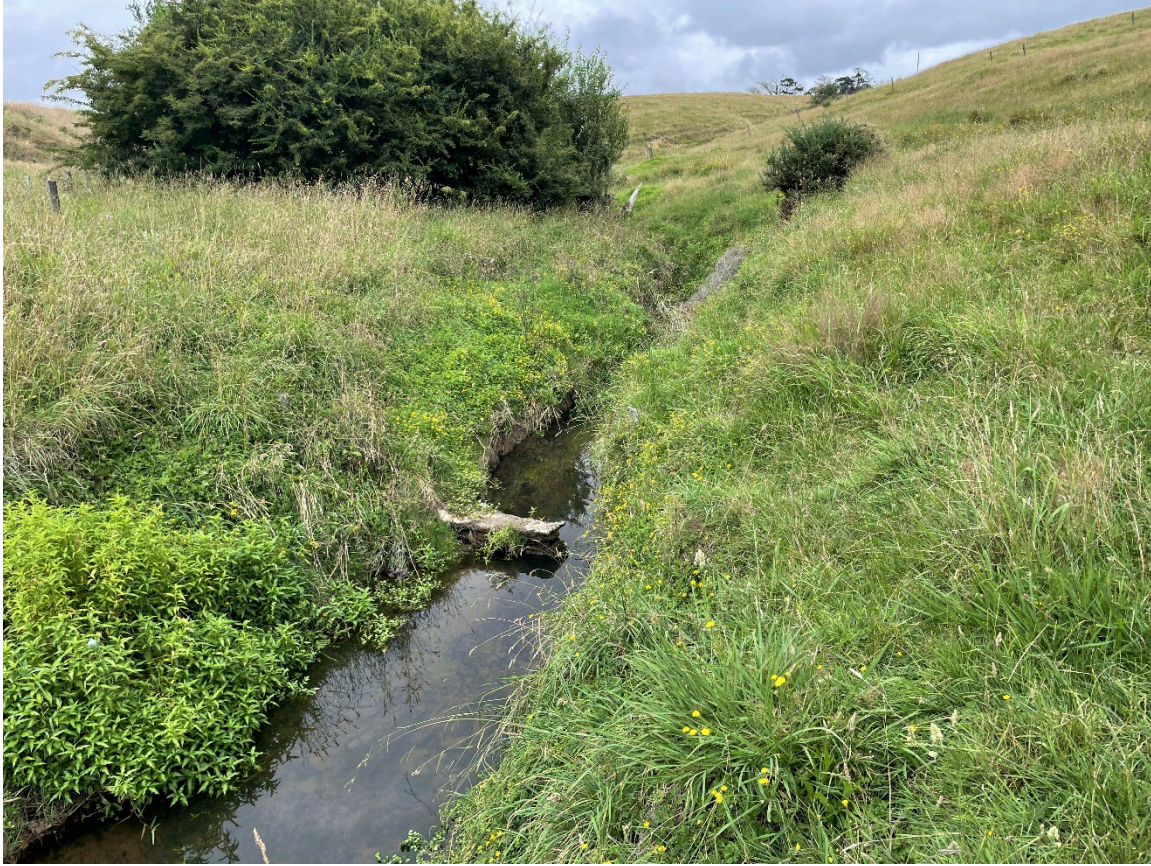
Upstream of Point C away from the culvert, Figure M shows a reasonably stable section of stream with naturally formed riffles, runs, pools and meandering stream.

Figure M: Upstream of Point C (18/01/2024 - Facing Upstream)

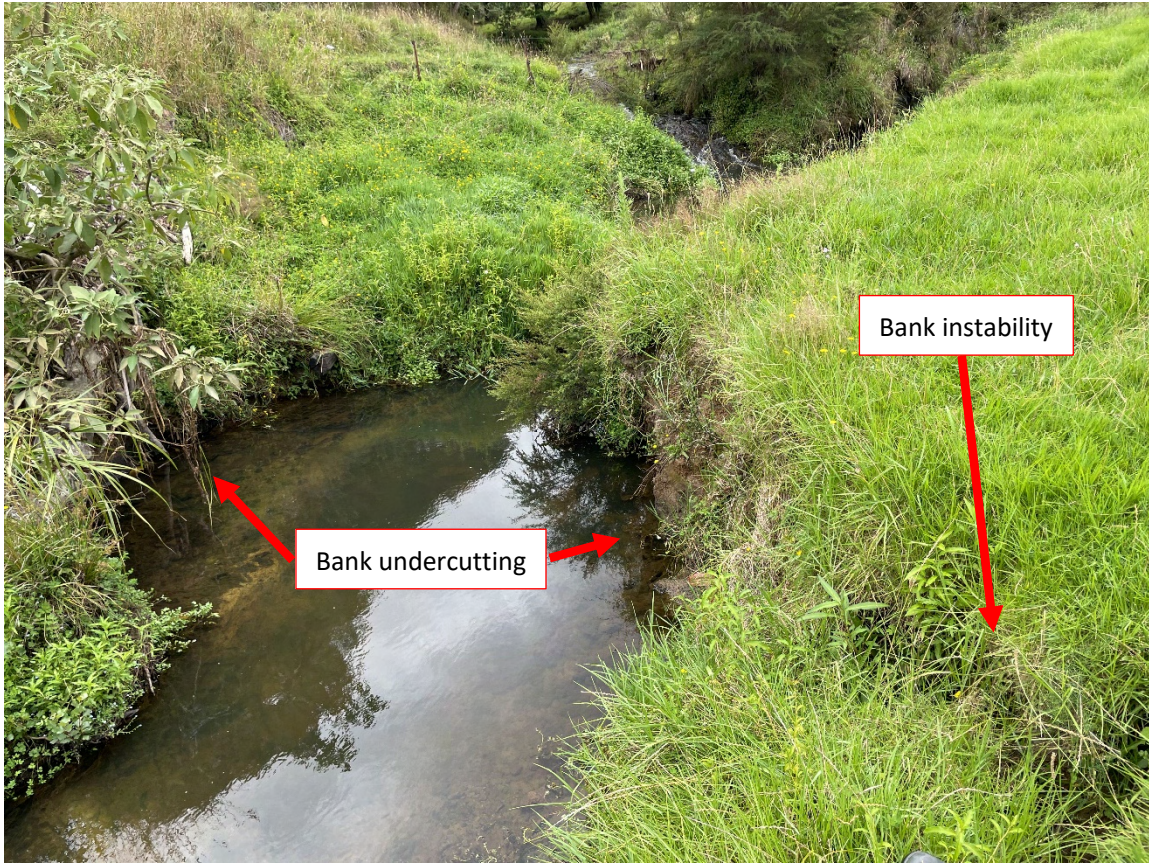
- ∴ Figure O shows banks being undercut and some instability adjacent to the stream. This bank erosion was observed downstream of the confluence and appears to be due to eddying formed by this increase in flow from the adjacent catchment during higher flows and the meandering of the stream through this section.

Figure O: Bank undercutting at Point C (18/01/2024 - Facing Upstream)

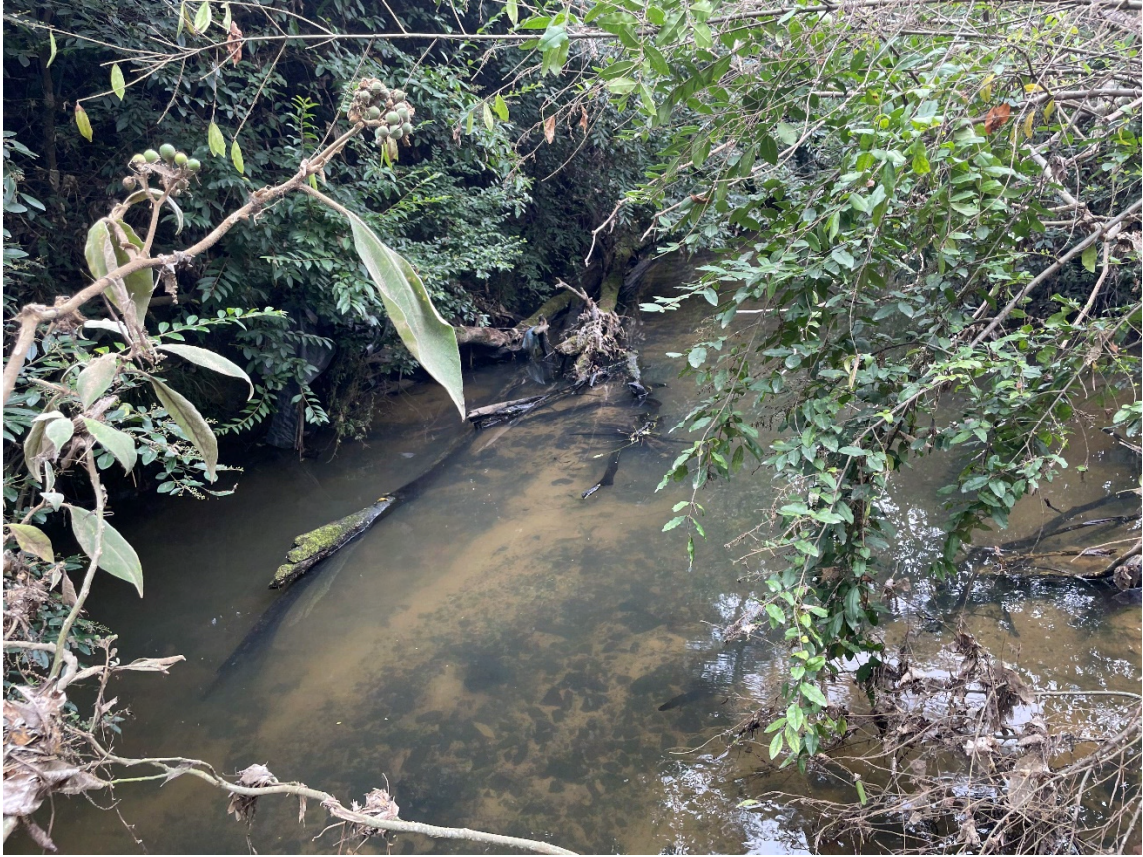
Figure Q shows the stream adjacent to the Quarry where vegetation growth around the stream increases and the stream widens as the grade of the stream decreases. No more than minor bank erosion was observed here.

Figure Q: Stream adjacent to Quarry (18/01/2024 - Facing Upstream)
