TO: Watercare Services Limited  
FROM: Laura Drummond

Date: 18 April 2024  
Job No: 67064

**TE PURU STREAM WWTP DISCHARGE ASSESSMENT OF EFFECTS ON STREAM HABITAT**

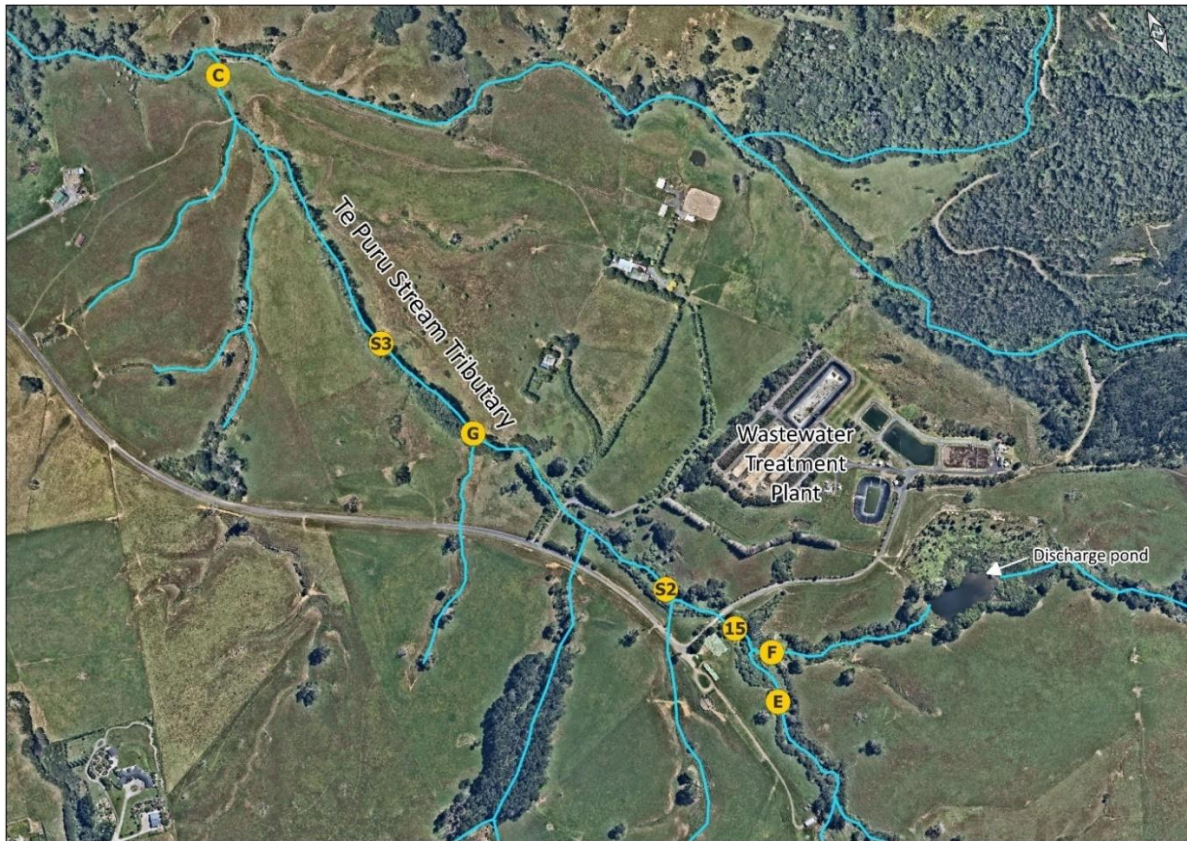
**Figure 1. Map of the Te Puru Stream Tributary and the associated monitoring sites references within this memorandum.**

This memorandum describes the current ecological condition of the Te Puru Stream Tributary throughout six “impact” sites and one control site (Figure 1), associated with the Biological Monitoring programme (Bioresearches, 2024<sup>1</sup>). It then assesses the potential effects on stream habitats of the proposed of up to 6,000 m<sup>3</sup> per day on those stream sites by reference to the control site, and monitoring data from sites downstream of the existing discharge. For the avoidance of doubt, this assessment of effects does not assume effects from the existing treated wastewater discharge of 2,000 m<sup>3</sup> per day from part of the existing environment.

A site assessment was undertaken over the 31st January to 2<sup>nd</sup> February, 2024, throughout six impact sites (Site F, 15, S2, G, S3 and C) and one control site (Site E) within a permanent tributary to the Te Puru Stream, in association with the biotic monitoring programme<sup>1</sup>. The impact sites referenced within this memorandum, are located downstream of the discharge point. The control site is located within a separate tributary and upstream of the discharge point.

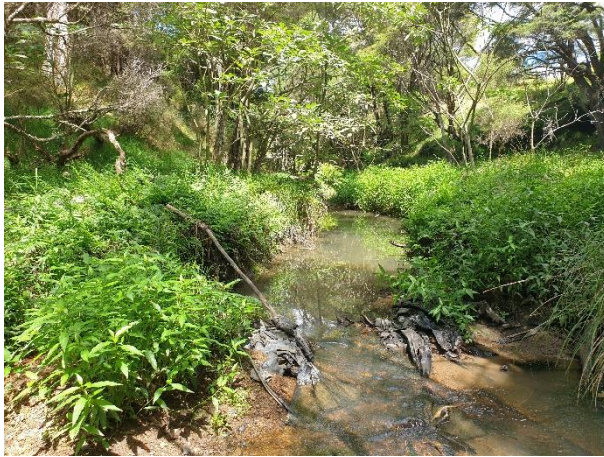
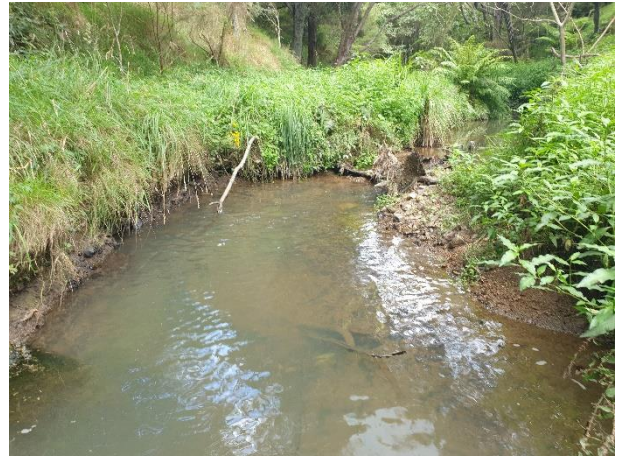
***Photo 1 and Photo 2. Control Site E***

The control site, Site E tributary consisted of a wide (average 2.16 m) and slow flowing stream with an average depth of 0.23 m. The stream banks were relatively incised and vertical and may not be inundated during regular flood flows. Substrates throughout Site E were predominantly comprised of silt and cobbles; and the hydrological heterogeneity relatively low, mainly consisting of run habitat with some small riffles upstream. Riparian vegetation was poor and consisted of herbaceous ground-cover with occasional exotic and native woody vegetation. However, due to the surrounding topography, shade was considered to be moderate.

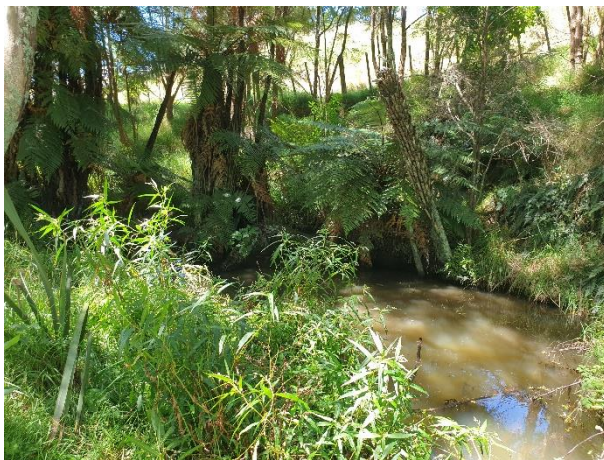
***Photo 3. Site F***

The Te Puru Stream Tributary was wide, with an average width of 2.16 m (1.82 m – 2.69 m), and an average depth of 0.25m (0.12 m – 0.51 m), generally flowing within incised, vertical banks. Substrates were made up of silt with cobble and gravels. High silt proportions were recorded at effect sites downstream of the discharge pond, generally decreasing with distance from the discharge and gravels becoming more abundant. However, sediment plumes were present when the substrate was disturbed. Fish habitat/cover types observed during the survey comprised macrophytes, instream debris (e.g. wood), undercut banks and bankside vegetation. Hydrological variation throughout the tributary was considered to be moderate, with slow runs, fast runs, pools and riffle habitat present throughout the entire length.

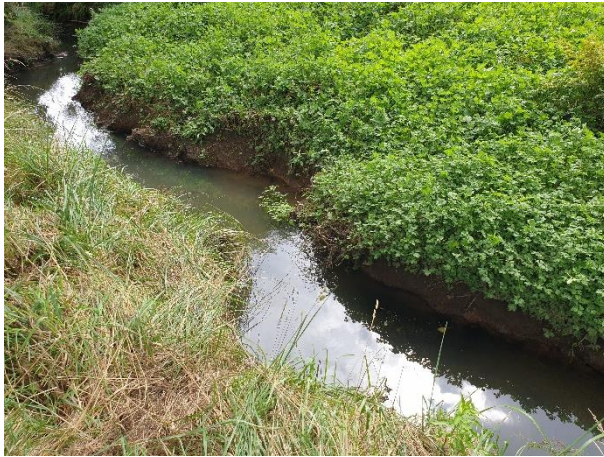
*Photo 7. Site S3*

Riparian vegetation throughout the Te Puru Tributary was variable, with the upstream reaches consisting of mixed exotic and native vegetation which transitioned to pastoral land and exotic trees towards the downstream reach. Due to this variability, riparian yard functions, particularly bank stability and shade were variable, with the lower reaches containing no significant riparian yard and evidence of bank erosion.

PDP assessments on bed and bank erosion show the majority of erosion will occur during storm events, and will be largely localised to meanders within the tributary. To minimise this potential erosion and scour during flood events, it is recommended infill riparian planting with deep rooting vegetation is undertaken within these more vulnerable meandering reaches. Recent work by Auckland Council<sup>6</sup> has shown cabbage

trees / tī kōuka (*Cordyline australis*) to be particularly effect in slope stabilisation, both within slopes and at the toe of slopes, and is recommended to be included within the riparian planting mix. This planting should first be concentrated within the meandering reaches within Watercare property boundaries. Further planting on the downstream reach will required to be discussed with the private property owners.
