3 Pigeon Mountain Rd, Half Moon Bay Western Boundary Wall

Preliminary Design and Groundwater Drawdown Assessment Report

Document Number: J00538AB

Prepared For: HND HMB Ltd

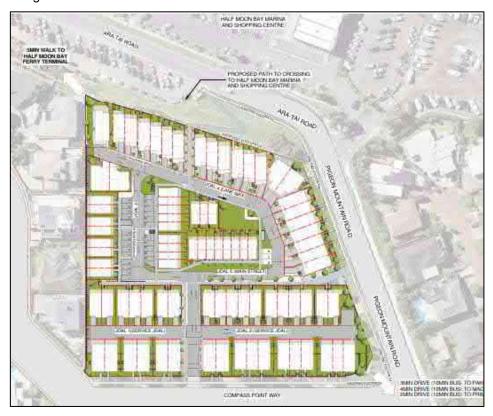
Figure 1, Development Plan by ASC Architect updated on 08 April 2024.

The proposed development includes 87 terrace houses. A site plan of the development is shown in Figure 1.

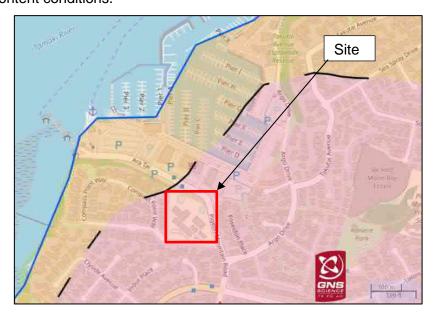
Figure 2. Site Geology Map

The map Indicates a geological boundary to the north of the site, mapped As East Coast Bays Formation (ECBF, coloured orange in Figure 2) of the Waitemata Group. The ECBF comprises alternating sandstone and mudstone with variable volcanic content and interbedded volcaniclastic grit beds.

The ECBF typically weathers at the surface forming stiff to very stiff silts and clays which can contain reactive clay mineralogy and be prone to shrinking and swelling due to varying moisture content conditions.

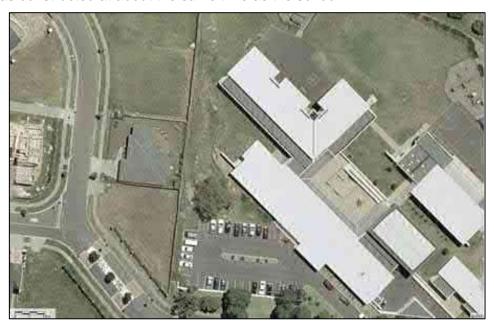
Figure 3. Aerial Photo from Auckland Council (2006)

The aerial photo (circa 2006) shown in Figure 3 from Auckland Geomaps indicates that the wall was constructed at about the same time as the school.

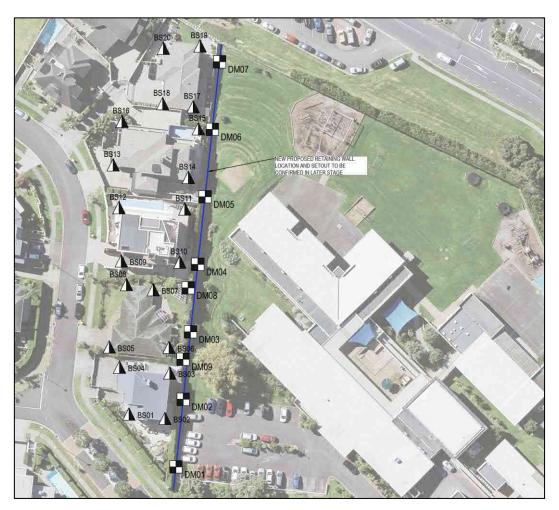
Figure 17. Updated Monitoring Plan.

We have also planned a set of building settlement marks BS1-20 around the neighbouring properties to monitor the potential ground deformation and its differential settlements during the construction.
