Geotechnical Investigation for Multi-Level Commercial Building at 538 Karangahape Road, Newton

Rev A

22 August 2023

Job No. 20111

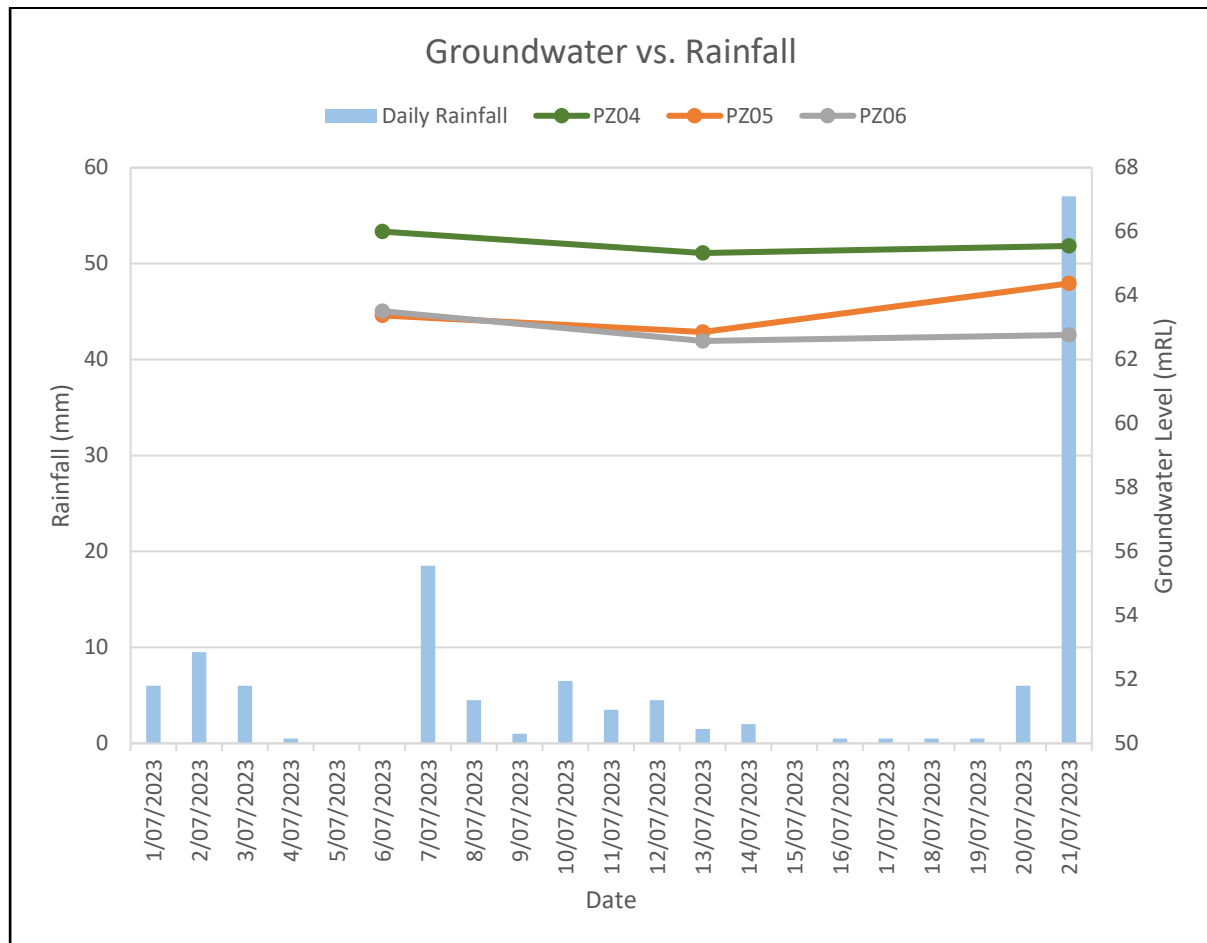
A significant rise (1.5m) was recorded in PZ05 between 13 and 21 July with rises of just 0.3m and 0.2m recorded in PZ04 and PZ06 respectively for the same period. No significant rainfall was recorded during this period, and we therefore infer these rises in groundwater levels are due to the significant rainfall event on the day of measurement (21 July).

The significant rise observed in PZ05 is therefore inferred to be the result of near-surface water ingress, and the groundwater level recorded in PZ05 on 21 July is therefore considered unrepresentative.

Figure 4: Hydrograph (Recorded Rainfall (Albert Park) and Groundwater Level)

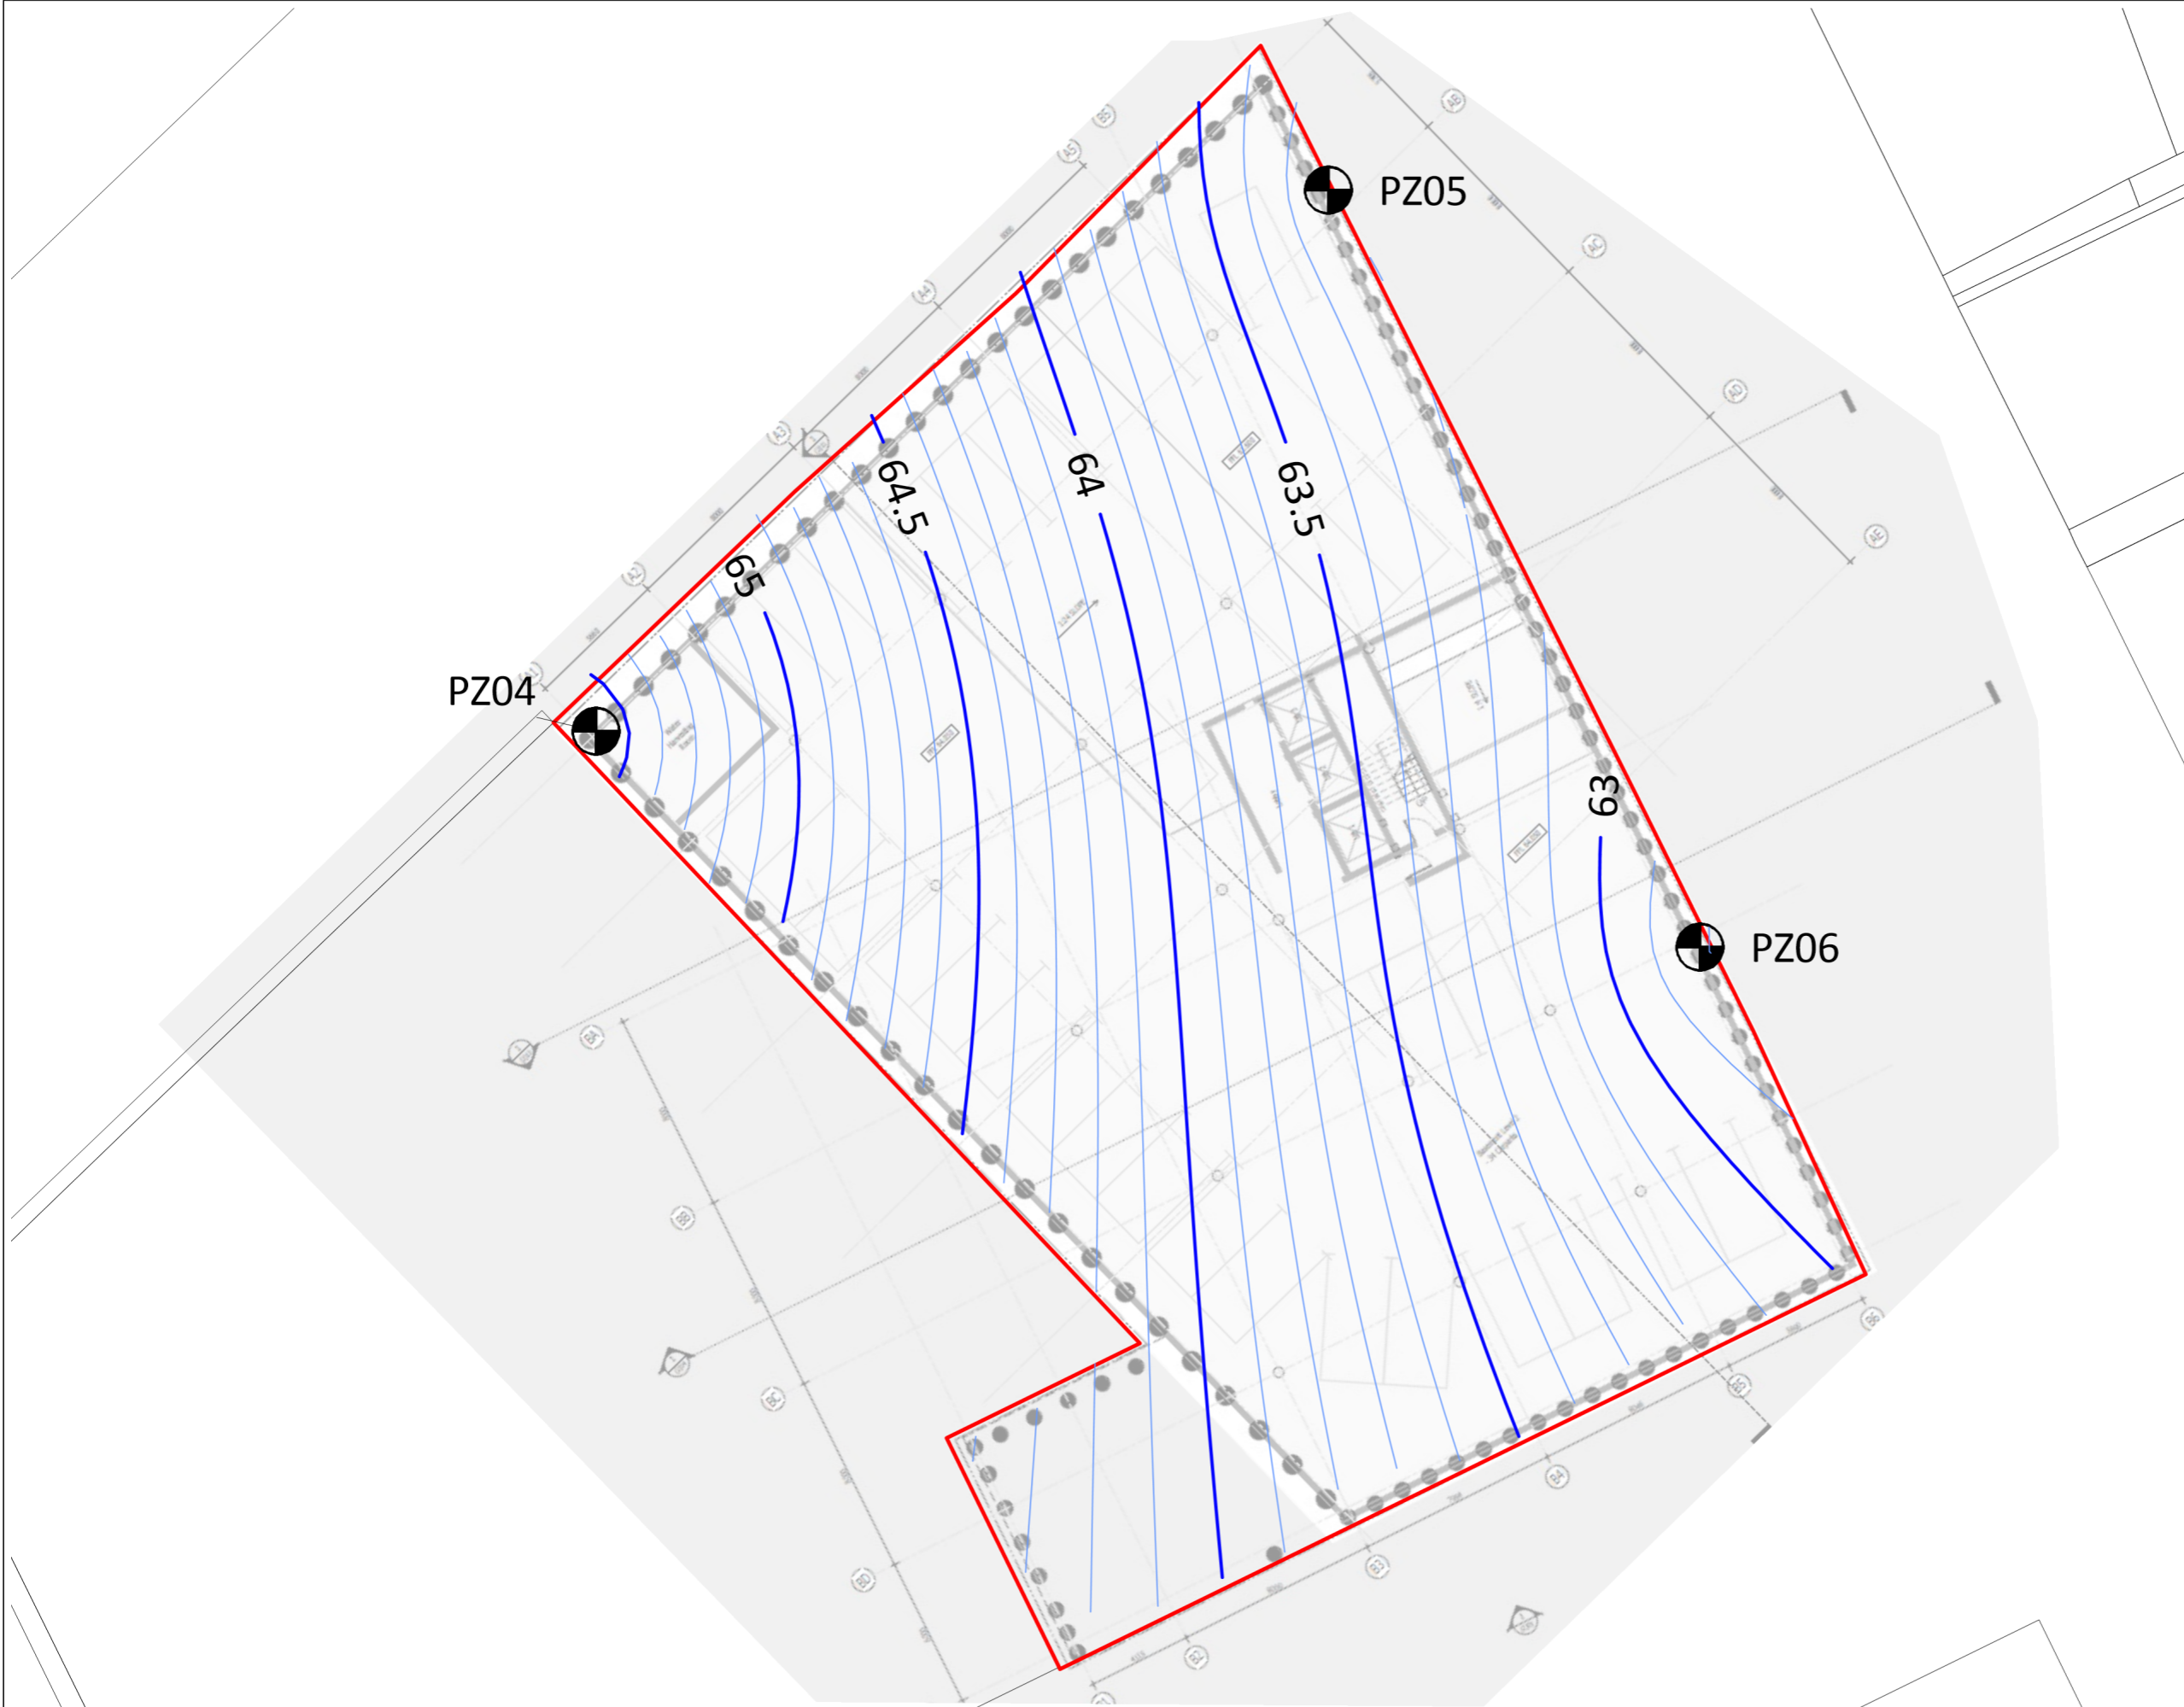
**GROUNDWATER
CONTOURS PLAN**

- Site Boundary
- Groundwater Contour
- PZ04 Approximate Piezometer Locations
Soil & Rock Consultants, July 2023

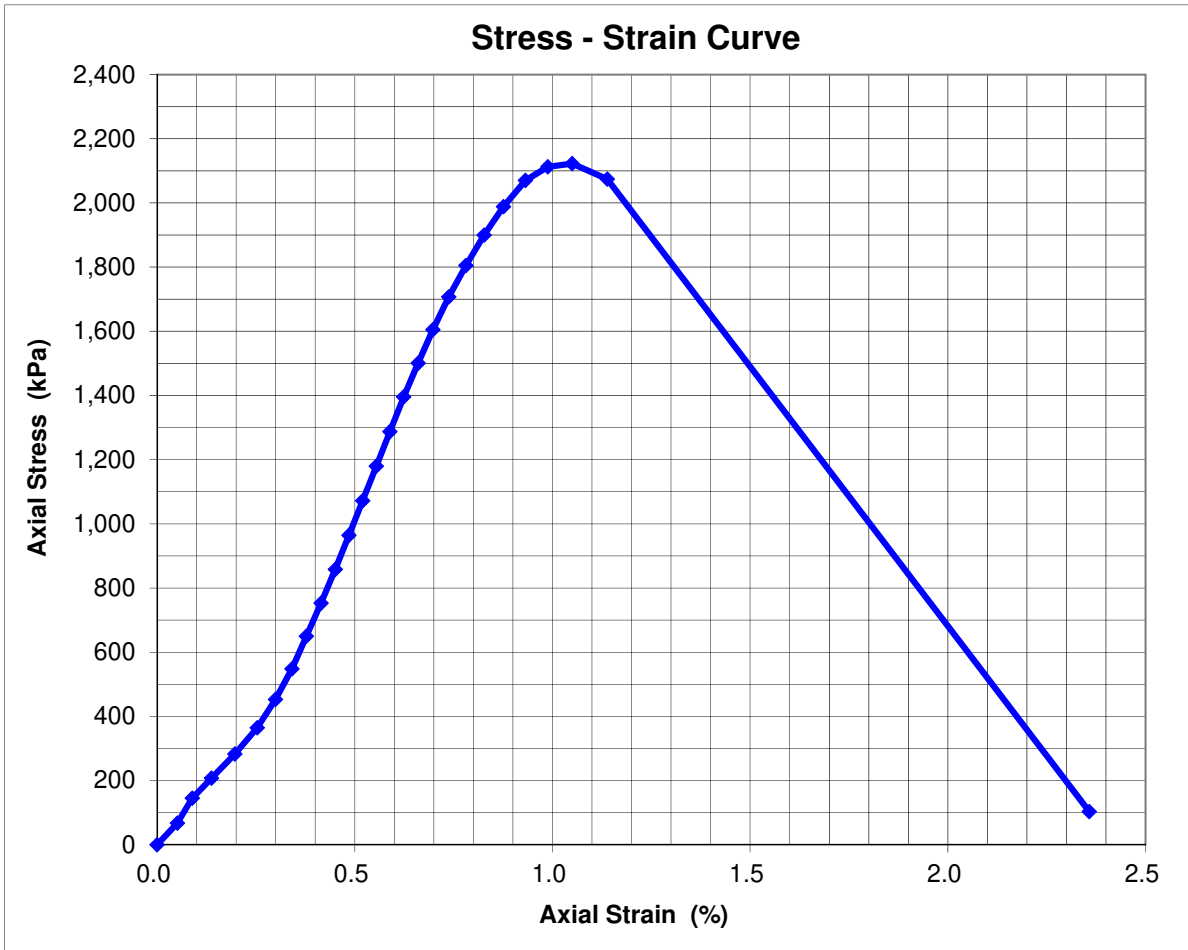
Mode of Failure: brittle

Unconfined Compressive Strength of Cohesive Soils

Borehole ID	UCS Test Depth	UCS Maximum Stress (kPa)	Failure Mode	Strain at Failure (%)
MB01	19.1 – 19.4	2,100	Brittle	1.0
MB03	9.5 – 9.7	510	Brittle	0.87

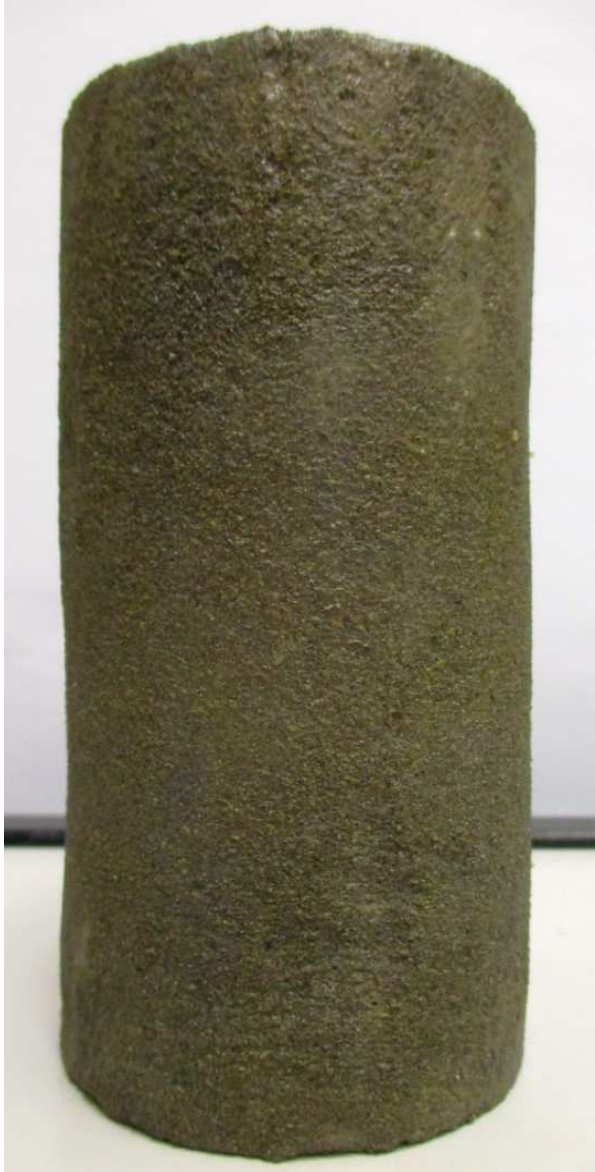
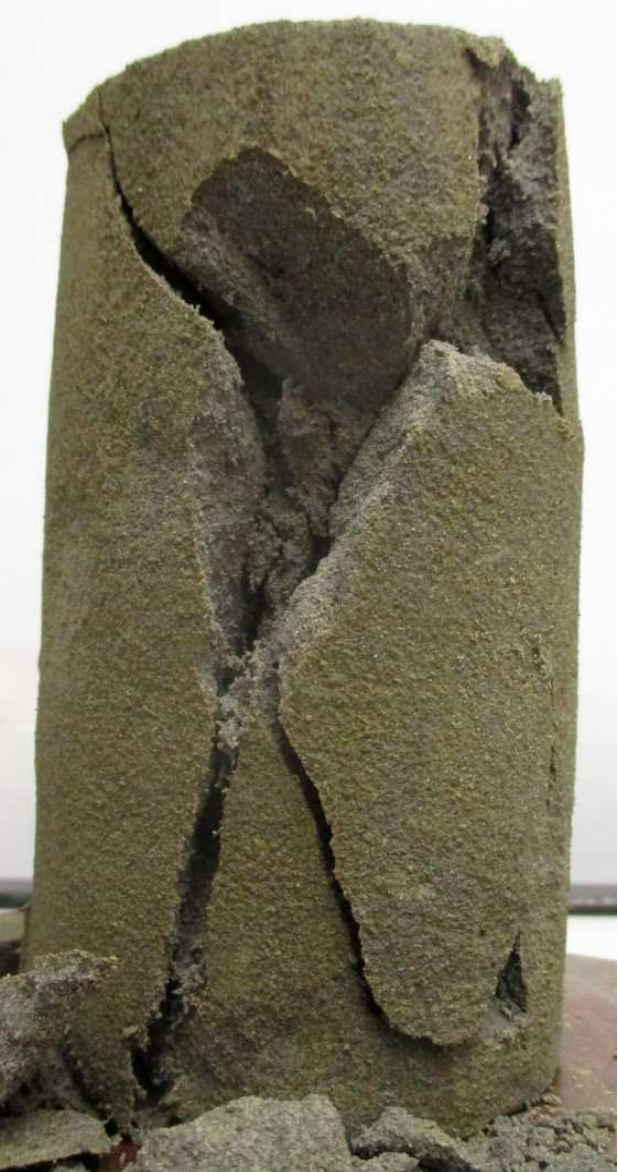
SAMPLE BEFORE TEST

SAMPLE AFTER TEST

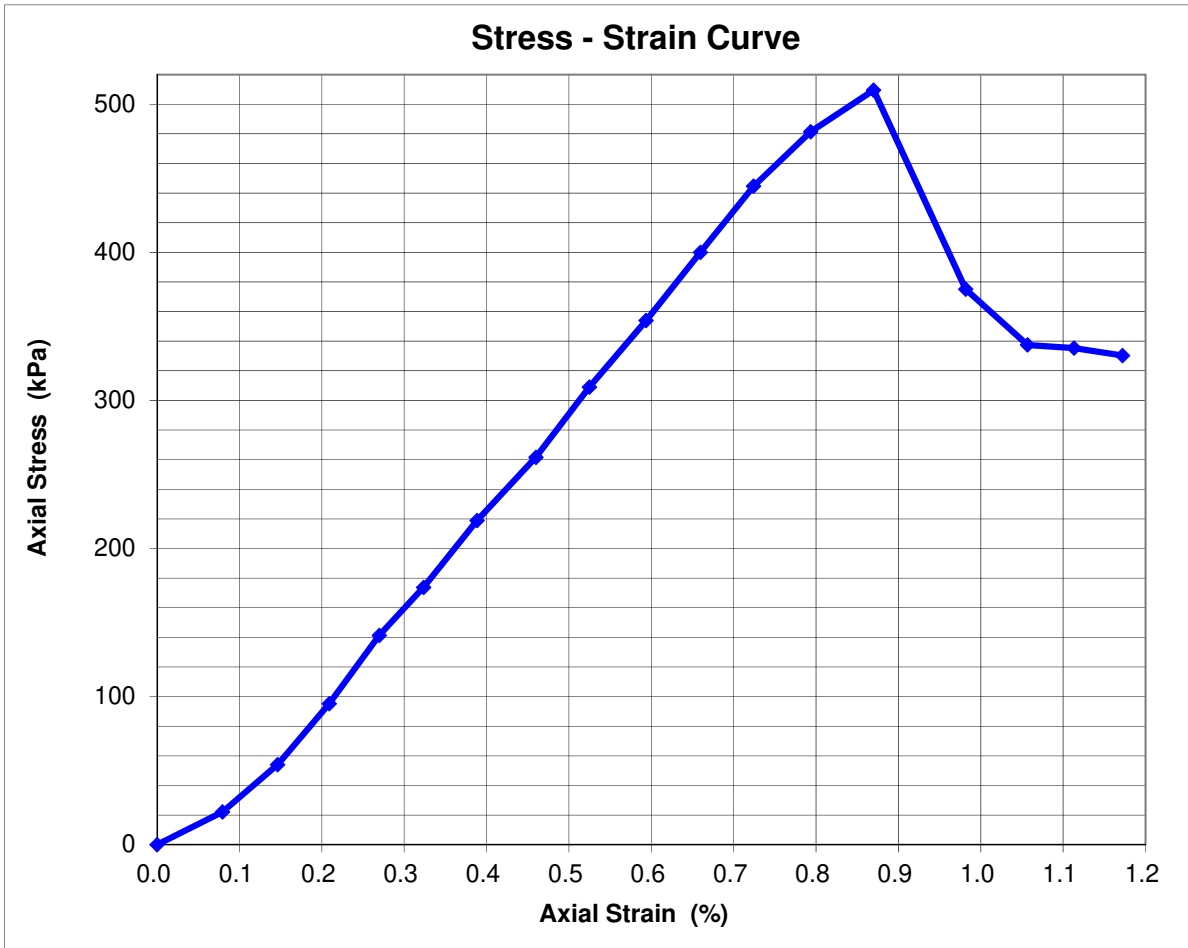
Stress - Strain Curve

Mode of Failure: brittle

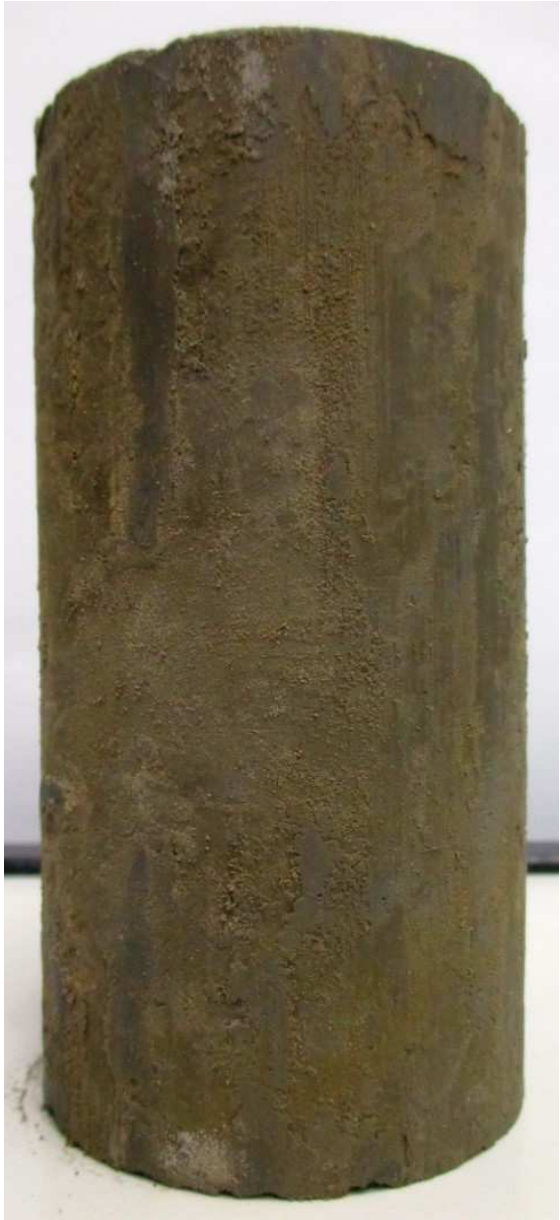
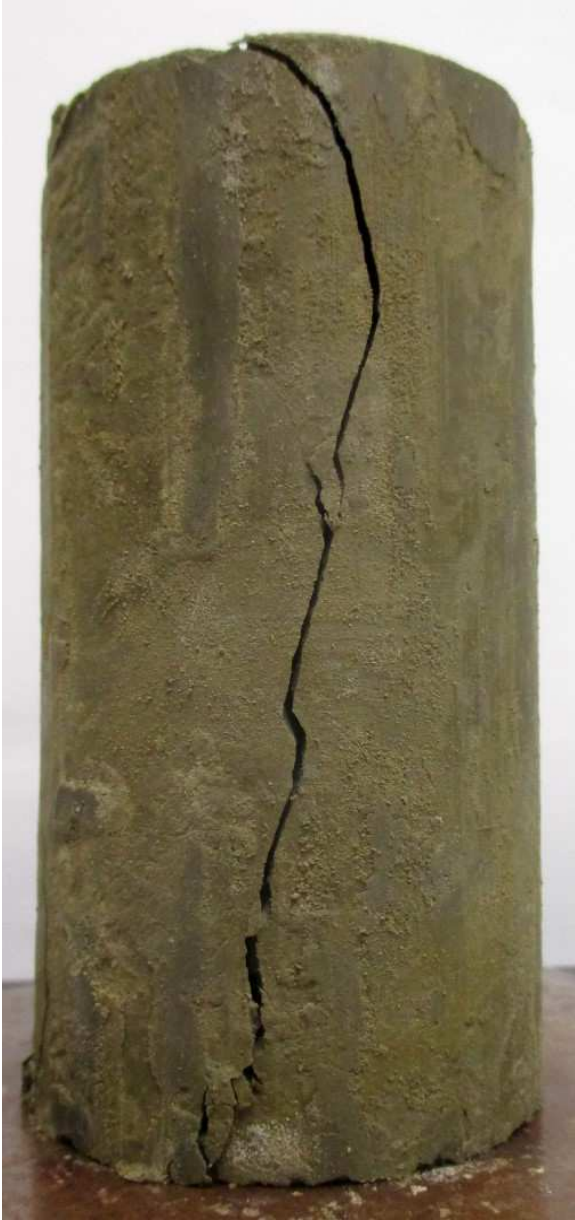
SAMPLE BEFORE TEST

SAMPLE AFTER TEST
