**SITE-SPECIFIC
STORMWATER
MANAGEMENT
PLAN (SMP)**

WHENUAPAI GREEN

98-100 & 102 Totara Road, Whenuapai

For Private Plan Change

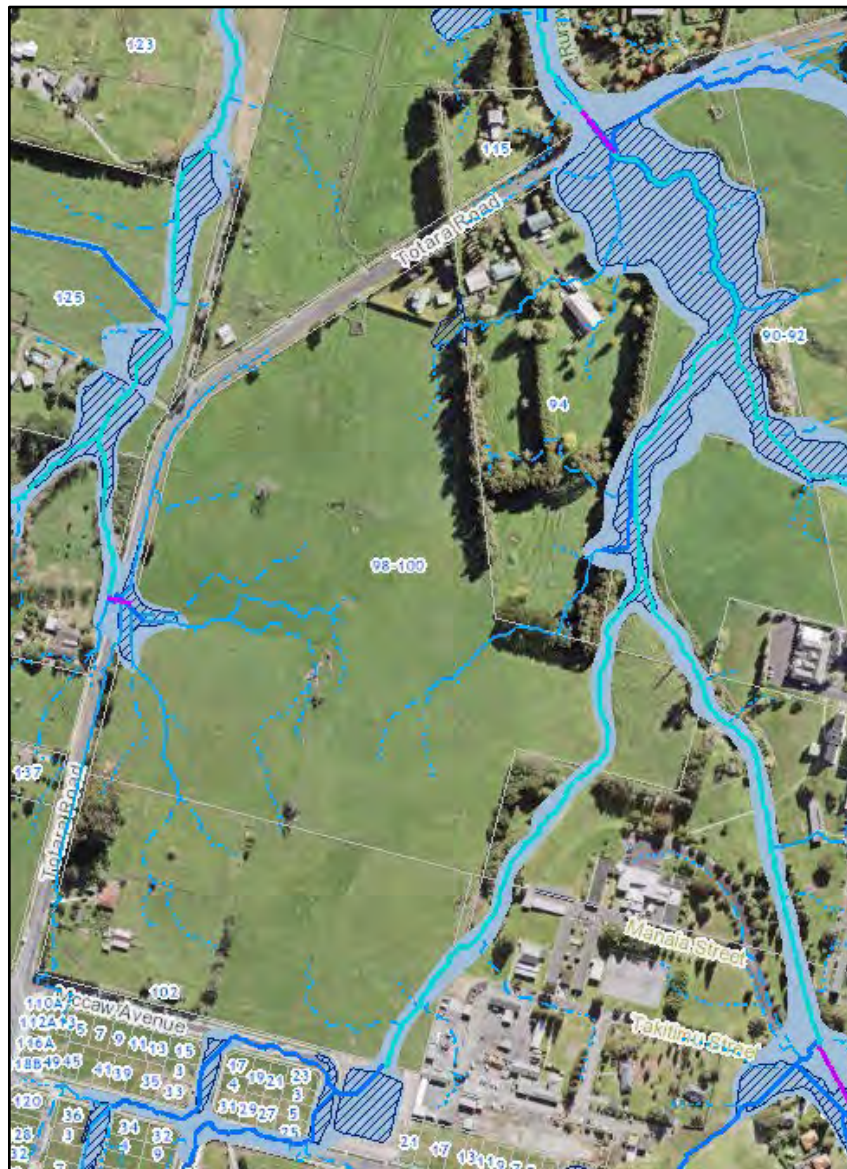
Figure 3: Overland Flow Paths and Flood Plains (Auckland Council GeoMaps 3.8°C increase due to climate change)

All these overland flow paths and streams discharge into the Rarawaru Creek that then flows through a 2300mm diameter culvert under Totara Road approximately 140m from the north-eastern corner of the PCA. The culvert outlet has been surveyed as having an invert level of RL1.41m. This level is similar to the existing Mean High Water Springs (MHWS) tide level of RL 1.39 and below the predicted constant tidal boundary condition of RL 2.89m used by the updated (Auckland Council RFHA model ID 1399, 2023).

Auckland Council GeoMaps does not show the *existing* areas of flooding but does show predicted future flood plains and flood prone areas, along with overland flow paths for the site. These areas have been established by modelling the 1% AEP rainfall event (Maximum Probable Development (MPD) - 80% impervious) and 3.8 degrees climate change scenario using 2016 LiDAR data. Refer to AECOM Memorandum Whenuapai Rapid Flood Hazard Assessment 03 Jun 2016 and Auckland Council Memo Whenuapai RFHA Model Update 1 September 2023 for details.

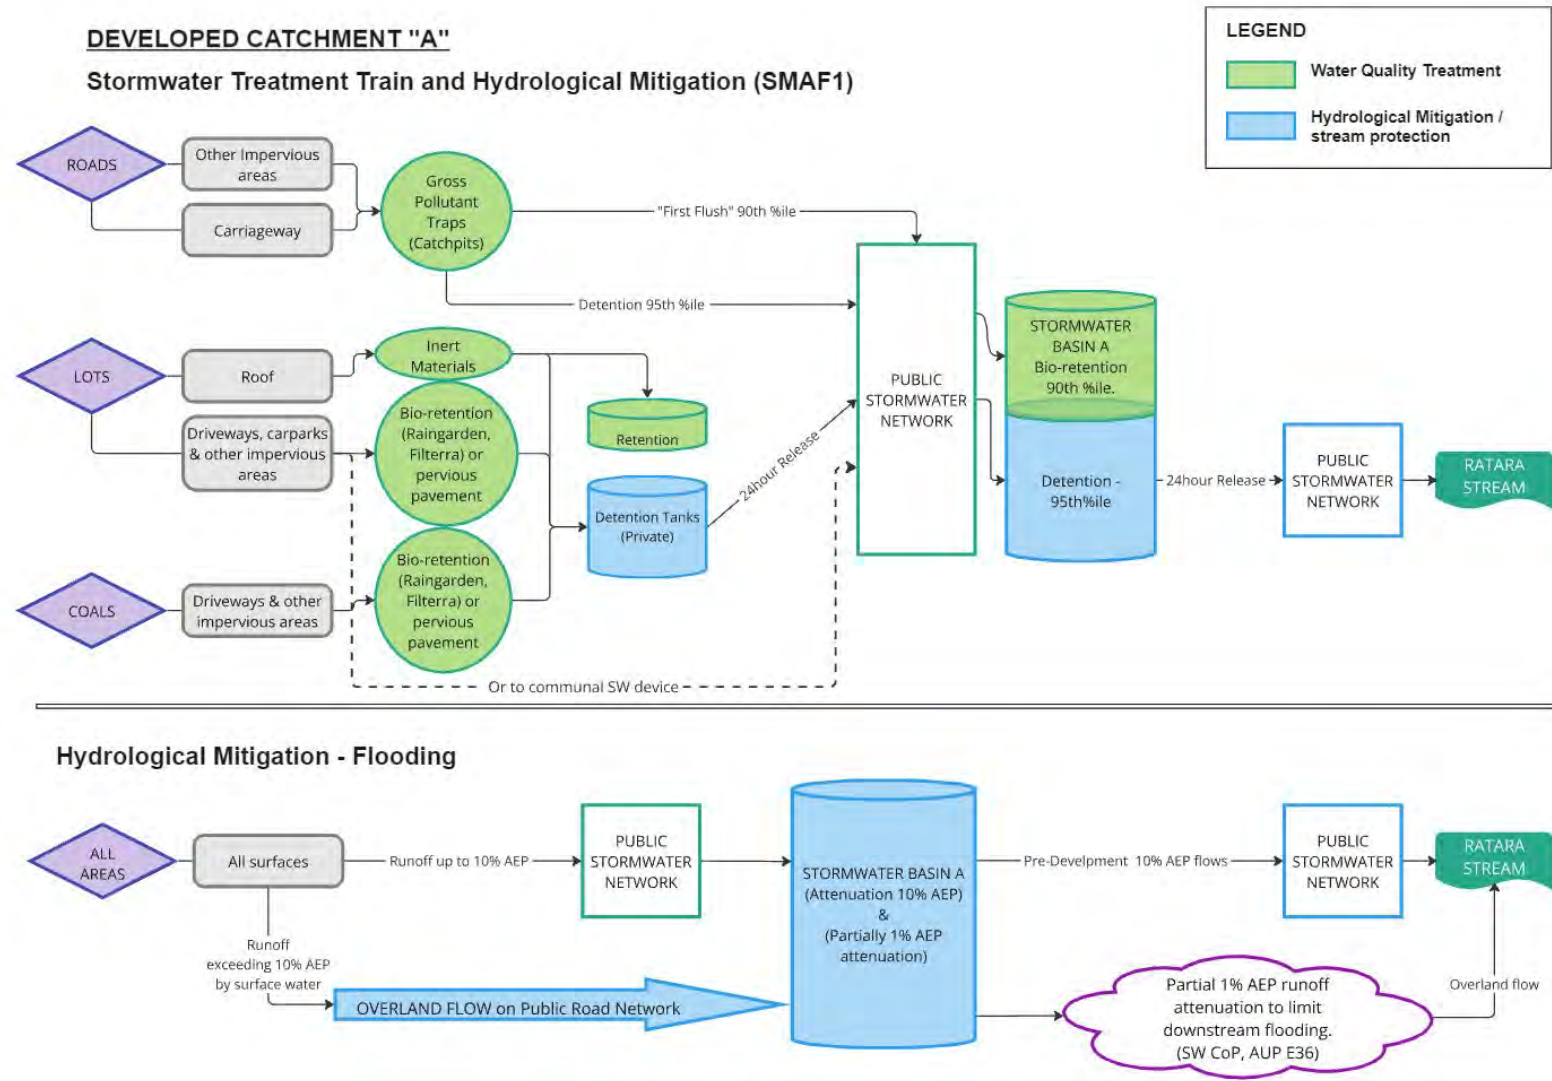
Figure 7: Developed Catchment "A". Stormwater Treatment Train and Hydrological Mitigation.

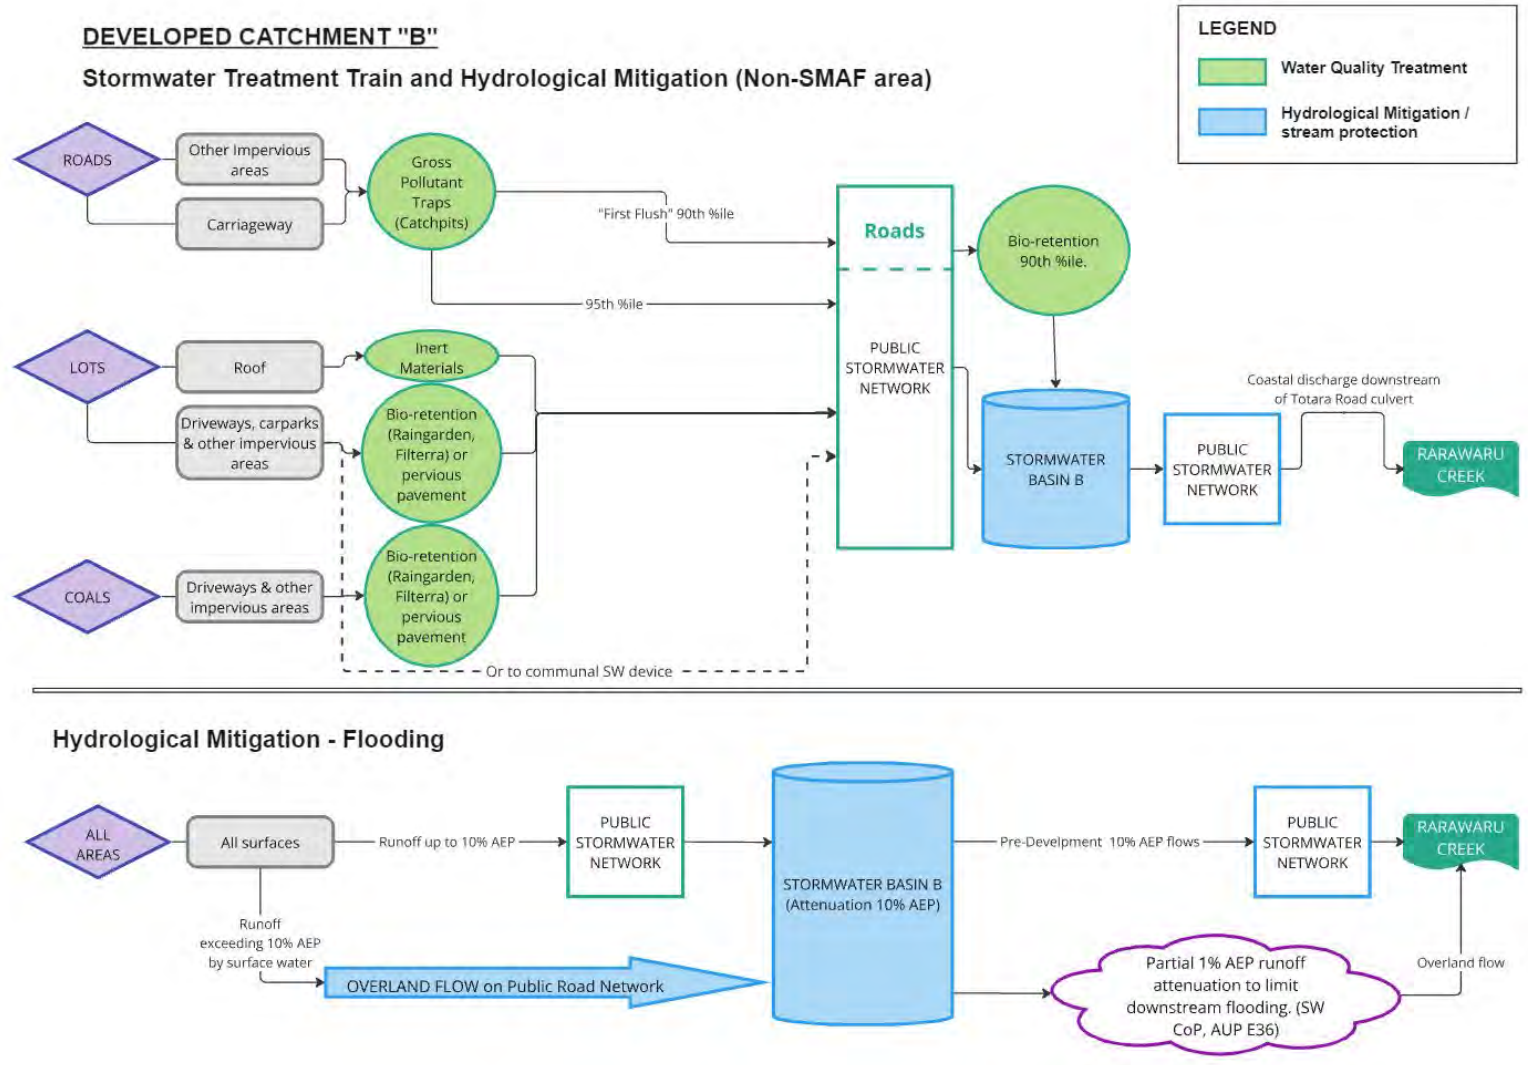
Figure 8: Developed Catchment "B". Stormwater Treatment Train and Hydrological Mitigation.

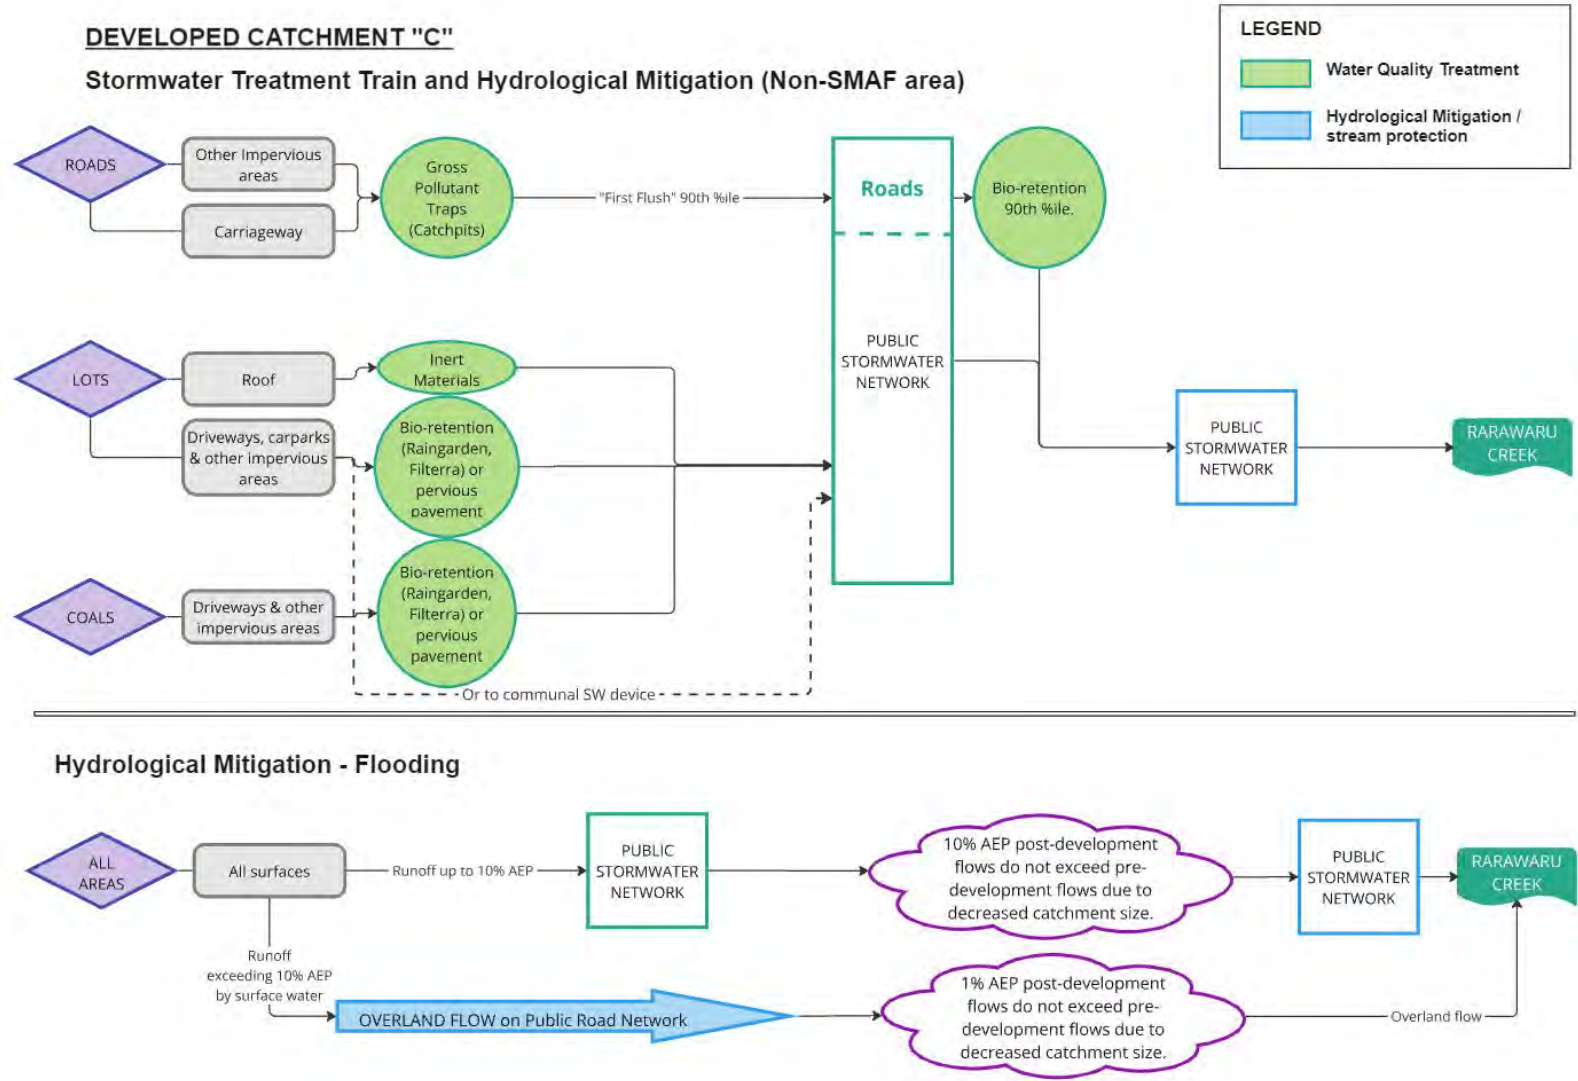
Figure 9: Developed Catchment "C". Stormwater Treatment Train and Hydrological Mitigation.

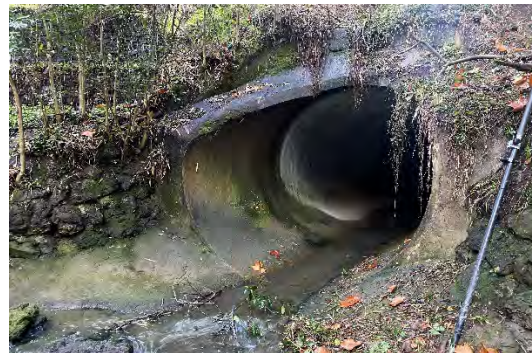
Figure: 6-2: Existing Totara Road DN2300mm culvert (view from downstream end)

The existing DN2300mm culvert is situated outside the proposed Plan Change Area at Totara Road (road sag), as shown in Figure: 6-1 below, providing flow continuity to the existing Rarawaru Creek. Table 6-1 provides a summary of the parameters used in the hydraulic model:

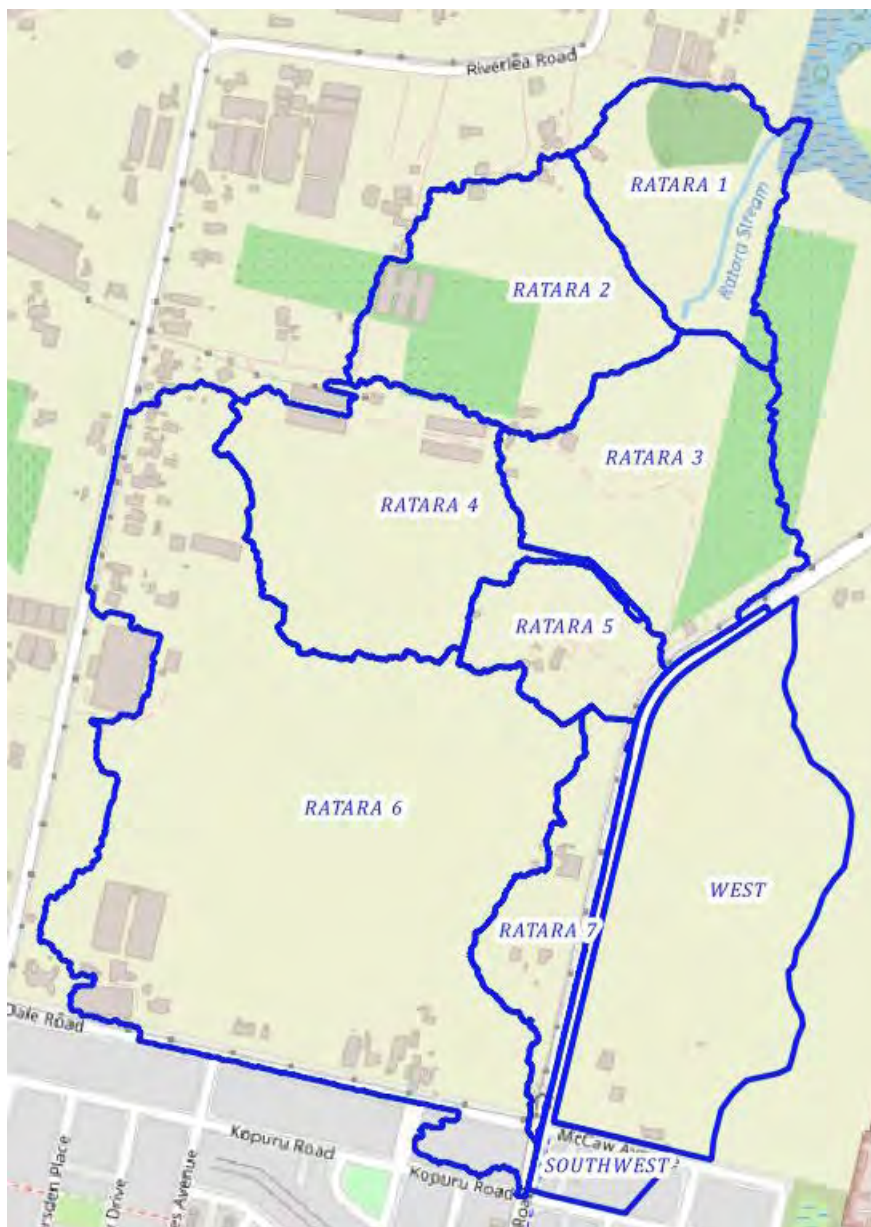
Figure 10-1 Ratara Stream Catchment delineation.

Catchment ID	Total Area (ha)	Imperviousness (%)	Tc Imperv. (min)	Tc Perv. (min)
WEST	9.353	0.83	11.1	10.9
SOUTHWEST	1.454	80%	10.0	10.0
RATARA 1	3.9700	1.3%	10.0	10.0
RATARA 2	5.5900	6.2%	10.0	10.0
RATARA 3	5.9500	3.8%	10.0	10.0
RATARA 4	6.2797	7.0%	14.5	14.3
RATARA 5	2.2200	8.0%	10.0	10.0
RATARA 6	22.140	11.1%	24.5	24.0
RATARA 7	2.4752	17.8%	10.7	10.5

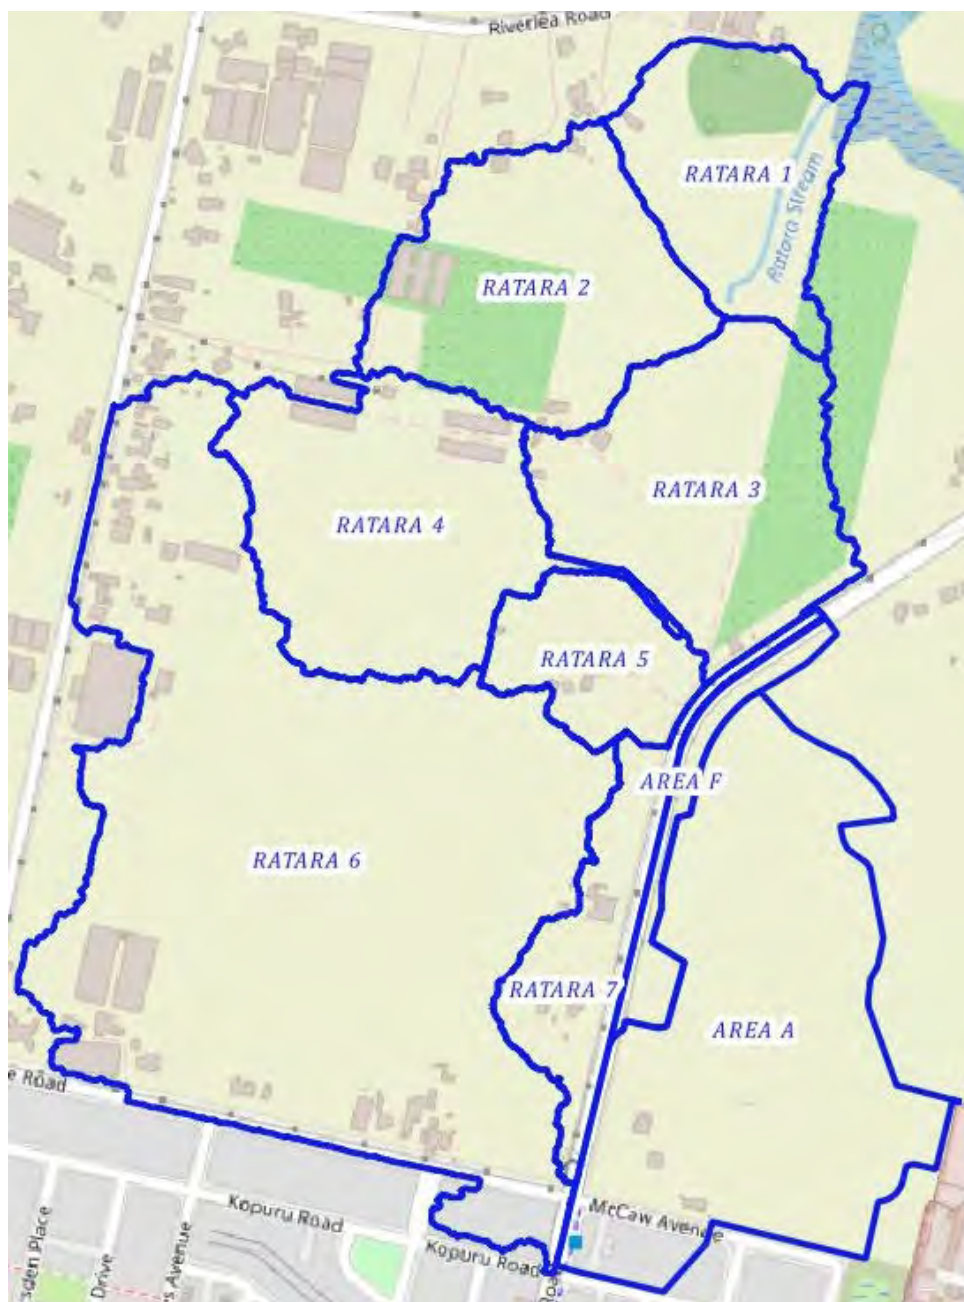
Figure 10-2: Ratara Stream Catchment delineation (Whenuapai Green developed).

Catchment ID	Total Area (ha)	Imperviousness (%)	Tc Imperv. (min)	Tc Perv. (min)
AREA A	10.581	64.2%	11.1	10.9
AREA F	1.017	85%	10.0	10.0
RATARA 1	3.9700	1.3%	10.0	10.0
RATARA 2	5.5900	6.2%	10.0	10.0
RATARA 3	5.9500	3.8%	10.0	10.0
RATARA 4	6.2797	7.0%	14.5	14.3
RATARA 5	2.2200	8.0%	10.0	10.0
RATARA 6	22.1400	11.1%	24.5	24.0
RATARA 7	0.0248	17.8%	10.7	10.5

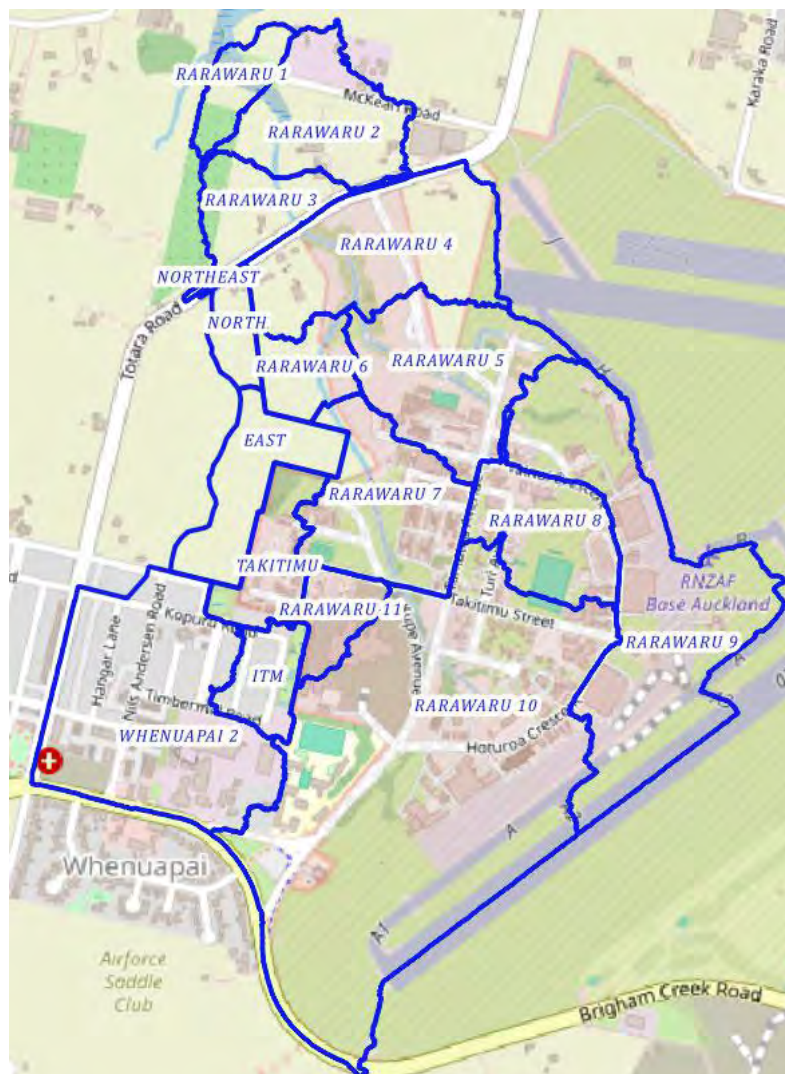
Figure 10-3: Rarawaru Creek Catchment delineation (Existing conditions).

Catchment ID	Total Area (ha)	Imperviousness (%)	Tc Imperv. (min)	Tc Perv. (min)
RARAWARU 1	2.4000	0.8%	10.0	10.0
RARAWARU 2	7.2599	13.4%	10.0	10.5
RARAWARU 3	4.2258	9.4%	10.0	10.0
RARAWARU 4	11.0830	6.0%	10.4	18.1
RARAWARU 5	3.1060	16.1%	10.4	18.3
RARAWARU 6	3.4990	0.1%	10.0	17.4
RARAWARU 7	8.6010	40.7%	10.2	17.9
RARAWARU 8	6.3454	40.4%	10.0	10.0
RARAWARU 9	19.1311	52.8%	15.4	27.0
RARAWARU 10	43.3620	45.1%	19.1	33.4
RARAWARU 11	2.5600	20.0%	10.0	10.0
TAKITIMU	2.8010	22.4%	10.0	16.1
WHENUAPAI 2	17.1620	68.0%	13.0	22.7
ITM	2.8000	23.7%	10.0	12.7
NORTH	1.7620	0.0%	10.0	10.8
EAST	5.2500	0.0%	10.0	10.0

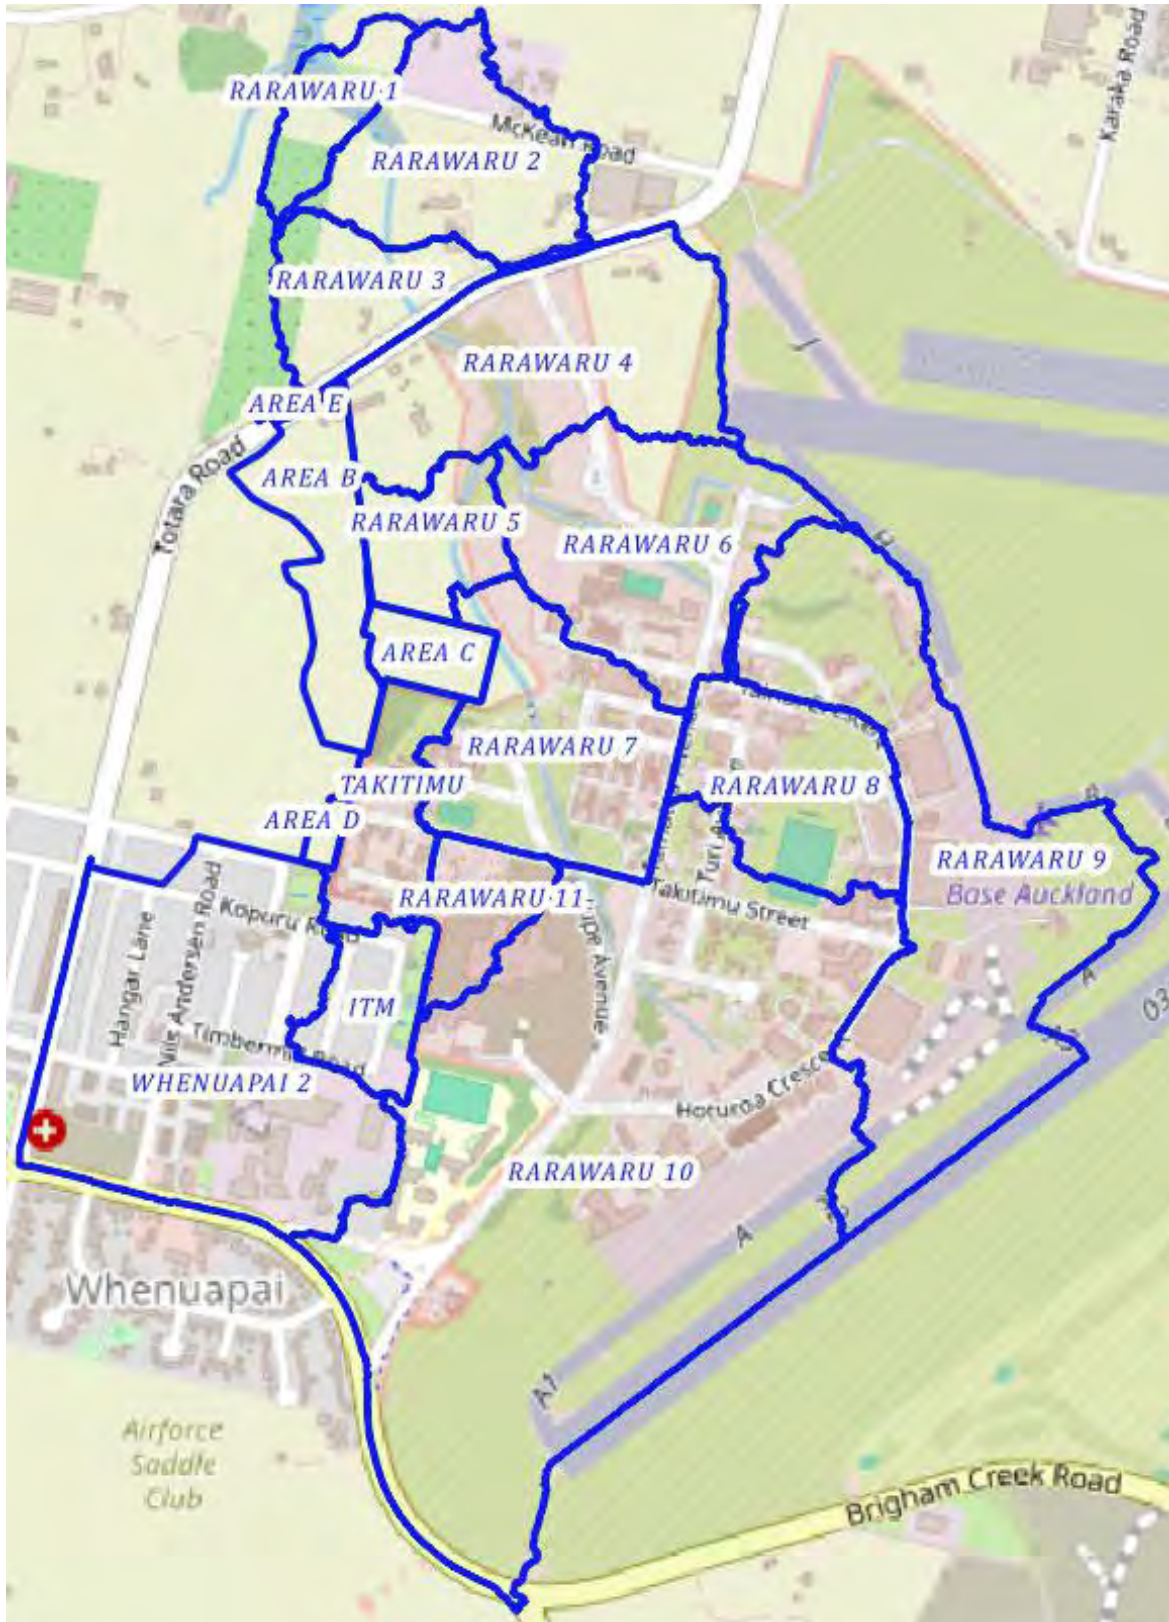
Figure 10-4: Rarawaru Creek Catchment delineation (Whenuapai Green developed).

Catchment ID	Total Area (ha)	Imperviousness (%)	TC Imperv. (min)	TC Perv. (min)
RARAWARU 1	2.4000	0.8%	10.0	10.0
RARAWARU 2	7.2599	13.4%	10.0	10.5
RARAWARU 3	4.2258	9.4%	10.0	10.0
RARAWARU 4	11.0833	6.0%	10.4	18.1
RARAWARU 5	3.1060	16.1%	10.4	18.3
RARAWARU 6	3.4994	0.1%	10.0	12.9
RARAWARU 7	8.6010	40.7%	10.2	17.9
RARAWARU 8	6.3454	40.4%	10.0	10.0
RARAWARU 9	19.1311	52.8%	15.4	27.0
RARAWARU 10	43.3620	45.1%	19.1	33.4
RARAWARU 11	2.5600	20.0%	10.0	10.0
TAKITIMU	2.8010	22.4%	10.0	16.1
WHENUAPAI 2	17.1620	68.0%	13.0	22.7
ITM	2.8000	23.7%	10.0	12.7
AREA B	4.2700	58.7%	10.0	10.8
AREA C	1.5170	69.0%	10.0	10.0

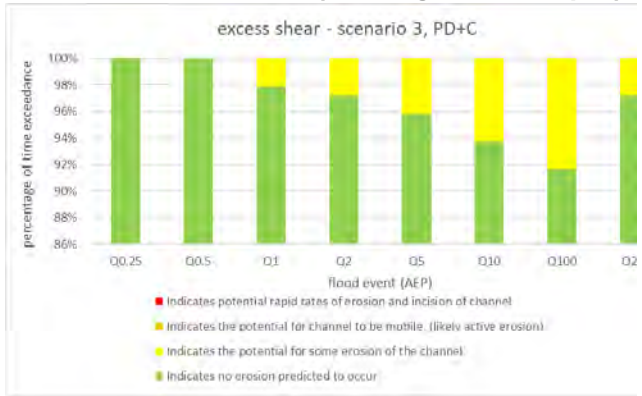
Cross-section A-A – Pre vs Post excess shear stress time of exceedance (Future rainfall depth)

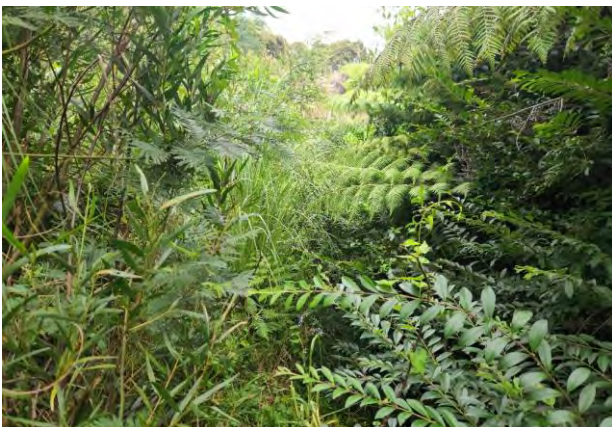
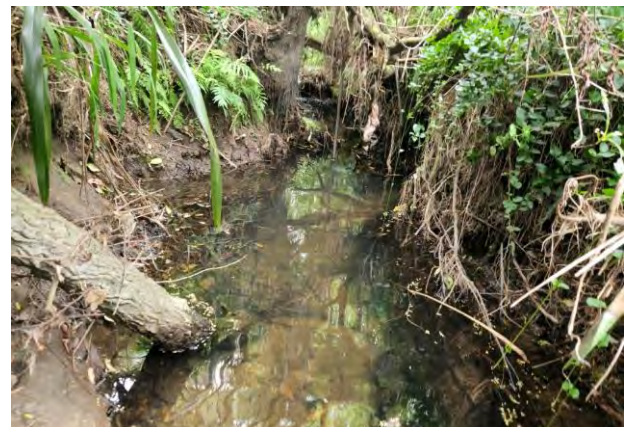
Figure 6: a) Vegetation around the unnamed tributary P1 and b) Organic input and bank stream P1.

The stream reach of this unnamed tributary (P1) within the site was well-shaded by the riparian vegetation described in section 4.1 and had a good amount of organic matter input. The stream provided moderate habitat for fauna with a good mix of pools and runs, and the substrate was comprised of a mix of bedrock, soft sediment and cobble.

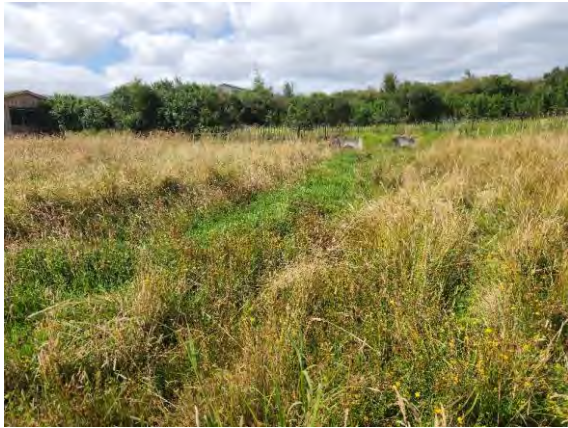
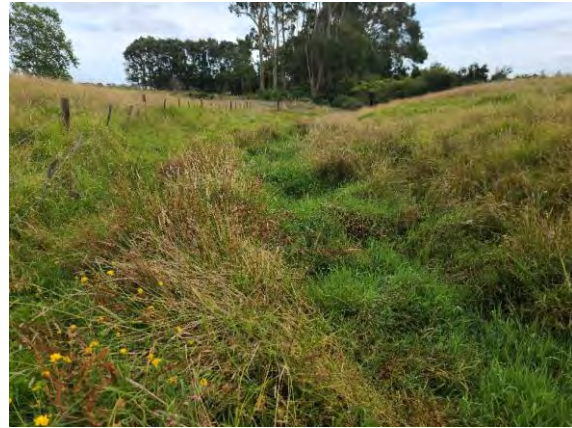
Figure 7. Mercer grass, soft rush, shallow channel and lack of shading along a) I1 and b) I2.

Two watercourses within the site have been identified as intermittent streams (Figure 7). These intermittent streams drained to the Rawawaru Creek and the greater Waitematā harbour. The intermittent stream reaches within the site had little riparian vegetation present, and the riparian margin consisted of managed pasture with very limited shading, organic matter input, and filtration functions. The streams are full of mercer grass and banks with soft rush (Figure 7).

The intermittent waterways were considered to currently have **low** ecological values. When water is present, they have the potential to support some of the fish species listed in Table 4, including At Risk – Declining fish species, specifically longfin eels. However, observations on site suggest water is not regularly present or present for long periods of time. Therefore, the likelihood of fish other than the tolerant shortfin eel being present is low.

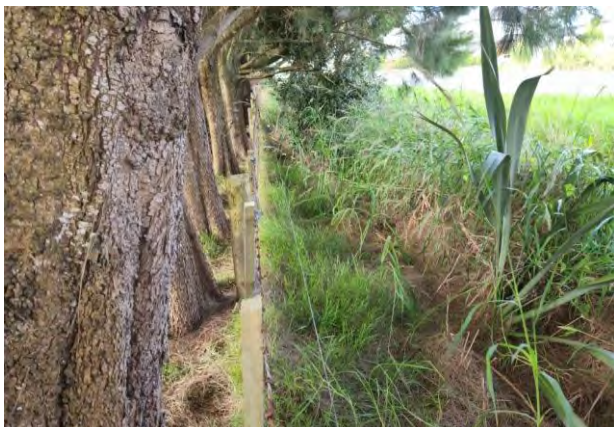
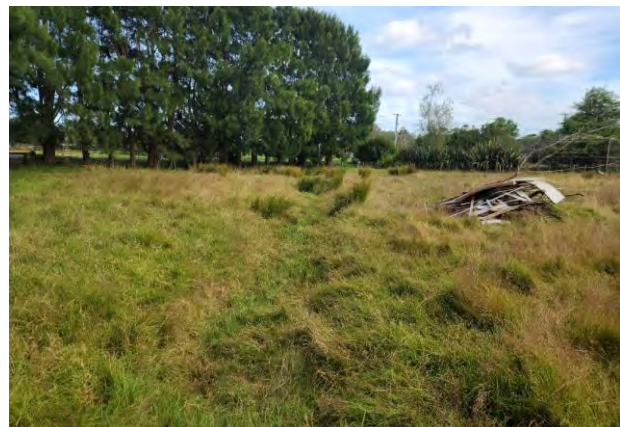
Figure 8: a) Example of artificial channel along the road on the southwestern corner of the site and b) artificial channel that cuts through the corner of the site.

Artificial channels also run along some site boundaries as roadside drains (Figure 8). The channel labelled A3 flowed along the northwestern boundary of the site and appeared to be dry. Another roadside drain, A2, which connects to an artificial drain A1 for farm purposes on the southwestern boundary of the site, also appeared dry.

The ecological value of the artificial drains was considered to be **negligible** due to their artificial nature and the channels being dry and considered likely to be dry for the majority of the time.

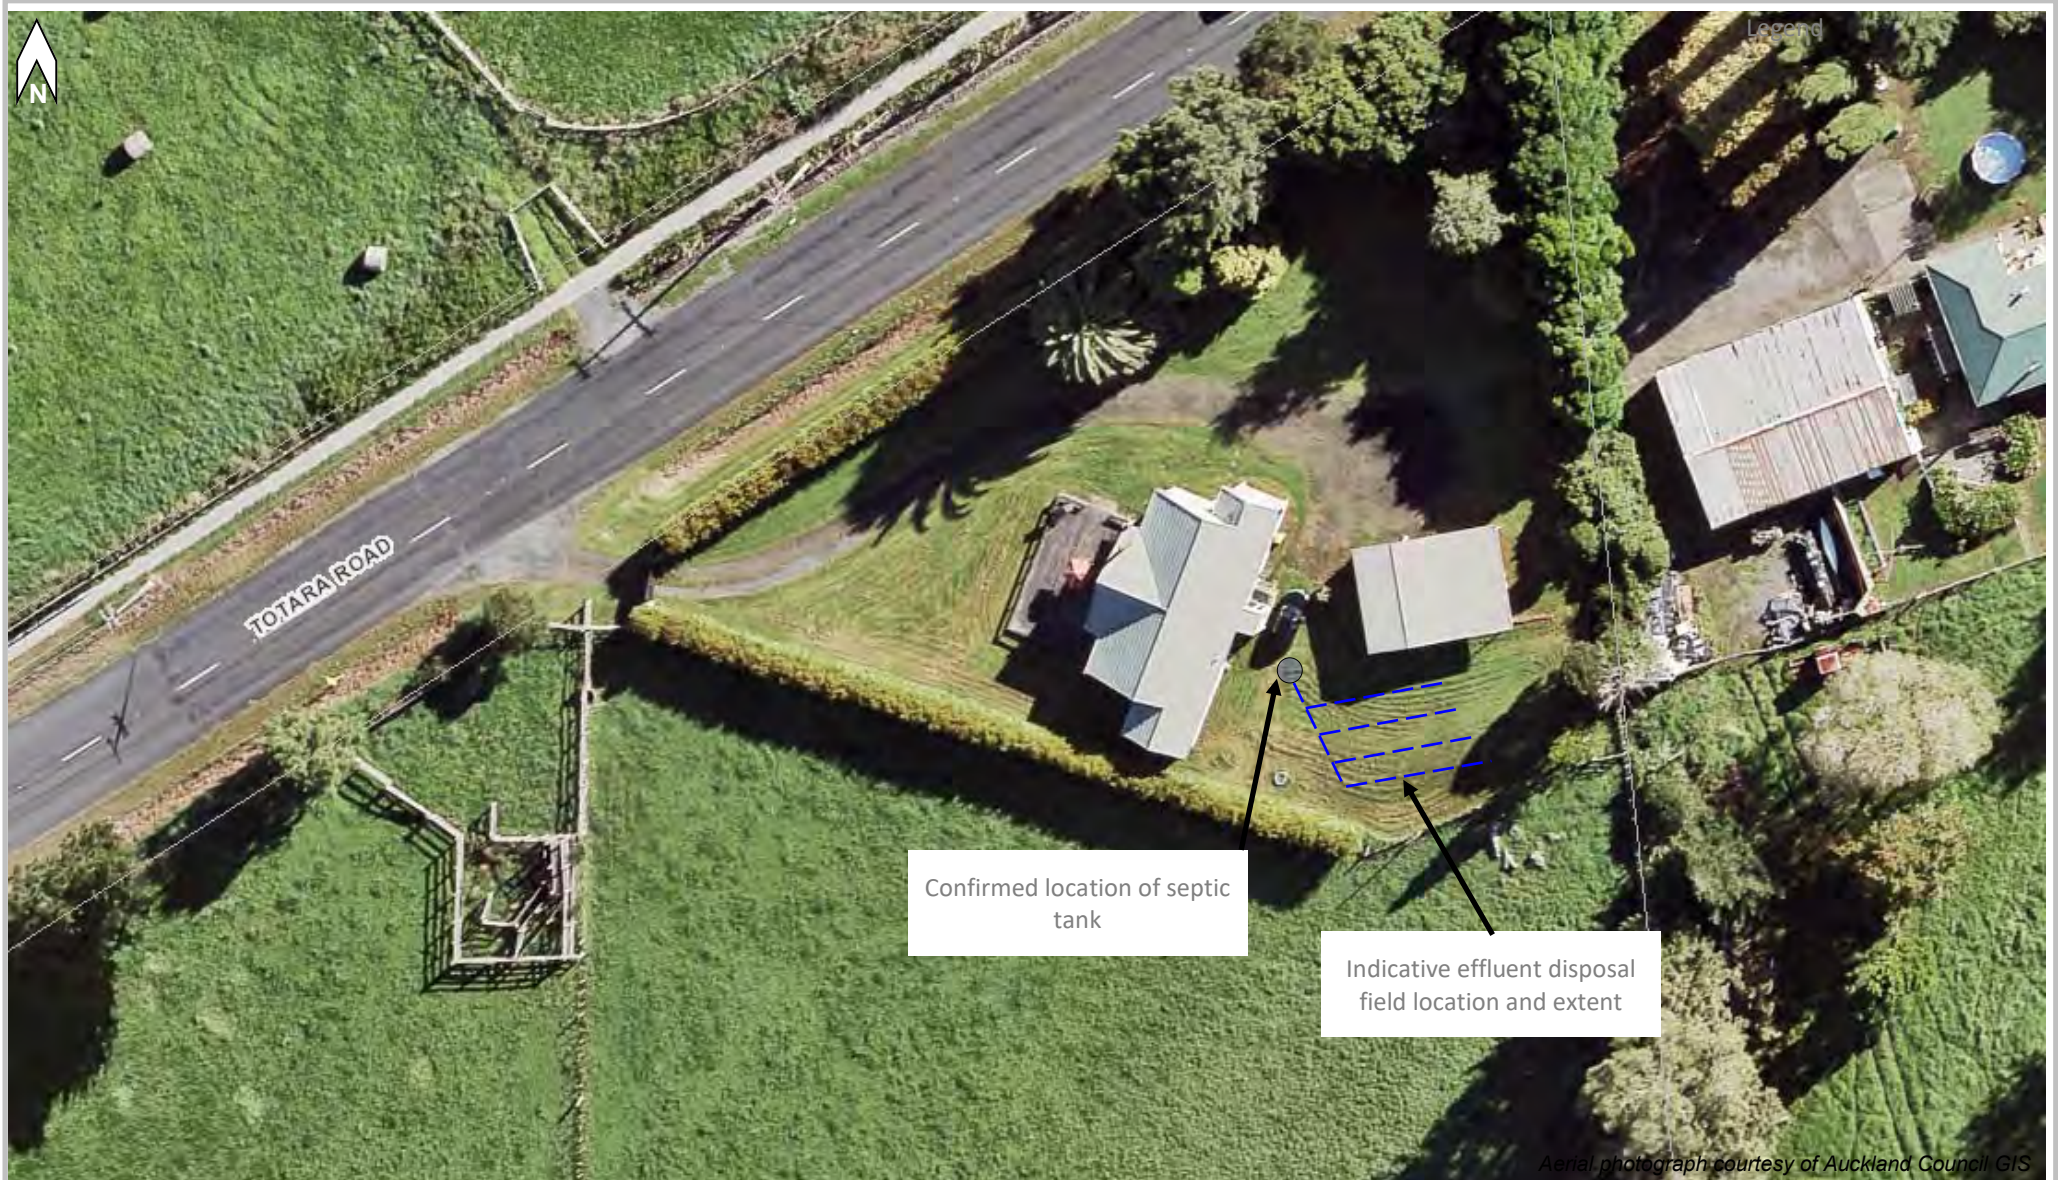
<p>geosciences Ltd ENVIRONMENTAL</p>	<p>Title:</p>	<p>Figure 2 - Septic Tank and Disposal Field Location</p>	<p>Reference: J1173 Date: 09/05/2018</p>
<p>Level 1, 47 Clyde Road, Browns Bay, 0630 Tel: (09) 475 0222</p>	<p>Project name:</p>	<p>98-100 Totara Road, Whenuapai</p>	<p>Drawn: DW Approved: COB</p>

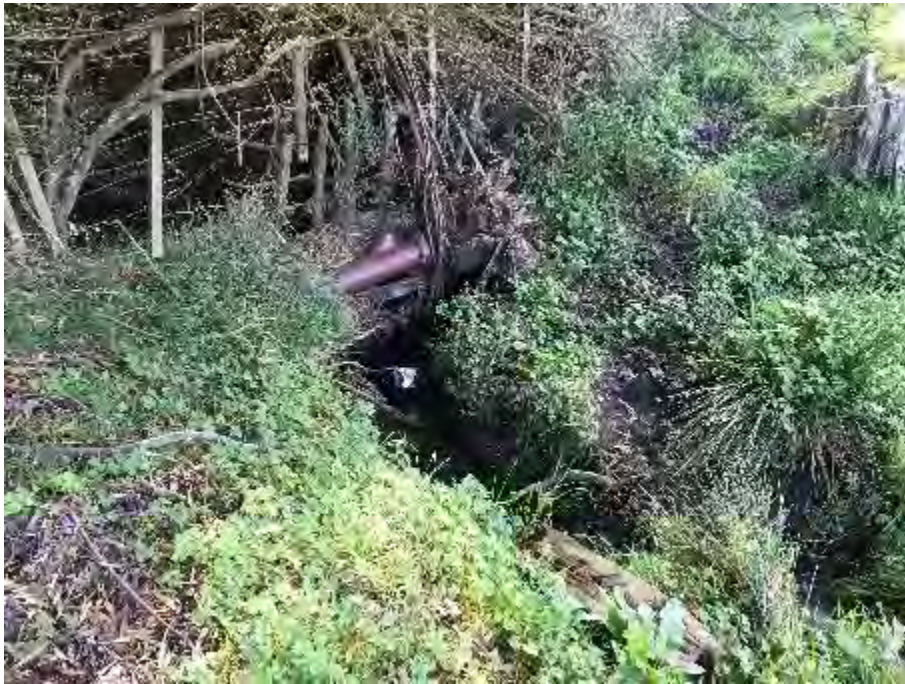
PLATE 5: CREEK RUNNING ACROSS EASTERN PORTION OF SITE

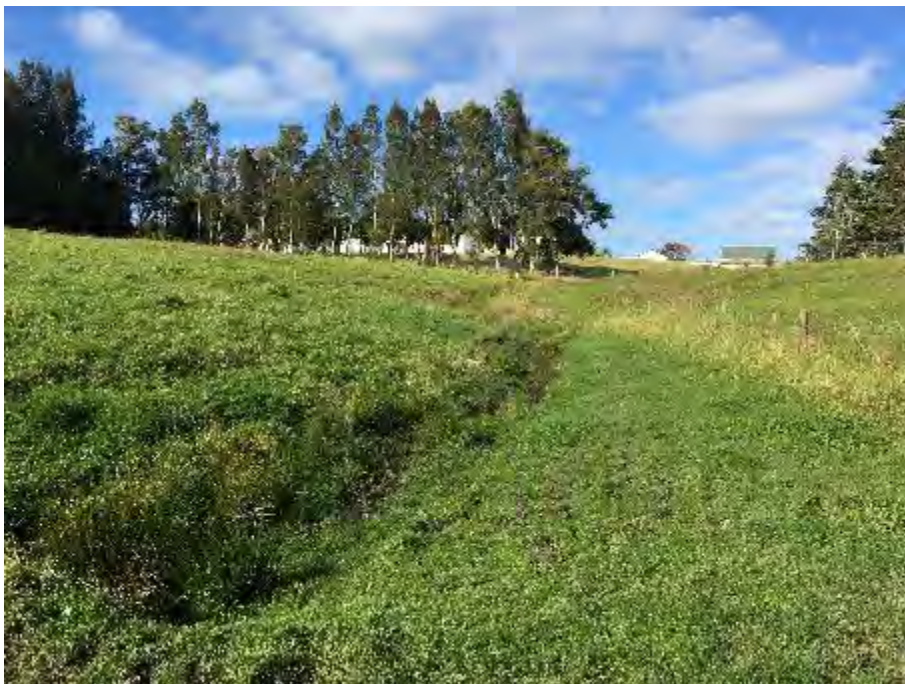
PLATE 6: CREEK RUNNING FROM AIRBASE ACROSS EASTERN PORTION OF SITE

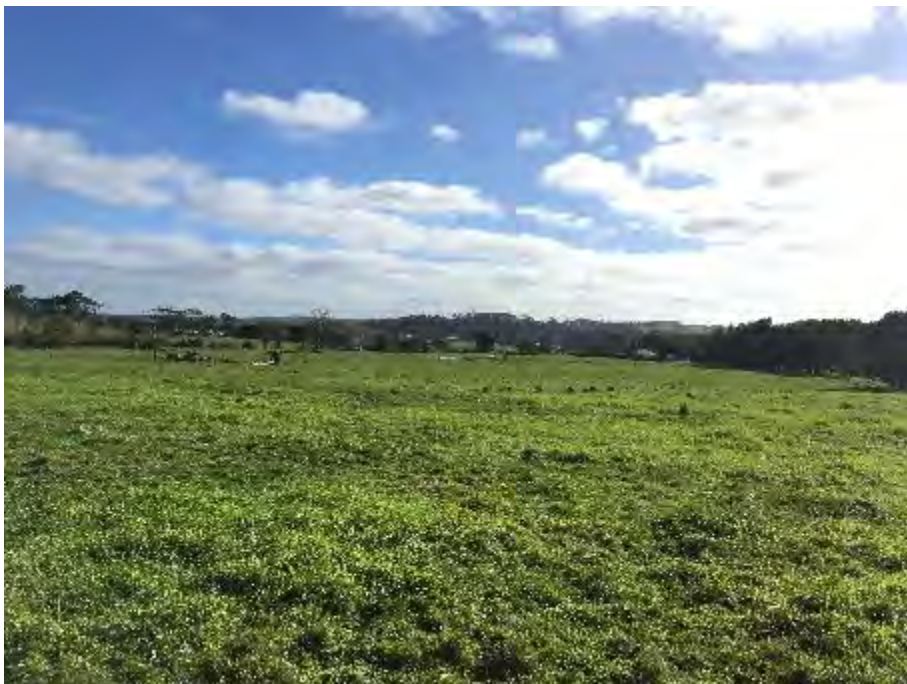
PLATE 8: SITE VIEWED FROM THE SOUTHERN BOUNDARY LOOKING NORTH
