**SITE-SPECIFIC
STORMWATER
MANAGEMENT
PLAN (SMP)**

WHENUAPAI GREEN

98-100 & 102 Totara Road, Whenuapai

For Private Plan Change

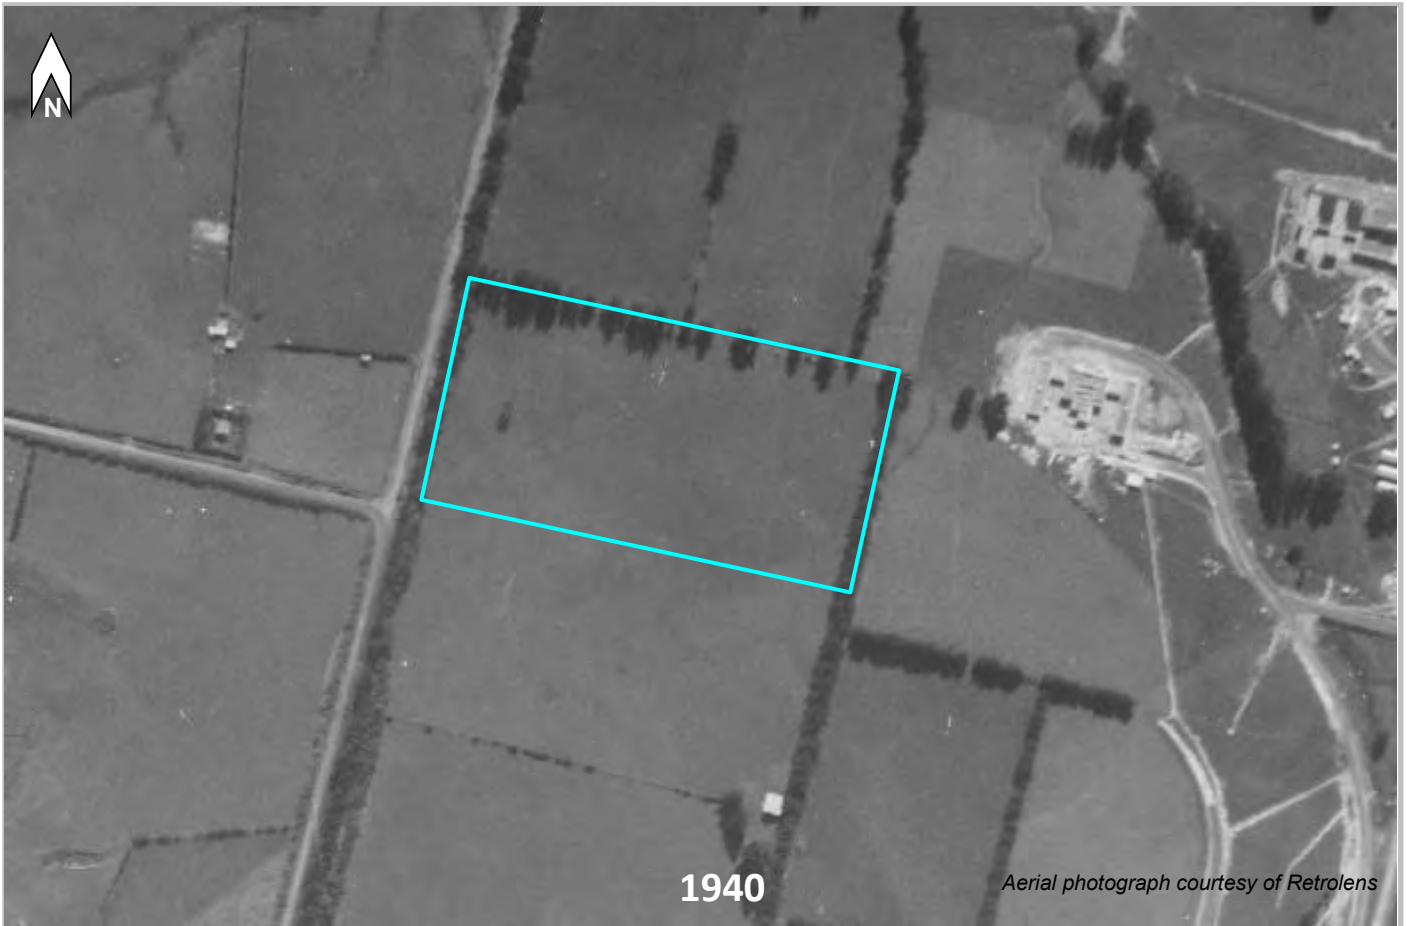
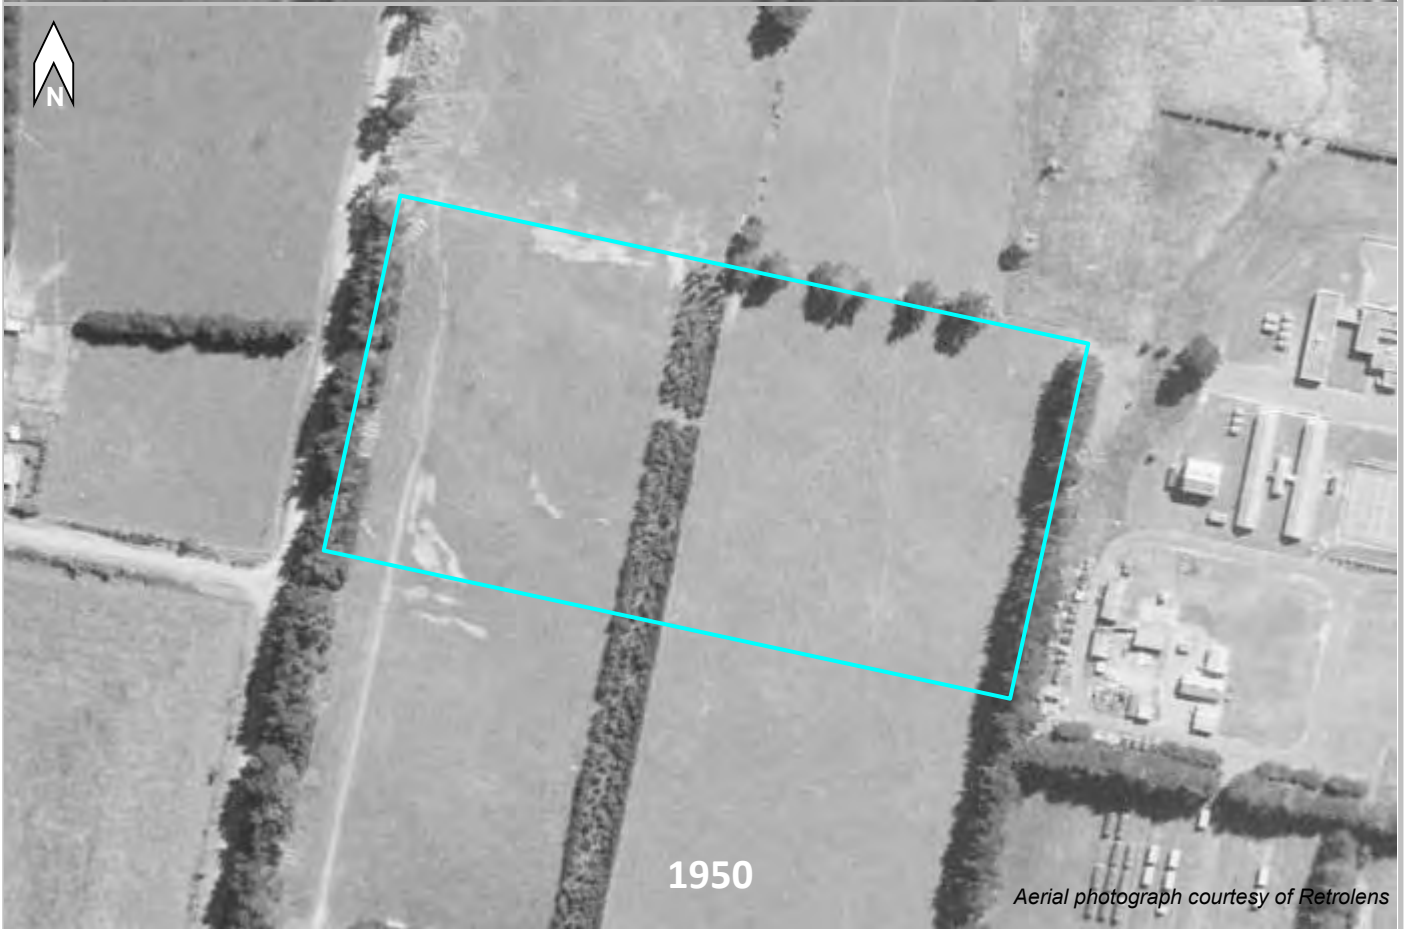
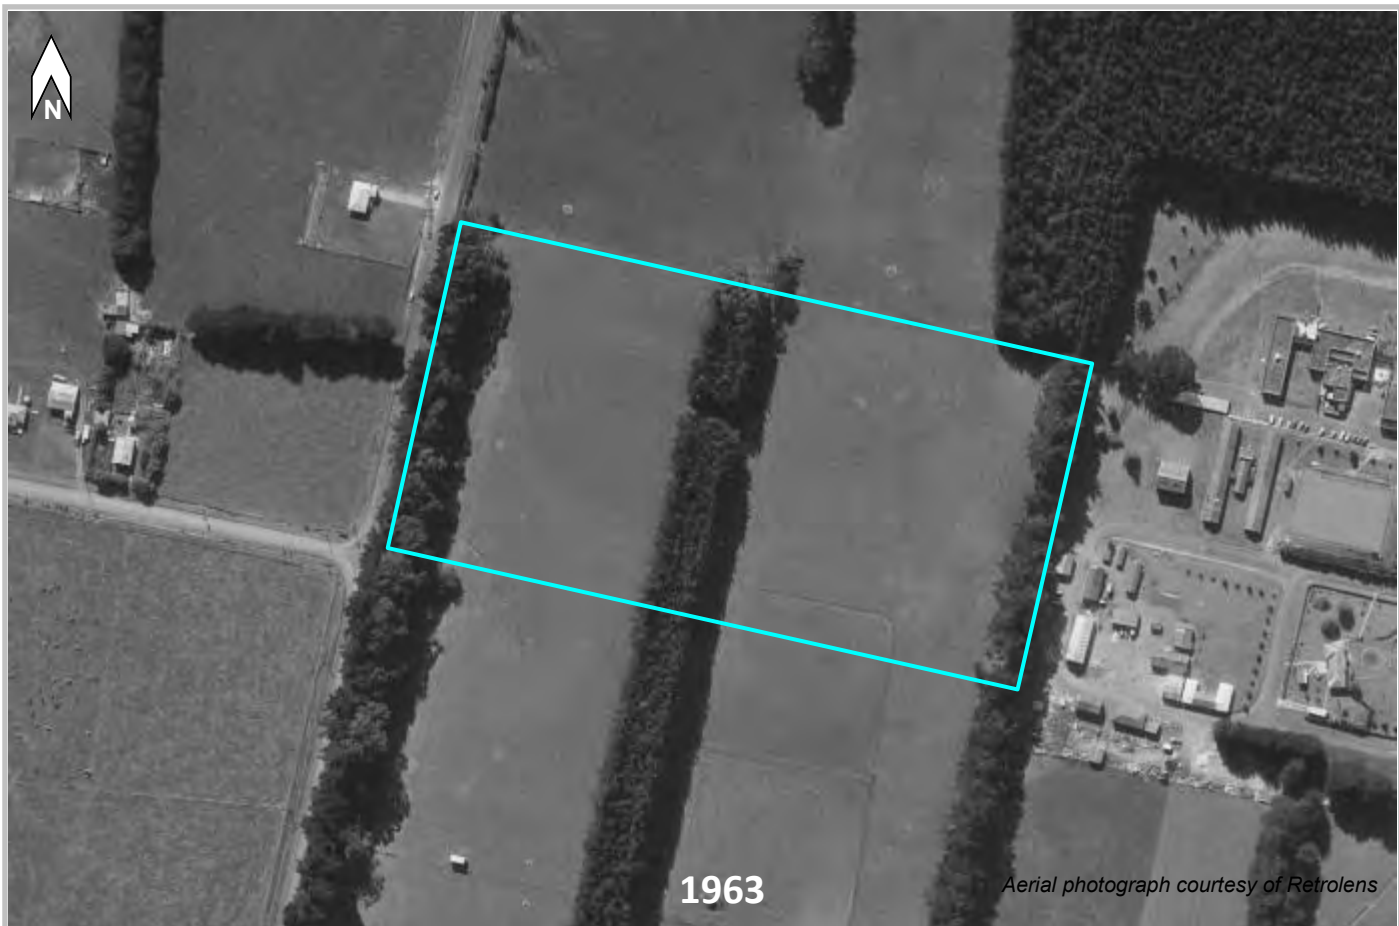
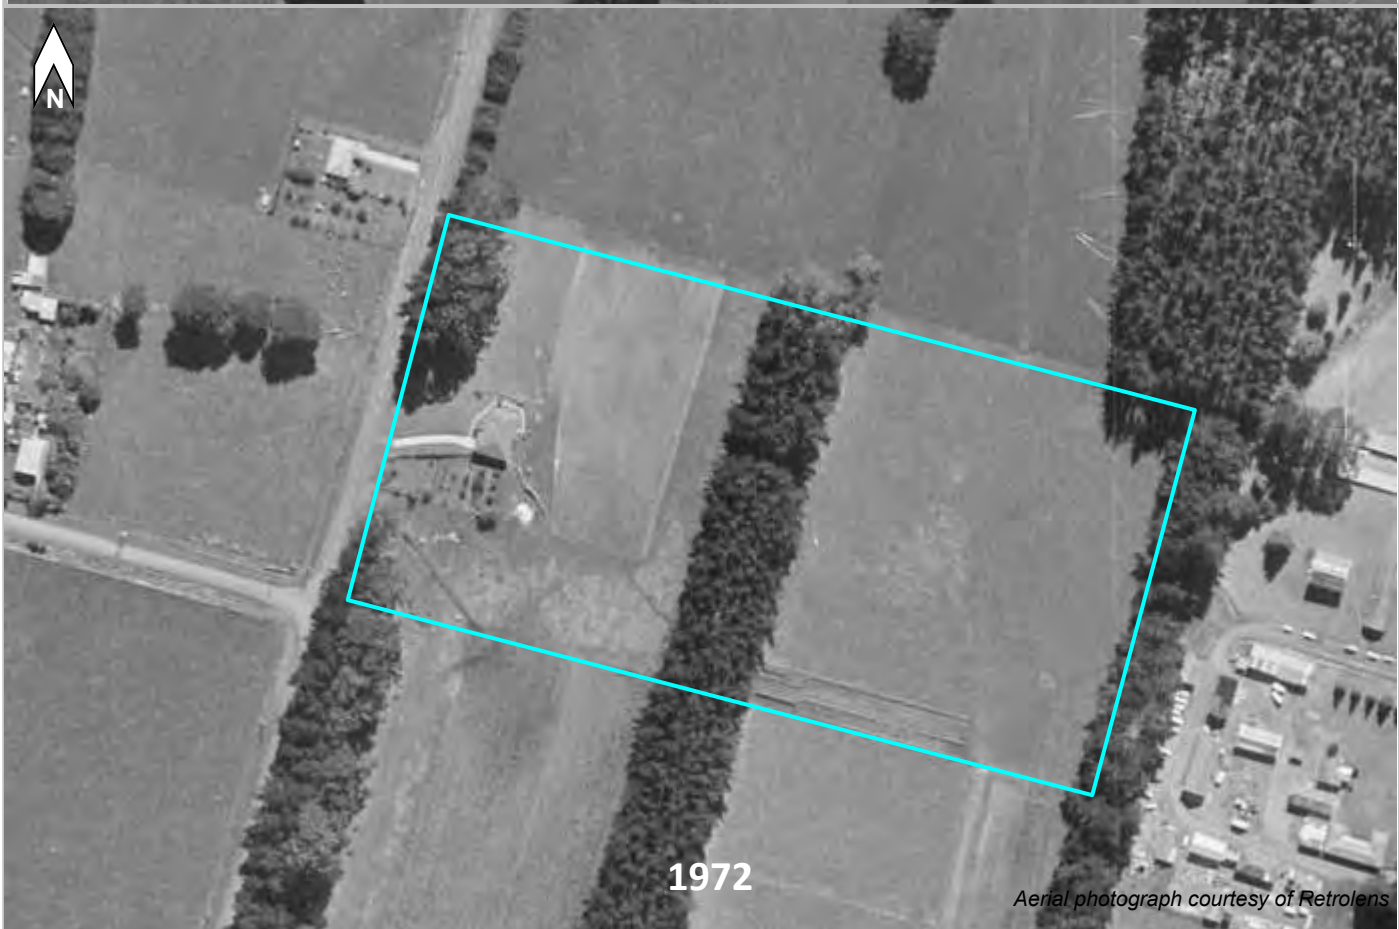
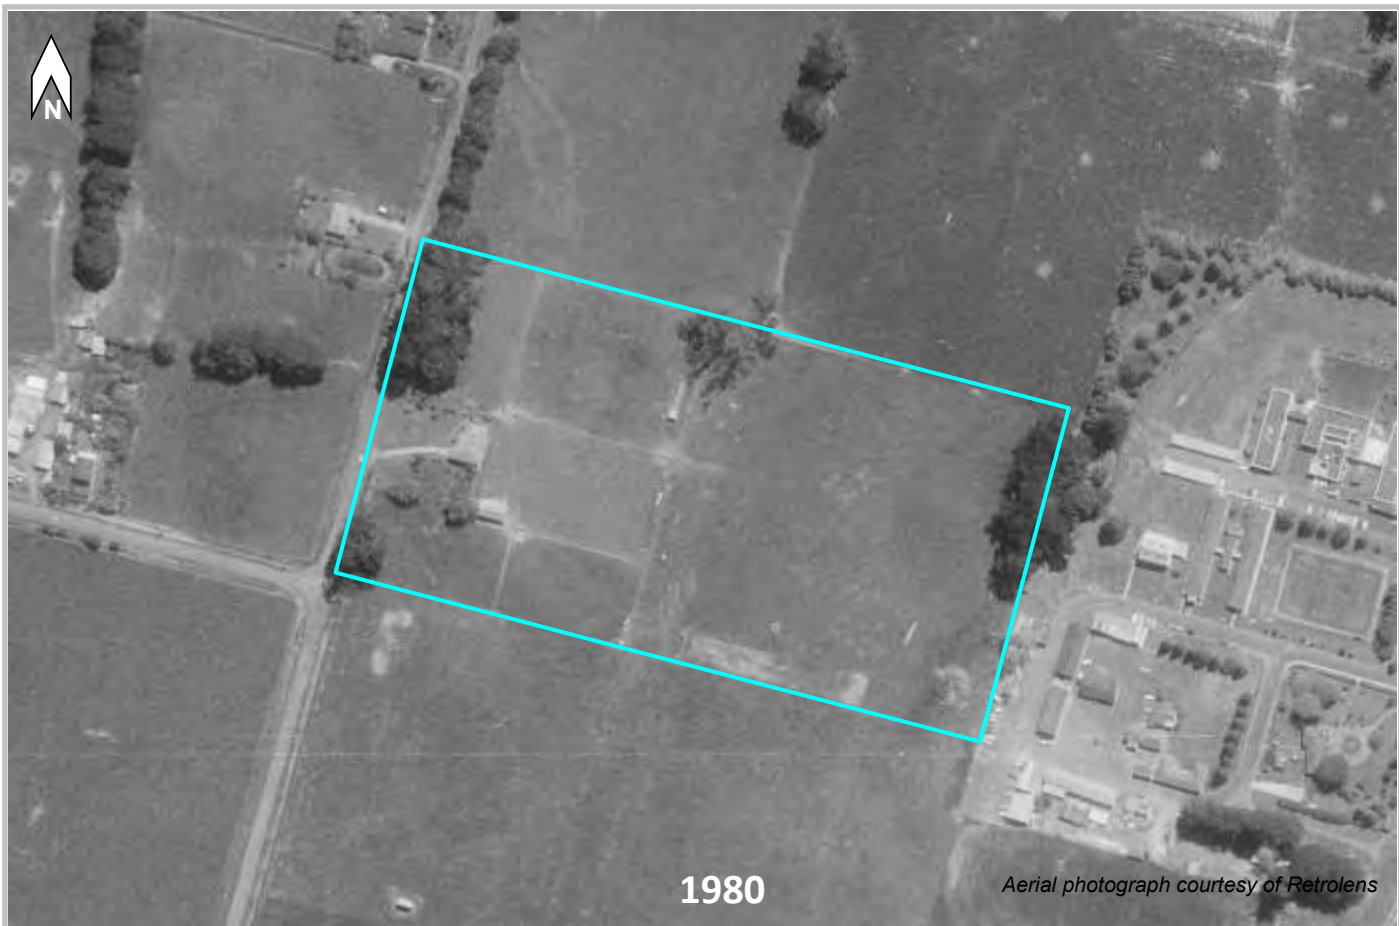
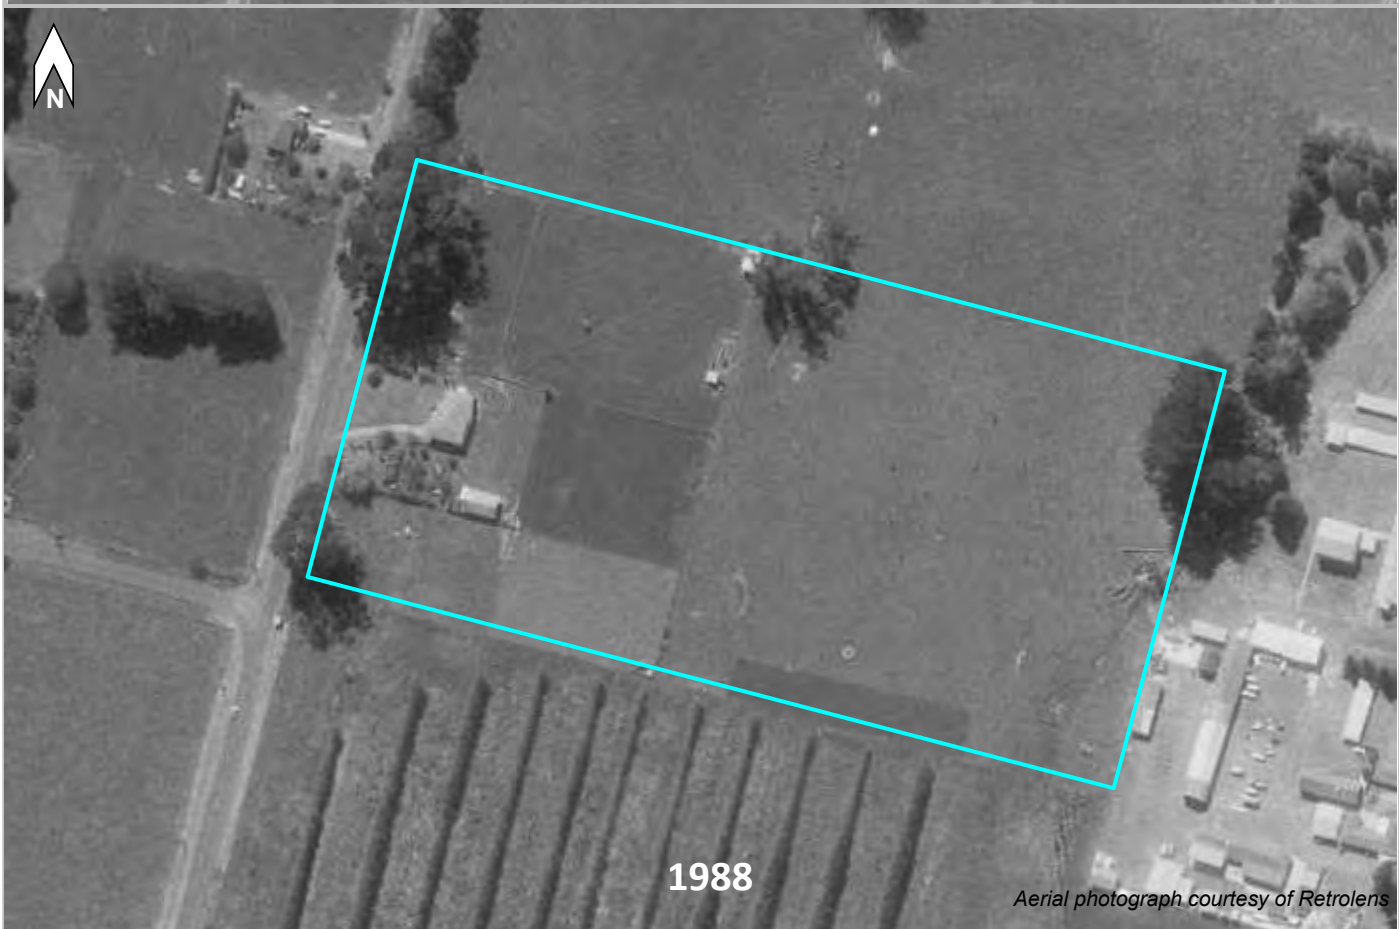
Title:	Figure 1—Historic aerials	Reference: J1394
Project name:	102 Totara Road, Whenuapai	Date: 17/09/2019

- 1980-1988** The shelter belt previously segregating the site down the middle has been removed. To the south of the residential dwelling a shed has been erected, a second small shed with a small, fenced enclosure is noted in the approximate centre of the site adjacent to the remnants of the former shelter belt.

- 1999-2003** By 1999 a new residential dwelling has been erected along the southern boundary of the site. The small shed in the southwest paddock, noted in the previous image, has been removed. There are no other discernible developments to the site through the images from 2000, and 2003.

- 2006** The 2006 image is of much higher quality making the sites features easily discernible, the sites use remains predominantly pastoral with the two residential dwellings and barn in the southwest quadrant of the site. The small shed appears to be an animal shelter and pen first noted in the 1980 image appears to be a small animal enclosure or run. To the south of the main dwelling and barn a small apparent portacom type shed has been placed on the paddock, this is assumed to be a portable structure as it has been removed again by the 2008 image. A small domestic sized shadehouse has been constructed in the gardens to the southwest of the original dwelling.

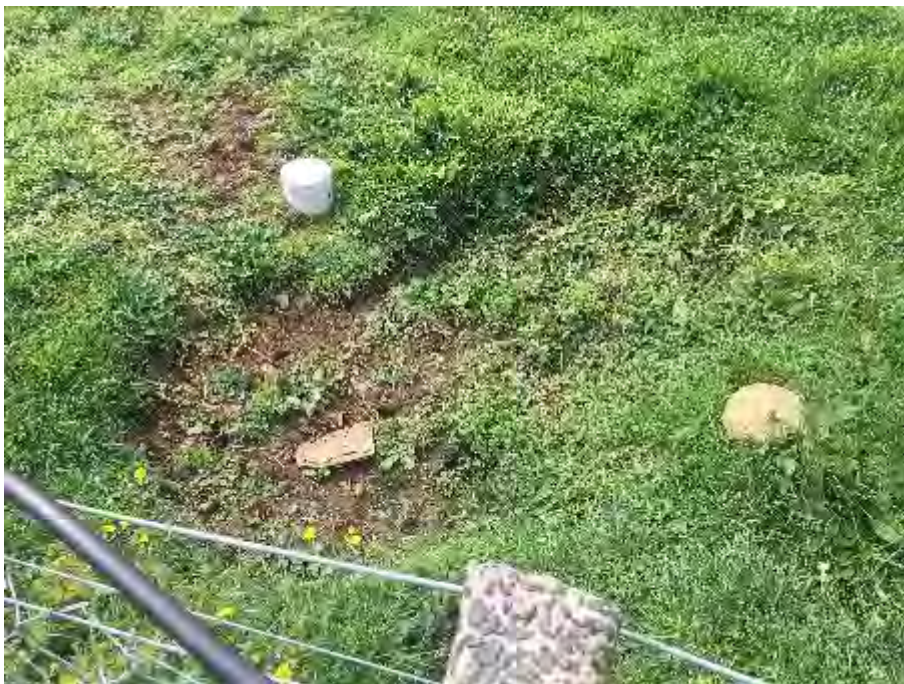
PLATE 4: BREATHER VALVE FOR SEPTIC TANK ASSOCIATED WITH THE ORIGINAL DWELLING

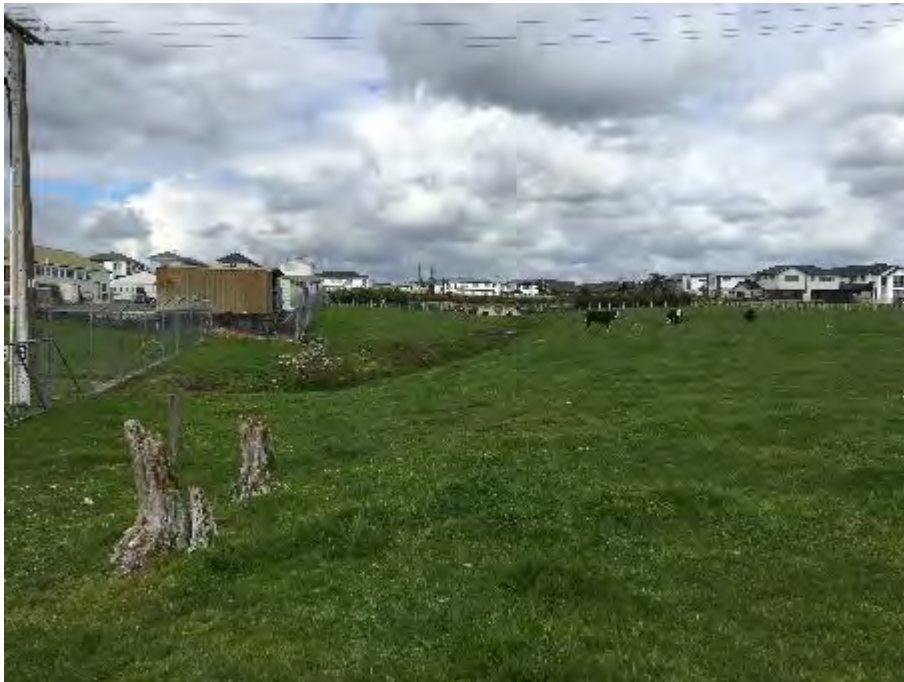
PLATE 7: STORMWATER FLOWPATH IN SOUTHEAST CORNER OF SITE, ADJACENT TO AIRBASE

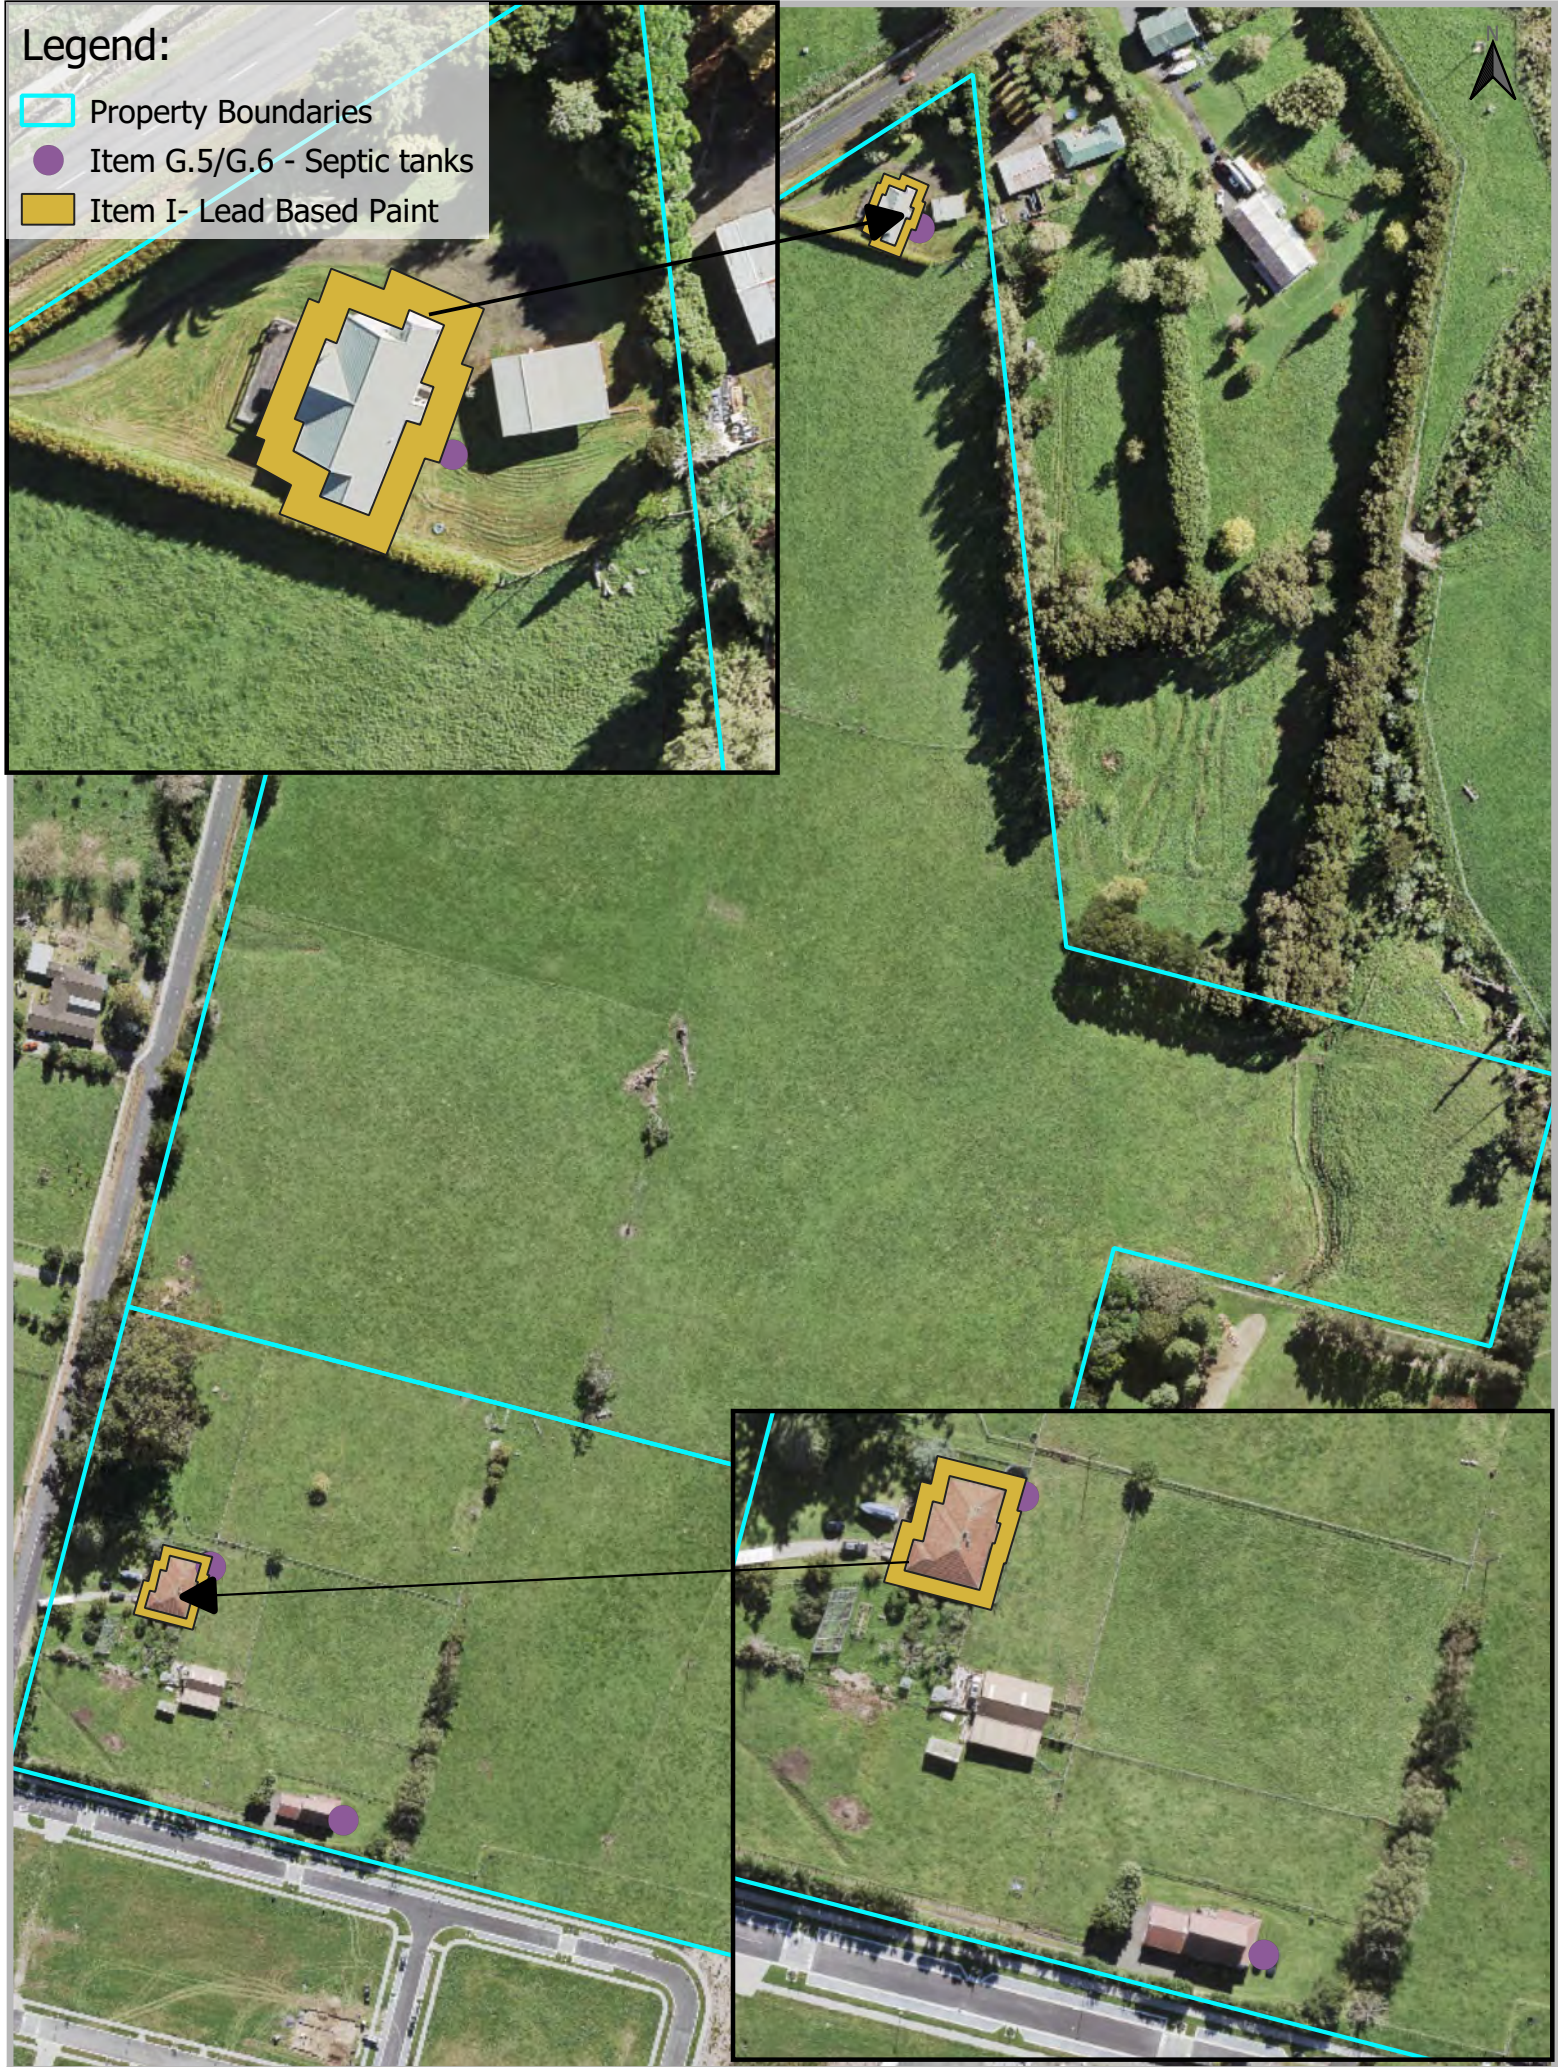
Figure 2 - Remediation Areas
98-102 Totara Road, Whenuapai
