THE HILL, ELLERSLIE RACECOURSE, AUCKLAND: ARCHAEOLOGICAL ASSESSMENT FOR PROPOSED PLAN CHANGE

Prepared for Fletcher Residential Limited

September 2023

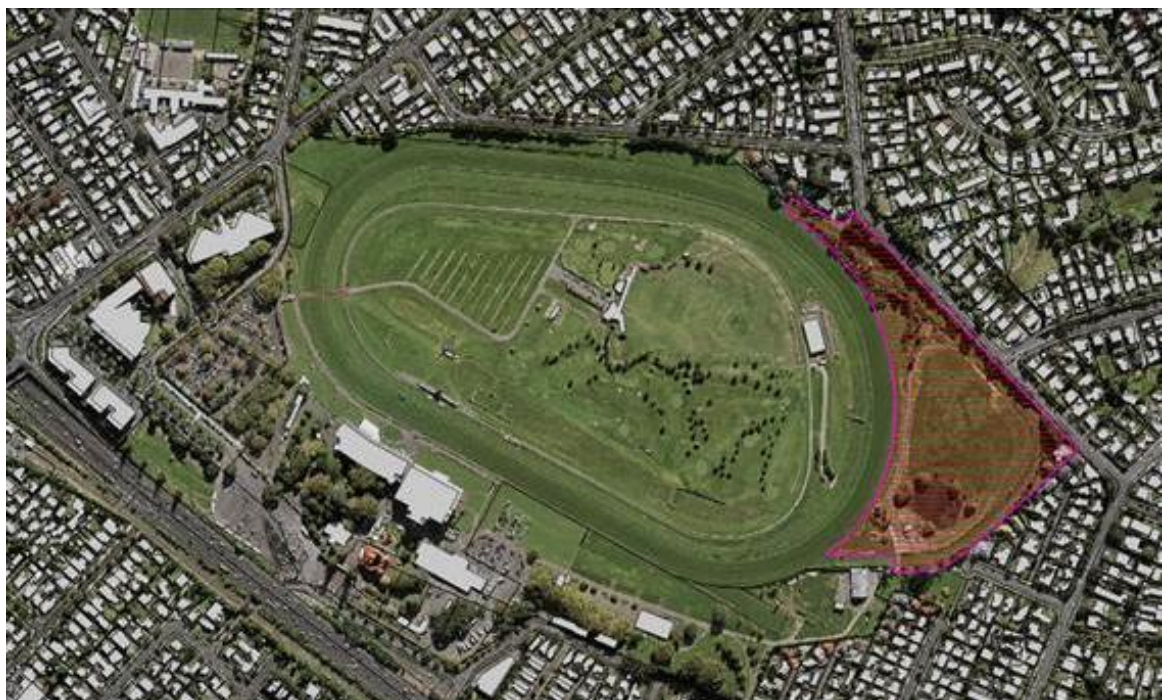
Figure 2. Ellerslie Racecourse aerial plan, with The Hill (plan change area) shaded

Auckland Thoroughbred Racing has decided to divest approximately 6.2 hectares of land from the eastern corner of the Ellerslie Racecourse Precinct (Figure 1–Figure 3). Fletcher Residential Limited (FRL) has purchased this area of land and has obtained resource consent (through the fast track process) to construct approximately 357 residential dwellings. The proposed 357 dwellings comprise a mix of detached, duplex and terrace houses, market apartments, and an apartment building for active retirement use. Building heights range from 1 to 7 storeys (above any basement levels). The Precinct is located at the western end of the racecourse site and is bound by Ladies Mile and Derby Downs Place. The area of land subject to this plan change is currently part of a Special Purpose – Major Recreation Facility Zone and a plan change is now proposed to recognise the consented residential development. The precinct is to be referenced as the Remuera Precinct (Figure 4).

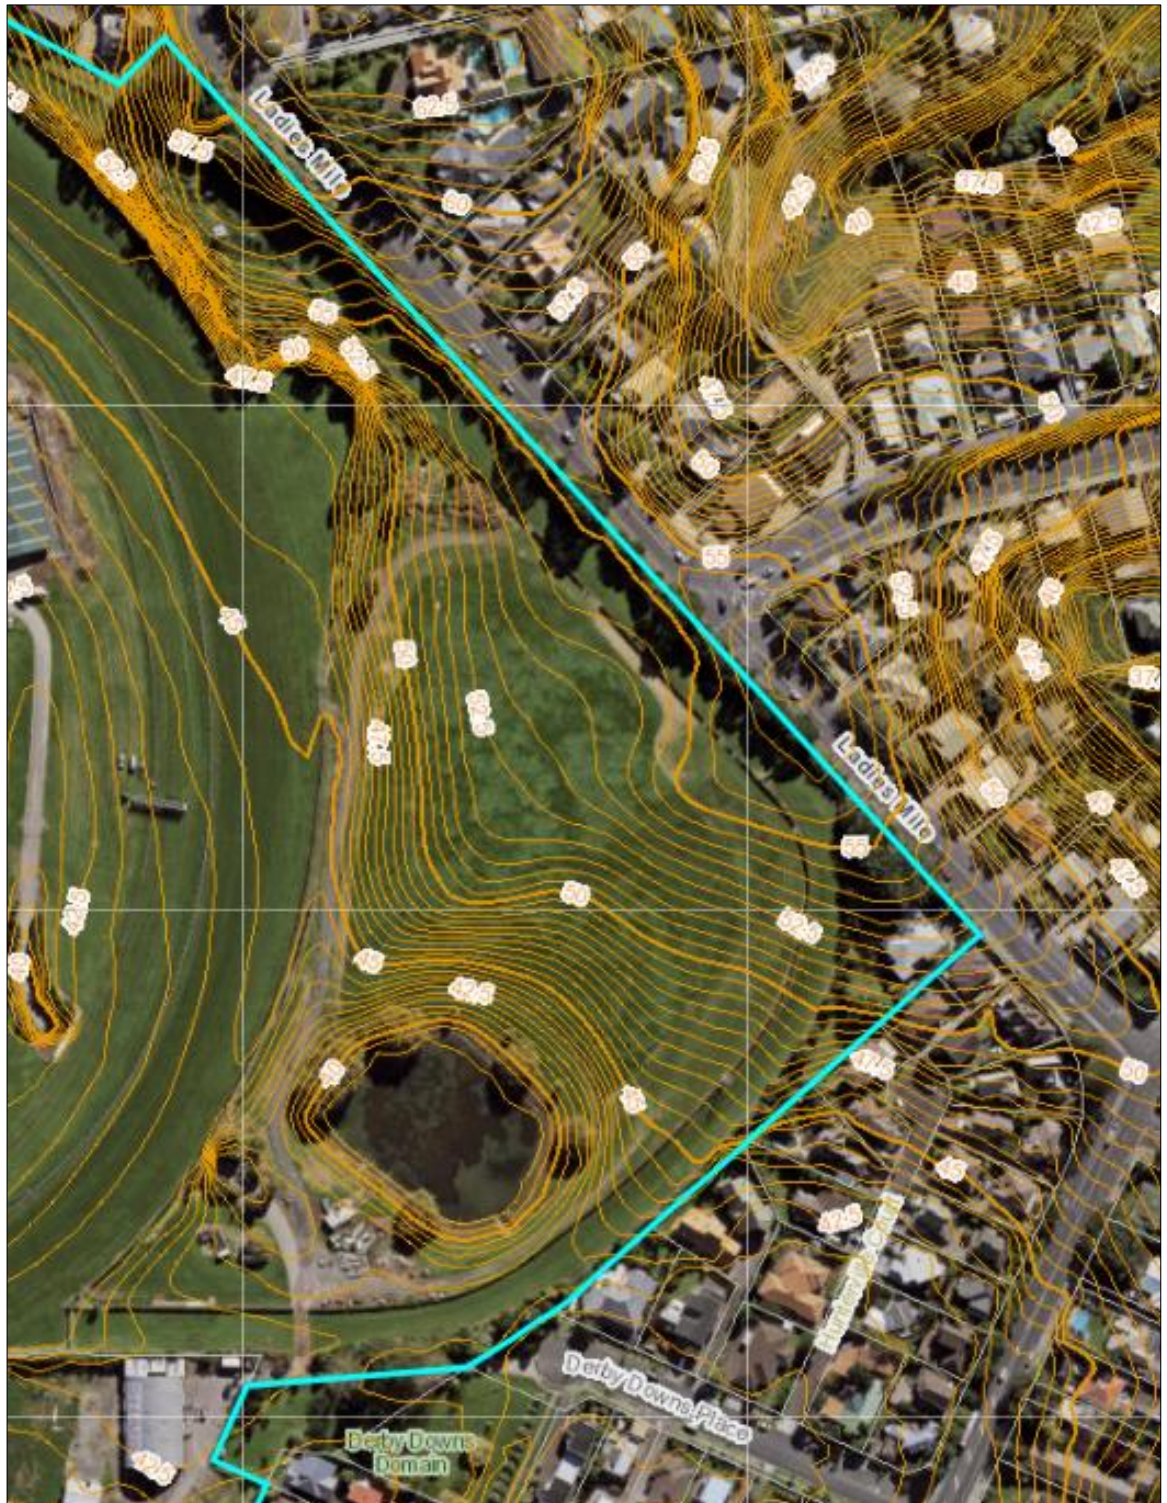
Figure 3. Aerial view of The Hill with contours overlaid (source: Auckland Council Geomaps)

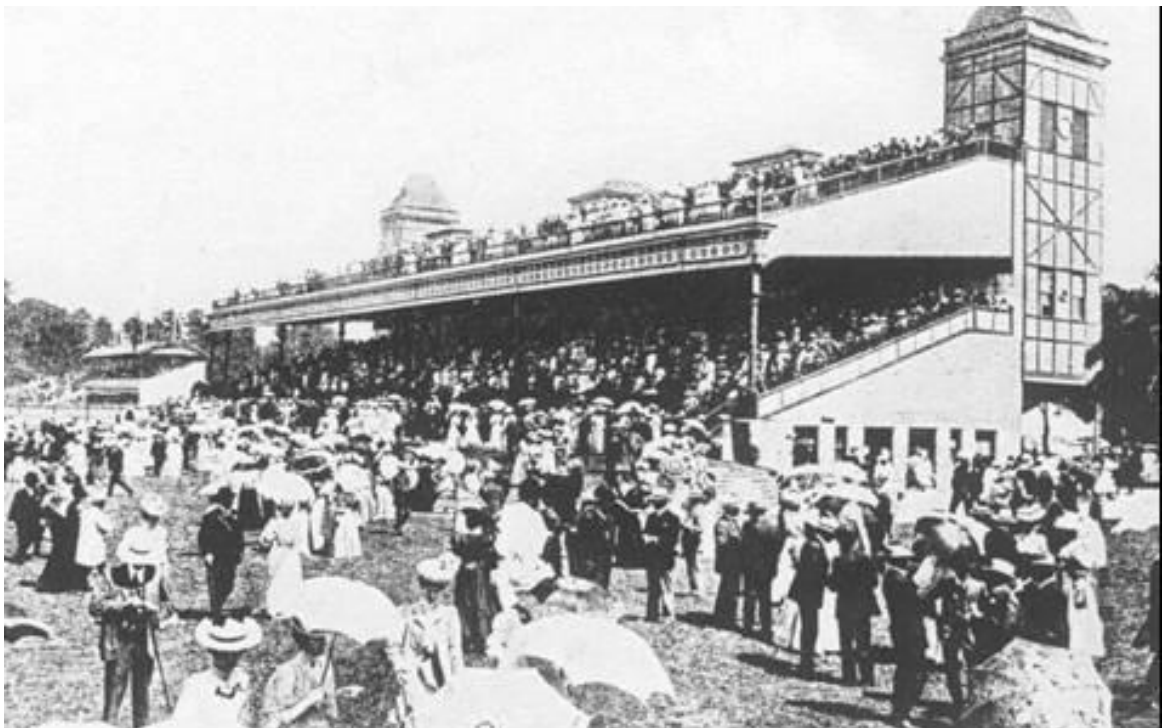
Figure 5. Main Grandstand (opened 1886) and relocated Derby Stand (to left)

The tender of John McColl for £7,436 was accepted and the new stand, with its two imposing towers and ornamental cast iron columns, was opened for the 1886-87 Summer Meeting (Figure 5). Concrete steps leading from the terrace to the lawn at the corner of the grandstand were added in 1893 and subsequently, in 1919, extended the entire length of the stand. Numerous other improvements over the years included the addition of tea/dining rooms, a ladies lounge and toilets, two new sets of stairs at the back of the lower gallery, and extra internal stairways. In 1912, the western end of the stand was extended by 52 ft (15.85m) and, four years later, the original sides of the towers were replaced with weatherboards.

Meanwhile, in 1882 the Derby Stand, a small wooden structure with a semicircular roof, had been constructed. This stand was to be relocated twice, the first time in 1886 when the new grandstand was built and again in 1920 to make way for the Leger Stand. As of 1974 it was located in what was known as the Derby enclosure. A free stand, situated in front of the Derby stand in its second position, was extended by 50ft (15.24m) around 1908.

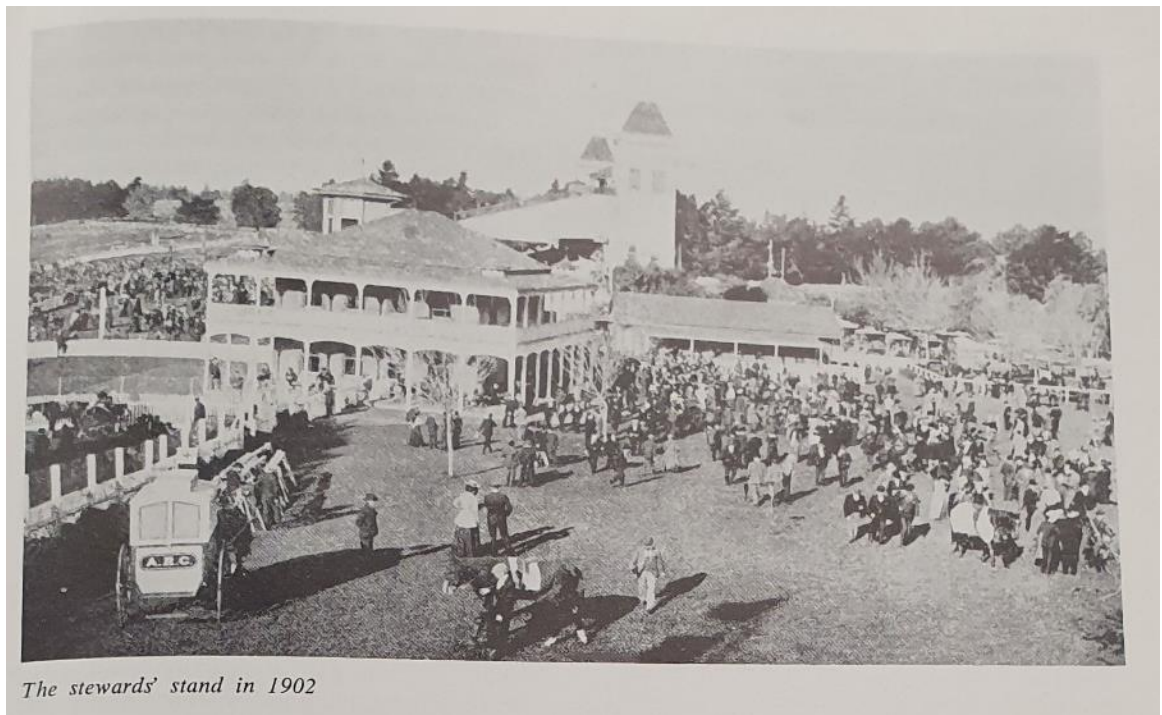
Figure 7. Showing the Steward's Stand in 1902, with the upper storey later used as the secretary's house and the lower storey used as the head gardener's and later course manager's house (from Mackie 1974:55)

The new stewards' stand, a two storeyed wooden structure on a stone base, was built in 1896-97. This building was replaced in 1908 with a newer stand incorporating facilities for members, stewards, press and jockeys. The earlier structure was subsequently removed and converted into two houses, one for the secretary, the other originally for the head gardener but later became the home of the course manager.

The secretary's house sited on land near the corner of Peach Parade and Ladies Mile was originally the upper storey of the Steward's Stand built in 1896/7 (Figure 7). In 1908 the two-storey steward's stand, originally built on a stone base, was replaced (Mackie

The residential dwelling at 99 Ladies Mile currently is the grounds manager's house and falls within the plan change area (at the eastern corner). Elements of this house came from the lower half of the original 19th century Steward's Stand (Figure 7) previously located elsewhere on the course. It was deconstructed and moved in parts, initially to storage and subsequently, the lower half was used to construct the dwelling at 99 Ladies Mile; the upper half being utilised in the construction of the Secretary's house on the corner of Ladies Mile and Peach Parade.

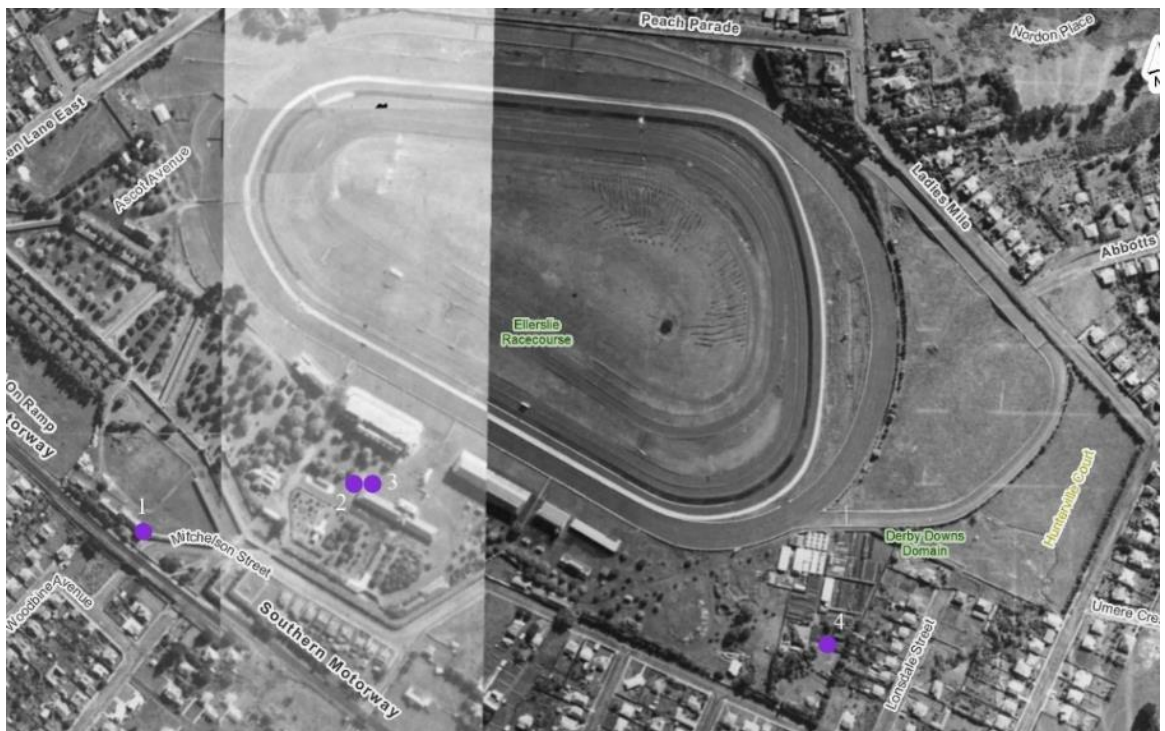
Figure 9. 1940 aerial photograph with cave locations as noted in 1925 plan marked as purple dots, numbered 1-4 (left to right). Aerial source: Geomaps

Mackie (1974:15) notes that in 1888 the caretaker had opened up the subterranean caves to facilitate surface drainage. These particular caves may be those identified as Caves 2 and 3 on the aerials below (Figure 9, Figure 10), later known to be utilised for drainage. Further caves (or possibly lava tubes) were present: ‘Mr Vi Hill...recalls that he opened many such caves and on no occasion that he bored into the ground did he fail to find a cave, some small but many of substantial size’ (Mackie 1974:15). The construction of the official stand in the late 1950s revealed one area where a foundation bore had passed next to a cave, resulting in ‘enormous amounts of liquid concrete [being] squirted under pressure to fill up any holes which remained’ (Mackie 1974:15).

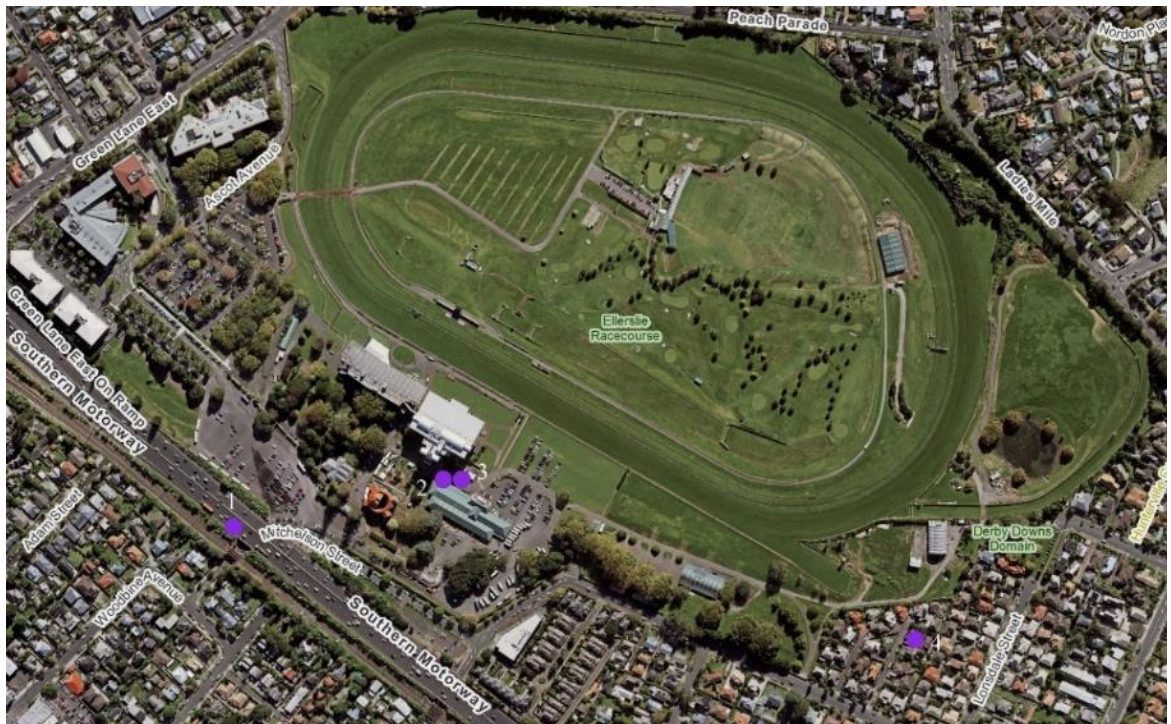
Figure 10. 2017 aerial photograph with cave locations as noted in the 1925 plan marked as purple dots, numbered 1-4 (left to right). Aerial source: Geomaps. None of the cave locations are in the vicinity of The Hill

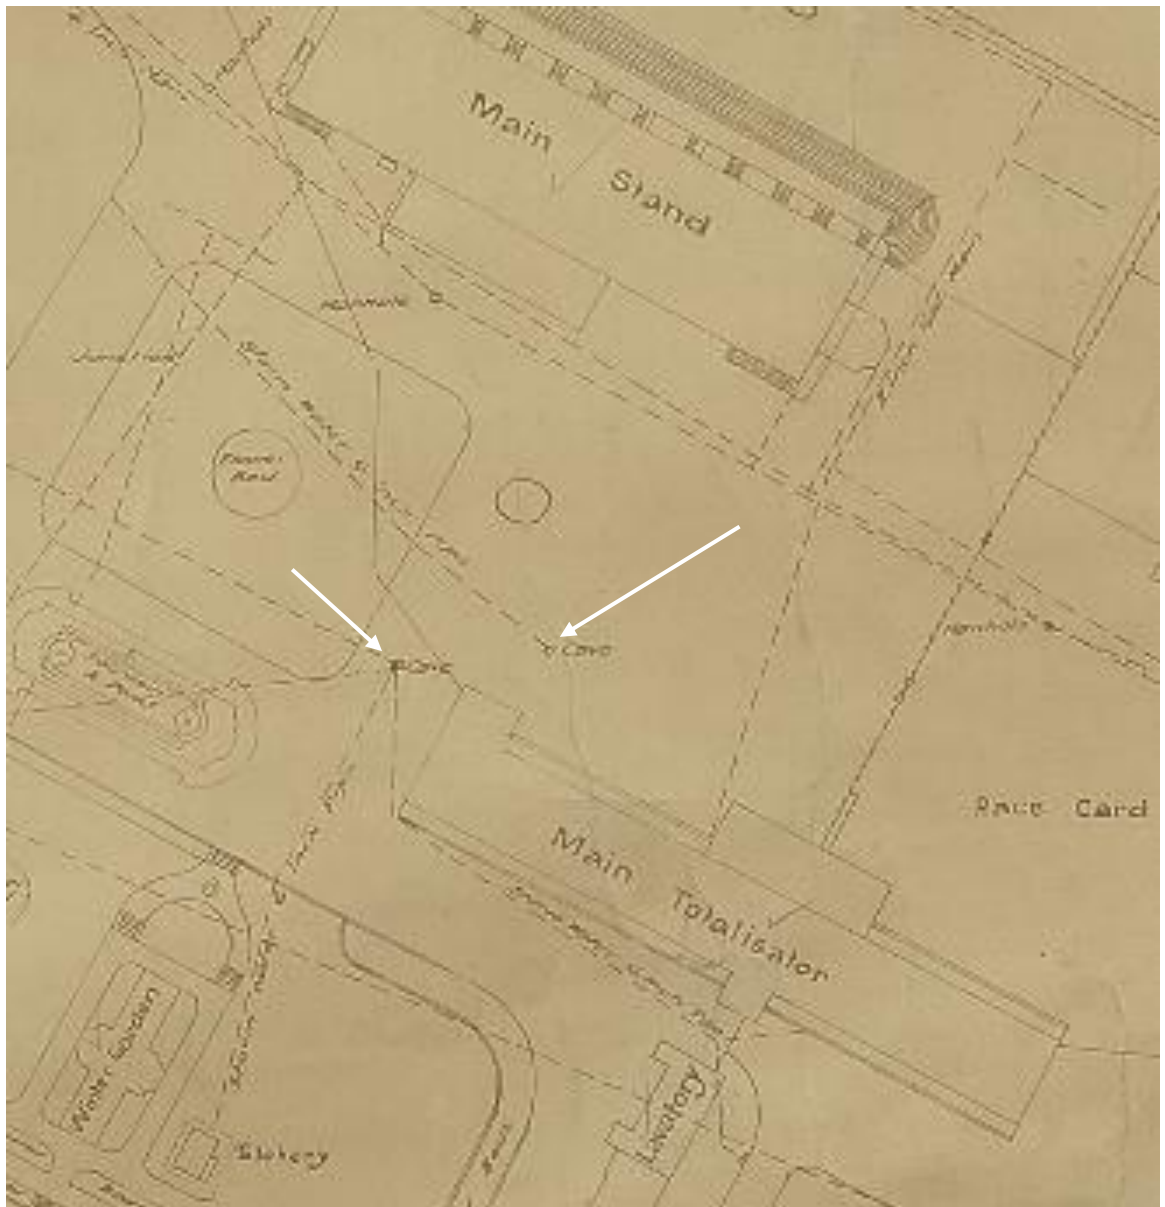
Cave 3, located to the north of the Main Totalisator, had only a single 6 inch pipe feeding into it, leading from the Saddling Paddock.

Given there are two caves in close proximity, one of which appears to have been larger than the other, Caves 2 and 3 could also potentially be the location of the caves containing moa and human remains.

Figure 12. Enlargement of 1925 plan showing location of Caves 2 and 3 near Main Totalisator, arrowed

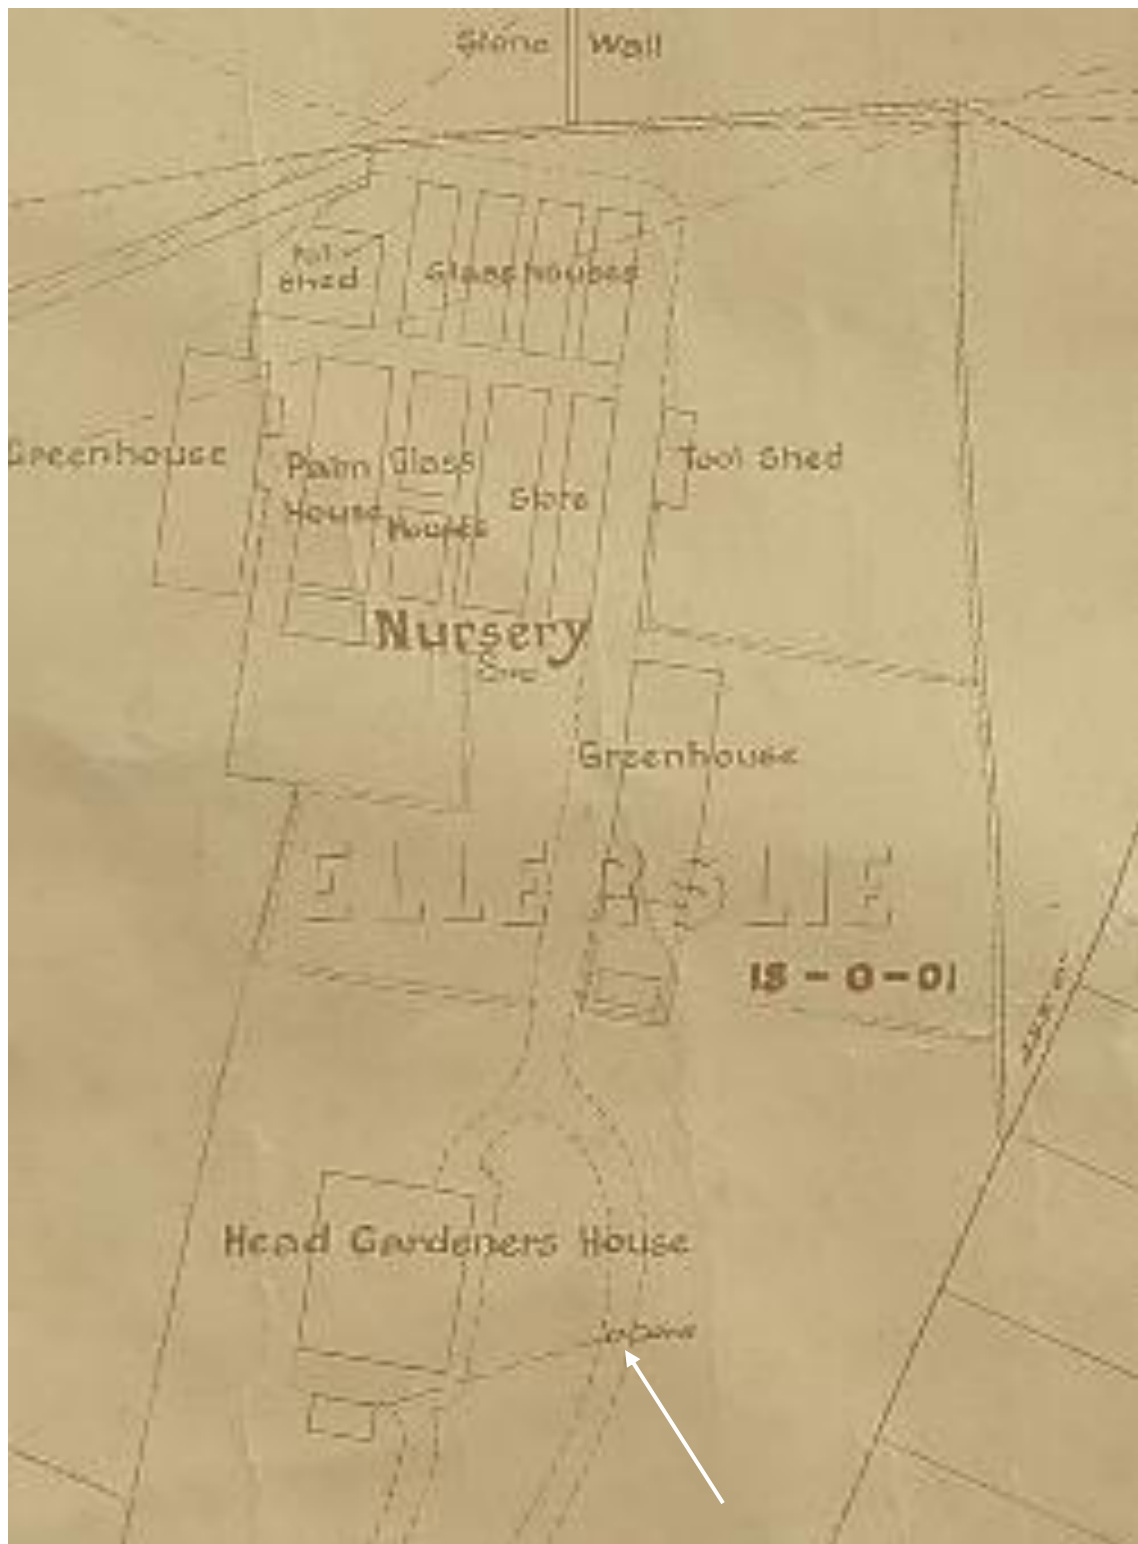
This particular cave is located to the east of the Head Gardeners House beneath a pathway leading towards the nursery and greenhouse. The cave entrance was likely covered over or filled in to facilitate the pathway construction. This portion of land is no longer part of the Ellerslie Racecourse, being subdivided and lots sold for housing. The location of Cave 4 now appears to be directly beneath a house situated at 7 Formosa Court, Ellerslie.

Figure 13. Enlargement of 1925 plan showing location of Cave 4 east of the Head Gardeners House

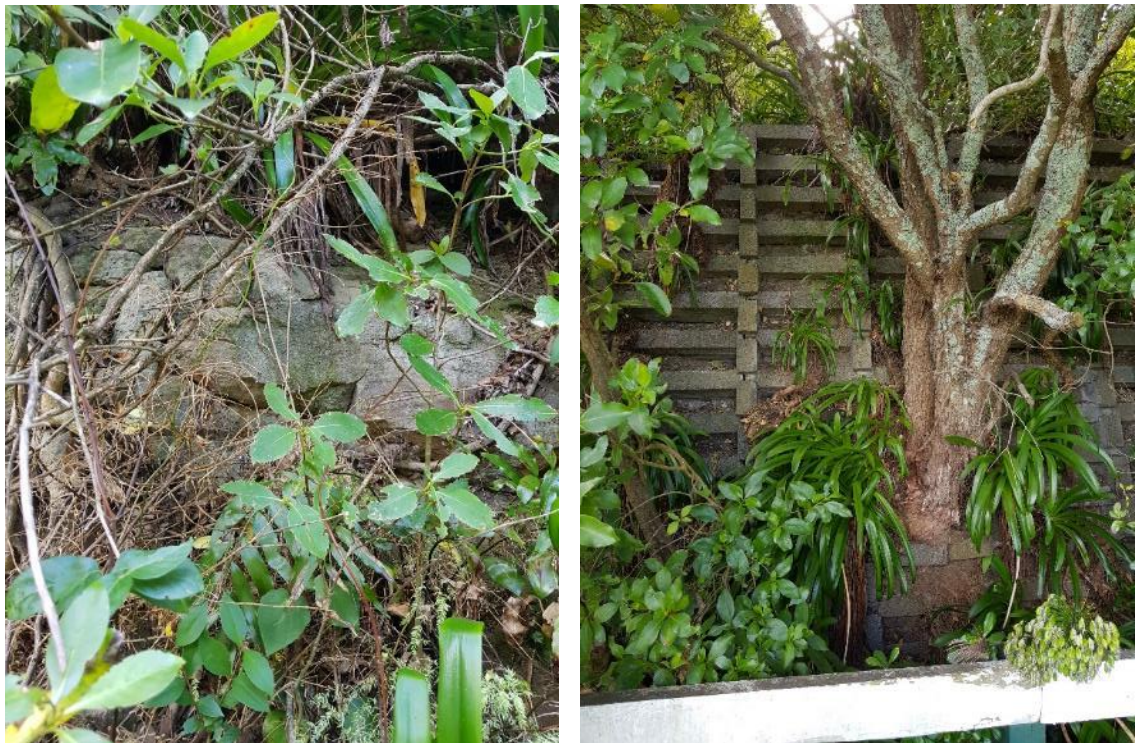
The Hill steeplechase track appears to be formed largely over a boxstone/mudstone outcrop with other areas being retained and infilled. Part of the underlying geology is exposed between the main track and the hill, although hidden behind billboards and regrowth (Figure 19).

Figure 19. Mudstone outcrop and retained sections of The Hill

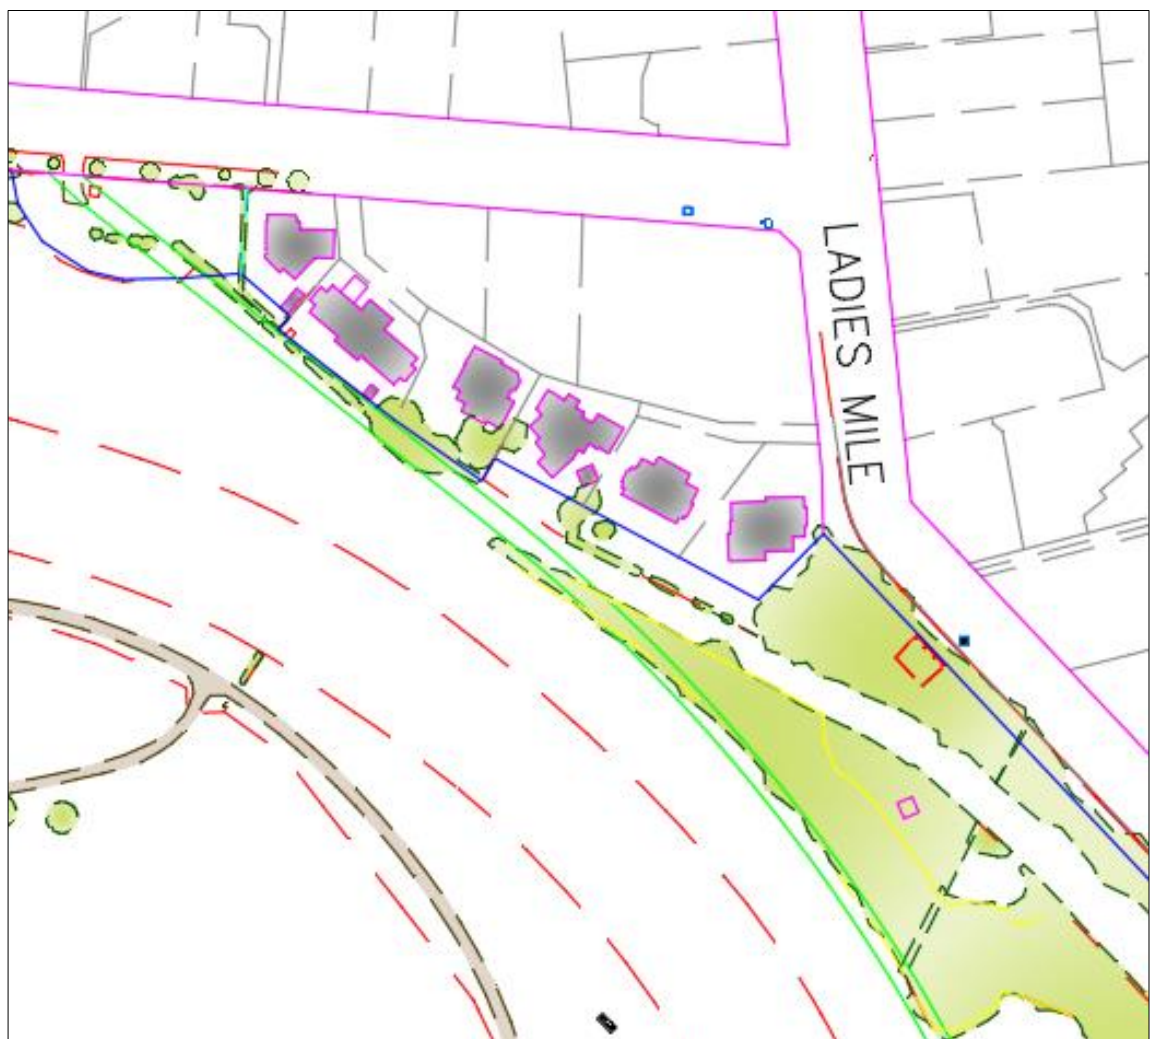
Only one archaeological feature was observed during the survey, located in the bush between the track and Ladies Mile at the top of the hill (see Figure 20). This was a square concrete foundation wall enclosing approximately 10 x 10m, with 700mm thick walls and standing up to 600mm above ground. The feature was largely covered by humic material and although it had the appearance of concrete it may be a brick structure which has been rendered (Figure 21 and Figure 22). A modern concrete block retaining wall is located

adjacent to the foundations (Figure 23). It is possible that this was the reservoir referred to in the Historical Background, and it has now been recorded as site R11/3378 in the NZAA site record database (see Appendix A).

Figure 20. Location of concrete/brick structure (potential 19th century reservoir foundations) (red outline)

Development of The Hill as a result of the proposed plan change will affect archaeological values associated with the concrete/brick foundations which could potentially be the remains of the 19th century reservoir (R11/3378). No other sites have been confirmed within the plan change area. However, in any area where archaeological sites have been recorded in the general vicinity it is possible that unrecorded subsurface remains may be exposed during development, in particular those relating to the historic water reticulation system for the course.

- There should be no major constraints on the proposed plan change on archaeological grounds, as only one potential pre-1900 archaeological site (concrete/brick foundations that could be the remains of a 19th century reservoir, site R11/3378) will be affected by future development resulting from the plan change, and the potential for further archaeological remains within the plan change area is low.

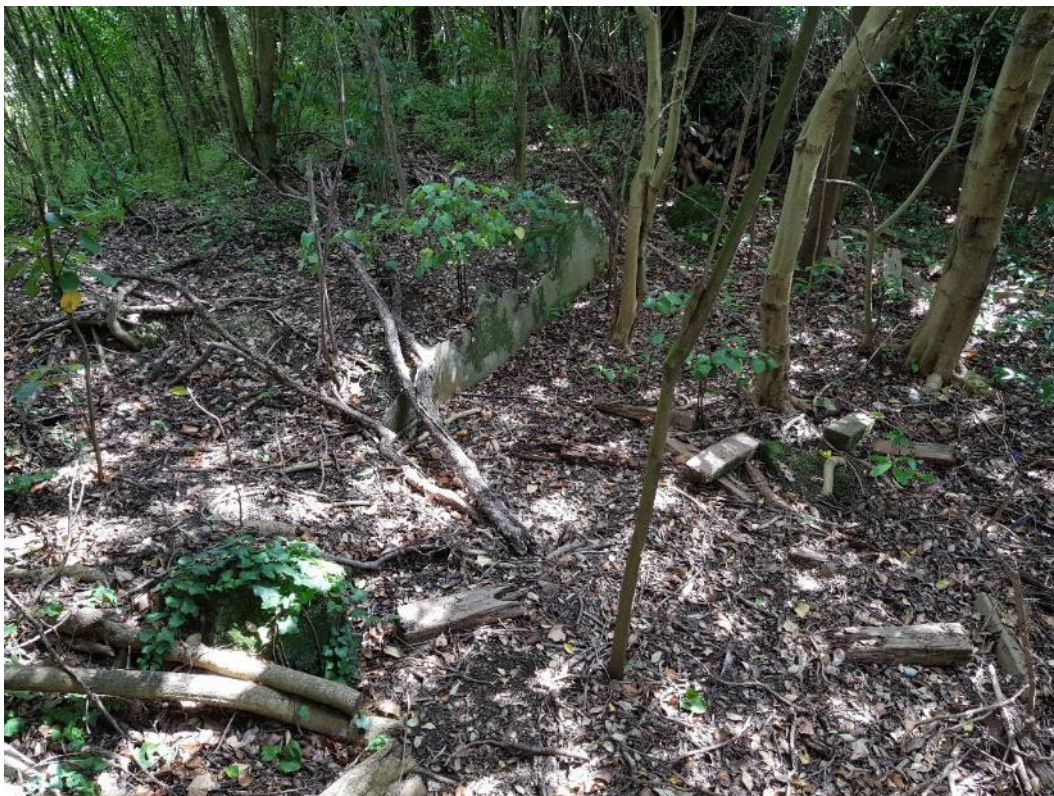
Figure 21. General view of feature – sunken interior covered in humic material

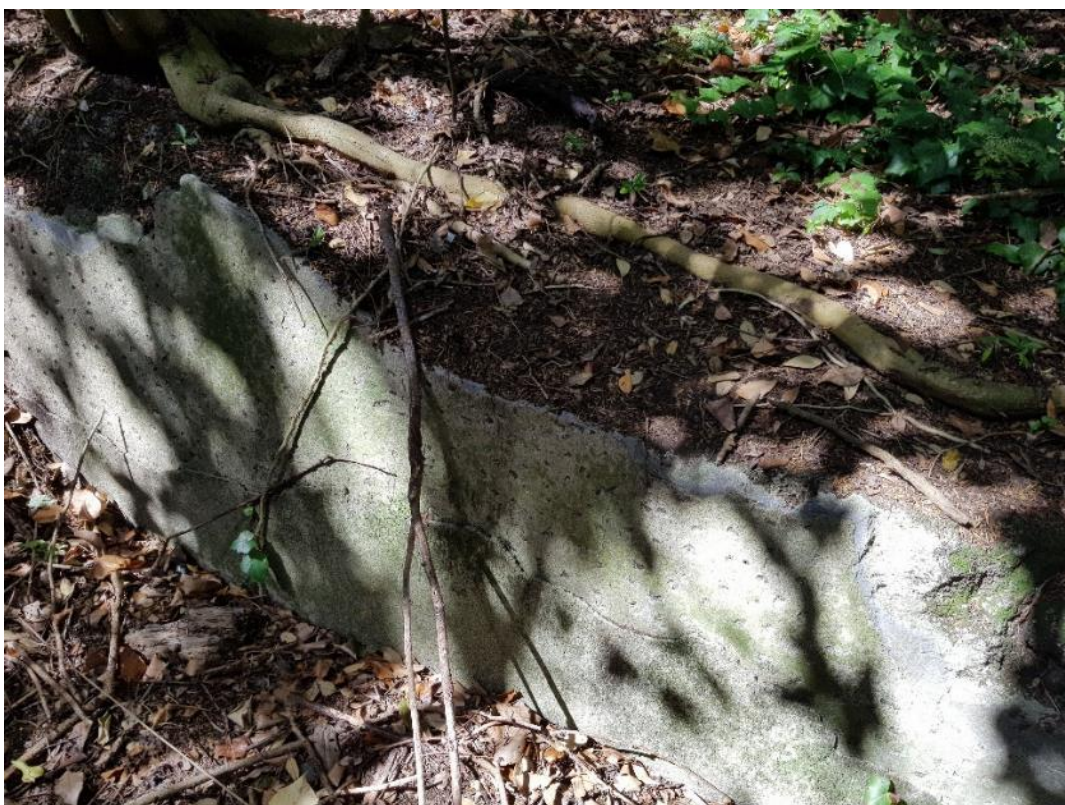
Figure 22. Close-up of one wall showing pecked surface (usually a preparation for plastering)

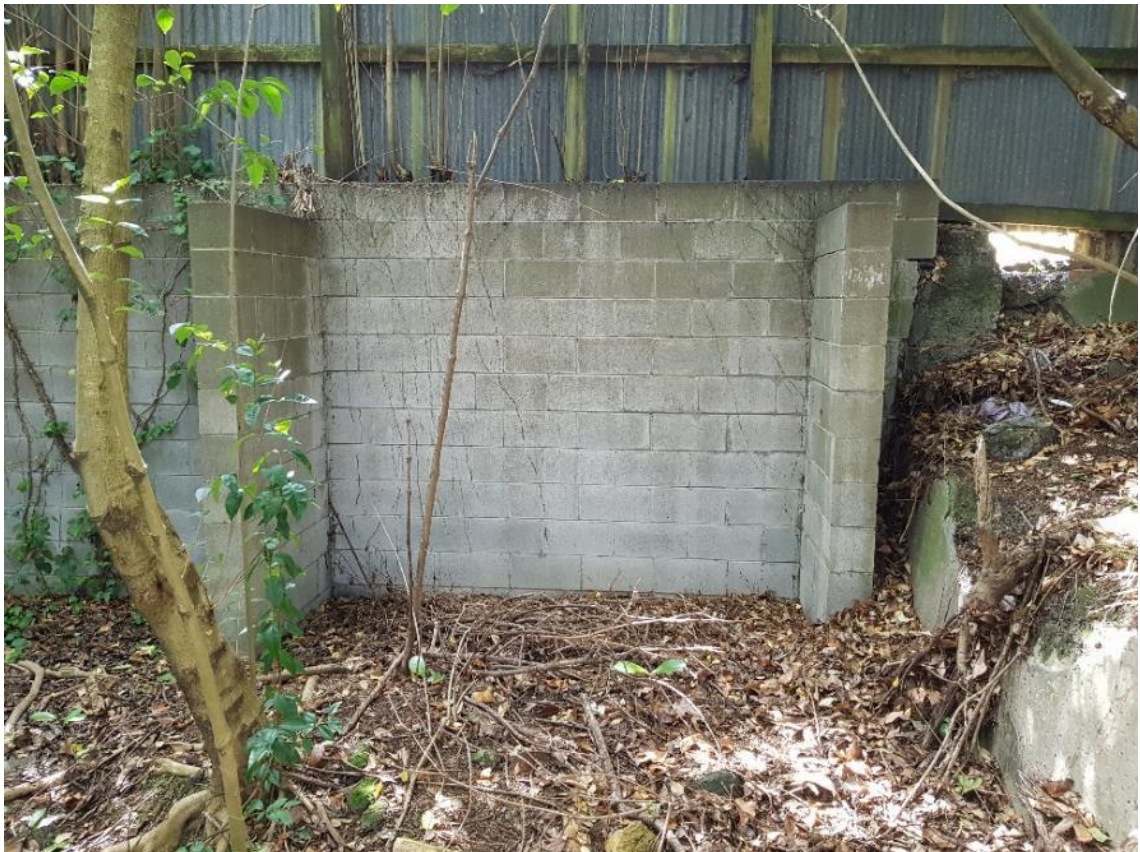
Figure 23. A retaining wall of concrete blocks adjacent to the feature is on the Ladies Mile boundary

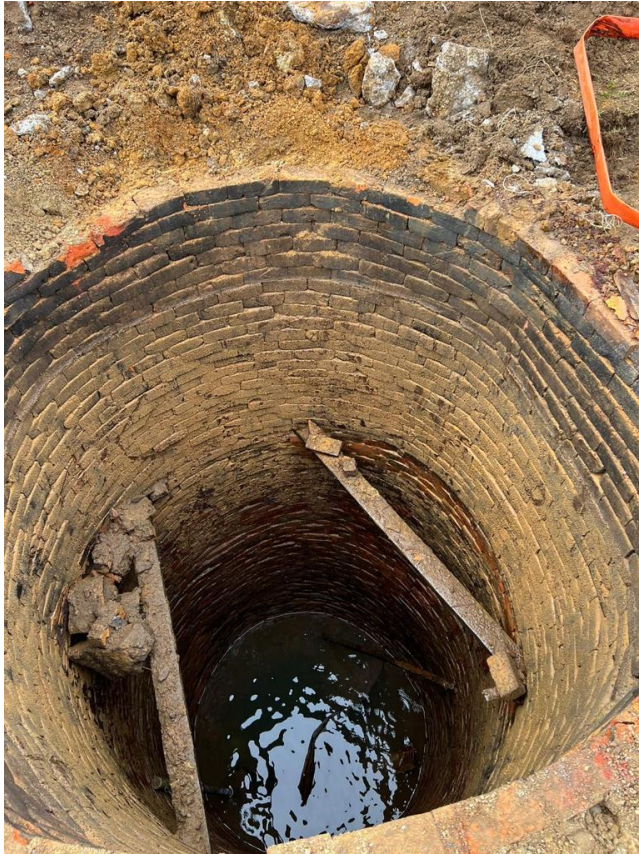
The well was drained and photographed (Figure 24) and then filled with sand prior to re-capping.

Figure 24. The well exposed near the golf driving range the racecourse area in October 2022

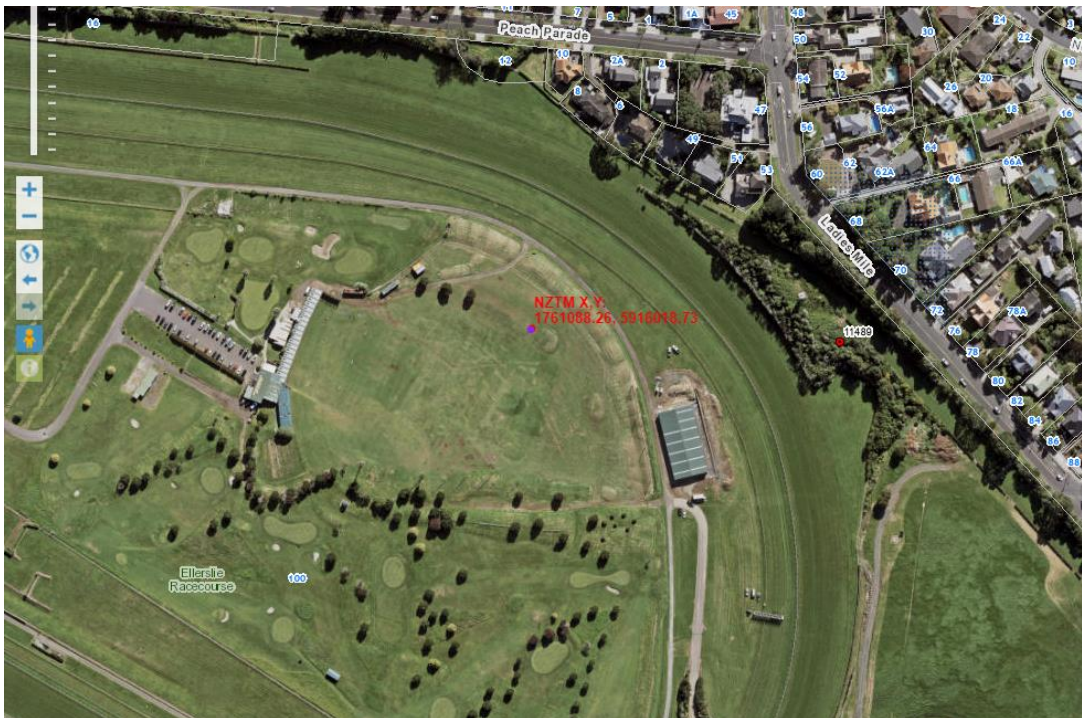
The location of the well has therefore been confirmed as being outside the plan change area (Figure 25). As the well relates to the water reservoir, information regarding the well and its location have been added to the site record for the probable reservoir foundations (R11/3378, see Appendix A).

Figure 25. Location of the well within the racecourse area (purple dot on left), and the probable reservoir (site R11/3378) (red dot on right) within the plan change area

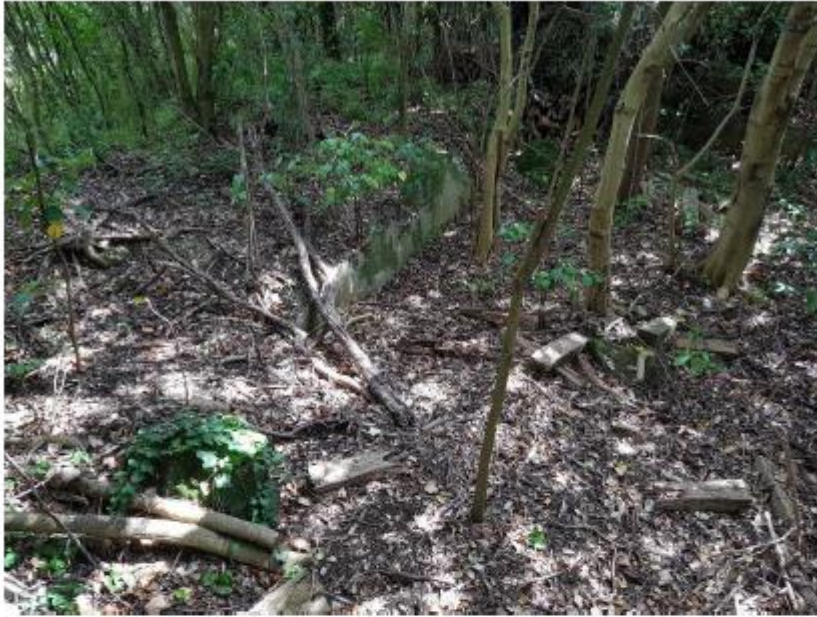
Figure 1. General view of feature at Ellerslie Racecourse (The Hill) – sunken interior covered in humic material

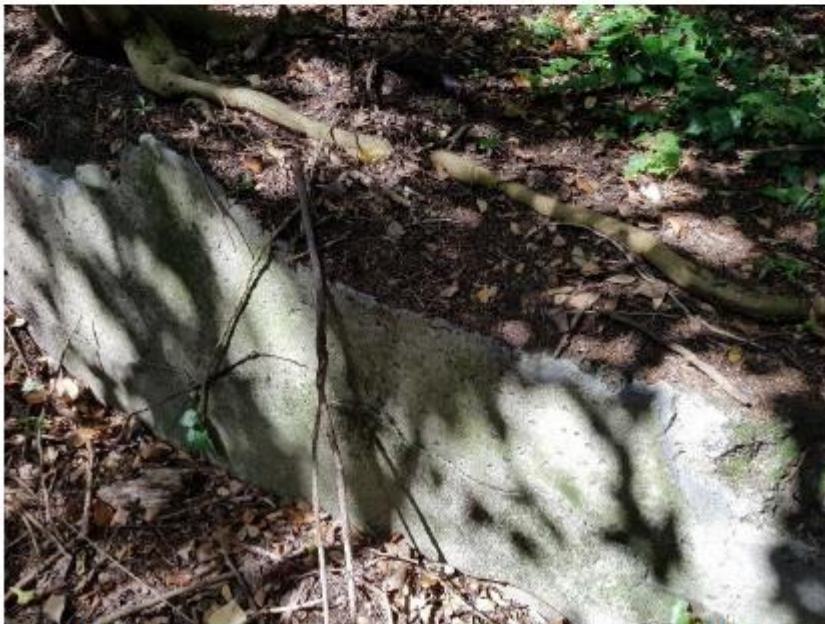
Figure 2. Close-up of one wall showing pecked surface (usually a preparation for plastering)
