FLETCHER RESIDENTIAL LIMITED

THE HILL – ELLERSLIE RACECOURSE

GEOTECHNICAL REPORT – FOR PLAN
CHANGE

INITIA REF 1218 REV B

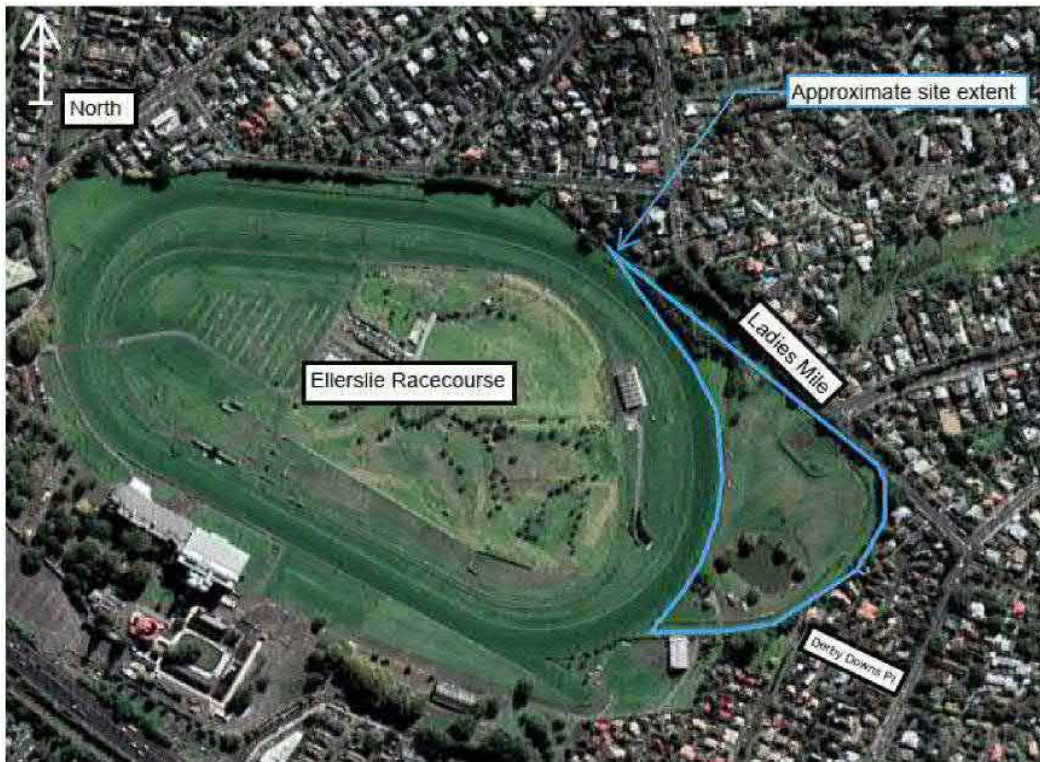
Figure 2-1: Indicative site location

The site is situated on the eastern end of the Ellerslie Racecourse, bound by Ladies Mile in the north and east and Derby Downs Place to the south (refer Figure 2-1).

Contours sourced from the Auckland Council GIS indicate the site slopes from about RL55 at the northern boundary to about RL 40 at the southern boundary.

An existing pond is situated near the southern end of the site. We understand that the pond is to be decommissioned and infilled.

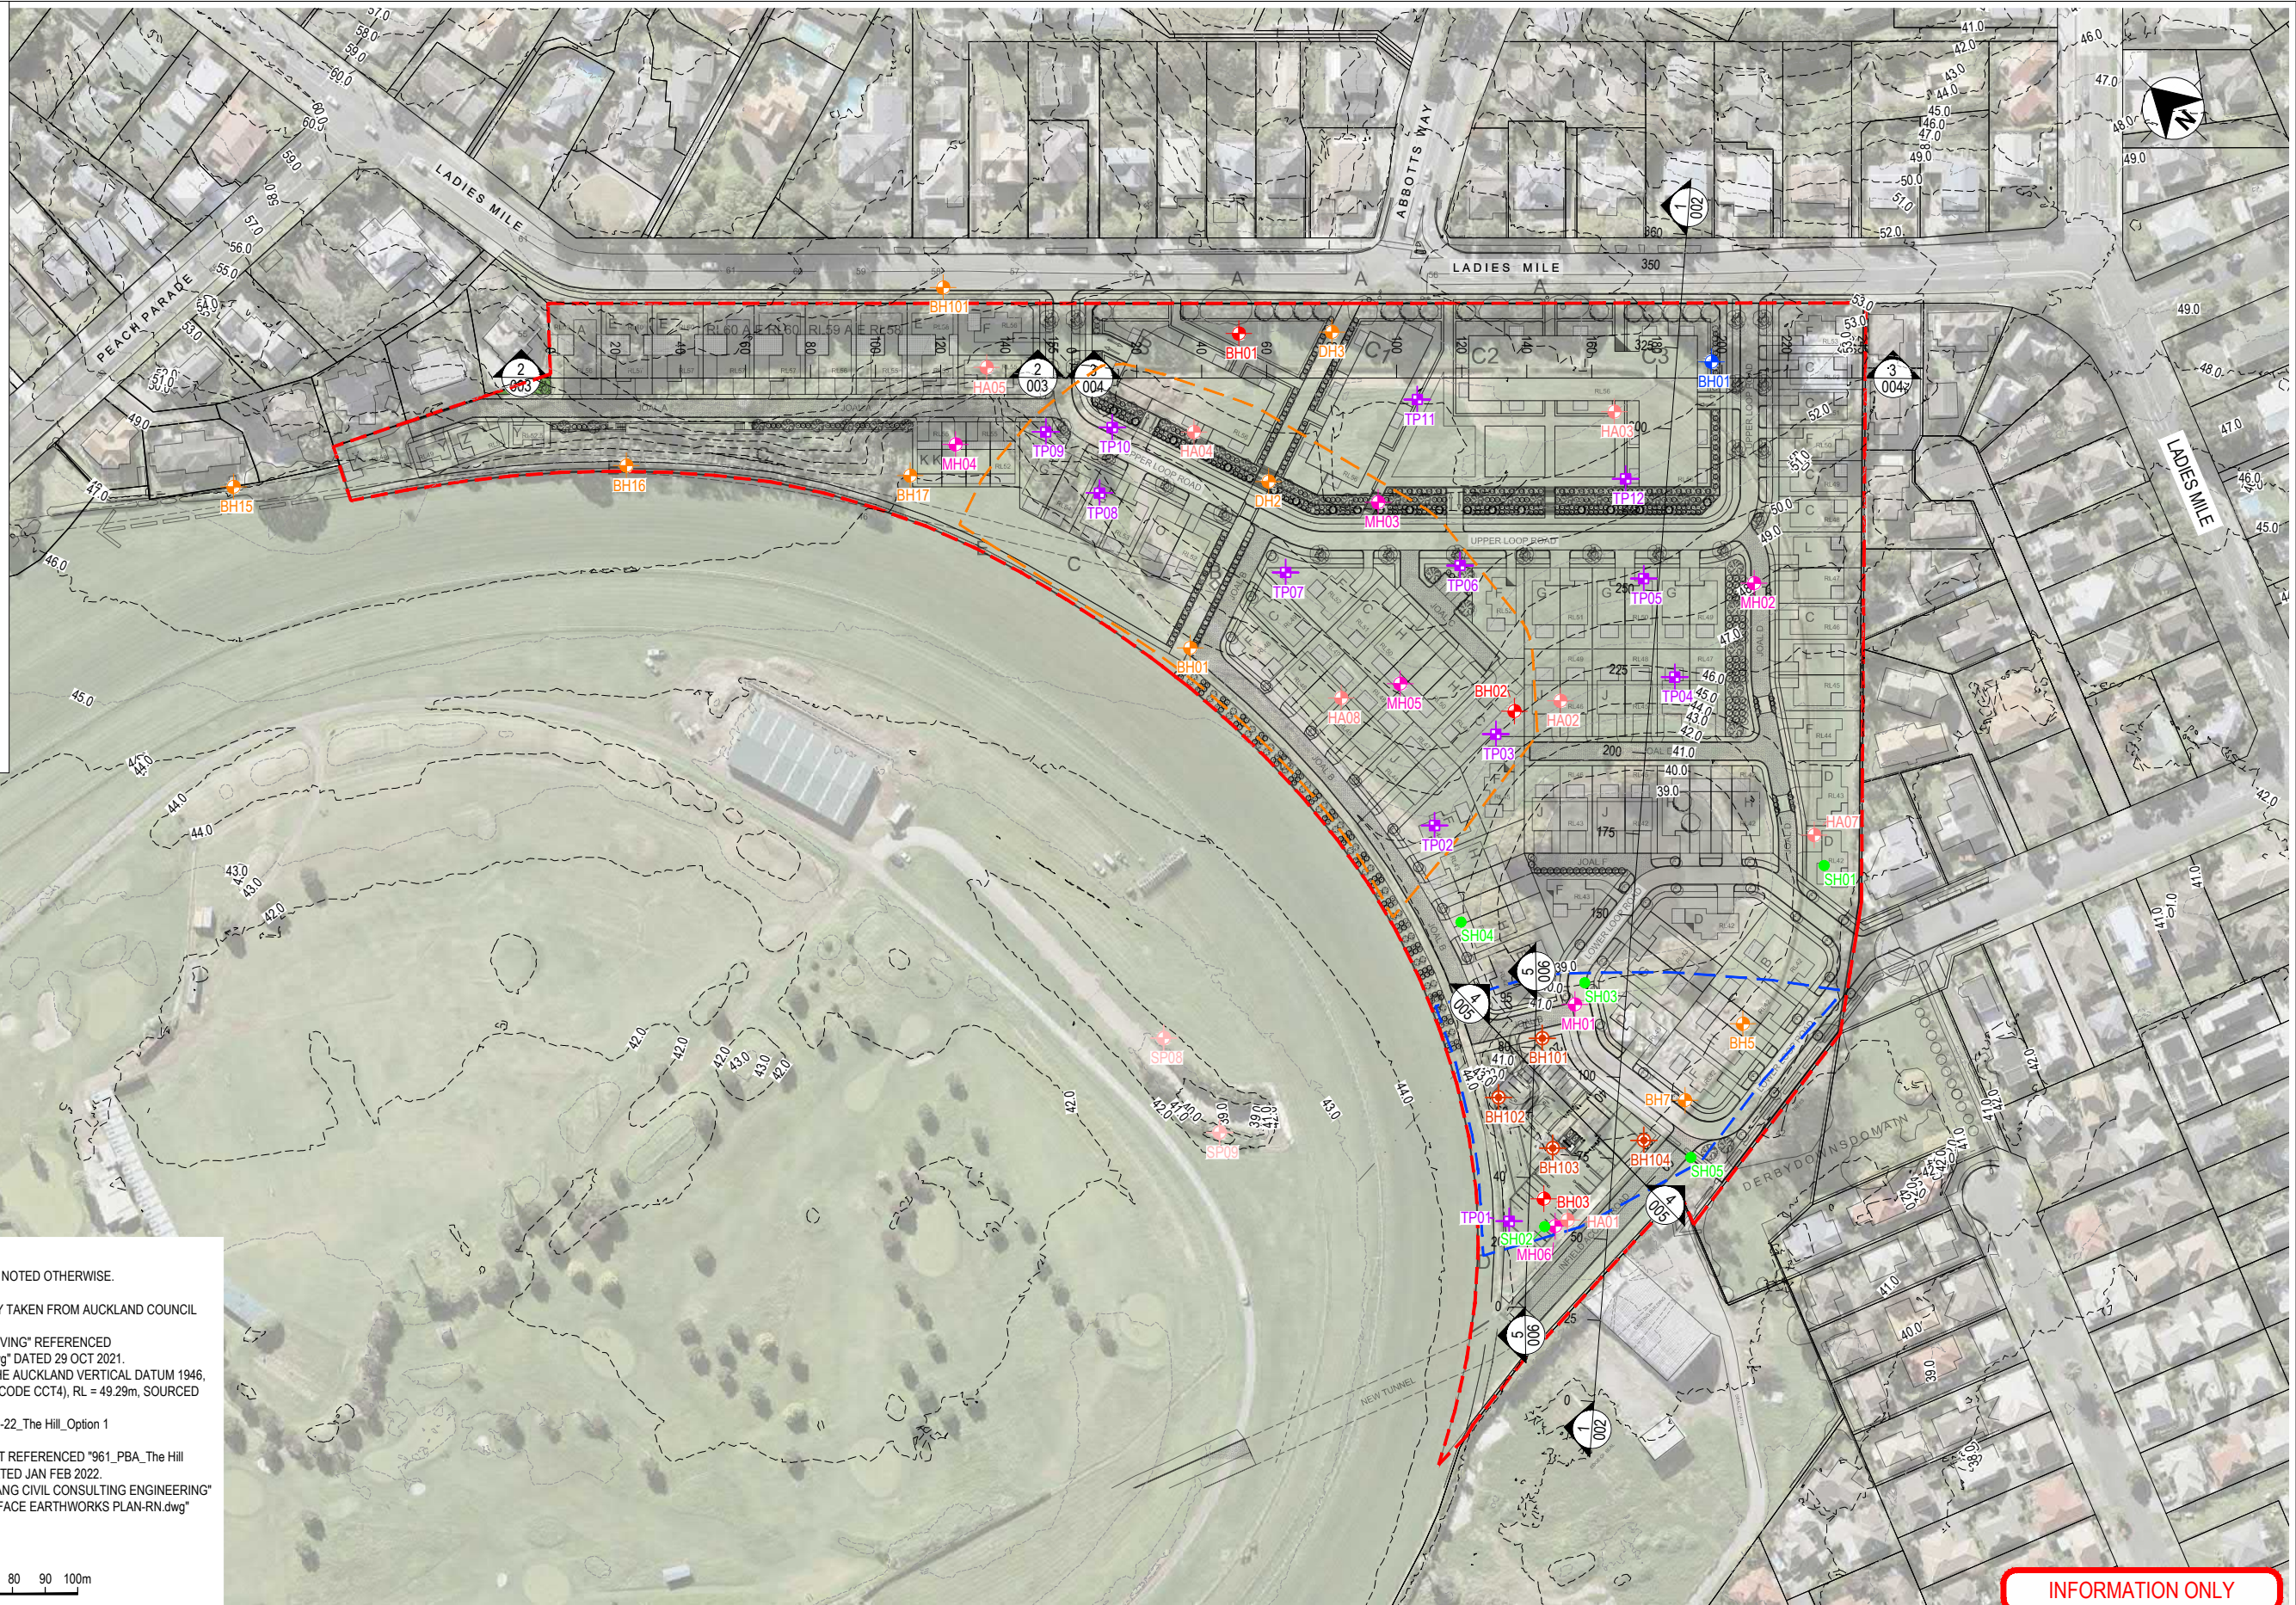
--- --- APPROXIMATE EXTENT OF BASALT

1. The approximate extent of non-engineered fill is shown on Figure 1218-001 in Appendix A. While it is expected that a large majority of the fill material will be suitable for re-use, it is recommended that supplementary test pit investigations be undertaken prior to construction.
2. Undrained shear strengths were measured at the end of the core barrel so may not be representative of in situ conditions.

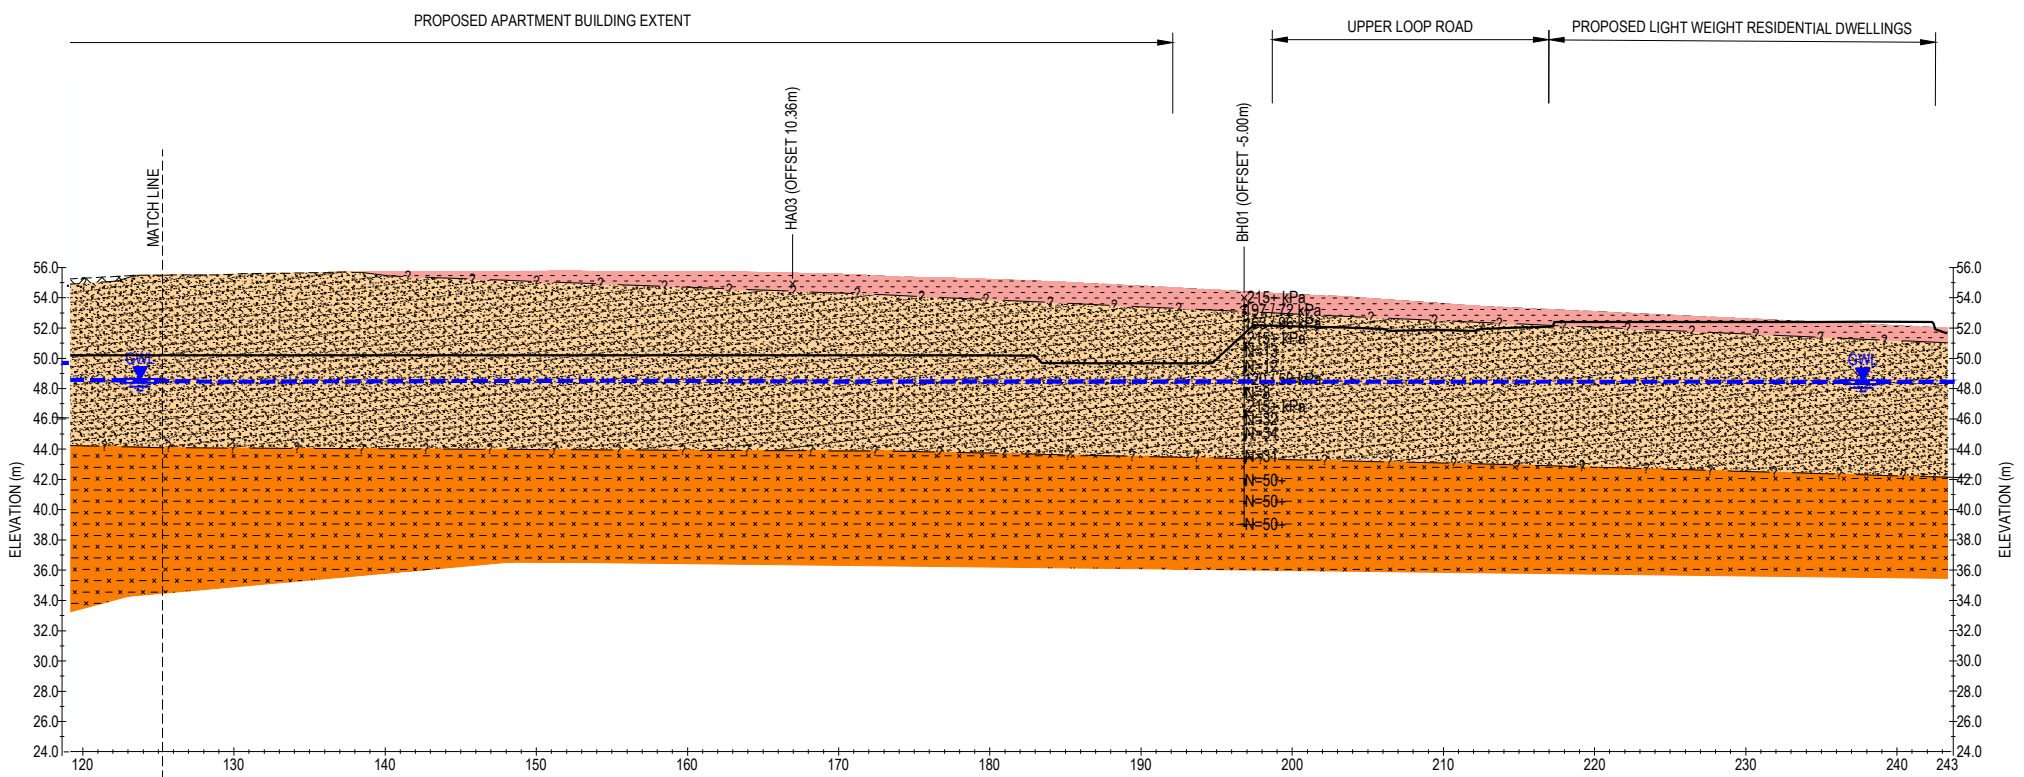
3 SECTION
001 SCALE 1:500 (A3)

LEGEND	
	EXISTING FILL
	VOLCANIC ASH - AUCKLAND FIELD
	RESIDUAL SOIL - ECBF
	ECBF - INTERBEDDED SANDSTONE AND SILTSTONE
	EXISTING GROUND
	DESIGN LEVEL (PROVIDED BY CRANG CIVIL CONSULTING ENGINEERS - JUNE 2022)
	INFERRED GEOLOGICAL BOUNDARY
	GWL GROUNDWATER LEVEL

A summary of the ground conditions is presented in Table 4-1 and Table 4-2 and illustrated on cross sections Figures 1218-02 to 1218-04 in Appendix A. Indicative depths to ECBF rock encountered during the investigations are summarised on the geological sections in Appendix A.

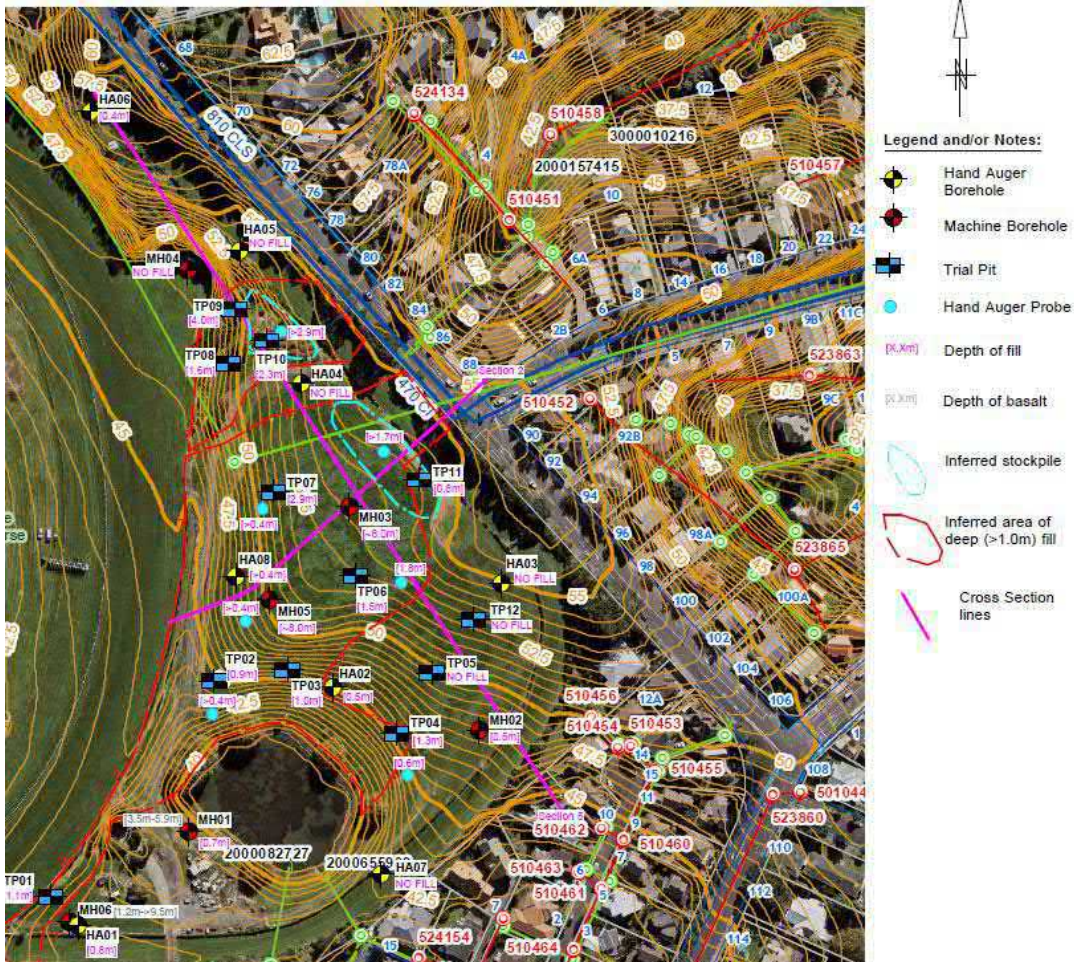
Insert A: Site Investigation Plan

As shown on the below plan (Insert A), considerable field testing has been undertaken between March and May 2021 for Auckland Racing Club of 'The Hills' area. Our field logs, cross-section profiles with interpreted geological units and site plan are attached for reference for the machine borehole, hand auger borehole and trial pit testing.

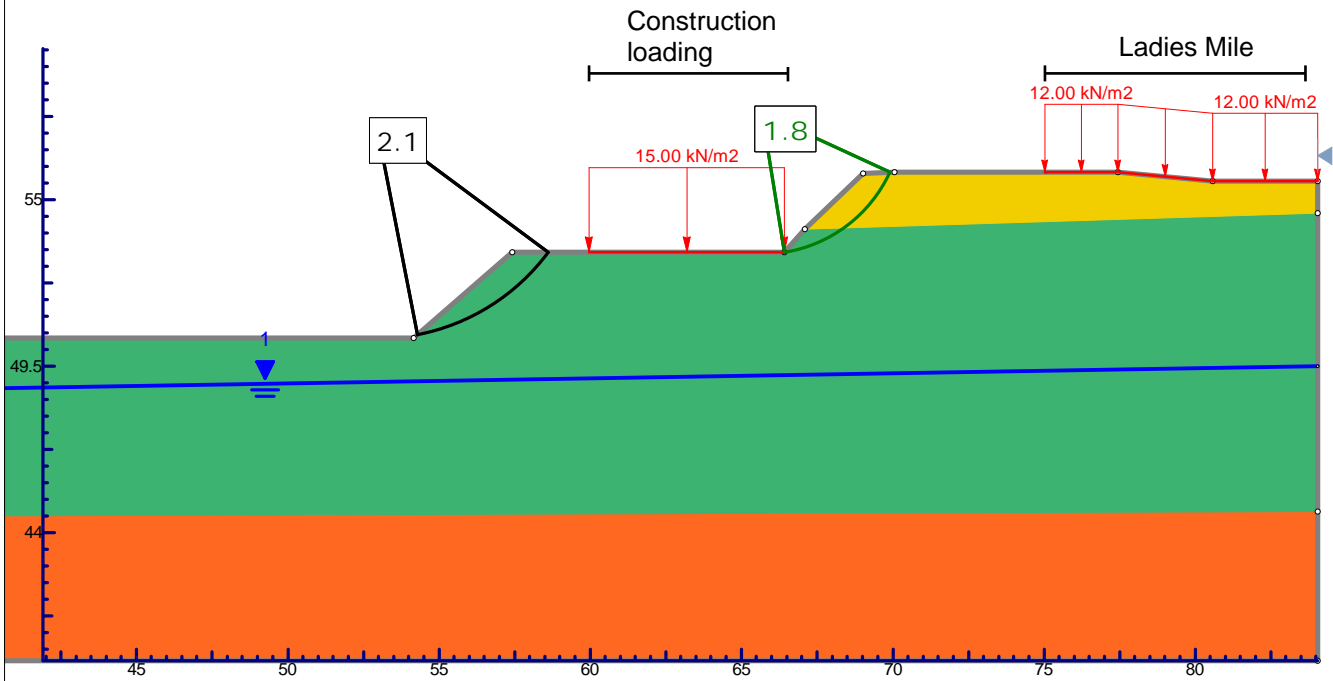
<i>Project</i>		The Hill, Ellerslie	
<i>Analysis Description</i>		Temporary Batter for Basement Construction - Section C	
<i>Project No.</i>	P-001218	<i>Scale</i>	1:250
<i>Company</i>	Initia	<i>Date</i>	30/05/2022
<i>Description</i>	Normal Groundwater

<i>Project</i>		The Hill, Ellerslie	
<i>Analysis Description</i>		Temporary Batter for Basement Construction - Section C	
<i>Project No.</i>	P-001218	<i>Scale</i>	1:250
<i>Description</i>	Elevated Groundwater	<i>Company</i>	Initia
		<i>Date</i>	30/05/2022

Analysis description	Analysis case	FoS criteria	Calculated FoS
Proposed conditions, adjacent to Ladies Mile (temporary) : 1V:1H cut batter	Static – normal groundwater	>1.5	1.8
	Static – elevated groundwater	>1.2	1.6

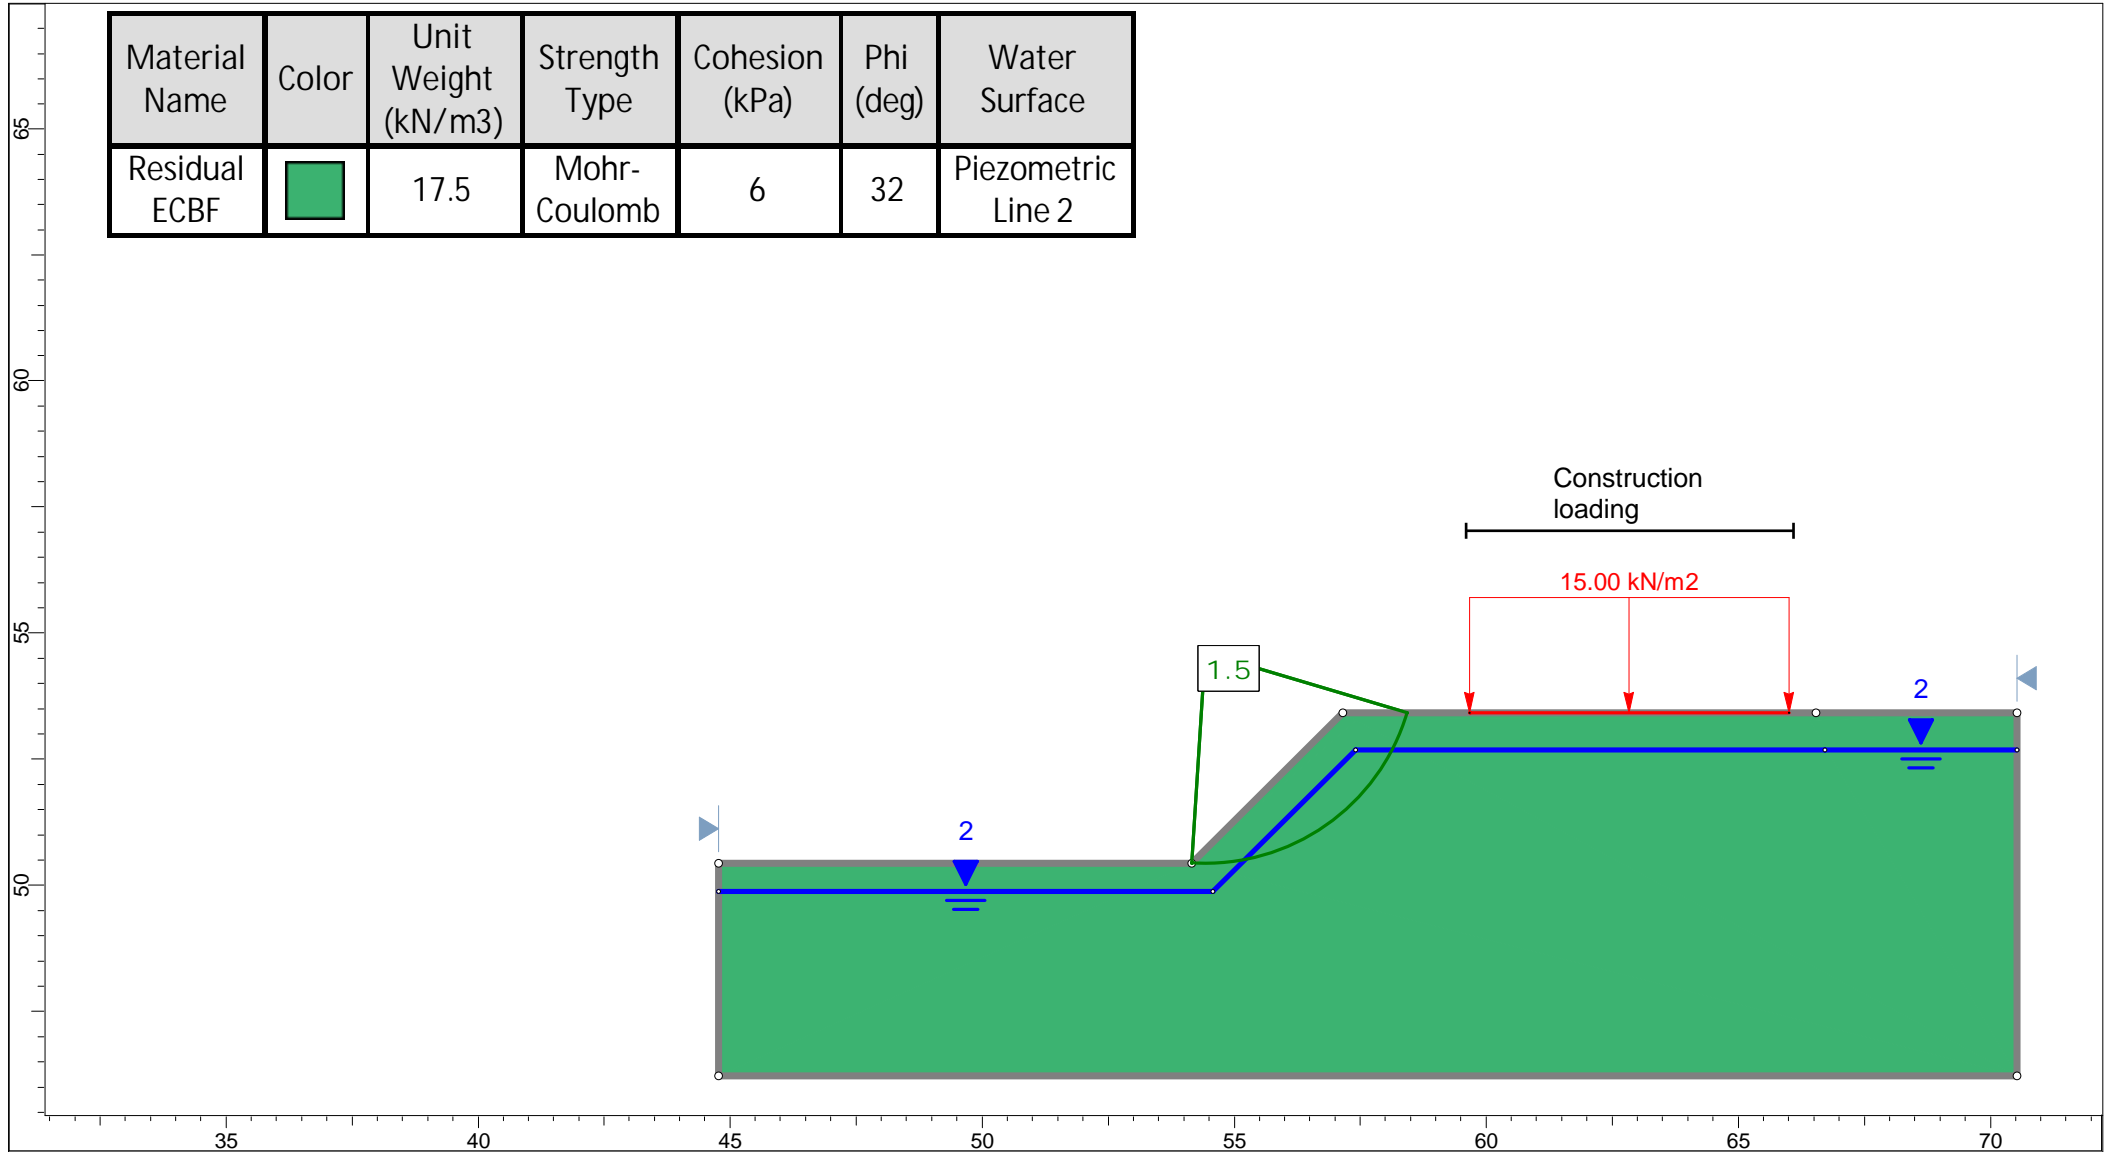
Project		The Hill, Ellerslie	
Analysis Description		1. Temporary Batter for Basement Construction (3 m high)	
Project No.	P-001218	Scale	1:150
Description		Date	30/05/2022
		Company	Initia
