**To:** Harbour View Heights LP

**Ref:** 66548

**Subject:** 28, 30, and 66,76 Crestview Rise and 170 Settlement Road – Freshwater Ecological Constraints 2

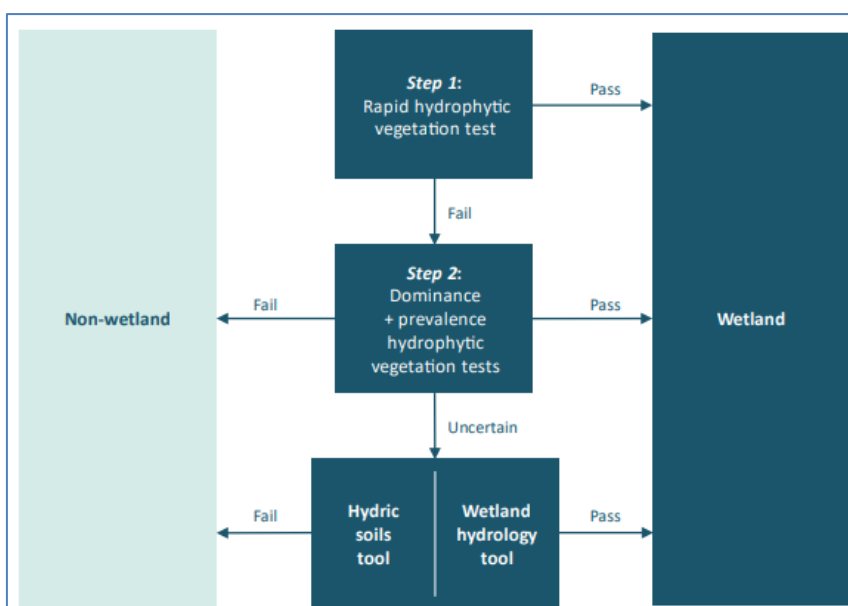
Potential natural inland wetlands were assessed following the Ministry for the Environment’s (MfE) wetland delineation protocols (MfE, 2022) to ascertain if the area presented with the physical characteristics to be considered an RMA wetland (Figure 3), which is defined as:

**Figure 3. Simple flow chart of steps for determining an RMA wetland using the hydrophytic vegetation, hydric soils and wetland hydrology tools. Reproduced from MfE (2022).**

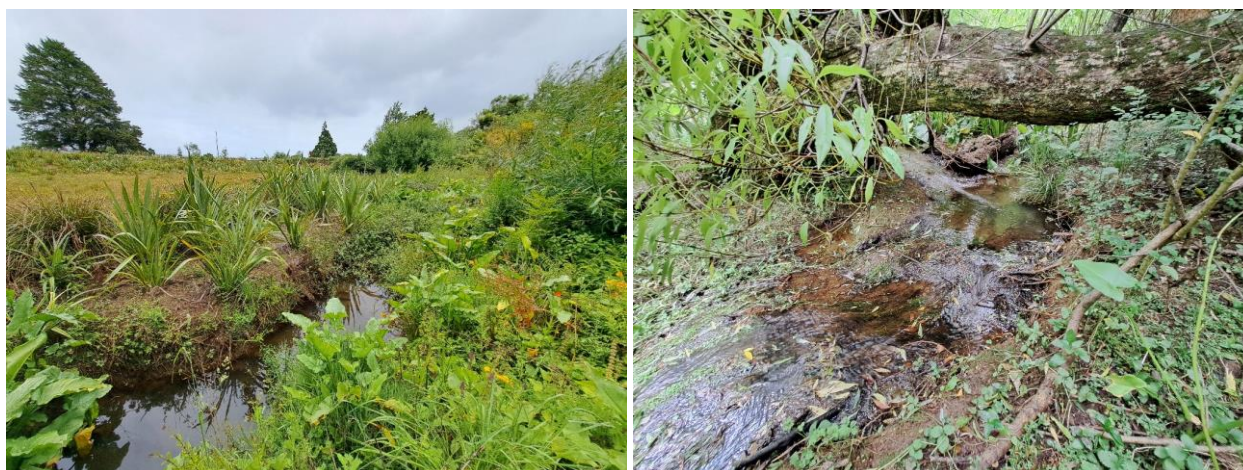
During a site visit on 13 December 2023, fast-flowing water was observed in the stream, following rainfall that had occurred a few days before. The wetted width of the stream varied between 0.4 m and 1.5 m. The channel depth ranged from approximately 0.2 m to 0.8 m. The streambed is soft bottomed, with exposed clay in some areas.

The lower assessed stream extent is incised (with some undercuts noted). The riparian vegetation provides substantial shading to the stream, with only the lower reach lacking shading due to recent replanting along the true left bank and Crestview Rise road embankment. There were no identified barriers to fish passage within the assessed stream reach. Hydraulic heterogeneity is high with natural pools, riffles, and runs present.

**Figure 7. Overview of the lower extent of the stream, noting recent plantings on the true left bank (left) and the stream reach draining through a forested area.**

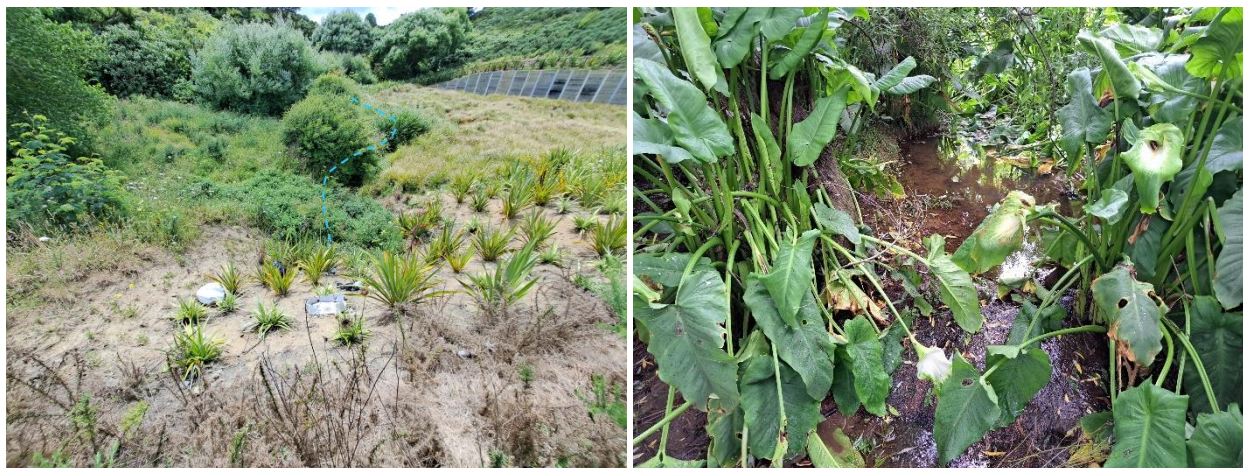
The canopy of the riparian margin is dominated by willow (*Salix sp.*) trees. Refer to the ecological assessment undertaken by Bioresearches (2023)<sup>5</sup> for a detailed description of the vegetation. Vegetation along the stream was dominated by exotic species such as arum lily (*Zantedeschia aethiopica*), creeping buttercup (*Ranunculus repens*), curled dock (*Rumex crispus*). Water celery (*Helosciadium nodiflorum*) dominated the lower reach of the stream where shading was limited. Overall, the riparian vegetation provides a high degree of filtration function and bank stability.

**Figure 8. (Left) lower stream reach draining into a wingwall culvert underneath Crestview Rise, indicated by blue dashed line, dominated by water celery; (Right) arum lily along stream embankments.**

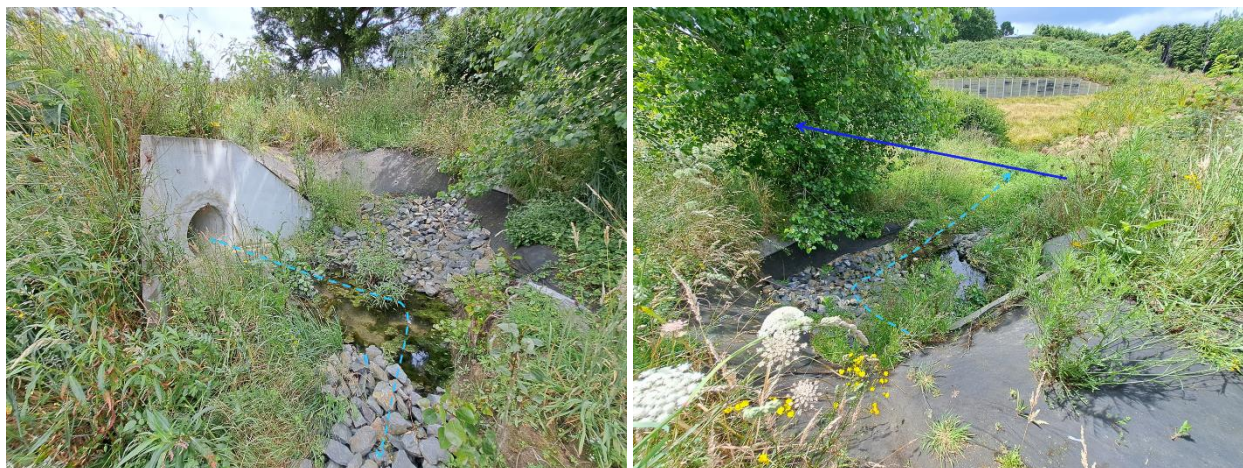
On site investigations reveal erosion and scouring of the banks adjacent to the wingwall. Due to an embankment approximately 3 m in front of the wingwall, stormwater from the outlet structure makes a 90-degree change of direction before eventually flowing into the stream. According to the engineering assessment by Envelope Engineering (2023<sup>6</sup>), only 3-4 m of riprap was installed, whereas the original design requires a 12 m long riprap apron, which was not fully installed.

Currently, stormwater is scouring and eroding the riprap apron and the opposite embankment; however, no erosion of the stream itself has been observed. There is sediment deposition between the wingwall outlet and the stream, providing a substrate for water celery.

**Figure 9. Existing culvert wingwall structure. The light blue dashed line indicated the stormwater flow path (including a 90 degree direction change) into the stream (dark blue line).**

Remedial works will likely be required to prevent further scouring at the existing stormwater wingwall structure (Figure 9) It is highly recommended that the riprap apron (remedial works) be extended to allow for improved scour protection and to avoid further sediment deposition in the stream.

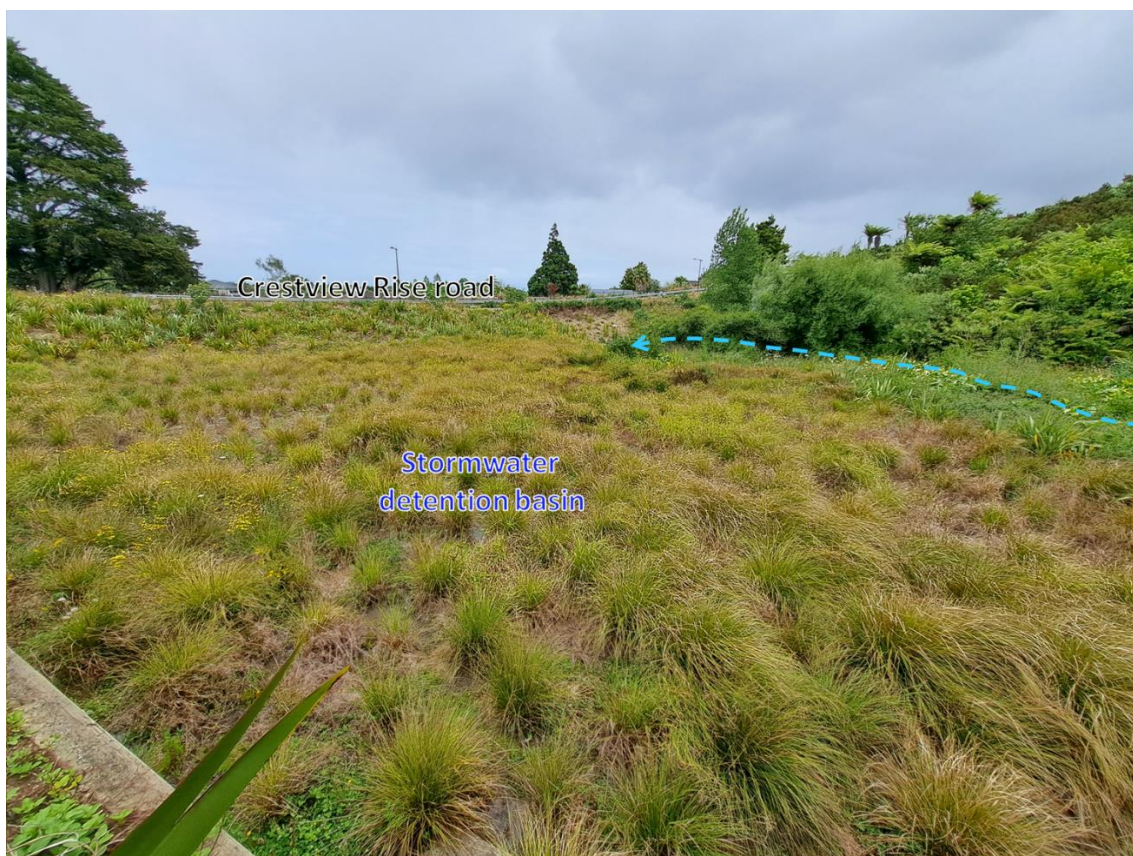
A flood detention basin is situated within the site along the western boundary of the site (along Crestview Rise road). Stormwater overflows from this basin discharge into the stream via a wingwall structure. Figure 5 illustrates the development of this detention basin from 2018. Since then, the basin has been vegetated with pūrei (*Carex secta*). Due to the intentional construction of this waterbody, it is excluded from the definition of a 'natural inland wetland' under the NPS-FM (exclusion (c); refer to Section 3.2).

**Figure 10. Stormwater detention basin located immediately south of the stream, and east of Crestview Rise road.**

Since the flood detention basin is an intentionally constructed waterbody, it falls outside the definition of a 'natural inland wetland' according to the NPS-FM. Therefore, it is not afforded protection and does not pose a constraint to future development within the site.
