MAURICE KELLY'S HOMESTEAD AND INN (R10/737): S56 EXPLORATORY INVESTIGATION

Completed in accordance with Authority 2023/392

Prepared for Fulton Hogan Ltd

11 April 2023

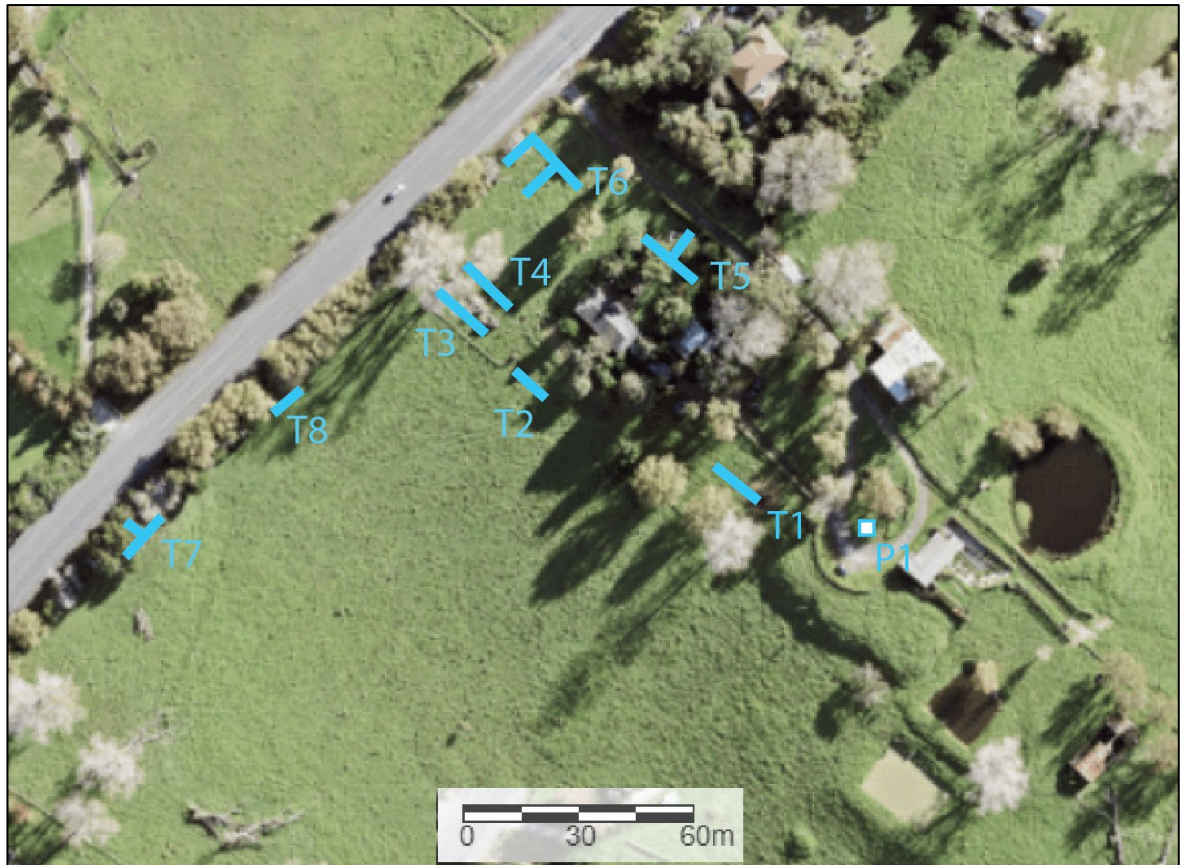
Figure 3 Aerial image showing the location of the test trenches (T1-8) and test pit location (P1)

1. Eight trenches of variable length and combination (some T shaped) and one test pit were excavated using a 5-tonne mechanical digger with a 1.3m width toothless bucket (Figure 3).
2. Excavation continued until subsurface archaeology was reached, or if no subsurface archaeology was present until natural subsoil was reached.
3. The trench and test pit locations were adapted on the ground due to overgrown vegetation, and paving.
4. Subsurface archaeology encountered was cleaned by hand and photographed, recorded, and trench plans and sections were drawn.
5. Artefacts observed within features/deposits were recorded and left in situ.
6. Following completion of the testing, the trenches and test pits were reinstated.

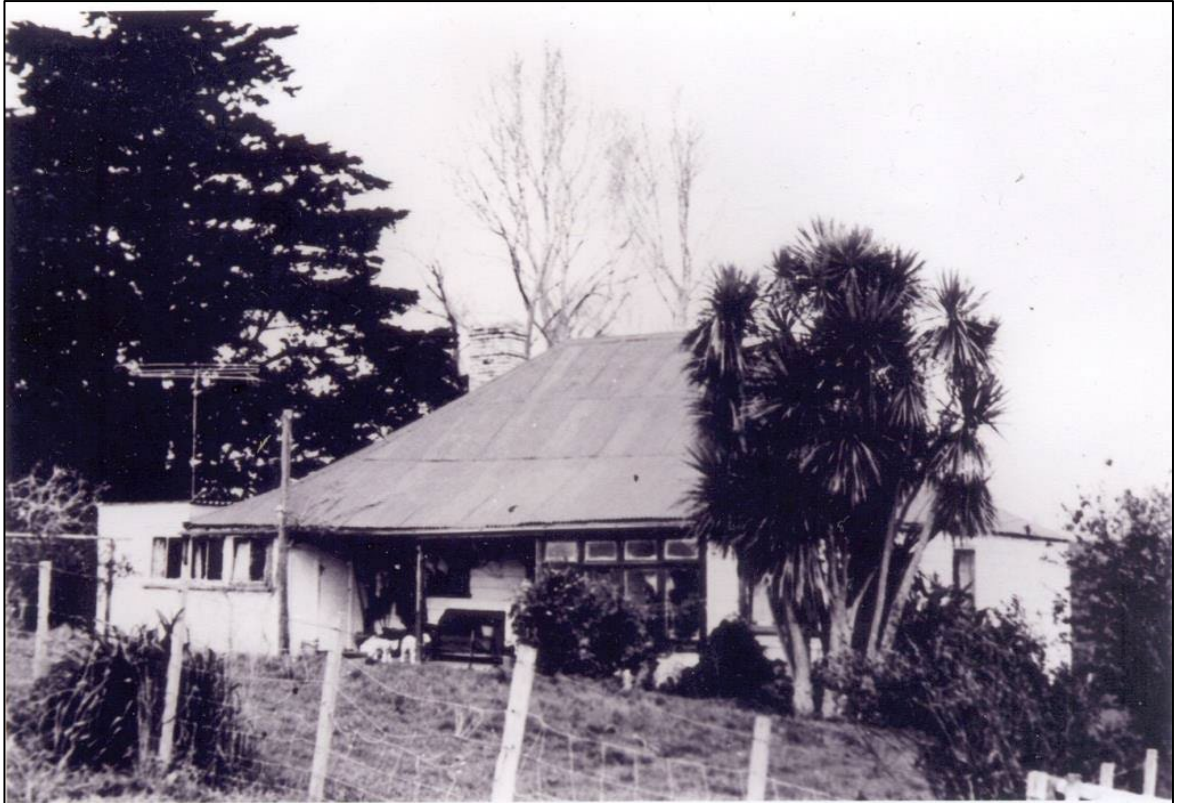
Few images of the original homestead exist, and none are known of the outbuildings. The Wainui Historical Society was able to provide two images of Kelly's house (Figure 5 and Figure 6), which no longer exists. The original floor plan of the house appears to have been square; however, an additional room was built on the northern face. No additions appear to have been made to the rear or eastern face of the building, although a water tank had been installed at the north-eastern corner.

Figure 5 Photograph taken by Cecil Wright, and dated 1972, showing the house which is thought to have contained remnants of Maurice Kelly's original homestead complex (source: F27/1603, 24.9.95, Silverdale & Districts Historical Society)

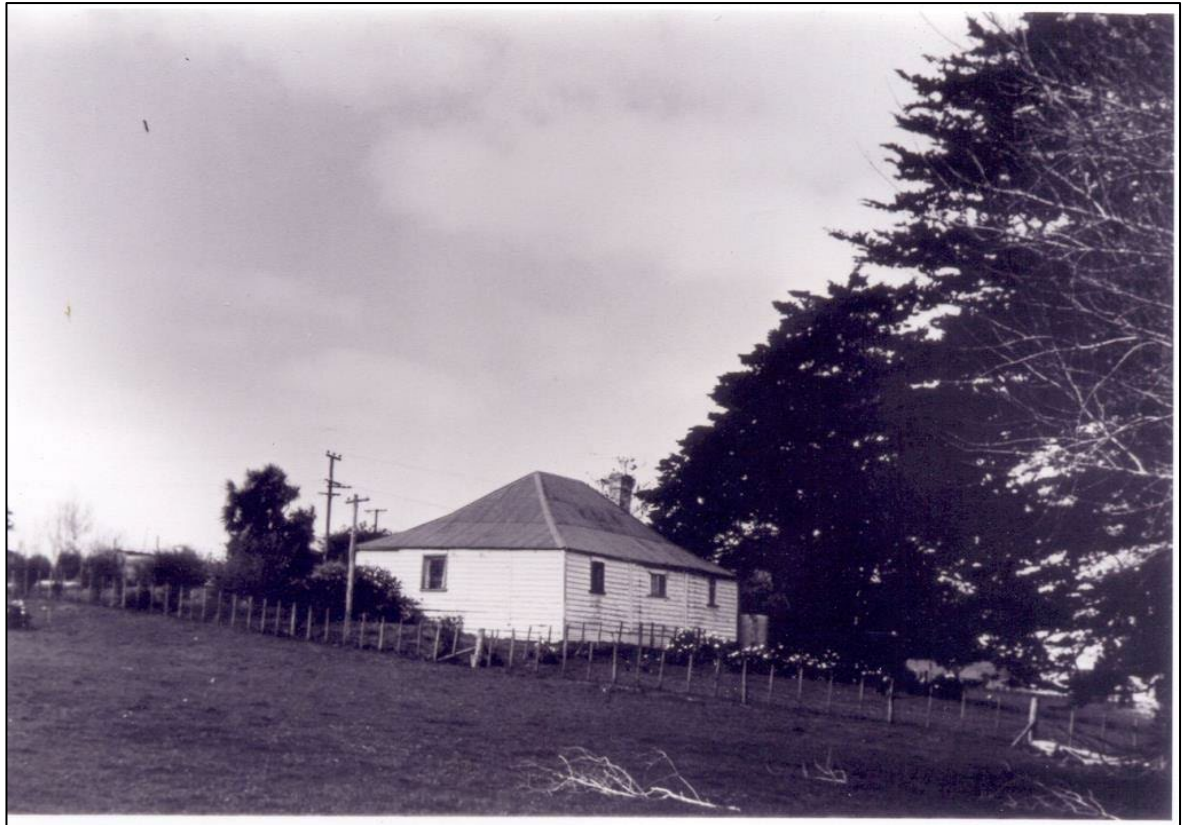
Figure 6 Photograph taken by Cecil Wright, and dated 1972, showing the rear (eastern and southern faces) of the house which is thought to have contained remnants of Maurice Kelly’s original homestead complex (source: 24.6.95, Silverdale & Districts Historical Society). Photo courtesy of Wainui Historical Society

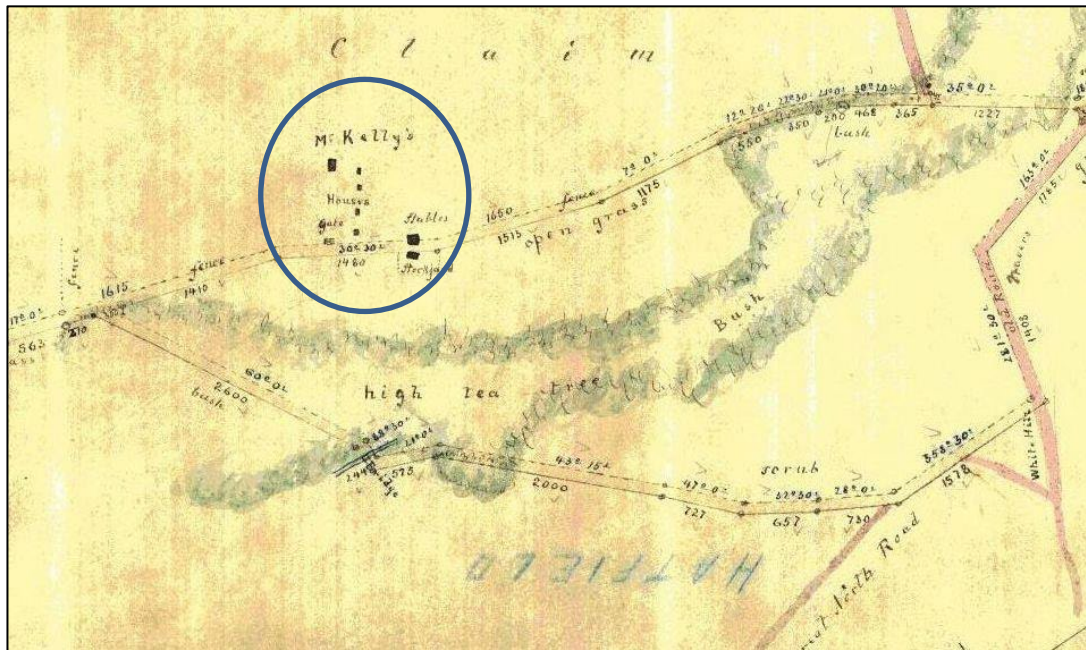
Figure 8 Enlargement of SO1118B (1873) showing houses, gate, stables and stockyard belonging to Maurice Kelly (source: LINZ)

SO1118B dated 24 April 1873 shows the line of road to be passed through Kelly’s land (now State Highway 17). The enlarged section of the plan below (Figure 8) clearly depicts a number of structures, the largest again presumably being Kelly’s main house, with three smaller structures, possibly outbuildings or workers cottages. The position of the gate is marked, along with the stables, and a stockyard. The line of road crosses directly over the footprint of the stables indicating that should the road have been placed as shown on the

plan, the stables would have been demolished and rebuilt elsewhere on the property. The stockyard is shown immediately to the west of the road and was in all likelihood also relocated. A tract of “high tea tree bush” can be seen.

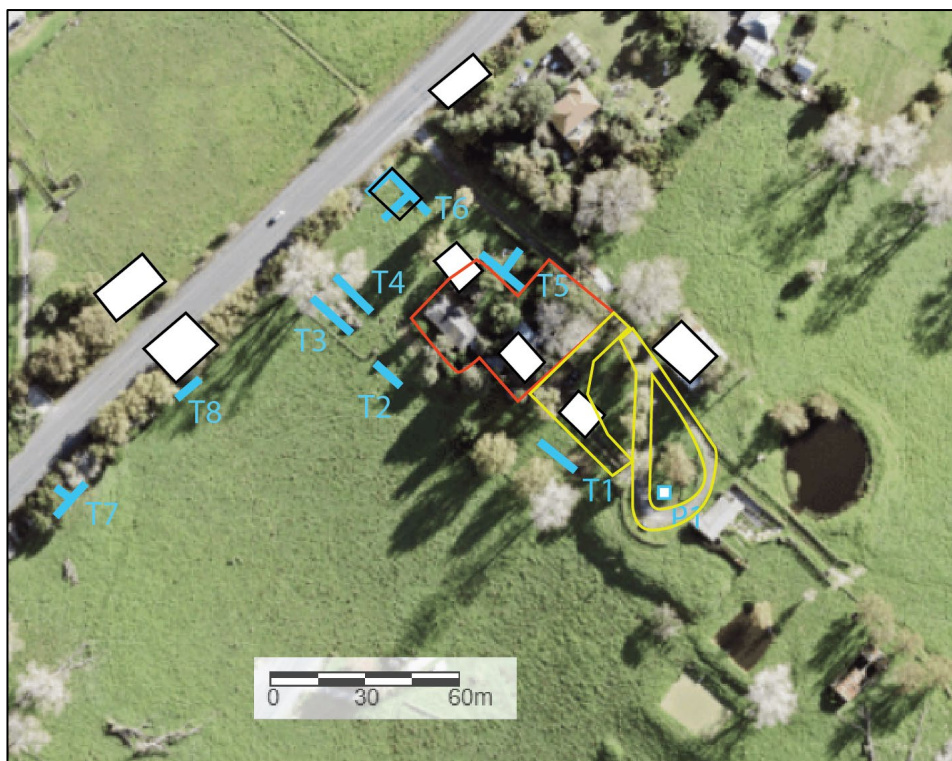
Figure 11 Trench location plan (in blue) showing the approximate location of the 1873 structures (white boxes); extent of modern house, garden and access (red outline); extent of wider farm access driveway and access (yellow outline)

The locations of the trenches to test for subsurface archaeology are shown in Figure 11. Also shown are the approximate location of structures identified on the 1873 survey², and modern disturbed areas around the existing house and driveway/access way areas (indicated in red and yellow).

² Note that this plan should not be considered accurate; there is some scale differentiation between the 1870 survey plan and modern aerial. This plan should be viewed considered an approximate location only of the former 19th century structures.

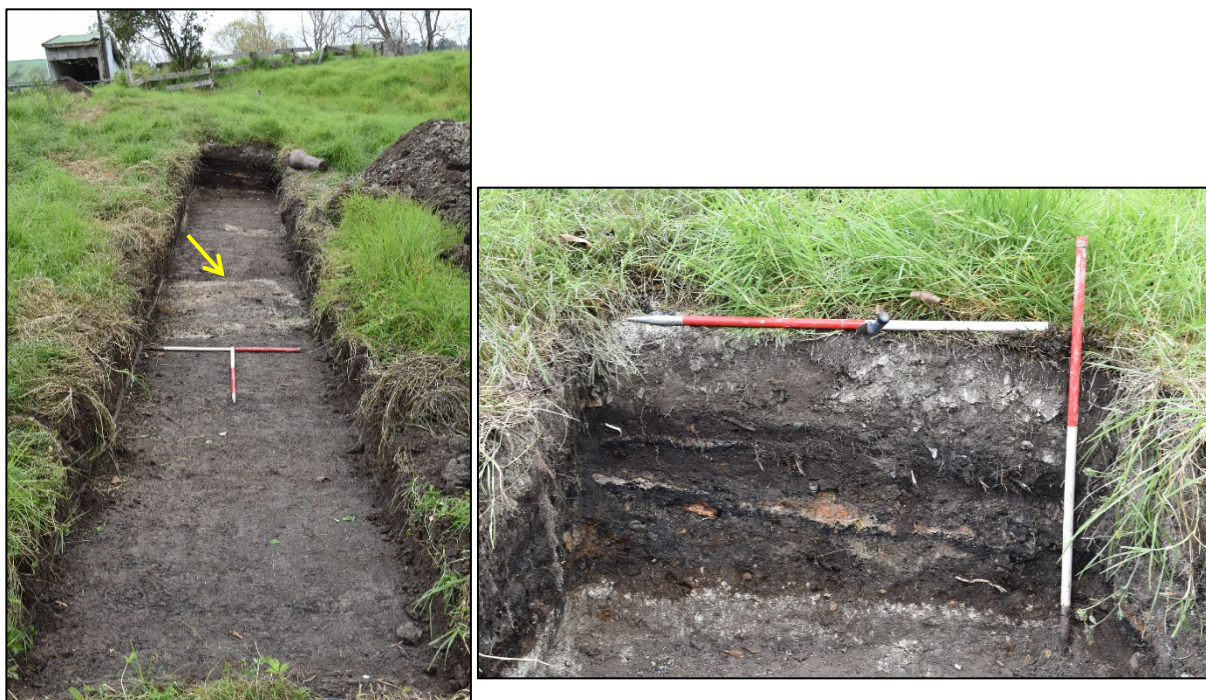
Trench 1 was located near the southern extent of the investigation area, adjacent and down slope from the farm access track and possible location of one of the Kelly houses (Figure 11). The trench was 12m long by 1.3m wide and excavated to a depth of 0.80m. Excavation commenced from south to north. Thick layers of made-ground were observed in this trench – initially in the form of a modern concrete dump above a silt layer and a sequence of burnt layers containing modern rubbish (see Table 1; Figure 12). Some 19th century artefacts (nails, iron pieces) were observed mixed in a silty clay layer below, which sat above a possible surface comprised of compacted limestone and mudstones with occasional ceramic and black beer bottle fragments located in the southern half of the trench only (context 105). The limit of excavation was within context 106, a clay silt layer containing fragments of bone (butchered and sawn), black beer glass, case gin, aqua, willow ware ceramic and flow blue, Asiatic pheasant, stoneware and clay tobacco pipe stem fragments. This layer likely built-up during use of the house up-slope to the northeast. A rectangular cut feature was cut through context 106, which extended through either side of the trench. It is likely a 19th century feature as the cut was not observed in the layers above (Figure 13). It was filled by yellowish brown clay that had occasional black beer fragments. The investigation halted here around 0.90m below the surface.

Figure 13 Photos of Trench 1: open trench with rectangular feature visible (arrowed), facing south (left); trench section (right). Scale: 2 x 1m

The layer containing artefacts and the pit feature found in Trench 1 are likely related to use of the house located to the east and upslope of this area. The stratigraphy recorded here indicates successive land-filling activities into the modern times to raise the ground surface, so it could be that this area was used to dump rubbish from Kelly's time on the property. The pit could be a cess-pit/long-drop; however further excavation would be required to confirm this.

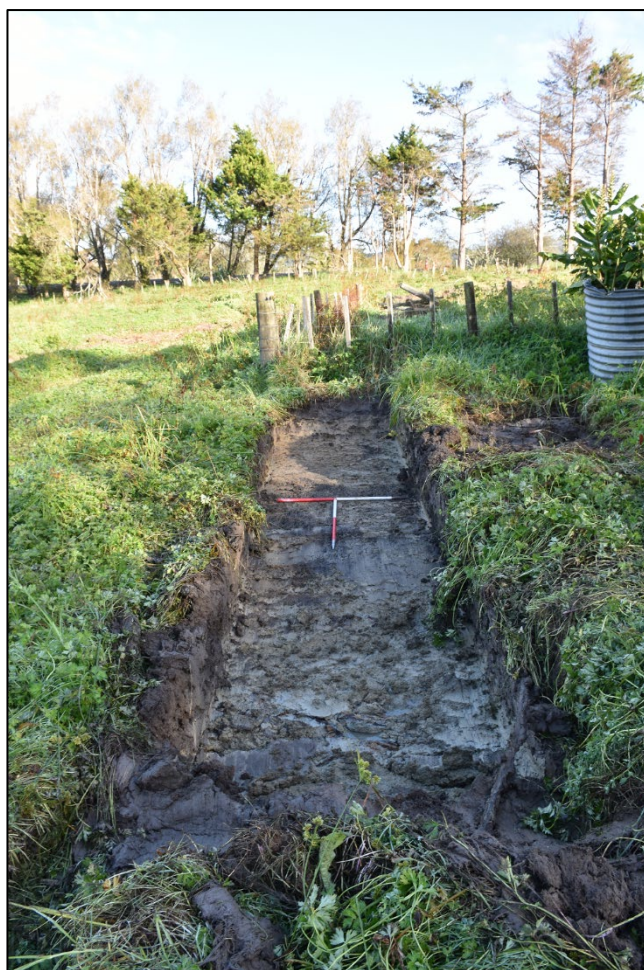
Trench 2 was located down slope to the southwest of the modern house and was 12m in length by 1.3m wide and excavated to a depth of 0.54m (Figure 11; Table 2; Figure 14). The clay was water logged and sticky in the southern half of the trench. No features were observed, with natural located around 40cm below the surface.

Figure 14 Photo of Trench 2, facing north. Scale: 2 x 1m.

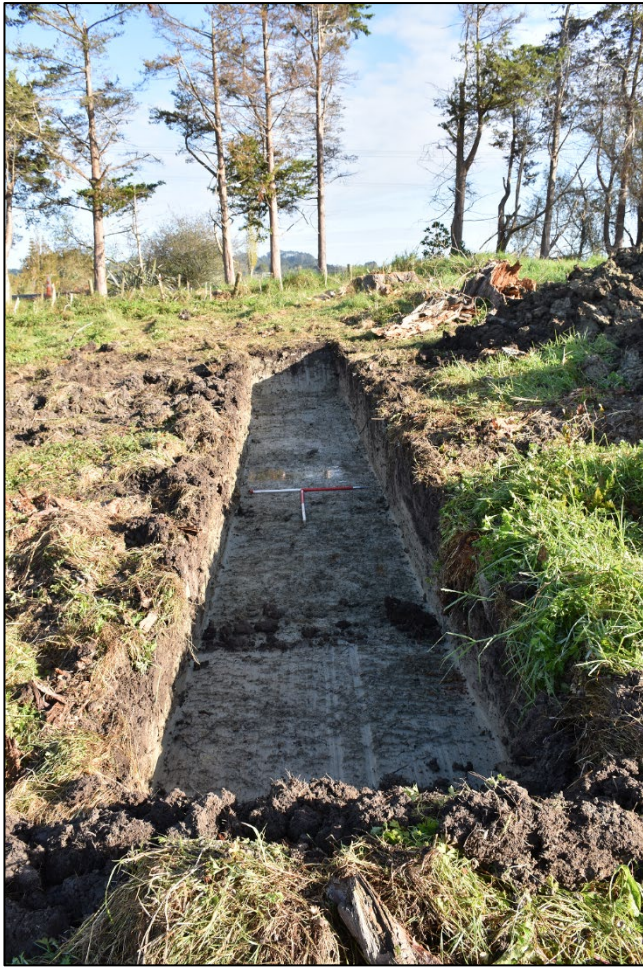
Trench 3 was located to the northwest of the modern house in the front paddock and was 11m long by 1.3m wide and 0.72m deep. The presence of gleyed soils indicated water logging which is consistent with the boggy soils observed during field survey (Figure 11; Table 3; Figure 15). No archaeological features were observed.

Figure 15 Photo of Trench 3, facing north. Scale: 2 x 1m.

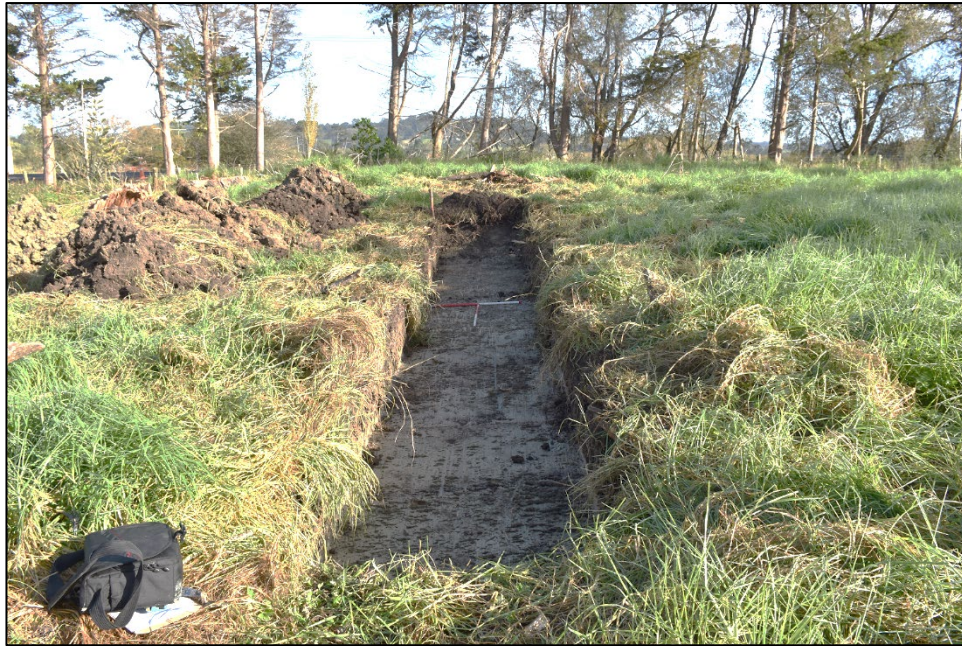
Trench 4 was located to the northeast of Trench 3 and was 11m long, 1.3m wide and 0.59m deep (Figure 11; Table 4; Figure 16). Similar stratigraphy was observed in Trench 4 as with Trench 3. No archaeological features were observed.

Figure 16 Photo of Trench 4 facing north. Scale: 2 x 1m.

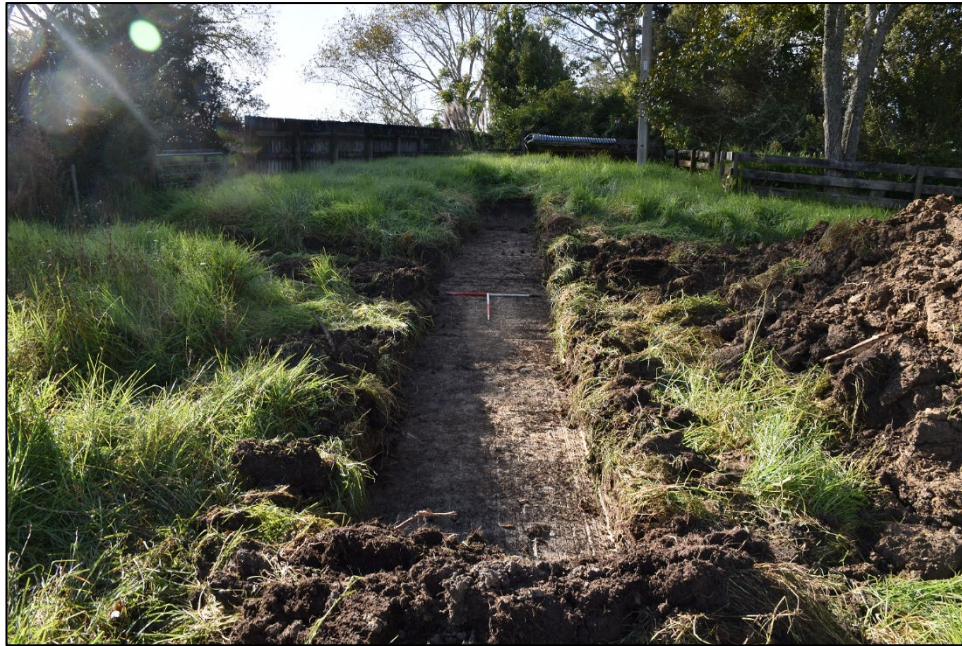
Trench 5 consisted of two bisecting trenches that formed a ‘T’ shape that were both 1.3m wide with one trench 9m long aligned northwest-southeast, and the other aligned 7m northeast-southwest for a length of 7 metres, with a maximum depth of 0.57m. The trenches were located to the northeast of the modern house and southeast of the possible location of one of the former Kelly houses (Figure 11). While no in situ archaeological features were observed in this layer, the topsoil contained some 19th century brick fragments and late 19th century ceramic fragments, which could relate to demolition of the former house structure (Table 5; Figure 18 and Figure 18).

Figure 17 Trench 5 facing south, long trench. Scale: 2 x 1m.

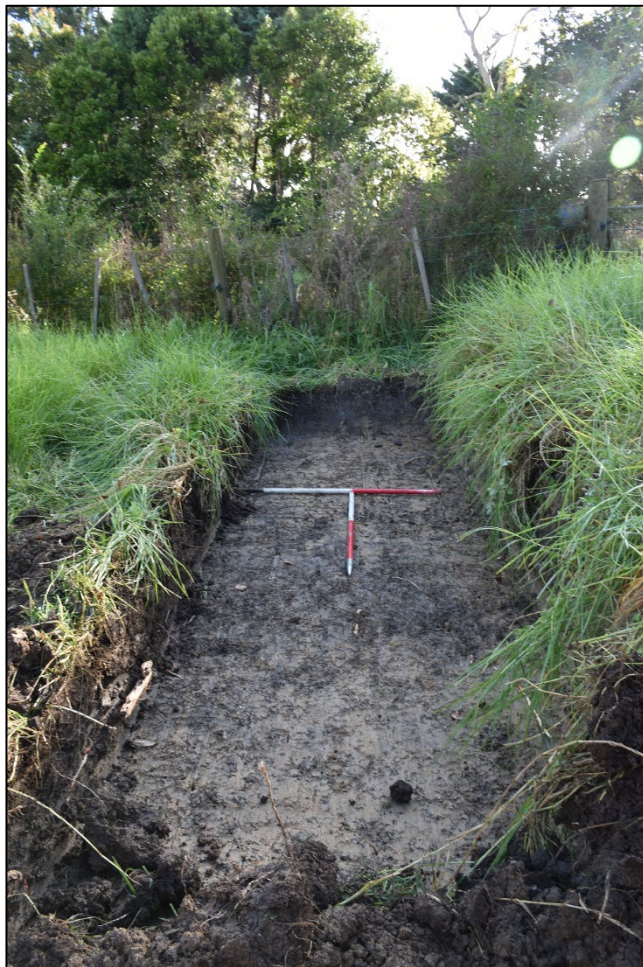
Figure 18 Photo of Trench 5, short trench facing east. Scale: 2 x 1m.

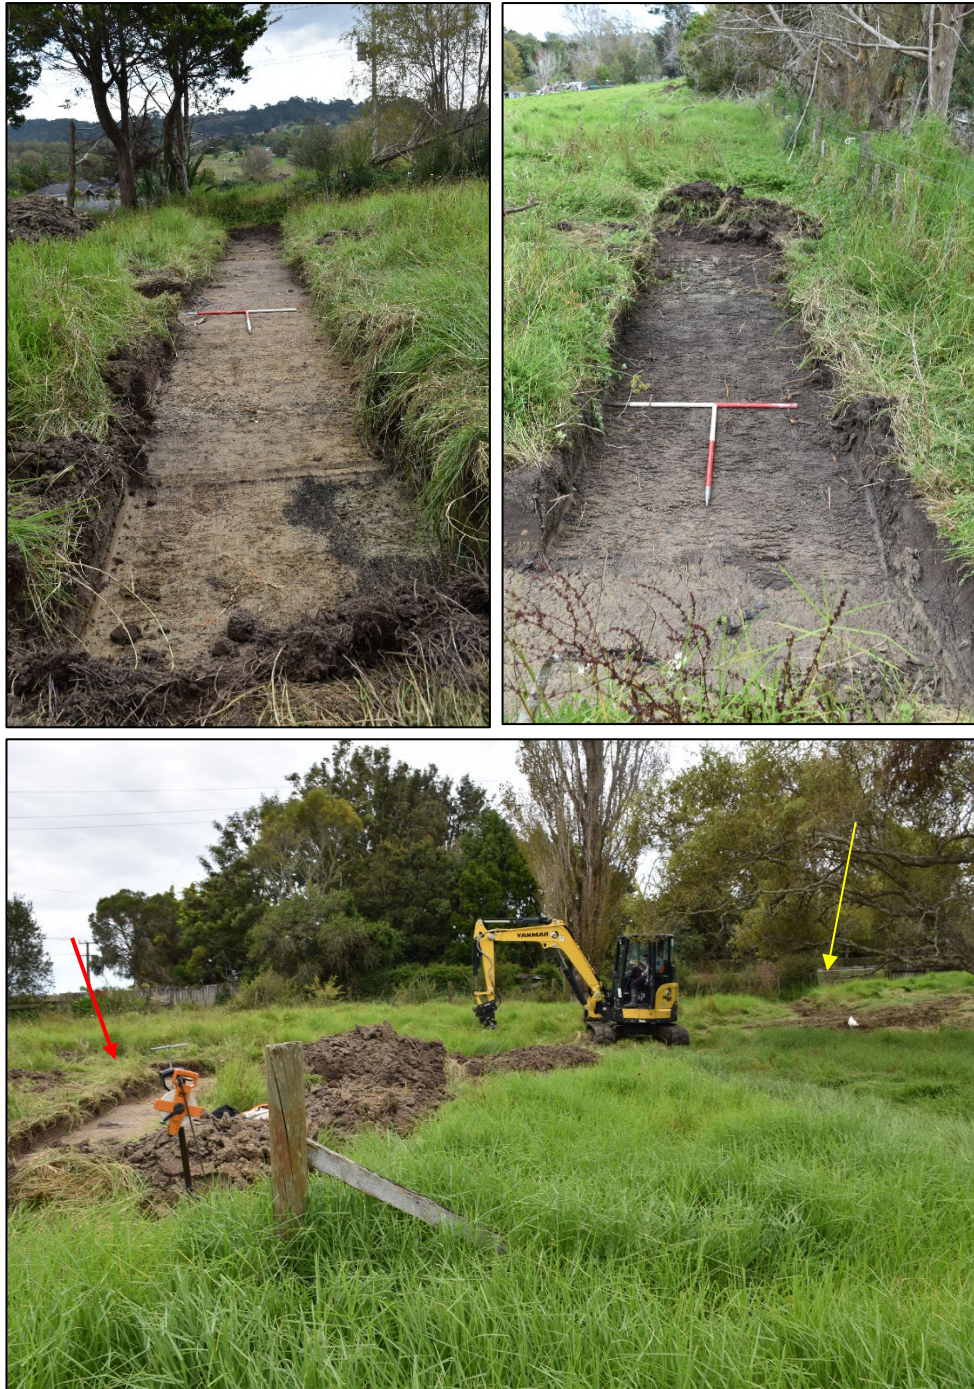
Trench 6 was located within the possible former footprint of one of Kelly's houses, the one which became closest to Dairy Flat Highway (the road having been built post-construction of Kelly's Homestead). The complex of three 1.3m wide bisecting trenches made a roughly 'F' shape plan, extending 17m northwest-southeast, with one 7.6m extension southwest to northeast, and a 5.5m section on the road frontage (Figure 11). Within this trench 16 postholes were observed and recorded, square and/or rectangular in shape (Figure 19; Figure 20). In addition, two possible beam slots or drains were also recorded, although the placement of the features suggests they are more likely drains than beam slots (Figure 19; Figure 20; Figure 21). Black beer bottles were located within the fill of many of the postholes, which could suggest they were deliberately placed there. The depth to natural was noticeably shallower in this series of trenches compared to others.

Figure 21 Trench 6 – longest trench on top left, facing north; short trench by road frontage on top right; and Trench 6 with postholes on the left (red arrow) and backfilled Trench 5 on the right (yellow arrow), facing northeast (1m scale bars)

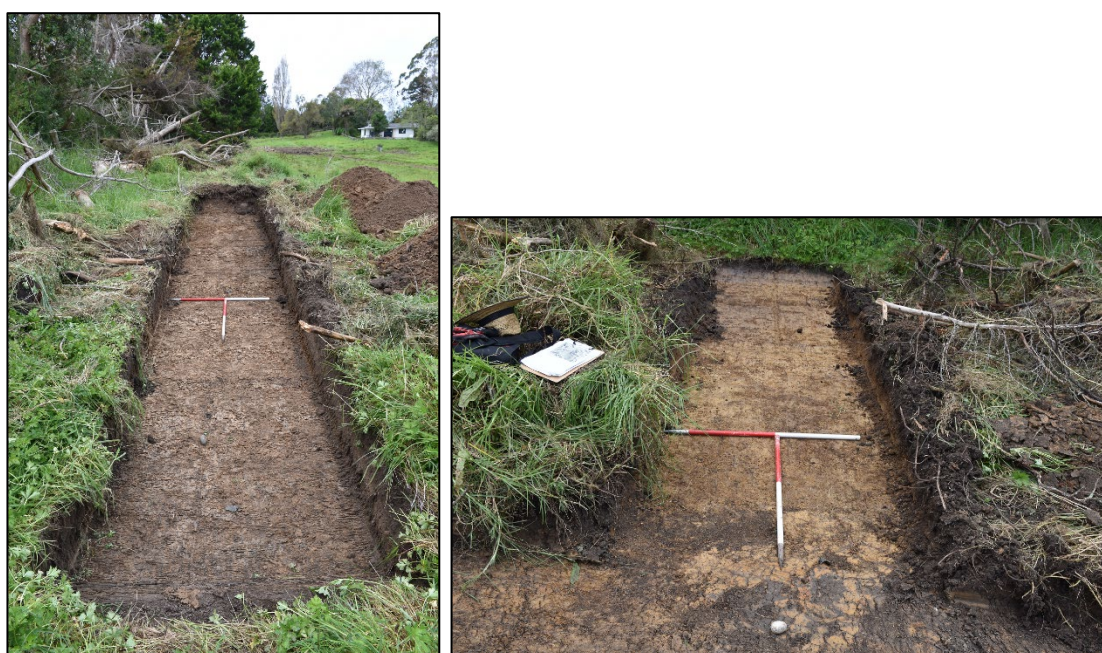
Trench 7 was placed to the southeast of the main house complex area in order to test the mounded area where 19th century artefacts had been observed on the surface during field survey (Figure 11). It measured 8m southeast northwest and had a 3m ‘L’ shaped extension at its northern end (Figure 22). No in situ features were recorded in this trench, suggesting

that the mound may have been formed during land clearance with isolated 19th century features mixed in the topsoil.

Figure 22 Trench 7 – long trench (left) and short trench facing the road frontage (right) (1m scale bars)

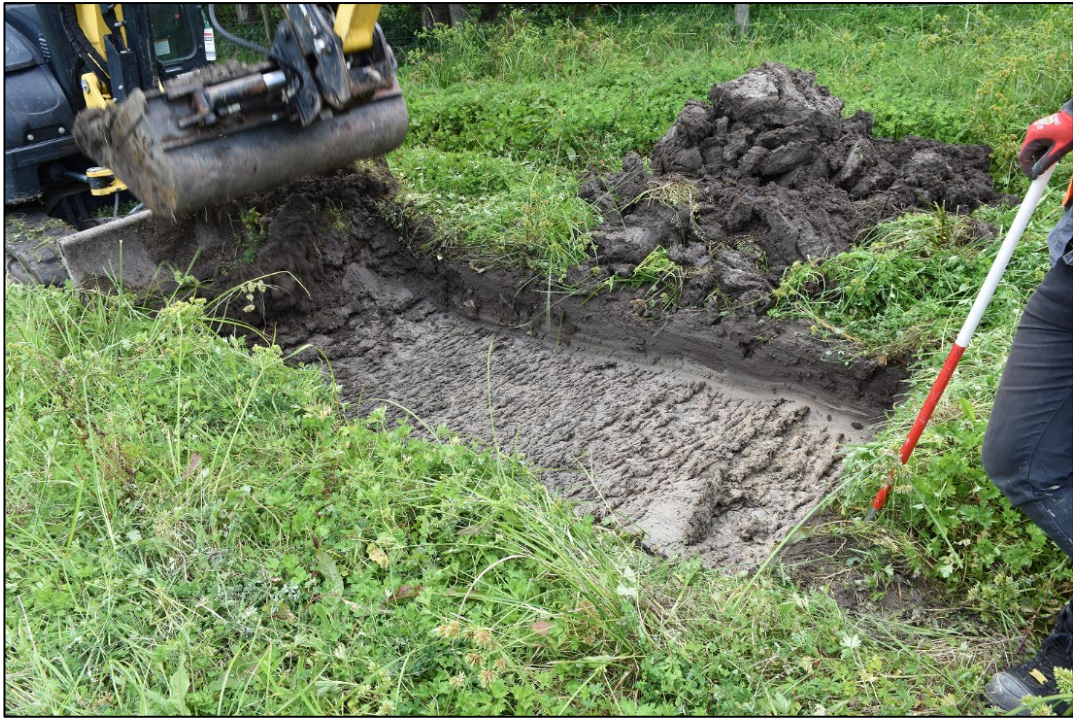
Trench 8 was located just northeast of Trench 7 along the property frontage where the map overlay indicated that the possible stables were located (Figure 11). Grey gleyed soil was observed just below the topsoil, and the trench was abandoned at this point as no features or artefacts were observed.

Figure 23 Photo of Trench 8 just before it was abandoned showing gleyed clay (facing northwest)

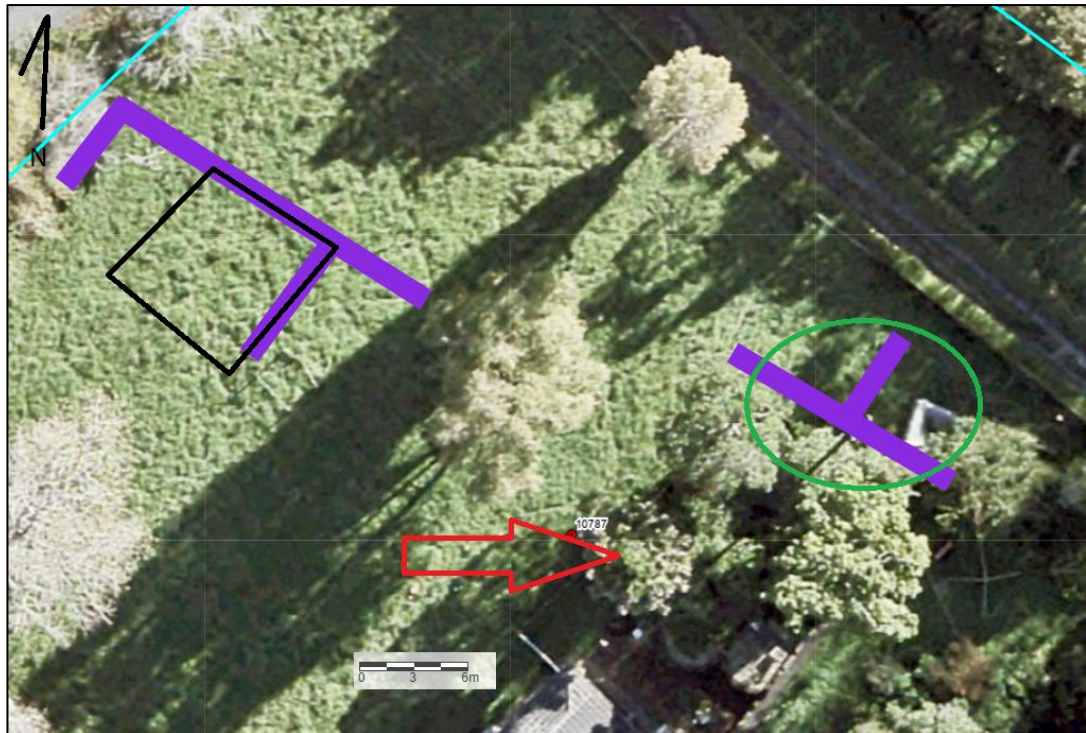
The exploratory investigation located the archaeological remains of a structure, most likely one of the Kelly houses, shown located closest to the road on the 1873 plan (Figure 24); demolition debris possibly related to the second house back from the road (the homestead); and a possible pit and artefact layer related to the fourth house from the road (Figure 25).

Figure 24 Projected layout of the house structure located within Trench 6 (square) based on the results of the exploratory testing; possibly demolition spread found in Trench f (green oval) with the probable house location (homestead) indicated by the arrow

The survival of the Kelly homestead and associated structures (R10/737) is likely to remain in variable condition across the property at 1636 Dairy Flat Highway. The most disturbed area where archaeological remains are likely to be vertically truncated and/or modified will be where the modern house and immediate gardens, drive and accessways are situated. The likely inn location has also been modified, but as the posts/foundations are likely to be quite large they should survive in part even if they have been vertically truncated. Subsurface remains of the stables are unlikely to survive due to the widening of the modern road. The potential for best surviving subsurface archaeology is in the area around Trench 6 where the remains of one of the houses was located.

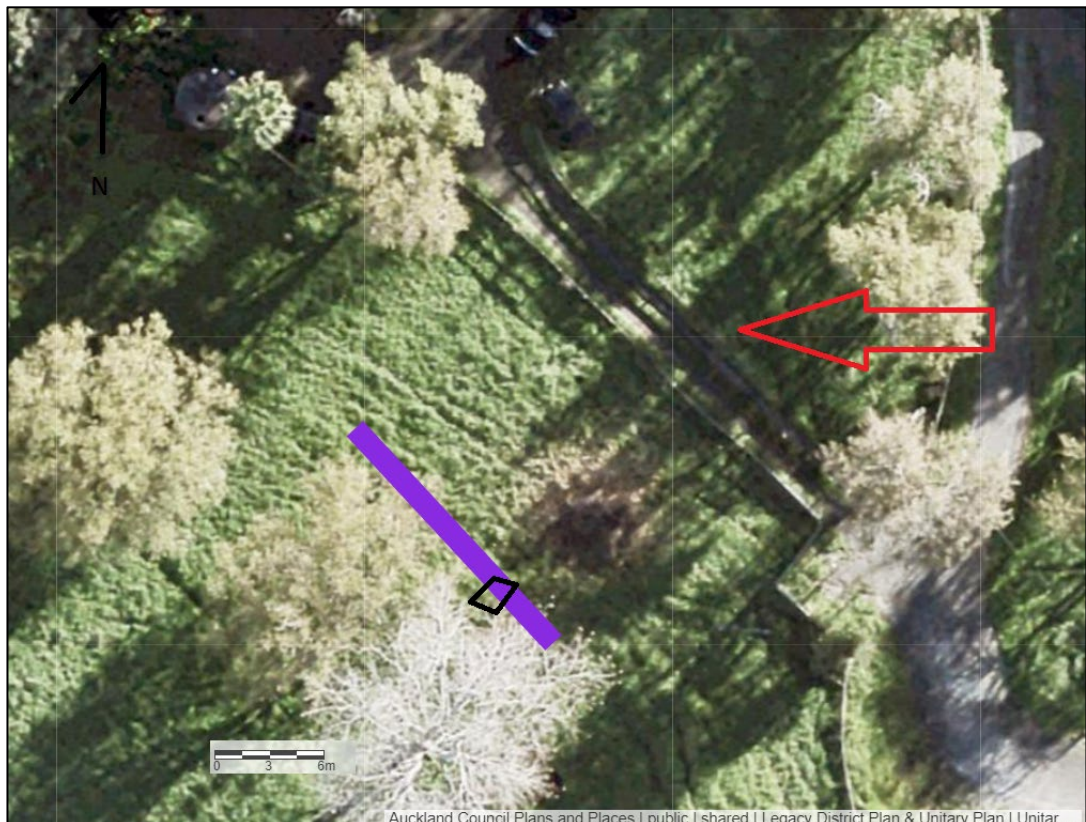
Figure 25 Location of 19th century pit feature and artefact layer located close to the fourth house structure (back from the road), the likely location indicated by the arrow

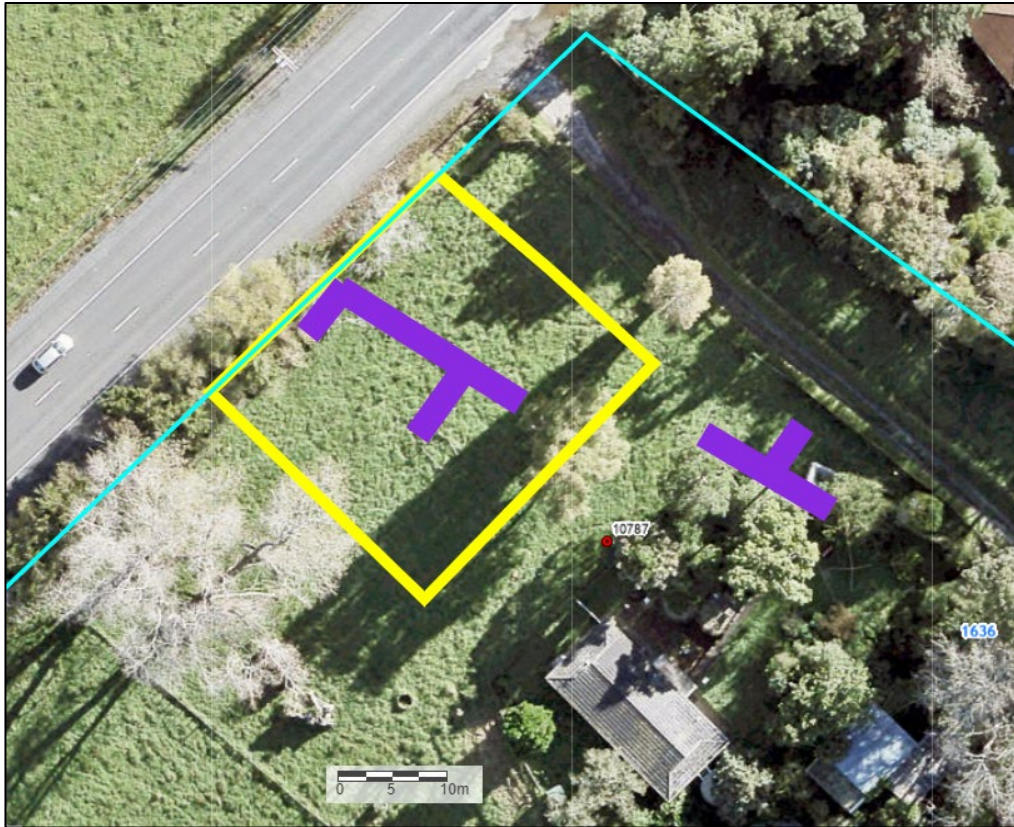
The exploratory authority investigation has confirmed that subsurface archaeology relating to Maurice Kelly's homestead/Inn R10/737 survives on the property at 1636 Dairy Flat Highway. While a large portion of the site could not be tested by trenches or test pits, the areas that were tested indicated that the paddock closest to the road where a house was located has surviving subsurface archaeology in good condition, and that it is likely further features survive in this immediate area.

Figure 27 Area at 1636 Diary Flat Highway where in situ archaeology in good condition is located (outlined in yellow)

- Based on the results of the investigation, consideration should be given to protecting the subsurface archaeological remains of site R10/737 within the area indicated on Figure 27 where the (probable) house structure closest to the road is located. Installation of interpretive elements such as surface demarcations of the house and an information panel should be considered.

- While any remaining subsurface archaeology relating to R10/737 on the property is likely to have been previously modified/vertically truncated, that a general archaeological authority will still be required from Heritage New Zealand Pouhere Taonga prior to commencement of any earthworks that may affect the site.

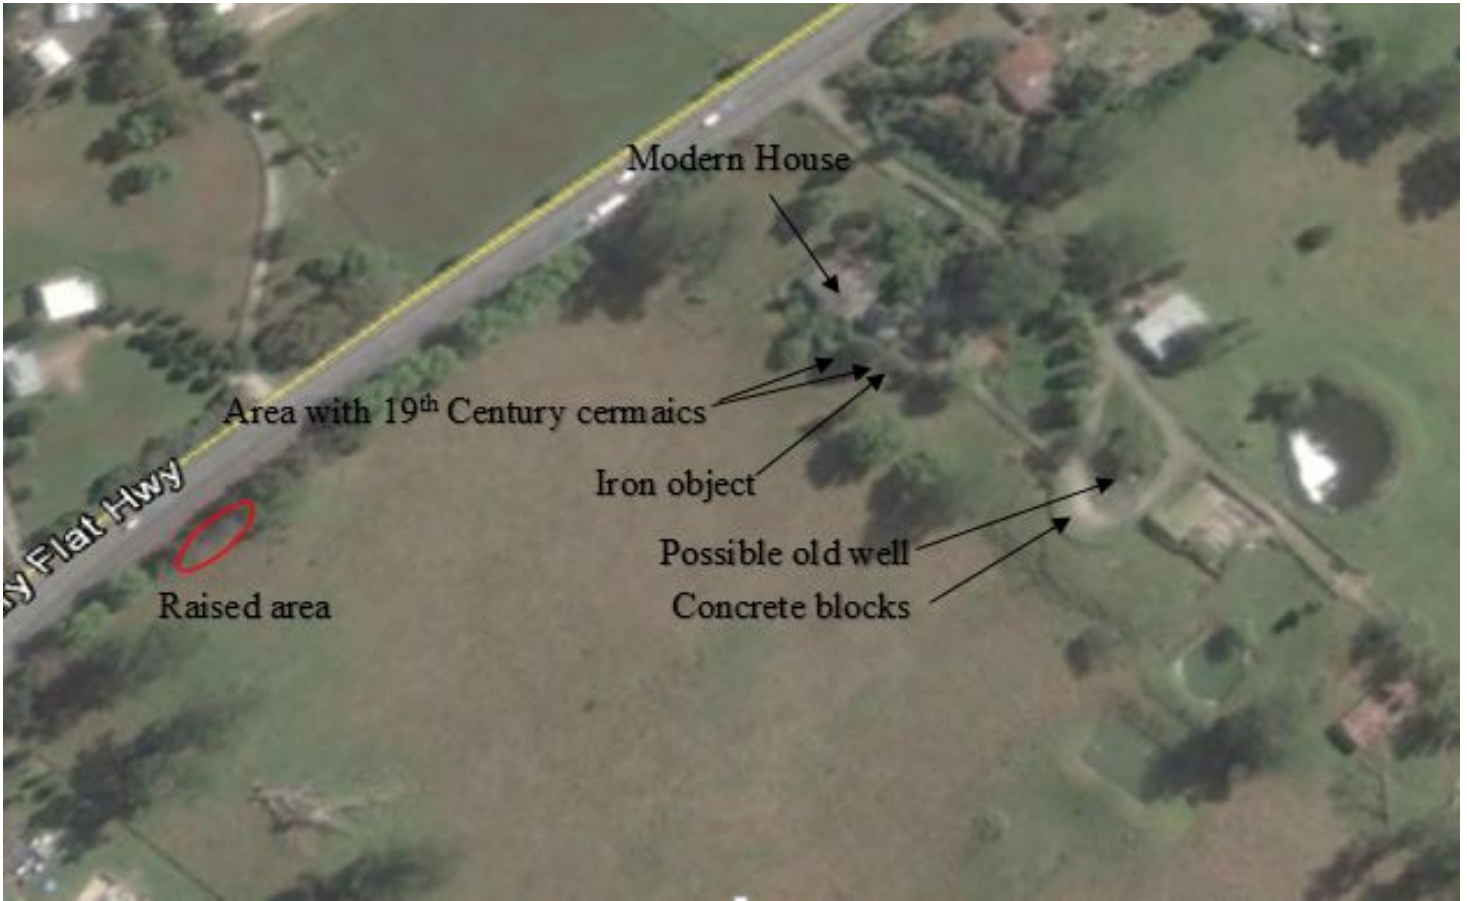
In the 2015 survey a slightly raised area was noted approximately 100 m to the south of the modern house location and situated just by the fence along Dairy Flat Highway. Surface finds of broken pieces of glass, typical of the 19th Century were found. The coordinates of the mound were taken by Handheld GPS (E1747694 N5944403±3m). From available information it would seem likely that this could represent a rubbish dumping area for the Kelly homestead and public house.

Locations of surface finds at 1636 Dairy Flat Highway; red circle indicates the raised area described in the text and black arrows pointing to other locations (source of aerial photograph Google Earth).
