Weigh Right Bombay - Site Investigation Report Review

Project No. 5-C4353.04
File/Ref 5C4353-WSP-04-LT-EH-1000-RevB

Project No: IZ105201
 Document Title: Bombay Contaminated Land Assessment - Soil Sampling
 Document No.: IZ105201-A.P4.TE.034.P034-NW-RPT-0001
 Revision: A
 Date: September 23, 2020
 Client Name: Waka Kotahi NZ Transport Agency
 Project Manager: Ashley Rideout
 Author: Kate Murray
 File Name: Bombay Contaminated Land Assessment - Soil Sampling_Rev A

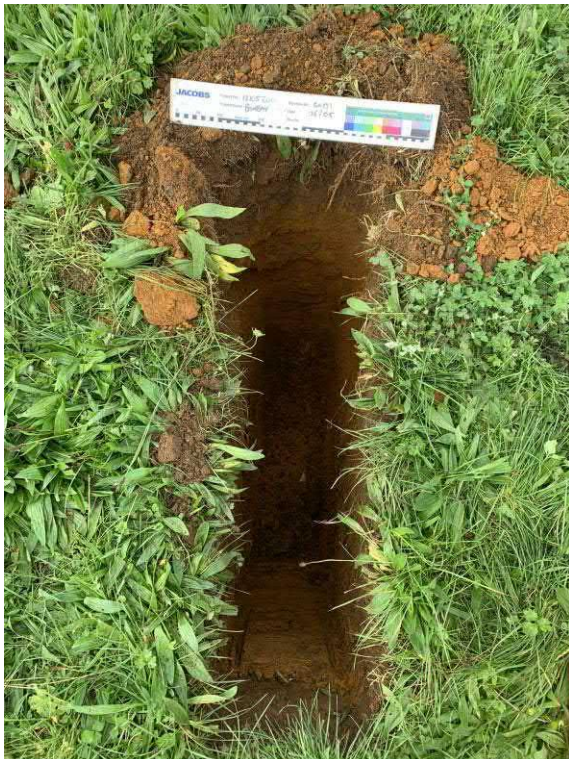
Photograph 2: The soil profile of SA01

Soils encountered were natural ground comprising a shallow surficial greyish brown clayey sand topsoil layer overlying a brownish orange clay layer. No visual or olfactory signs of contamination were observed in any of the sampling locations.

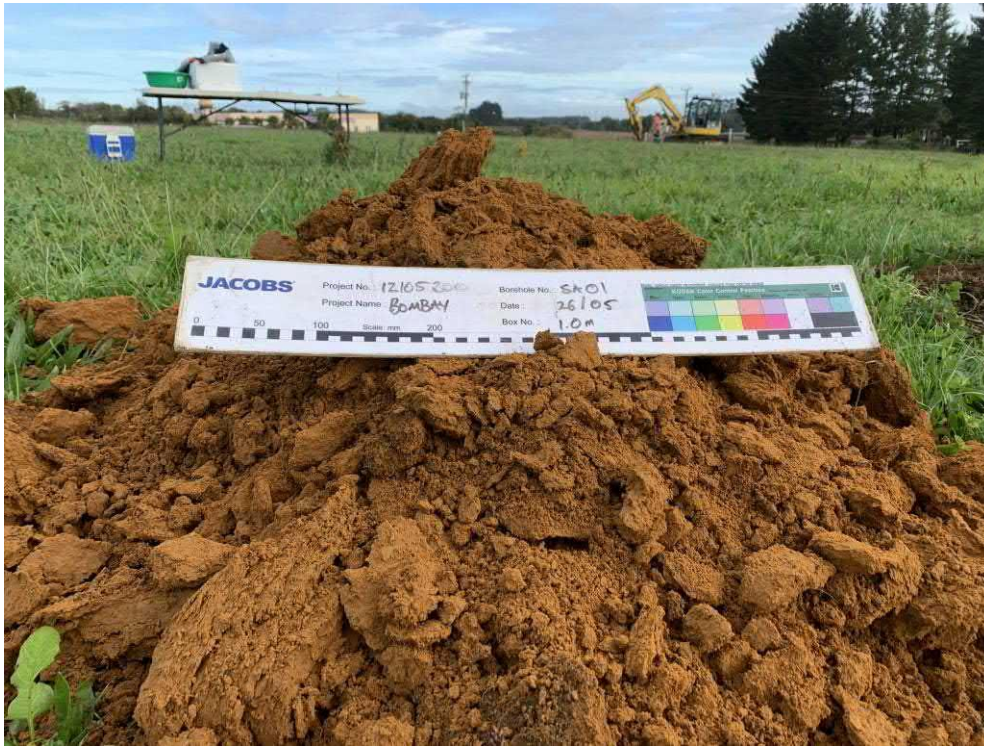
Photograph 3: Facing west from the site of SA01, the brownish orange clay from SA01 in the foreground

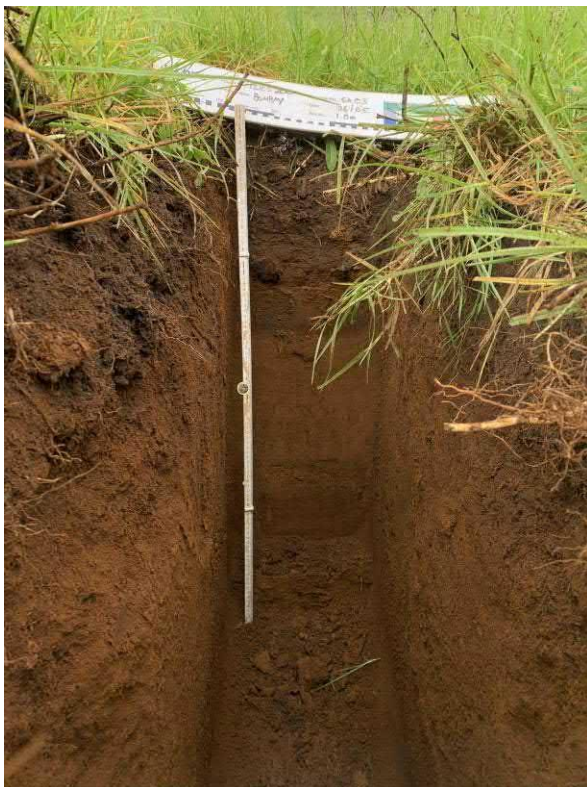
Photograph 6: The soil profile at SA03

A surface sample collected at SA03 was reported with an Arsenic level of 20 mg/kg which exceeded an expected background of 12 mg/kg. A single trace detection of asbestos less than 0.001 % w/w was also identified in SA03. A deeper sample from SA03 at 0.5 m bgl was reported with metal concentrations not exceeding expected background. Asbestos was not analysed.

- d) OCPs: test results for soil within the proposed development area were less than the limits of reporting (LOR).
- e) Asbestos: Results show that one sample (SA03) out of the five that was analysed for asbestos contained asbestos material (Crocidolite (blue) asbestos) in the form of loose fibres (minor). The asbestos in ACM as a percentage of total sample for SA03 was <0.001%. The weight of asbestos as asbestos fines (friable) was 0.0003 g dry wt. The combined fibrous asbestos & asbestos fines (FA & AF) as percentage of total sample for this sample was <0.001%. This sample does not exceed the FA and/or AF guidelines set out in Table 5 of the BRANZ Guideline Document
