TO: Goodman Nominee (NZ) Limited  
COPY TO: Mary Wong, Barker & Associates  
FROM: Brittany Pearce, Ecologist

Date: 21 June 2023  
Document No: 10010-002-1

## VILLA MARIA – FRESHWATER CLASSIFICATIONS

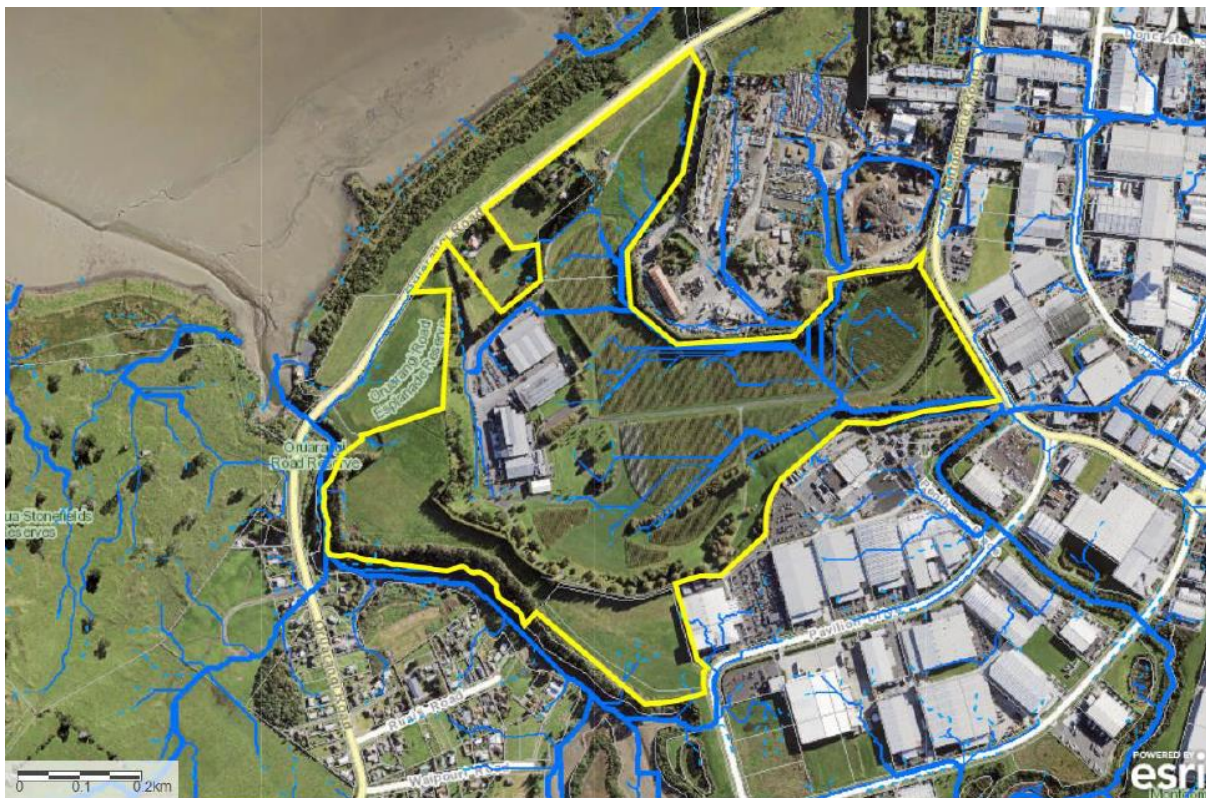
**Figure 1. The site at Villa Maria Estate (yellow polygon) and Auckland Council's predicted overland flow paths overlay (blue lines), sourced from Geomaps.**

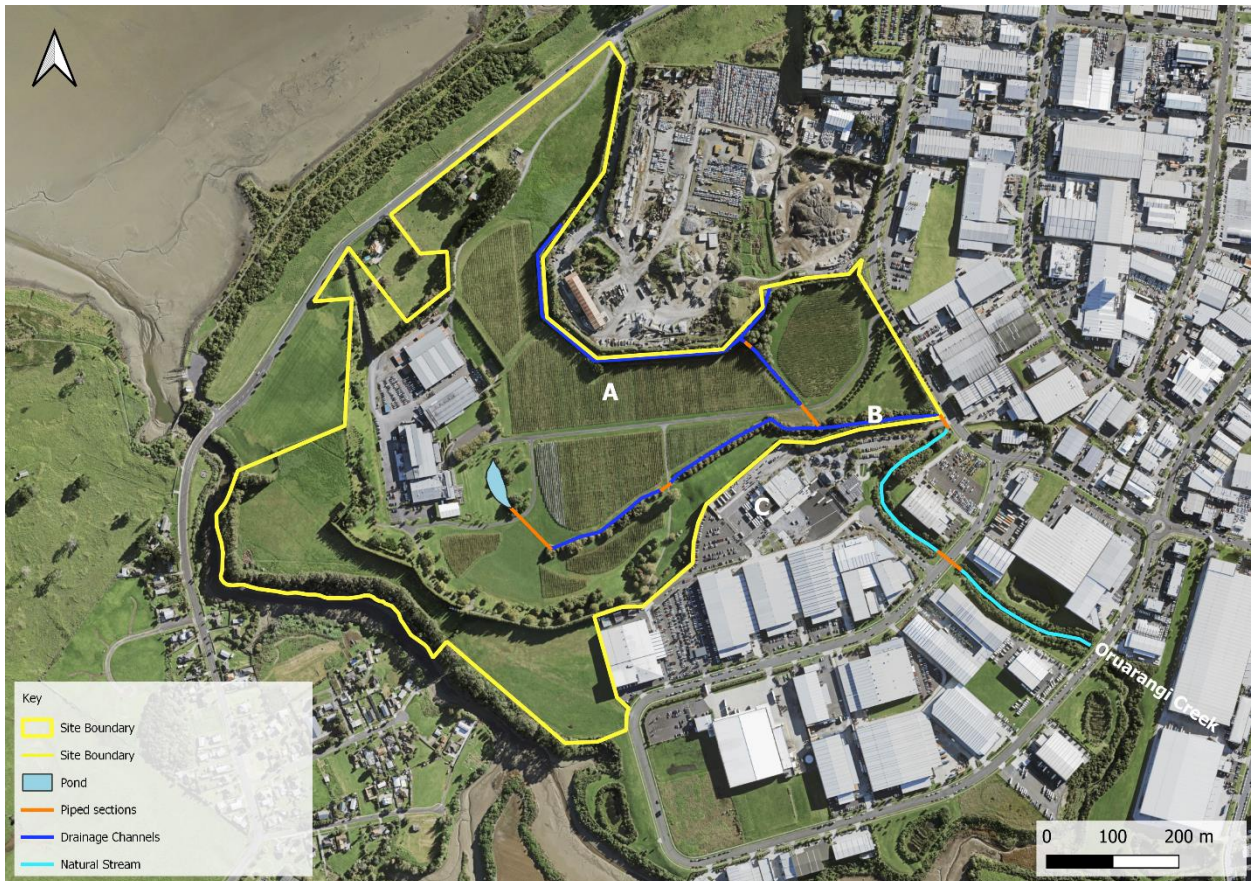
Freshwater features within the site have been identified as per Figure 2. Three watercourses, labelled A-C, have been assessed to meet the definition of 'artificial watercourses' as per the AUP definition<sup>6</sup>. This assessment is consistent with previous classifications undertaken by FSL and Bioreserches, and agreed upon by Auckland Council's specialist.

Upon visual inspection, watercourses A-C had artificial straightened alignments, had been widened/deepened, and contained no natural portions from headwaters to confluence. Given the naturally high water table within the site and the land use, it is clear that the watercourses have been constructed for drainage purposes. The flat nature of the caldera and the lack of a natural outlet would not have historically supported the formation of natural streams. In the eastern corner of the site, an artificially created opening in the tuff crater allows for watercourse C to drain to the Oruarangi Creek (Figure 2). A constructed pond is located roughly in the middle of the site which is piped to the upper portion of watercourse C (Figure 2).

**Figure 2. Freshwater features identified within the Villa Maria site.**

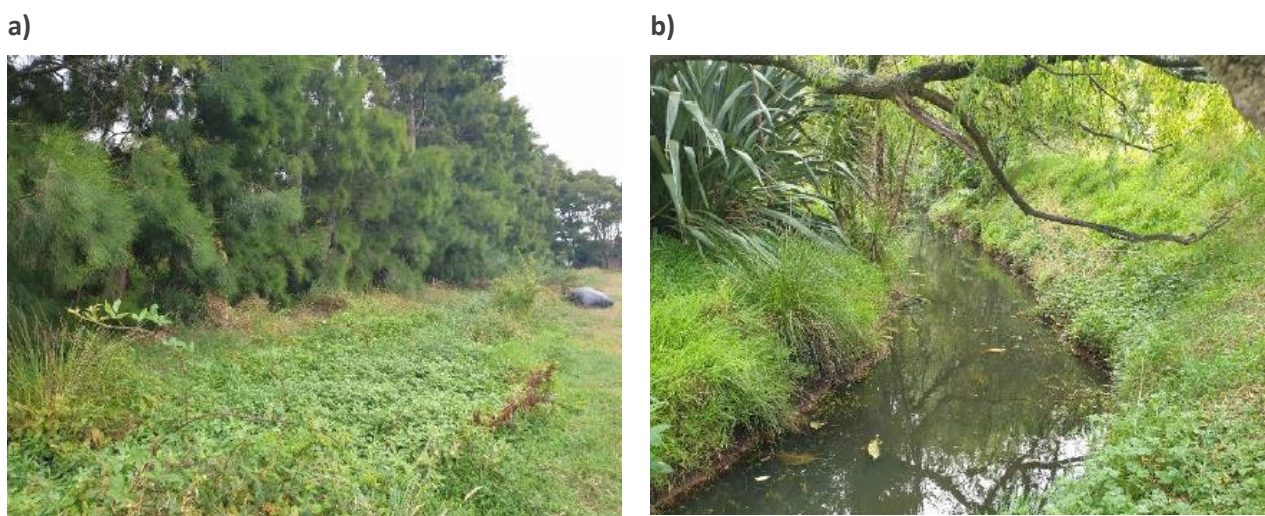
Descriptions of the channel environments and habitat values have previously been detailed by Bioresarches and FSL<sup>1,2</sup>. Ecological values of the artificial channels were assessed as ‘low’ in both reports. We agree with this assessment, largely due to the modified nature of the channels for their intended drainage purposes, which provide poor quality aquatic habitat, limited flow, and are overgrown with exotic macrophytes (Figure 3).

**Figure 3. a) Example of Watercourse A channel showing a lack of water and overgrowth of macrophytes, and b) Example of Watercourse C showing artificially aligned and deepened channel (images sourced from Bioresarches).**

The drainage channels have been assessed to have a generally low ecological value, aside from the lower portion of watercourse C which At-Risk fish species may intermittently utilise. Therefore, despite the drainage channels having no protection under the AUP, it is recommended that a fish management plan be prepared and implemented to relocate native fish from the site prior to any in-stream works.

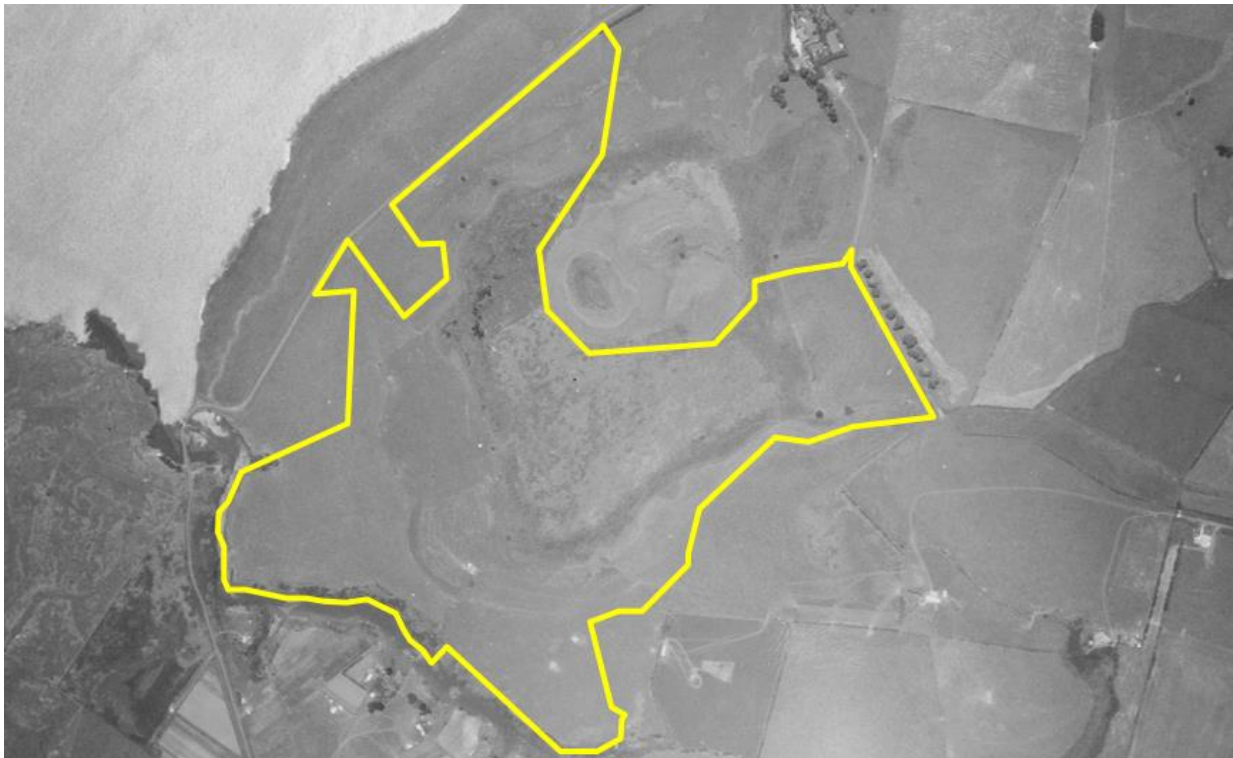
A review of historic aerial imagery shows no evidence of natural streams present within the site (Figure 3). The oldest aerial that could be sourced was from 1939 (Figure 3). This aerial shows that the site has been used for horticultural/agricultural purposes for more than 80 years, and artificially constructed watercourses B and C are visible. Darker areas of vegetation within the site indicate the presence of poorly drained soils within the caldera in 1939. As mentioned previously, the environment within the site and caldera was expected to be present historically (at least prior to 1939). The drainage channels, including the artificially cut outlet in the tuff ring that drains the site, effectively reclaimed this freshwater wetland environment.

**Figure 4. Historic aerial of the site (yellow polygon), Waitomokia volcanic crater and general surrounding environment. Drainage channels are present (image sourced from Retrolens).**
