VILLA MARIA

GEOTECHNICAL FACTUAL REPORT

INITIA REF P-000982-2 REV 0

MAY 2022

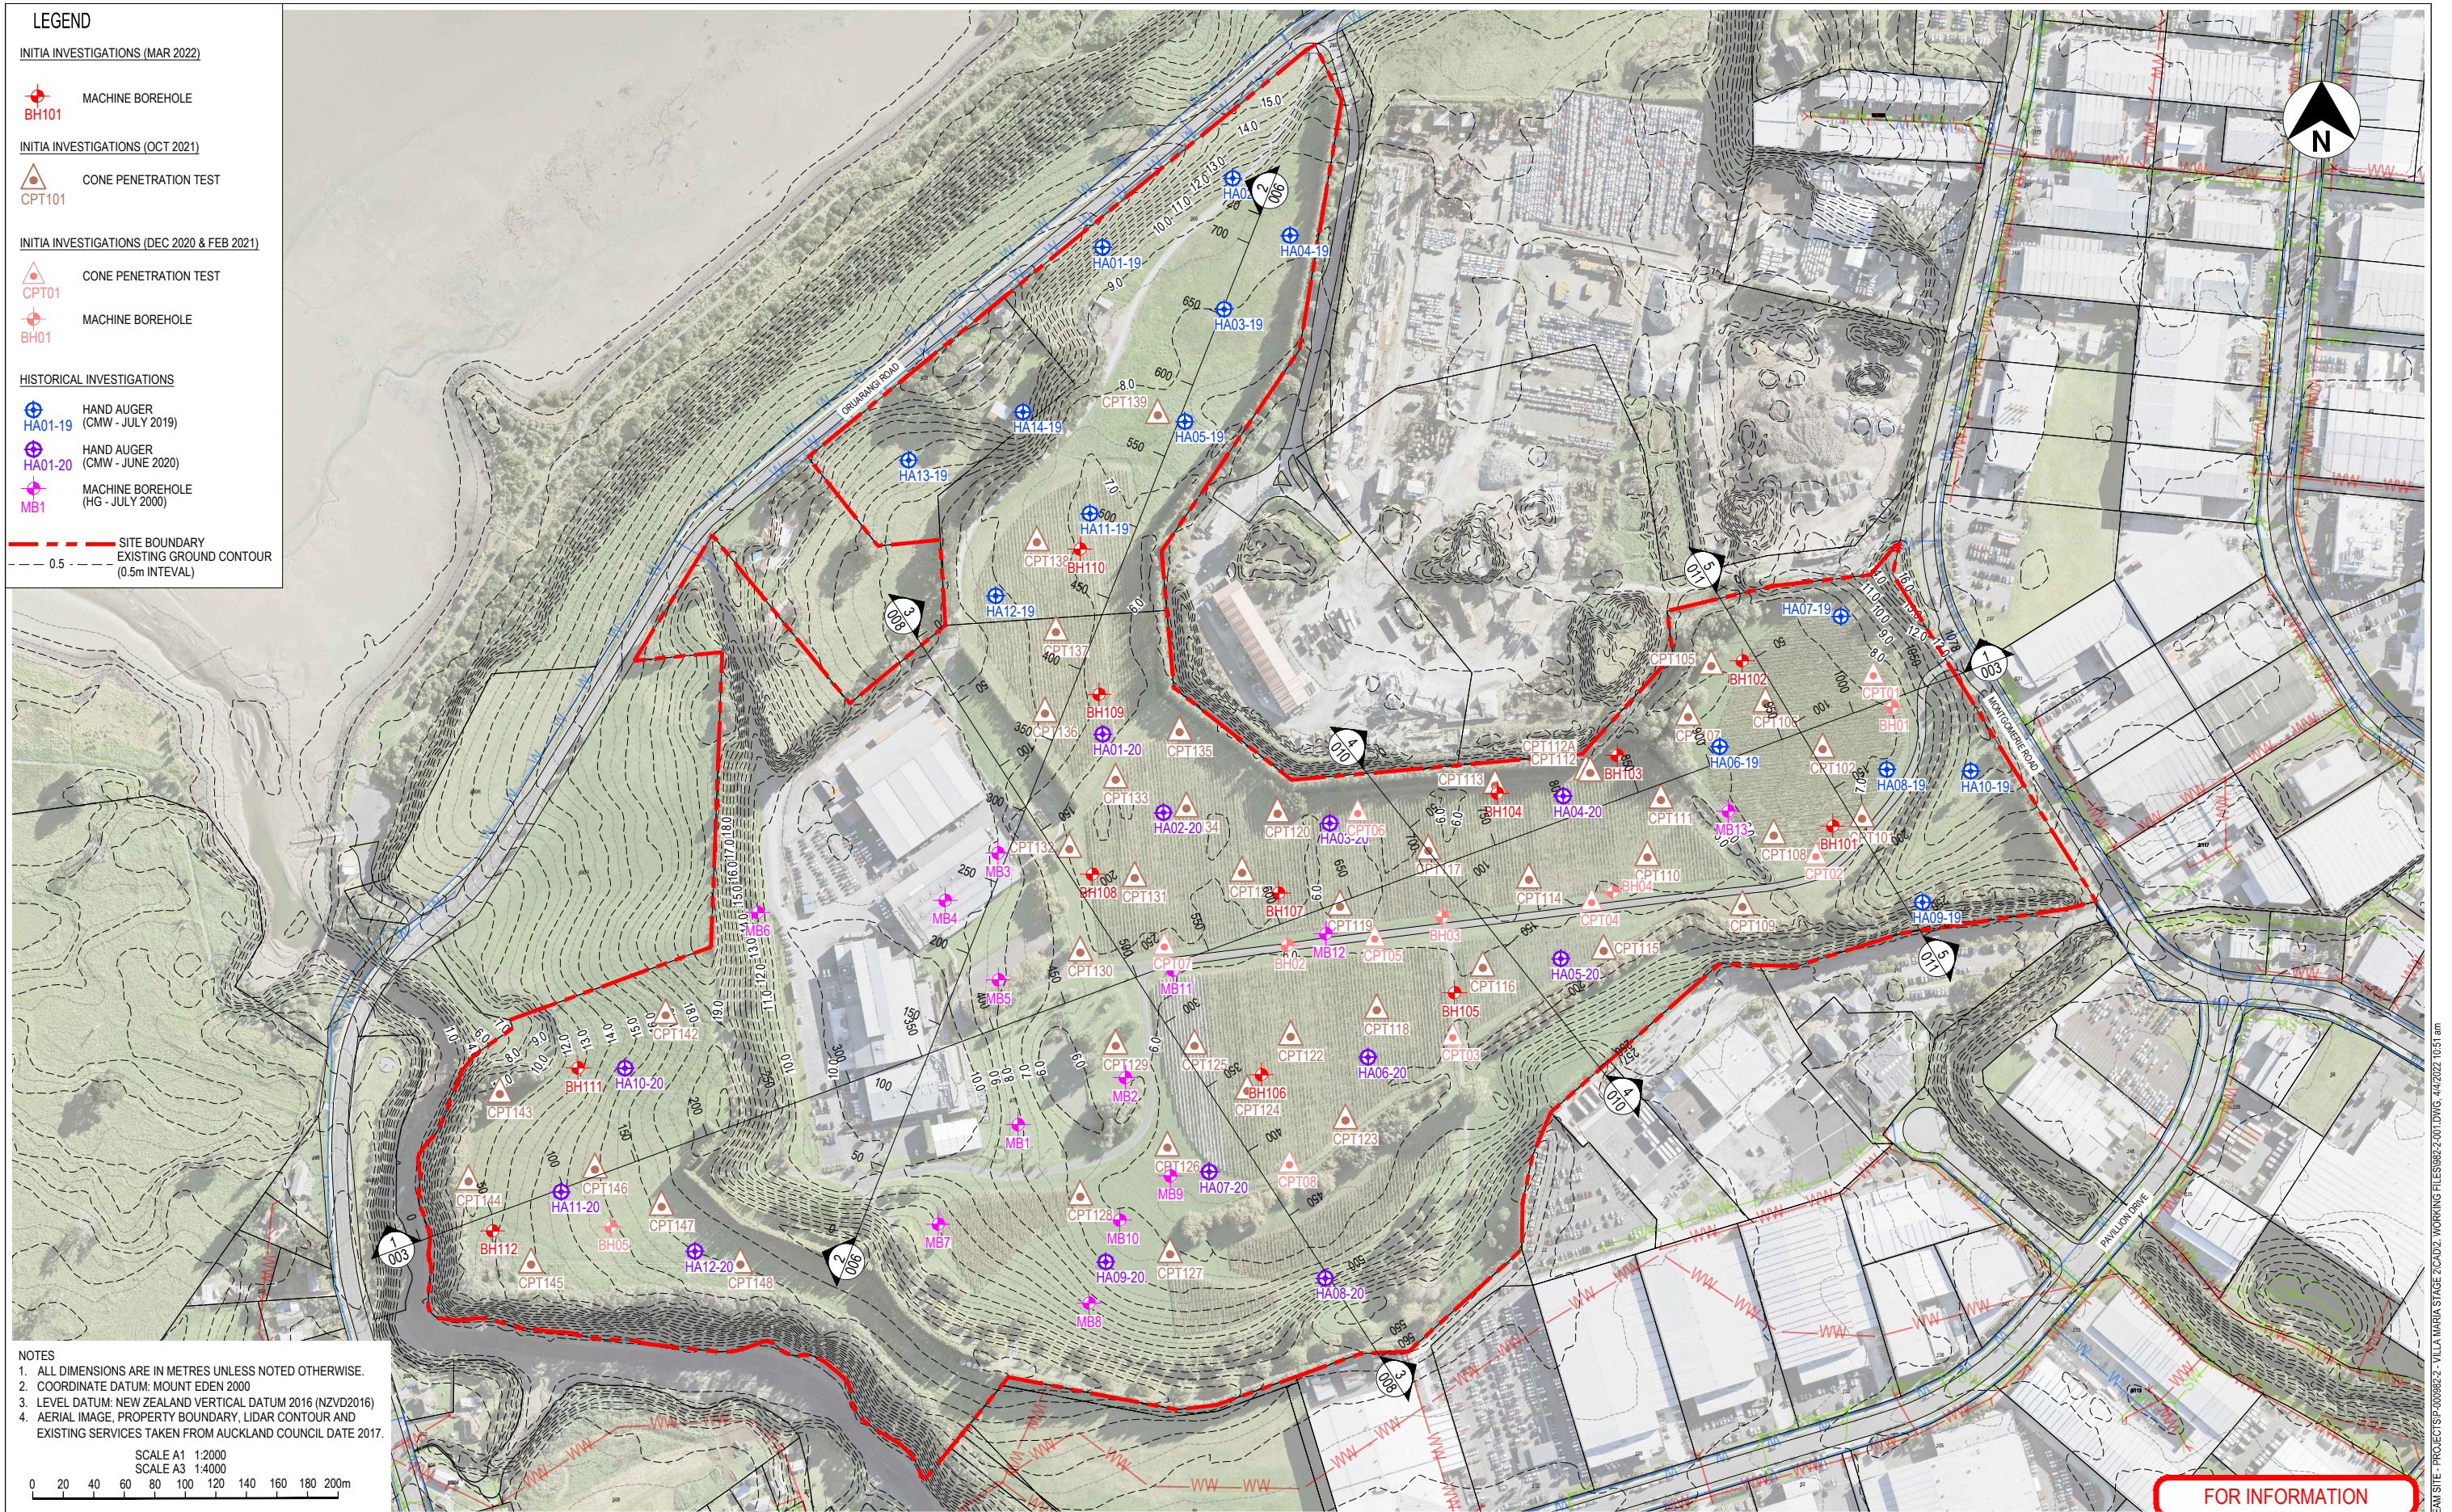
SITE BOUNDARY  
 EXISTING GROUND CONTOUR (0.5m INTERVAL)

A series of geotechnical investigations have been carried out to support the development of a 41 Hectare land parcel formerly known as Villa Maria, at 118 Montgomerie Road, Mangere, near Auckland Airport. This factual report summarises the investigation undertaken. Investigation locations are shown on Figure 982-2-001 in Appendix A.

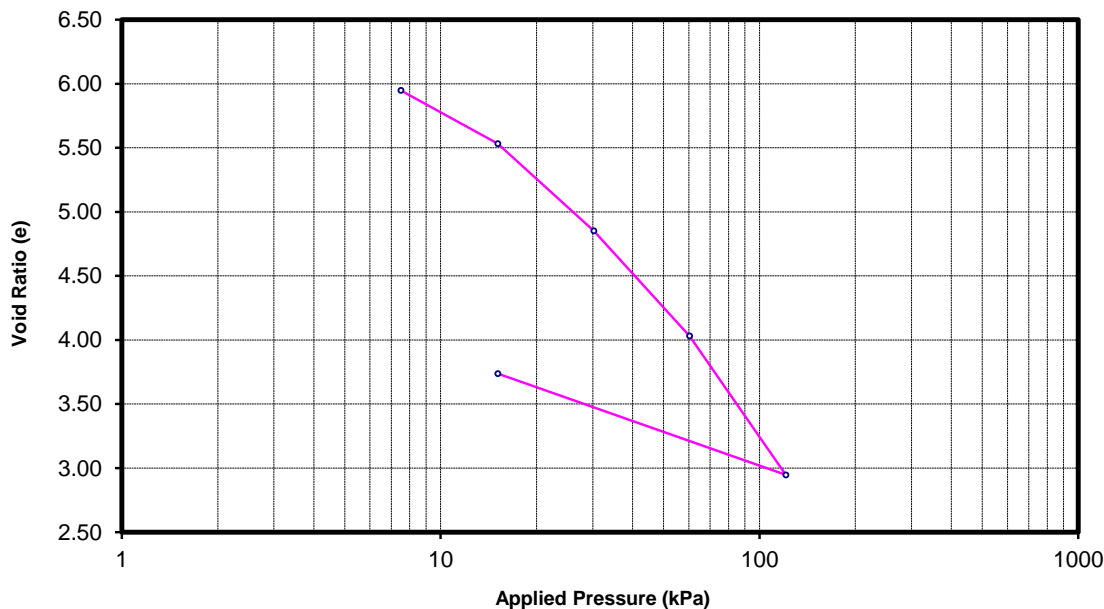
**ONE-DIMENSIONAL CONSOLIDATION TEST**

Pressure (kPa)	Void Ratio (e)	Pressure Increment (kPa)	Coefficient of Consolidation Cv (m <sup>2</sup> /yr)	Coefficient of Volume Compressibility Mv (m <sup>2</sup> /MN)
As received	0			
Preload	7.5	0 to 7.5	NA	8.0
	15.1	7.5 to 15.1	0.59	7.8
	30.2	15.1 to 30.2	0.42	6.9
	60.3	30.2 to 60.3	0.28	4.7
	121	60.3 to 121	0.17	3.6
Unload	15.1	121 to 15.1	NA	NA

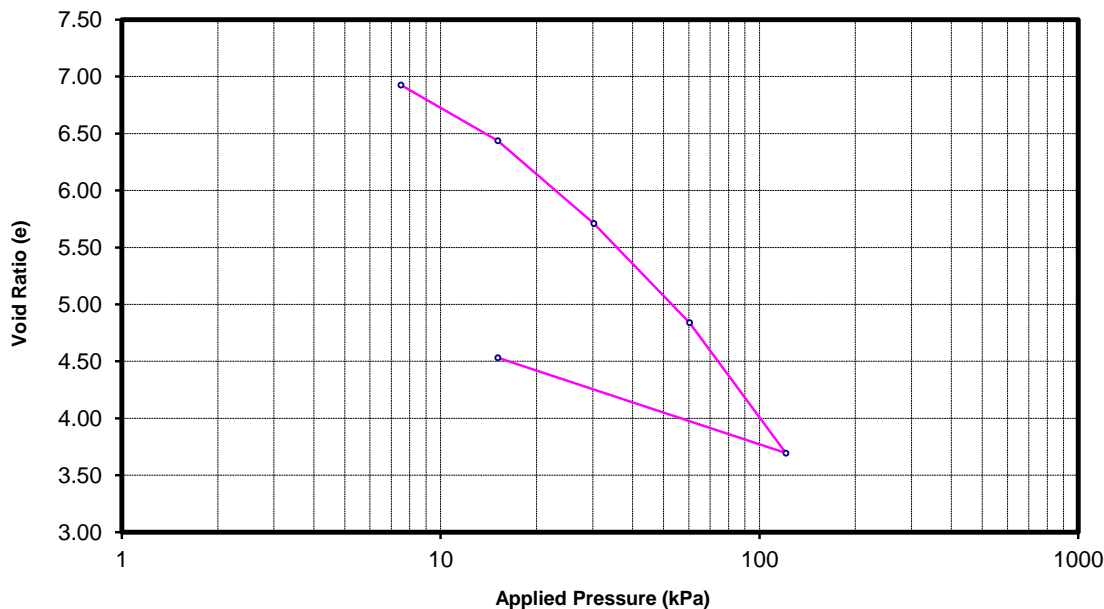
**ONE-DIMENSIONAL CONSOLIDATION TEST**

Pressure (kPa)	Void Ratio (e)	Pressure Increment (kPa)	Coefficient of Consolidation Cv (m <sup>2</sup> /yr)	Coefficient of Volume Compressibility Mv (m <sup>2</sup> /MN)
As received	0	7.684		
Preload	7.5	6.927	0 to 7.5	NA
	15.1	6.438	7.5 to 15.1	0.33
	30.2	5.710	15.1 to 30.2	0.27
	60.3	4.841	30.2 to 60.3	0.19
	121	3.696	60.3 to 121	0.13
Unload	15.1	4.532	121 to 15.1	NA

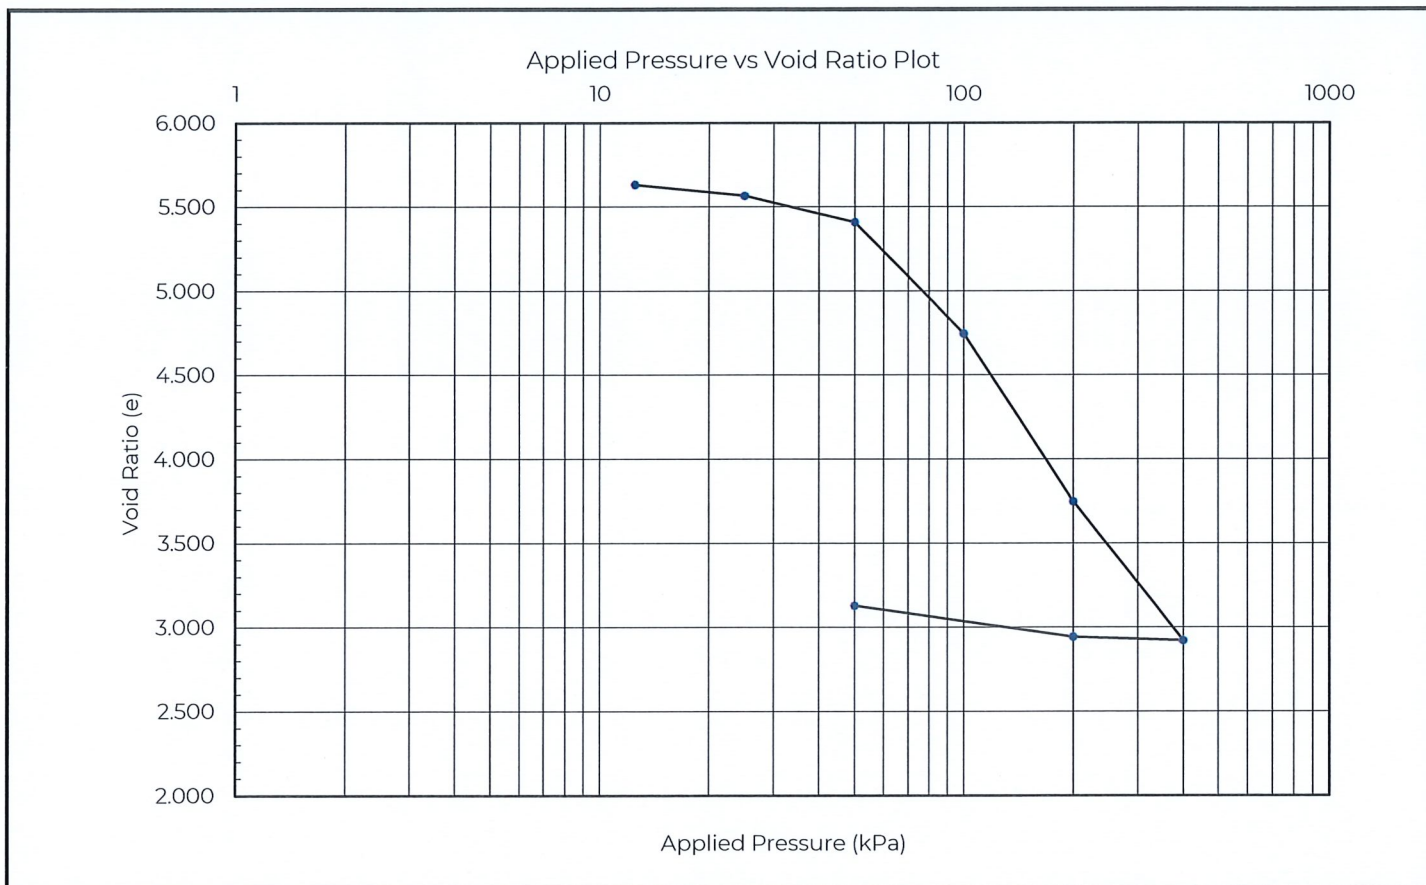
Test Method:	Notes:
One Dimensional Consolidation Test: NZS 4402:1986 Test 7.1	Sample is saturated during test. Load Increments applied at 3.75hr intervals All information provided by client

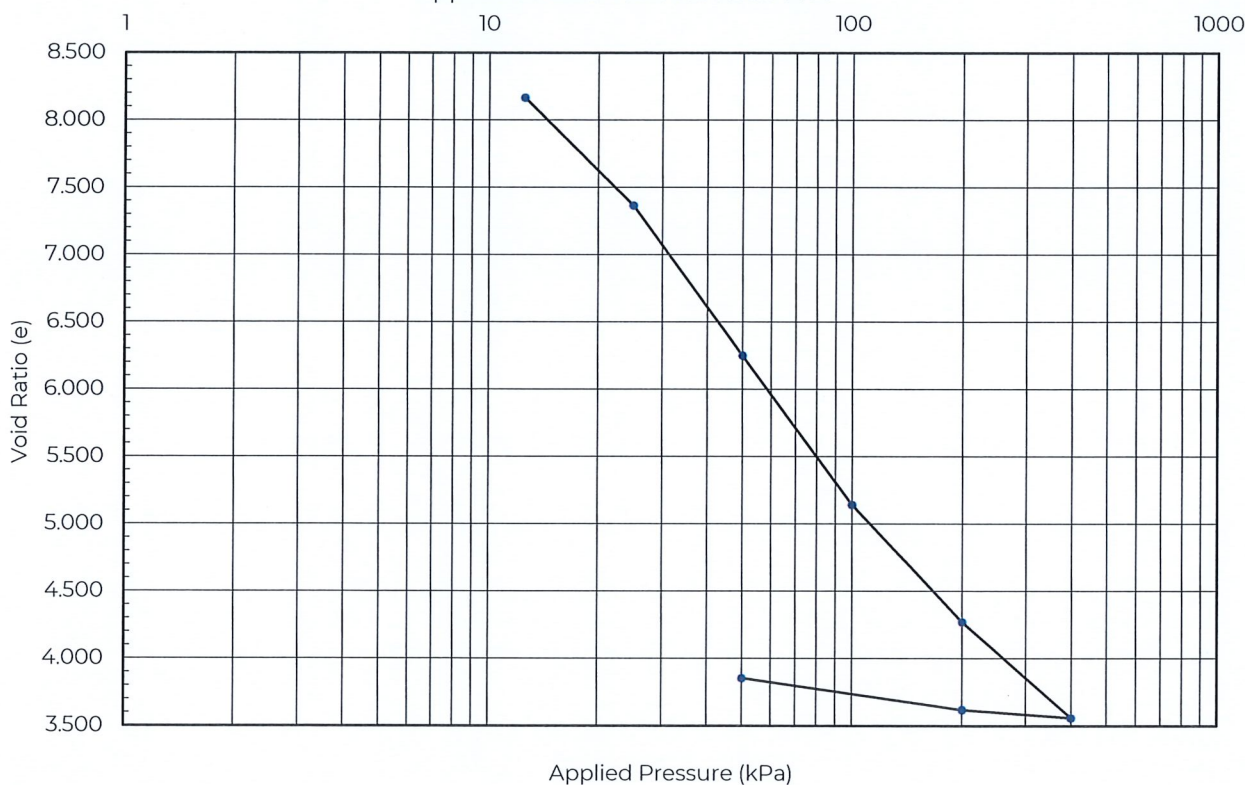
Applied Pressure vs Void Ratio Plot

Test Method:	Notes:
One Dimensional Consolidation Test: NZS 4402:1986 Test 7.1	Sample is saturated during test. Load Increments applied at 3.27hr intervals All information provided by client
