Whenuapai Business Park Private Plan Change

Ecological Impact Assessment

Prepared for: Neil Construction Limited

October 2024

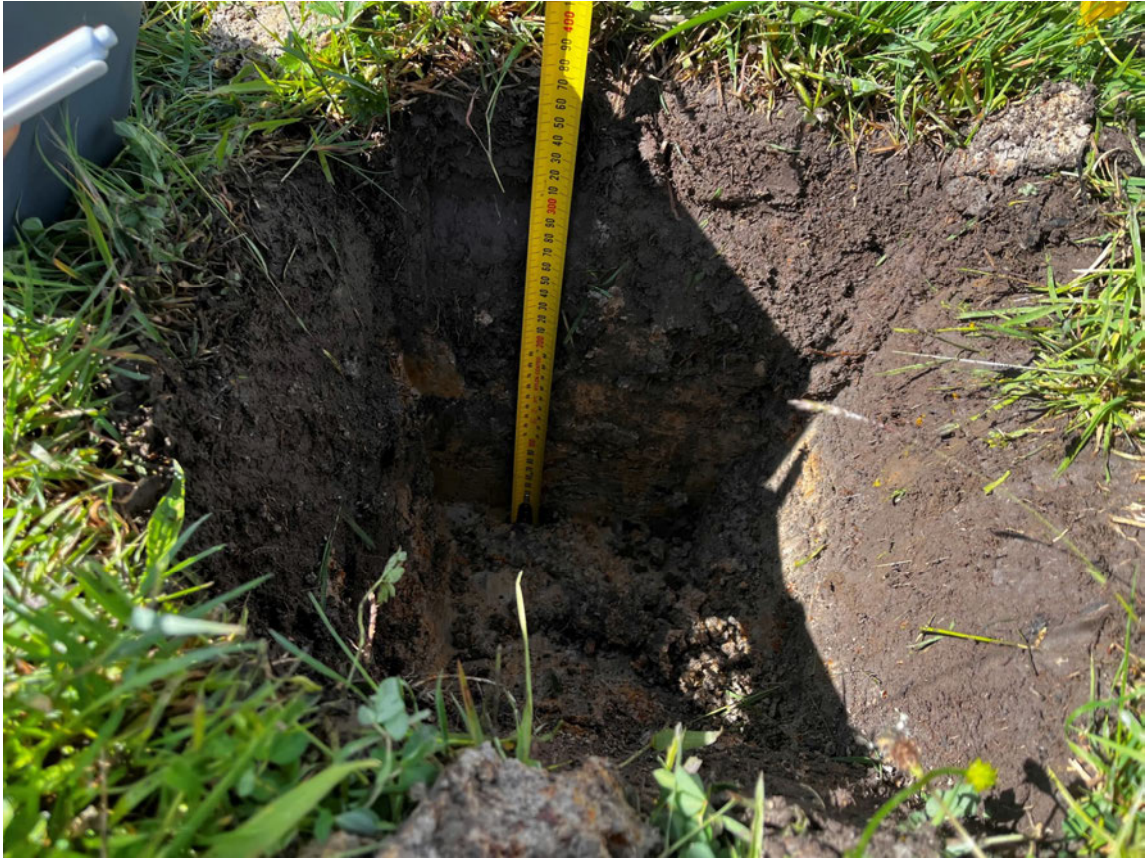
102
0-20cm Clayey
SILT: Medium
Brown. Moist.
Minor rootlets.
(Topsoil)

10YR
Topsoil – 5/3

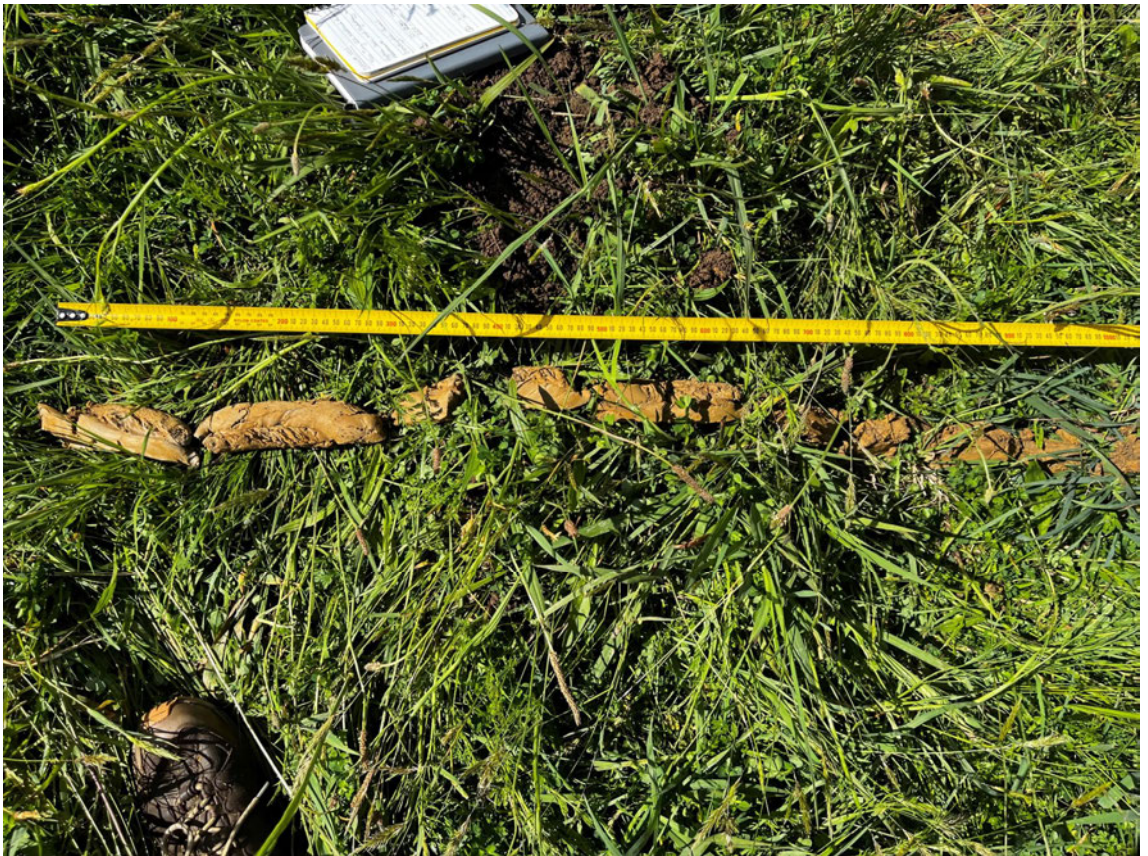
20-100cm Clayey
SILT: Orange.
High plasticity
(Puketoka
Formation)

10YR
Clay – 7/6

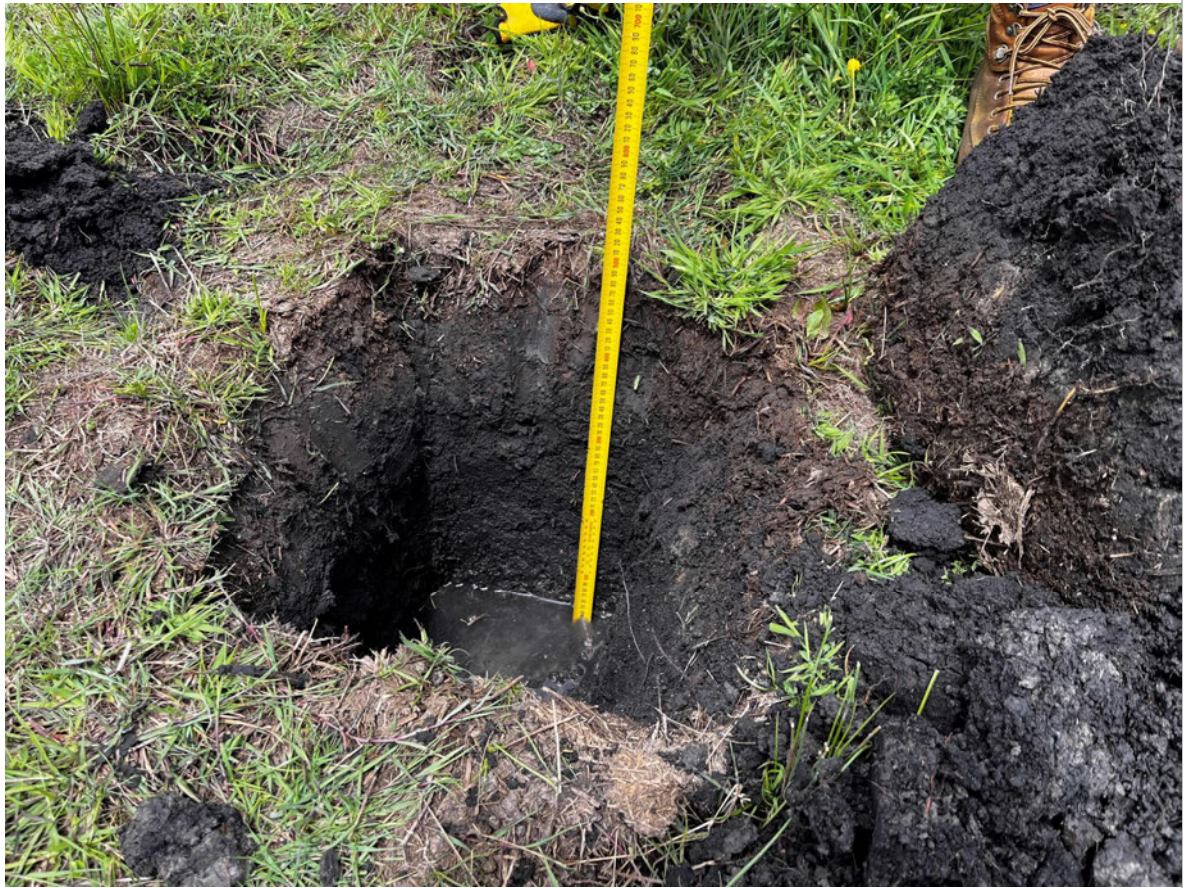
114
0-10cm Clayey SILT:
Dark Brown. Moist.
Minor rootlets.
(Topsoil)

10YR
Topsoil – 3/2
Subsoil – 8/1

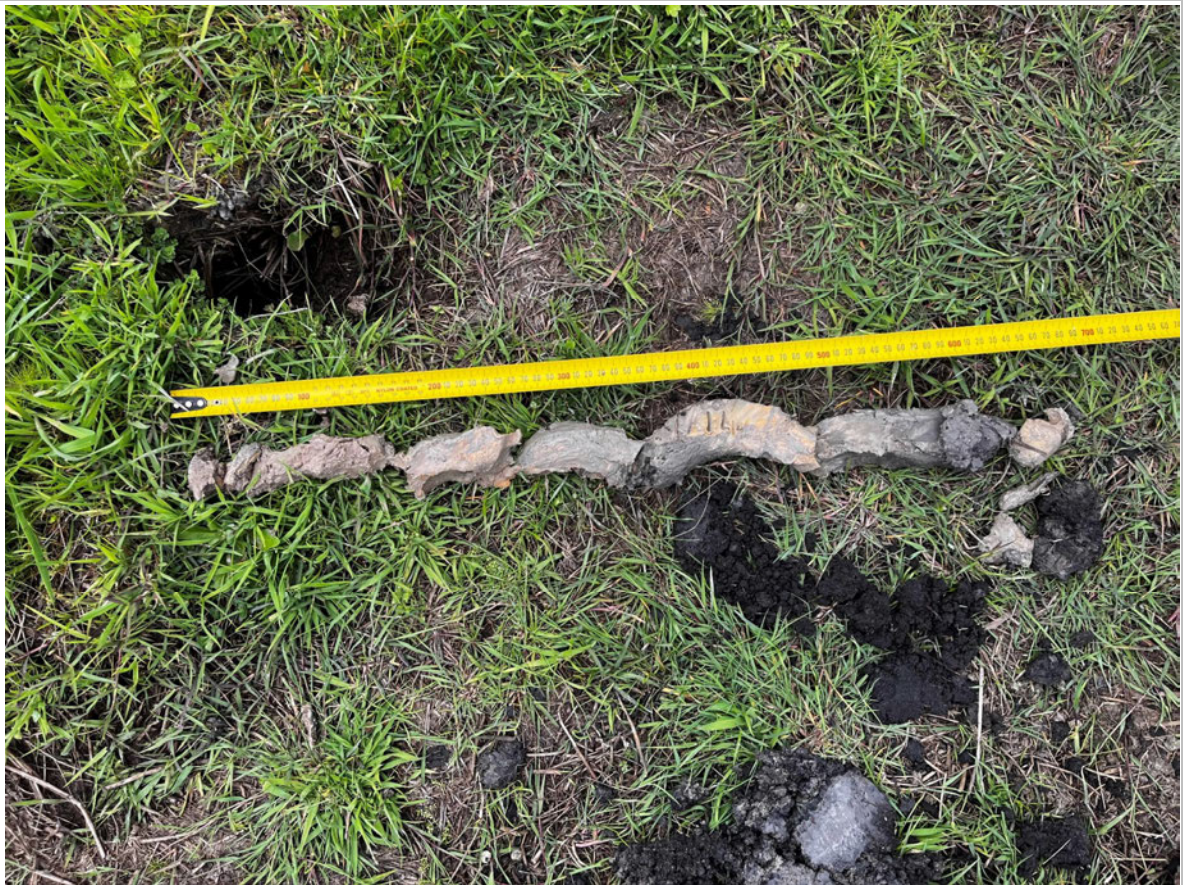
10-80cm SOIL: Black.
Moist. Minor rootlets.
(organic rich soil)
80-100cm Clayey
SILT: Grey. High
plasticity (Puketoka
Formation)

10YR
Clay – 6/1

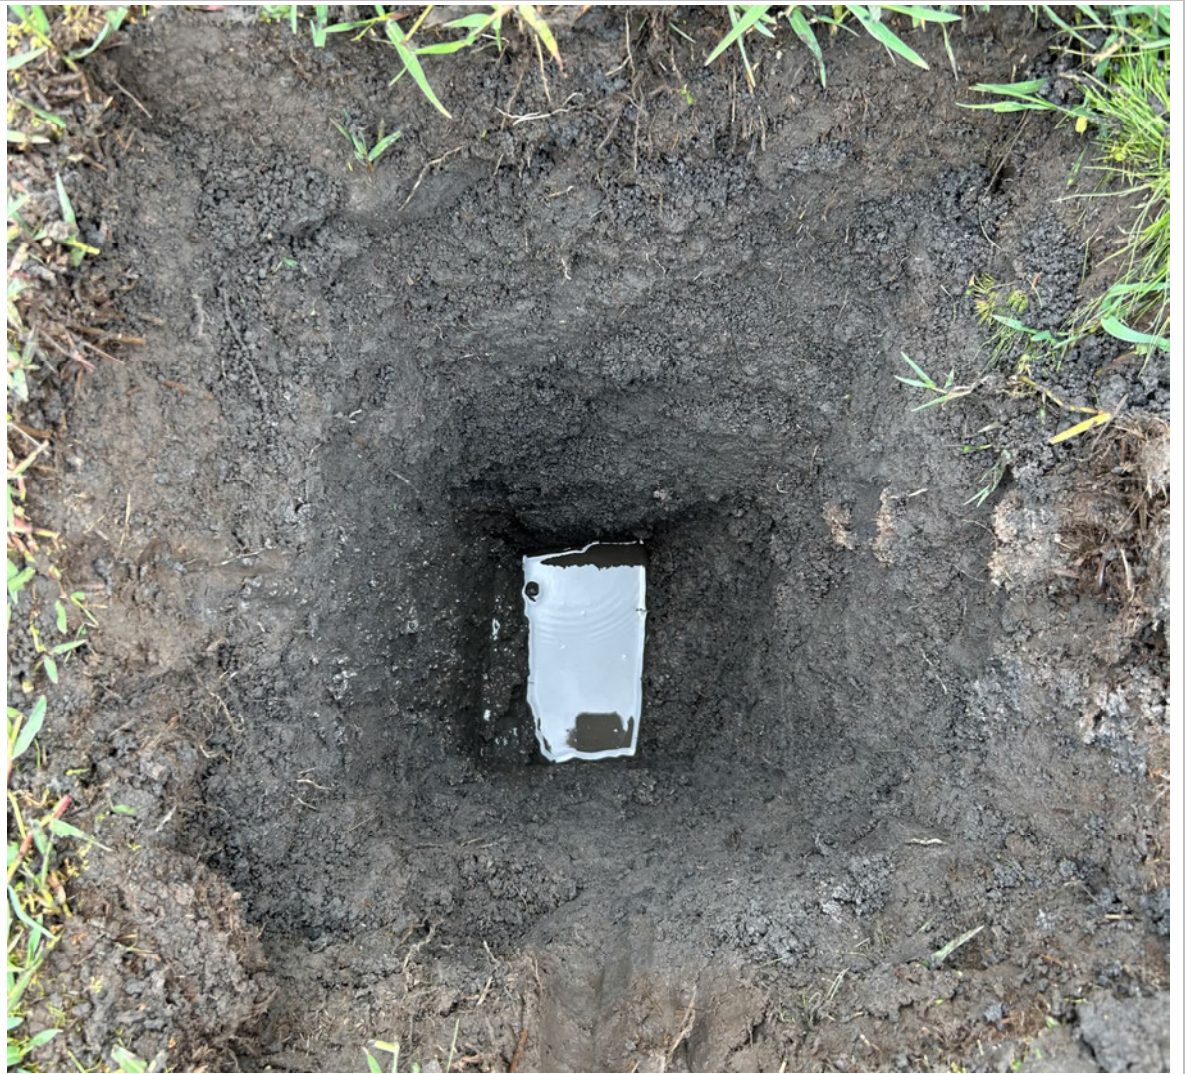
0-10 cm. TOPSOIL.
Very dark brown.
Spongy and fibrous.
10-750 mm. Dark
brown-black silty
organic rich soil.
Water table
encountered at 650
mm – rapid seepage.
10YR –
Topsoil – 2/2

205	0-10 cm. TOPSOIL. Very dark brown. Spongy and fibrous. 10-750 mm. SOIL. Dark brown-black silty organic rich soil. Water table encountered at 650 mm – rapid seepage.	Drainage – Moderately well drained to shallow groundwater table at 650 mm. Matrix Colour (10YR – Value/Chroma) Topsoil – 2/2	Y
206	0-30 cm. TOPSOIL. Dark yellowish brown clayey silt.	Drainage – Moderately well drained. Matrix Colour (10YR – Value/Chroma) Topsoil – 4/4	N
207	0-30 cm. TOPSOIL. Dark brown clayey silt.	Drainage – Moderately well drained. Matrix Colour (10YR – Value/Chroma) Topsoil – 3/3	N
208	0-30 cm. TOPSOIL. Brown clayey silt.	Drainage – Moderately well drained. Matrix Colour (10YR – Value/Chroma) Topsoil – 4/3	N
209	0-30 cm. TOPSOIL. Dark brown clayey silt.	Drainage – Moderately well drained. Matrix Colour (10YR – Value/Chroma) Topsoil – 3/3	N
210	0-30 cm. TOPSOIL. Dark brown clayey silt.	Drainage – Moderately well drained. Matrix Colour (10YR – Value/Chroma) Topsoil – 3/3	N
