PRELIMINARY SITE INVESTIGATION (PSI)

WHENUAPAI BUSINESS PARK PRIVATE PLAN CHANGE AREA

REFERENCE NUMBER: REP-1886/PSI/SEP23

PREPARED FOR: NEIL CONSTRUCTION LIMITED

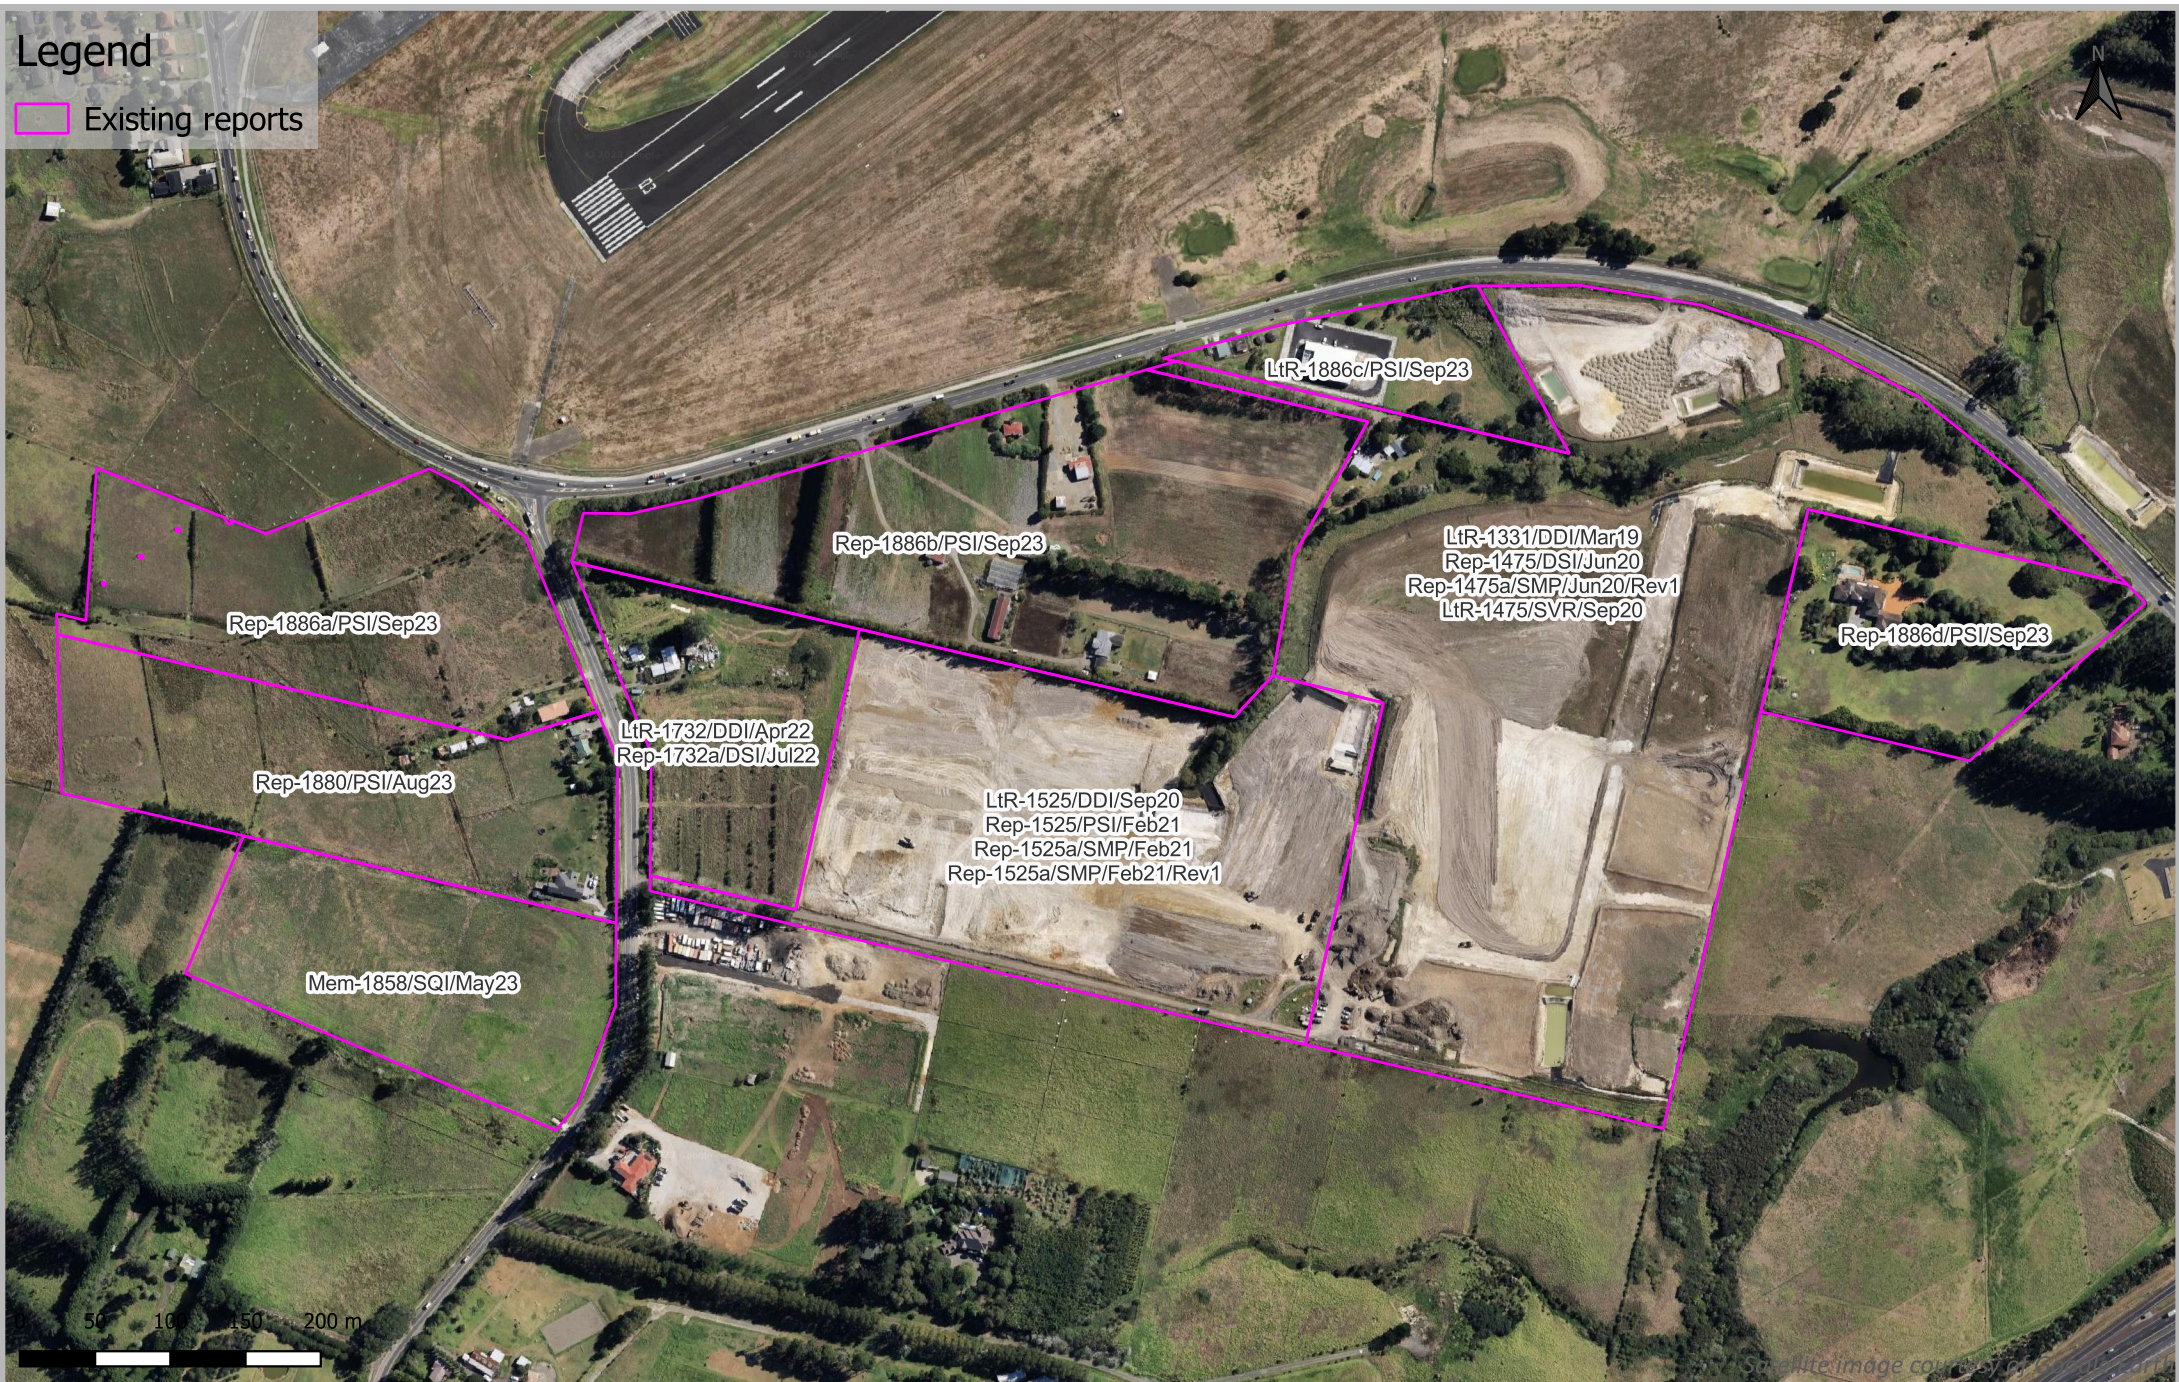
Figure 2 - Previous site investigation reports
Whenuapai Plan Change, Auckland

All properties within the area covered by the proposed plan change have been subjected to a site contamination investigation to the minimum requirements for that of a Preliminary Site Investigation (PSI) as defined by the Ministry for the Environment's Contaminated Land Management Guideline No. 1; *Guidelines for Reporting on Contaminated Sites in New Zealand* (References 1). Some properties have been investigated as a cluster along with other neighbouring properties while other properties have been assessed individually. Site investigation works conducted for each property (singular or as a cluster), along with investigation report references,

are provided in Table 2 below and are shown in Figure 2. Copies of these reports can be obtained on request.

Address	Report Reference	HAIL Activities Identified
151 Bringham Creek Road 155 Bringham Creek Road 69 Trig Road	LtR-1331/DDI/Mar19 Rep-1475/DSI/Jun20 Rep-1475a/SMP/Jun20/Rev1 LtR-1475/SVR/Sep20	Item G.5: Waste disposal to land Item I: Land that has been subject to the intentional or accidental release of hazardous substances.
71 Trig Road	LtR-1525/DDI/Sep20 Rep-1525/PSI/Feb21 Rep-1525a/SMP/Feb21 Rep-1525a/SMP/Feb21/Rev1 Mem-1525-ACM-Feb22 Mem-1525-SVR-Mar22	Item A.10: Bulk storage or use of persistent pesticides. A.17: Above ground fuel storage tanks. Item I: Storage of end of life machinery & lead-based paint on buildings. Item E.1: Asbestos building materials used on a barn onsite.
73 Trig Road	LtR-1732/DDI/Apr22 Rep-1732a/DSI/Jul22	No HAIL activities identified
94 Trig Road	Mem-1858/SQI/May23	No HAIL activities identified
96a Trig Road	Rep-1880/PSI/Aug23	No HAIL activities identified
96 Trig Road	Rep-1886a/PSI/Sep23	No HAIL activities identified

141 Bringham Creek Road 145 Bringham Creek Road	Rep-1886b/PSI/Sep23	No HAIL activities identified*
153 Bringham Creek Road	LtR-1886c/PSI/Sep23	No HAIL activities identified
159 Bringham Creek Road	Rep-1886d/PSI/Sep23	No HAIL activities identified

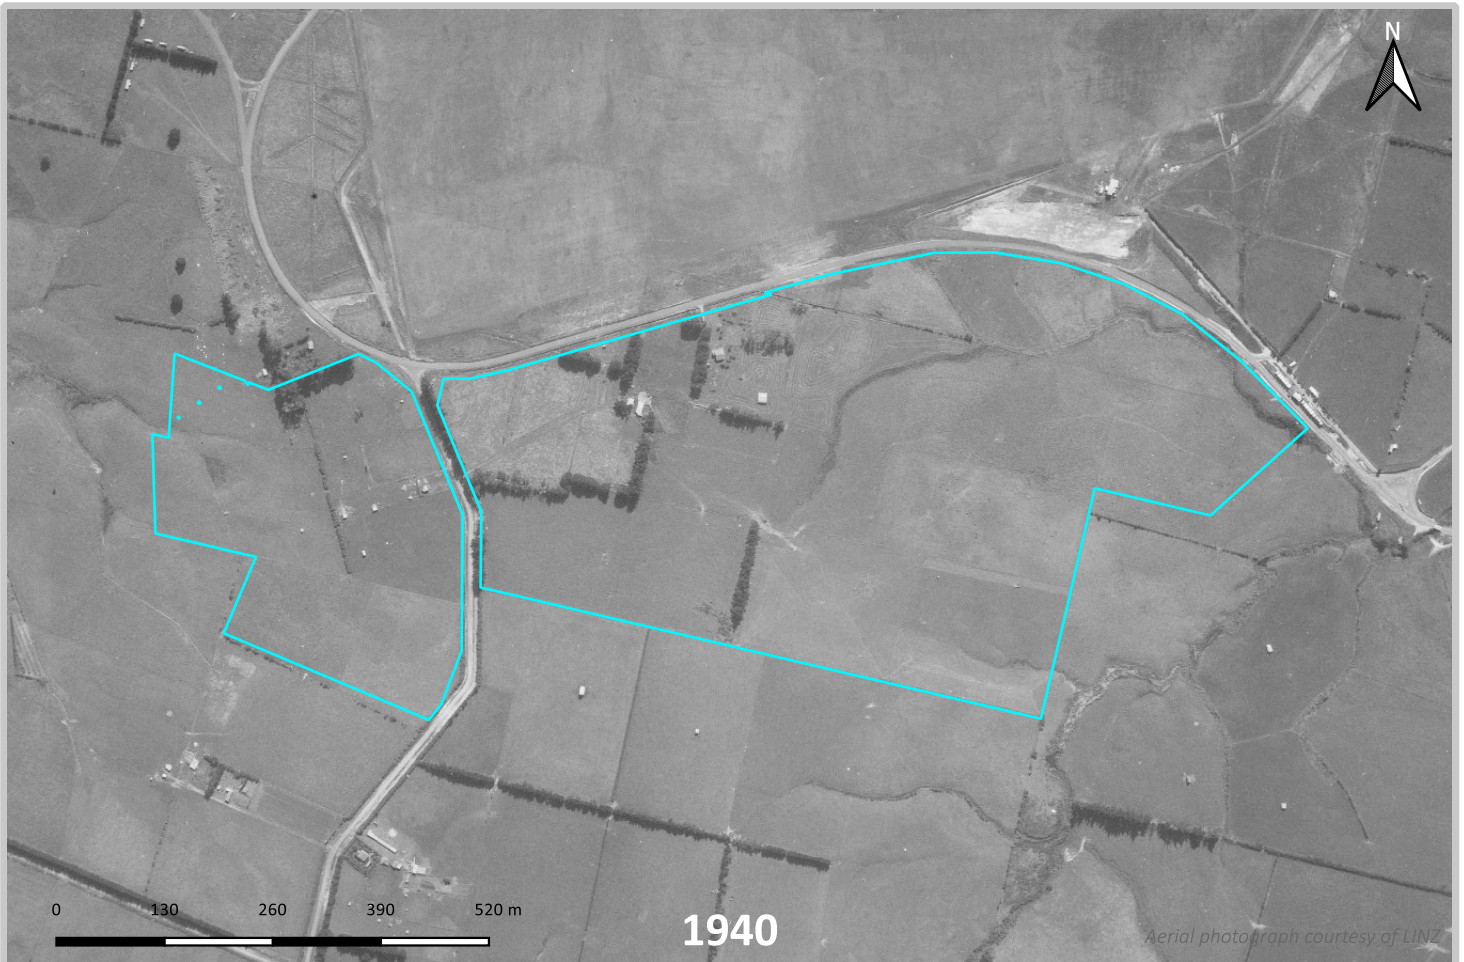
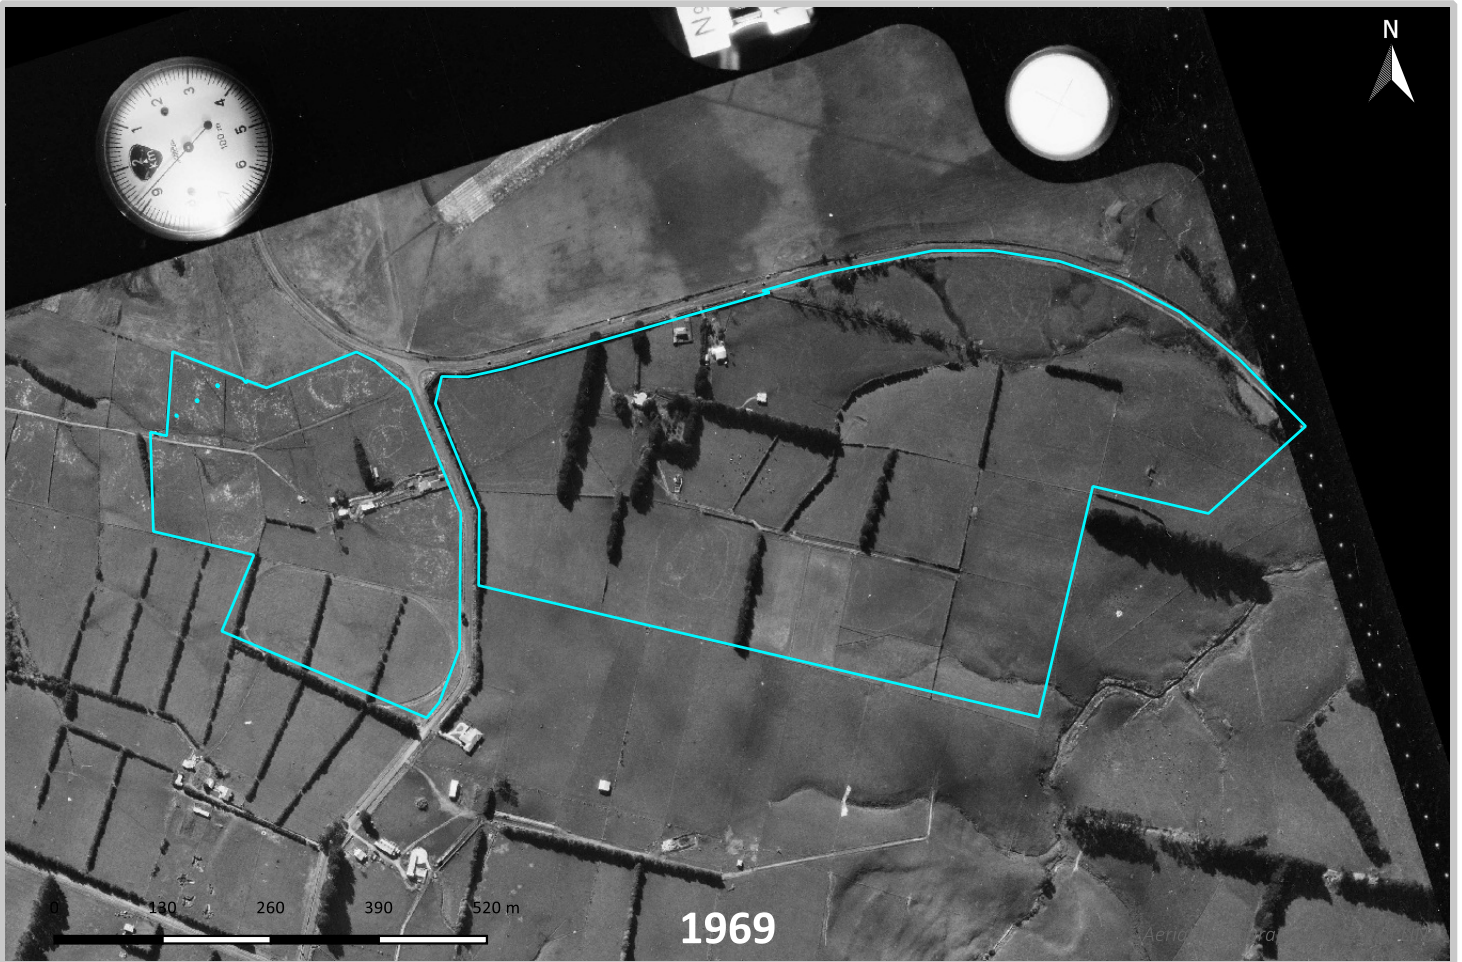
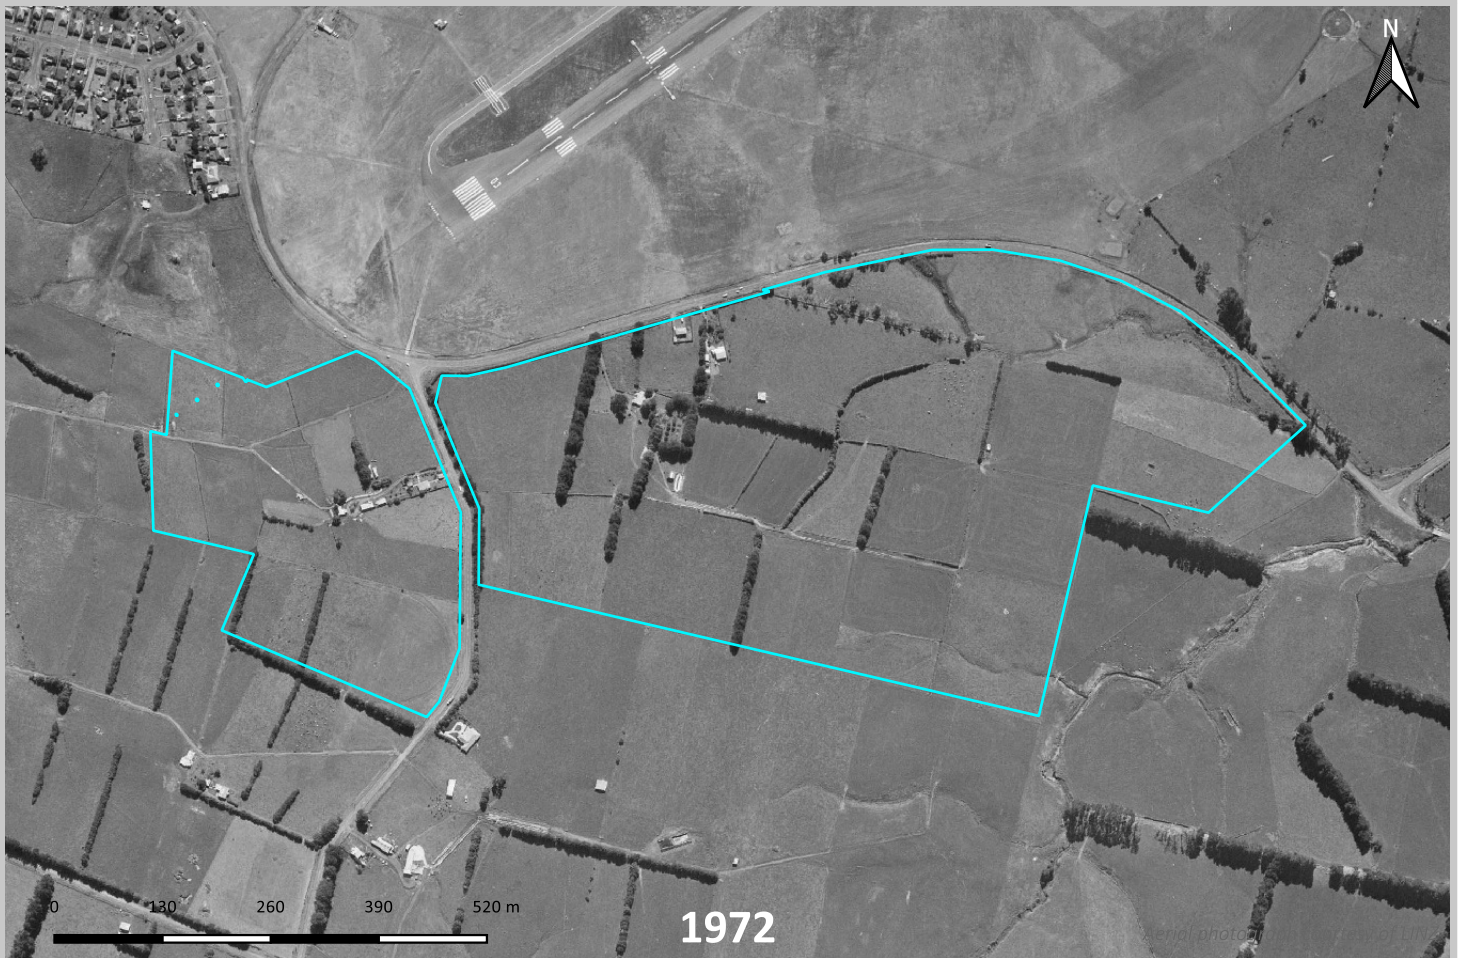
Historic Aerial Photographs
Whenuapai Plan Change, Auckland

1940	Brigham Creek and Trig Roads have been established. The land comprising the site is open pasture with fences and hedgerows defining paddocks within the larger area. An overland flow path cuts from south to north through the centre of the portion of the site east of Trig Road. A farmhouse and milking shed are located on this portion of land while a farmhouse and water troughs with animals grazing can be seen in the portion of land to the west of Trig Road.
1950	This image is similar to the former one but much clearer. It shows a number of drinking troughs located in the open paddocks as well as man-made open drains that channel surface water to the east and north away from the site. The runways of the RNZDF airfield have been established.

1959	This image is similar to the one of 1950 but shows a typical horse training track in the southern portion of land to the west of Trig Road. Stables have also been established to the north of the track. A second dwelling has been established to the west of the farmhouse along Brigham Creek Road on the land to the east of Trig Road.
1963	This image is similar as the one above but shows a small orchard established to the south-east of the milking shed on the portion of land to the east of Trig Road.
1969	This image is similar to the former ones but shows a small packing house established to the south of the orchard noted above.
1972	There is no discernible difference between this image and the former one.
1980	The first signs of horticultural activities are evident by the planting pattens in the north-western corner of the block of land to the east of Trig Road.
1988	By this time almost the entire portion of land to the east of Trig Road appears to be under orchard or cultivated as market gardens. The portion of the site to the west of Trig Road is still undeveloped and open pasture.

1996	This image is similar to the former one with only notable changes in the cropping pattens in the paddocks of the block of land to the east of Trig Road.
2000	As above with only the small glasshouse and larger packing shed established to the south-east of the milking shed.
2006 to 2017	By 2006 the horticulture in the eastern block of land has been replaced by crops of plants and a plant nursery firmly established onsite. The site infrastructure remains the same until 2017 with only minor changes to the buildings and roads while the plant nursery patterns across the entire site changes continually as a result of plant rotation and variations in the planting regime.
2022	By 2022 it is evident that the nurse operations have ceased and that the cropping fields are no longer being cultivated or attended to. A large portion of land in the eastern and central portions of the site is being developed and earthworks across this portion of the site is clearly in progress. The portion of land to the west of Trig Road remains undeveloped open pasture.

The historical aerial photograph study has confirmed the T&T and Aecom observations that the main source of potential soil contamination within the WBPPPC area is that of the possible bulk use and application of persistent pesticides. However, this observation is also questionable given that the use of most persistent pesticides was banned in New Zealand during the 1960s and first horticulture activities noted within the area of investigation is only seen in the historical aerial photograph of 1980.
