Project Number #21253.000.001

Geotechnical Investigation

9, 33 & 49 Heights Road, Pukekohe, Auckland

GBar Properties Limited

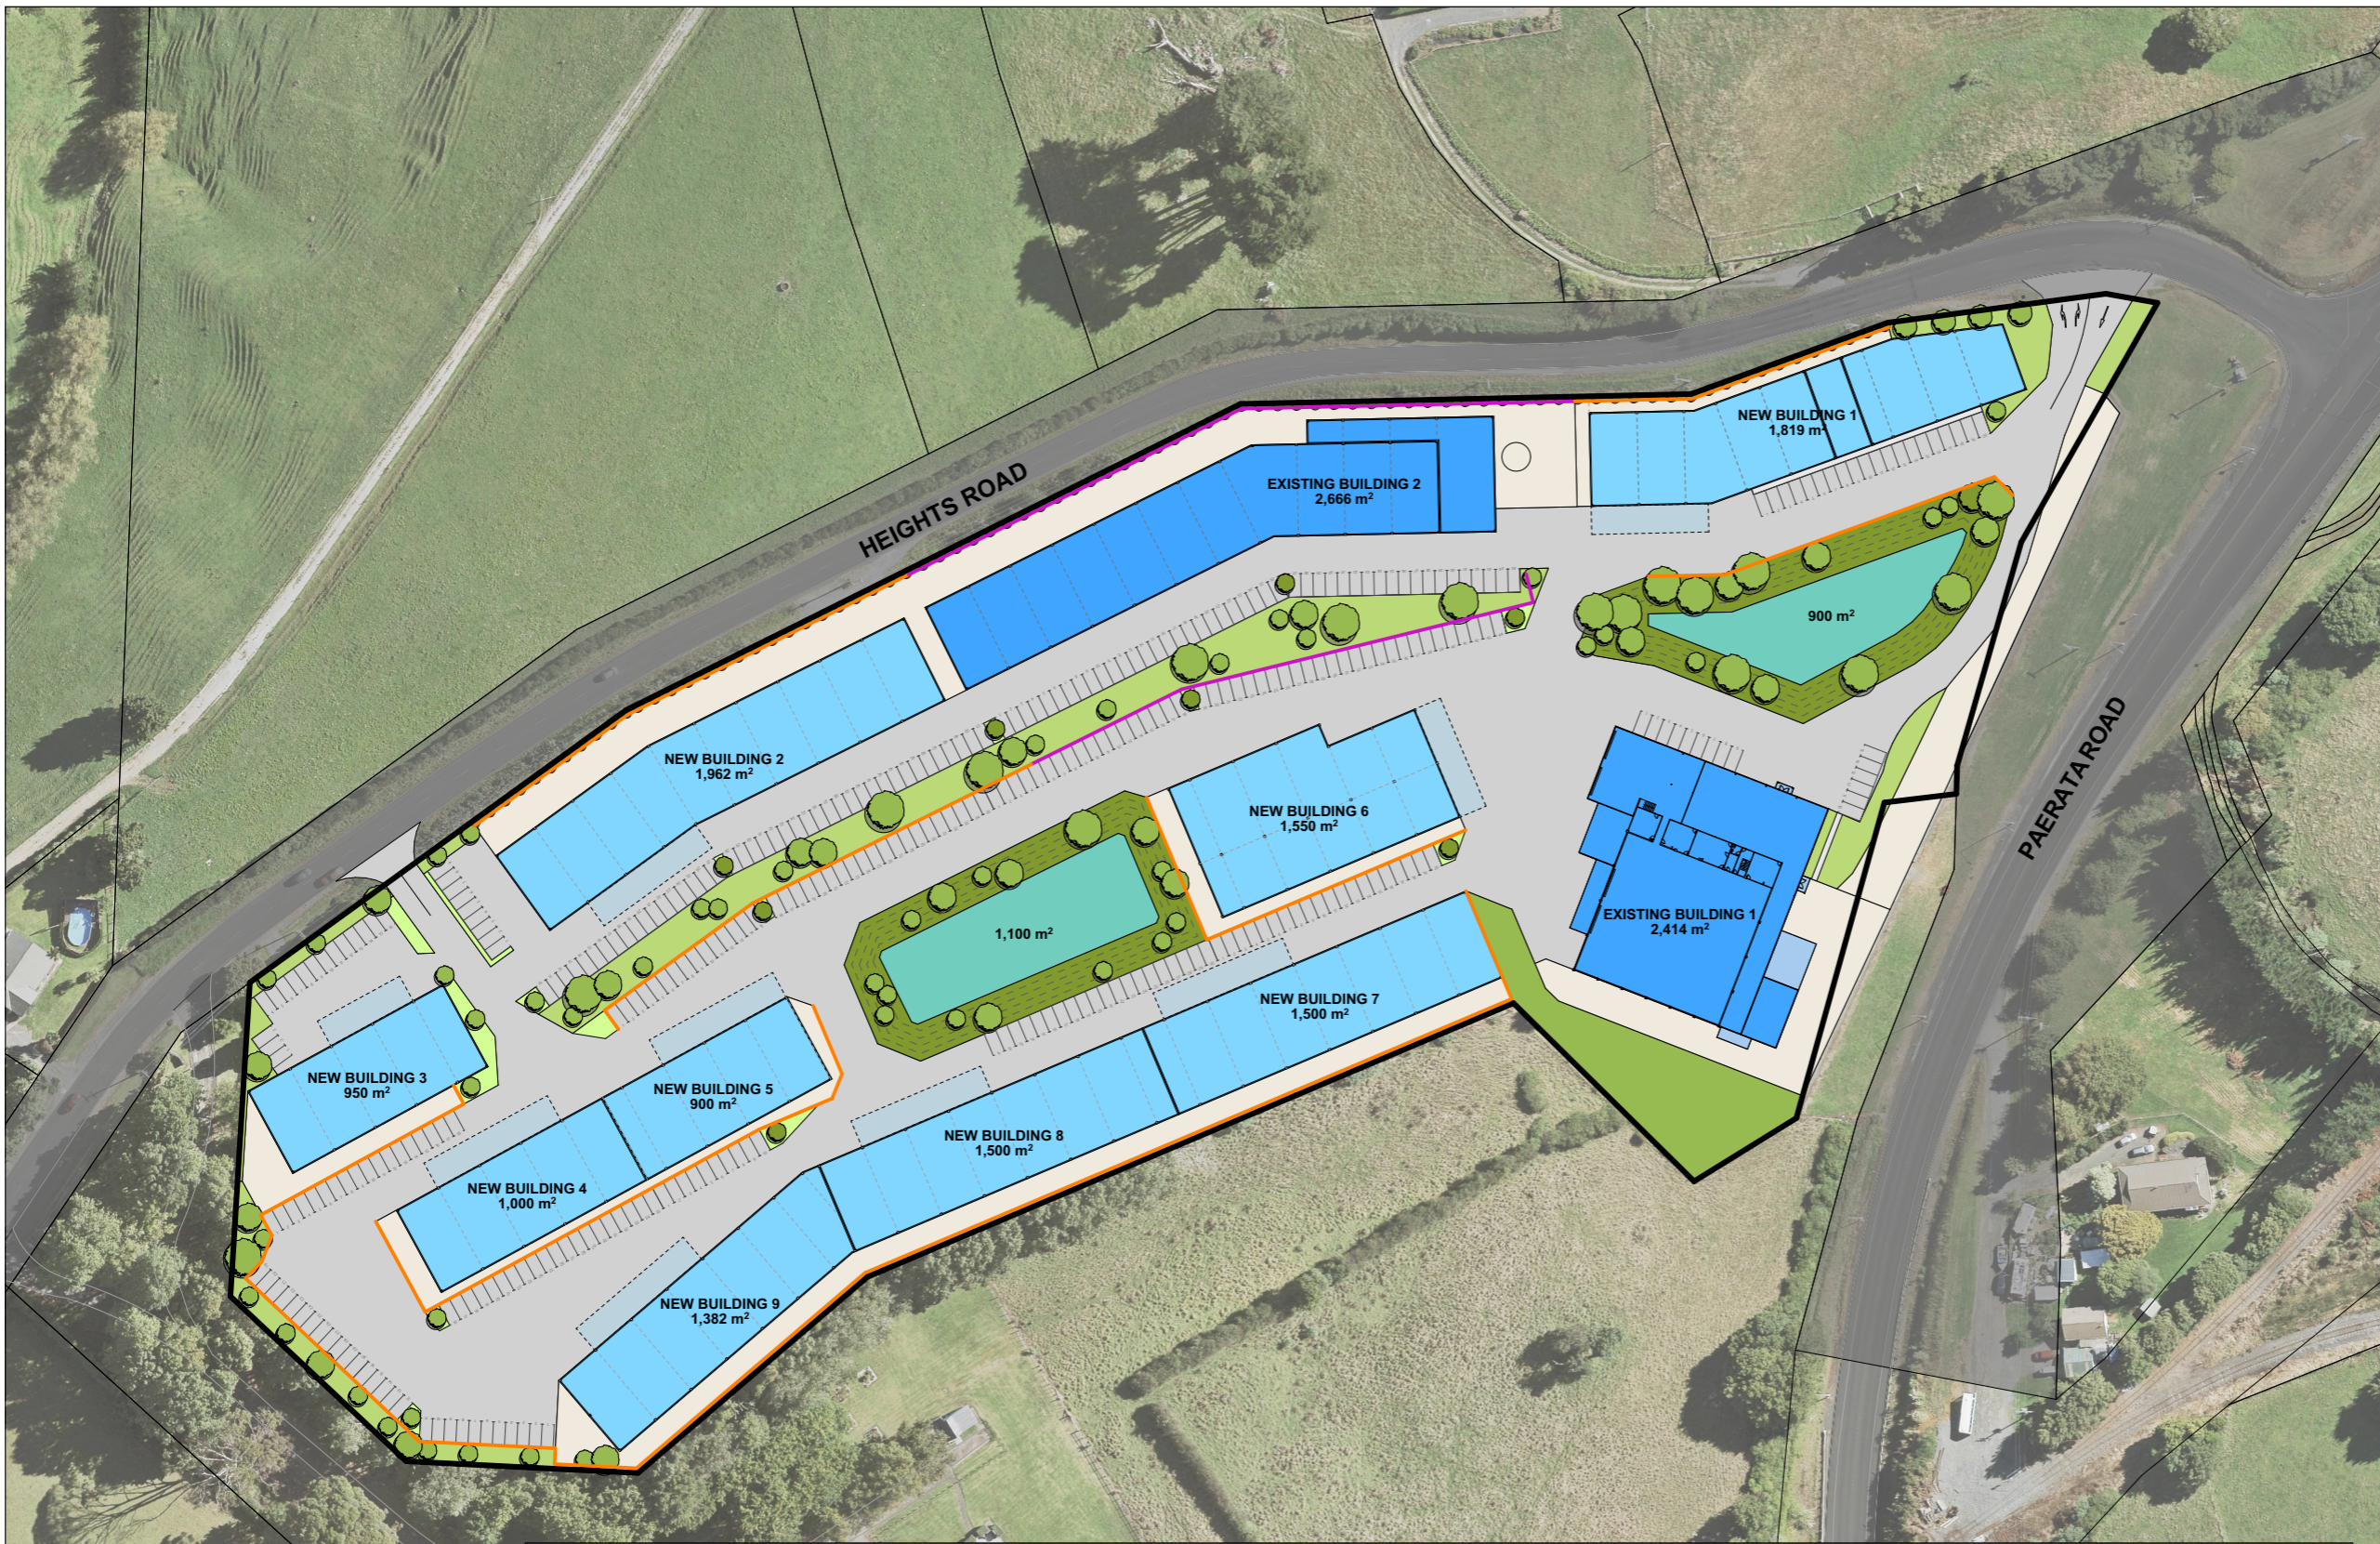
DESIGNED	SW	9, 33, and 49 HEIGHTS ROAD, PUKEKOHE
DRAWN	SW	
CHECKED	EW	
APPROVED	EW	WOODS.CO.NZ

The purpose of the assessment is to support a plan change application with respect to a conceptual proposal to redevelop the properties to support a light industrial complex of a nature comparable to that already established at the eastern end of the site.

We have been provided with the Woods Limited Topographic Survey (P18-088-00-0500 to -0501; Appendix 1) and the Indicative Masterplan (P18-188-UD101; Appendix 1) depicting a conceptual development comprising new warehouse buildings, landscaped areas, and two proposed stormwater ponds. Although earthworks concepts are not prepared at this stage, we have assumed that a future development of this nature is to be constructed on terraces involving cuts and fills to be supported by specifically designed retaining walls or formed as engineer designed permanent batters, in line with the existing land use.

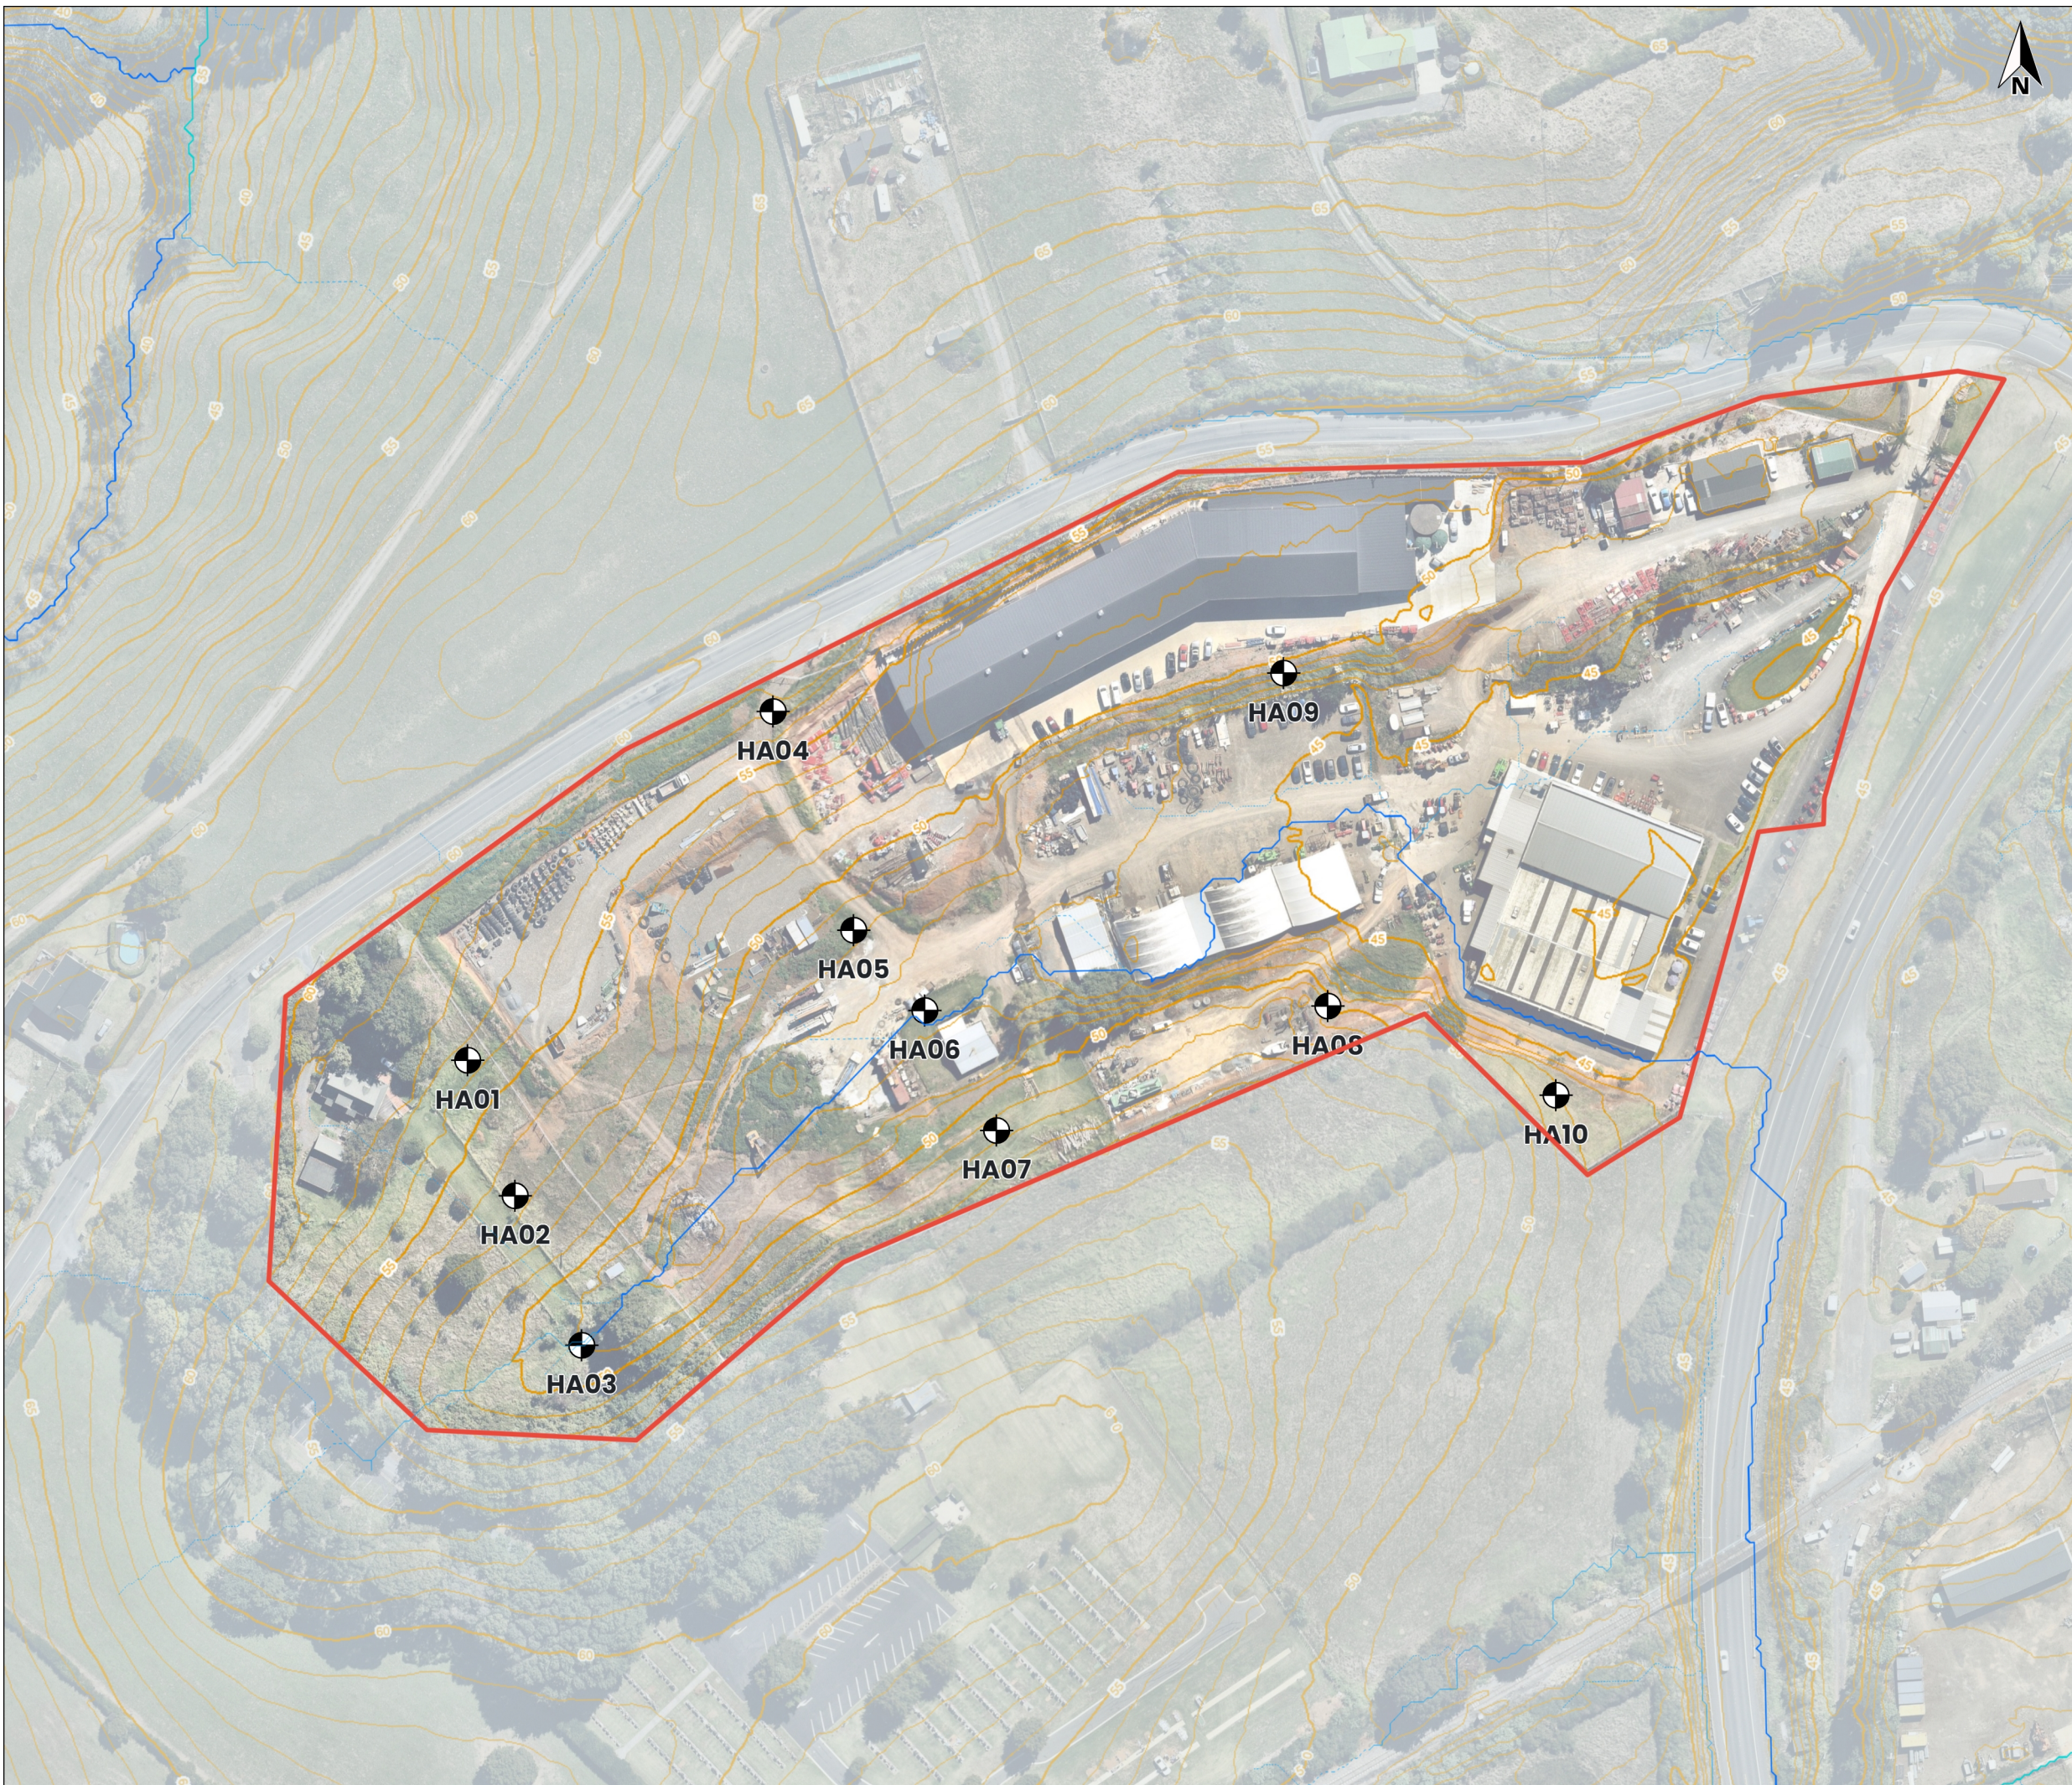
APPENDIX 2:
Investigation Location Plan

These features are depicted on the Investigation Location Plan presented in Appendix 2.

Ten hand auger boreholes (HA01 to HA10) were drilled across the site to depths of up to 5.0 m below ground level (bgl) with associated *in situ* strength testing.

All hand auger boreholes were logged in accordance with the New Zealand Geotechnical Society Field Classification Guidelines (NZGS, 2005). Full logs are presented in Appendix 3, and test locations are shown on the Investigation Location Plan in Appendix 2.
