9 June 2023

Site Soakage Testing - 9, 33, 49 Heights Road, Pukekohe Auckland

(Our Reference: 21253.000.001_03)

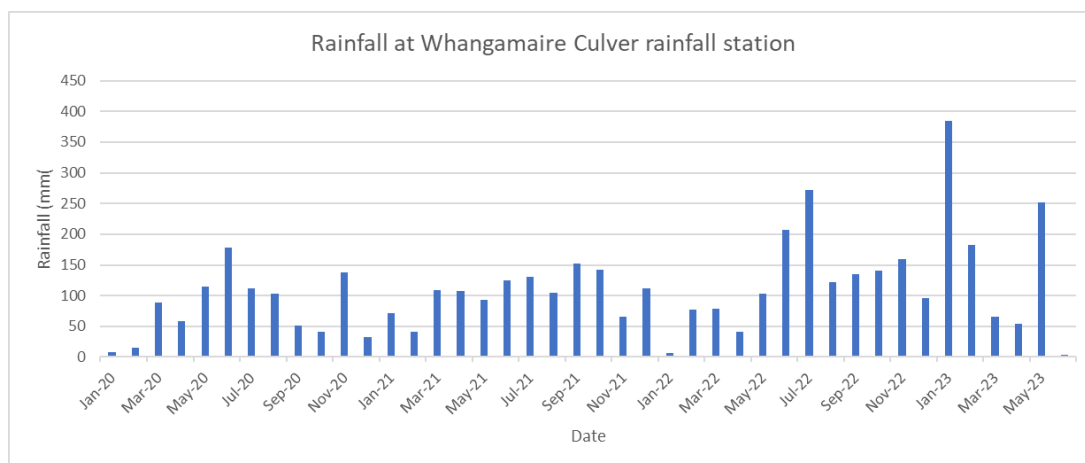
Figure 1: Rainfall at Whangamaire Culvert rainfall station

The closest rainfall station to the site is situated at Whangamaire Culvert, located approximately 5 km to the east of the site. Data from this rainfall station indicated that the rainfall recorded for the month of May 2023 showed the third highest rainfall month recorded since 2020, and therefore, the groundwater conditions on-site at the time of our testing is considered to be representative of the winter (worst-case) groundwater. The rainfall graph for the site is shown in Figure 1.

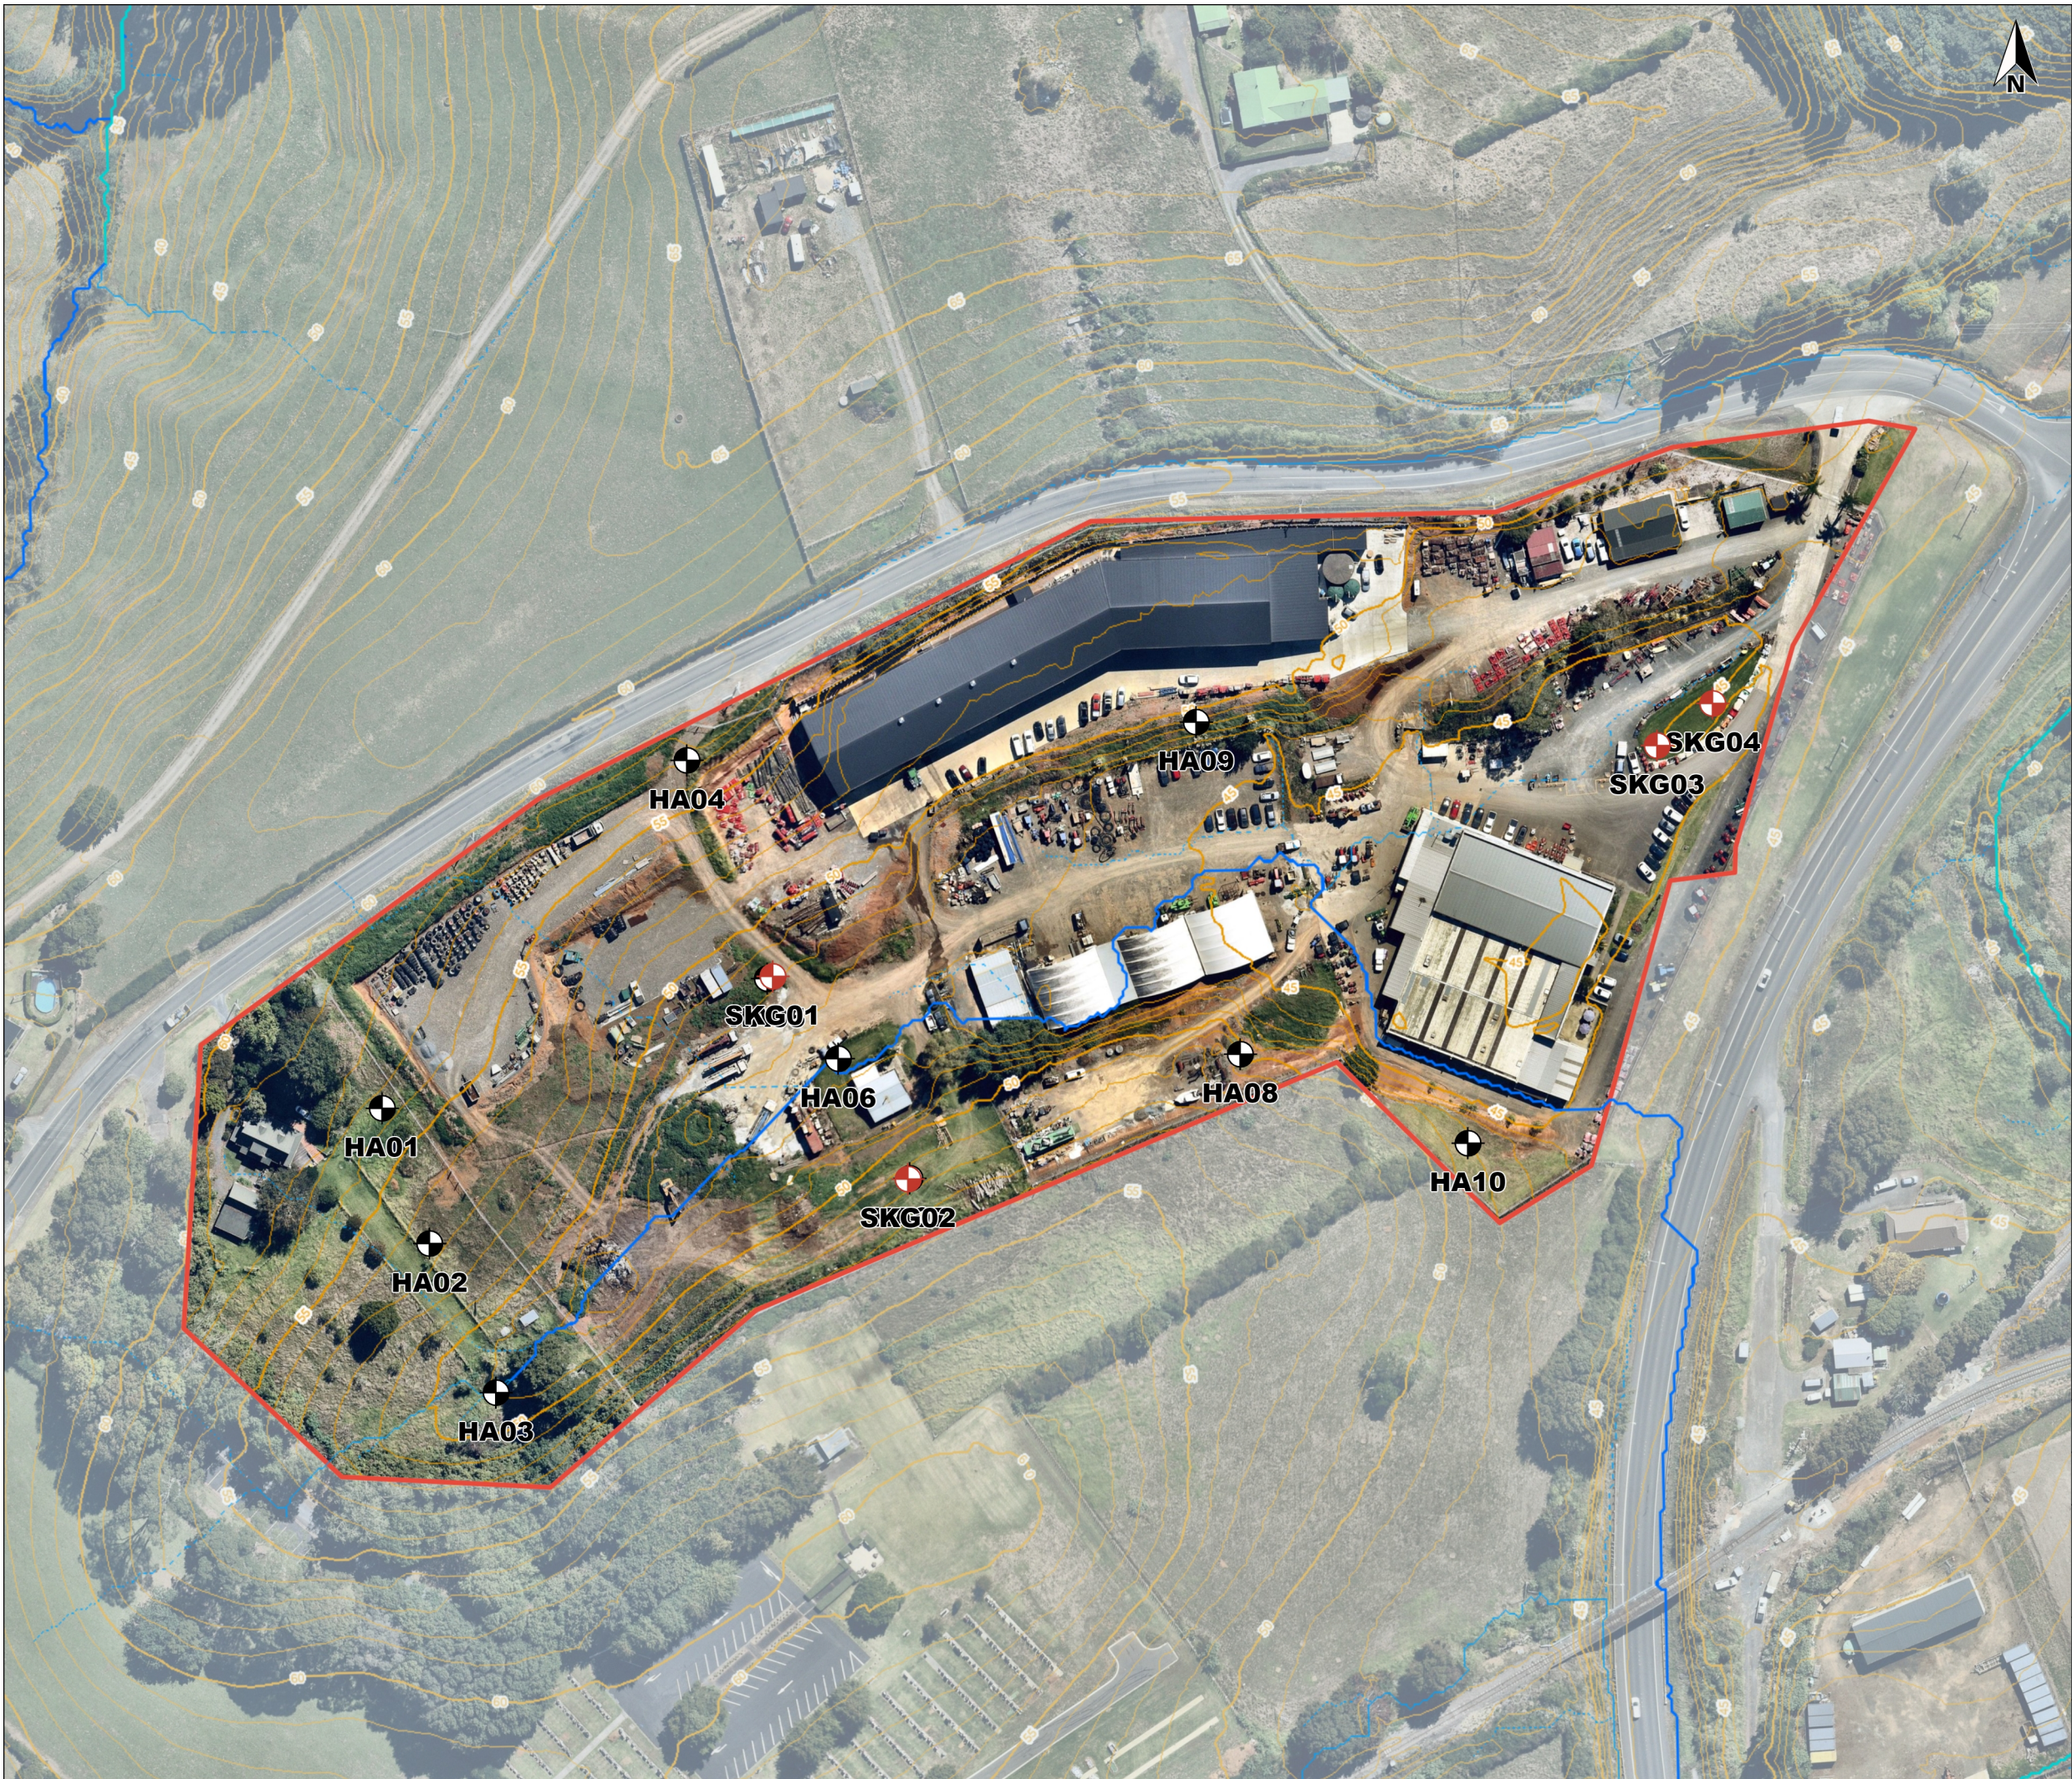
ENGEO attended site on 29 May 2023 to drill four 100 mm diameter auger holes (SKG 01, SKG 02, SKG 03 and SKG 04) to facilitate soakage testing. The borehole locations are presented on the Soakage Testing Plan (Appendix 1). Boreholes SKG01 and SKG04 were drilled to 2.2 m below ground level (m bgl) and boreholes SKG 02 and SKG 03 were drilled to 2.0 m bgl. At the conclusion of drilling all borehole locations were filled with water to ground surface to pre-soak the ground prior to infiltration testing.

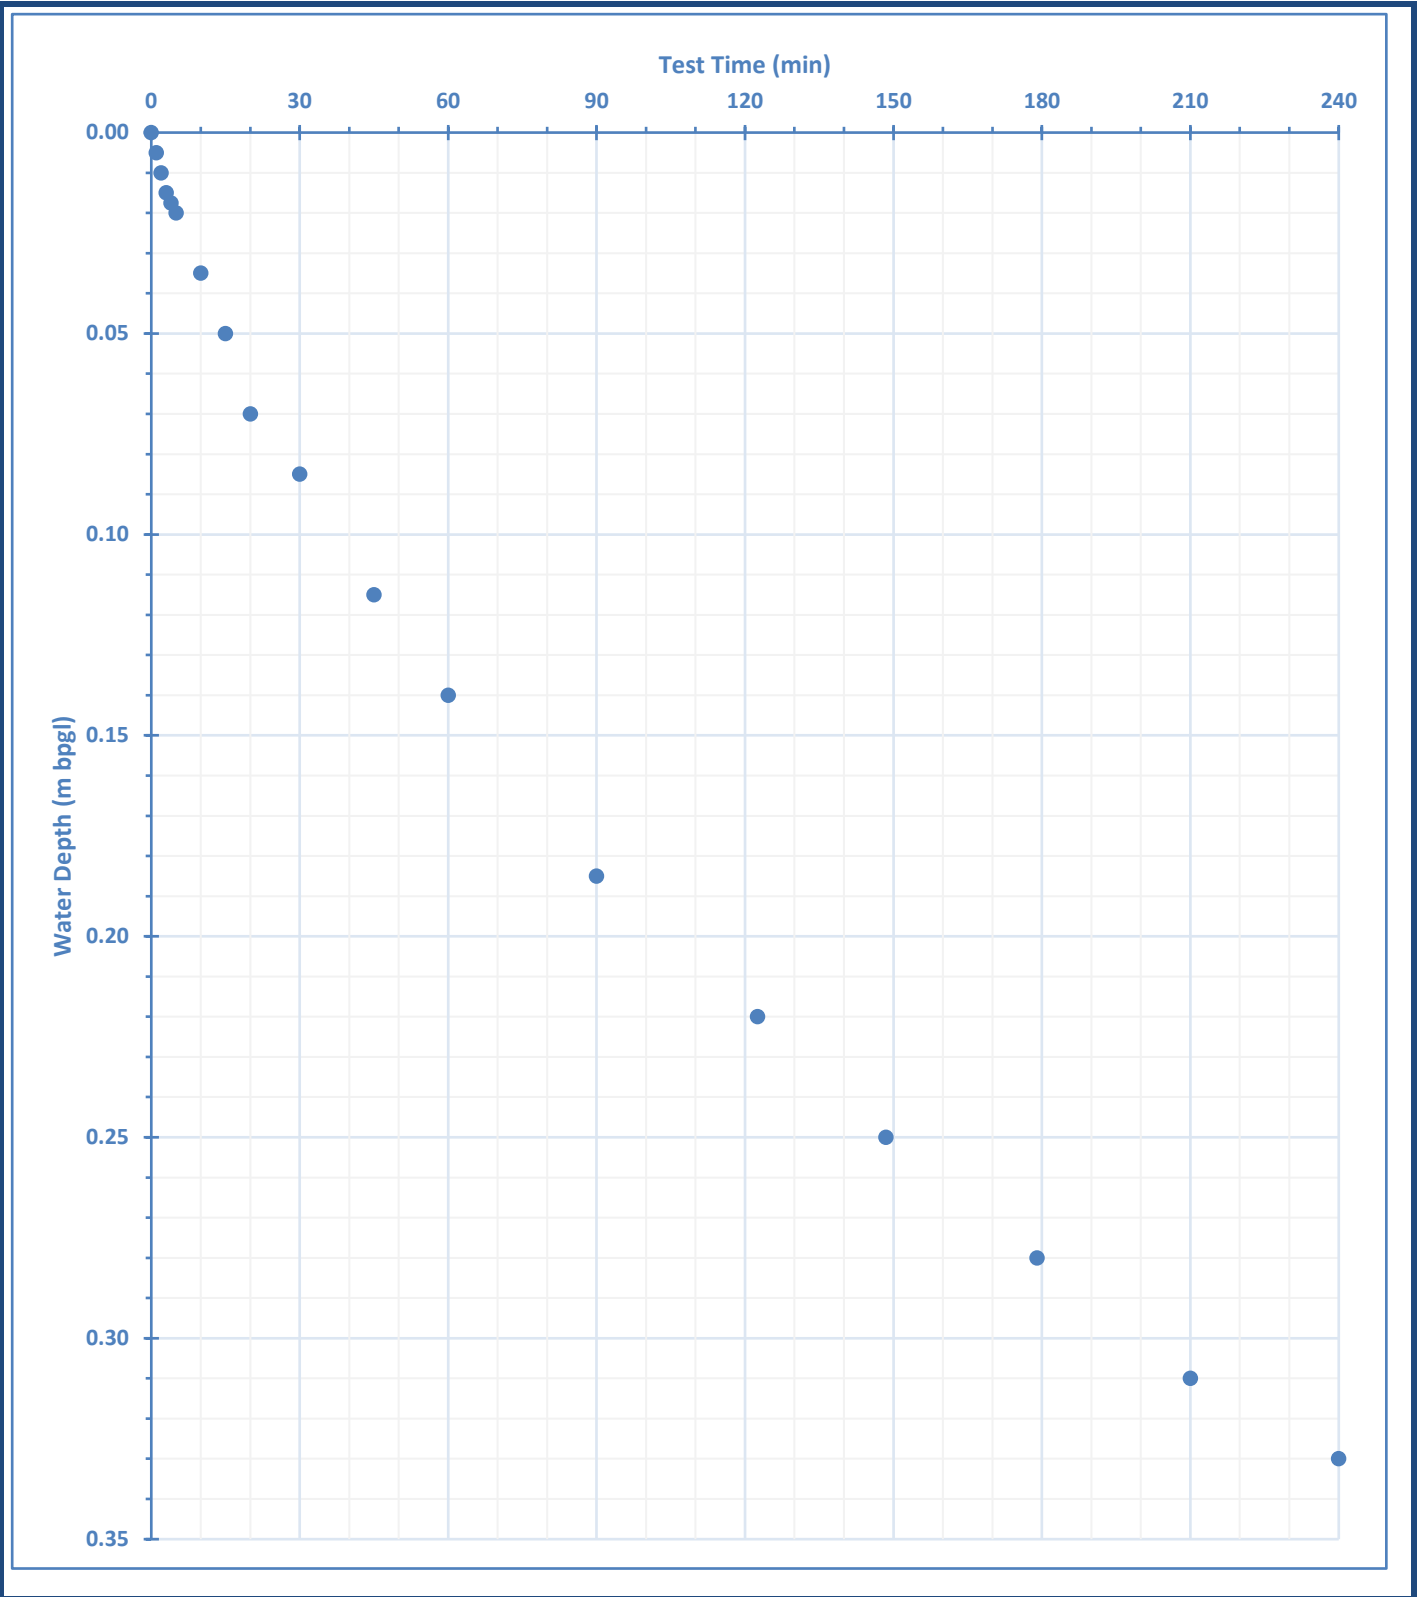
Worksheet 1: Falling Head (Variable Head) Percolation Test (graph)

$$\begin{aligned} \text{Minimum Gradient}^2 &= \frac{y}{x} \\ &= 0.0010 \text{ m/min} \\ d &= 0.68 \text{ m} \end{aligned}$$

$$\text{Percolation Rate}^3 = P_{(total)} = \frac{D \times \text{gradient} \times 1000}{4 \times d} = \boxed{0.04 \text{ L/min/m}^2}$$

$$\text{Soakage Rate}^{3b} = \text{min. } \frac{\delta \text{ Depth}}{\delta \text{ Time}} = \boxed{5.8 \text{ mm/hr}}$$

Project Number: 21253 Date: 30/05/2023 Time: 9:30:00 AM
Site Address: 9, 33, 49 Heights Road, Pukekohe
Borehole #: SKG 01 Test #: 1 of total 1 tests Test by: LL

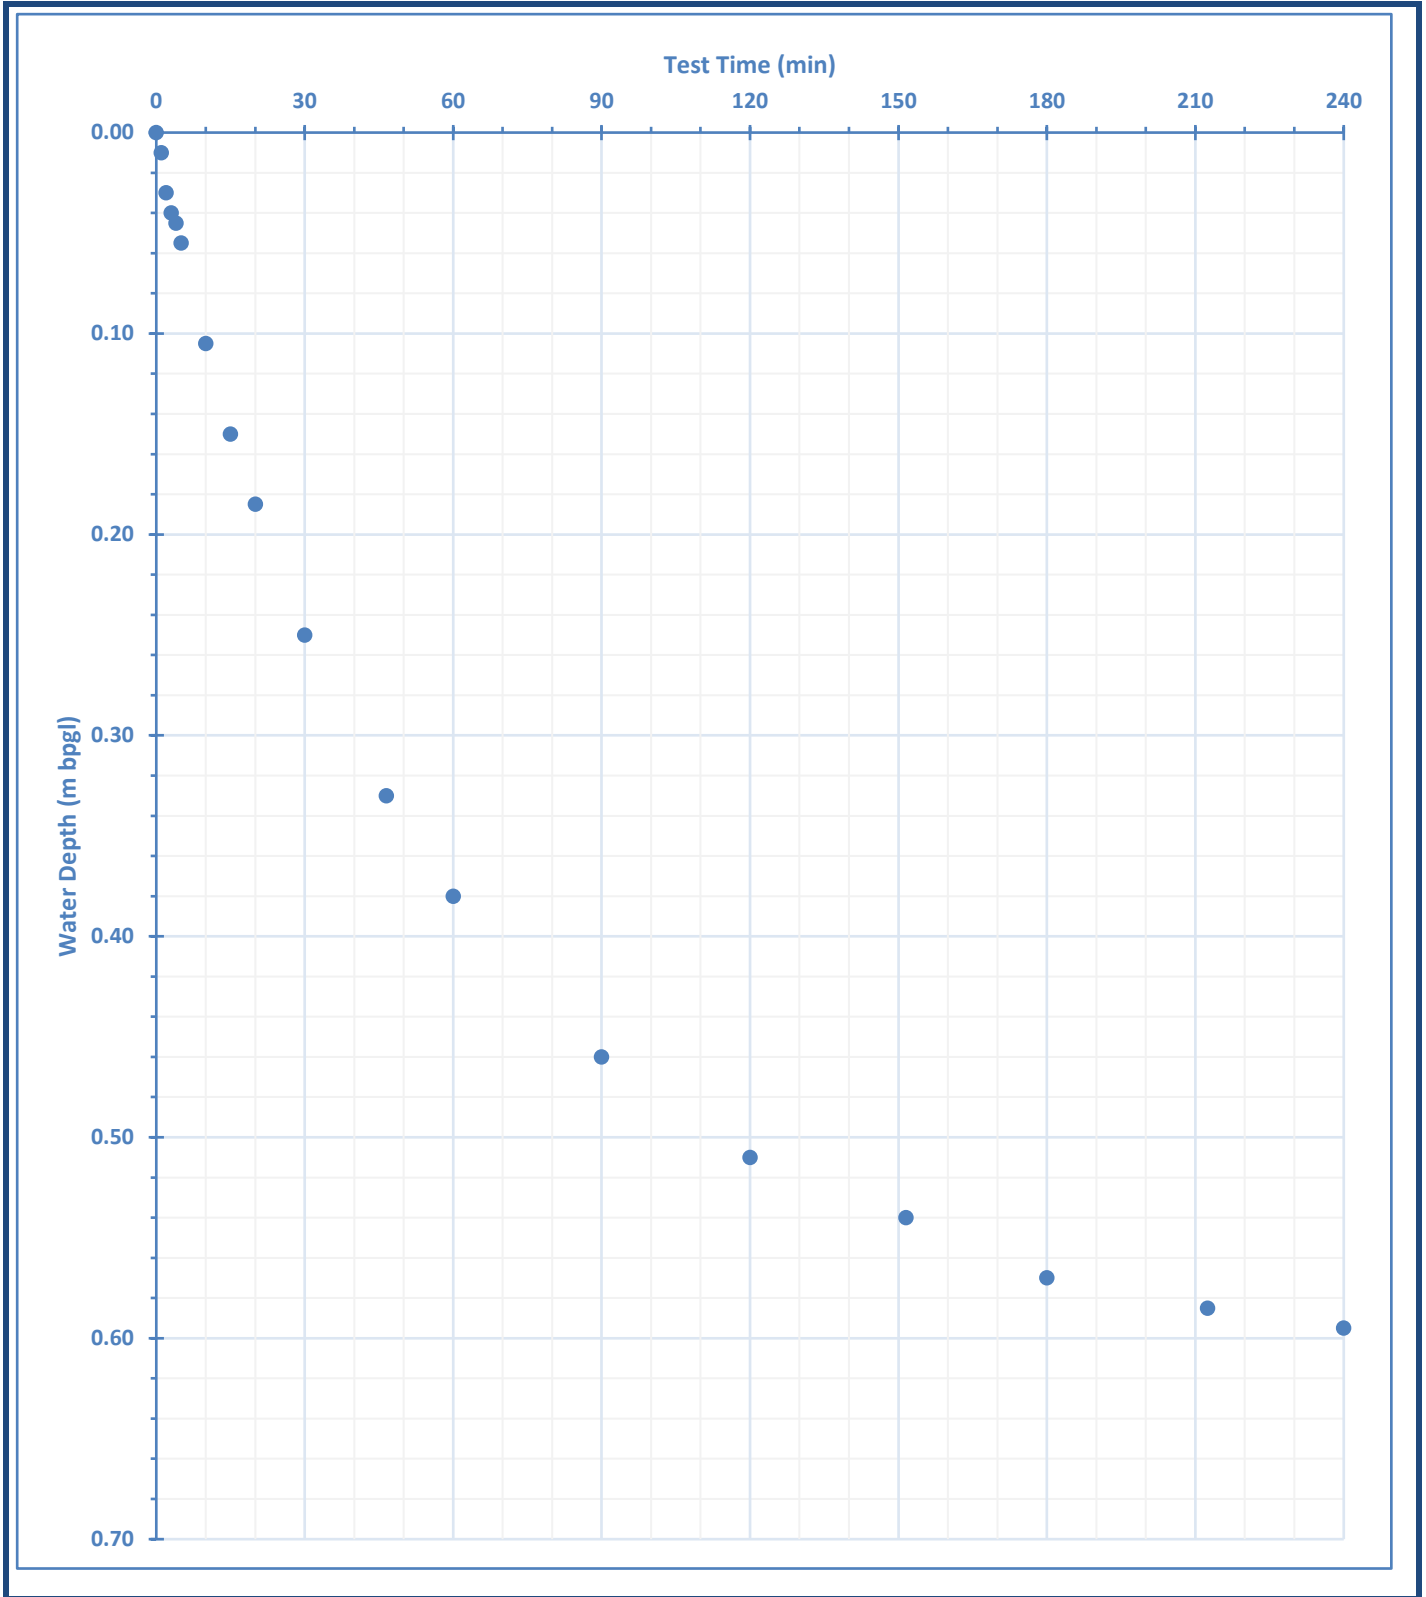
Worksheet 1: Falling Head (Variable Head) Percolation Test (graph)

$$\begin{aligned} \text{Minimum Gradient}^2 &= \frac{y}{x} \\ &= 0.0005 \text{ m/min} \\ d &= 1.01 \text{ m} \end{aligned}$$

$$\text{Percolation Rate}^3 = P_{(total)} = \frac{D \times \text{gradient} \times 1000}{4 \times d} = \boxed{0.01 \text{ L/min/m}^2}$$

$$\text{Soakage Rate}^{3b} = \text{min. } \frac{\delta \text{ Depth}}{\delta \text{ Time}} = \boxed{5.5 \text{ mm/hr}}$$

Project Number: 21253 Date: 30/05/2023 Time: 9:30:00 AM
Site Address: 9, 33, 49 Heights Road, Pukekohe
Borehole #: SKG 02 Test #: 1 of total 1 tests Test by: LL

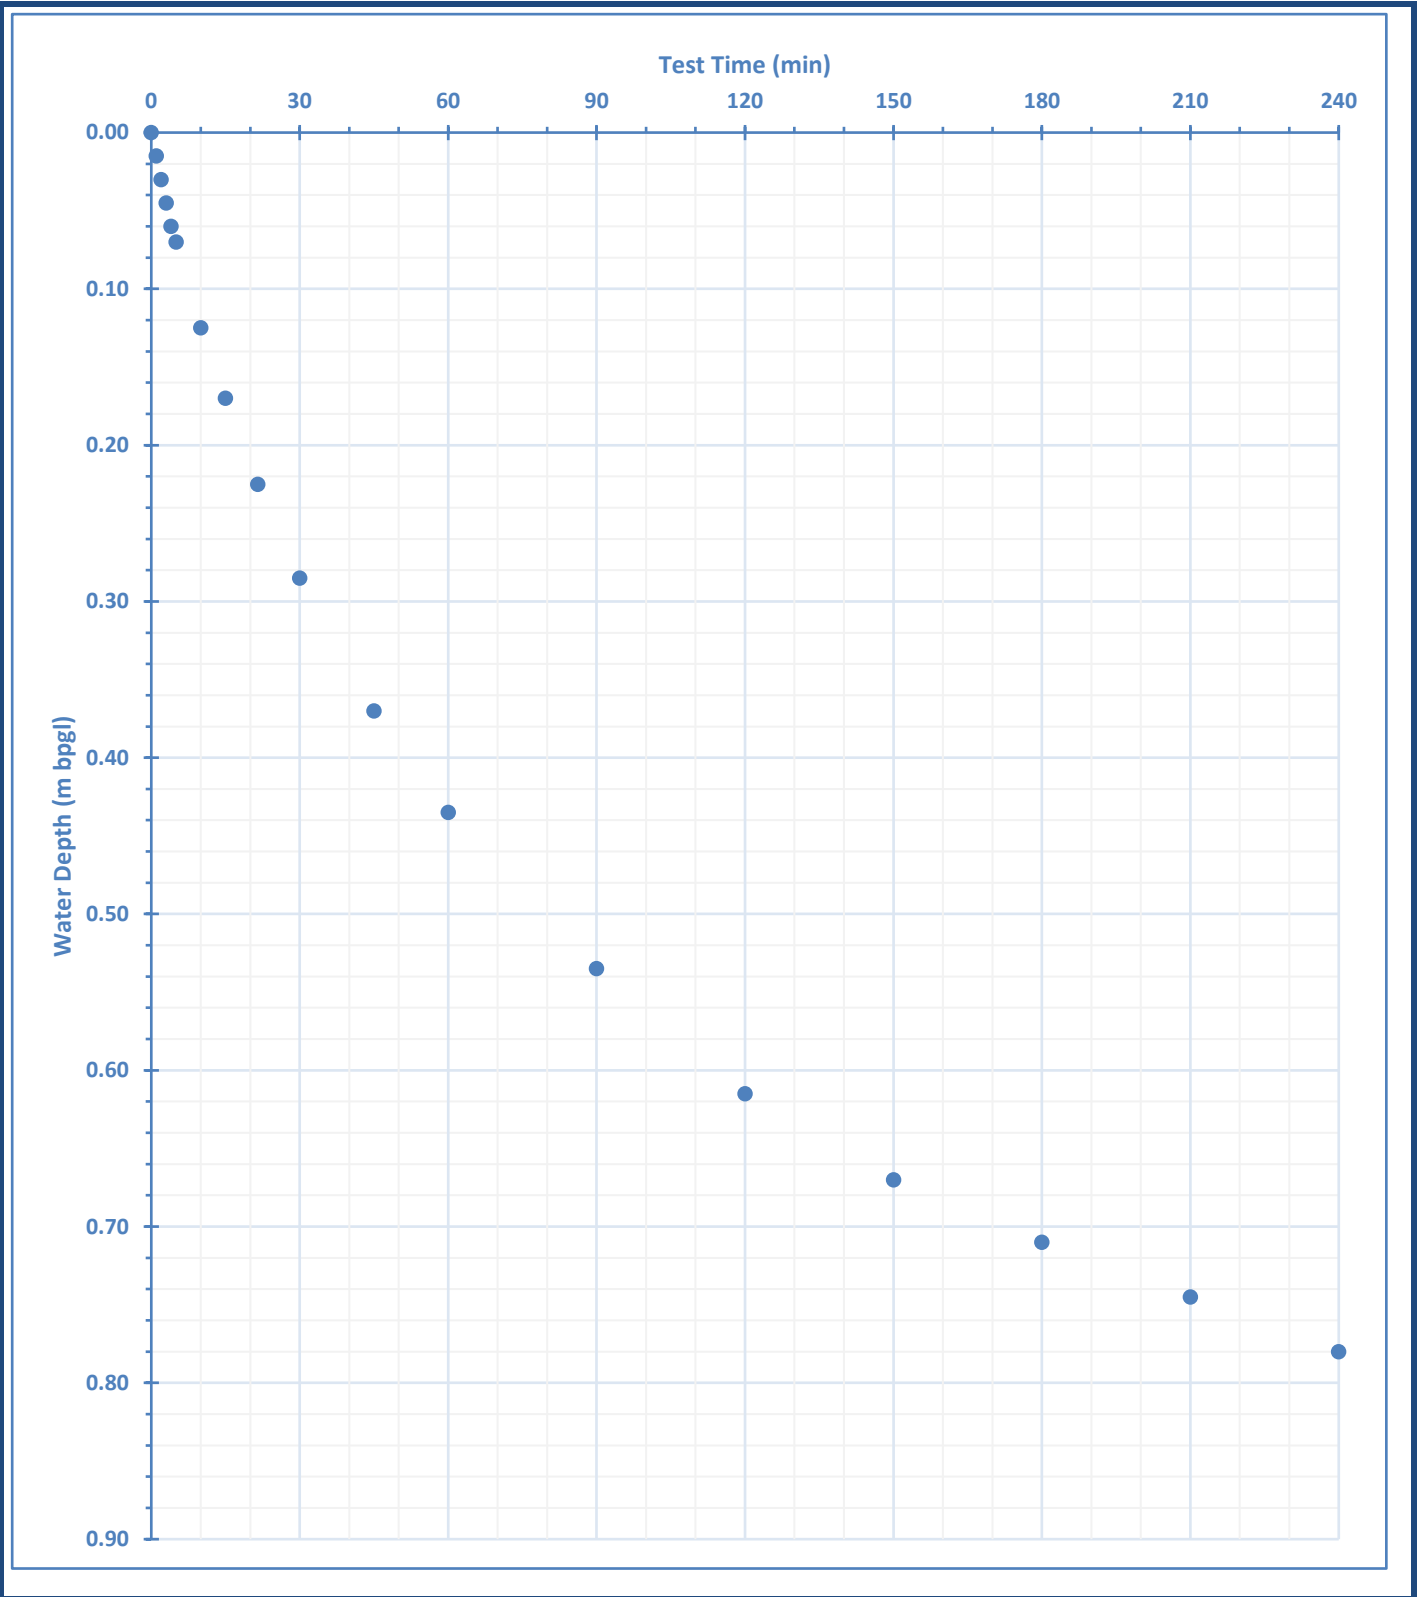
Worksheet 1: Falling Head (Variable Head) Percolation Test (graph)

$$\begin{aligned} \text{Minimum Gradient}^2 &= \frac{y}{x} \\ &= 0.0012 \text{ m/min} \\ d &= 0.3375 \text{ m} \end{aligned}$$

$$\text{Percolation Rate}^3 = P_{(total)} = \frac{D \times \text{gradient} \times 1000}{4 \times d} = \boxed{0.09 \text{ L/min/m}^2}$$

$$\text{Soakage Rate}^{3b} = \text{min. } \frac{\delta \text{ Depth}}{\delta \text{ Time}} = \boxed{8.0 \text{ mm/hr}}$$

Project Number: 21253 Date: 30/05/2023 Time: 9:30:00 AM
Site Address: 9, 33, 49 Heights Road, Pukekohe
Borehole #: SKG 03 Test #: 1 of total 1 tests Test by: LL

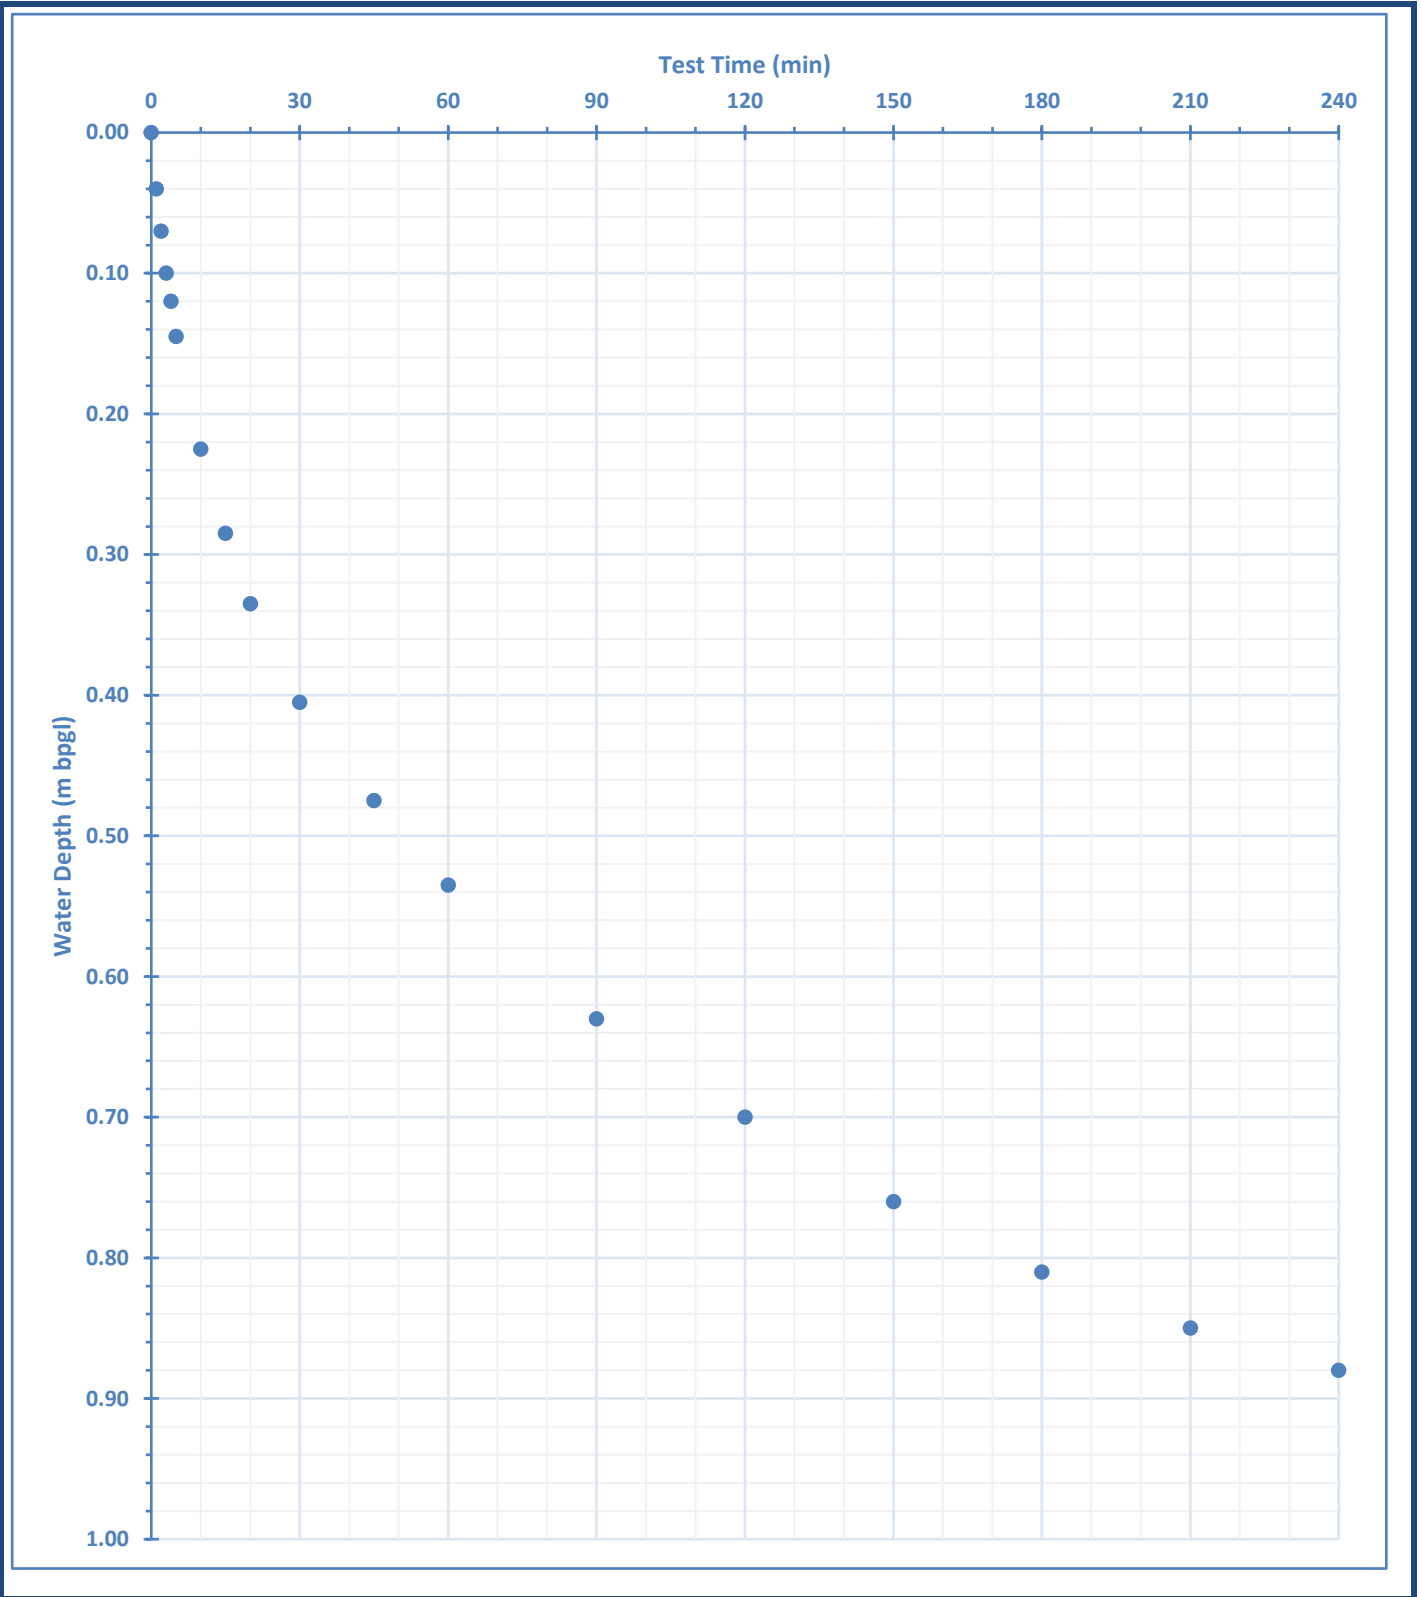
Worksheet 1: Falling Head (Variable Head) Percolation Test (graph)

$$\begin{aligned} \text{Minimum Gradient}^2 &= \frac{y}{x} \\ &= 0.0013 \text{ m/min} \\ d &= 0.135 \text{ m} \end{aligned}$$

$$\text{Percolation Rate}^3 = P_{(total)} = \frac{D \times \text{gradient} \times 1000}{4 \times d} = \boxed{0.25 \text{ L/min/m}^2}$$

$$\text{Soakage Rate}^{3b} = \text{min. } \frac{\delta \text{ Depth}}{\delta \text{ Time}} = \boxed{10.0 \text{ mm/hr}}$$

Project Number: 21253 Date: 30/05/2023 Time: 9:30:00 AM
Site Address: 9, 33, 49 Heights Road, Pukekohe
Borehole #: SKG 04 Test #: 1 of total 1 tests Test by: LL

The maximum unfactored infiltration rate was observed at SKG 04 which has an infiltration rate of 0.25 L/min/ m² (10mm/hr). The unfactored infiltration rates recorded in the rest of the hand auger holes was less than 8 mm/hr when unfactored.

The maximum unfactored infiltration rate was observed at SKG 04 which recorded an infiltration rate of 0.25 L/min/m² (10mm/hr). The unfactored infiltration rates recorded in the rest of the auger hole locations were less than 8 mm/hr.
