AUSTINO HOBSONVILLE 2 LIMITED
PROPOSED RESIDENTIAL DEVELOPMENT
DETAILED SITE INVESTIGATION (DSI) &
SITE MANAGEMENT PLAN (SMP)
86-90 & 100 HOBSONVILLE ROAD, HOBSONVILLE

Reference Number: REP-1329/DSI/MAR19

PREPARED FOR: AUSTINO HOBSONVILLE 2 LTD

22 MARCH 2019

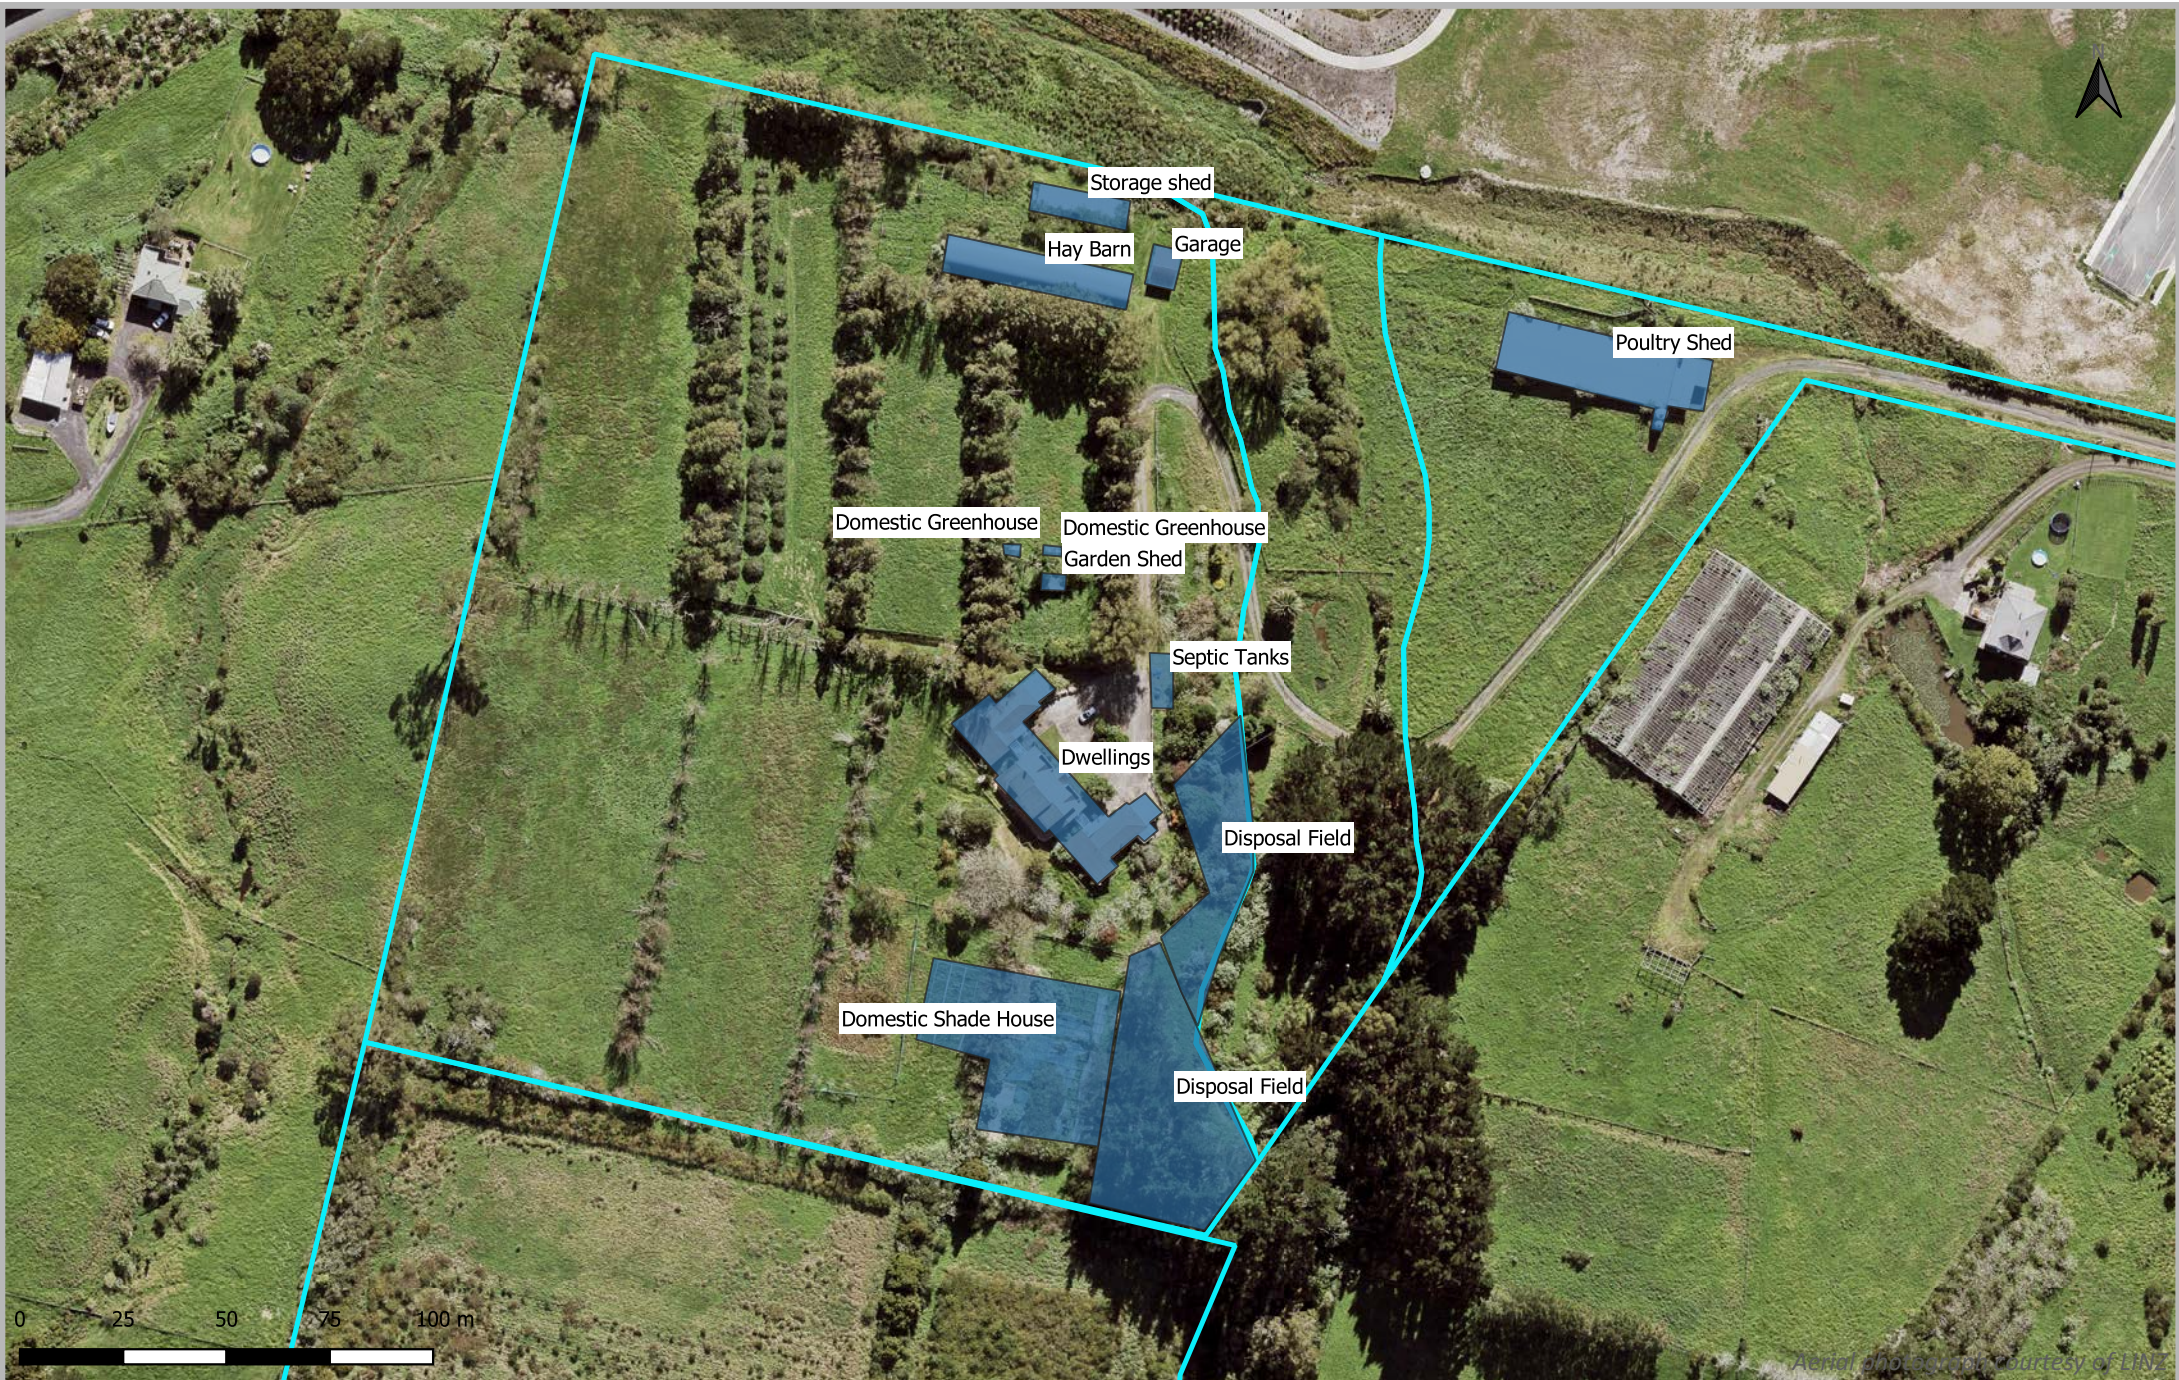
Figure 2 - Site Infrastructure
86-100 Hobsonville Road, Hobsonville

The only structures present on the piece of land were within 100 Hobsonville Road. The main structure is a large residential dwelling constructed on a U-shape around a large driveway / turn-around, located at the termination of the access road. The dwelling consists of three wings, with the southeast wing comprising the original dwelling located on the site, the main central wing and northwest wing are adjoined through glass conservatories. GSL did not note any visually obvious ACM on the dwelling, and no materials in broken or degraded condition that would impact soil quality. The dwelling is in excellent condition with no obvious signs of deterioration, painted surfaces are all in excellent condition with no areas of flaking etc. no paint flakes or chips were noted surrounding the dwelling. A full hazardous building materials survey will be required for demolition as set out in Section 13 below.

Along the northern boundary of the site is sited the poultry shed noted in the above sections, the shed is clad externally with fibre cement sheets considered likely to be asbestos containing materials and a corrugated iron roof, the building is constructed on a concrete foundation slab which extends approximately 1 m out from the walls of the shed, two grain silos are sited on the concrete slab at the southeast corner of the shed. The exterior cladding on the poultry shed is in generally good condition with the exception of one panel which has been broken (see Plate 2 in Appendix F), GSL considers the risk of gross soil contamination as a result of the fibre cement cladding to be low, however GSL notes that prior to demolition the building will require a hazardous building materials survey to be undertaken in order to confirm the location and extent of ACM with respect to specific demolition requirements. The volume of potential ACM is in excess of 10 m² and as such will likely trigger Class B Asbestos Removal works.

To the east of the poultry shed is a large gully, on the western side of the gully is a large arched storage barn noted in the desktop review, the barn is timber framed and clad with corrugated iron with a bare earth floor, adjacent to the barn is a garage with a concrete foundation slab and again clad with fibre cement weatherboards, the cladding on the garage is noted to be in good condition, with no broken panels or fragments of material noted.

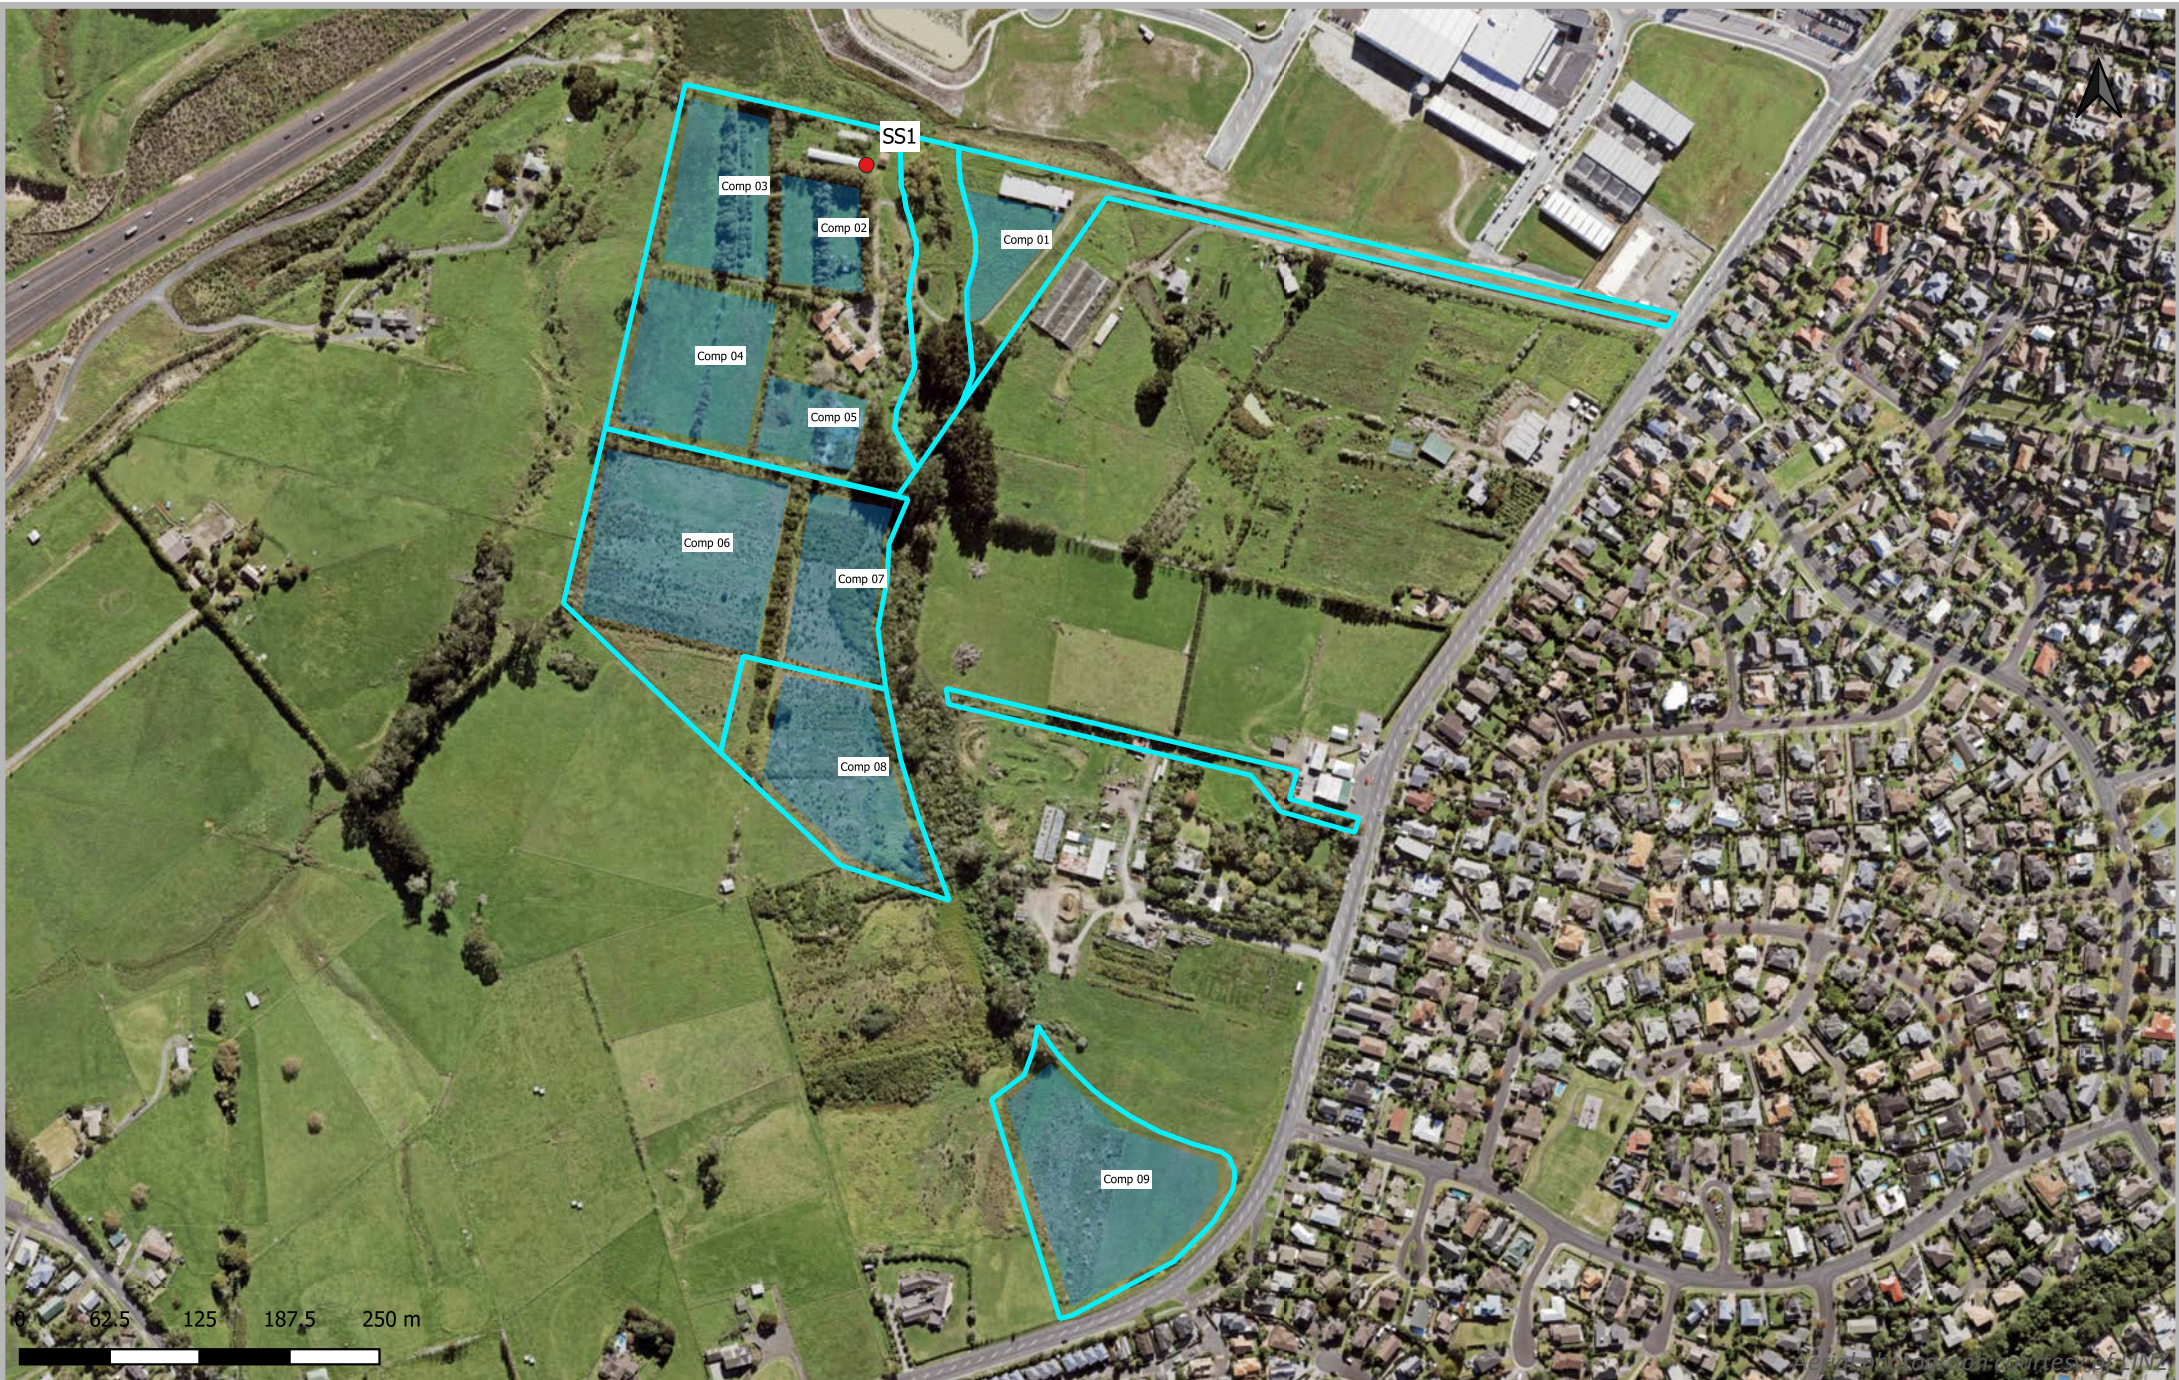
Figure 3 - Soil Samples Locations
86-100 Hobsonville Road, Hobsonville

Based on the conceptual model developed in the above sections, GSL carried out a judgemental soil sampling regime which included the collection of composite soil samples from former horticultural blocks. The former horticultural areas of the site were divided into nine areas with one composite soil sample, composed of four discrete subsamples, collected from each area. Subsamples were collected using a stainless steel foot corer following the removal of any surficial vegetative cover. Each subsample was placed into a plastic zipper bag with the date, composite soil sample identification number, location and initials of the sampler noted on the bag. Once the four subsamples had been collected in the sample bag the soil was thoroughly mixed in order to homogenate the composite sample. GSL notes that the topsoil horizon across the full extent of the site was assessed to be a uniform organic rich silty loam, as the conceptual model identified that any potential contamination is likely to be uniformly distributed through the topsoil layer, the conditions on site are considered ideal for use of the composite methodology.

One discrete soil sample was collected from within the storage barn in an area where some minor surficial hydrocarbons staining was noted on the earth floor of the barn. The soil sample was collected using a stainless steel foot corer and placed directly in a laboratory prepared glass sample jar with the date, sample identification number, sample depth, location, and initials of the sampler noted on the label.

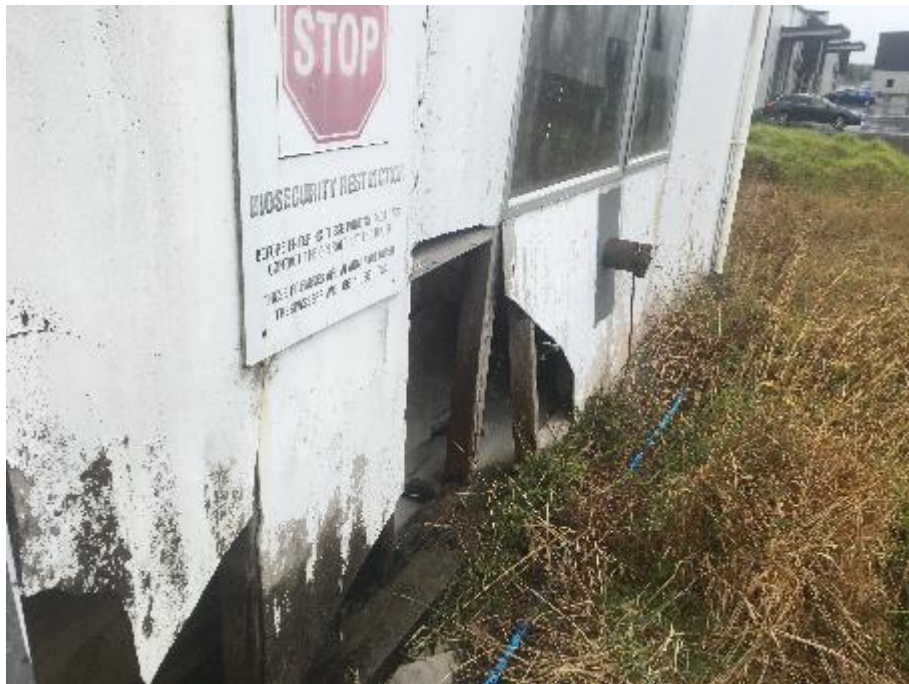
While ACM products may be present in buildings constructed prior to 1 January 2000, asbestos containing materials only pose a risk for soil contamination where they are found to be in degraded condition. With the exception of one broken panel of fibre cement cladding on the poultry shed, any potentially ACM products were noted to be in good condition and therefore highly unlikely to result in a risk of fibre generation or soil contamination. With respect to the panel on the poultry shed, while broken the product remained in un-weathered condition and was unable to be crumbled by hand, which indicates that it is unlikely to be friable and should therefore be addressed during demolition of the poultry shed.

PLATE 2: BROKEN FIBRE CEMENT PANEL ON EASTERN END OF POULTRY SHED

With respect to the demolition of any building constructed prior to 1999 the *Health and Safety at Work (Asbestos) Regulations 2016*, demands a fully intrusive pre-demolition hazardous building materials survey to be undertaken before demolition works can commence. The survey must be conducted by a suitably WorkSafe NZ licensed asbestos assessor, and will identify the location and extent of any hazardous building materials, specifically ACM. Should ACM be identified in the survey then asbestos removal works will be required prior to the demolition of the dwelling, the removal must be completed by an appropriately licensed asbestos removal contractor and under the controls of an asbestos removal control plan (to be provided by the appointed contractor. The hazardous building materials survey will form the basis of any asbestos removal control plan.

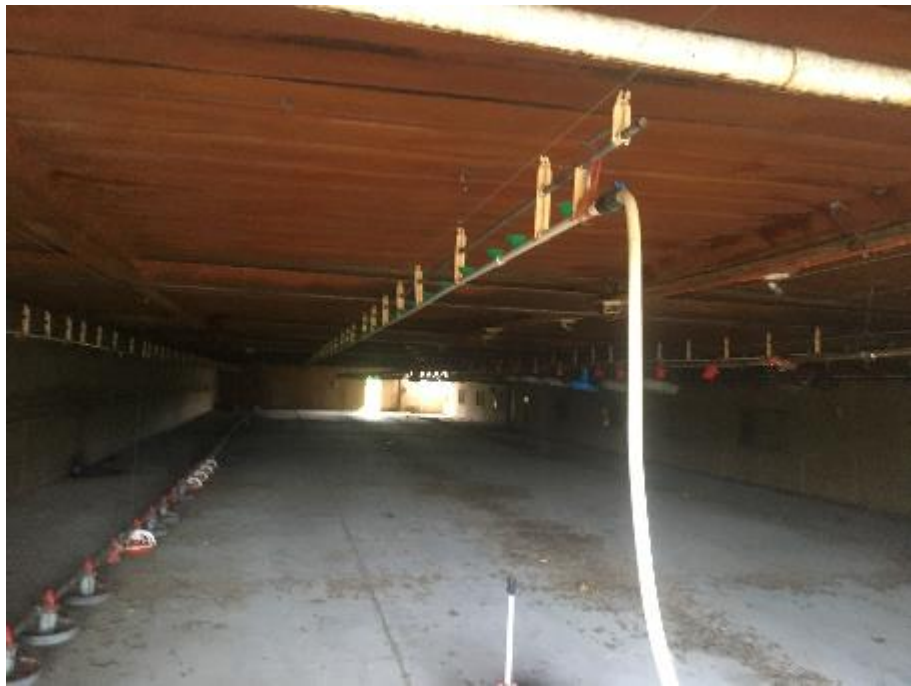
PLATE 3: INTERIOR OF POULTRY SHED

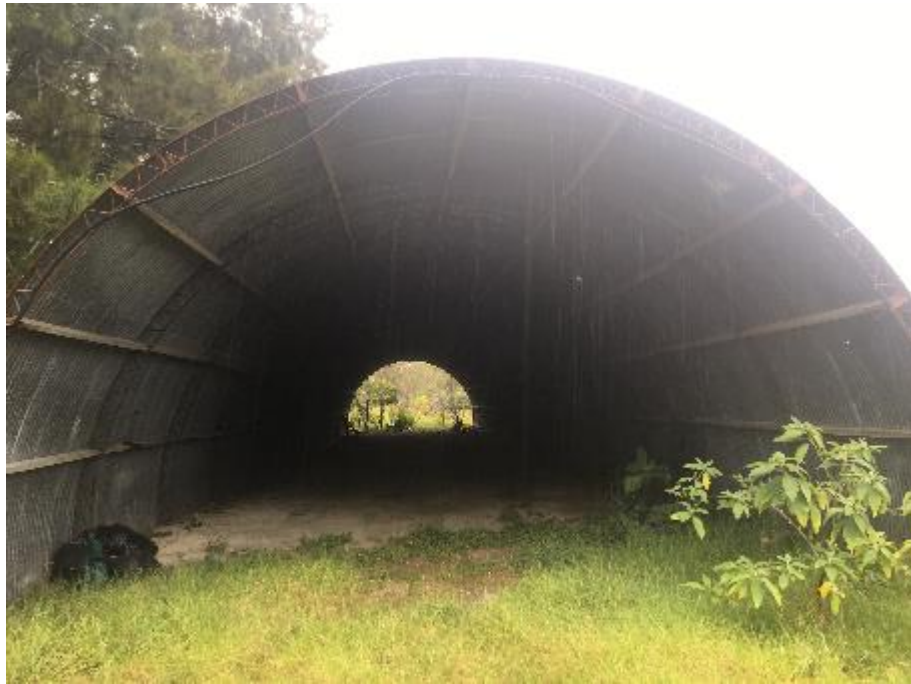
GSL did note the presence of some minor hydrocarbon staining in a discrete area at the eastern extent of the hay barn, likely as a result of the storage of farm machinery. Where leaks or spills of oils and fuels are present, they result in small highly constrained hotspots and contaminants generally do not infiltrate deeper soils or migrate far from the source.

GSL notes that the area impacted by hydrocarbon staining in the barn is extremely limited, being less than 20 m² in the eastern end of the barn, staining is constrained to the uppermost 10 mm of surface soil and not present below that depth. Disturbance required to address the visual staining is expected to be minimal

PLATE 5: BARN IN NORTHER PORTION OF 100 HOBSONVILLE RD, STAINED AREA IN FOREGROUND

With respect to the hydrocarbon stained topsoil in the barn, while the soil does not meet the definition of cleanfill due to visual staining and detectable PAH, there is no reason that soil from this area cannot remain on site for reuse as top cover of landscaping. That being said, should off-site disposal of the soil be desired, while the soil will be required to be disposed of at a suitably licensed facility, the removal of the soil can be undertaken as a permitted activity alongside the decommissioning of the septic tanks and disposal fields.

While detectable concentrations of PAH are noted in the barn in the northern portion of the site, the volume of disturbance required to address the stained areas of soil will be minimal and limited to a surface scrape of the stained area. GSL notes that there is no reason why unstained soil may not remain on site for re-use as topcover or landscaping.

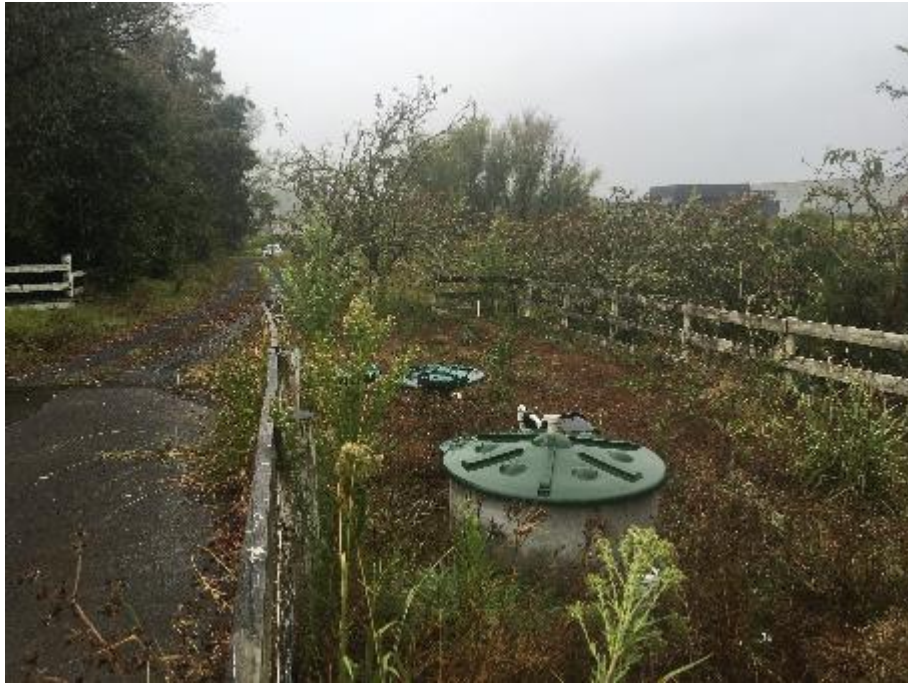
Effluent disposal fields and domestic wastewater treatment systems are considered to encompassed by Items G.5 and G.6 of the MfE HAIL. The area which has the highest potential for impacts resulting from the wastewater treatment is the disposal field where effluent liquor is, in this case, pumped to drip lines and drained into the soil. The discharge can result in impacts to the soil along those driplines, however it would not be expected that any impacts to soil would be found outside the immediate area of the disposal field. The disposal field remains currently in use and as such, sampling at this time does not provide any value with respect to ongoing landuse. While Council have previously identified the contaminants of concern to be heavy metals, bacteria and viruses. GSL notes that laboratory techniques used for soil testing make the analysis for contaminants such as bacteria and viruses cost prohibitive and difficult to assess. Therefore, GSL considers the heavy metals are adequate as an indicator of any potential impacts or risks related to the disposal field. As the disposal field remains in use and are generally considered a low risk for potential contamination, GSL considers that during demolition of the dwelling the disposal systems can be removed, and validation soil sampling can be undertaken following the removal.

Plans contained within the property file indicate that the system is comprised of an Hynds Septic System, which consists of a multi chamber system with two disposal fields constructed of approximately 400 m of driplines. The specification of the tanks are not noted in the property file, however it appears to be concrete and covers an area of approximately 14 m², the depth is likely to not exceed 2 m below surface resulting in approximately 28 m³, while the drip lines are expected to be situated in the topsoil horizon (i.e. the uppermost 400 mm of the soil profile).

PLATE 9: SEPTIC TANKS ON 100 HOBSONVILLE RD

Prior to the excavation of the septic tank and disposal field, the site manager appointed by Austino Hobsonville 2 Ltd will arrange for the tank to be emptied through the use of an approved waste removal company utilising a suction truck specifically designed for this purpose. The waste will be disposed of by the appointed contractor to an approved liquid effluent receiving facility. Once empty, the tank will be carefully excavated and removed from site. Depending on the construction material and condition of the tank, it will either be disposed of to an appropriately licensed facility (e.g. landfill) or sent to a location for recycling under approved conditions.

engineering inspection and report held on the Council property file. That said, it is noted that this is not an as built plan and as such the effluent disposal pipes should be 'chased out' using an excavator starting at the septic tank through to termination.

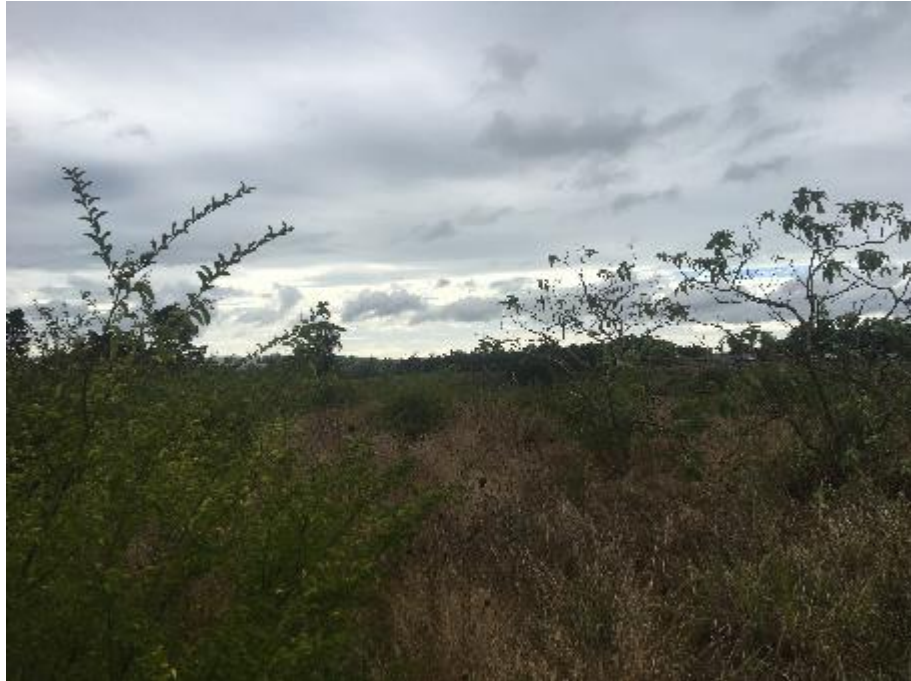
PLATE 11: COMPOSITE AREA 8, INDICATIVE OF CONDITION OF FORMER HORTICULTURAL AREAS
