Waitākere Ranges Local Board Workshop Record

Workshop record of the Waitākere Ranges Local Board held at the Waitākere Ranges Local Board office, 39 Glenmall Place, Glen Eden, Auckland on Thursday 9 May 2024, commencing at 10.15am.

Bethells Beach Surf Life Saving Facility Feasibility Assessment March 2023

Auckland Transport West Auckland Recovery Progress Report Waitakere Ranges Local Board May 2024

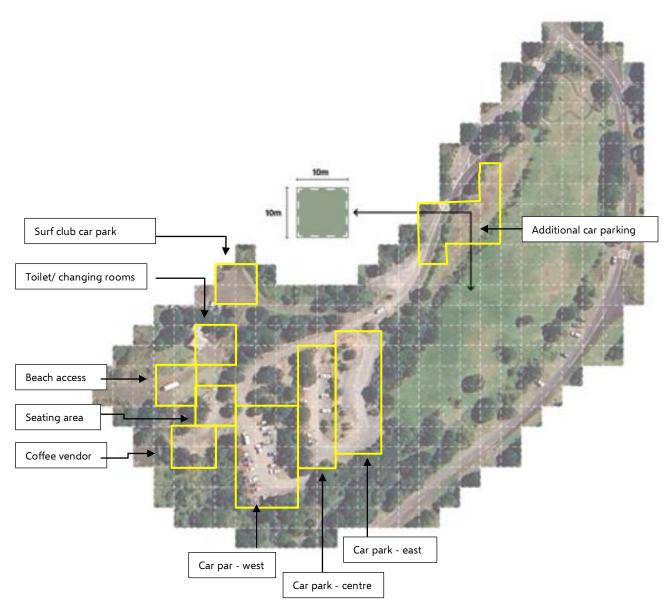
Figure 1 Overview of study area with 10m x 10m grids and usage scale

It should be noted that, as people walk/move through a site, they may pass through multiple cells at the time of surveying which can result in double counting. To resolve this, Hook Consulting deduplicates and removes the data of duplicate visitors to only count one visitor spatially per cell per hour.

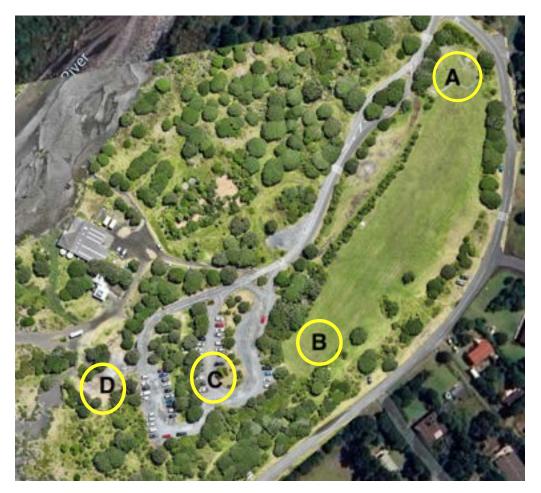
Figure 2 Map showing location of observational study

Observation studies were undertaken at arrival at the park and between the three drone flights at 9.30am, 12.30 pm and 3.30pm. The four locations are shown in the map and table below (see larger scale location map in Appendix <u>4</u>):

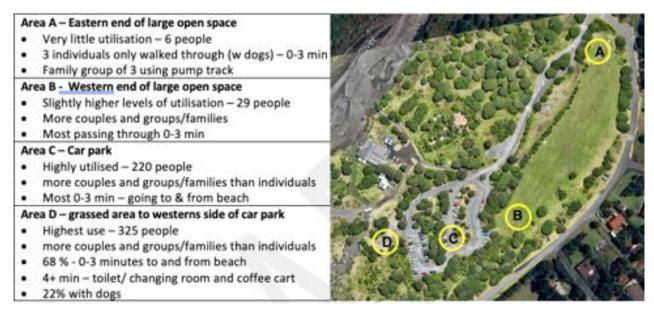
Figure 10 Summary of observation study findings

Key observations about park use at the four locations are set out in detail in Appendix $\underline{6}$ and summarised in Figure 10 below.

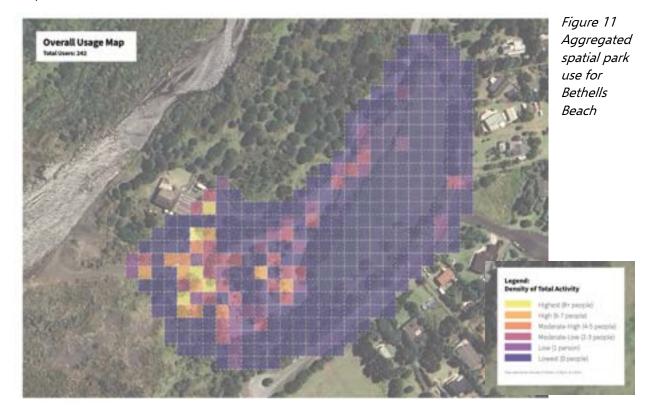
Figure 11 below shows the aggregated usage over the three flight days. As can be seen, the areas receiving the highest use over the three days are in the vicinity of the toilet/changing rooms, surf club car park and the area where the mobile coffee vendor is located.

The four heat maps that created based on drone footage, showing use one each of the three days. A fourth map show aggregated use over three days. See Appendix $\underline{8}$ for maps.

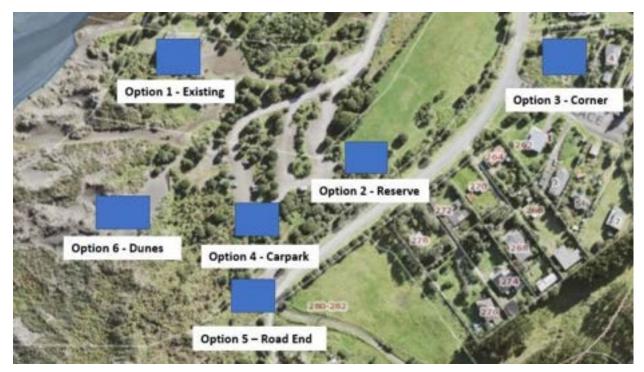
Figure 1: Site Location Options

Six potential location options including the existing location have been considered (See Figure 1). The characteristics of each option have been examined via a series of desktop site investigations, including preliminary planning, ecological, three waters and geotechnical assessments by third party technical experts (See Table 1). Additional privately owned options have been pursued and analysed, however the risks associated with these locations have outweighed their potential benefits.

This assessment has led to the identification of a recommended location for the new facility. This site (Option 4 - Carpark) is located within a planted reserve area, situated between the existing carpark and Bethells Road (See Figure 1). Strengths of this location include:

Whilst Option 3 - Corner was strongly considered, its benefits were outweighed by planning, stormwater and access constraints. It is recommended to either retain location Option 3 - Corner for future club storage requirements or to consider selling to achieve funding requirements.

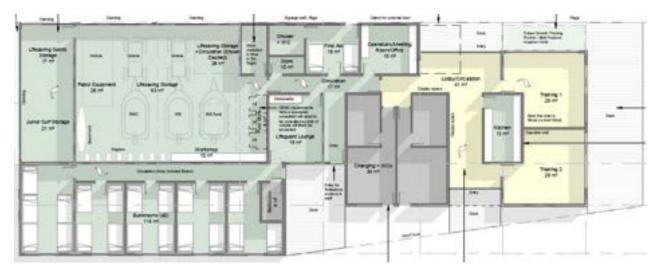
Figure 2: Initial concept design

- \$4.6 million capital build requirement (Stage 1A and Stage 1B)
- \$51,500 per annum operating costs.

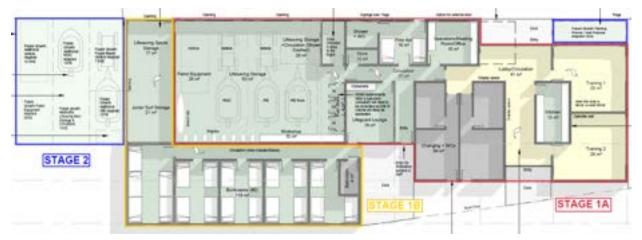
Figure 3:Proposed staging of initial concept design

This involves submitting staged resource and building consents, with a smaller building delivered initially to reduce upfront cost and allow the balance to be completed later. Development costs for this initial build (Stage 1A) is \$3.8 million, with ongoing operating costs of approximately \$41,500 per annum.

This approach provides BBSLSP the ability to scale the first stage of delivery to align with the funding they manage to secure. The balance of the project can be progressed as additional funding is secured. The modular nature ensures that staging does not add significant costs to the project.

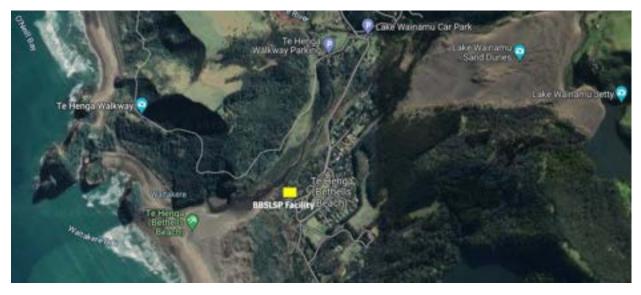
An approximately 8,500m² area of open park area is situated between the clubrooms and Bethells Road, this is part of the wider Te Henga Reserve.

Figure 4: BBSLSP Facility Location, and wider Te Henga features

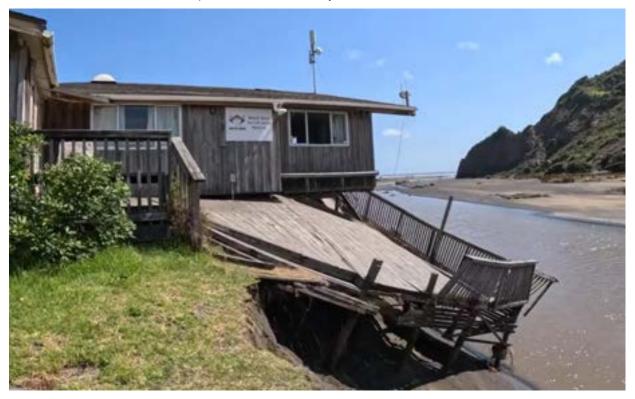
Figure 5: Cyclone Gabrielle erosion damage

the clubs beach access path was washed away.

As a result, the building has been "Yellow Stickered" by Auckland Council, restricting access to the building, damage assessments are ongoing.

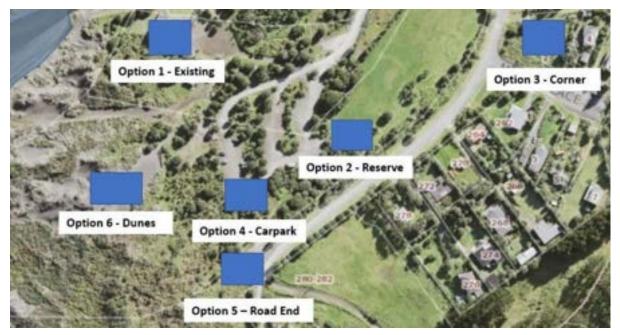
- The **length of visit** for most people ranged from 1-4 hours; 1-2 hours (45%) or 2-4 hours (31%). Only 16% stay for less than one hour and only 8% stay for longer than 4 hours. See Figure 7 below.

- Most visitors (81%) **spent the majority of their visit** at the beachfront. A small number were based at the Waitakere River area (5%) and the open space park area (8%). Only one respondent specified they were going to O'Neills Beach. See Figure 5 below.

- The most common **reasons for visiting** Te Henga/Bethells Beach were spending time with friends/whanau (49%), beach walking (43%), swimming at the beach (31%), enjoying nature (21%), surfing/boogie boarding (21%) and dog walking (21%). Only a few people go to fish, swim in the river (3%), run and go to the café. See Figure 6 below.

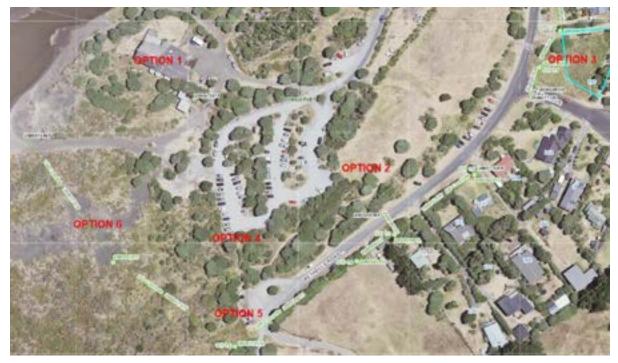
Figure 13: Stormwater network in green

The report finds that Option 6 is the most appropriate location from a stormwater and flood hazard perspective, followed by Option 4. Option 5 is not recommended, and Option 3 has additional resource consent requirements and increased costs in delivering a complying stormwater detention system.

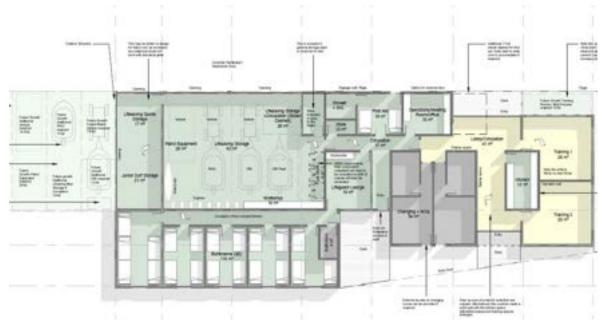
Figure 17: Initial concept design

- Total floor area of 532m², excluding decking
- 63m² in Lifesaving Storage
- 26m² in Patrol Equipment Storage
- 38m² in Junior Surf and Lifesaving Sport Storage
- 19m² First Aid Room with external and internal access
- 15m² Operations Room
- Total changing room space of 54m², split male/female
- Two multi-purpose meeting/training rooms of 26m² each. Capable of opening into a single space
- 120m² of bunk room lodging.

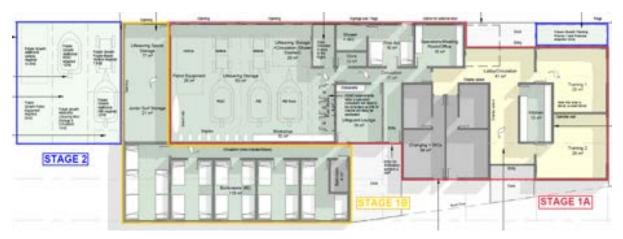
Figure 18: Proposed staging of initial concept design.

The initial output of this analysis assessed a total development cost that was potentially prohibitive to progressing with the development in a timely manner. Consequently, we have included analysis for a smaller initial footprint, known as Stage 1A, to provide construction flexibility based on funding outcomes.

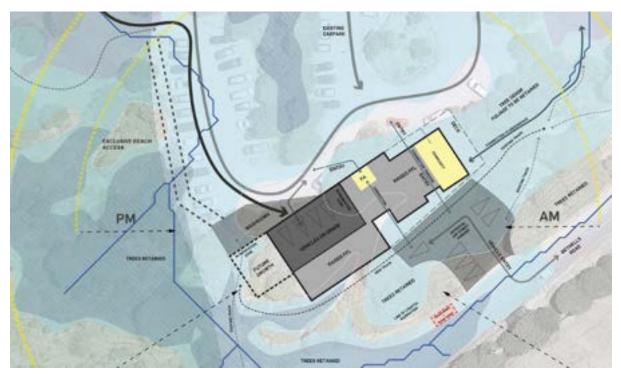
Figure 19: Preferred location - Option 4, site layout

As outlined in Section 4.8: Preferred Location, site location Option 4 provides the most favourable access points for both beach access for lifesaving operations movements and emergency services, a reduced risk from natural hazards, good access to existing infrastructure and opportunity to mitigate visual impact.

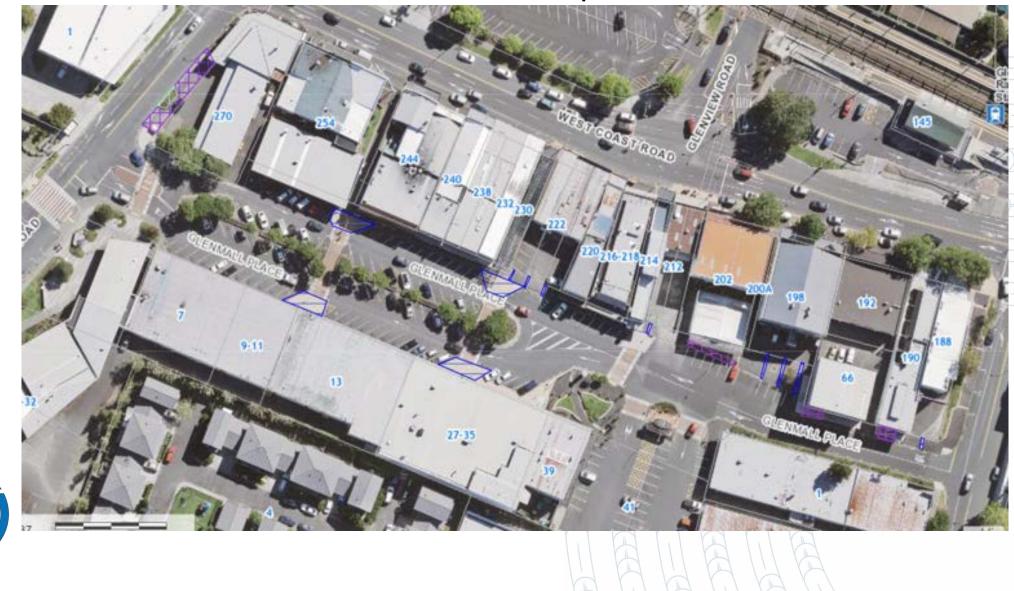
Aerial view of areas of essential improvements

Remove and replace the existing planted island and vehicle crossing & footpath area on Glendale Road, with a

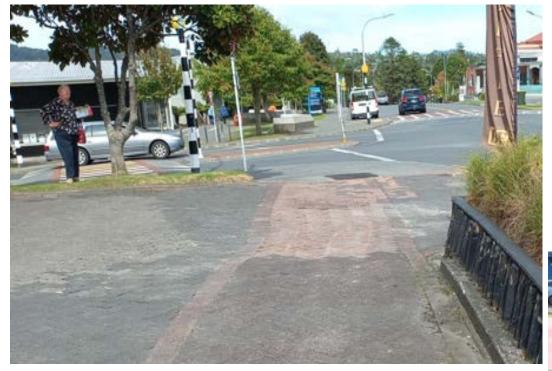
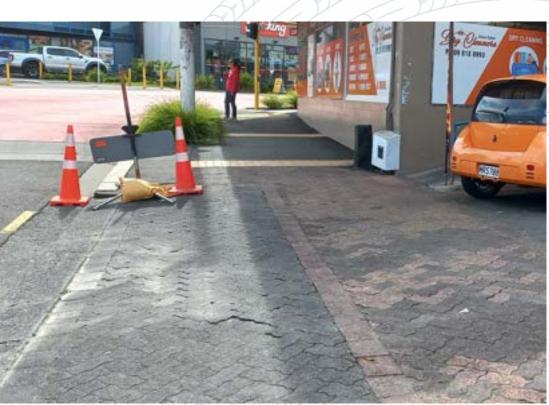
Existing footpath/vehicle crossing on Glendale road

Replace pavers on both sides of raised crossings with concrete. Approx \$30,000 (blue hatching)

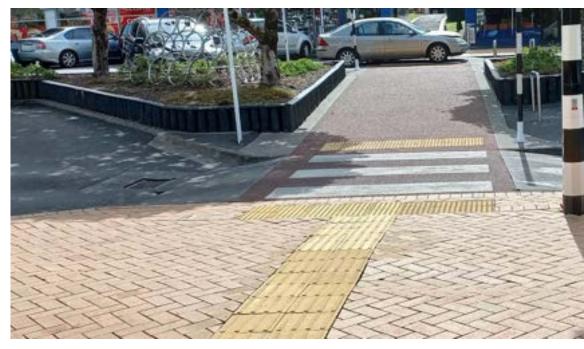
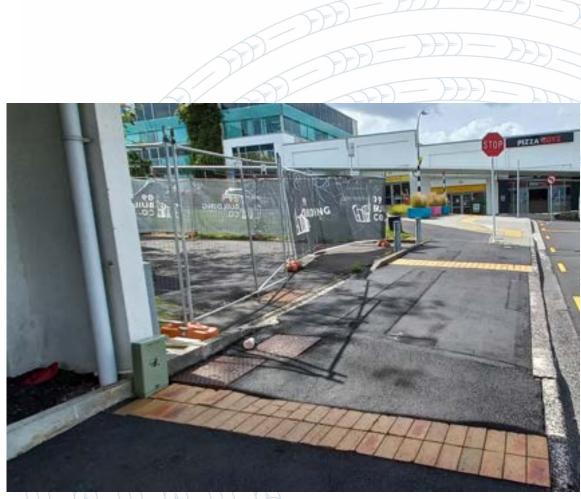
Paver areas near the zebra crossing

Replace ashphalt footpath (localized treatment) and pavers with asphalt on the eastern side of Glenmall place.

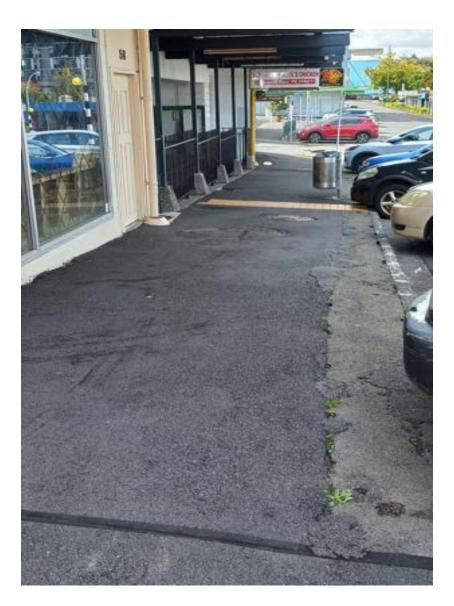
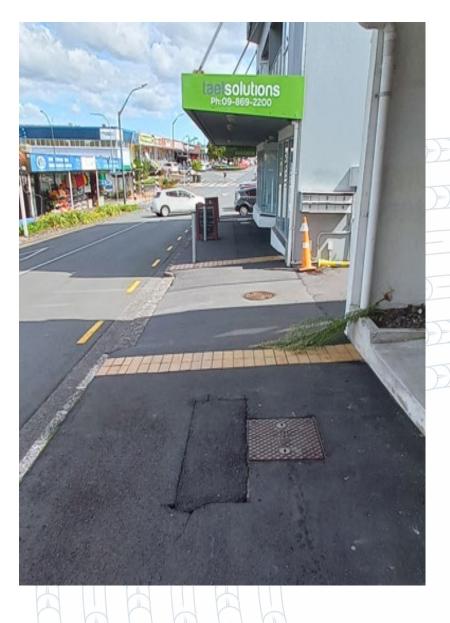
Existing footpath on the eastern side on Glenmall Place

Option 1 (Localized footpath renewal) – Identify and repair ashphalt footpath as required, approx. \$20,000

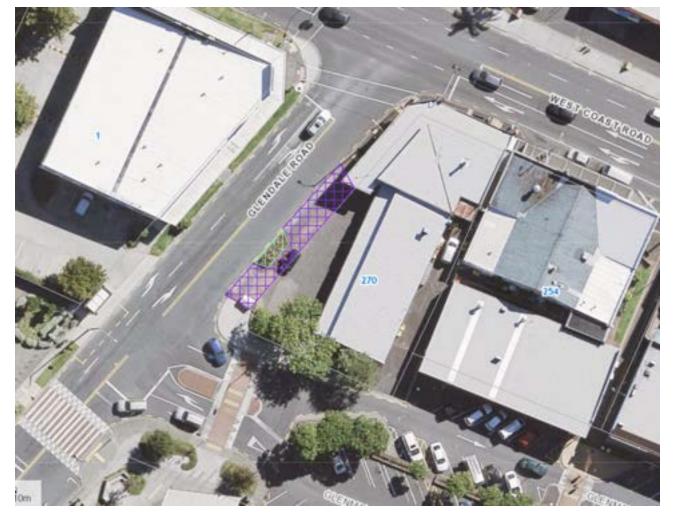
Aerial View of Scope of Essential (must do) Works

Proposed Essential Works on Glendale Road - Renew vehicle Crossing(in Purple), Remove Planted Island and reinstate with Grass berm (in Green)- Approx \$25,000.00

Proposed Essential Work on GlenMall Place – Uneven Pavers to be replaced by concrete (in Blue) – Approx \$30,000.00

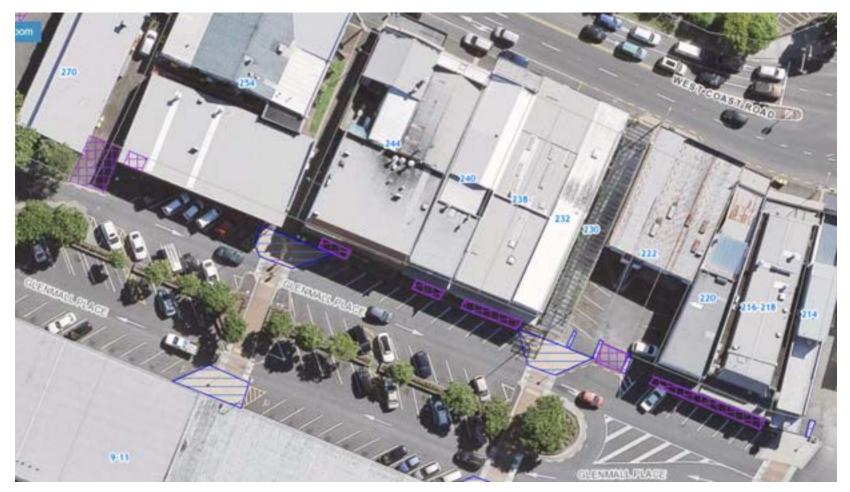
Approach 1 – Localized Renewals – Repair footpath where it's in poor condition (in Purple) – Approx \$20,000.00 – Deliver by June 2024

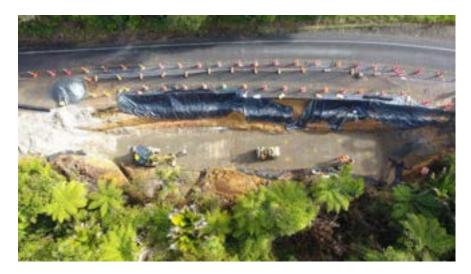
Work continues on the under slip ahead of building a 30m long, 2m high stone wall to support the road.

Over 500m3 of material has been removed from the site. Our team are currently working on the base block platform and will be installing the blocks next. We are on track to complete this, weather dependent by mid-May 2024.

Birds eye view of the site

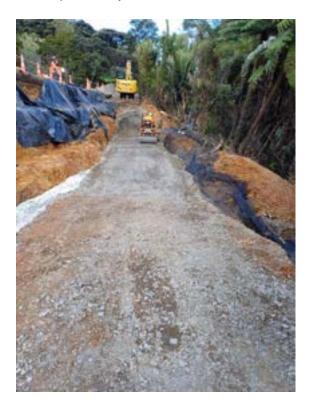
Preparing the site for the block wall to support the road.

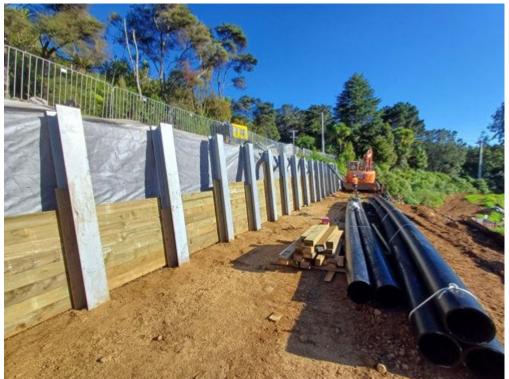
The second of three stages of piling and anchoring is complete, and the drainage works have begun with the installation of the first manhole for the culvert crossing. Works are due to be completed in mid-May, weather dependent.

Caton Road retaining wall April 2024

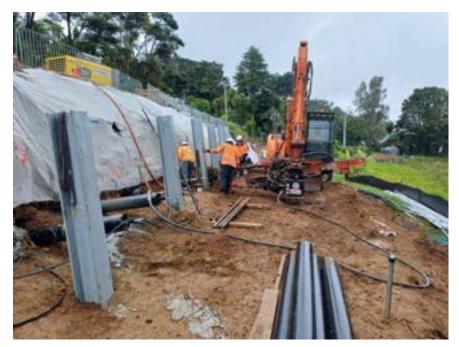
Anchor being installed on Caton Road March 2024

On advice from Geotechnical Engineer and for everyone's safety, a 3.5 tonne vehicle restriction will apply until the repair works are complete. There are large materials being delivered to site which require a temporary closure, during this time traffic will be stopped by traffic controllers to allow work crews time to safely stop and clear the road of plant and equipment. There is a white board at the entrance on Caton Rd to show when these deliveries are expected.

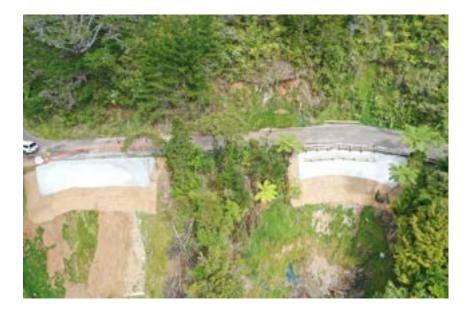
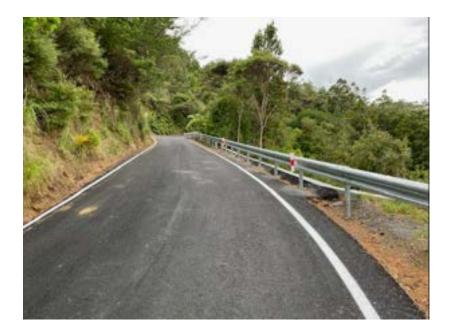
Karekare Road RP1.141 (1140m from Piha Road)

Works have been completed on the 2 x slip sites located at this location.

As well has repairs to the slips, surfacing, drainage and a new guardrail were also installed.

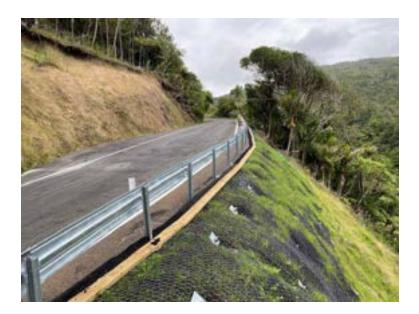
Karekare Road RP1.260 (1260m from Piha Road)

Works have now been completed with the sprayed hydroseed now taking and coming through the duramat mesh blending the slip remediation works blending into the surrounding environment.

As well as slip remediation works, drainage and a guardrail were installed.

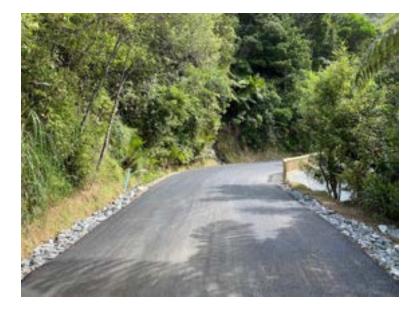
Karekare Road RP0.582 (582m from Piha Road) (Not completed yet)

Works have now been completed on this site. This includes slip remediation works drainage, surfacing and timber balustrade have also been installed.

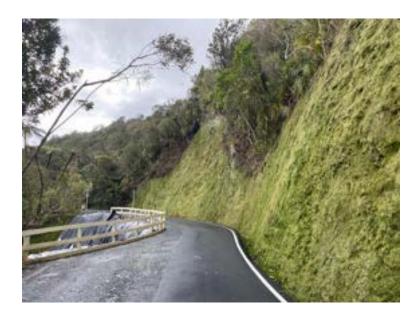
RP5.170 Lone Kauri Road (5170m from Piha Road)

Design has been completed and reviewed, start date in following completion of the RP0.600 site which is expected to be in May.

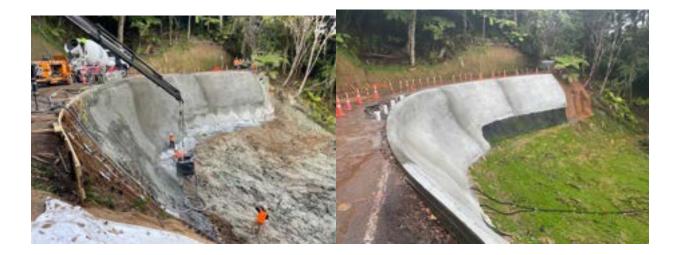
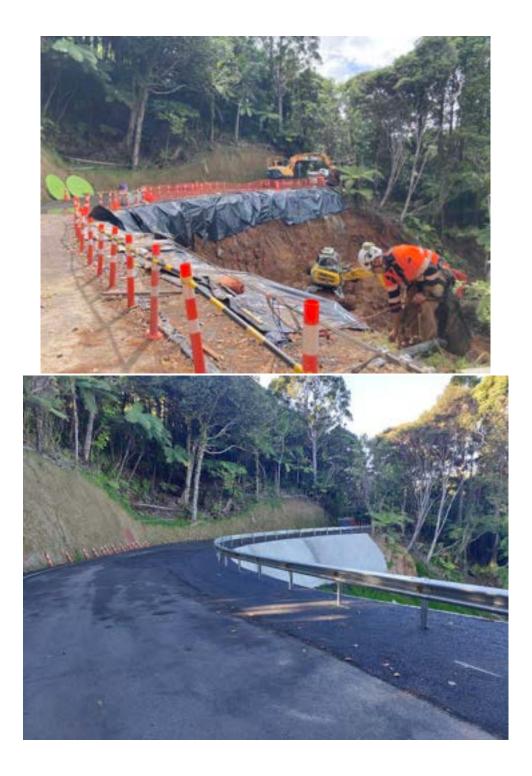
RP2.50 Lone Kauri Road

Slip remediation works have now been completed with all the soil nails and shotcrete installed. Drainage and pavement works have also been completed with surfacing and guardrail install still to be completed.

The site has also had hydroseeding completed, this has already started to grow through the duramat.

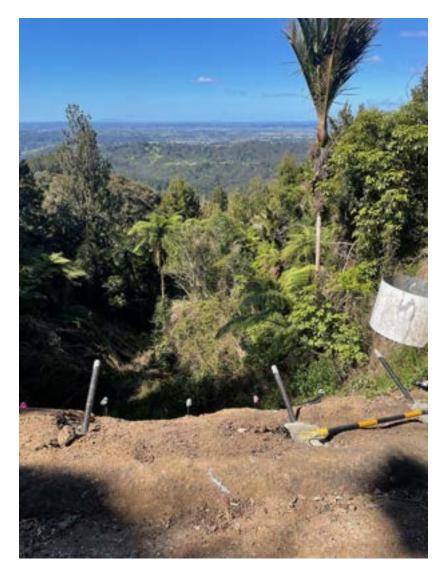
Soil nails being installed on Mountain Road

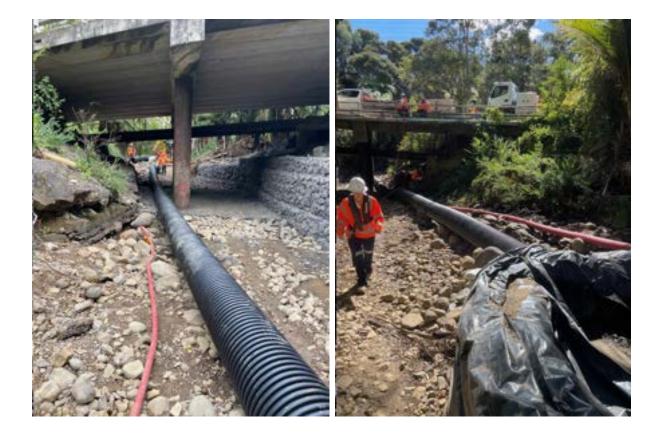
The Mountain Road Stoney Creek bridge project was completed in the month of April. Ventia successfully completed the scour repairs with no large issues on a very environmentally complex worksite.

The crew completed all gabions, rock backfill and shotcrete spray and then with the help of our ecologists hired to monitor our work, disestablished the fish passage, and reopened the stream with no issue. The site was completed before the recent heavy rainfall.

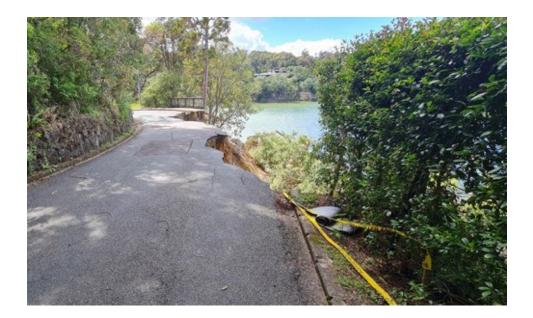
- The underslip has occurred below an existing timber pole retaining wall, which appears to still be in place, but is undermined
- An Overland flow path is running through this location which will have to be considered during the design phase along with existing storm water network which needs to be reviewed
- Temporary traffic management/ weight limits are in place until repairs are completed
- An underslip extends from the driveway of 12 Paturoa Road for 23 m to the north-east.

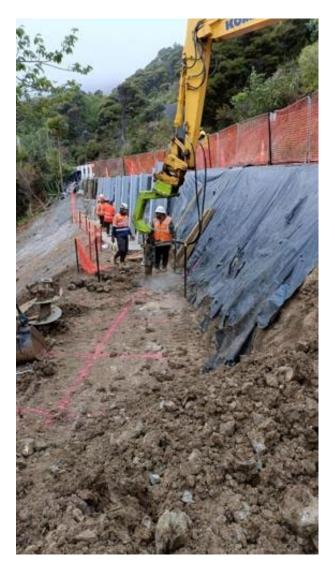
Retaining wall works Page | 19

Works on the slip site at 73 Piha Road were completed December 2023.

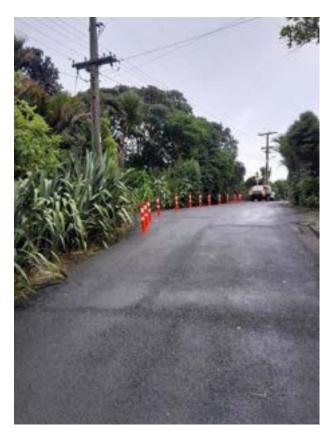
Flexiposts have been installed to keep vehicles away from the slip side of the road. The weight restriction is lifted. Our contractor is continuing to monitor this section of the road.

Flexiposts installed on Rayner Road, March 2023

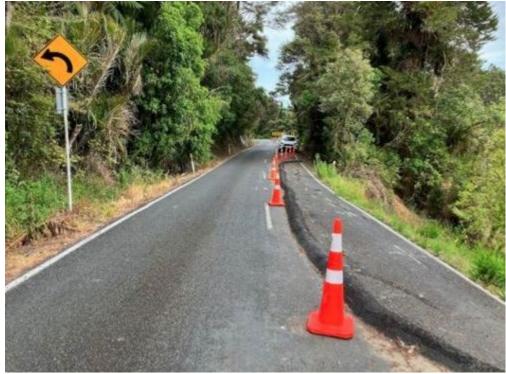
Site 1 - 6.58km from the start of Scenic Drive

Scenic Drive site 6.58km from start of Scenic Drive

An option report - with 3 options for the repair is under review currently, to decide on the repair for this site.

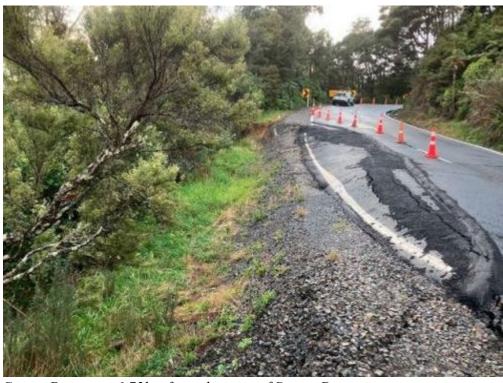
Site 2 - 6.73km from the start of Scenic Drive

Scenic Drive site 6.73km from the start of Scenic Drive

Draft design is complete - is progressing through the approval processes. We anticipate this site to start construction in the second quarter of 2024.

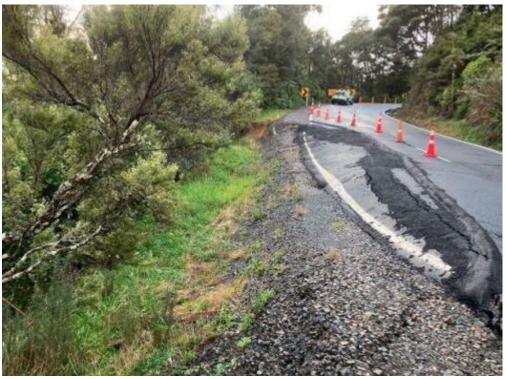
Site 3 - 6.84km from start of Scenic Drive

Scenic Drive 6.84km from start Scenic Drive

Repair works were completed in March with the crew putting the finishing touches on the job including the sight rail and resurfacing work.

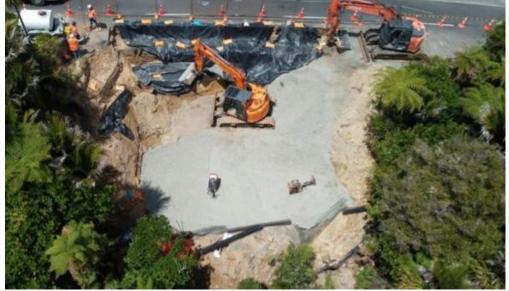
Drone photo of the site 3

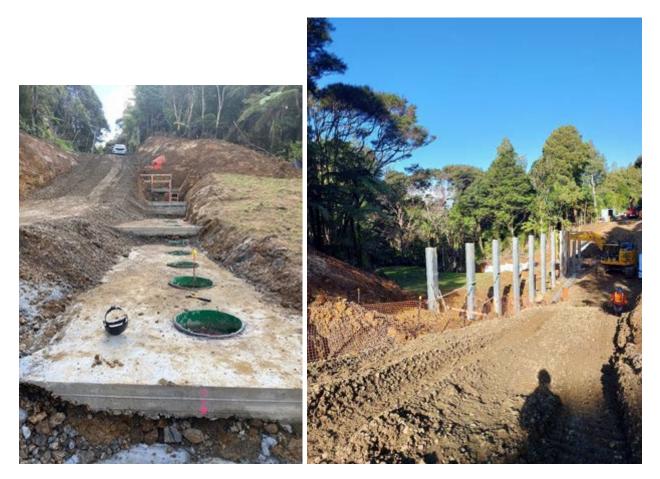
The excavation of this site took longer than expected, with poor ground conditions. A lot of the material had to be removed from site, as its condition meant we were unable to reuse it.

This programme is likely to be delayed past the end of June. We have had some collapse and water egress in a lot of the holes that have been drilled, so have had to back fill a lot of the holes to enable the piles to be sturdy.

Works progressing

Now we are working on drilling and installing the steel piles which will form the retaining wall to support the road.

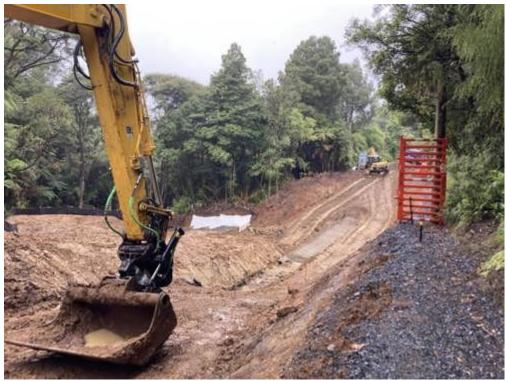
Initial works on the site on Scenic Drive, just past Arataki

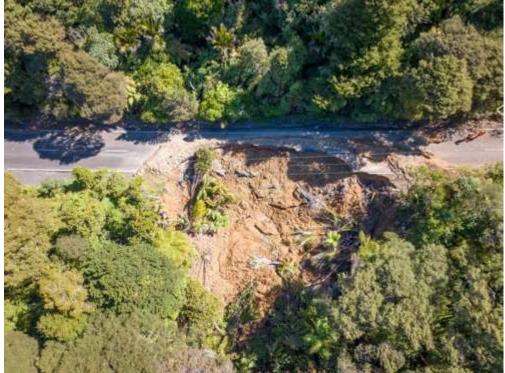
Initial Slip at 412 Scenic Drive

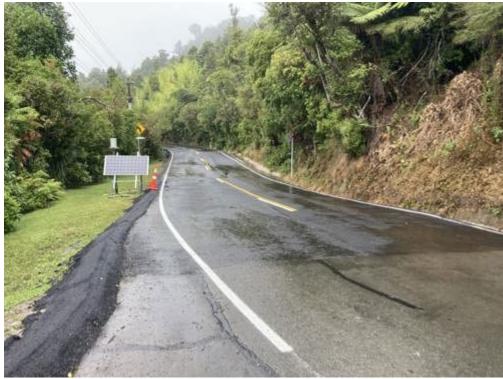
Scenic Drive, Waiatarua, open in both directions

Road repair works have been completed at this site, and the road is open two way. We are pleased to have this important connection open for the community. We will complete a final road reseal when other works in this area are completed.

Since the temporary traffic lights and the 1 lane closure has been removed, some levelling works was completed to remove the severe bump that was in the road as result of the slip. Further work will be required to remediate the final shape of the road. Drainage works have also been completed with uncovering of an existing culvert that was unknown.

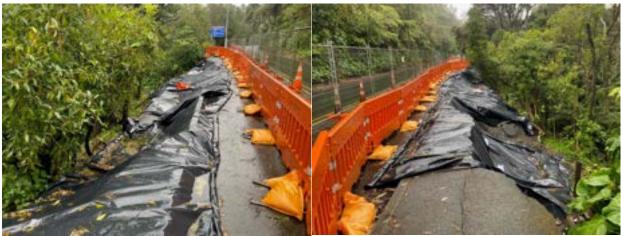
3. Site RP0.90 (900m from the Roundabout)

RP0.90 Scenic Drive Titirangi

This site will start in May and will tie into the works completed in the other two sites.

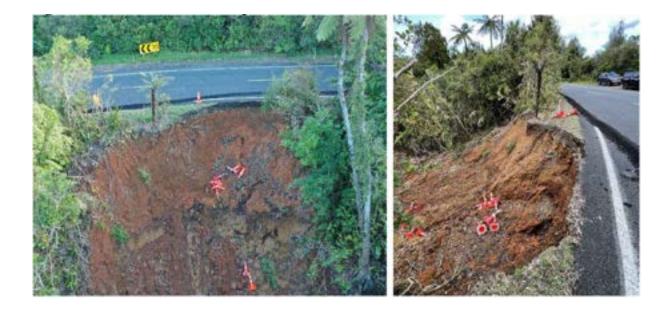
We are currently working through the soil nail design, a programme start date has not been confirmed but is looking at mid-late June 2024.

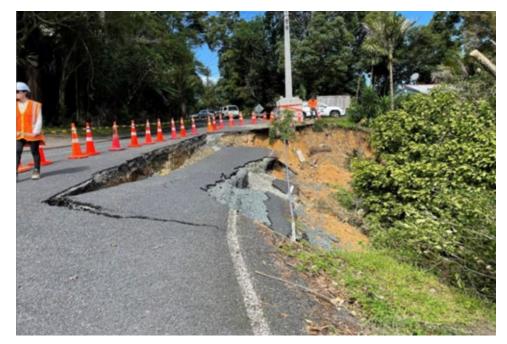
Slip on Takahe Road

We anticipate works to repair the slip on Takahe Road will begin in May.

We expect the works to take about 12 weeks to complete (weather dependant), and one lane will be closed during the works.

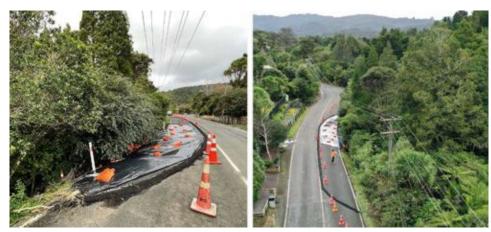
There is a slip on the side of the road. The road is open with one lane, give way rules apply.

Slip on Te Henga Road, near number 74

The design of this repair needs to take into consideration the proximity of the power lines. We are working with Vector on this, and will update the community when repair work will start.

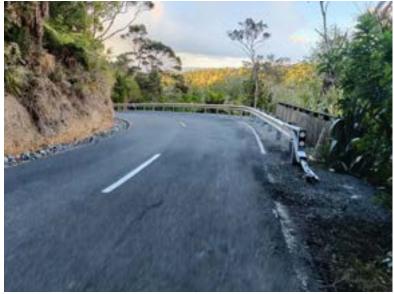
Titirangi Beach Road repairs have been completed. Many thanks to the community for your patience through the works.

Repairs with guardrail completed

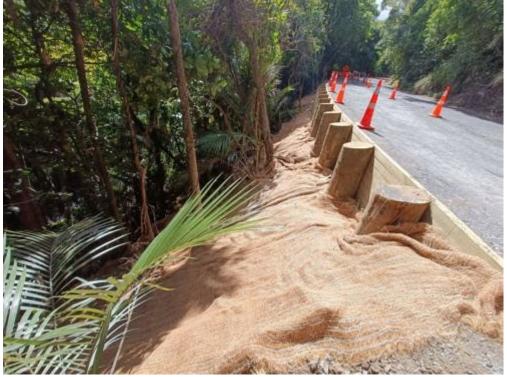
Timber retaining wall on Titirangi Beach Road

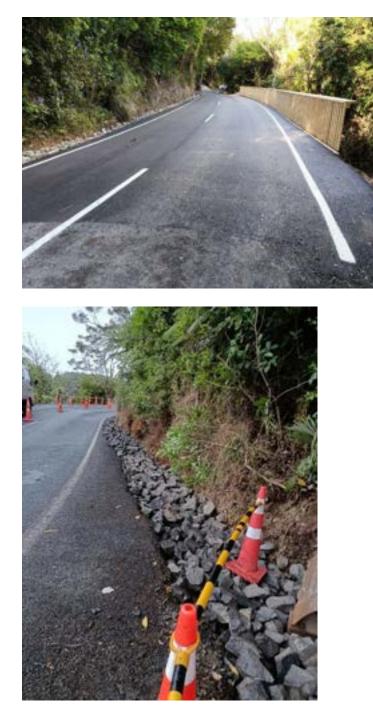
Riprap swale on Titirangi Beach Road

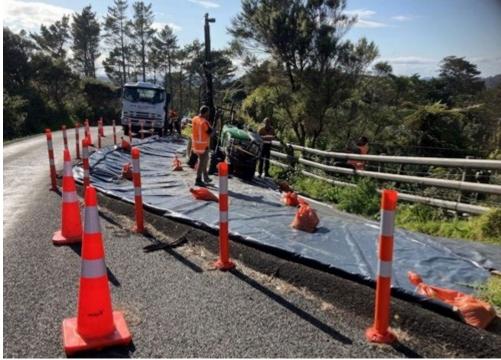
Wairere Road slip site

We have reviewed the geotechnical testing that was completed at this site and are working on a repair that we anticipate will start in May 2024.

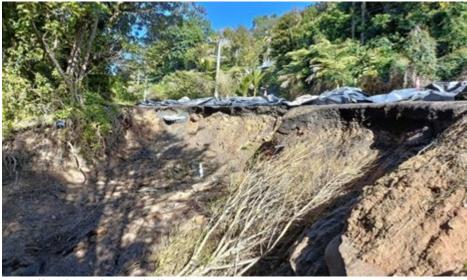
Woodlands Park Road slip site

At the end of 2023 we were completing further geo tech testing in the slips. We are currently in the design phase of the repair for Woodland Park Road.

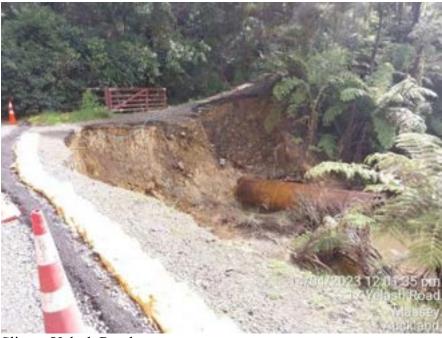
Multiple underslips have occurred along Yelash Road near property number 13. The stream and a couple of culverts will need to be worked into the design.

Slip on Yelash Road

We are working on a design for this road, and we are communicating with the property owner. As this site only affects one resident, who has access to his property, other sites are taking a higher priority.
