# Waitakere Coastal Communities

## Appendix E – Muriwai Landslide Risk Assessment Report

Auckland Council

15 May 2024

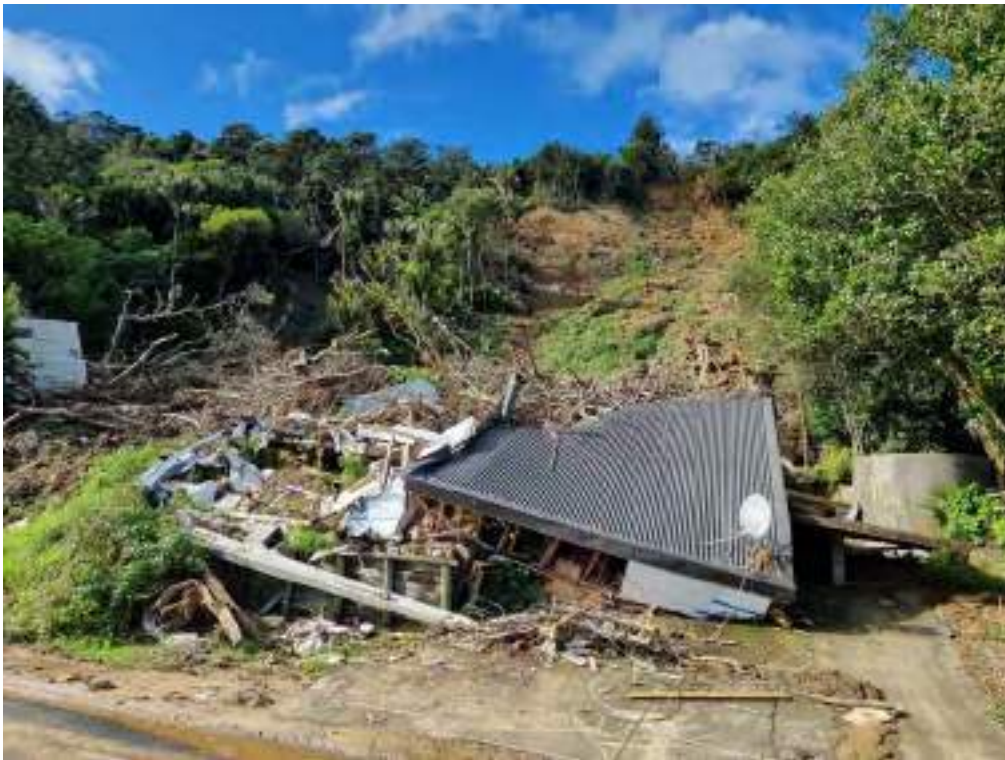
**Figure E2** Example of a dwelling completely destroyed on Motutara Road where two fatalities occurred.

In many observed instances trees entrained in the landslide mass played a large role in the destruction of dwellings in the 2023 event (Figure E4 to Figure E7). Accumulations of trees and other vegetation were commonly rafted and entrained towards the top of each slide mass which subsequently impacted the upslope side of dwellings. The thickness of these accumulated piles of vegetation debris sometimes exceeded 3 m. It is clear that the direct impact effects of the vegetation piles into dwellings were responsible for extensive damage and complete destruction in a number of circumstances.

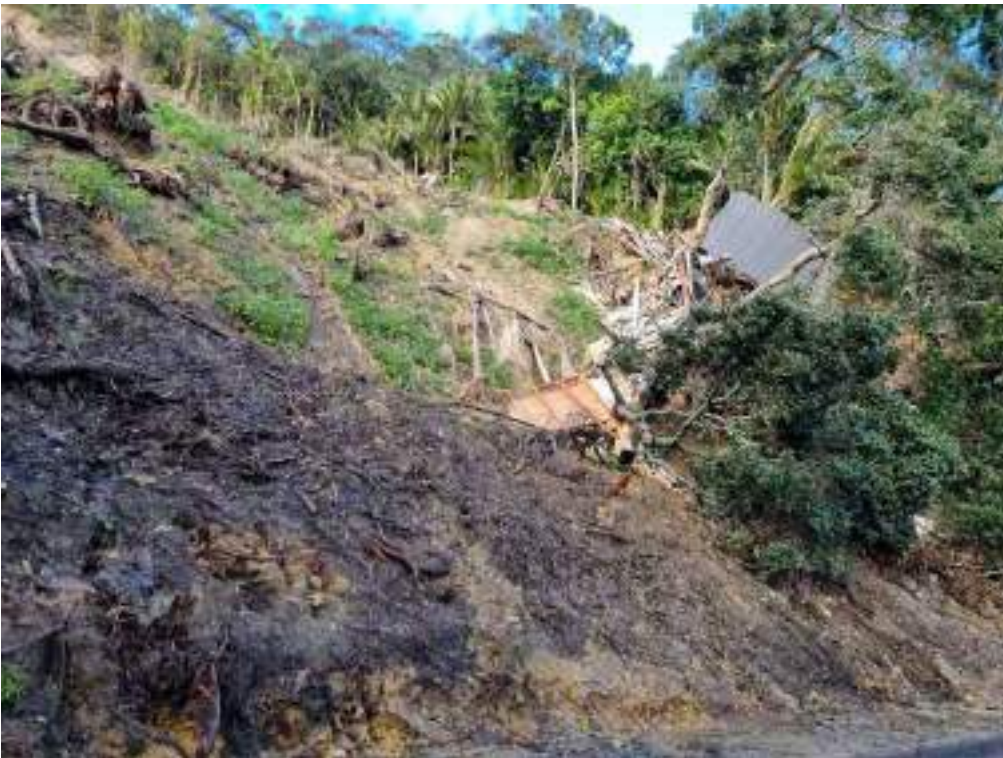
**Figure E7** *View of remains of completely destroyed house on slope above Motutara Road. Note mixture of soil debris and vegetation.*

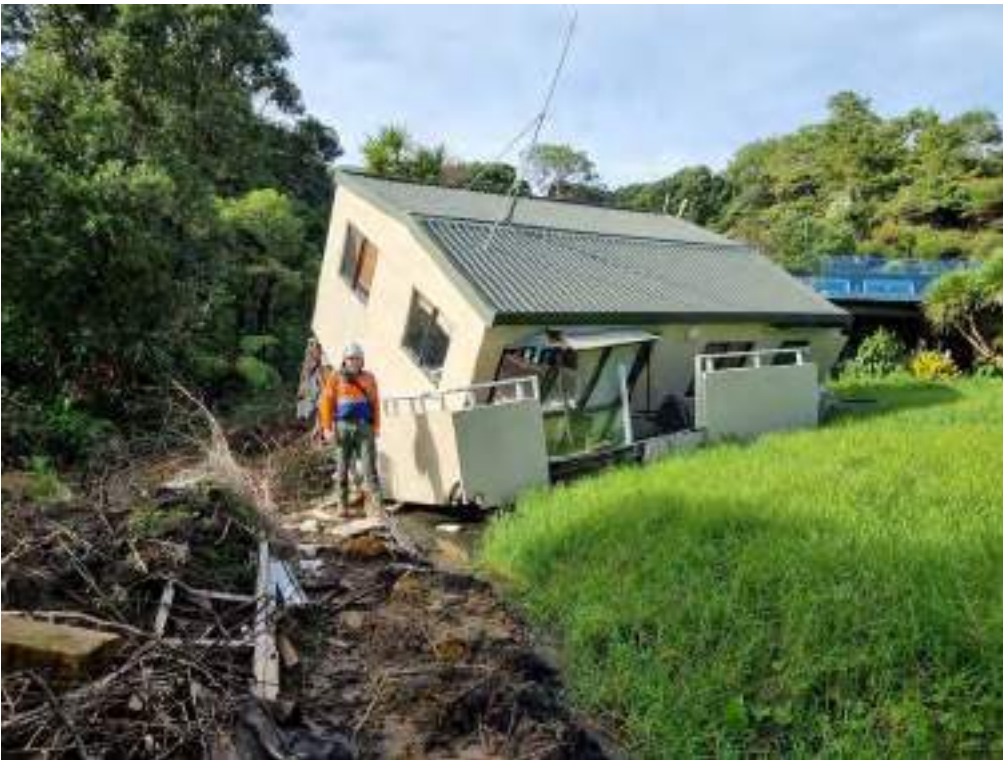
**Figure E9** *Example of a dwelling on Domain Crescent where ground floor of the structure has collapsed causing house to topple over with the upper storey remaining largely intact.*

There are many factors that could have contributed to some houses experiencing significantly less damage than others, despite the reasons not being immediately obvious based on observations alone. For example, the flow velocity in some instances may have been very low by the time the distal end of the flow reached a house. Alternatively, the construction methods of some houses may be more resistant to landslide impacts than others. Given these uncertainties it is not reasonable or practical to assign unique vulnerability values to different dwellings at the site.

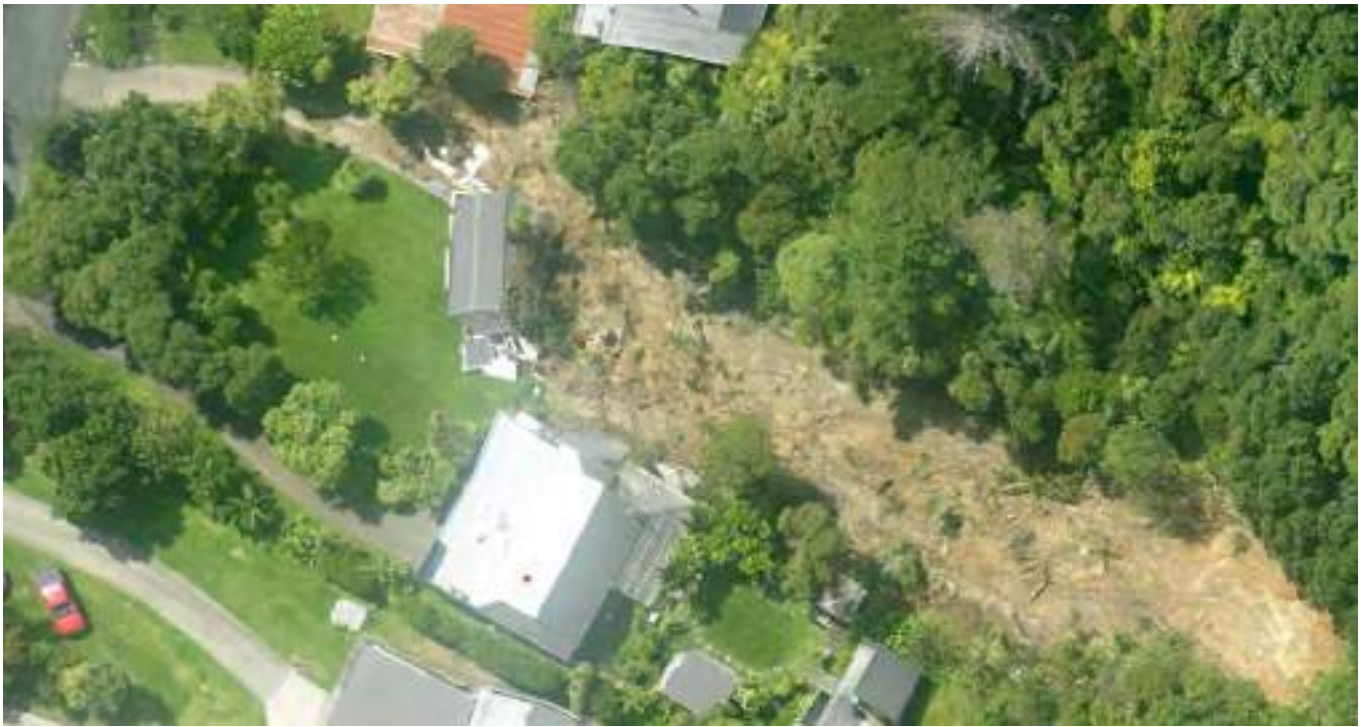
**Figure E11** Aerial view of dwelling pictured in Figure E10. The debris flow originated at the far right of the photo.

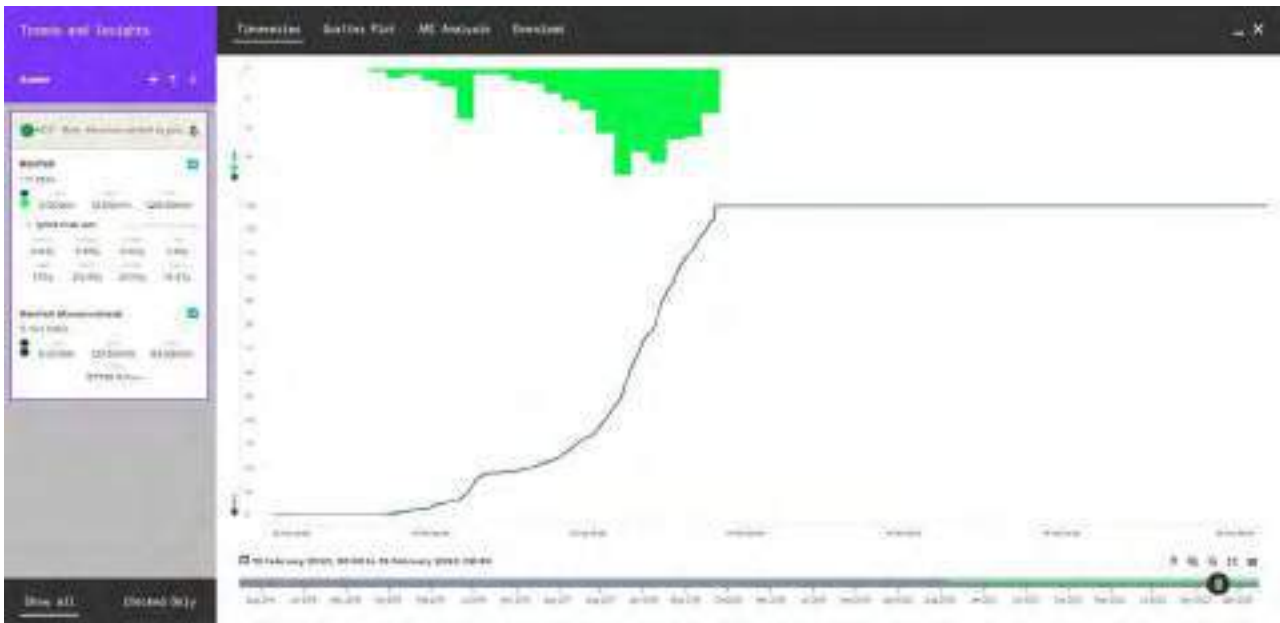
**Figure 1: Muriwai TB3 tipping bucket rain gauge hourly totals and cumulative total. (note, the event is missing data from 01:15am 14th February due to being inundated)**

Due to the missing record and the site being inundated during the event, this record is not recommended to be used to describe the event.

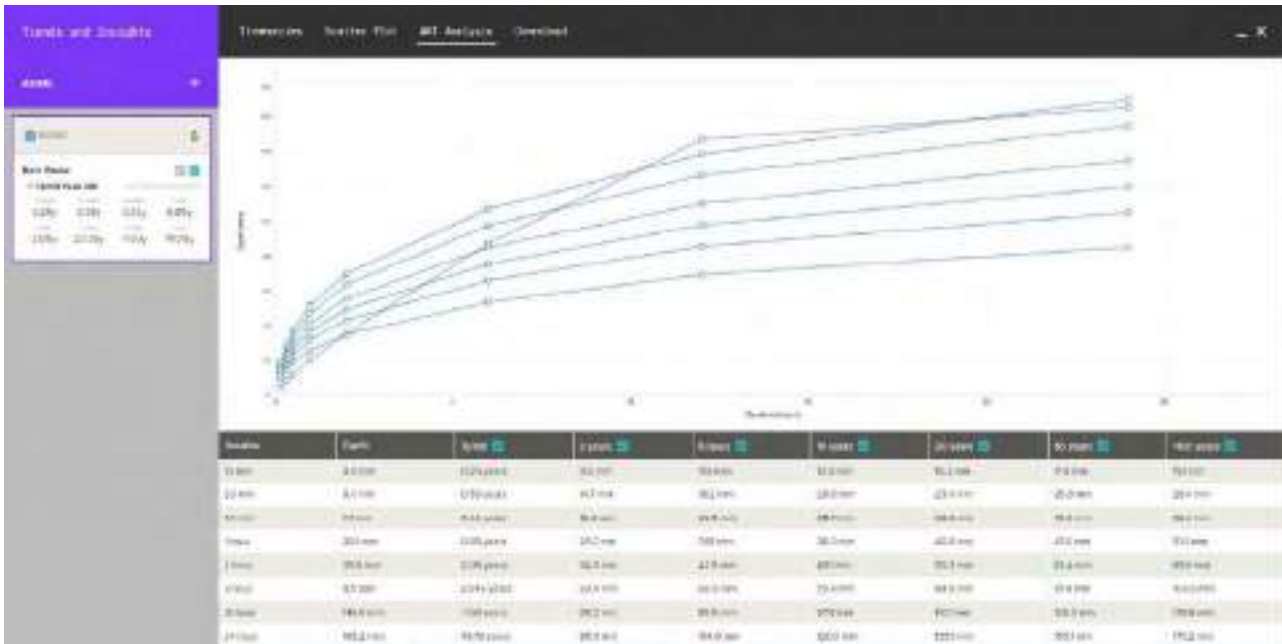
**Figure 4: Depth-duration-Frequency curve for the QPE grid location at Muriwai (90767).**

What happened during the event is plotted in purple. This analysis and the figures in table 1 shows that the peak rainfall total during the event of 146.9mm occurred over 12-hour period. This total is >100-year event at a 12-hour duration.

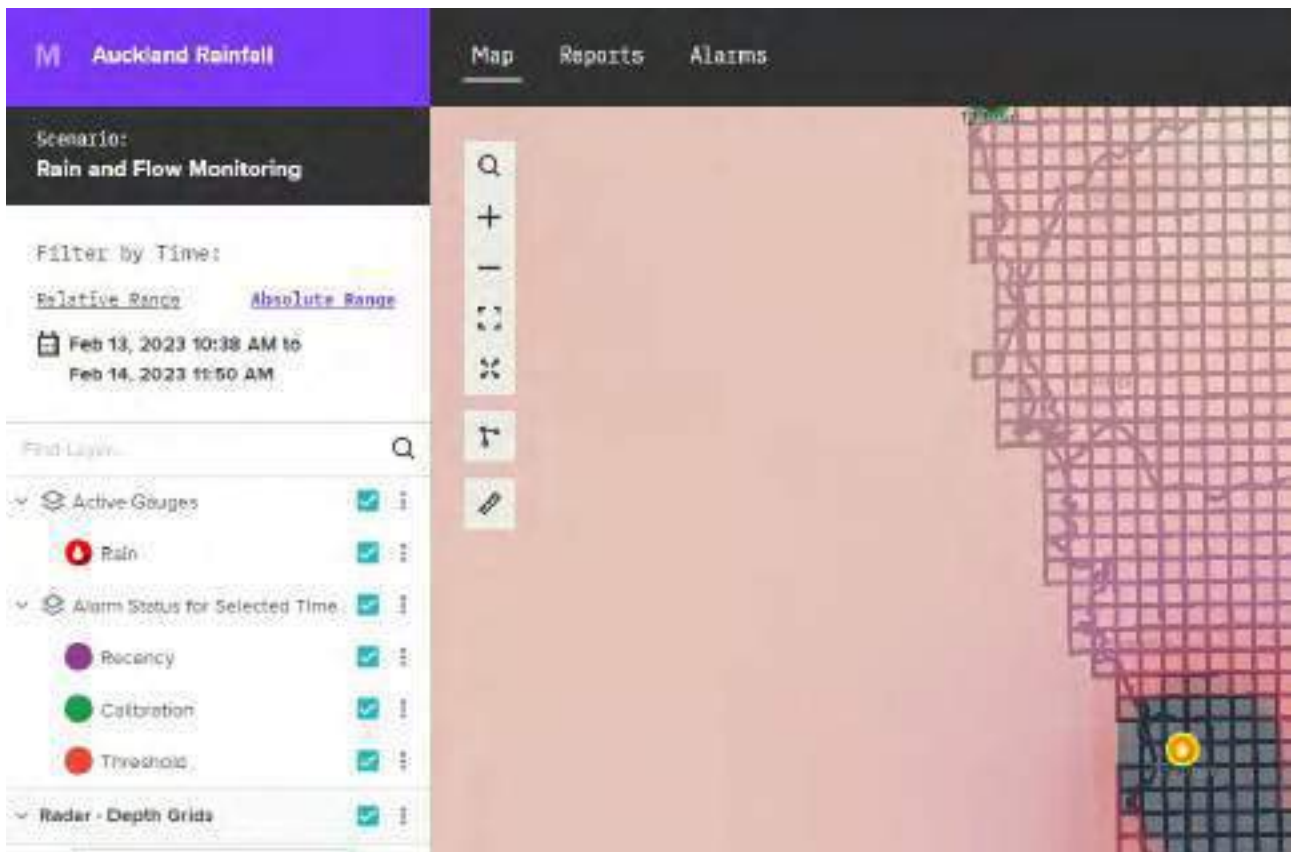
Figure 7: QPE Rain radar depth accumulations 13 February 2023 to 15 February 2023. The yellow grid location is the rainfall at the rain gauge location at Piha

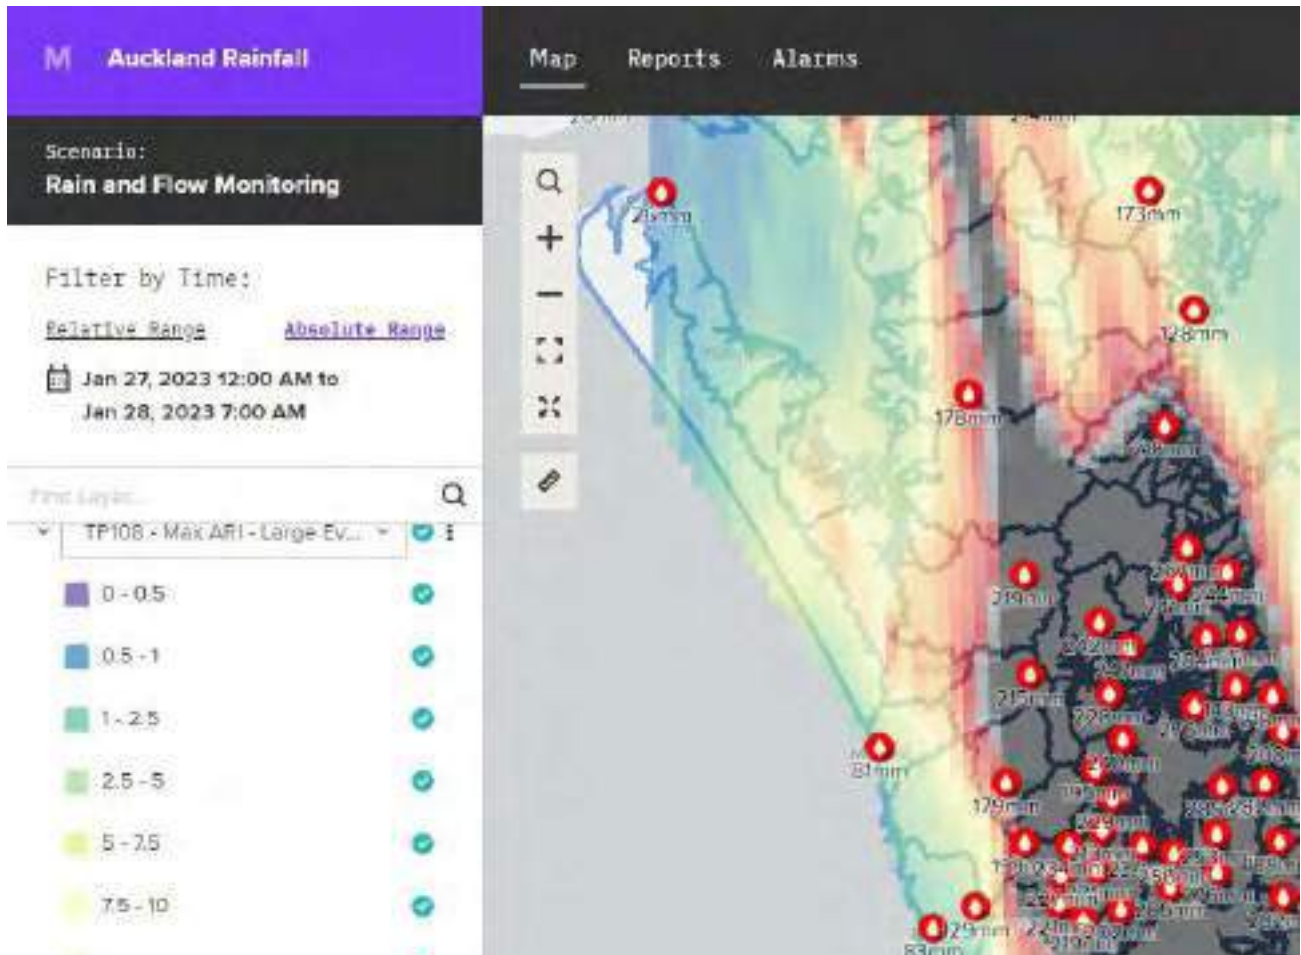
**Figure 11: Recorded Rainfall Radar Max Average Recurrence Interval (ARI). The black area is where rainfall was greater than a 100yr ARI (for any of the 10,20,30 min and 1,2,6,12,24-hour durations) In the black area the event was greater than 100yr for the vast majority of durations.**

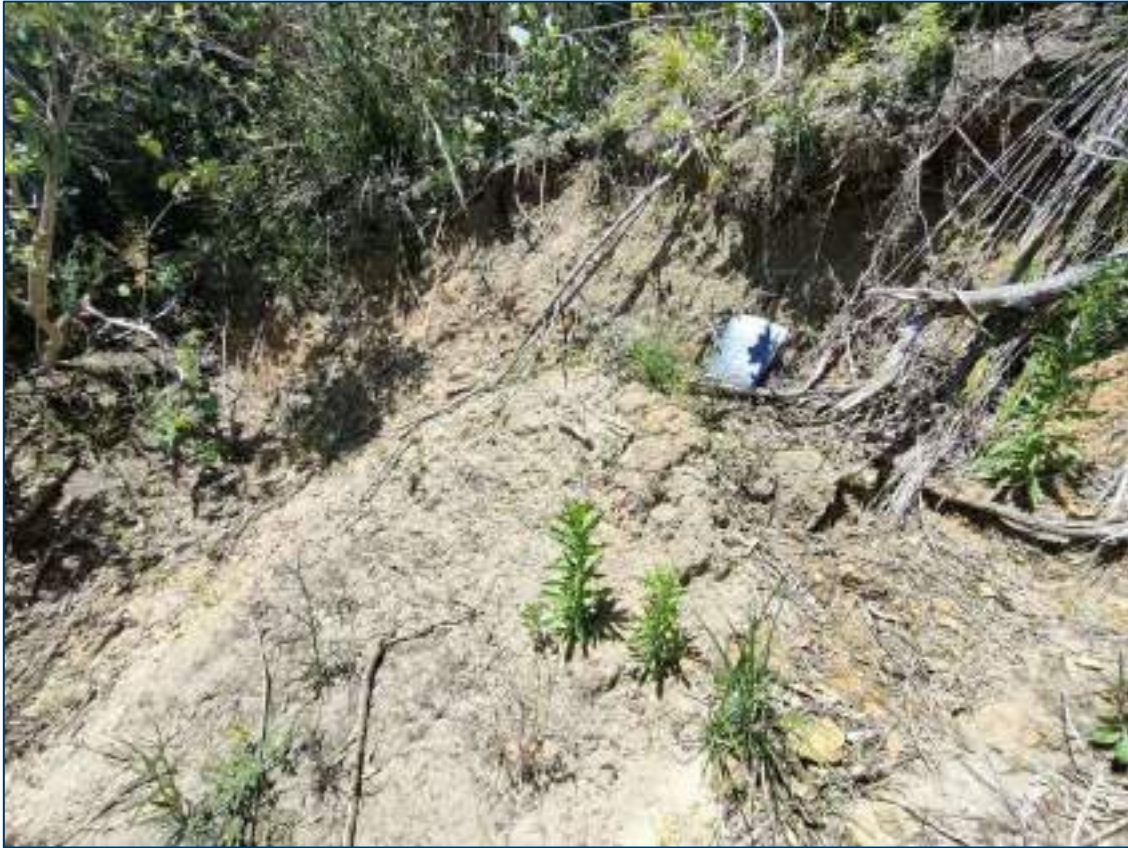
The landslide headscarp (Figure 2.8) has an approximate width of 7 m and is approximately 10 m above the rear of the dwelling near the crest of a ridgeline. Following a high degree of ground saturation, it initiated on a 30-35° vegetated slope as a shallow (~ 0.5 m deep) translational failure (Figure 2.9) which developed into a debris flow, likely entraining additional material on its descent. The initial landslide source volume was approximately 20 m<sup>3</sup>, increasing to approximately 60-80 m<sup>3</sup> following entrainment. The landslide impacted the rear of the dwelling (Figure 2.10). The resulting damage to the dwelling included widespread structural deformation (see Figure 2.11 and T+T, 2023) with no immediate building collapse. Inundation of the decking was also recorded, which, according to our mapping is likely a result of secondary silt discharge from the large-scale landslide that occurred to the south of the site.

**Figure 2.8** Exposed headscarp of landslide.

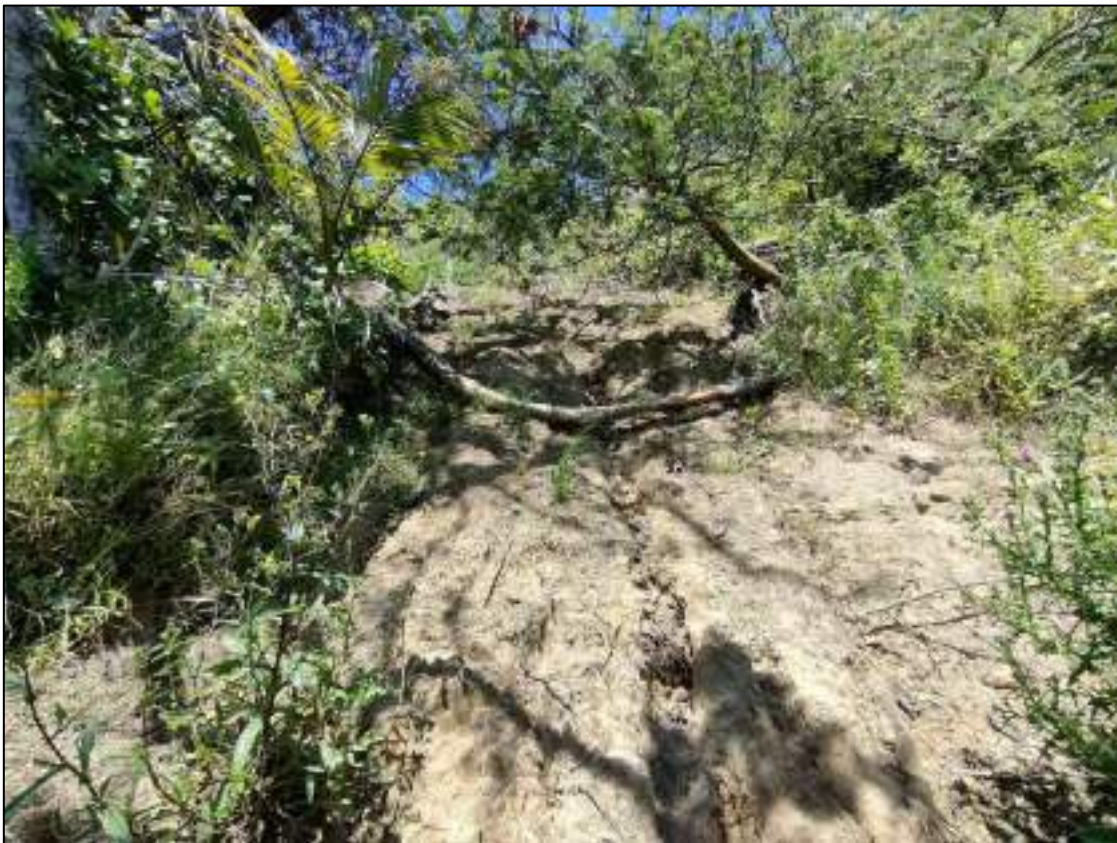
**Figure 2.9** Failure surface (evacuated zone) exhibiting evidence of post failure erosion. Looking upslope.

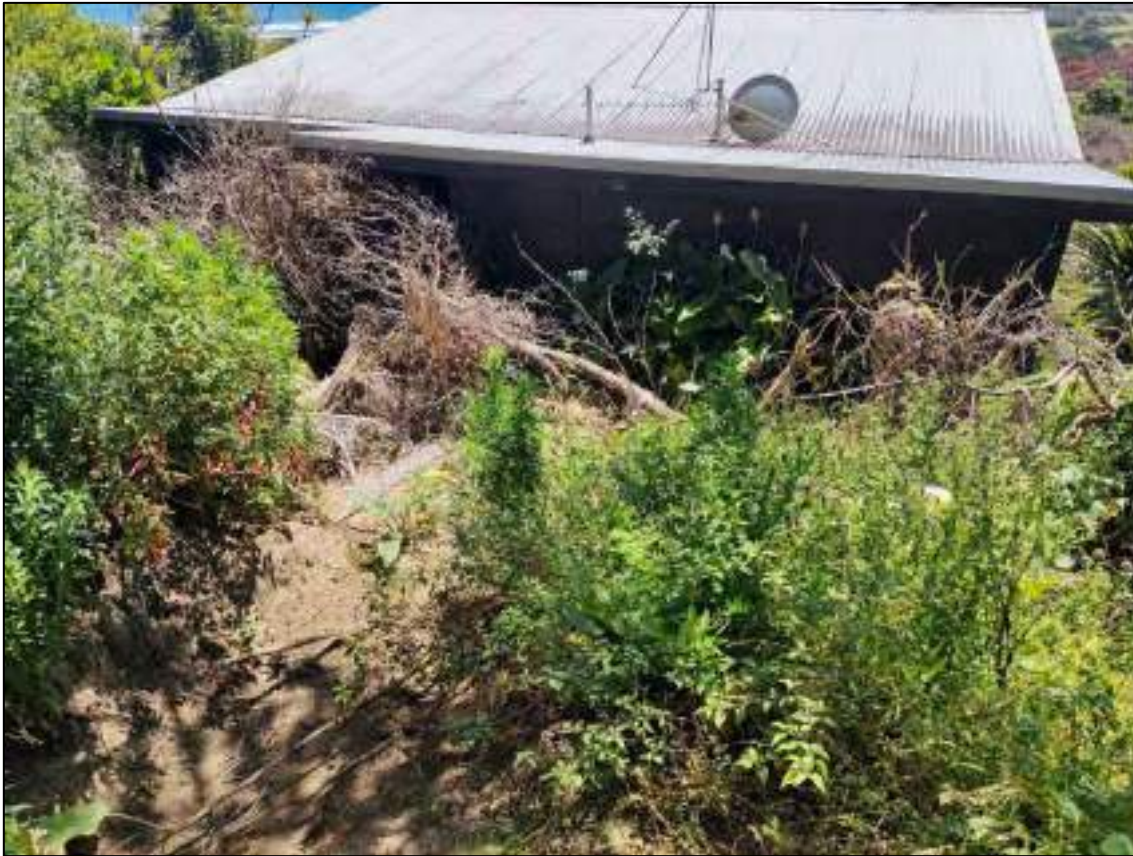
**Figure 2.10** Debris piled up at the rear of dwelling (estimated up to 1.5 m thick)

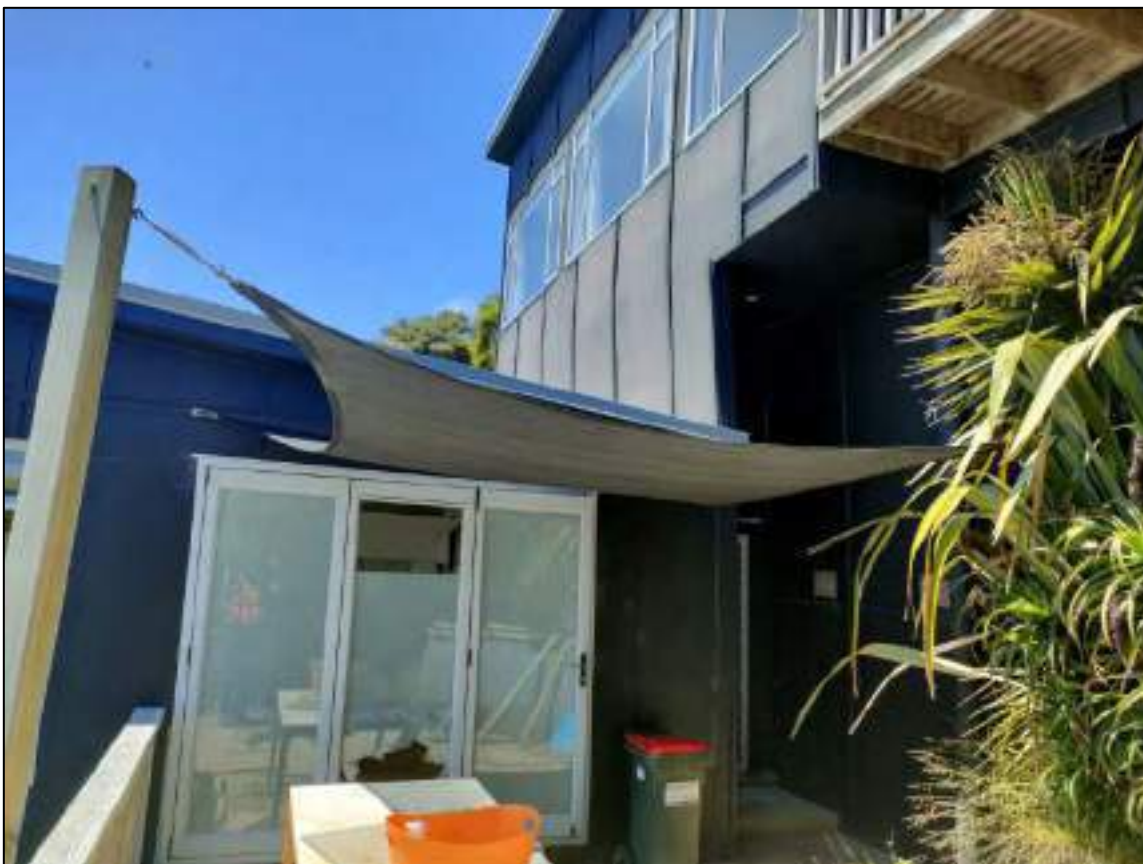
**Figure 2.11** Damage caused by landslide includes racking of entire building (exhibited by bending of exterior wall)

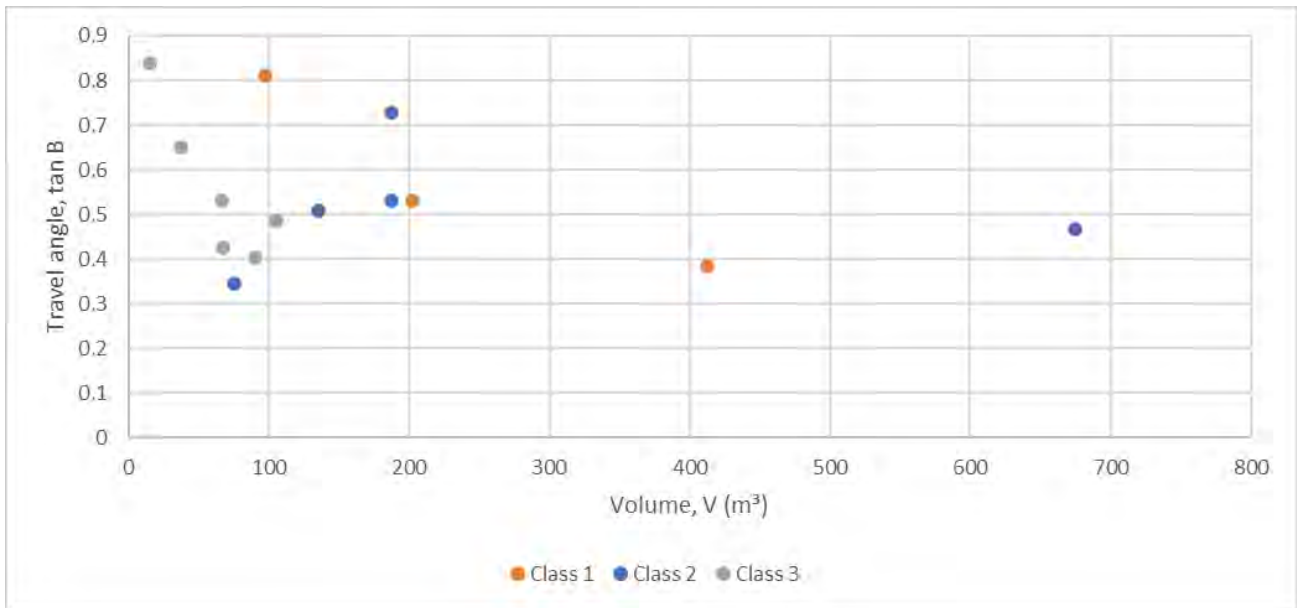
**Figure A4** Plot of only those debris flows known to have caused some degree of damage to dwellings and buildings. Note Class 1 = Complete destruction/collapse of building, Class 2 = Partial destruction/collapse of building, significant inundation and Class 3 = Limited damage to building but no collapse or inundation, damage is other property infrastructure e.g., access stairs.

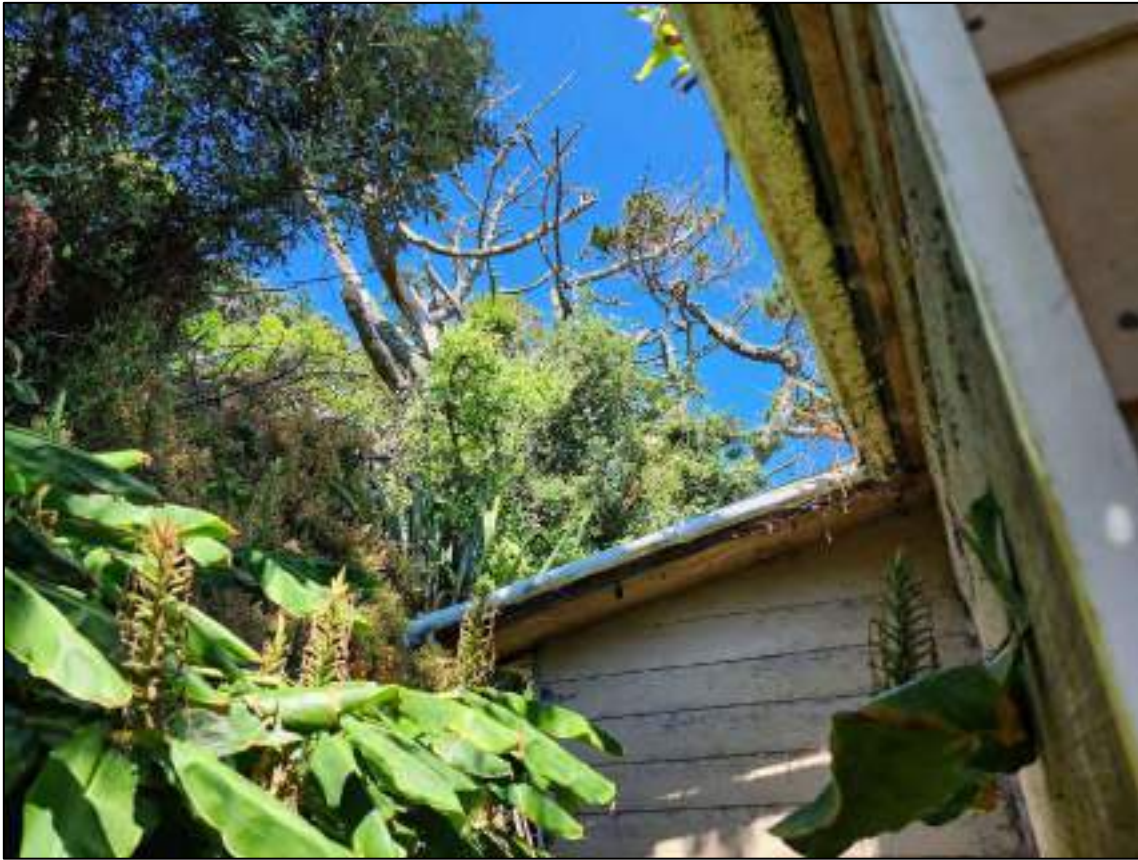
*Figure 2.1 Steep vegetated slope at the rear of the dwelling*

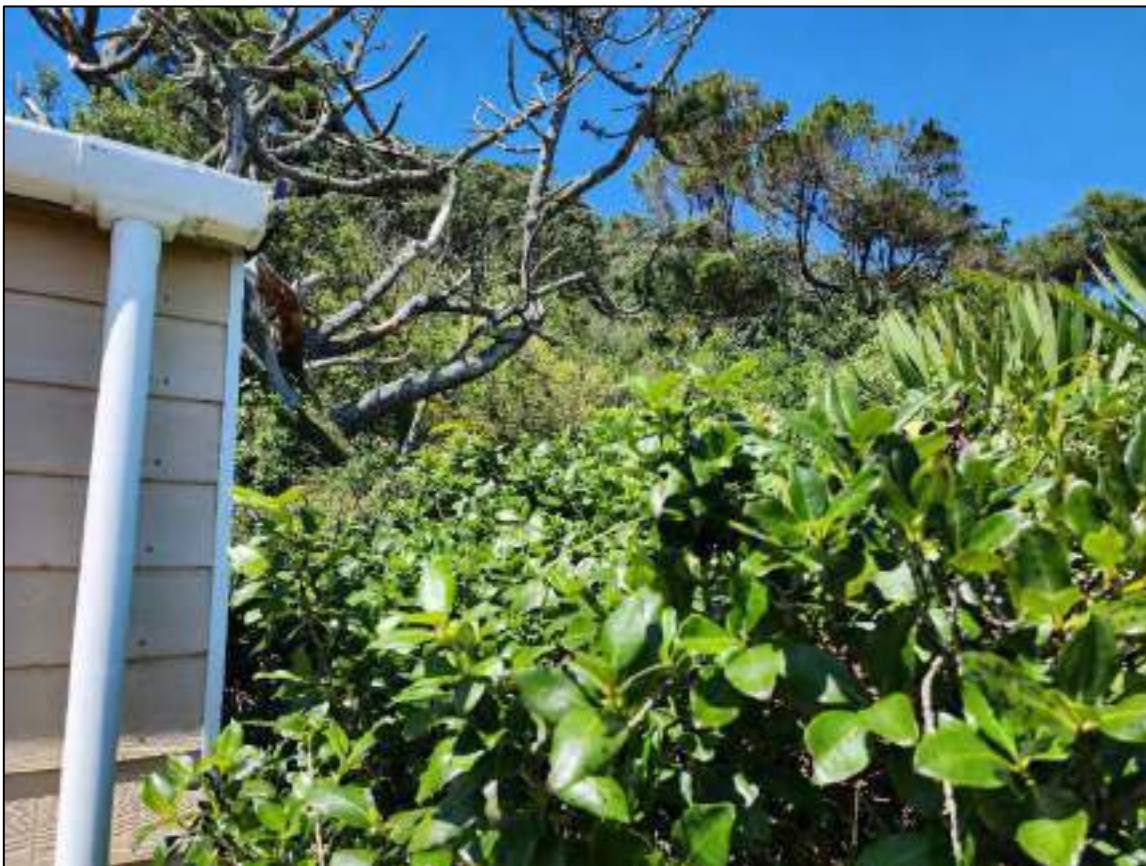
*Figure 2.2 Steep vegetated slope at the rear of the dwelling*

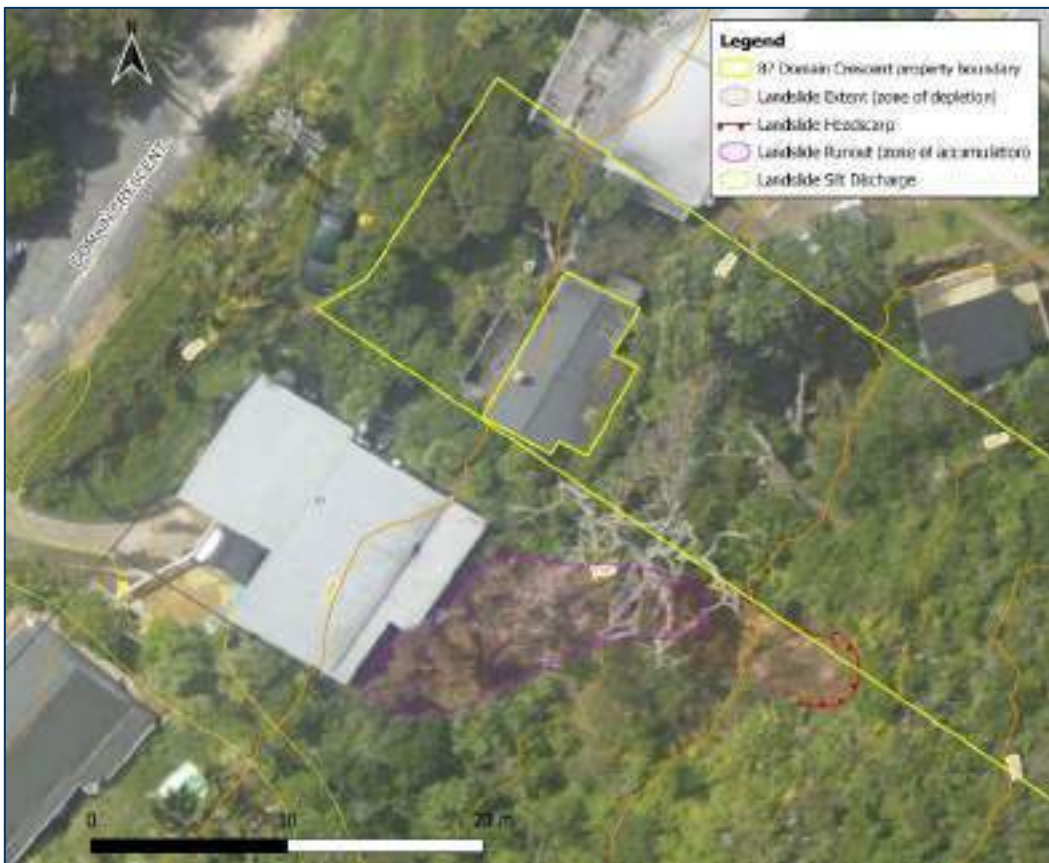
Figure 2.5 GHD site mapping of the landslide affecting the site

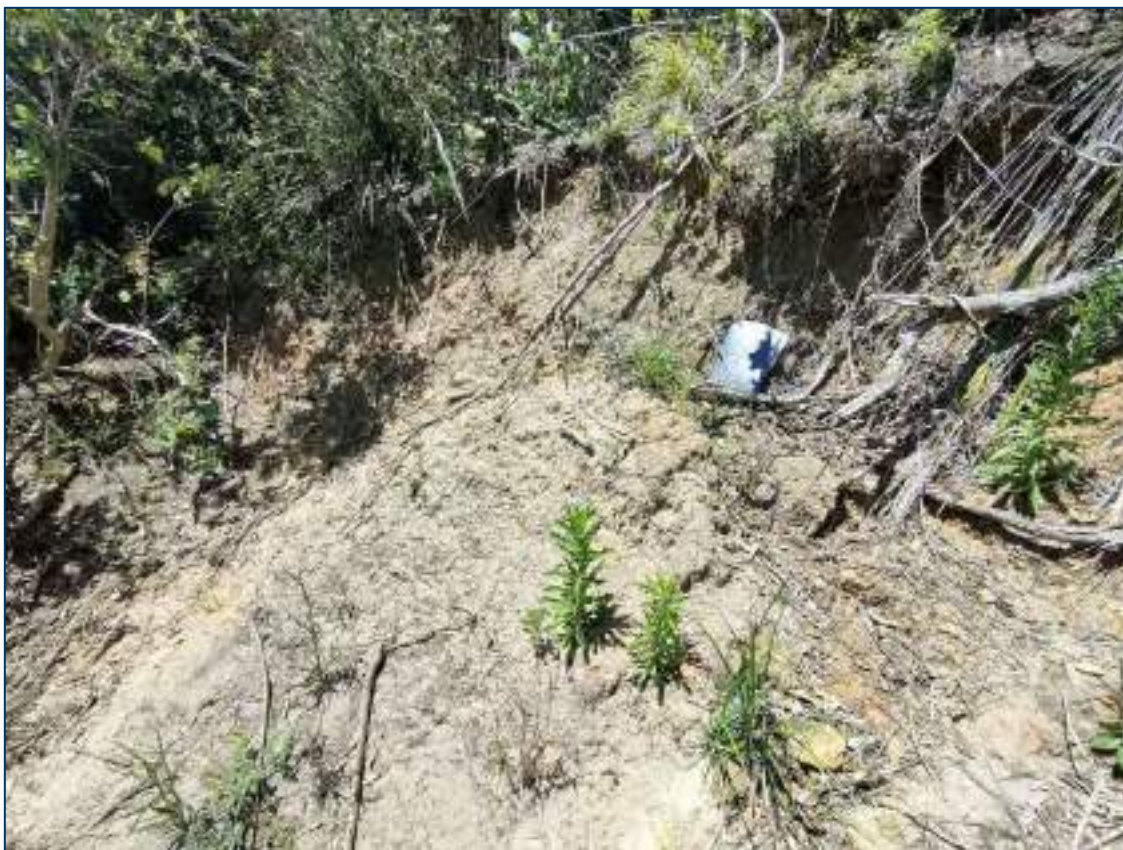
Figure 2.8 Exposed headscarp of landslide.

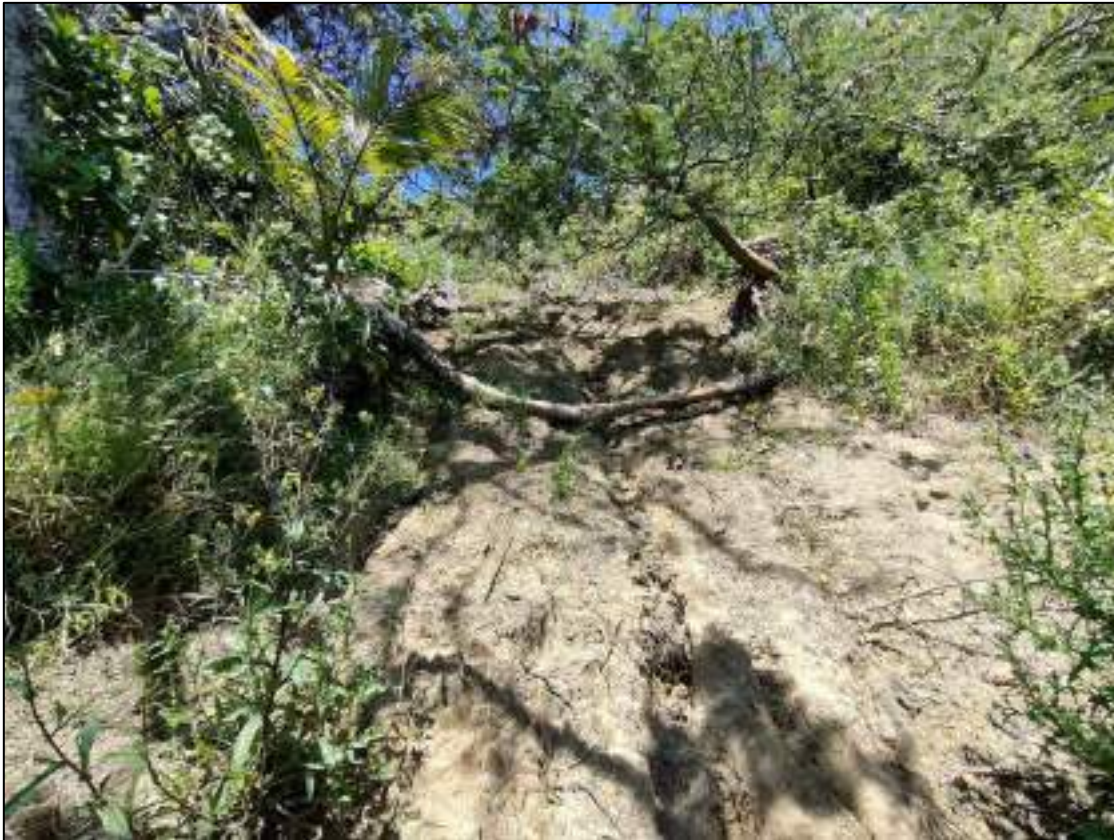
**Figure 2.9** Failure surface (evacuated zone) exhibiting evidence of post failure erosion. Looking upslope.

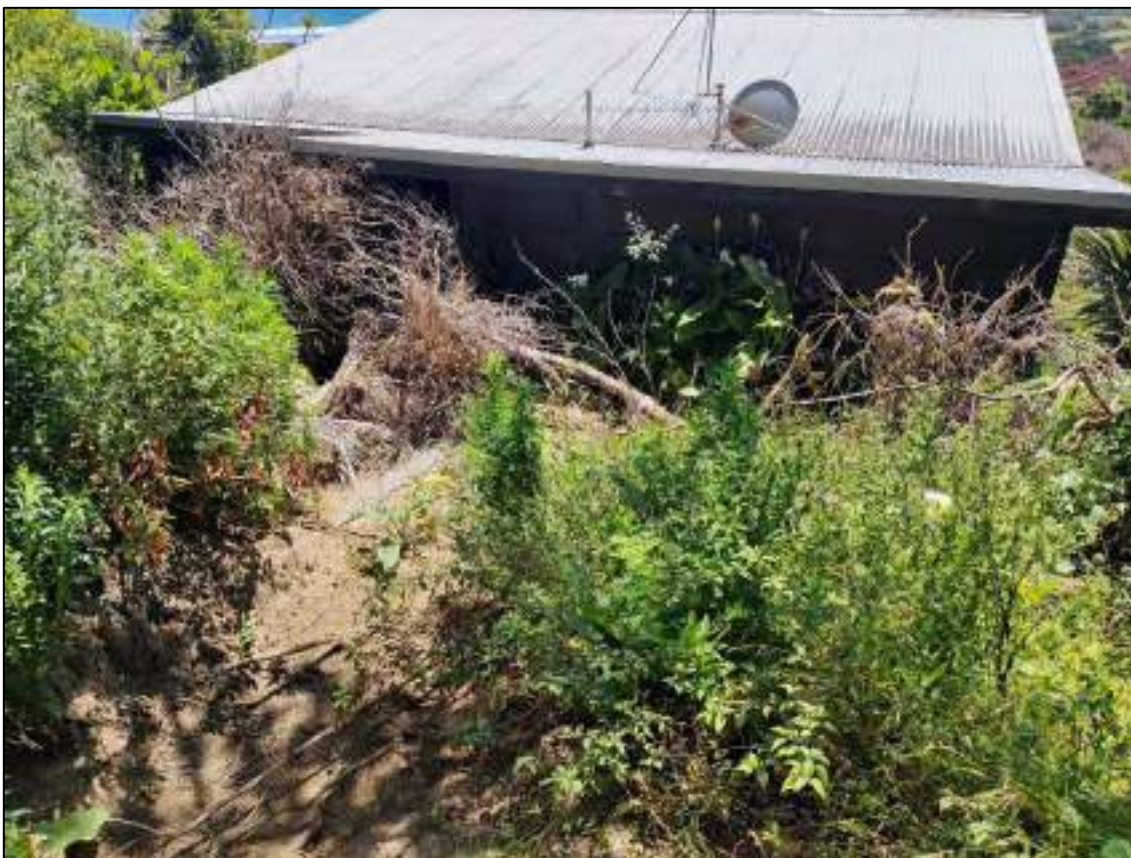
**Figure 2.10** Debris piled up at the rear of the dwelling at No. 85 Domain Crescent (estimated up to 1.5 m thick)

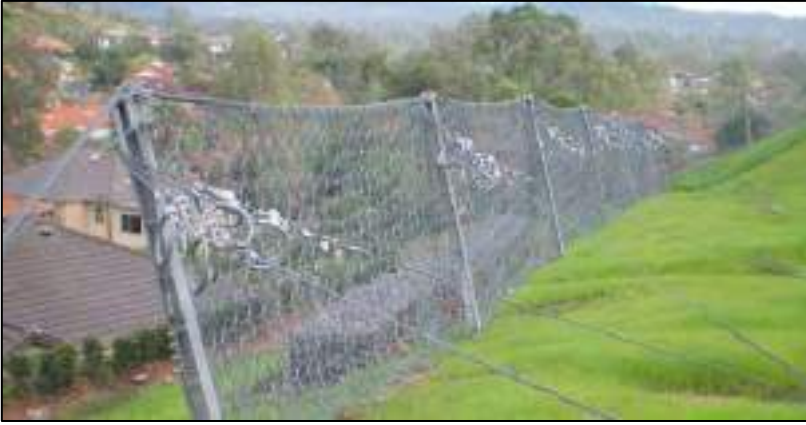
**Figure 4.1** *Example of proprietary flexible debris flow barrier*

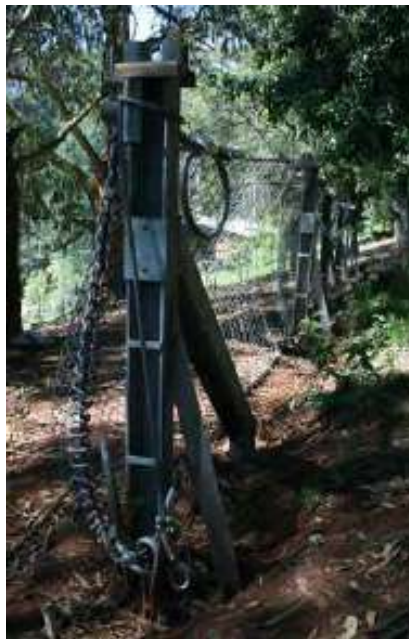
**Figure 4.2** *Example of a pressure post that can be used at the end of flexible barriers that may be used at property boundaries*

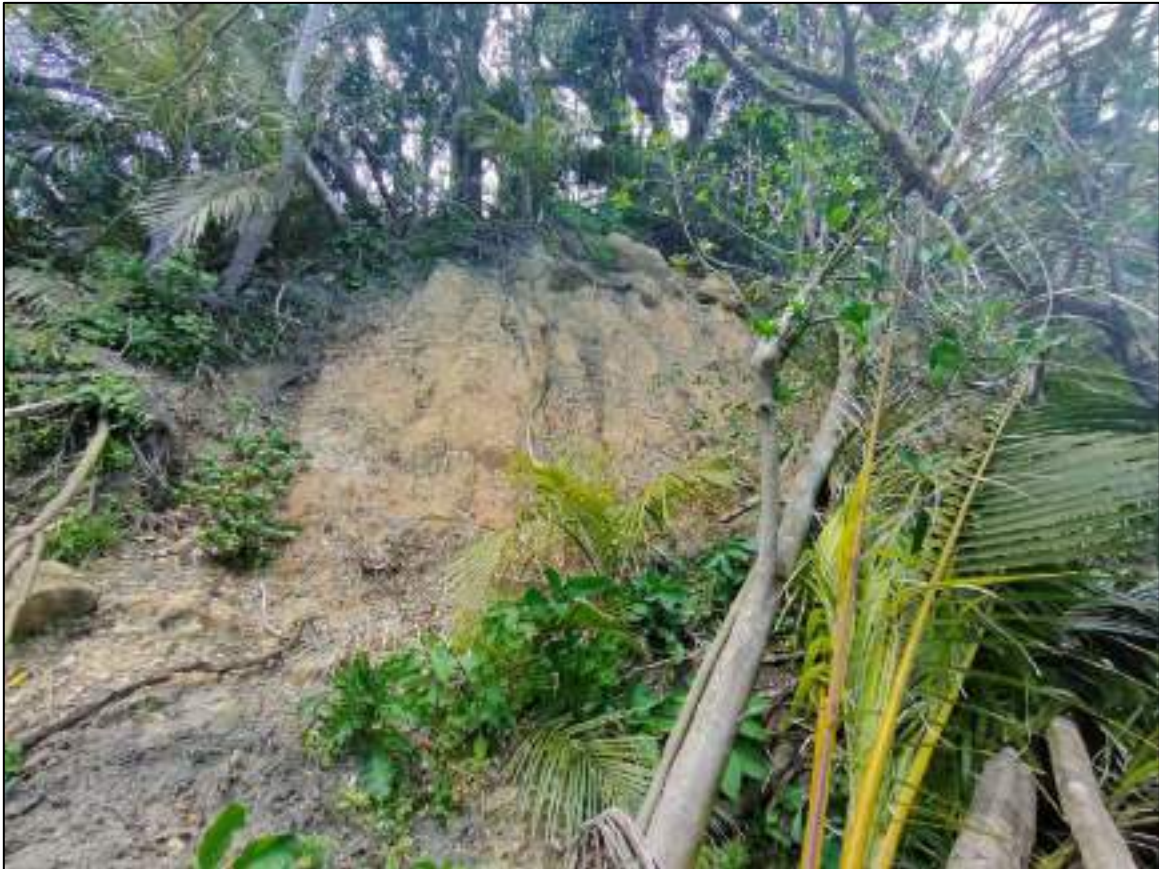
**Figure 2.7** *Awhitu Sand Formation in the exposed landslide headscarp.*

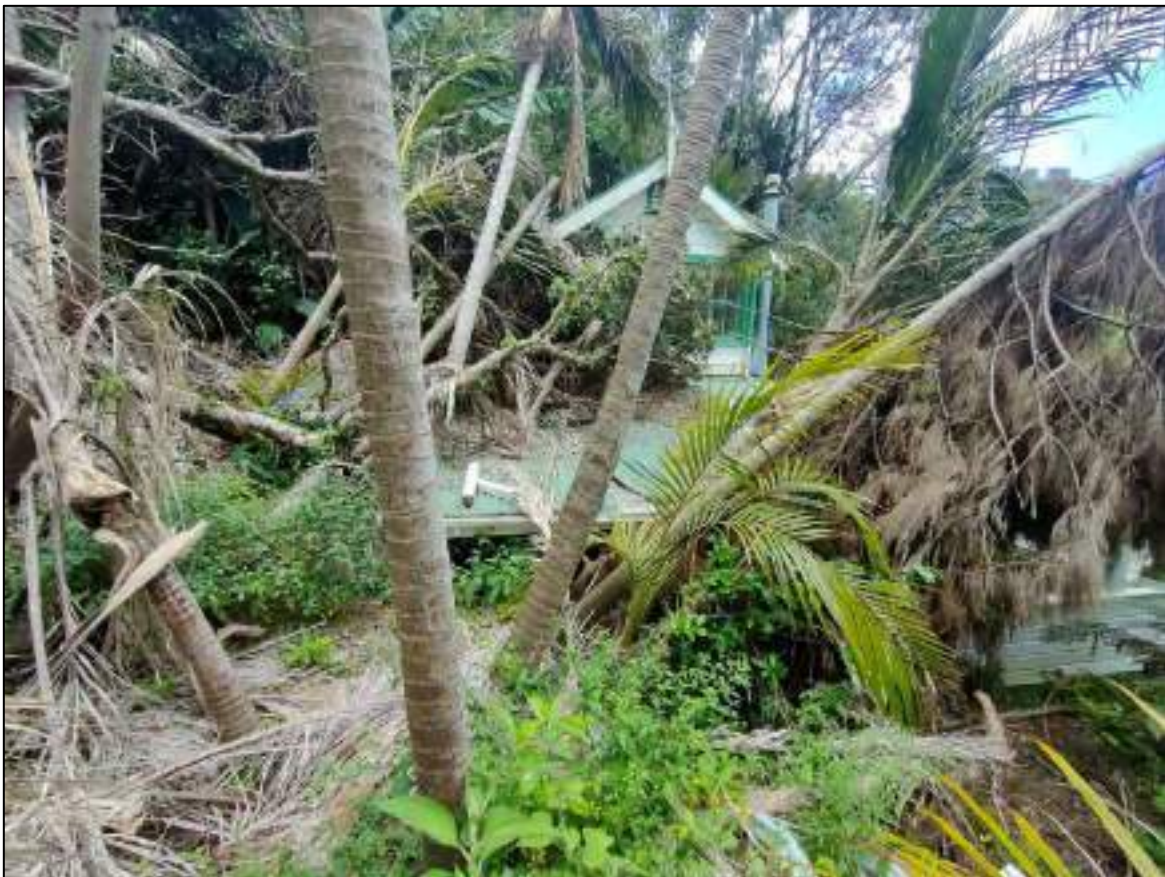
**Figure 2.8** *Close to the lateral extent of the landslide debris at the rear of the dwelling, looking southwest.*

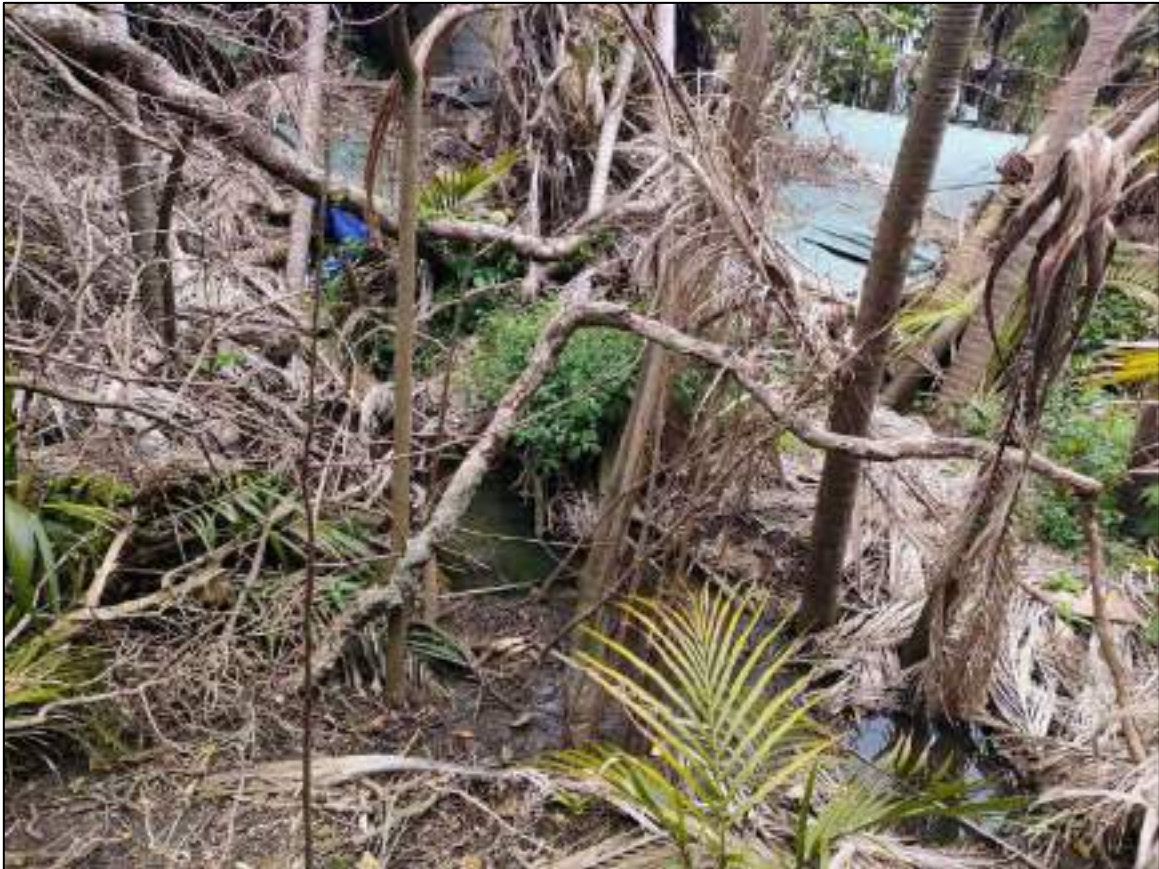
*Figure 2.9 Ponding of water on top of the landslide debris at the rear of the dwelling, looking west.*
