Waitakere Coastal Communities Landslide Risk Assessment

Appendix F – Geotechnical Investigations Report - Muriwai

Auckland Council

15 May 2024

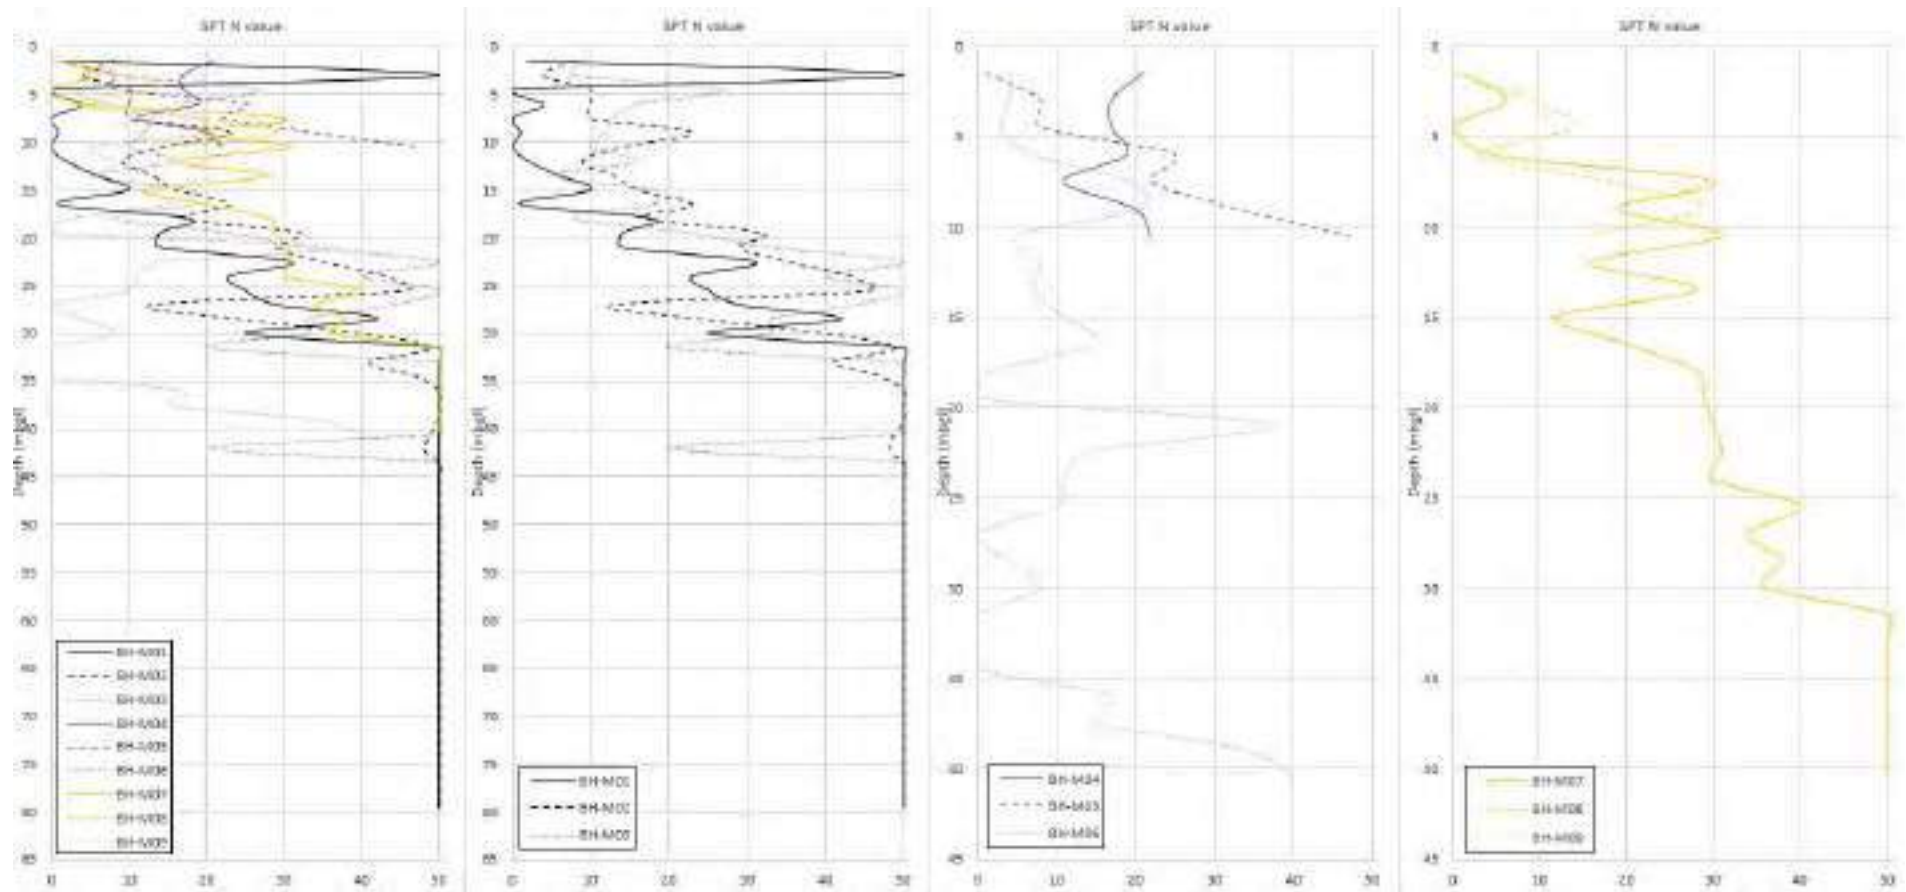
Figure F2 Uncorrected SPT 'N' value graphs against depth (m bgl) for all boreholes (left graph), with the same information separated into borehole groupings for clarity

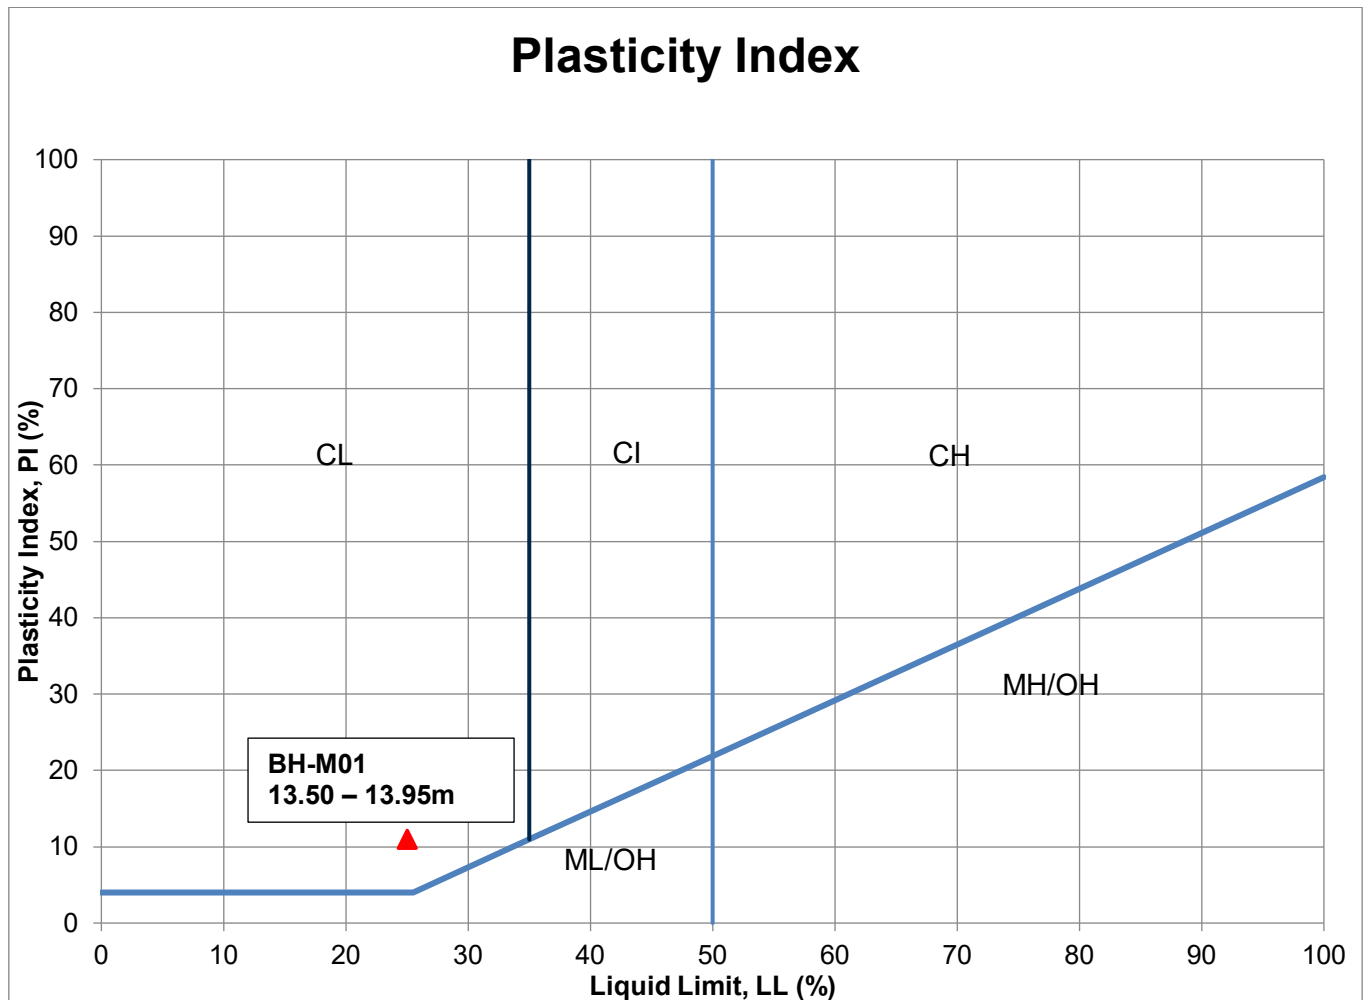
One sample was tested for Atterberg Limits, (NZS 4402:1986, Test 2.2, 2.3 & 2.4); the result is plotted on the plasticity index chart in Figure F3.

Figure F3 Plasticity Index chart

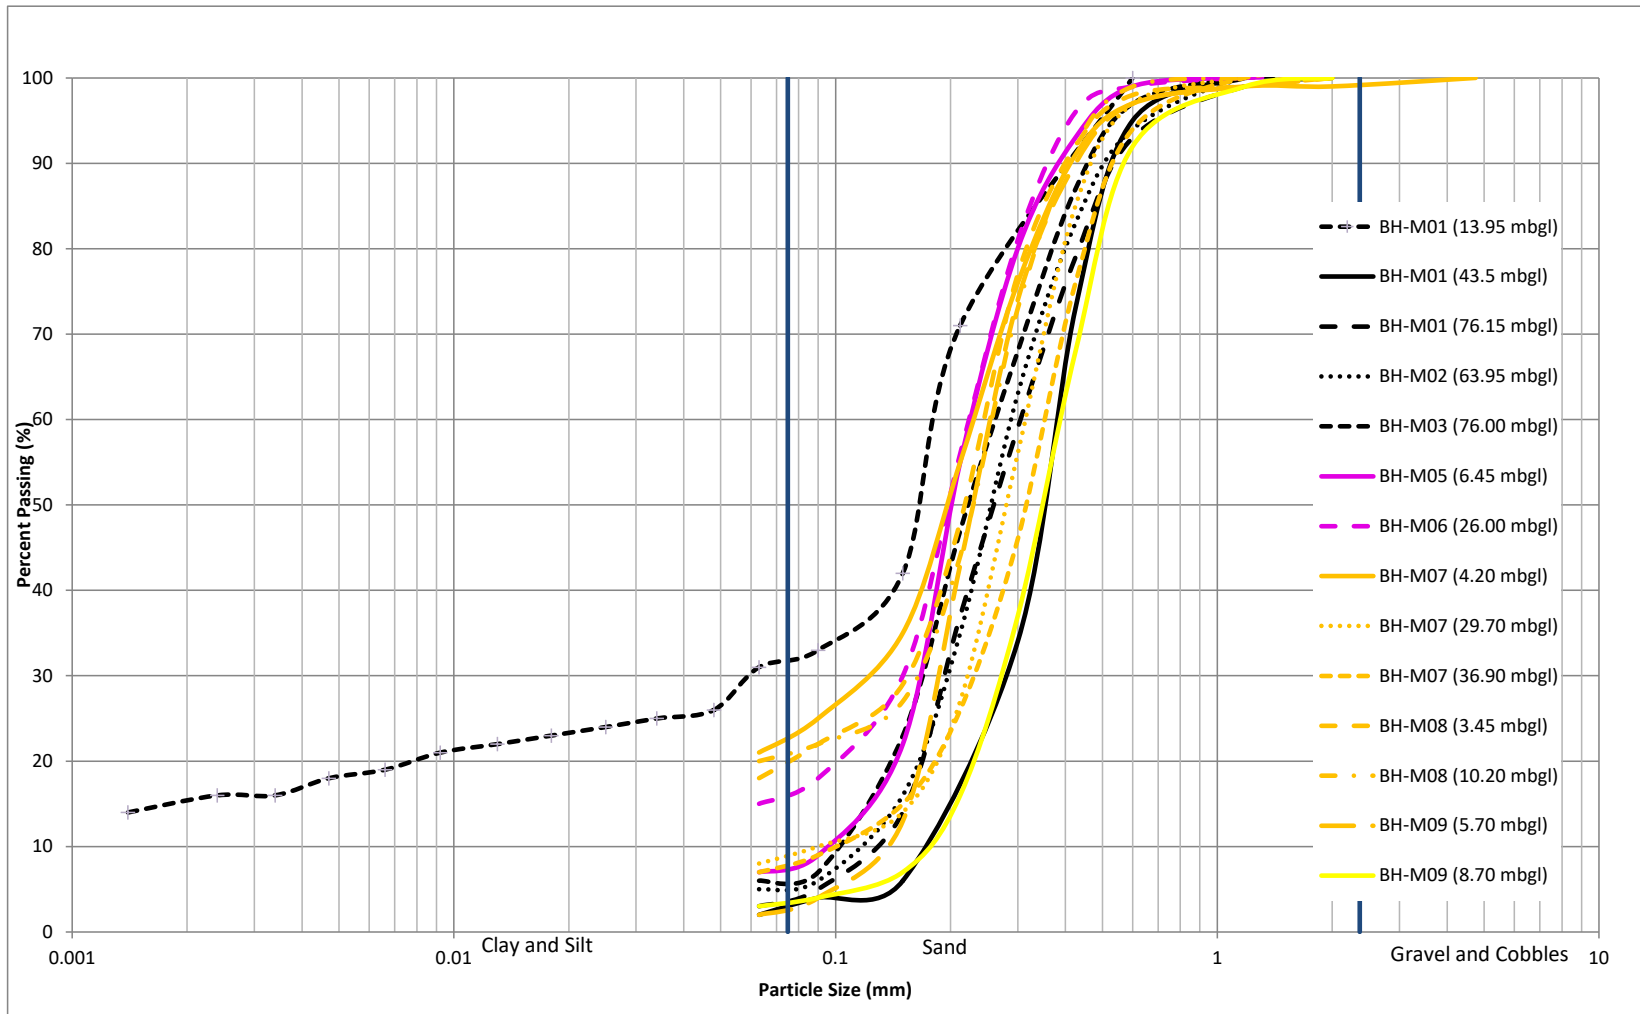
Thirteen samples were taken from BH-M01 to BH-M09 and tested for Particle Size Distribution (PSD - wet sieve). One PSD sample from BH-M01 was tested for PSD - hydrometer (NZS 4402:1986 Test 2.8.4). The results are presented in Figure F4.

Figure F4 Particle Size Distribution chart

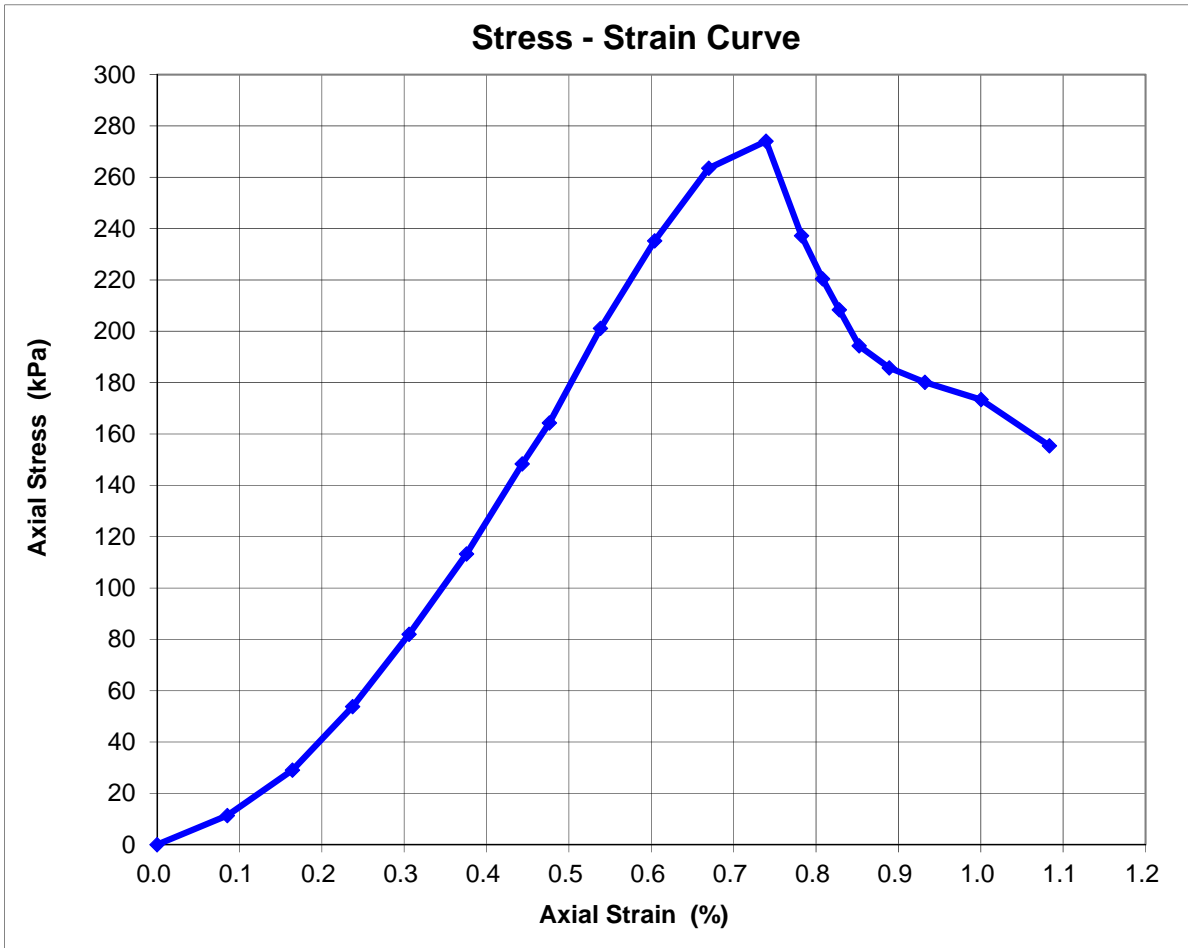
Mode of Failure: **planar**

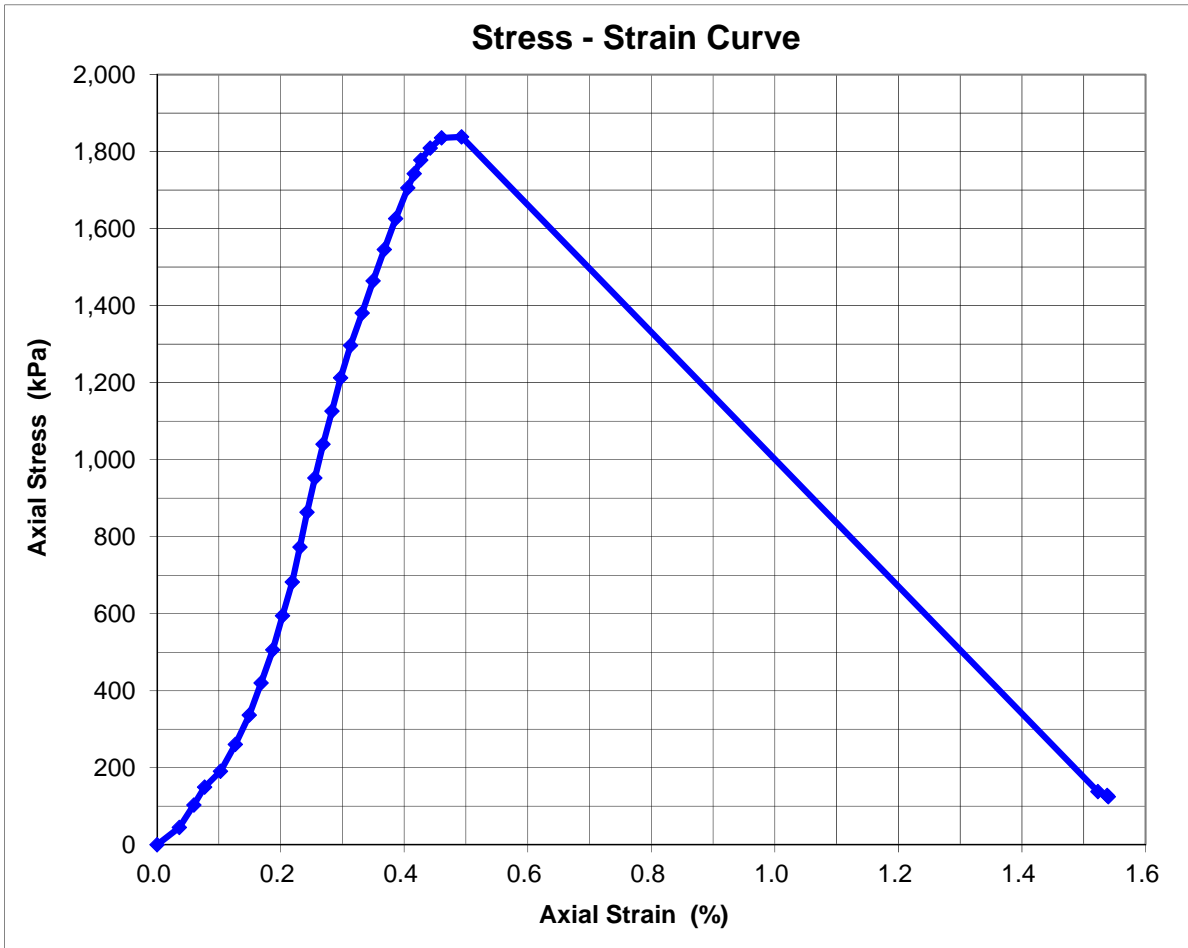
Mode of Failure: brittle

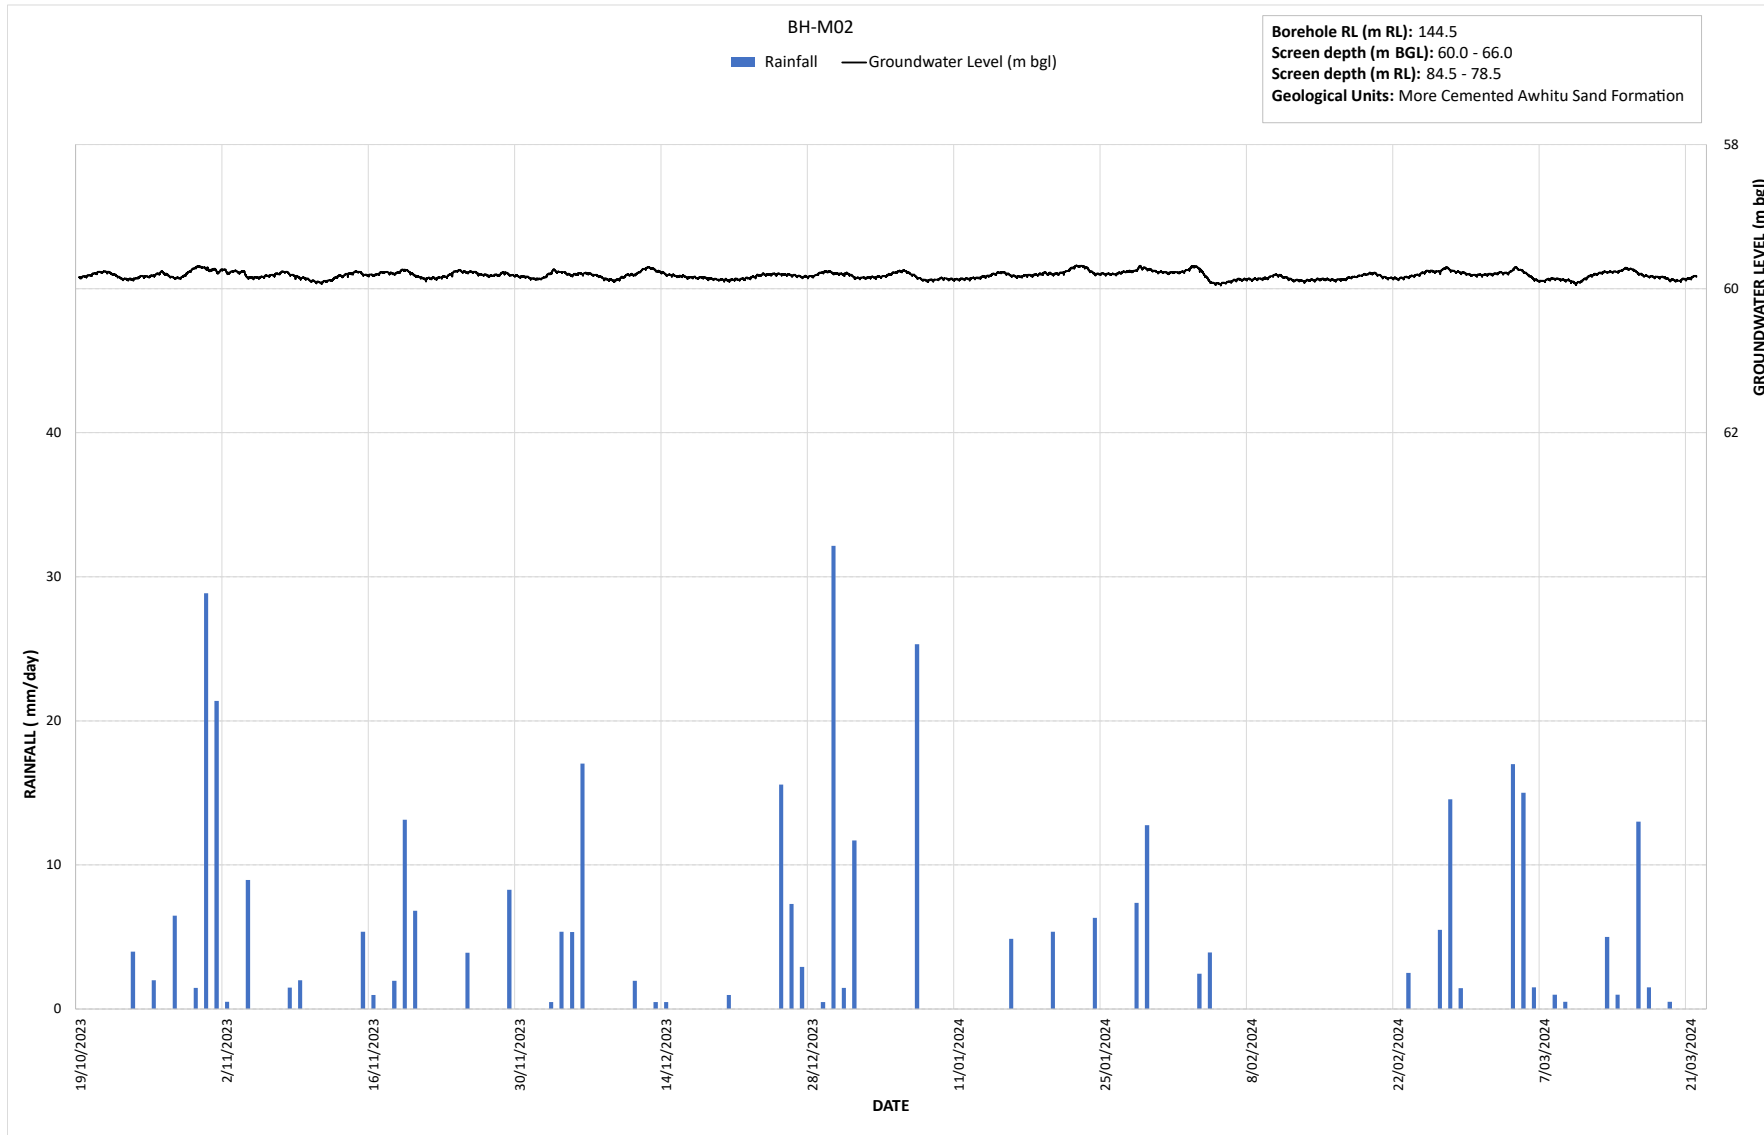
Figure F5-1: Plot of rainfall and telemetered groundwater data from BH-M02. Rainfall data sourced from Auckland Council's Environmental Data Portal

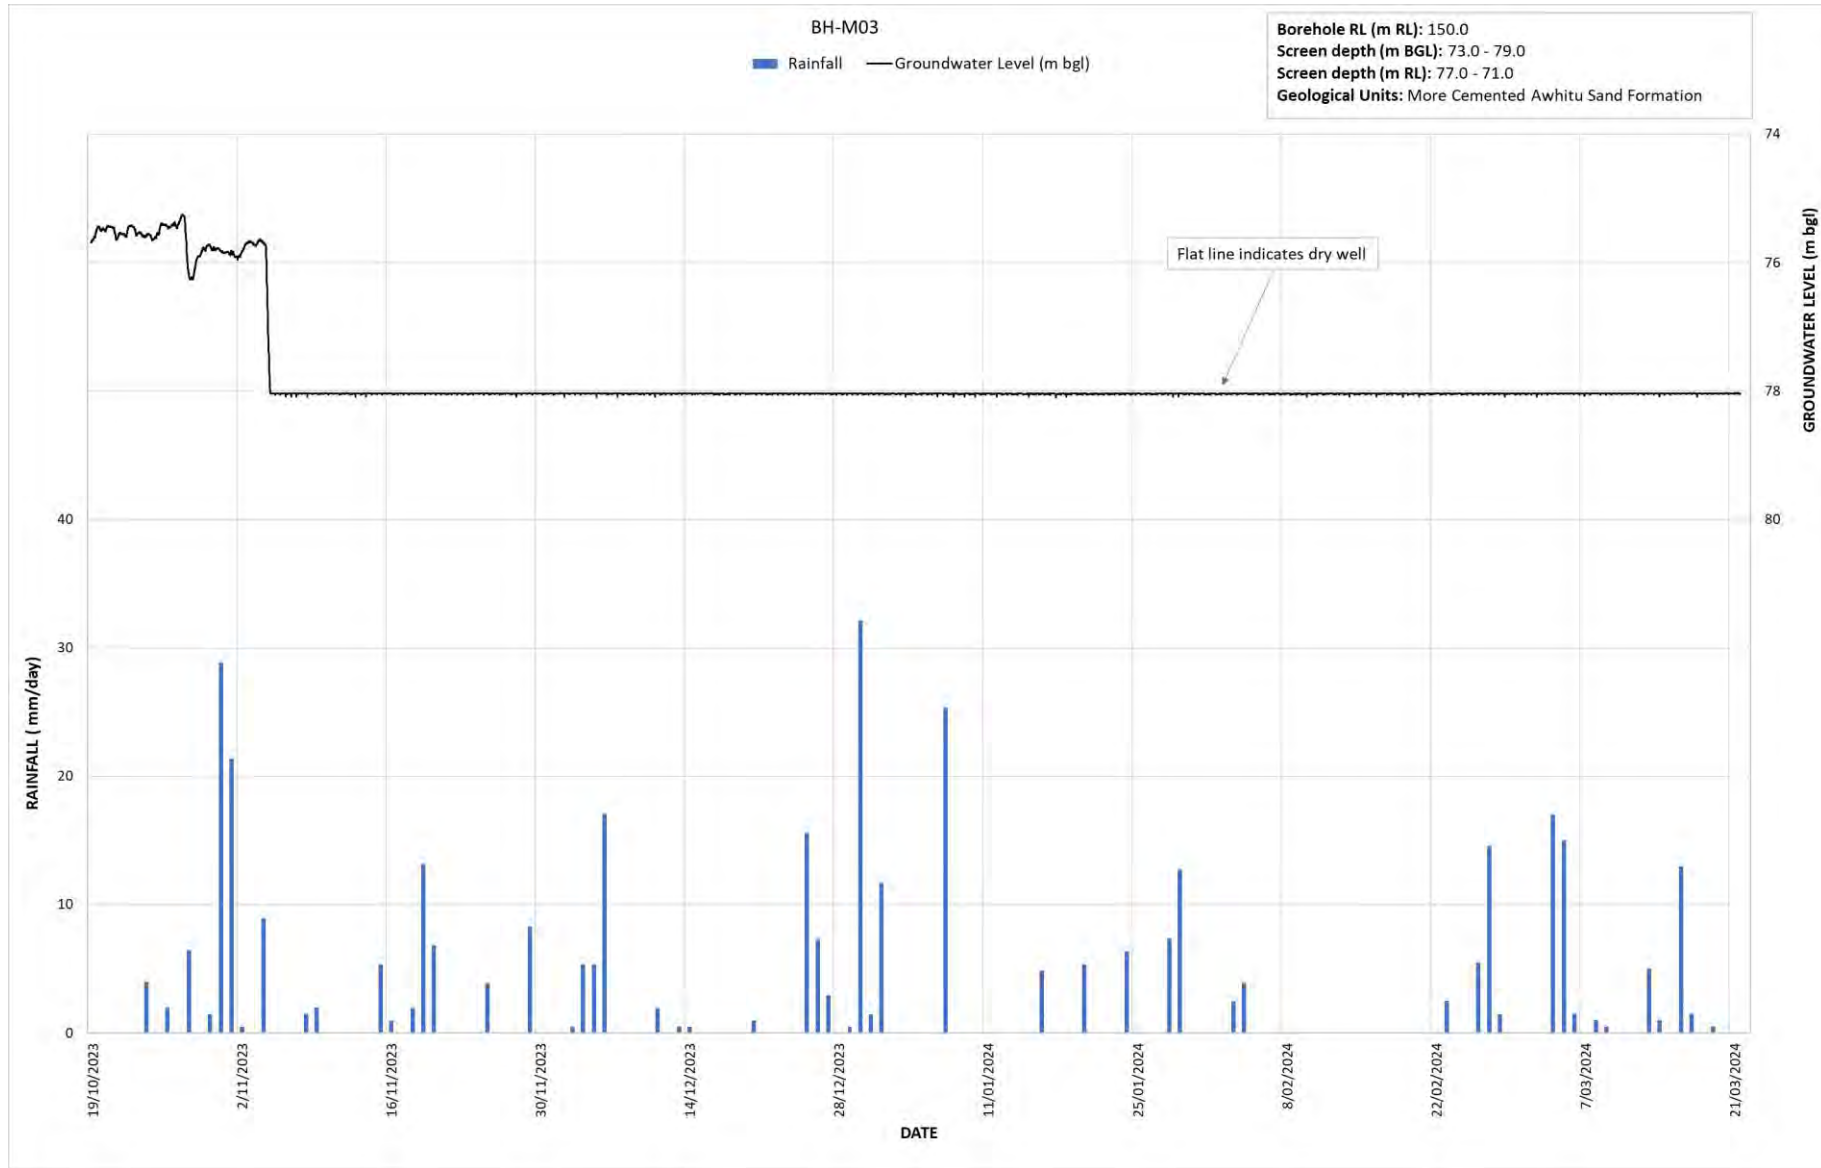
Figure F5-2: Plot of rainfall and telemetered groundwater data from BH-M03. Rainfall data sourced from Auckland Council's Environmental Data Portal

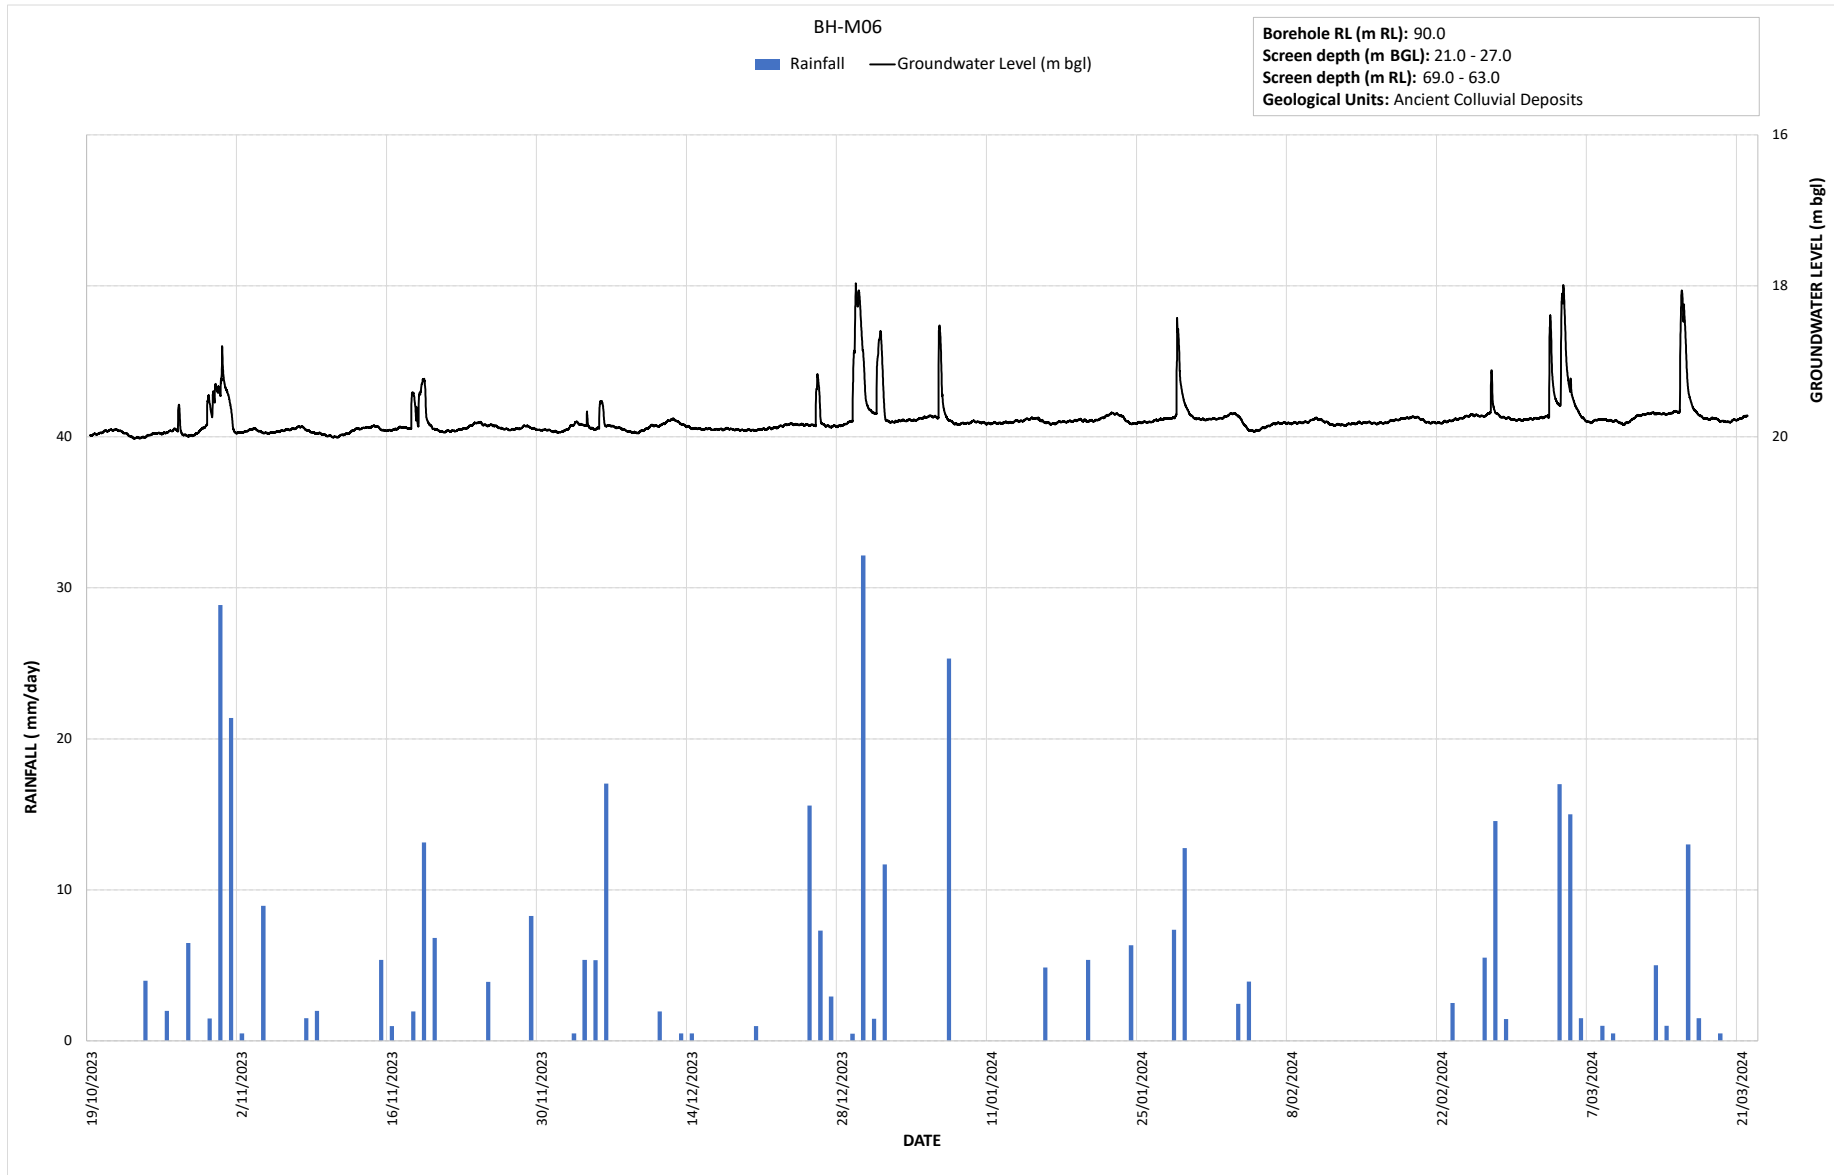
Figure F5-3: Plot of rainfall and telemetered groundwater data from BH-M06. Rainfall data sourced from Auckland Council's Environmental Data Portal

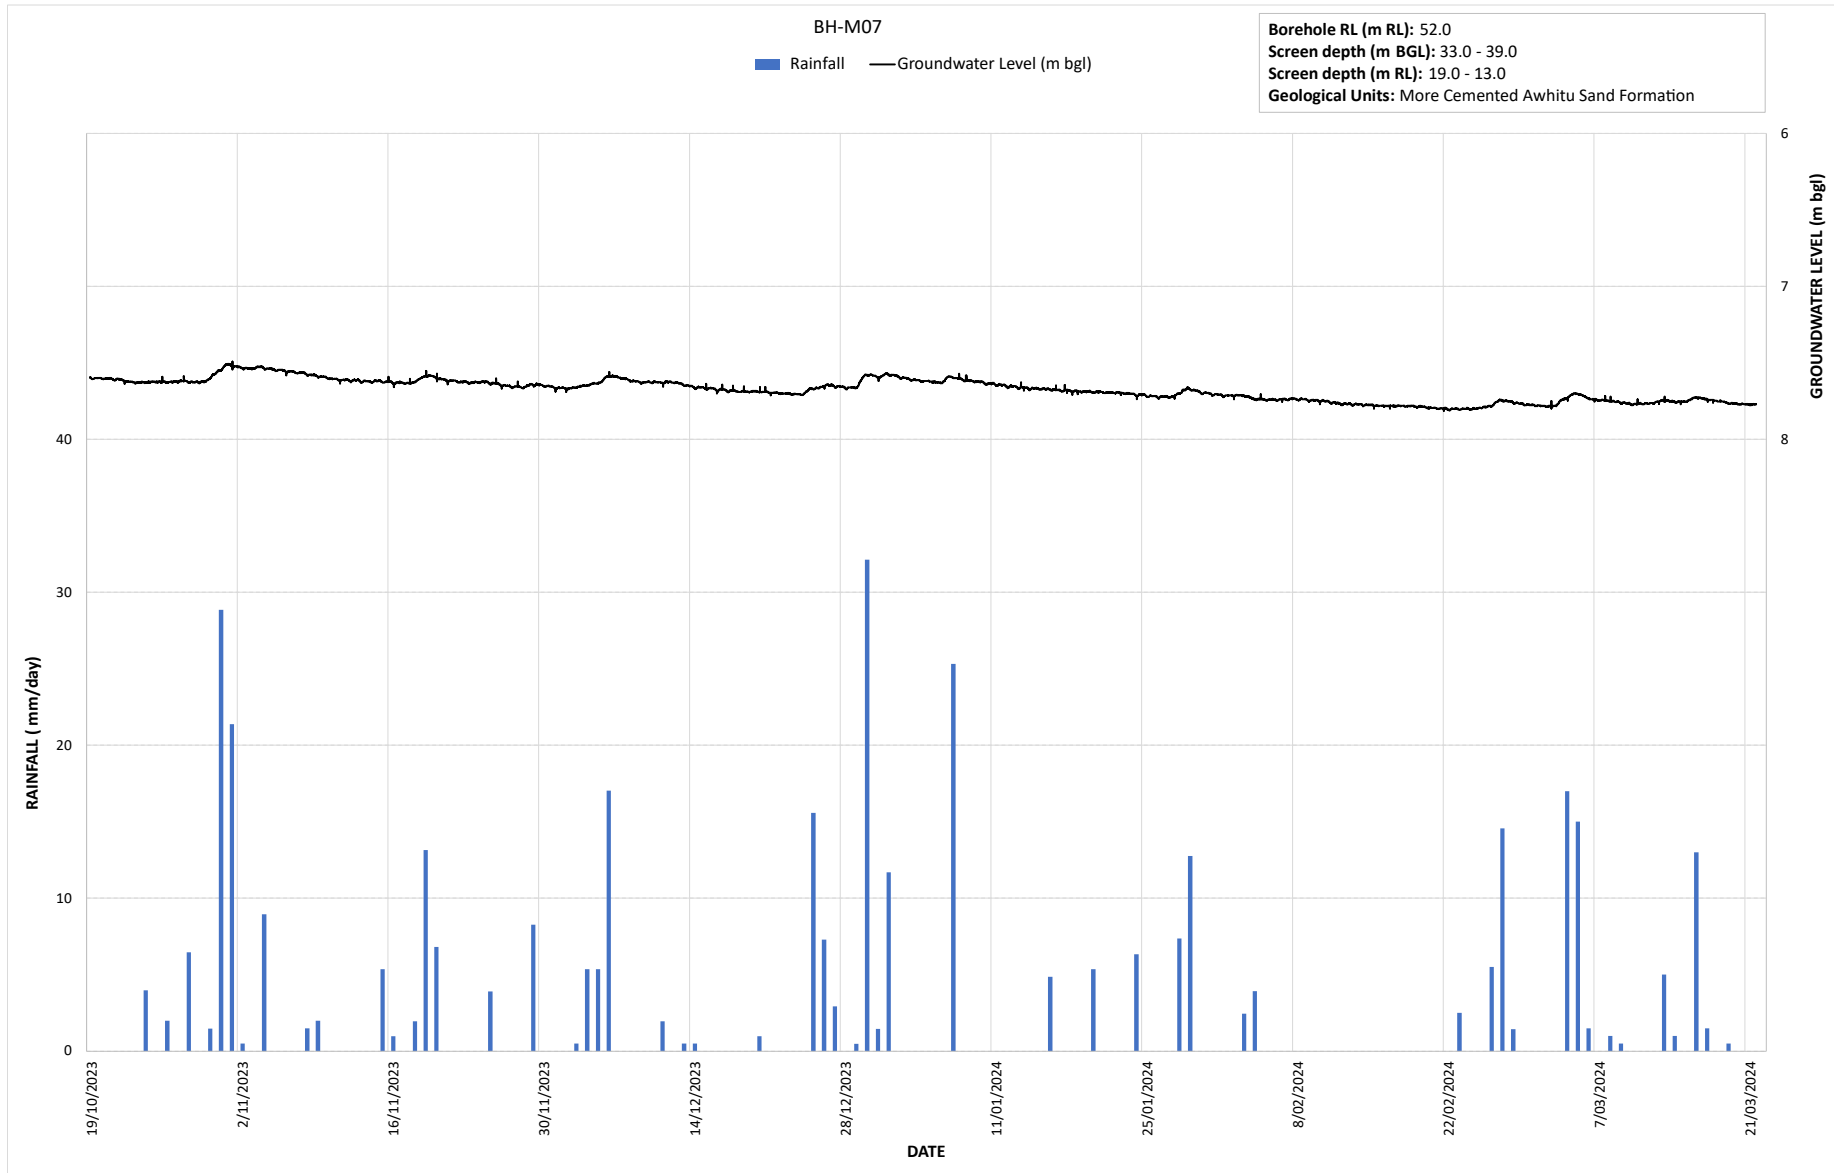
Figure F5-4: Plot of rainfall and telemetered groundwater data from BH-M07. Rainfall data sourced from Auckland Council's Environmental Data Portal
