Arboricultural Assessment of Effects and Tree Protection Plan

Removing a culvert and building a new bridge, including associated construction and traffic management activities within a public reserve

Black Bridge Reserve and Te Ararata Creek Reserve,
Walmsley Road, Māngere

Date 25 October 2024
Job ref # 3055

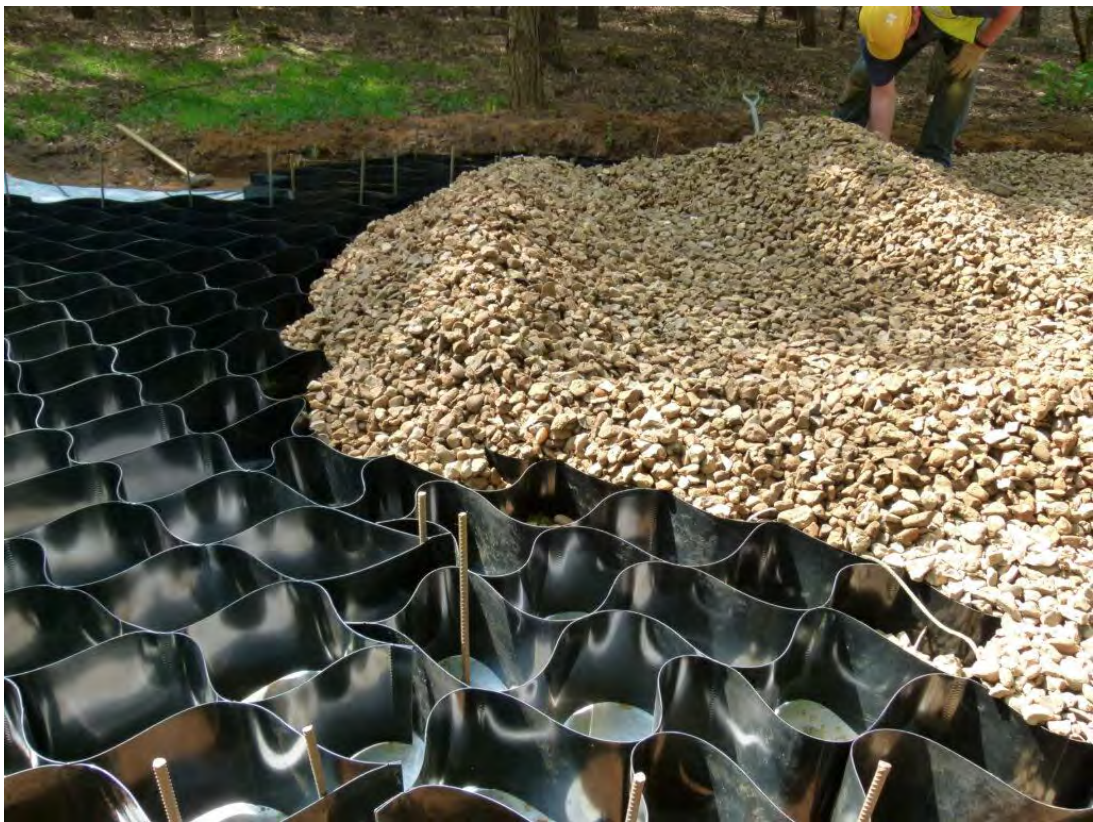
Figure 3: An example of a cellular confinement mesh (ABG Geosynthetics)

- 9.10 The construction yard configuration must be such that no soil scraping or excavation or deposition of aggregates is to take place in the tree protection zones of trees 12 and 13 or any other nearby trees. A 100 mm-thick later of woodchip mulch must be laid over the ground in these areas. If necessary, a cellular confinement mesh can be laid on top after first placing a piece of geofabric over the mulch, and the confinement mesh can be filled with stones to create a hard surface.

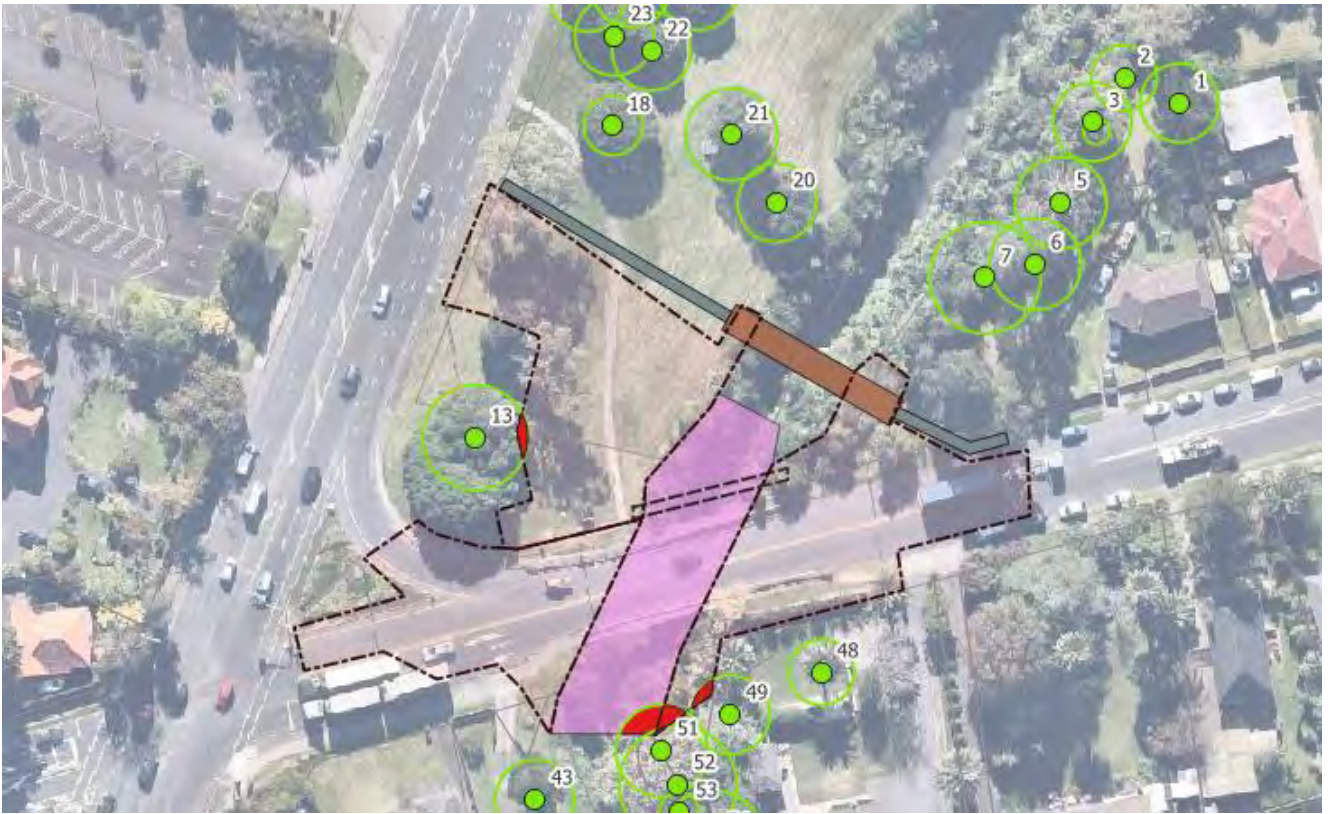
Figure 4: A screenshot from a geospatial analysis depicting protected root zone (green circles around trees) incursions (red areas).

- 7.5 A geospatial analysis of the proposed site features reveals that 19% of tree 51's **protected root zone will** be disturbed (Figure 4). What is unknown at this stage is whether the machines used to reshape the stream banks will be fitted with straight-blade buckets, or whether roots from the tree 51 measuring 80 mm or more in diameter will need to be cut when the stream banks are reshaped. Furthermore, temporary load-bearing surfaces will be very challenging to use when operating machinery from stream banks, as level ground is usually required for their safe and practicable installation. Therefore, conservatively, the Permitted Standards for working in the protected root zone will not be met.
