Healthy Waters - Te Ararata Flood Resilience Works -Walmsley Road Bridge Replacement

Ecological Impact Assessment

Prepared for
Auckland Council
Prepared by
Tonkin & Taylor Ltd
Date
October 2024
Job Number
1017033.2003 v1

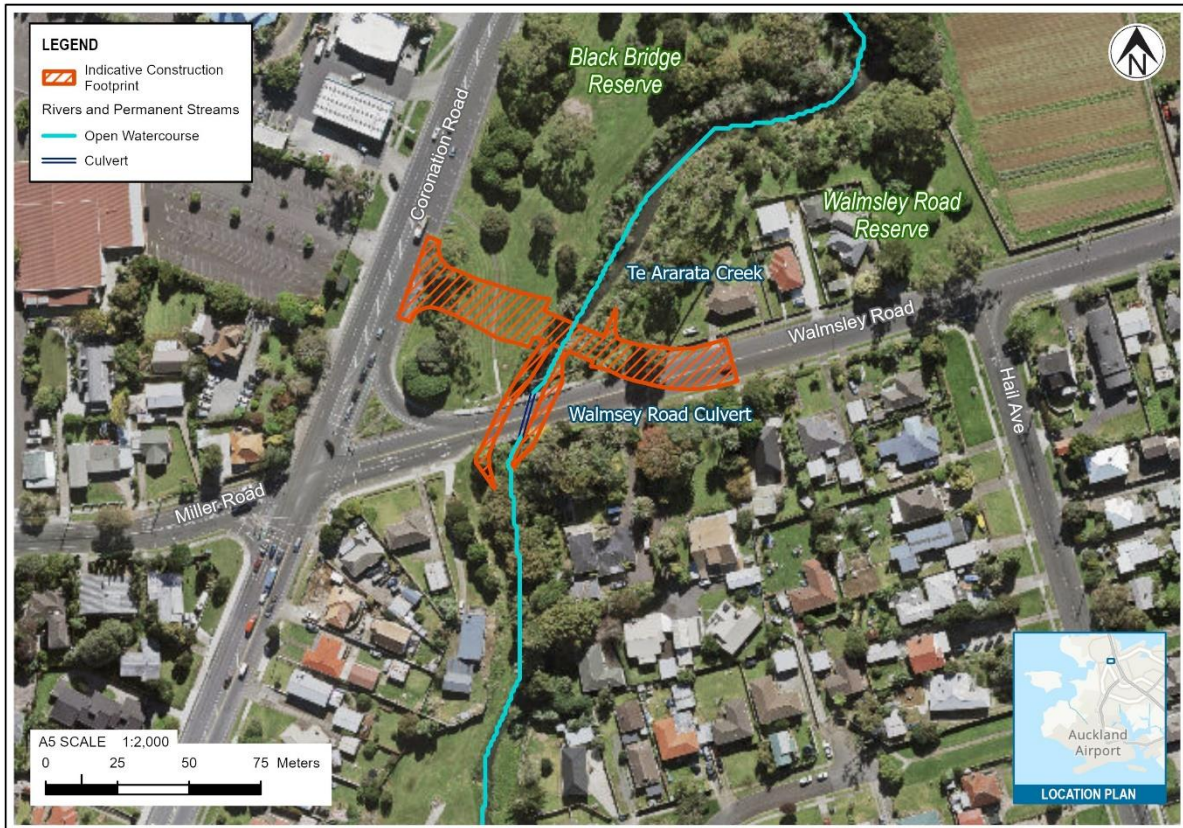
Figure 1.1: Site location and surrounding area ('the site').

A detailed description of the proposed work and indicative methodology is provided in the AEE prepared for the application. The Project is located within the existing Walmsley Road bridge, Te Ararata Creek, Black Bridge Reserve and Walmsley Road Reserve (refer to Figure 1.1). Overall construction of the Project is anticipated to take approximately 10 – 12 months, with closure of the existing Walmsley Road bridge required for approximately seven months during this period.

A reasonable worst case and effects envelope (Figure 1.1) has been assumed within this assessment to account for potential changes to activities and programme. Minor changes to the final methodology and detailed design are unlikely to change the overall envelope of effects as presented in this report.

An assessment of potential wetlands within 100 m of the project footprint (

Figure 1.1) was undertaken. The assessment was undertaken through a visual assessment of potential wetland vegetation and hydrological indicators. Potential wetland areas were assessed against Resource Management Act 1991 (RMA) and NPS FM wetland definitions. No wetland areas were identified and so are not discussed further.

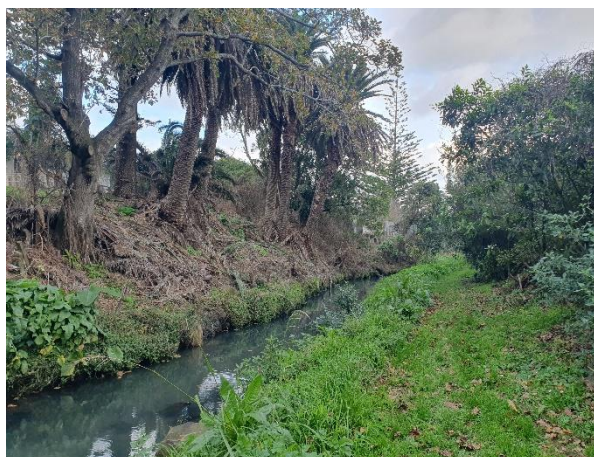
Photograph 3.1: Stream reach upstream of Walmsley Road Bridge, facing upstream.

Te Ararata Creek is relatively straightened and channelised upstream of the project footprint. There is limited in-stream habitat heterogeneity with substrate primarily comprising soft substrates, along with some areas of gravel and cobble. The riparian margin is primarily mown grass on the true left bank, with periodic riparian vegetation on the true right (Photograph 4.1), most of which has been planted by active local community groups in the upper catchment. Closer to the project footprint at Walmsley Road Bridge, the stream channel exhibits a more natural channel shape, however still has limited in-stream habitat heterogeneity and lacks a cohesive native riparian margin (Photograph 4.2). Where the riparian margin is lacking in woody vegetation, Te Ararata Creek is effectively unshaded contributing to increased solar access leading to elevated instream temperatures and aquatic plant growth. At times in summer, the stream is known to become choked with macrophytes and algae can be present on the hard substrates.
