Te Ararata Flood Resilience Works - Walmsley Road Bridge Replacement

Geotechnical and Groundwater Assessment Report

Prepared for
Auckland Council

Prepared by
Tonkin & Taylor Ltd

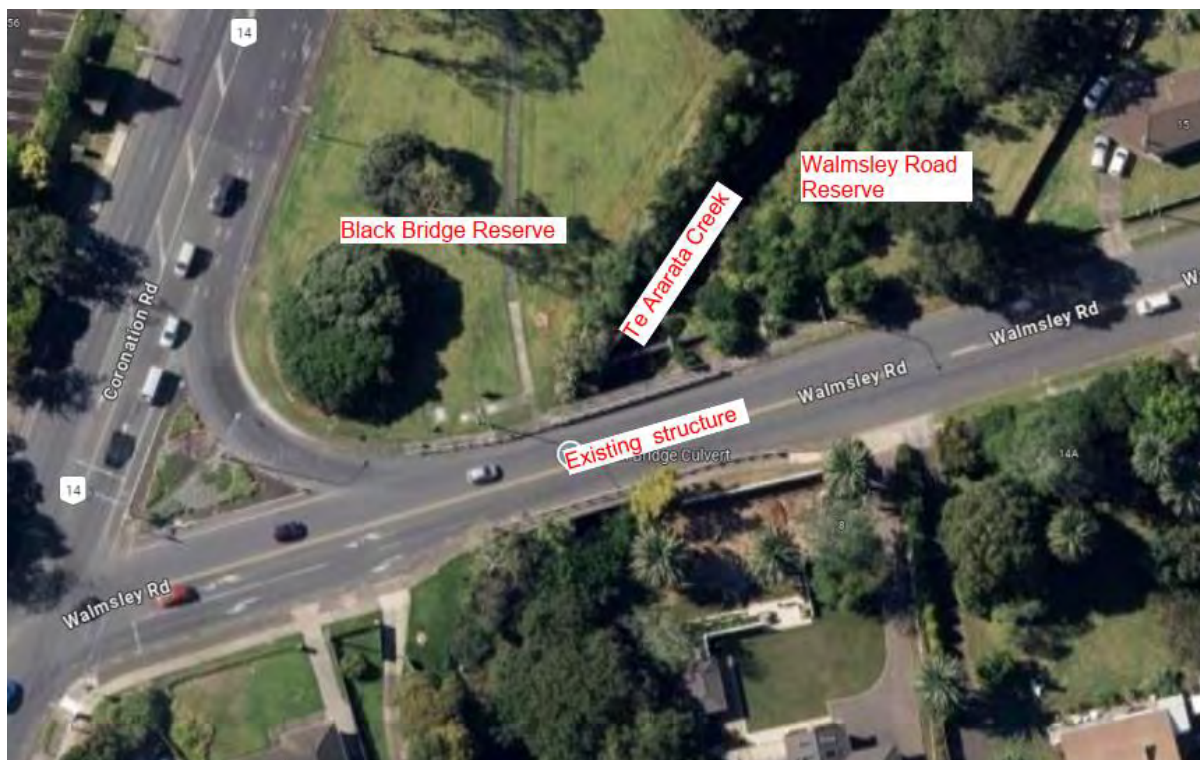
Figure 1.1: Project location – Site plan.

The existing Walmsley Road bridge structure is located on Walmsley Road in Māngere, Auckland. It is a two-lane road structure that spans the Te Ararata Creek, located at the southern edge of both the Black Bridge Reserve and Walmsley Road Reserve, which lie to the west and east of the creek respectively. Residential neighbourhoods are situated to the east of Walmsley Road Reserve and south of the bridge.

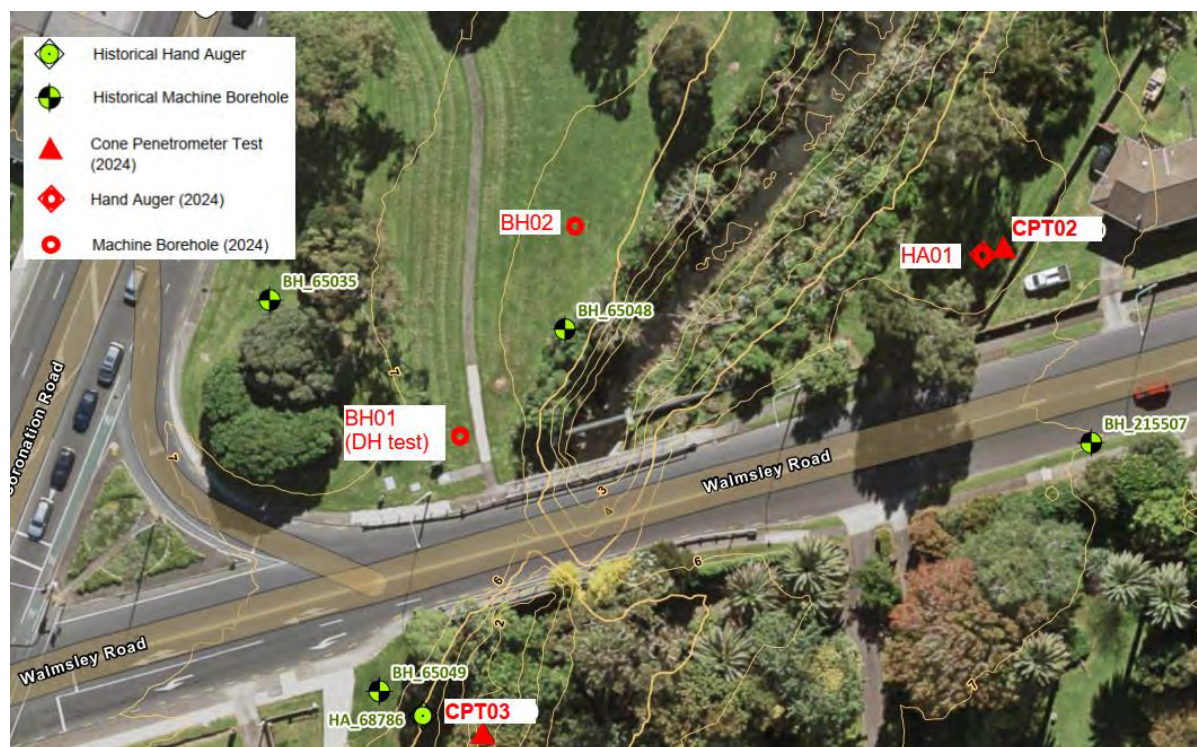
Figure 2.1: Location of geotechnical investigations within the site.

More information on the geotechnical investigations and testing is included in Appendix A.

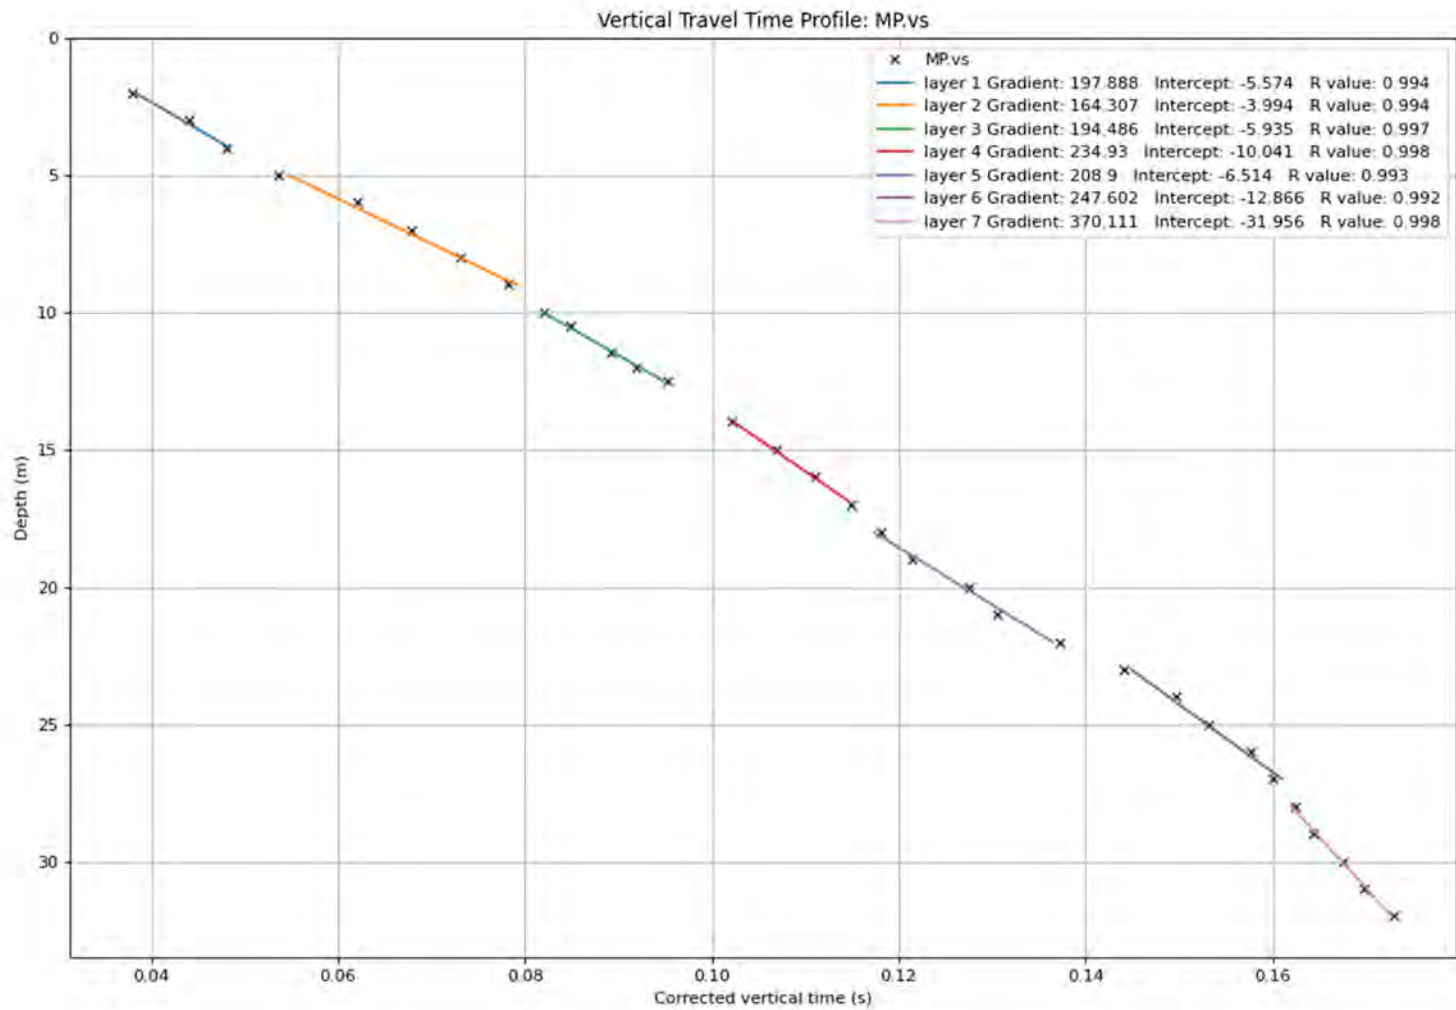
TITLE	BH001 Shear Wave Tx Curve - Max Peak	PROJECT	240669			
PROJECT	Black Bridge Culvert DH Seismic	DRAWN BY	EB	DATE	11/09/24	FIG
CLIENT	Tonkin + Taylor	CHECKED BY	OG	DATE	11/09/24	03

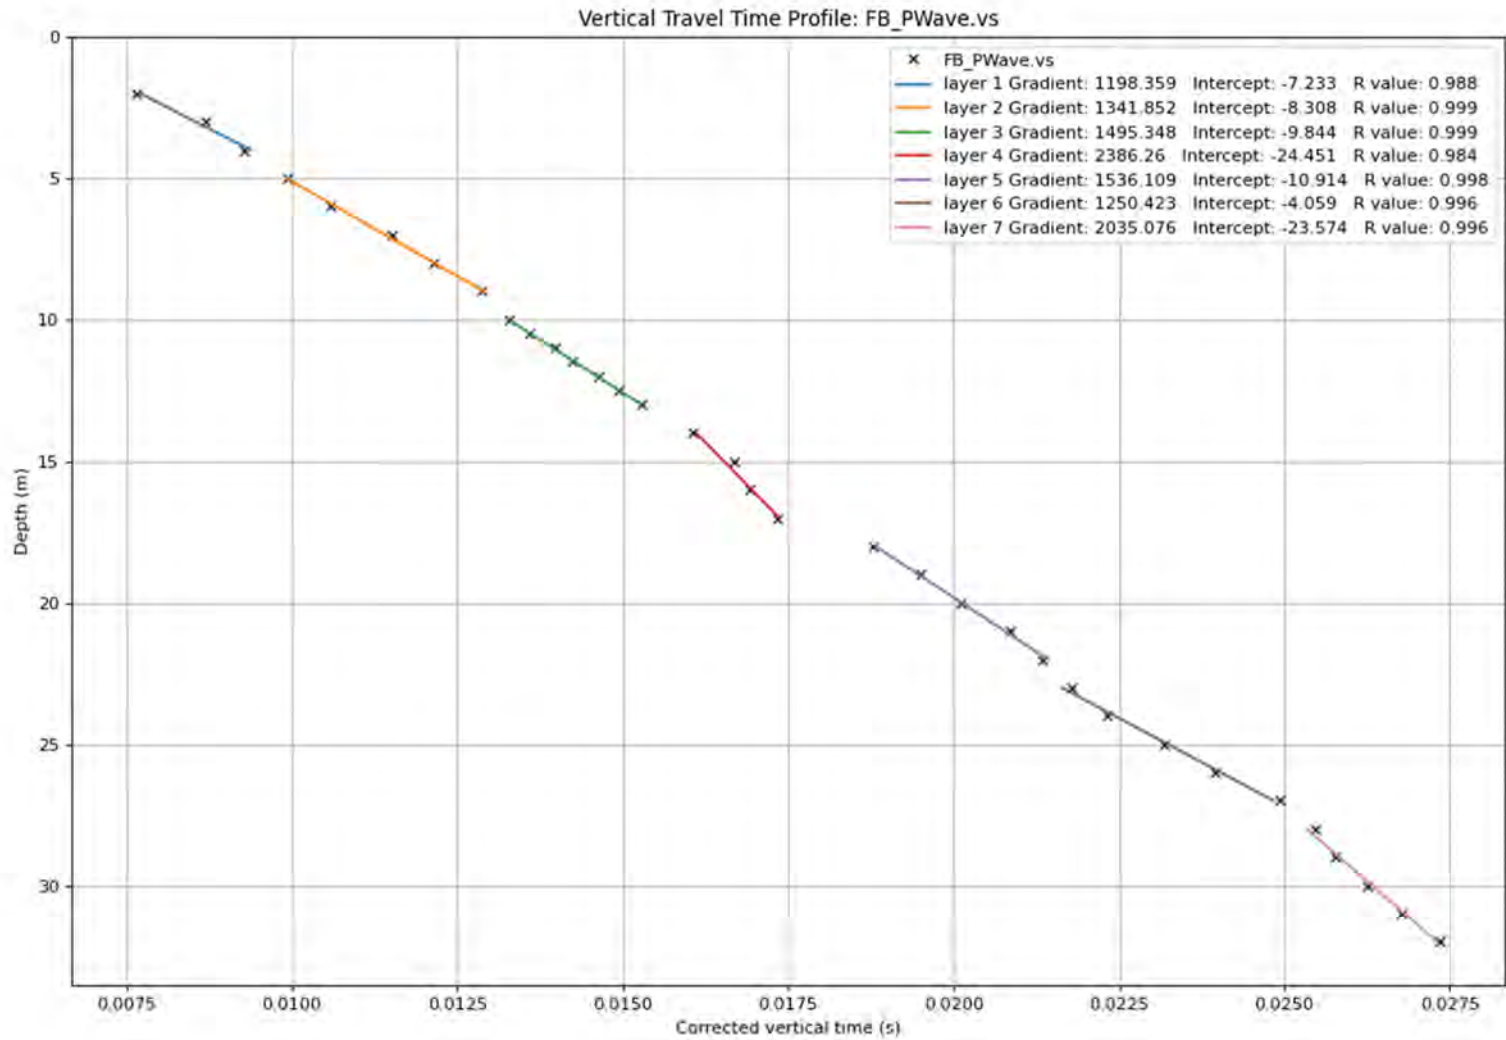
TITLE	BH001 P Wave Tx Curve - First Break	PROJECT	240669			
PROJECT	Black Bridge Culvert DH Seismic	DRAWN BY	EB	DATE	11/09/24	FIG
CLIENT	Tonkin + Taylor	CHECKED BY	OG	DATE	11/09/24	04
