Healthy Waters - Te Ararata Flood Resilience Works - Walmsley Road Bridge Replacement

Blue Green Network: Walmsley Road
Bridge

Prepared by
Tonkin & Taylor Ltd

Title: Preliminary Site Investigation					
Date	Version	Description	Prepared by:	Reviewed by:	Authorised by:
September 2024	0	Preliminary Site Investigation Report for submission to Council.	C. Thornton	L. Phuah	C. Bauld
October 2024	1	Updated Preliminary Site Investigation Report for submission to Council.	C. Thornton	L. Phuah	C. Bauld

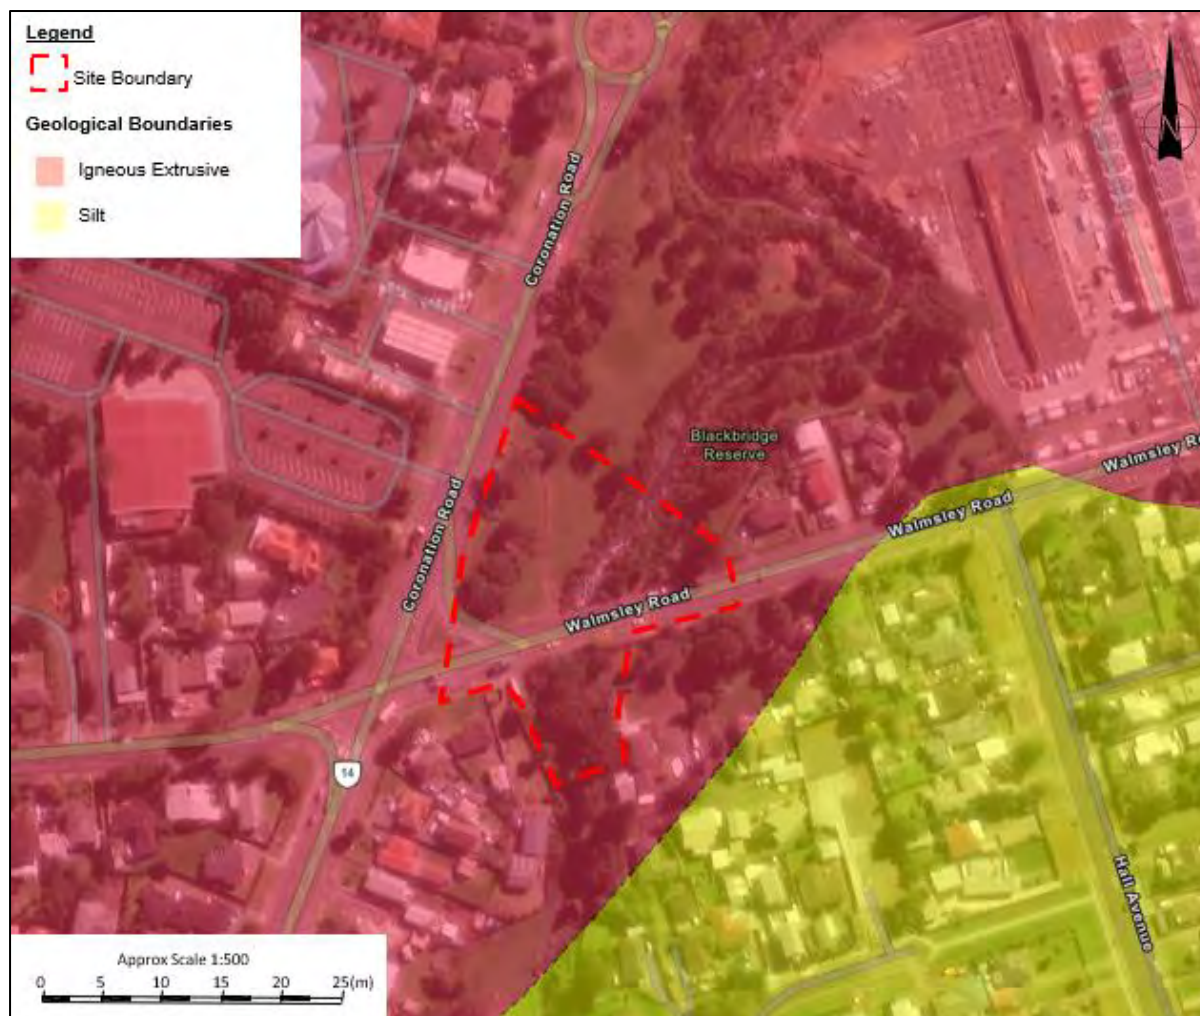
Figure 2.1: Published geological map in relation to the project area (Source T+T Map Viewer⁶).

Published geological information (Figure 2.1) indicate that the site is underlain by lithic tuff of the Auckland Basalts formation. These sediments predominantly consist of pre-volcanic materials with basaltic fragments, and unconsolidated ash and lapilli deposits of the Kerikeri Volcanic group. A geologic boundary lies close to the south of the site, where the area to the south is underlain by clastic Holocene River deposits comprising sand, silts, mud and clay of the Tauranga group.

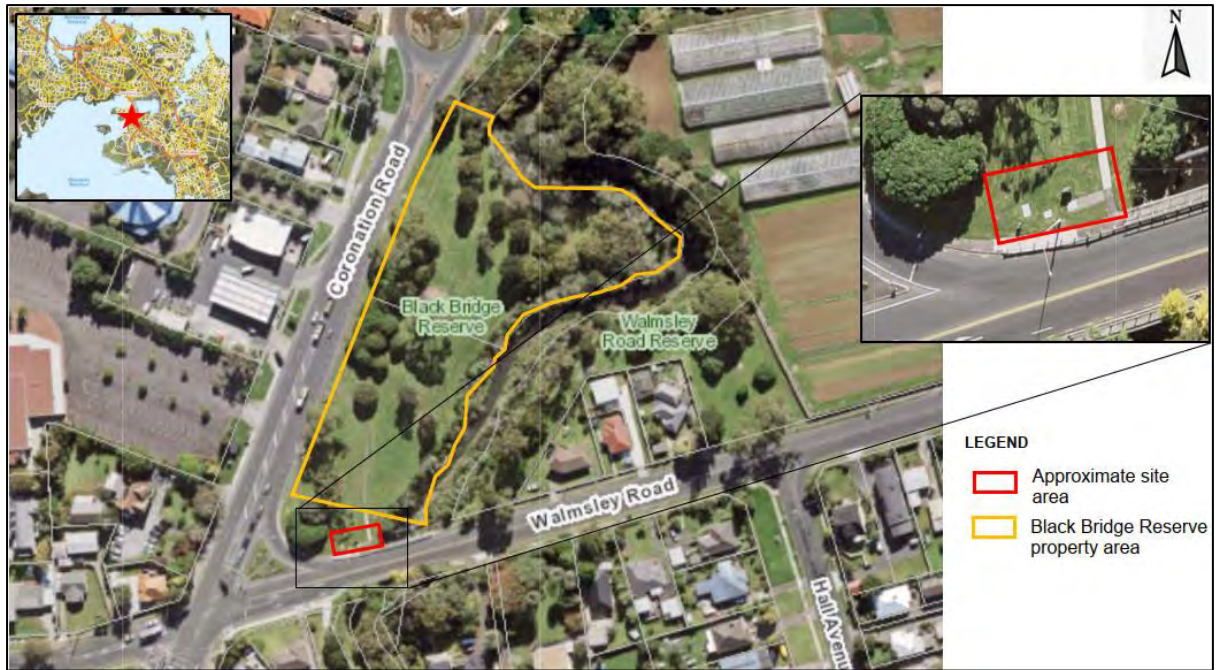
Figure 3.2: Site layout (Source, WSP, 2023).

A review of the available information found no evidence of the site being used for landfill activities. However, it should be noted that the WSP investigation was limited to a 20 m² area in the road reserve along Walmsley Road. The site plan is shown in Figure 3.2.

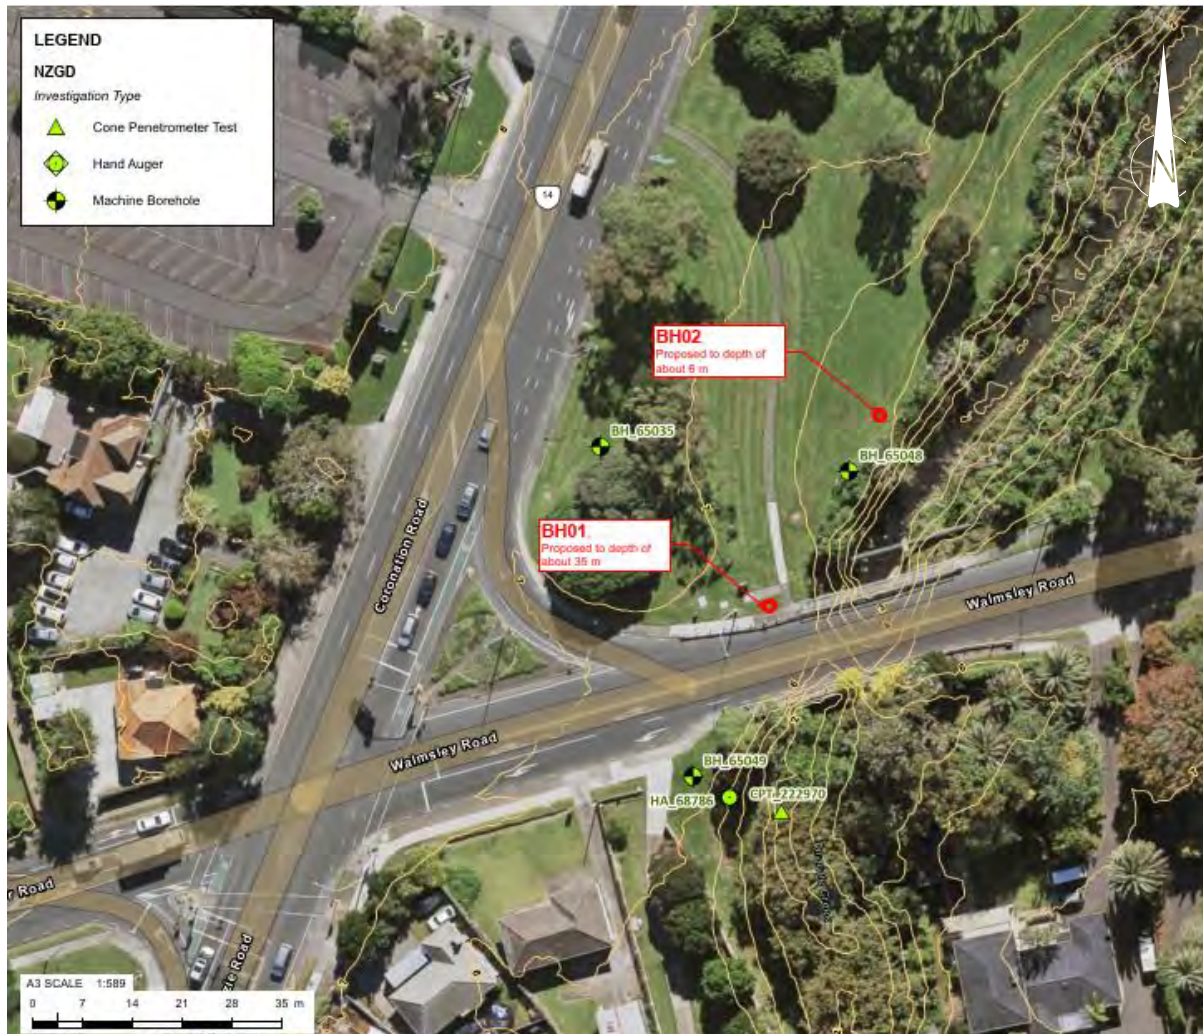
Figure 5.1: Soil sampling locations, BH01 and BH02.

- The site was generally overlain by a thin layer of topsoil consisting of clayey silt with some fine gravels, dark greyish brown, with some rootlets. Firm to stiff, moist, medium to high plasticity.

- Fill was observed at both locations. At BH01, fill was present to 1.2 mbgl, and consisted of clayey gravelly SILT with the inclusion steel waste at 0.4 and 0.6 mbgl. At BH02, there was a 1.7 m layer of fill which underlain the topsoil to 2.2 mbgl. This layer comprised of silty boulders with some gravels.

- Natural geology underlain the observed fill layers at both machine borehole locations, the site itself straddles geology strata change of Basalts from the Auckland Volcanic field and clayey SILT of the Takanini formation. At BH01 the natural underlying geology consisted of dark grey slightly to moderately weathered Basalt from the Auckland Volcanic field. Whilst at BH02, silty SAND and clayey SILT of the Takanini formation was encountered beneath the fill layer from 2.2 m bgl.

- No significant staining or odours or demolition material were observed in any of the soils sampled.

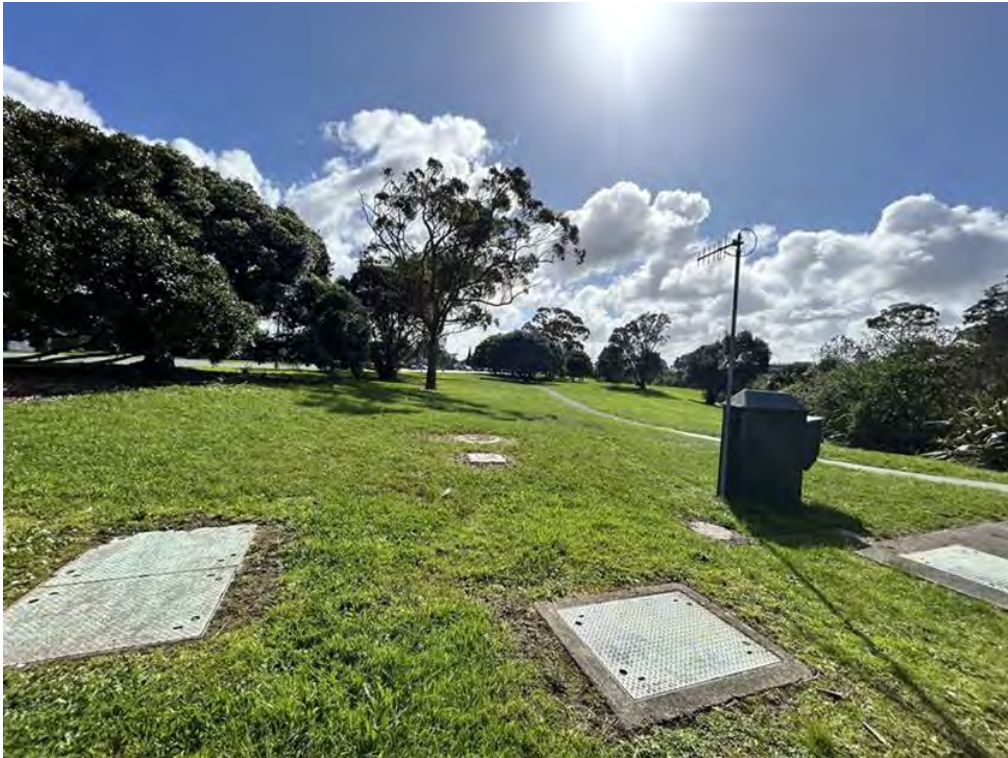
A water pipeline was observed traversing the site, just north of Walmsley Road. This pipeline runs below ground across the majority of the site, although it is visible above ground as it crosses Te Ararata Creek.

Photograph Appendix B.1: Looking south towards Walmsley Road access. Photo shows the visible access points to the water pipeline which traverses the site.

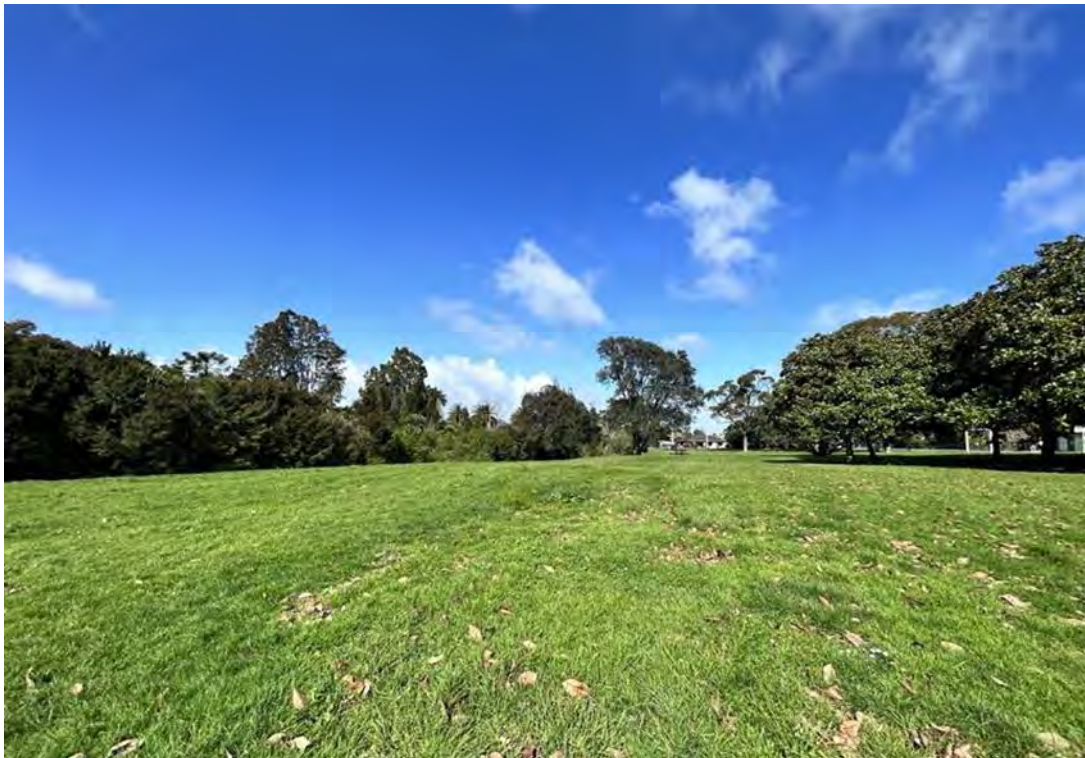
Photograph Appendix B.2: Photo shows the site to the north, showing the Black Bridge reserve parcel of the site.

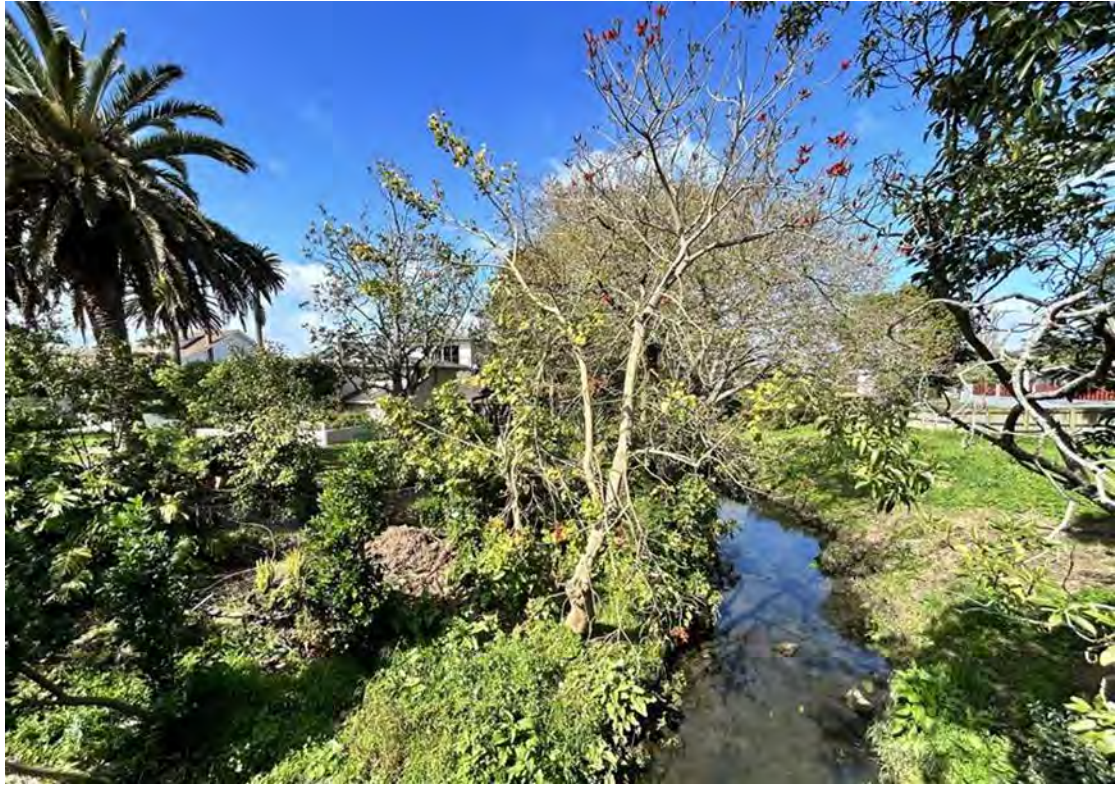
Photograph Appendix B.3: Photo shows the site to the south, with Te Ararata Creek.

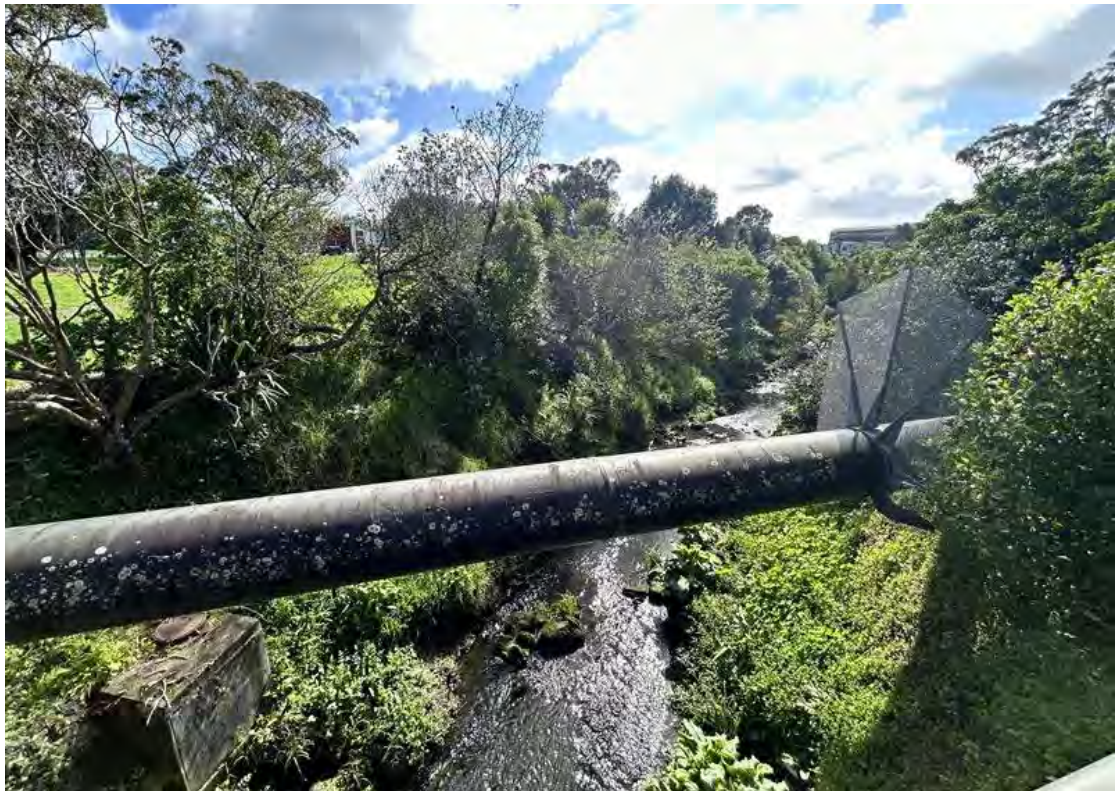
Photograph Appendix B.4: View facing north of water pipeline.

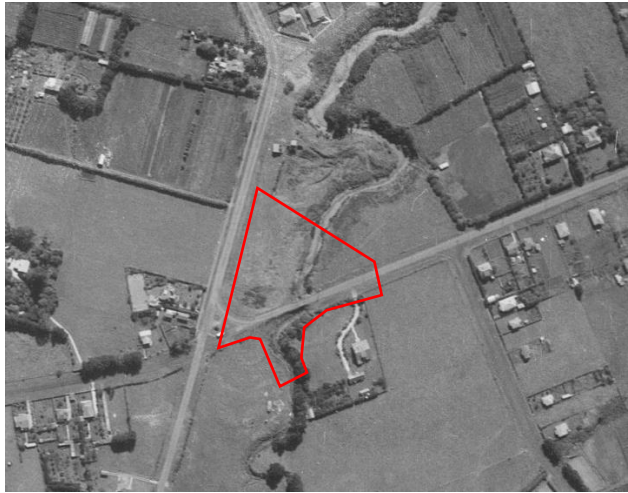
Year and source	Site observations	Surrounding land use	Imagery
1940 Auckland Council Geomaps	The site is largely in its present-day state; consisting of Te Ararata Creek which runs north to south through the. Walmsley to the south, Coronation Road to the west, and Black Bridge Reserve to the north and Walmsley Road Reserve to the east of the site.	Surrounding land mainly consists of life-style block parcels to the south and west, and horticulture land to the northeast and northwest of the site.

A black and white aerial photograph showing a site outlined in red. The site is a roughly rectangular area with a creek running through it. The surrounding area includes residential blocks, fields, and roads. A road runs north-south through the site, and another road runs east-west across it. The creek flows from the north towards the south, passing through the site.

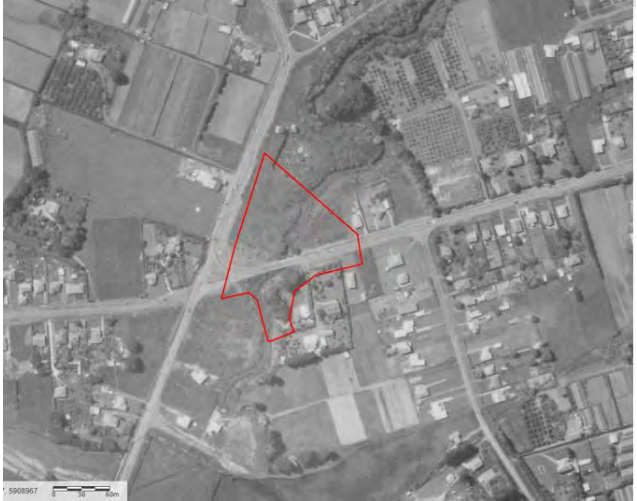
Year and source	Site observations	Surrounding land use	Imagery
<p>1959 Auckland Council Geomaps</p>	<p>No significant changes are evident</p>	<p>Further development of horticultural land and residential housing to the south of the site.</p>

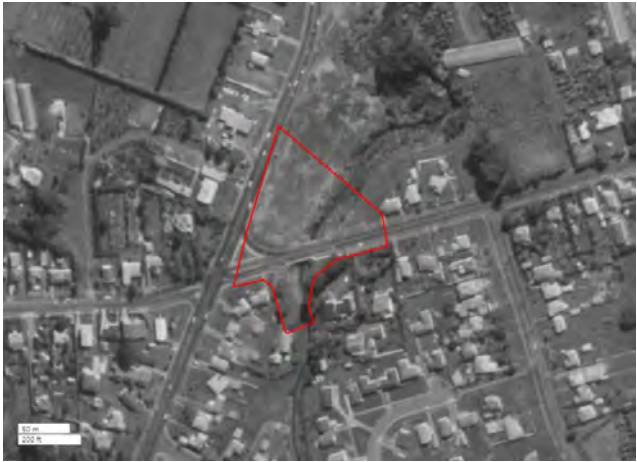
<p>1975 Retrolens</p>	<p>A road lane has been added to the intersection of Coronation and Walmsley Road which cuts through the southwestern corner of the site. No other significant changes were evident.</p>	<p>Further residential intensification has occurred on land to the south and west of the site. Development to the north remains sparse, with market gardens remaining in the northeast of the site.</p>

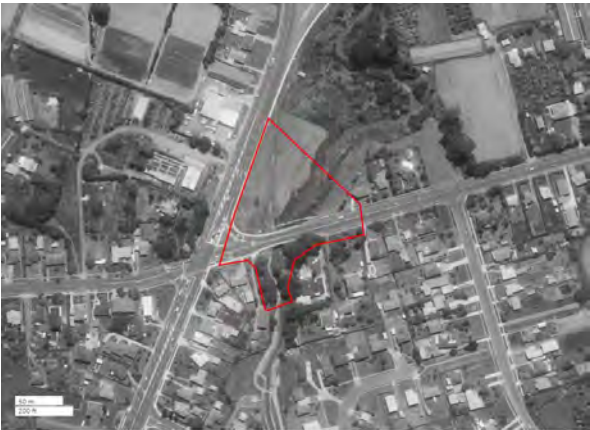
Year and source	Site observations	Surrounding land use	Imagery
1980 - 1981 Retrolens	<p>The water pipeline has been installed across the banks of Te Ararata Creek, north of Walmsley Road.</p> <p>Soil disturbance is visible across Black Bridge Reserve, with a path which has been constructed running north to south through the reserve.</p> <p>Further channelization and riparian planting has occurred along Te Ararata Creek.</p> <p>Coronation Road has been widened.</p>	<p>Further residential intensification has occurred in the surrounding area.</p> <p>Market gardening still remains to the northeast and northwest of the site.</p>

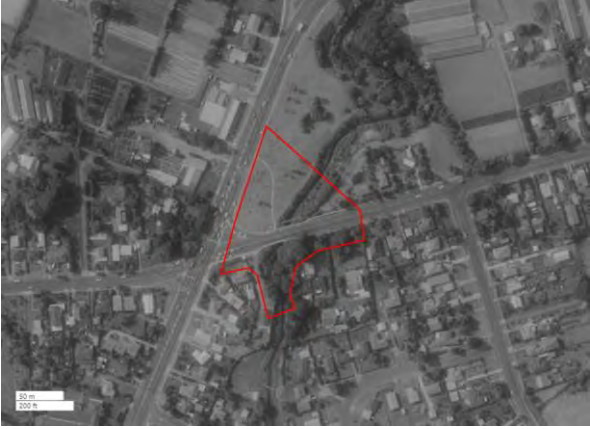
1987 Retrolens	<p>No significant changes to the site.</p>	<p>No significant changes to the area surrounding.</p>

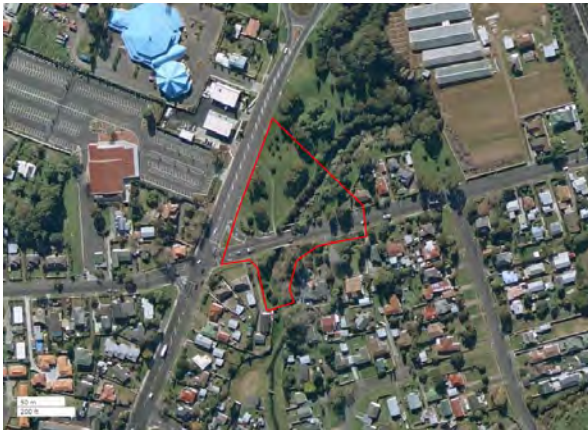
Year and source	Site observations	Surrounding land use	Imagery
2001 Auckland Council Geomaps	Further trees have been planted in Black Bridge Reserve. No further changes to the site.	Development has occurred to the east and northeast areas of the site being; residential dwellings, a church, Pacific Christian School and large associated carparking area. A BP petrol station occupies previous market gardening land. Market gardening still remains to the northeast of the site.

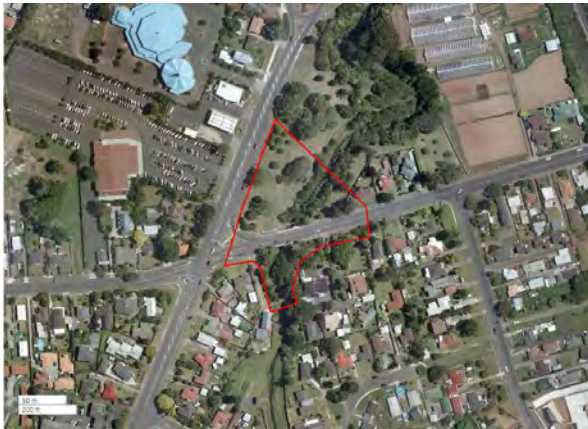
2008. Auckland Council Geomaps	No significant changes to the site.	No significant changes to surrounding area.

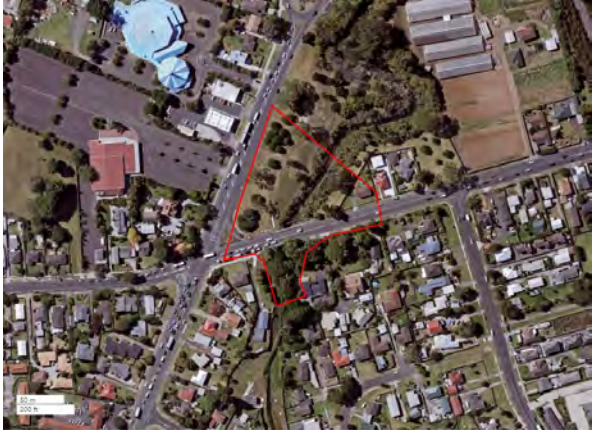
Year and source	Site observations	Surrounding land use	Imagery
<p>2015 and 2016 Auckland Council Geomaps</p>	<p>No significant changes to the site.</p>	<p>No significant changes to surrounding area.</p>

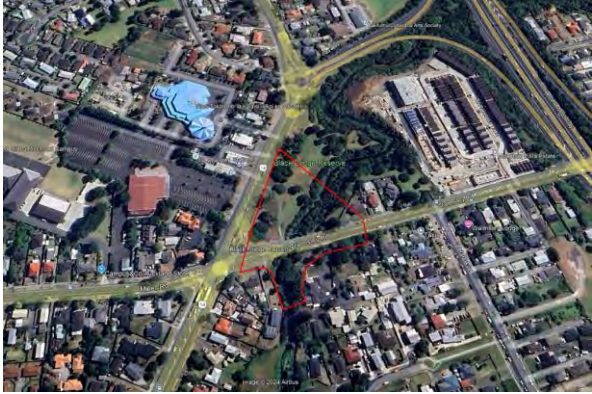
<p>2024 Google Earth Imagery</p>	<p>Further riparian zones are present along Te Ararata Creek.</p>	<p>Development has occurred to the northeast, with the development of high density residential properties.</p>

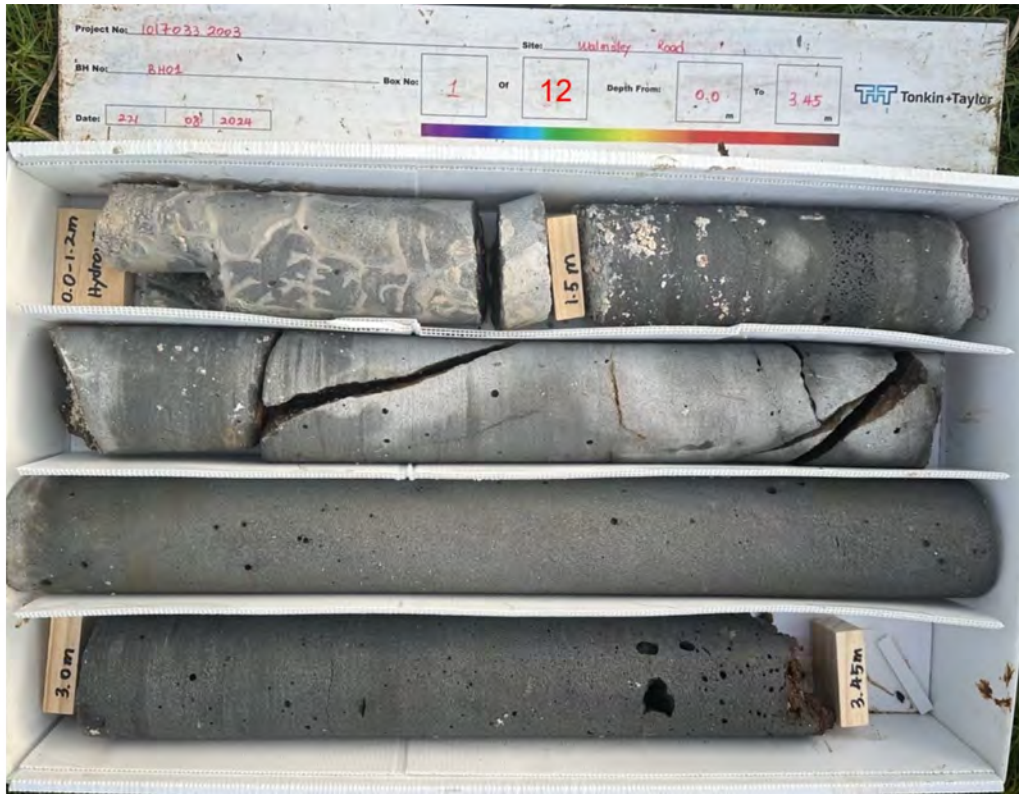
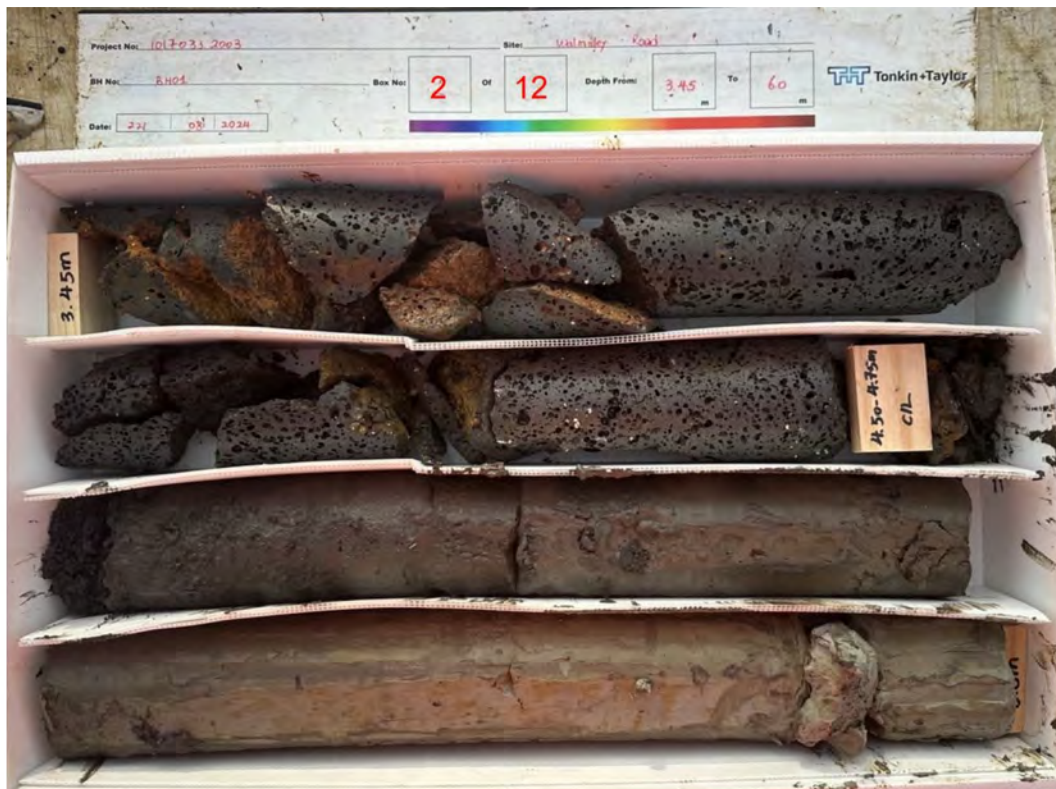
BOREHOLE No.: **BH01**
 Hole Location: 5R Walmsley Road, Mangere
 SHEET: 1 OF 6

GEOLOGICAL UNIT	MATERIAL DESCRIPTION		Rock Weathering	Rock Strength	Sampling Method	Core Recovery (%)	Testing	RL (m)	Depth (m)	Graphic Log	ROCK MASS DISCONTINUITIES			Description & Additional Observations	Water Level / Fluid Loss (%)	Casing	Installation	Core Box No
	SOIL: Classification, colour, consistency / density, moisture, plasticity	ROCK: Weathering, colour, fabric, name, strength, cementation									Fracture Spacing (mm)	RQD (%)	2000 2000 2000 90 90					
Fill	0.00m: Clayey gravelly SILT; dark greyish brown. Stiff, moist, medium to high plasticity. [FILL].

3.40m: Becomes highly vesicular 3.45 - 3.80m Crush Zone				PQTT	100												
Takanini Formation	4.50m: Core Loss																	
	4.75m: Medium to coarse SAND, some gravel; dark grey. Loosely packed, moist. Gravel, fine. [TAKANINI].				PQTT	83
