Subject:	Stream Erosion Risk Assessment	Date:	18/10/2024
		Memo No:	44712-ME-C-EG04-D
Site Address:	Whenuapai Business Park, Whenuapai, Auckland	Status:	For Notification
Author:	Paul Kleynhans (CPEng, BE)	No of Pages:	35

Memo

WHENUAPAI BUSINESS PARK – STREAM CONDITION ASSESSMENT

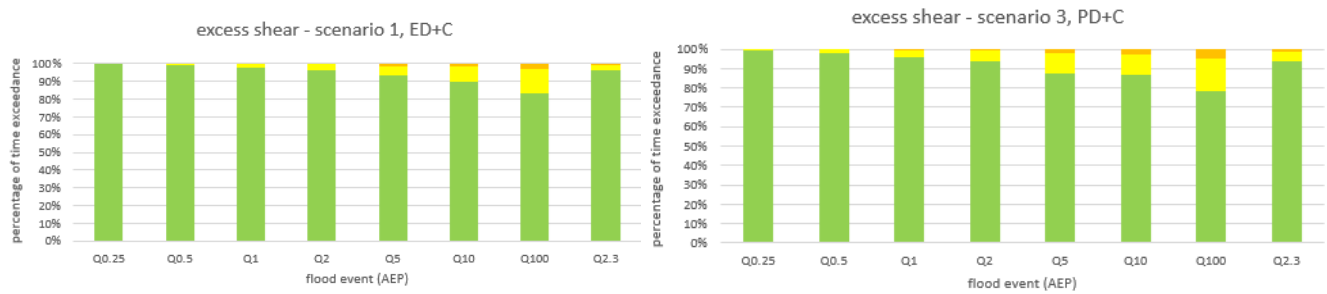
Figure 3 Location 1 Percentage of Time Exceedance

The results show that there is some potential for erosion in both pre- and post-development scenarios from 1 year ARI and above storm events at Locations 1 and 2, potential for some erosion from 0.5 year ARI and above storm events at location 3, and minor potential for some erosion from 2 year ARI and above storm events at Location 4. However, the excess shear remains low at the assessed locations with small percentage changes in erodibility potential between the pre-development and post-development scenarios.

Table 4 shows the changes in erosion potential are small between pre- and post-development. However, the Figures 3 to 5 show that there is potential for some erosion in the storm events of 0.5-year ARI and above at Locations 1, 2 and 3, which are not consistent with the site observation described in the “Stream Condition Assessment” Memo provided by Viridis Ltd.

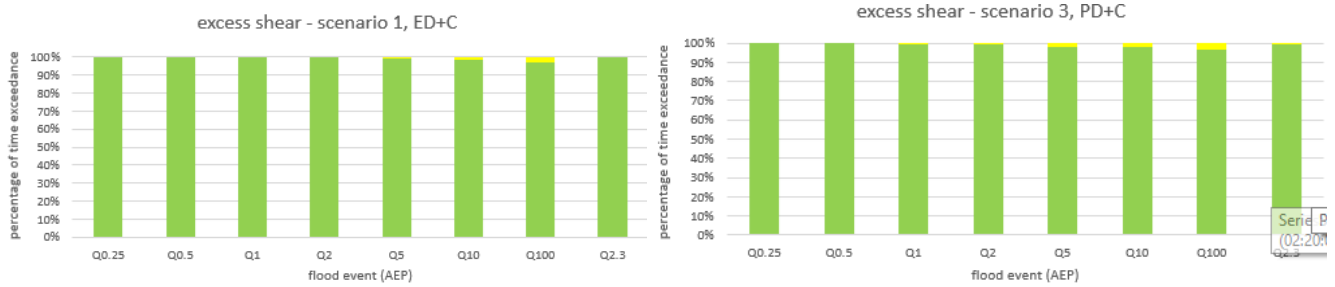
Figure 7 Location 1 Percentage of Time Exceedance (Critical shear stress 71.6N/m²)

As shown in Table 2, the 75th percentile critical shear stress in Auckland streams is 71.6N/m². Figures 7 to 10 show the percentage of time exceedance when critical shear stress of 71.6N/m² is applied at all assessed locations. The EST results are more aligned with the existing situation and show that the changes between pre- and post-development are insignificant.
