# Waitakere Coastal Communities Landslide Risk Assessment

**Overall Report - Muriwai**

Auckland Council
15 May 2024

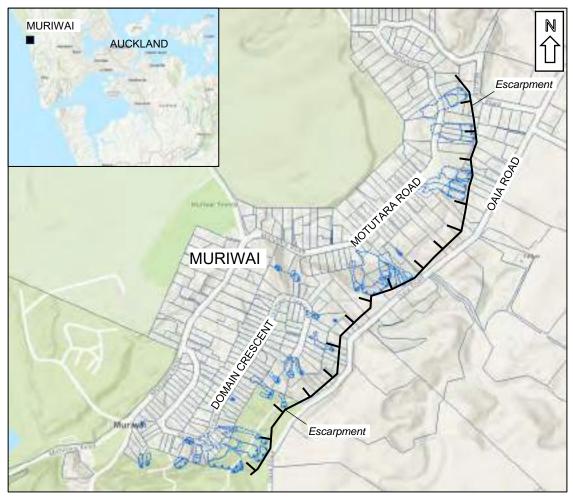
Figure 1 Muriwai location showing the February 2023 landslides mapped by GHD (blue lines)

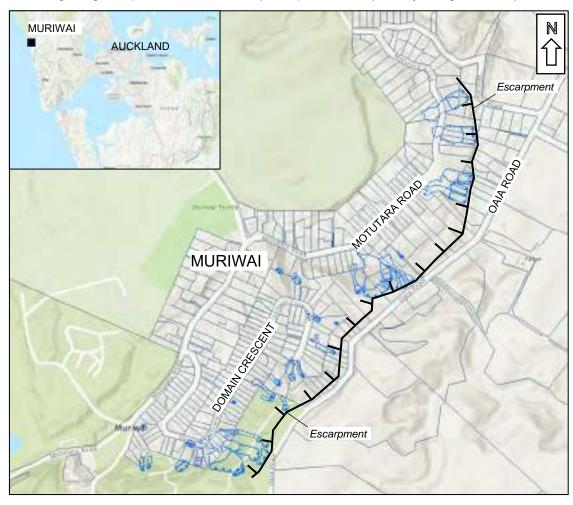
The crest of the escarpment is irregular along its length – some areas are inset further than others (Figure B1). Domain Crescent and Motutara Road are located within two larger inset areas and provide access to properties at the base of the escarpment. Oaia Road runs parallel to and setback from the crest and provides access to properties above the escarpment. Muriwai Beach, which comprises a long open coastline extending beyond the study area to the north, is accessed several hundred meters west of the escarpment, from which it is separated by sand dunes.

Figure B1 Muriwai location showing the February 2023 landslides mapped by GHD (blue lines)

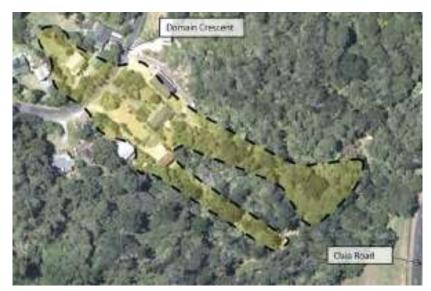
The two separate debris paths coalesced near the bottom of the escarpment and flowed across Domain Crescent (Figure B5 and Figure B6). Both the destroyed dwellings were located on the uphill side of the road and were translated with the debris flow.

Figure B5 Mapped extent of 1965 Landslides (after Wright 1966)

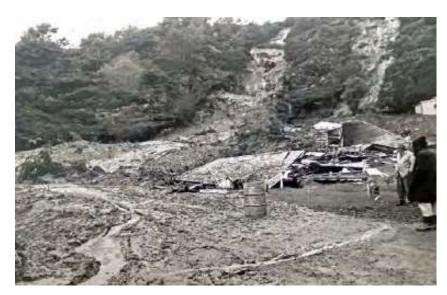
Figure B6 View from Domain Crescent of 1965 landslides and destroyed dwellings (after Wright 1966)

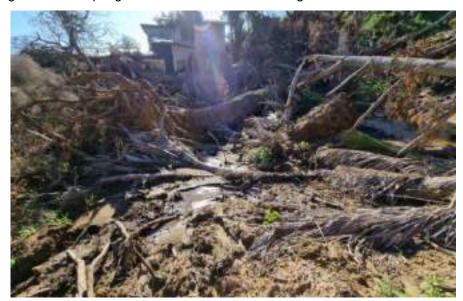
Figure B7 Entrained vegetation and sand/silt comprising the overall 'colluvial debris', GHD 2023. Debris resulting from Landslides M-LS07,08,09.

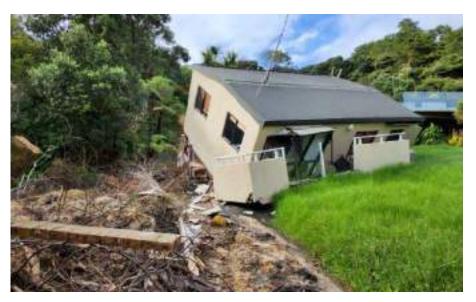
Figure B8 Example of significant destruction of dwelling, associated with landslide debris runout, GHD 2023. Debris resulting from Landslides M-LS12.

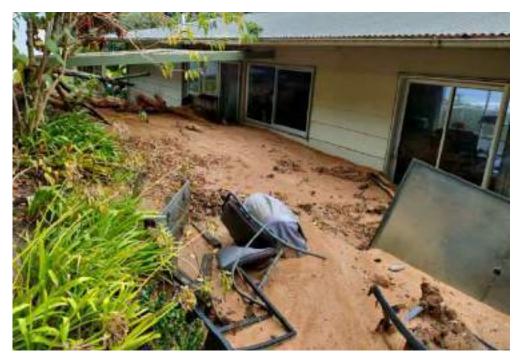
Figure B9 Example of engineering geological unit '2023 Recent Colluvium'. Medium grained sand, unconsolidated, spread out thinly across existing surfaces.

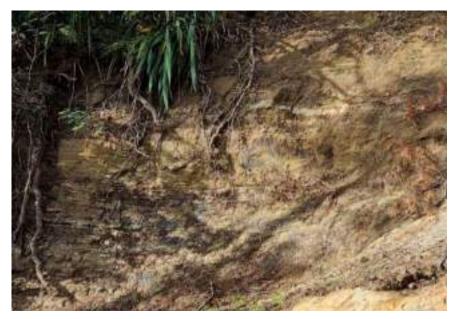
Figure B13 Outcrop of Awhitu Sand Formation - Less Cemented Sands, cross bedding evident (left). Exposed within 2023 landslide, Domain Crescent.

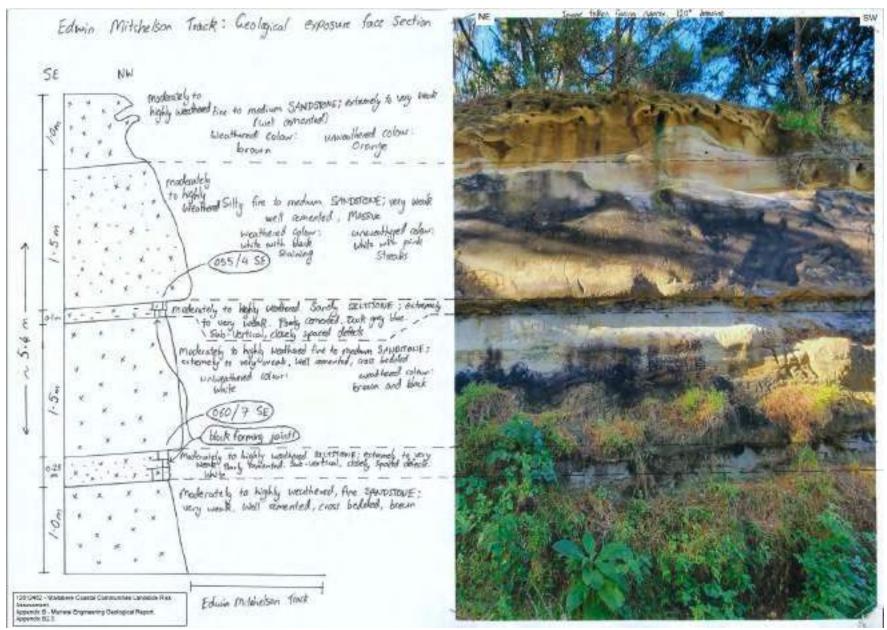
Figure B15 Face log of Awhitu Formation Less Cemented Sands preserving rock fabric and structure, Edwin Mitchelson Track cut slope. Refer Figure A116 for specific location (marked).

Recently exposed sands (landslide slip surfaces) often retain near-vertical bluffs and rock mass fabric (block jointing and bedding, Figure B15); however, it is easily disrupted when physically agitated or when water is passed through it, as observed by sections of shallow core having disaggregated upon recovery. This is not observed with core at depth.

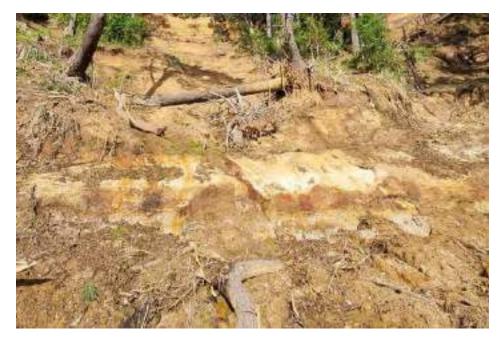
Figure B16 Outcrop of Awhitu Formation – Less Cemented Sands, layer of finer grained material (silt, clay). Approximate thickness 1 m.

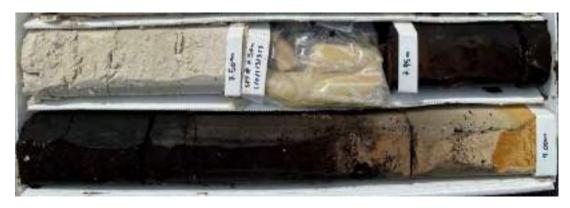
Figure B17 Example of layer of peat/organic soil within Awhitu Formation Less Cemented and Cemented Sandstones, from BH-M02, between 7.95 8.75 m bgl.

Silt/clay rich beds and thinner lenses are encountered randomly at depth with poorly defined lateral connection. They are not interpreted to be continuous over the study area however are observed to extend at least 100 m laterally approximately (Figure B23). These layers are often associated with areas of flatter slope profile, illustrated as 'mid-slope benches' on Figures A112-116. Organic layers are less common and only observed as <1.0m layers/lenses within borehole core (Figure B17).

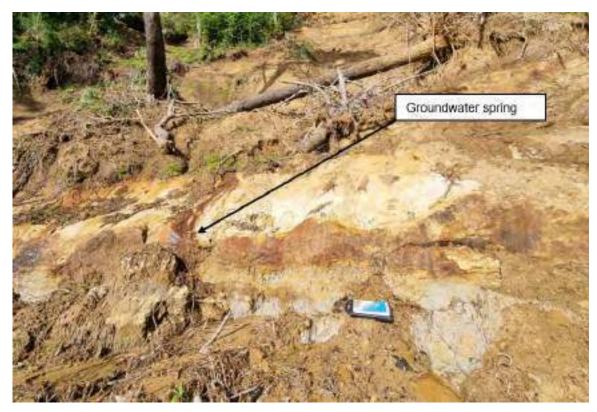
Figure B21 Groundwater spring emitting above silt/clay bed within Awhitu Formation 'less cemented' sand.

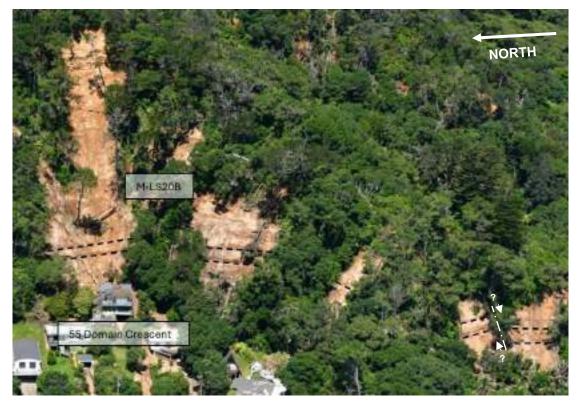
Figure B23 Example of lateral extent of near horizontal silt/clay beds within Awhitu Group, indicated by dashed line. Domain Crescent, M-LS20B for reference. Gentle dip due north – northeast.

- The landslides expose less cemented Awhitu Formation sands with silt and clay beds, along the sliding surface (Figure B23). The height of observed main scarps and corresponding depth of slip surface relative to the pre-existing ground profile was observed during field mapping to be between 0.5 m and 1.5 m.

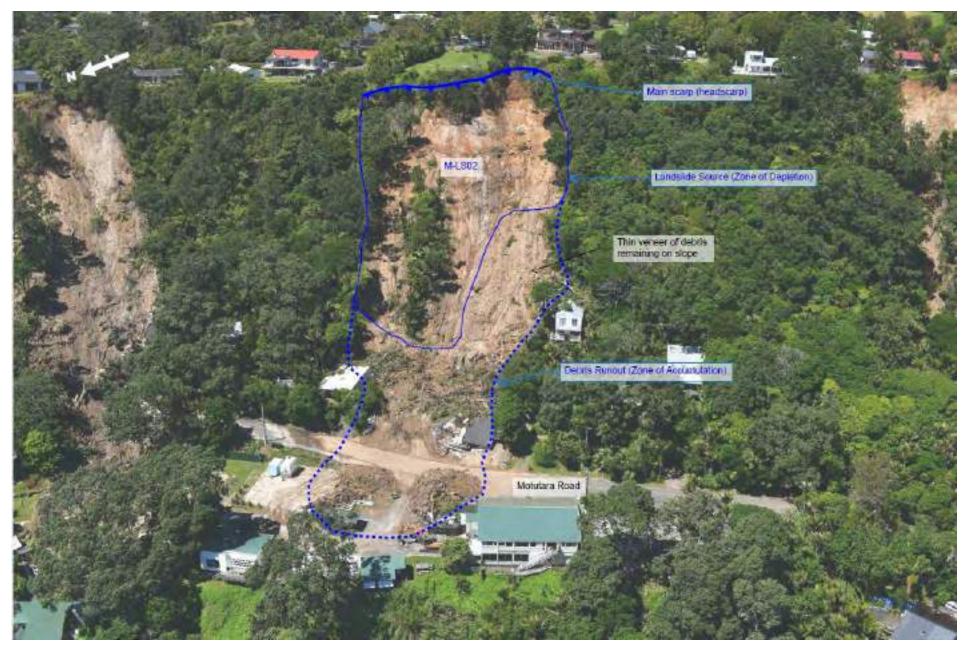
Figure B24 Typical features of single landslides areas.

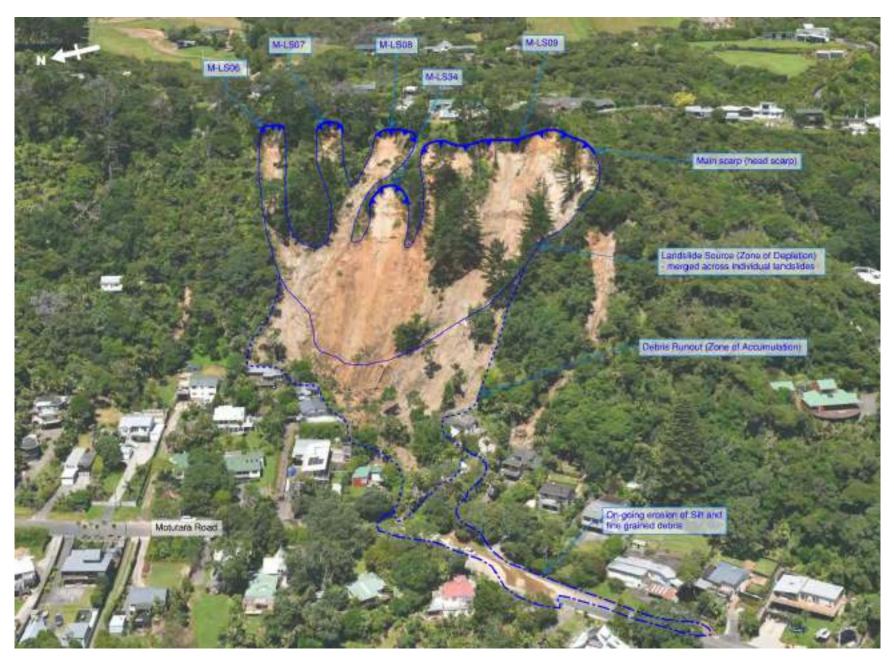
Figure B25 Typical features of larger, merged landslide areas.

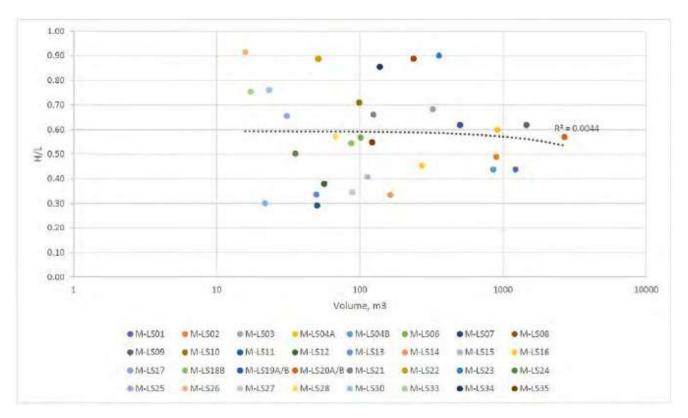
We have also compared the relationship between landslide volume and runout distance by presenting the data on a H / L vs volume plot (Figure B28). As is apparent from the plot, there is a broad scatter of data with a poor correlation between the H / L ratio and landslide volume. Runout estimation methods based on a volume relationship such as Finlay et al (1999) therefore do not appear to be useful in the case of Muriwai. This is consistent with commentary in the literature by Hungr et al. (2005).

Figure B28 Height / Length ratio vs volume plot for all Muriwai landslides on the main escarpment

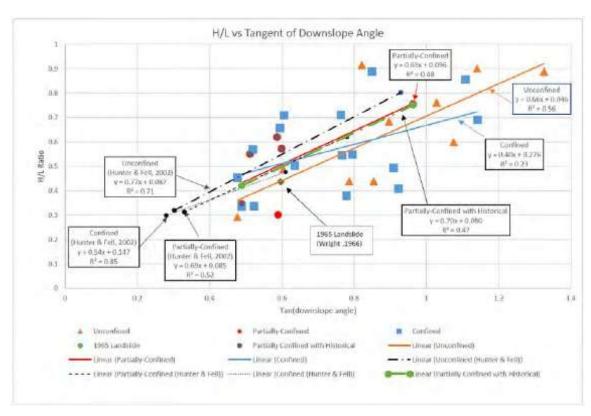
The Muriwai landslide data is presented on a H / L ratio vs tangent of the downslope angle plot according to the Hunter & Fell (2002) method (Figure B29). This also includes data for the 1965 landslide. Regression lines have also been established based on the degree of confinement. The regression line for a 'partially confined' travel path was found to be very similar to the Hunter & Fell (2002) regression line for a 'partially confined' travel path.

The predicted travel distances using the Muriwai relationship are very similar to the Hunter & Fell (2002) method, albeit usually at the higher end of the travel distance angle range. Based on the results of this exercise there is a good correlation between landslide runout and the downslope angle for the landsliding at Muriwai, meaning that landslide runout will vary across the escarpment depending on the local geomorphology. The close similarity between the Hunter & Fell (2002) predictive method and the Muriwai relationship probably suggests that while some variability is to be expected, future landslides are unlikely to travel appreciably further than the observed February 2023 runout distances.

Figure B29 H/L versus tangent of the downslope angle  $\alpha_2$  plot for Muriwai data together with Hunter & Fell (2002) relationships for rapid slides on steep natural slopes in dilative soils.

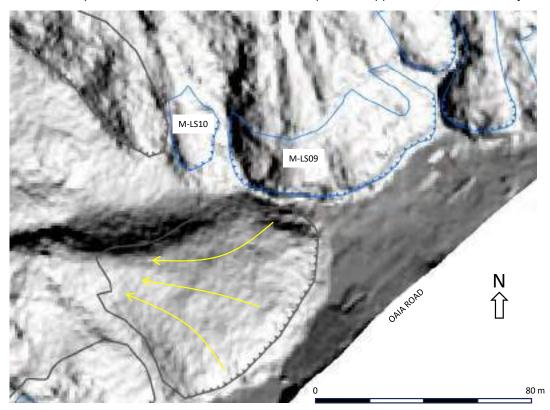
Potential landslide failure zones have been identified based on having similar geomorphology (ground shape) and geology to February 2023 landslide source areas. For example, the bowl-shaped head-scarp shape of recent landslides observed at the crest of the escarpment is similar to the shape of the escarpment where failures did not occur in 2023 (Figure B30) but have almost certainly occurred at some time in the past. Hence, we infer that the whole of the escarpment has similar landslide susceptibility due to the likely similar conditions of geology and possibly groundwater. We have assumed that future landslides on the escarpment have the potential to fail with similar damaging effects as the February 2023 landslides. Inferred landslides were used as RAMMS debris flow source areas to model potential future landslide hazard areas (see the Appendix D RAMMS analysis report).

Figure B30 Potential landslide failure zones have been identified by GHD based on having similar geomorphology (ground shape) and geology to February 2023 landslide source areas. The above example shows a potential landslide source zone (grey outline) that has similar bowl-shaped characteristics to recently failed blue areas. Yellow lines indicate expected debris flow path. Background surface model has a 'hill shade' applied to highlight the geomorphology. Location is below the escarpment and west of Oaia Road.

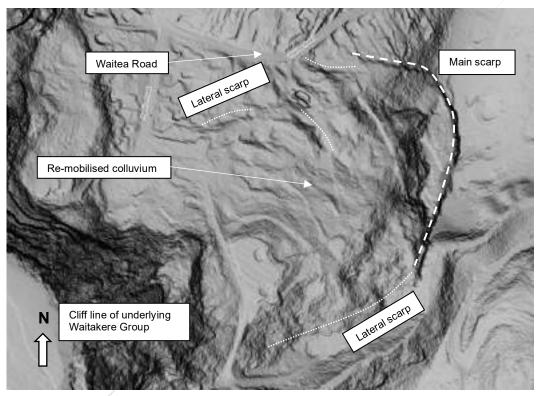
Figure B31 Deep seated landslide (earthflow) within Awhitu Sand Formation, underlying contact with Waitakere Formation daylighting in toe area (cliffs). Background surface model has a 'hill shade' applied to highlight the geomorphology.

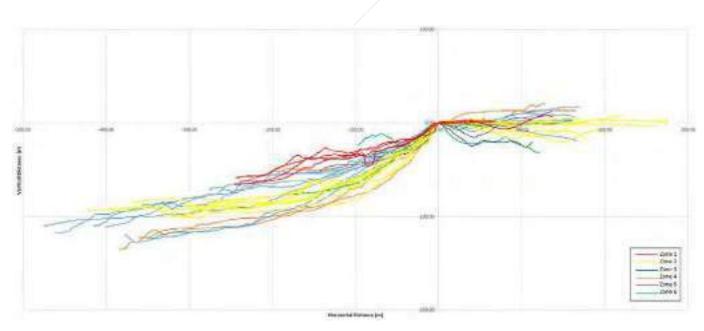
Figure B32 Slope profile comparison of 27 cross sections in Zones 1 to 6 (see Figure A137). Profiles are mostly viewed in a north-looking direction and have been centred on the crest of each slope (in most cases this is the top of the escarpment).

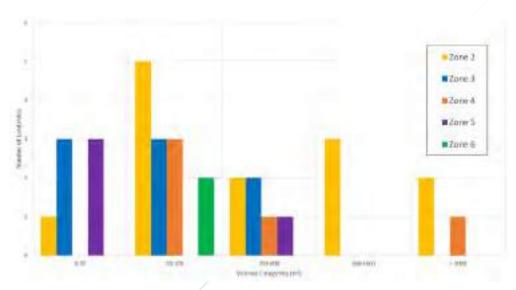
Figure B34 Number and size of February 2023 landslides shown per zone

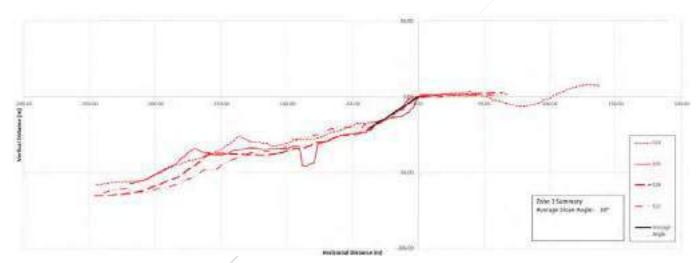
- The steepest part of the slope at the top of Motutara Road is approximately 30°, which is relatively flat (see Figure B36).
- The vertical height of the slope at this steepness is approximately 20 m, which is one of the lowest on the escarpment.
- No large landslides occurred in this area in the February 2023 storm event.
- The general slope-facing direction is towards the southwest, which may not directly face the direction of origin for sub-tropical cyclone storm events.

Figure B36 Slope profile comparison of Zone 1 surface cross sections (see Figure A137 for location of sections)

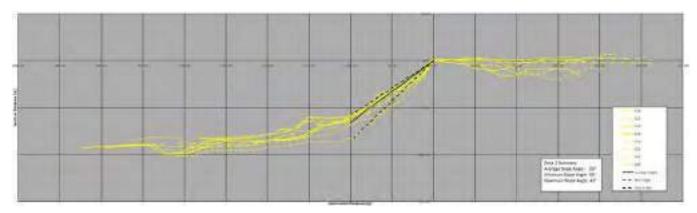
- The average slope angle is 33° but is locally much steeper (see Figure B37).
- The vertical height of the slope is greater than 70 m on average, which is the highest of all zones.
- Thirteen large landslides occurred in Zone 2 in the February 2023 storm, with two having a volume greater than 500 m<sup>3</sup>. The landslides are commonly broader relative to other zones (e.g. Zone 3).
- The general slope-facing direction is to the west, which is expected to be towards future sub-tropical cyclone storm events.
- The shape of the escarpment tends to be mostly gently and continuously curving. Elsewhere on the escarpment, for example in Zone 3, there are many distinctive, tightly curved headscarp features.

Figure B37 Slope profile comparison of Zone 2 surface cross sections (see Figure A137 for location of sections)

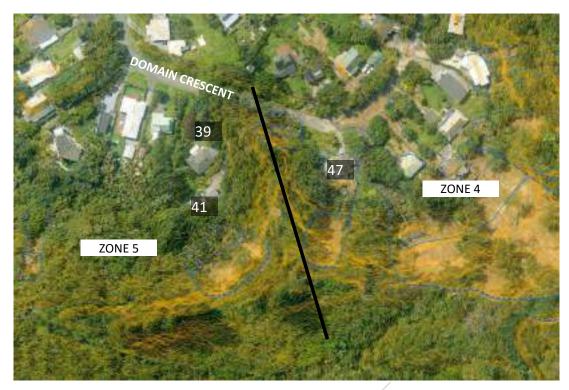
Figure B40 Location of the Zone 4 / Zone 5 boundary. North is to the top of the page.

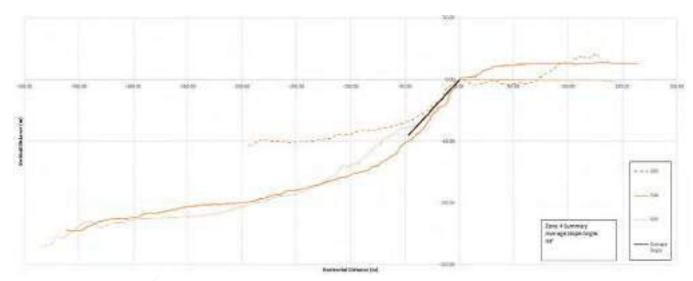
- The average slope angle is 44°, which is relatively steep (see Figure B41).
- The vertical height of the slope at this steepness is approximately 50 m, which is less than in Zones 2 and 3.
- Five large landslides occurred in February 2023, with one over 1000 m<sup>3</sup> in volume. Note that Zone 4 is smaller than other, similar zones and so the number of landslides may give a false impression of the exposure of dwellings at the slope base.
- This is the location of the large 1965 landslide (see Section B3.3.2).
- The general slope-facing direction is to the west, which is expected to be towards future sub-tropical cyclone storm events.
- The escarpment has many distinctive, tightly curved headscarps.

The observations above indicate a regime with a demonstrated potential for large, destructive landslides on a similar scale to Zone 2.

Figure B41 Slope profile comparison of Zone 4 surface cross sections (see Figure A137 for location of sections)

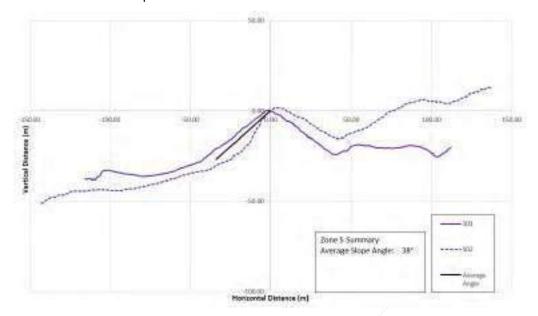
- The slope is approximately 38°, which is derived from only two cross sections (see Figure B42).
- The slope facing Domain Crescent is one side of a ridge, meaning that the catchment for surface water or groundwater recharge is limited compared with escarpment zones. This may mean that Zone 5 is less susceptible to landslides.
- Four landslides occurred in the February 2023 storm, most of which were less than 50 m³; none impacted dwellings.
- The general slope-facing direction is towards the northwest, which may be the direction of origin for future sub-tropical cyclone storm events.

When considering the potential for future landslides, we suggest that Zone 5 may have favourable conditions due to the topography, which does not encourage storage of groundwater behind the slope, and the limited potential for surface runoff to saturate the slope.

Figure B42 Slope profile comparison of Zone 5 surface cross sections (see Figure A137 for location of sections)

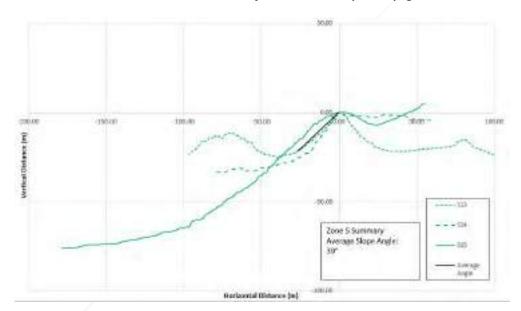
- The average steepness of the three cut profiles is about 39°, although the variability of the profiles is noted (see Figure B44).
- The vertical height is approximately 20 m, which is relatively low.
- Two landslides in the range of 50 to 150 m<sup>3</sup> were recorded following the February 2023 storm event.
- The general slope-facing direction is towards the north.

When considering the potential for future landslides, we consider that Zone 6 may have favourable conditions due to the topography, which does not encourage storage of groundwater behind the slope, the low slope height, and limited potential for surface runoff/saturation.

Figure B44 Slope profile comparison of Zone 6 surface cross sections (see Figure A125 for location of sections)

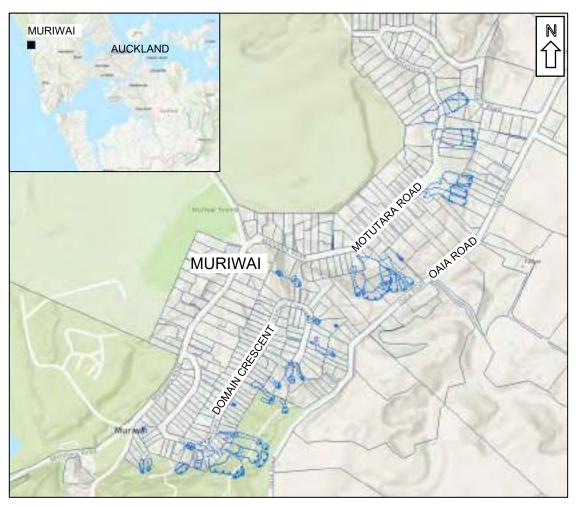
Figure C-1 Muriwai location showing the February 2023 landslides mapped by GHD (blue lines)

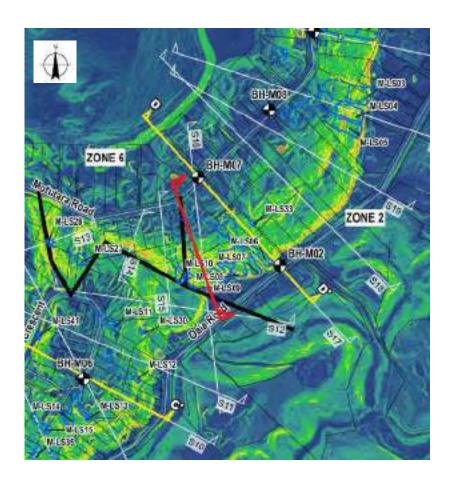
The cross section shown in Figure C-2 was selected for assessment purposes as being a conservative (i.e. steep) example of the range of failure geometries. The cross-section extends for approximately 260 m horizontally approximately 100 m vertically. A comparison of landslide cross section profiles is presented in Figure C-3.

Figure C-2 Assessment area plan indicating the major February 2023 slip areas and the analysed cross-section A-A (retrieved from Google Earth Pro and GHD Atlas). A close-up view of Figure A125 (see Appendix A) showing the analysed cross section 'A' relative to other slope profiles, cross sections and boreholes.

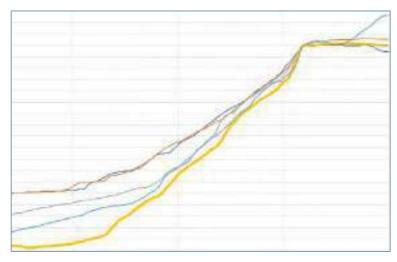
Figure C-3 Indicative comparison of cross section slope profiles at February 2023 landslide sites. The slope profiles at the upper slope have a similar geometry. The thick orange line is the analysed profile.

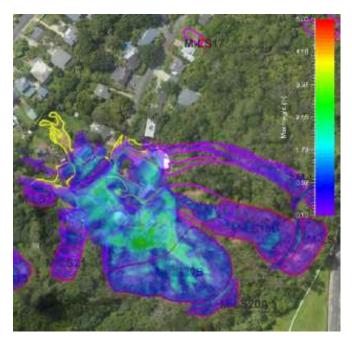
Figure D2 Best calibration of large slides southeast of Domain Crescent (M-LS18A, 18B, 19A, 19B, 20A, 20B, 21, 22 & 23). Mu = 0.225, Xi = 87.5, showing with 0.01-5 m filter. Note small landslide on the left that modelled as travelling further than observed.

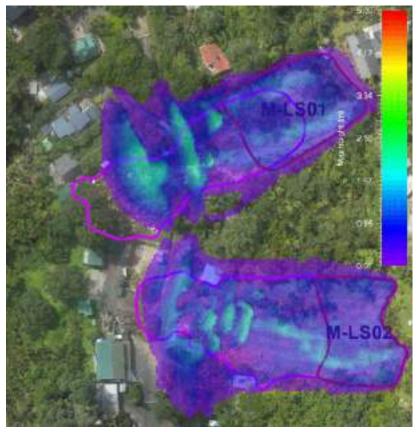
Figure D3 Best calibration of large slides at north end of Motutara Road (ID M-LS01 and M-LS02). Mu = 0.225, Xi = 87.5, showing with 0.01-5 m filter. Note modelled debris flow lobe is wider than observed.

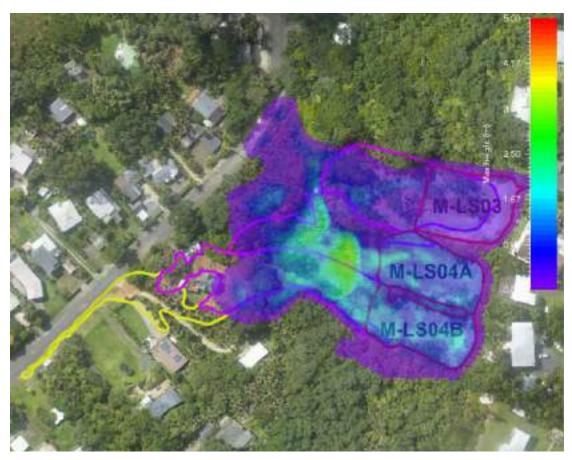
Figure D4 Best calibration of large slides at Motutara Road (M-LS03, M-LS04A and M-LS04B). Mu = 0.225, Xi = 87.5, showing with 0.01-5 m filter

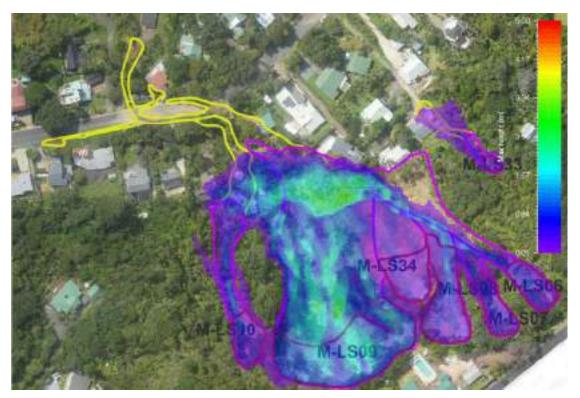
Figure D5 Best calibration of large slide at Motutara Road (M-LS06, 07, 08, 09, 10, 33 & 34). Mu = 0.225, Xi = 87.5, showing with 0.01-5 m filter

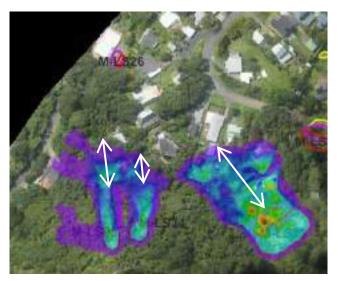
Figure D7 Zone 5 RAMMS simulation showing how the use of (Revision 0) analysis parameters are overly conservative. White arrows show the debris travelling beyond the mapped landslide extents.

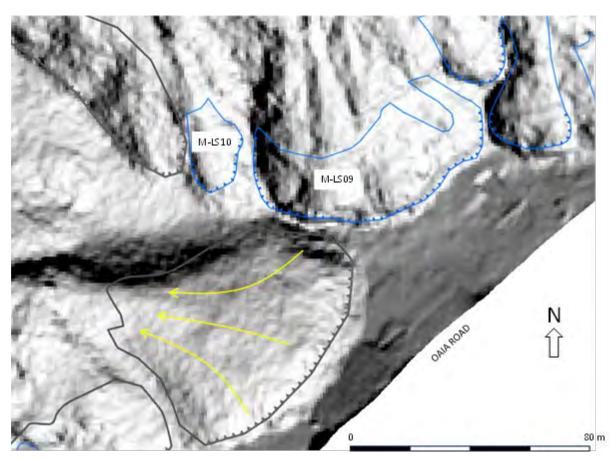
Potential landslide failure zones have been defined by GHD based on having similar geomorphology (ground shape) and geology to February 2023 landslide source areas. The above example shows a potential landslide source zone (grey outline) that has similar bowl-shaped characteristics to recently failed blue areas. Background surface model has a 'hill shade' applied to highlight the geomorphology. Location is below the escarpment and west of Oaia Road (see Figure A115 in Appendix A).

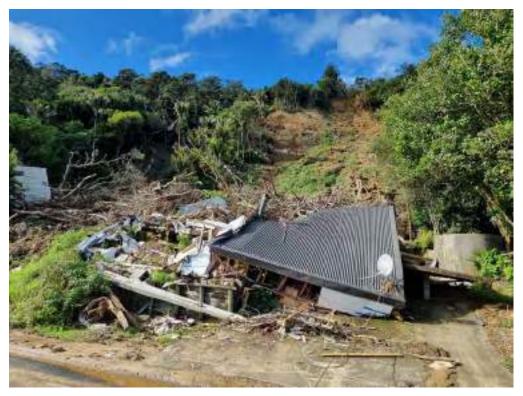
In many observed instances trees entrained in the landslide mass played a large role in the destruction of dwellings in the 2023 event (Figure E4 to Figure E7). Accumulations of trees and other vegetation were commonly rafted and entrained towards the top of each slide mass which subsequently impacted the upslope side of dwellings. The thickness of these accumulated piles of vegetation debris sometimes exceeded 3 m. It is clear that the direct impact effects of the vegetation piles into dwellings were responsible for extensive damage and complete destruction in a number of circumstances.

Figure E2 Example of a dwelling completely destroyed on Motutara Road where two fatalities occurred.

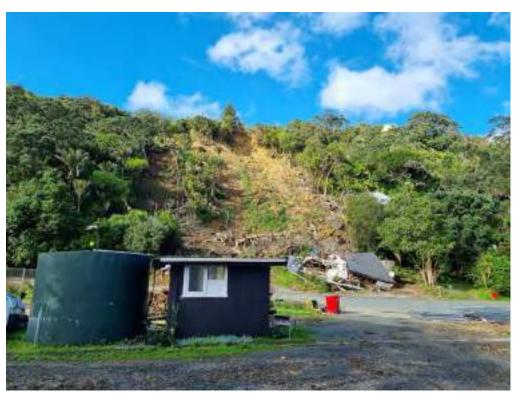
Figure E3 View of same dwelling pictured in Figure E2 showing overall view of landslide with accumulated vegetation at toe of slide.

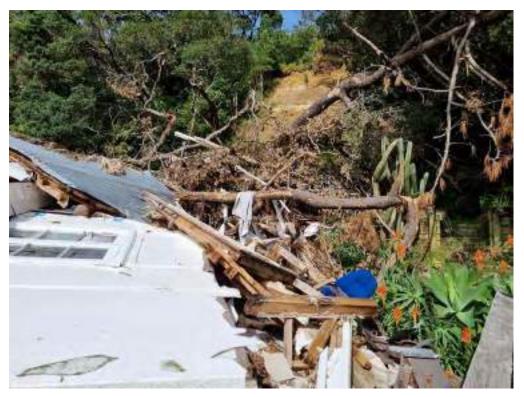
Figure E4 Example of a dwelling on Domain Crescent completely destroyed by landslide with large pile of accumulated vegetation debris on upslope side.

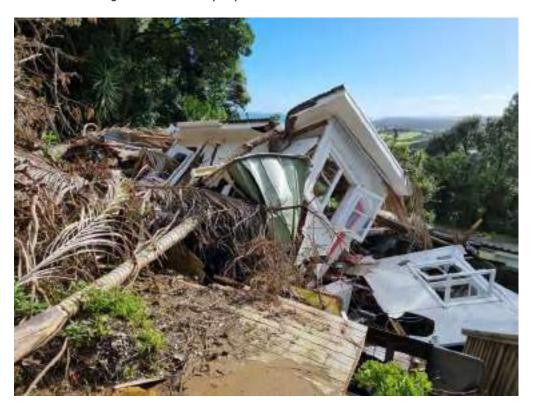
Figure E5 View of upslope side of completely destroyed timber frame dwelling. Note large pile of accumulated vegetation debris on left.

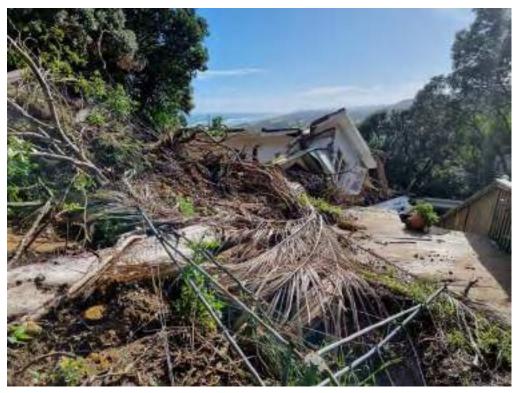
Figure E6 View of the same dwelling pictured in Figure E5 taken further upslope. Note mixture of soil debris and vegetation. Residence has been moved several metres downslope.

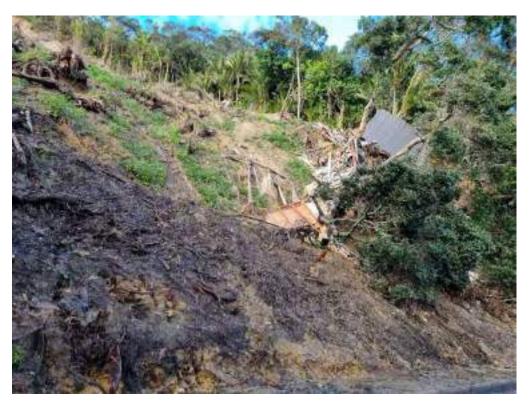
Figure E7 View of remains of completely destroyed house on slope above Motutara Road. Note mixture of soil debris and vegetation.

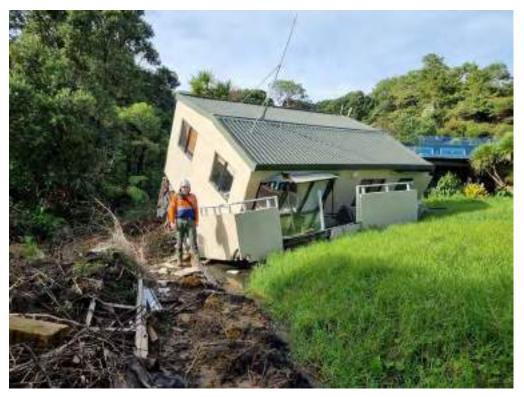
Figure E9 Example of a dwelling on Domain Crescent where ground floor of the structure has collapsed causing house to topple over with the upper storey remaining largely intact.

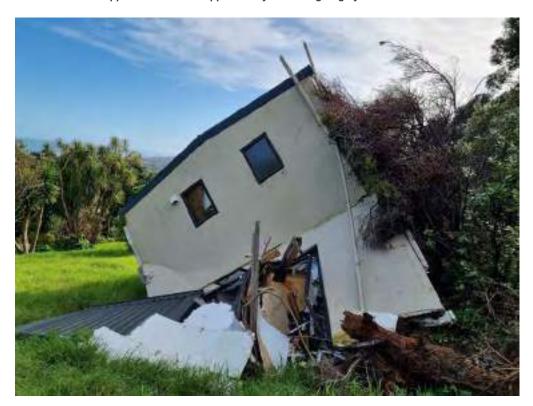
Figure E10 View of side profile of dwelling pictured in Figure E9, showing collapse of the ground floor and build-up of vegetation debris at rear.

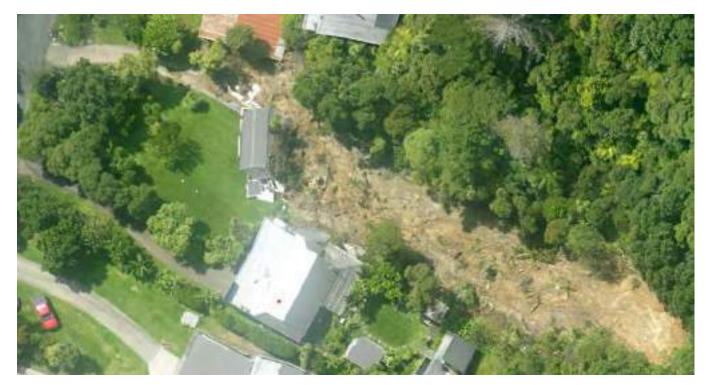
Figure E11 Aerial view of dwelling pictured in Figure E10. The debris flow originated at the far right of the photo.

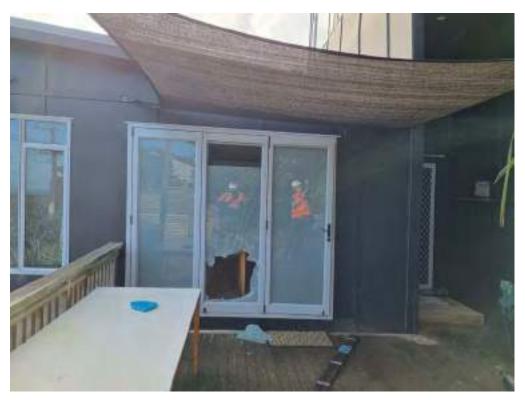
Figure E12 and Figure E13 present another example of a two-storey timber frame house impacted by a landslide. The dwelling has deformed as is evident by the tilting of walls and distortion of door frames, but the structure is largely intact, and no inundation appears to have occurred. The survivability from this damage is also considered to be very high.

Figure E12 Side view of home above Motutara Road. Note tilting of upper storey wall and deformed window frame.

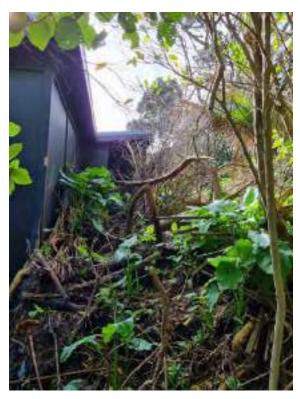
Figure E13 View of upslope side of dwelling pictured in Figure E12 showing accumulated landslide debris against rear wall.

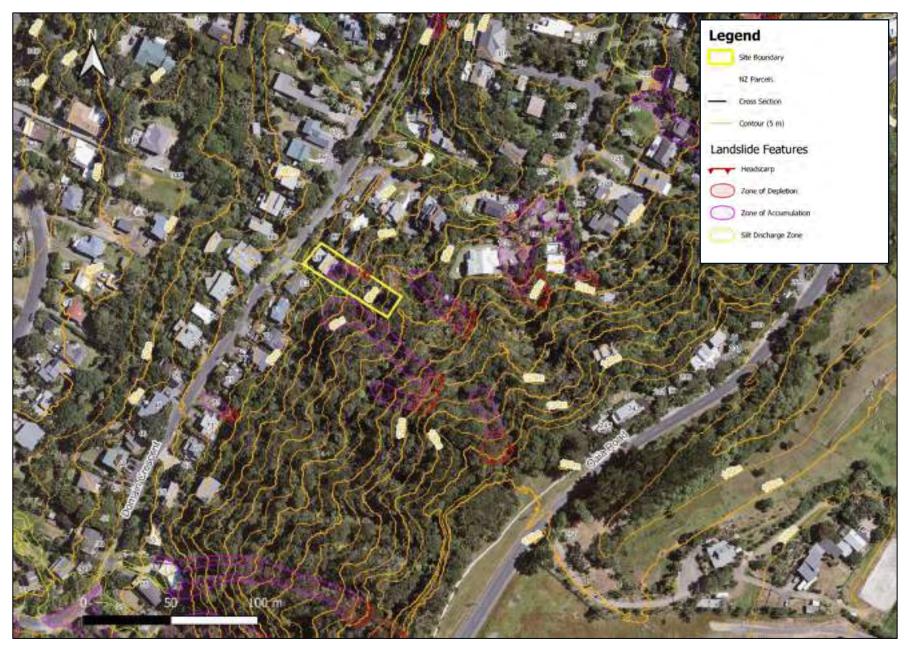
Figure 2.1 Site location along Domain Crescent

Two 'large' landslides (mapped on Figure 2.1) originating to the west of the site occurred during Cyclone Gabrielle but did not affect the dwelling. A third, smaller scale, localised failure originating from within the property boundary at approx. 83 m RL developed into a debris flow which impacted the rear of the dwelling causing structural damage.

One of the large-scale failures originating on slopes at higher elevations above the site (approx. 120 m RL) developed into a channelised debris flow reaching Domain Crescent. Silt discharge from the debris partially inundated the elevated timber deck on southern side of the dwelling.

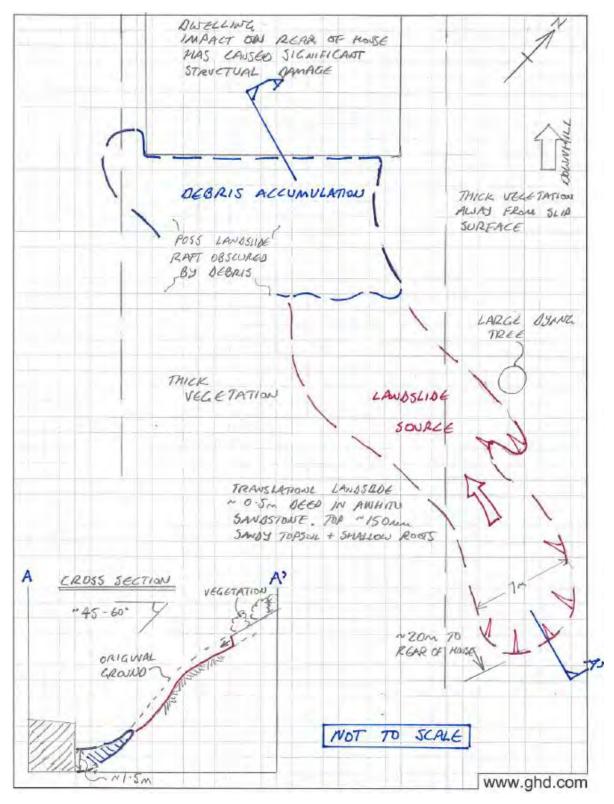
Figure 2.5 GHD site mapping of the landslide (completed 11 December 2023)

The landslide that occurred within the site is illustrated by site mapping on Figure 2.5 and is also shown in the context of different imagery on Figure 2.6 and Figure 2.7 below. An interpretive cross section prepared through the site is presented in Figure 2.12. Ground conditions have been interpreted from a combination of historical data, site mapping and nearby geotechnical investigation data. The cross section is indicative only and may not be representative of actual conditions.

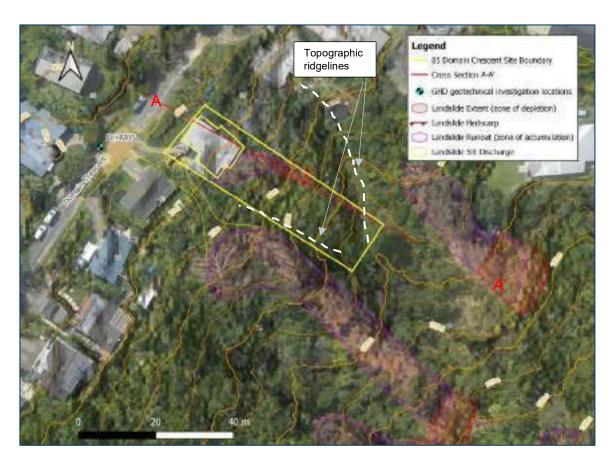
Figure 2.6 Landslide locations relative to the site shown on February 2023 aerial image.

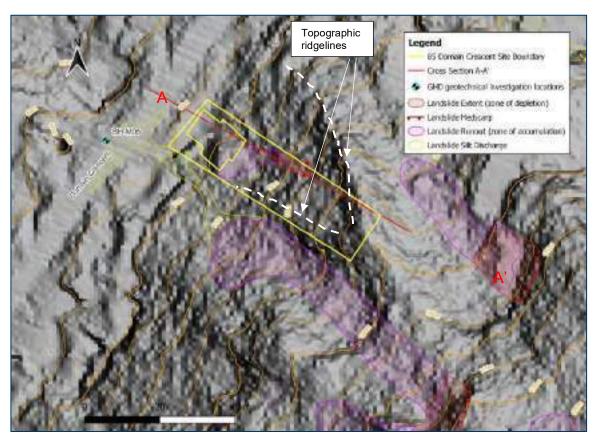
Figure 2.7 Landslide location relative to the site shown on LiDAR Hillshade (source: Auckland Council Feb 2023).

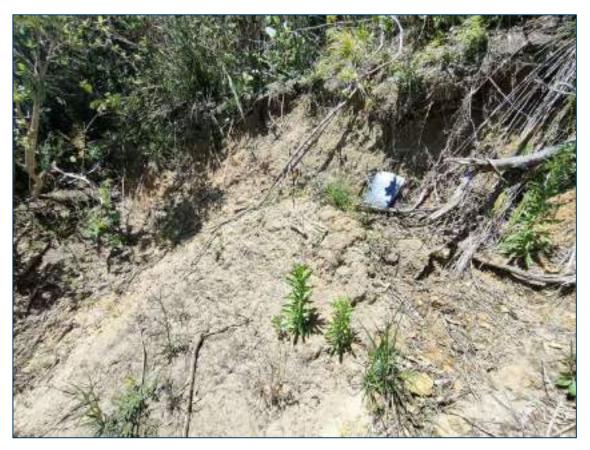
Figure 2.8 Exposed headscarp of landslide.

The landslide headscarp (Figure 2.8) has an approximate width of 7 m and is approximately 10 m above the rear of the dwelling near the crest of a ridgeline. Following a high degree of ground saturation, it initiated on a 30-35° vegetated slope as a shallow (~ 0.5 m deep) translational failure (Figure 2.9) which developed into a debris flow, likely entraining additional material on its descent. The initial landslide source volume was approximately 20 m³, increasing to approximately 60-80 m³ following entrainment. The landslide impacted the rear of the dwelling (Figure 2.10). The resulting damage to the dwelling included widespread structural deformation (see Figure 2.11 and T+T, 2023) with no immediate building collapse. Inundation of the of the decking was also recorded, which, according to our mapping is likely a result of secondary silt discharge from the large-scale landslide that occurred to the south of the site.

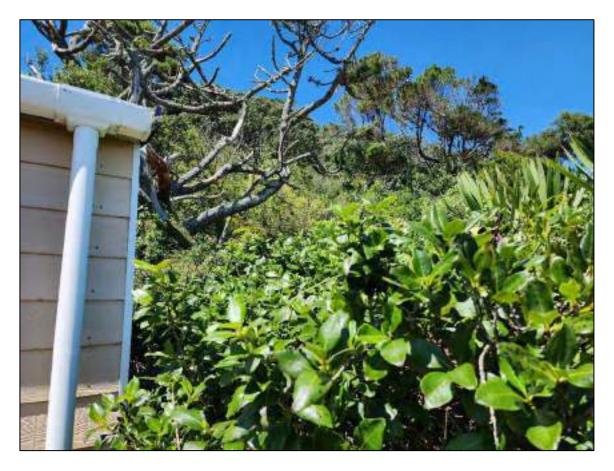
There is a single dwelling on the property located towards the base of the slope, adjacent to Domain Crescent. The dwelling is constructed on timber poles built into the slope which has been modified slightly to accommodate it. The natural, vegetated slope behind the dwelling (Figure 2.1 and Figure 2.2) has an average slope gradient of approximately 35° which increases to approximately 60° where it meets a prominent north-trending ridgeline at the eastern extent of the property boundary.

Figure 2.2 Steep vegetated slope at the rear of the dwelling

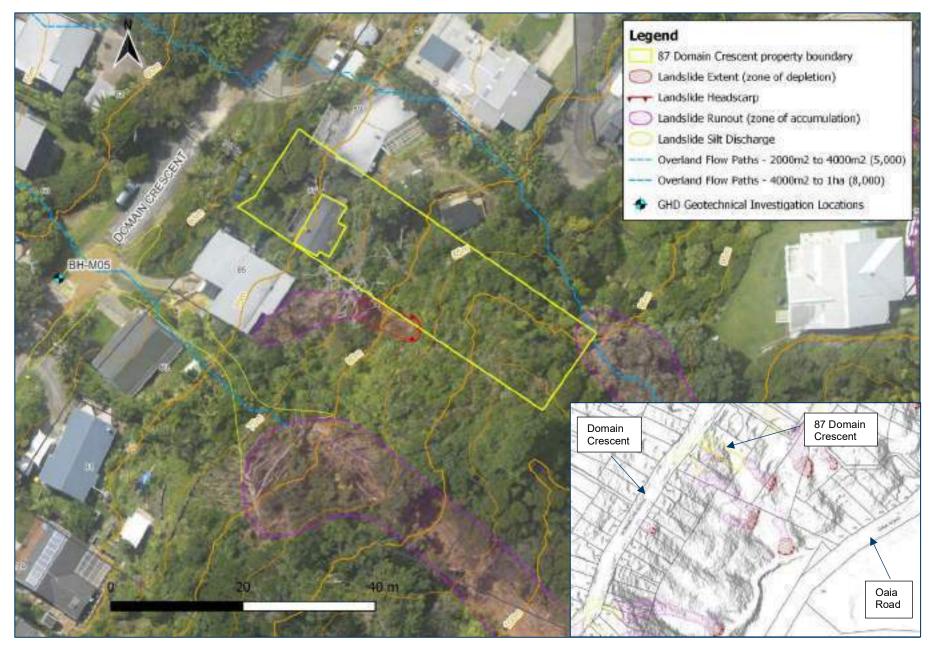
Figure 2.3 Site location along Domain Crescent

Two 'large' landslides originating at an elevation of approximately 110 m above the site occurred during Cyclone Gabrielle but did not affect the dwelling. A third, smaller scale, localised failure originating within the neighbouring property (No. 85) that partly encroaches within the property boundary of No.87 (mapped on Figure 2.3) at approx. 83 m RL developed into a debris flow which travelled in a southwest direction impacting the rear of the neighbours dwelling (No. 85) causing structural damage.

Two overland flow paths are mapped from Auckland Council's GeoMaps to the north and south of the property boundary (Figure 2.3) originating at approximately 105 m RL and 75 m RL to the southeast of the dwelling. Both overland flow paths have a catchment size of approximately 2000 m² to 4000 m². The travel paths of the debris associated with the two large scale landslides above the site, to the north and south, appear to correlate with the mapped overland flow paths. No overland flow paths are mapped on the slopes within the property boundary.

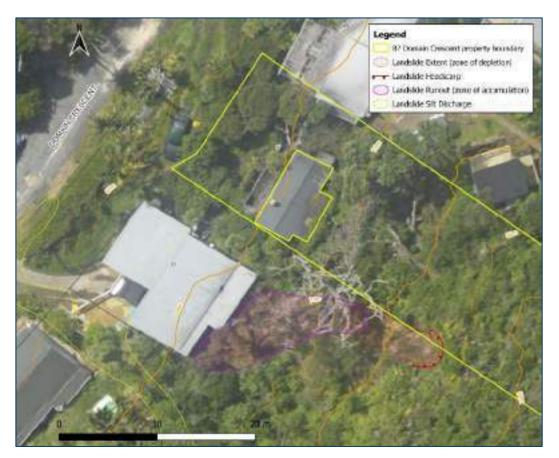
The landslide that occurred above the site, within the neighbour's property, is illustrated by site mapping on Figure 2.5 and is also shown in the context of LiDAR Hillshade imagery on Figure 2.6 below. An interpretive cross section prepared through the site is presented in Figure 2.7. Ground conditions have been interpreted from a combination of historical data, site mapping and nearby geotechnical investigation data. The cross section is indicative only and may not be representative of actual conditions.

Figure 2.5 GHD site mapping of the landslide affecting the site

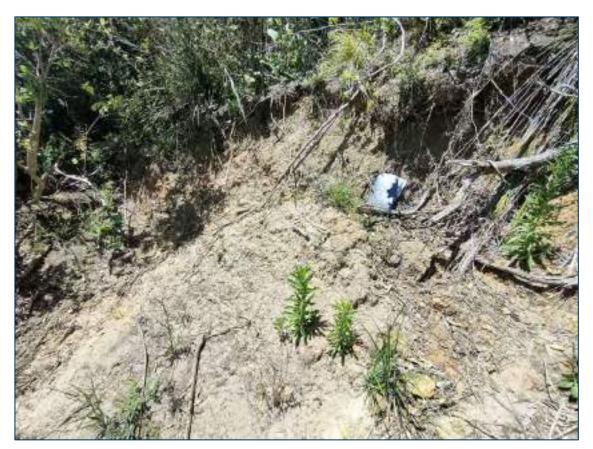
Figure 2.8 Exposed headscarp of landslide.

The landslide headscarp (Figure 2.8) has an approximate width of 7 m and is approximately 10 m above the rear of the dwelling, close to the crest of a ridgeline. Following a high degree of ground saturation, the landslide initiated on a 30-35° vegetated slope as a shallow (~ 0.5 m deep) translational failure (Figure 2.9) which developed into a debris flow, entraining additional material on its descent. The initial landslide source volume was approximately 20 m³, increasing to approximately 60-80 m³ following entrainment. The landslide impacted the rear of the neighbouring dwelling (Figure 2.10). No landslide debris entered the property of No. 87.

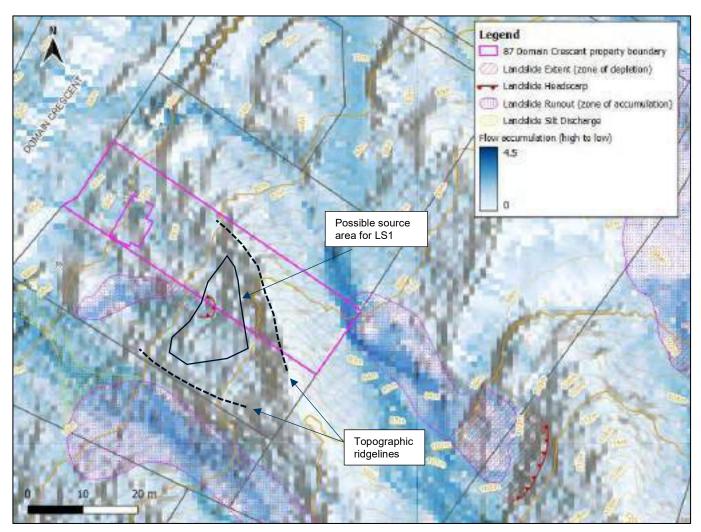
Figure 3.2 Flow accumulation map of 87 Domain Crescent and surrounding area. Indicates preferential flow path for surface water. Modelling based on 2023 DTM data.

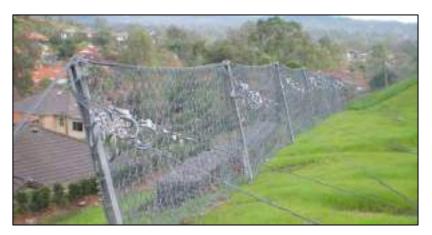
Figure 4.1 Example of proprietary flexible debris flow barrier

A flexible debris flow 'fence type' barrier has been selected as the most feasible option to mitigate the risk to the dwelling on the site. The limited access at the rear of the property and the steep slope conditions preclude alternative options such as a mass gravity embankment-type barrier. As shown in Figure 4.1 below, the flexible barrier comprises mesh supported by steel posts with upslope and lateral wire support ropes that are anchored several metres into the ground. An example of a commercially available proprietary system that could be adopted is a Geobrugg SL150 (3.5 m constructed height) or a modified RXI300 (5 m constructed height) or equivalent.

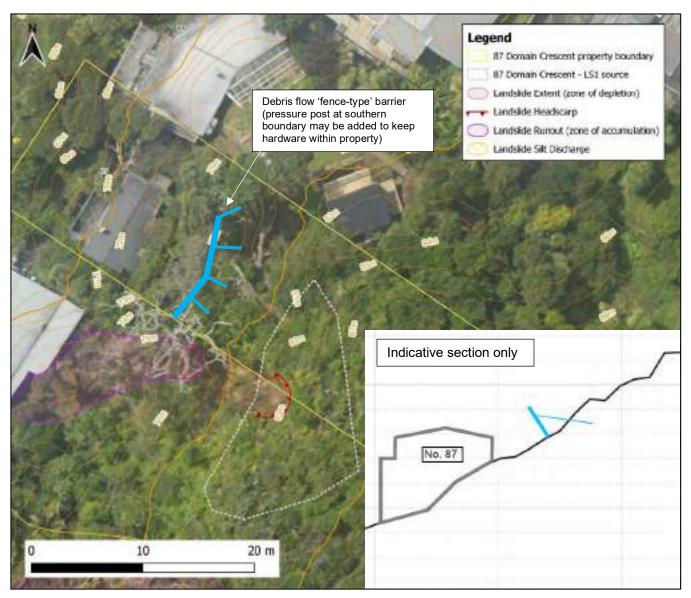
Figure 4.3 Site plan showing proposed mitigation option for 87 Domain Crescent

- Part of the barrier is located outside of the property boundary (within 85 Domain Crescrent).
- Access is considered to be 'hard' as there is no clear access to the proposed barrier location, which is on a slope of approximately 35°. Enabling works are likely required.
- The property is within the Significant Ecological Area (SEA) and damage to trees/vegetation would be likely for both access and construction.
- The subsurface conditions are likely to comprise medium dense to very dense sands overlying massive, extremely weak sandstone.
- Based on an estimated volume of debris of 40 m<sup>3</sup>, a fence type barrier height of 3.5 m would be adequate.

The proposed barrier location is above the dwelling at an approximate elevation of 76 m RL and has an approximate length of 10 m (Figure 4.3 below).

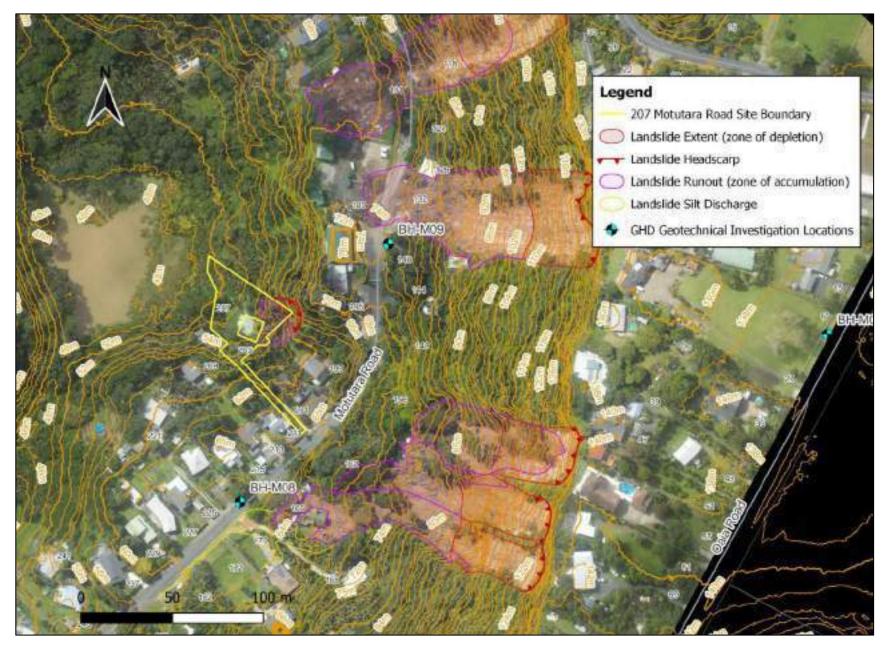
Numerous 'large' landslides (mapped on Figure 2.1) originating from the crest and upper slopes of the main escarpment to the east of the site occurred during Cyclone Gabrielle but did not affect the dwelling, terminating at or close to Motutara Road. A smaller scale, localised failure originating from the slopes below Motutara Road, just outside (to the east) of the property boundary, at approx. 65 m RL impacted the eastern side of the dwelling.

Figure 2.1 Site location at 207 Motutara Road, Muriwai

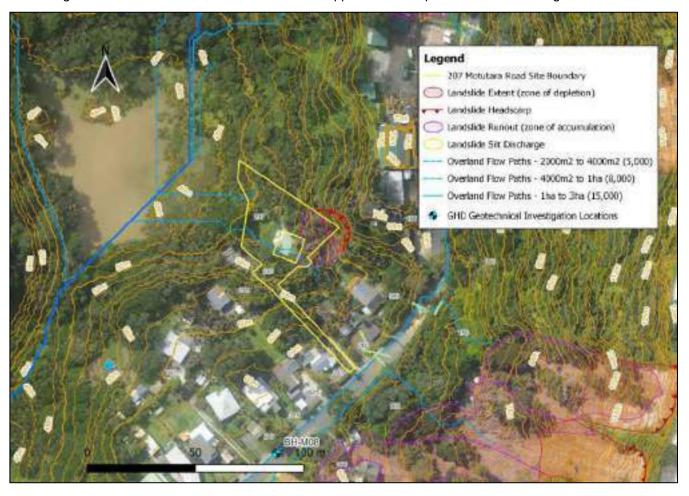
The landslide that impacted the dwelling does not appear to directly correlate with either of the mapped overland flow paths (see Figure 2.2).

Figure 2.2 Overland flow paths and underground services for the site (source: Auckland Council GeoMaps).
