# Waitakere Coastal Communities Landslide Risk Assessment

**Overall Report - Muriwai**

Auckland Council
15 May 2024

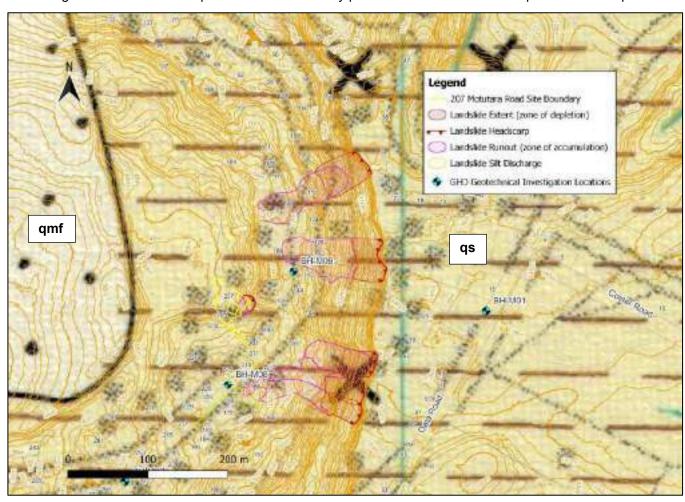
The published 1:50,000 scale geological map of the area (Hayward, 1983) indicates the site is entirely underlain by the Awhitu Sand Formation (qs), part of the Kaihu Group (Figure 2.3). More recently deposited Holocene aged (less than 10 kya) dune sands (qmf) are present at lower elevations, as part of the coastal landscape. These are approximately 100 m west of the property.

Figure 2.3 Excerpt of the Waitākere 1:50,000 scale geological map (Hayward, 1983<sup>5</sup>), illustrating the underlying geology at the site location.

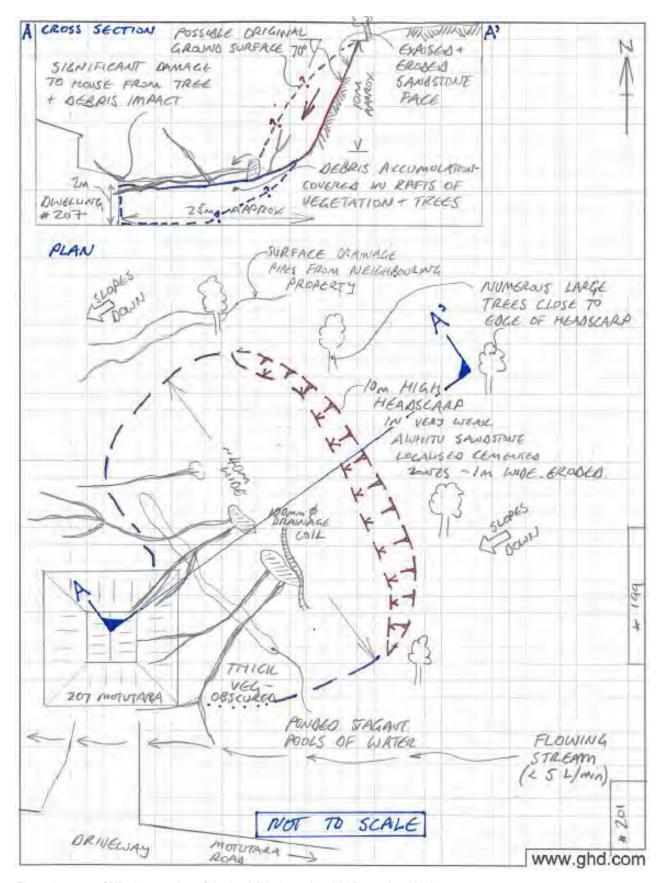
The landslide that impacted the dwelling at 207 Motutara Road is illustrated by site mapping on Figure 2.4 and is also shown in the context of different imagery on Figure 2.5 and Figure 2.6 below. An interpretive cross section through the site is presented in Figure 2.11. Ground conditions have been interpreted from a combination of historical data, site mapping and nearby geotechnical investigation data. The cross section is indicative only and may not be representative of actual conditions.

Figure 2.4 GHD site mapping of the landslide (completed 12 December 2023)

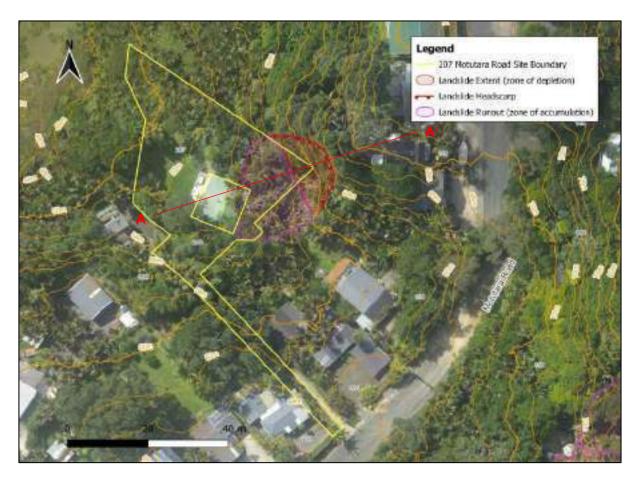
Figure 2.5 Landslide location relative to the site shown on February 2023 aerial image.

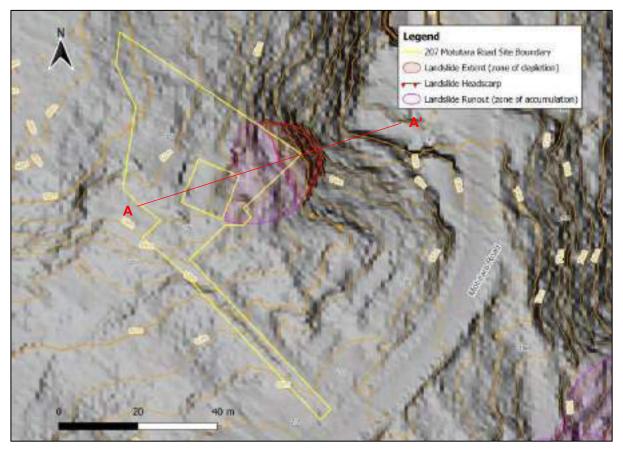
Figure 2.6 Landslide location relative to the site shown on LiDAR Hillshade (source: Auckland Council Feb 2023).

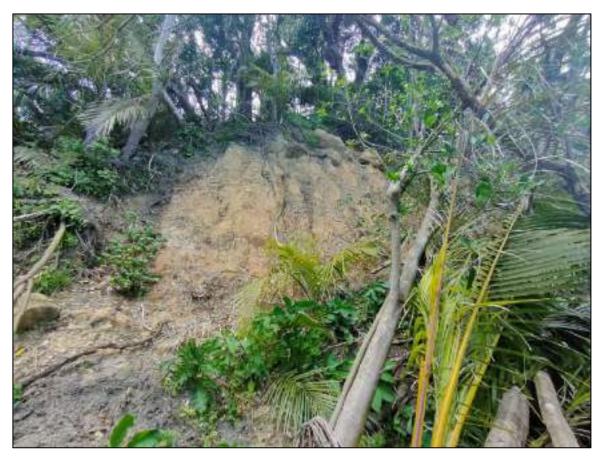
The landslide headscarp (Figure 2.7) has an approximate width of 15 m and is at an elevation approximately 15 m above the rear of the dwelling, near the crest of the localised escarpment below the topographic bench feature on which Motutara Road is located. Following a high degree of ground saturation, it initiated on a 30-40 $^{\circ}$  vegetated slope as a  $\sim$  1-2 m deep translational (with a possible rotational component) failure. The exposed headscarp has left a steeper 45-55 $^{\circ}$  slope profile.

Figure 2.7 Awhitu Sand Formation in the exposed landslide headscarp.

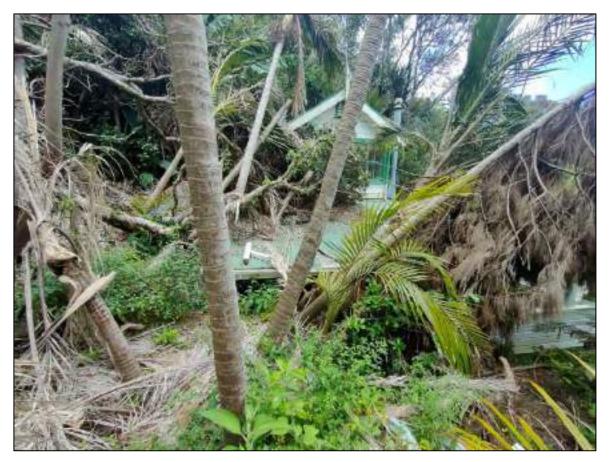
The landslide does not appear to have developed into a debris flow similar to failures seen elsewhere in Muriwai, likely due to its relatively short travel distance. A large volume (potentially up to 300 m³) of landslide debris was deposited at the base of the slope, with a maximum thickness of approximately 2 m impacting the rear of the dwelling (Figure 2.8 and 2.9). A significant portion of the damage to the rear wall of the dwelling was caused by the entrainment of large trees within the debris (Figure 2.9). No building collapse as a result of landslide damage was noted.

Figure 2.8 Close to the lateral extent of the landslide debris at the rear of the dwelling, looking southwest.

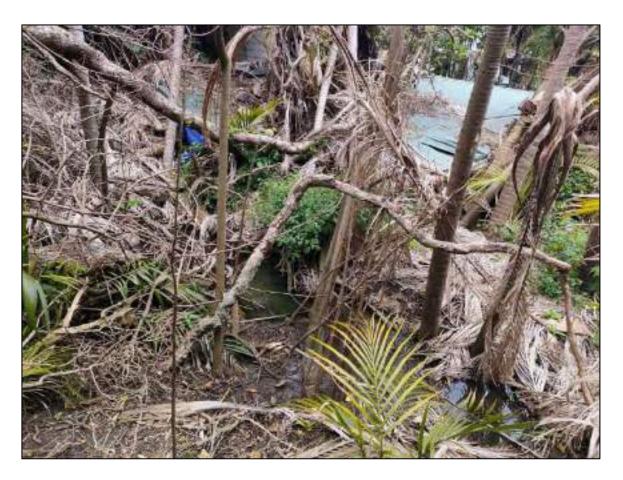
Ponding of water on the body of the landslide (Figure 2.9) as well along its lateral extents has occurred following the event and a video provided by the homeowner indicates that water seepage and secondary silt discharge has entered the ground floor of the dwelling. This likely occurred during subsequent relatively frequent rainfall events as a consequence of poor drainage conditions. Figure 2.10 shows landslide debris did not flow around the sides or front of the house.

Figure 2.9 Ponding of water on top of the landslide debris at the rear of the dwelling, looking west.

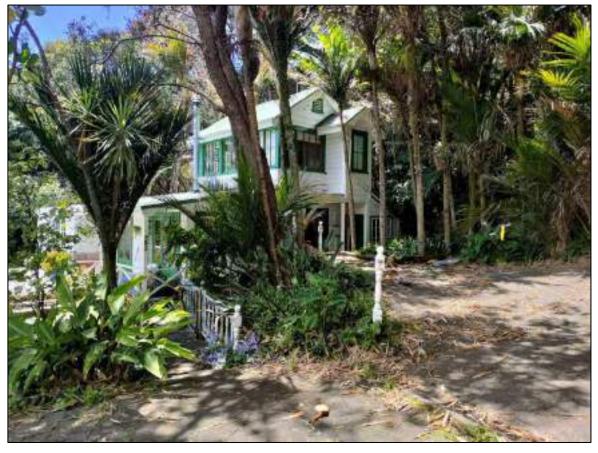
Figure 2.10 Relatively flat area in front of the dwelling, looking east.

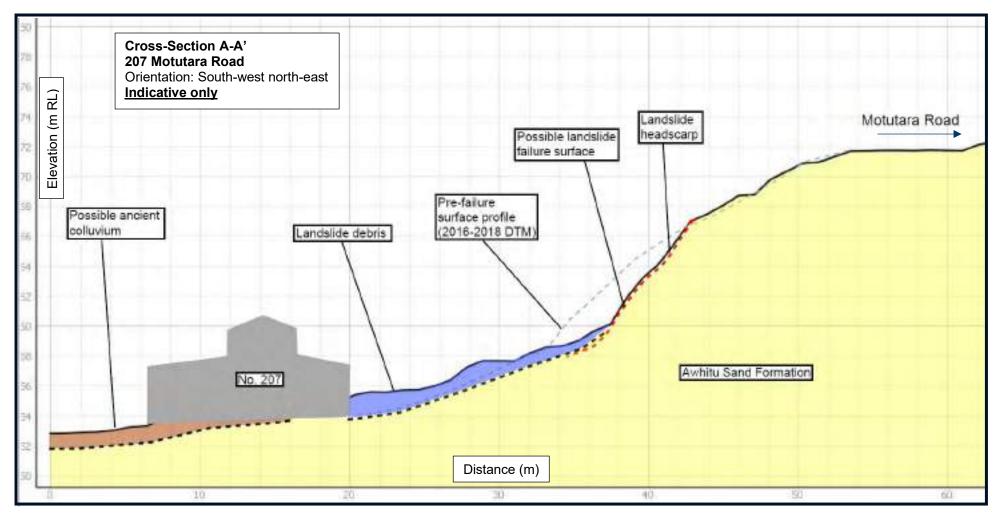
Figure 2.11 Indicative interpreted geological cross section through the site at 207 Motutara Road.

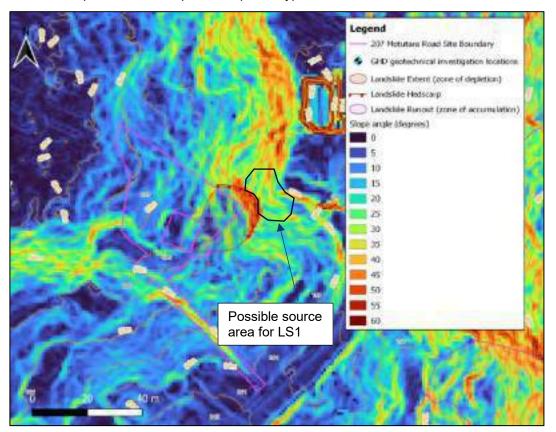
Figure 3.1 Slope map of 207 Motutara Road and surrounding area. Slope angles based on 2023 DTM data.

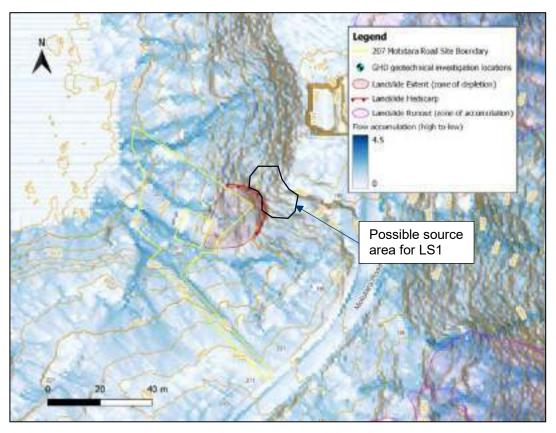
Figure 3.2 Flow accumulation map of 207 Motutara Road and surrounding area. Indicates preferential flow path for surface water. Modelling based on 2023 DTM data.

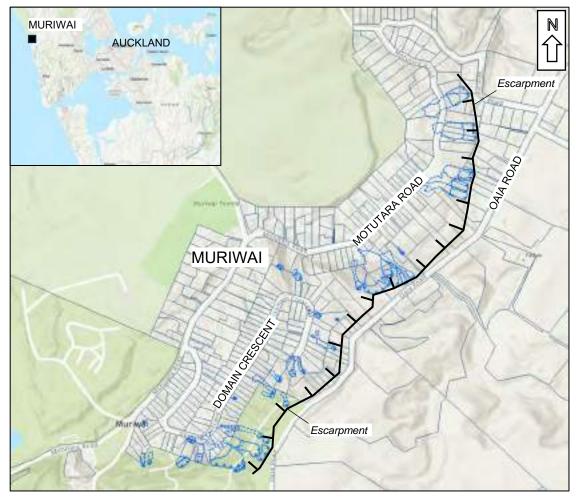
Figure F1 Muriwai location showing the February 2023 landslides mapped by GHD (blued lines)
