Report Title	Geotechnical Investigation - 28, 30, and 66 Crestview Rise, Papakura					
Project No. 13230.001.004		Doc ID	07			
Client Client Co		Client Contact	Fred Lin			
Distribution (PDF)	Russell Baikie					
Date	Revision Details / Status	Author	Reviewer	WP		
19/12/2023	Issued to Client	BF	PF	DF		
19/09/2024	Revised for revised plan sets	BF	PF	JT		
		BF	PF	НО

The purpose of this report is to determine ground conditions within the site and assess geohazards that may affect the site's suitability for the proposed subdivision. We understand that this report will also be used to support applications for resource consent for the conversion of three rural lots to 32 medium to high density residential lots that will support 63 residential dwellings.

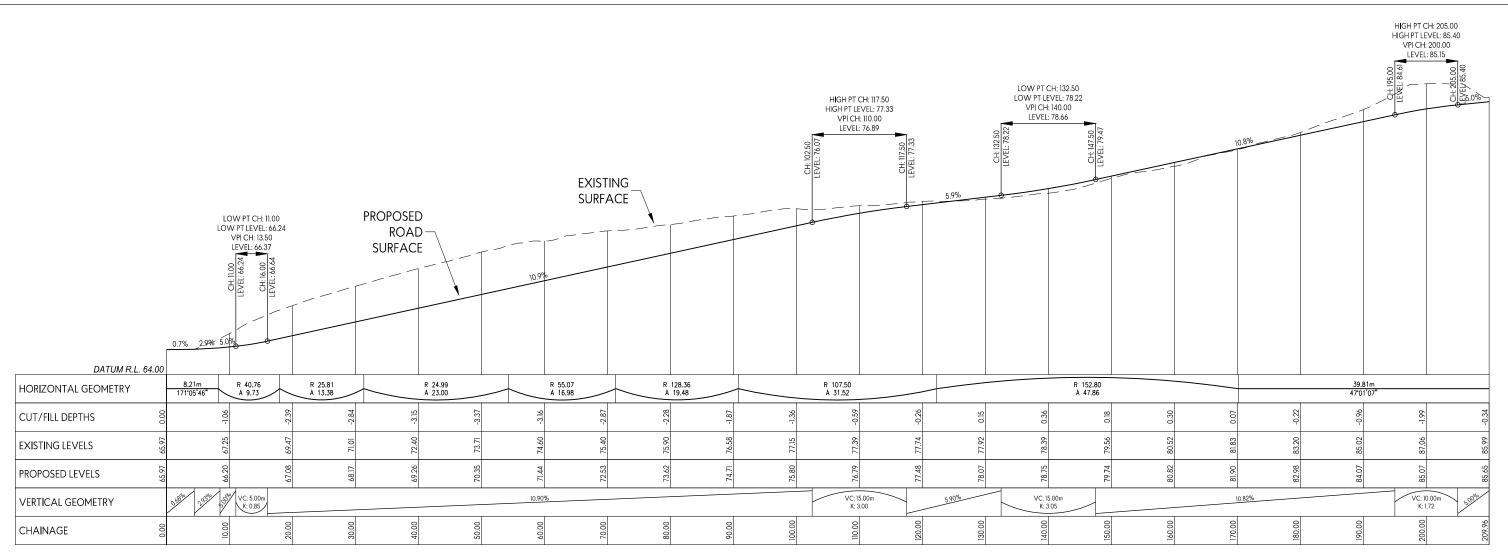
LONGSECTION BETWEEN 0.00 AND 209.96

LONG SECTION - ROAD 1 SCALE: 1:300-A1, 1:600-A3 (Horizontal) 1:150-A1, 1:300-A3 (Vertical)

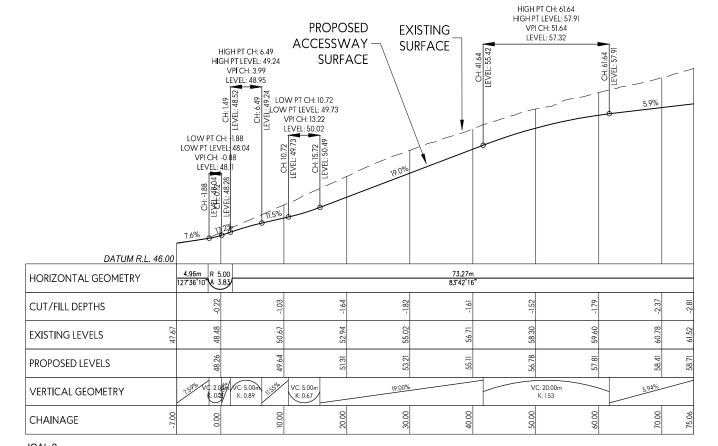
LONGSECTION BETWEEN -7.00 AND 75.06

SCALE: 1:300-A1, 1:600-A3 (Horizontal) 1:150-A1, 1:300-A3 (Vertical)

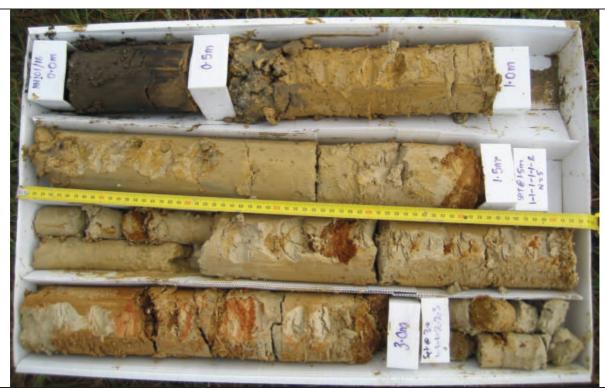
Borehole ID: MH101/16 **Depth:** 0.0 m to 3.45 m

Client:	RDL Limited	Project no:		GENZAUCK11786AB					
Project:	162 166 Sattlement Boad Banakura	Figure no:							
coffey ?	162 – 166 Settlement Road, Papakura	Compiled:	JJ	Date:	02/03/16				
Title:	MH101/16 CORE	ВОХ РНОТО	RAPI	HS	•

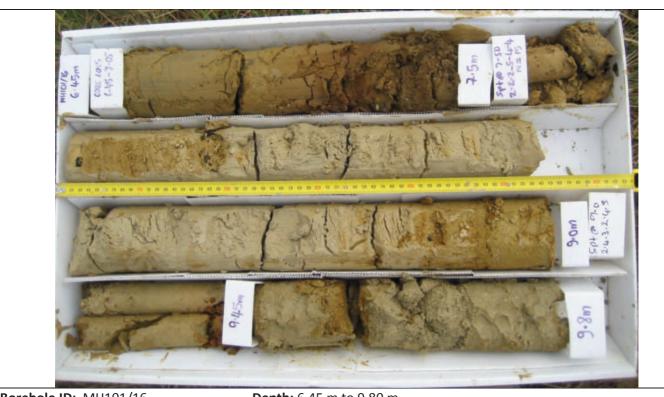
Borehole ID: MH101/16 **Depth:** 6.45 m to 9.80 m

Client:	RDL Limited	Project no:		GENZAUCK11786AB					
Project:	162 166 Sattlement Boad Banakura	Figure no:							
coffey ?	162 – 166 Settlement Road, Papakura	Compiled:	JJ	Date:	02/03/16				
Title:	MH101/16 CORE	ВОХ РНОТО	RAPI	HS	•

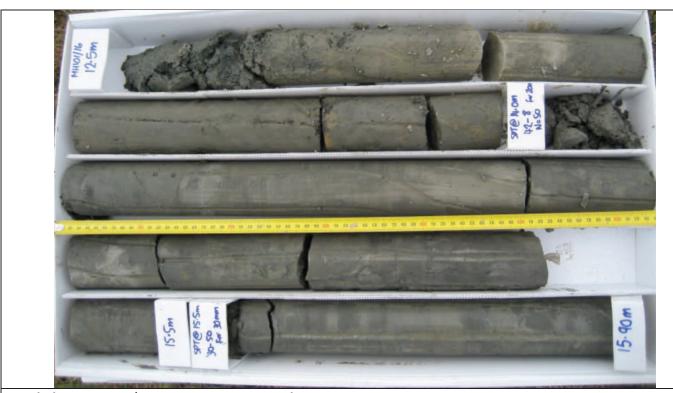
Borehole ID: MH101/16 **Depth:** 12.50 m to 15.90 m

Client:	RDL Limited	Project no:		GENZAUCK1	1786AB
Project:	162 – 166 Settlement Road, Papakura	Figure no:			
coffey ?	102 – 100 Settlement Roau, Papakura	Compiled:	JJ	Date:	02/03/16
Title:	MH101/16 CORE	вох рнотос	RAPI	HS	•

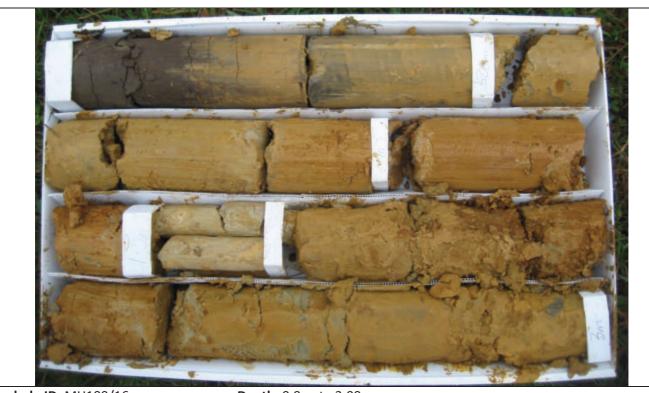
Client:	RDL Limited	Project no:		GENZAUCK1	1786AB
Project:	162 – 166 Settlement Road, Papakura	Figure no:			
coffey ?	102 – 100 Settlement Roau, Papakura	Compiled:	JJ	Date:	01/03/16
Title:	MH100/16 CORE	вох рнотос	RAPI	HS

Borehole ID: MH100/16 **Depth:** 0.0 m to 3.00 m

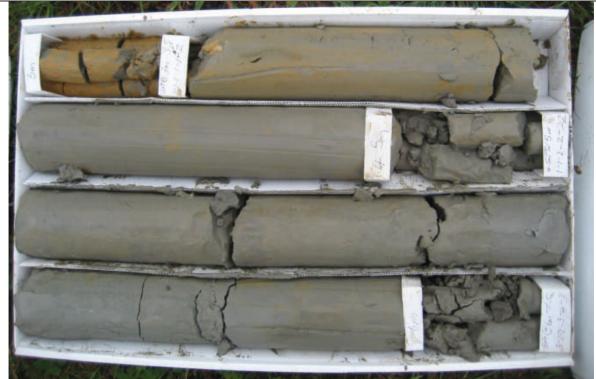
Borehole ID: MH100/16 **Depth:** 3.00 m to 6.45 m

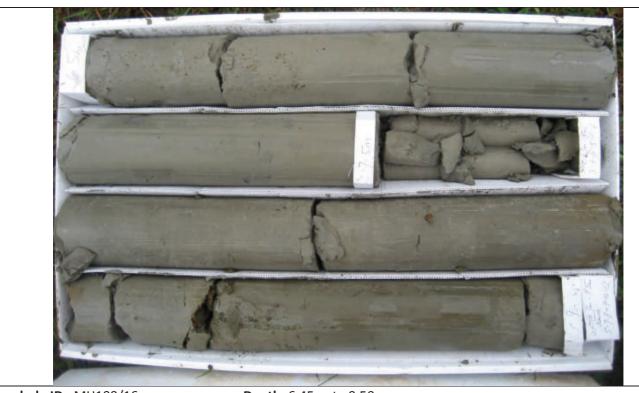
Client:	RDL Limited	Project no:		GENZAUCK1	1786AB
Project:	162 – 166 Settlement Road, Papakura	Figure no:			
coffey ?	102 – 100 Settlement Roau, Papakura	Compiled:	JJ	Date:	01/03/16
Title:	MH100/16 CORE	вох рнотос	RAPI	HS	•

Borehole ID: MH100/16 **Depth:** 6.45 m to 9.50 m

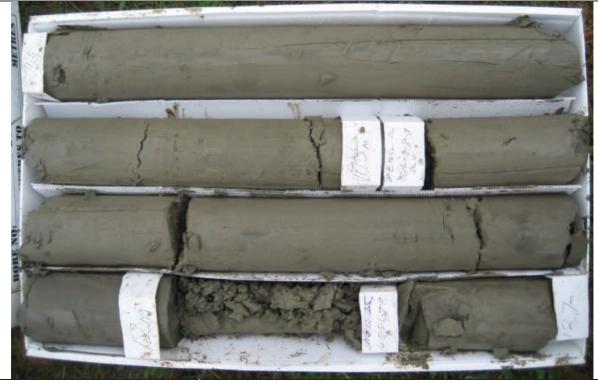
Borehole ID: MH100/16 **Depth:** 9.50 m to 12.70 m

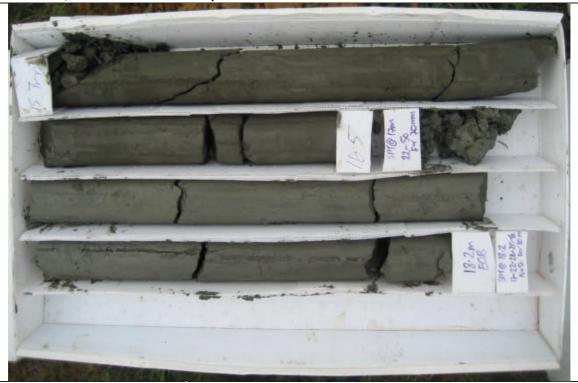
Borehole ID: MH100/16 **Depth:** 15.70 m to 18.20 m

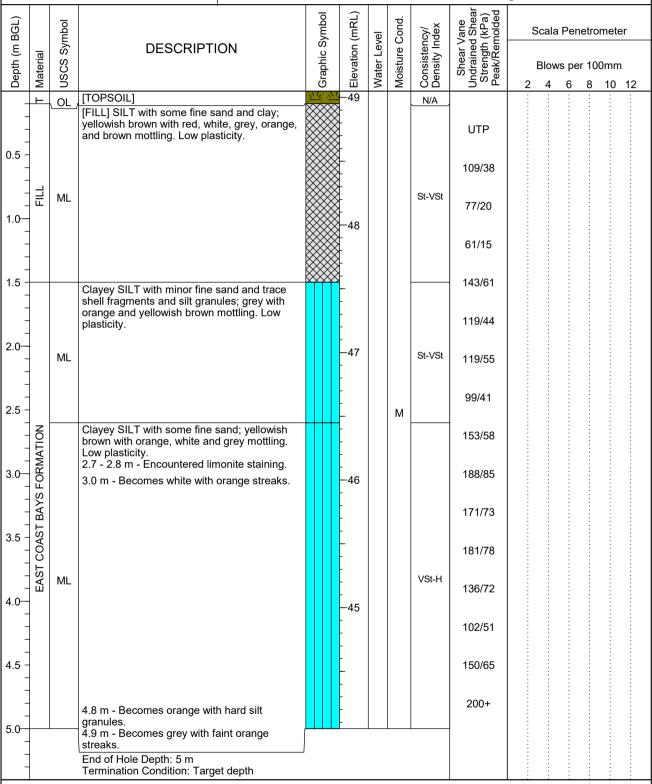
Hole Depth
 : 5 m
 Latitude
 : -37.062539

Hole Diameter
 : 50 mm
 Longitude
 : 174.9730977

Hand Auger met target depth at 5 m. Standing groundwater was not encountered. T = Topsoil, N/A = Not Assessed. Coordinates obtained from handheld GPS.

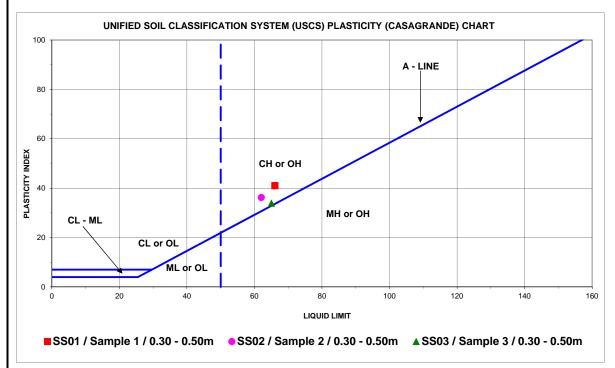
SUMMARY OF TESTING								
Borehole Number	Sample Number	Depth (m)	Liquid Limit	Plastic Limit	Plasticity Index	Soil Classification Based on USCS Chart Below		
SS01	Sample 1	0.30 - 0.50	66	25	41	СН		
SS02	Sample 2	0.30 - 0.50	62	26	36	СН		
SS03	Sample 3	0.30 - 0.50	65	31	34	CH / MH

The chart below & soil classification terminology is taken from ASTM D2487-17^{e1} "Standard Practice for Classification of Soils for Engineering Purposes (Unified Soil Classification System)", April 2020, & is based on the classification scheme developed by A. Casagrande in the 1940's (Casagrande, A., 1948: Classification and identification of soil. Transactions of the American Society of Civil Engineers, v. 113, p. 901-930). The chart below & the soil classification given in the table above are included for your information only, and are not included in the IANZ endorsement for this report.

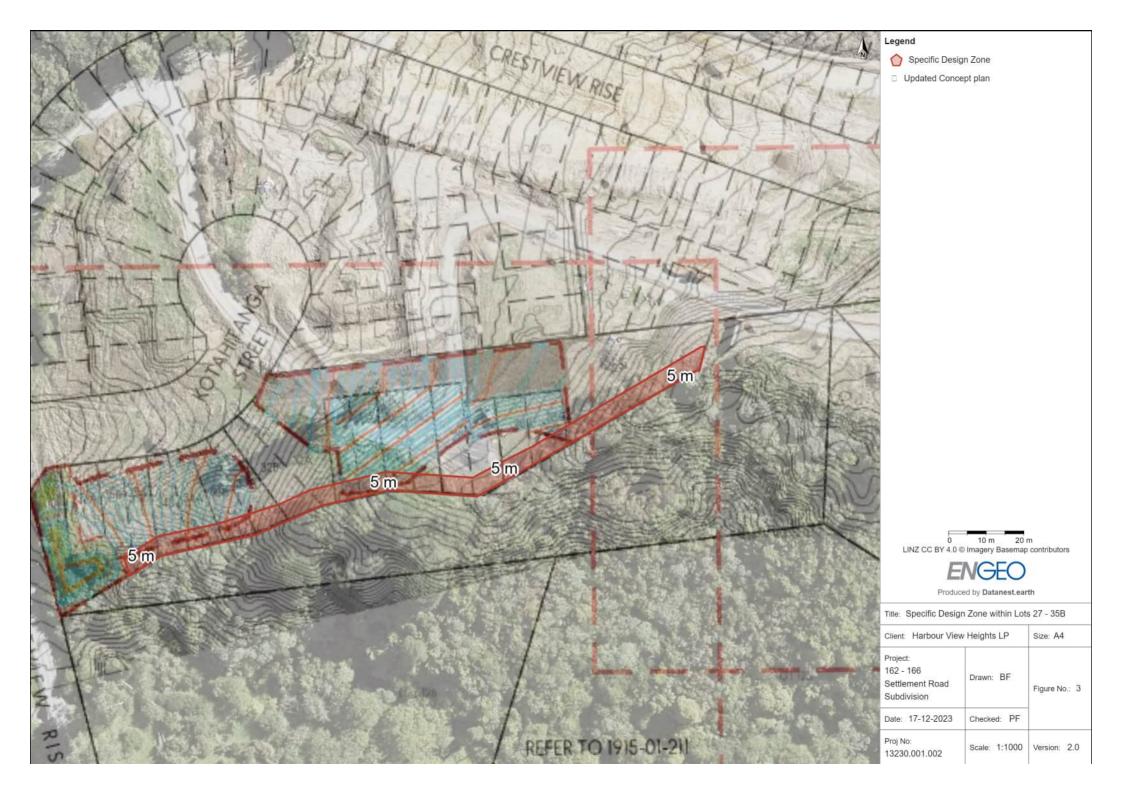
APPENDIX 10:

Specific Design Zone

Appendix 10: Specific Design Zone
